**INSPECTION OF STRYKER TRANSMISSIONS
EVALUATED USING SCPL IN A 20K MILE RAM-D
TEST**

**INTERIM REPORT
TFLRF No. 457**

**U.S. Army TARDEC Fuels and Lubricants Research Facility
Southwest Research Institute[®] (SwRI[®])
San Antonio, TX**

July 2014

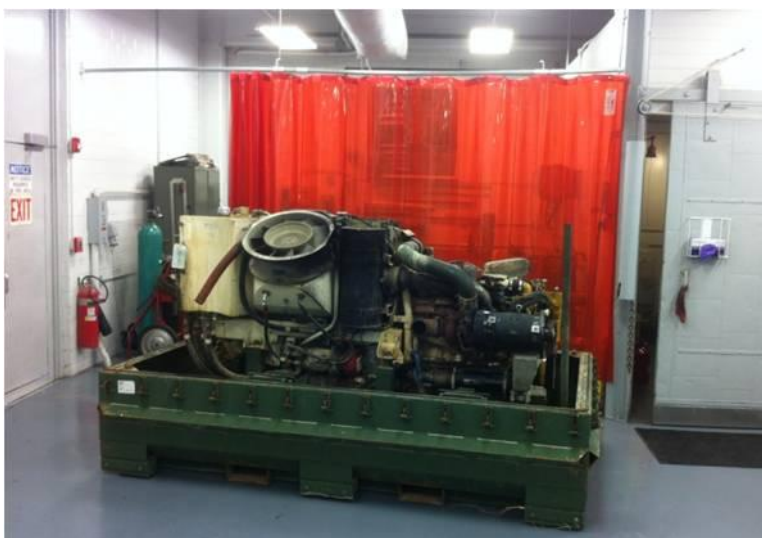
Figure 1. Stryker MEV-013 Powerpack 1

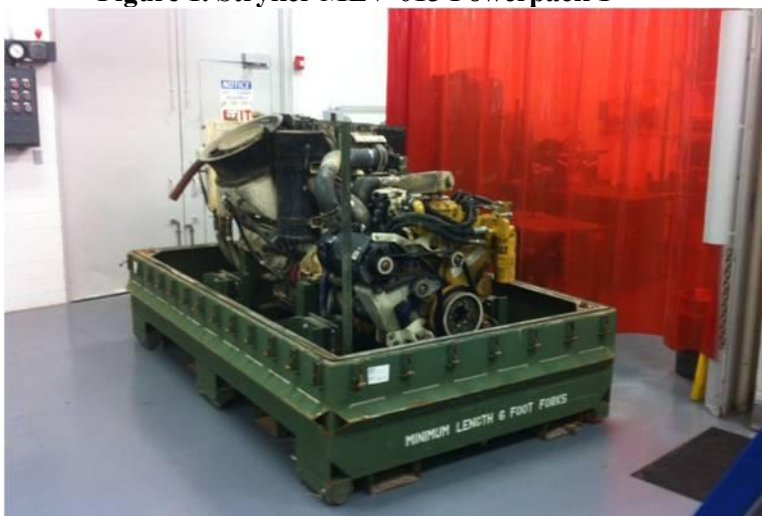
Figure 2. Stryker MEV-013 Powerpack 2

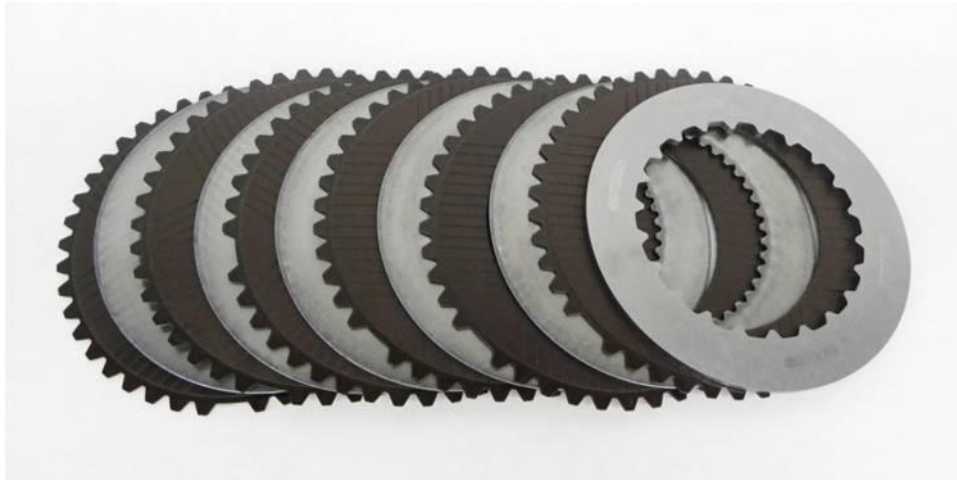
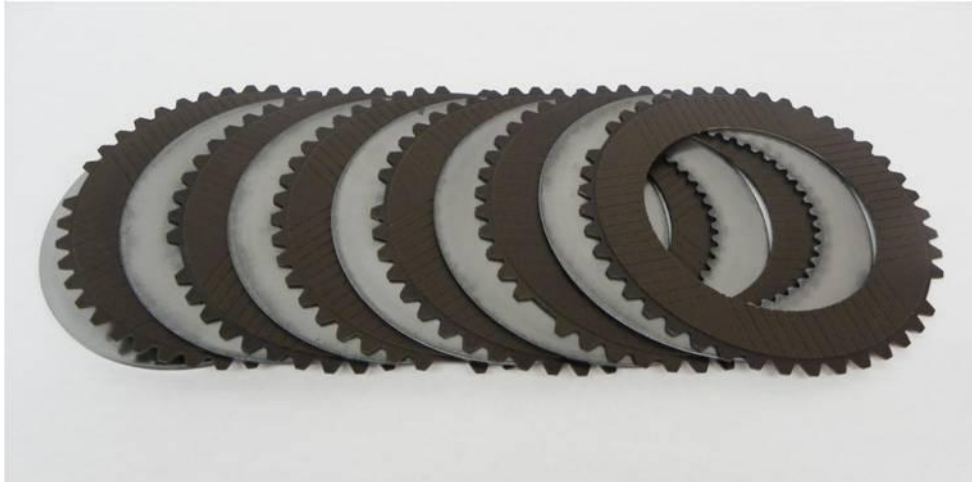
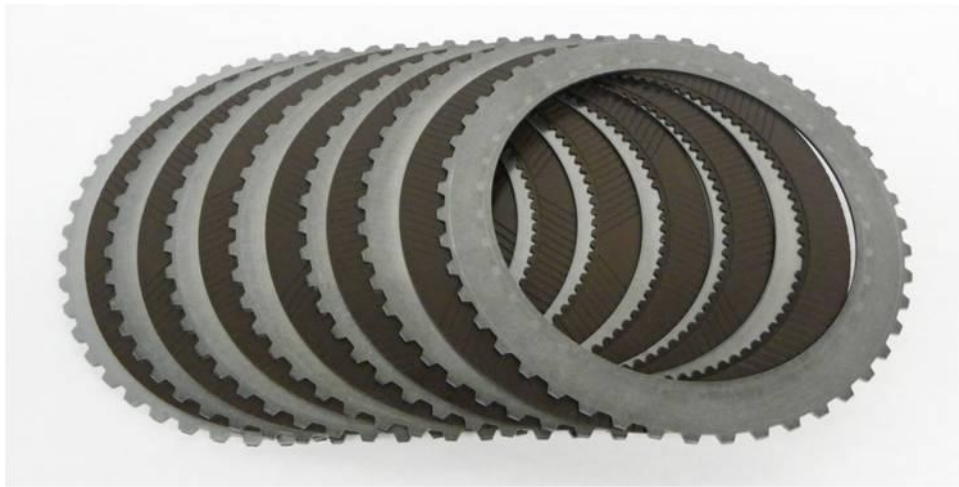
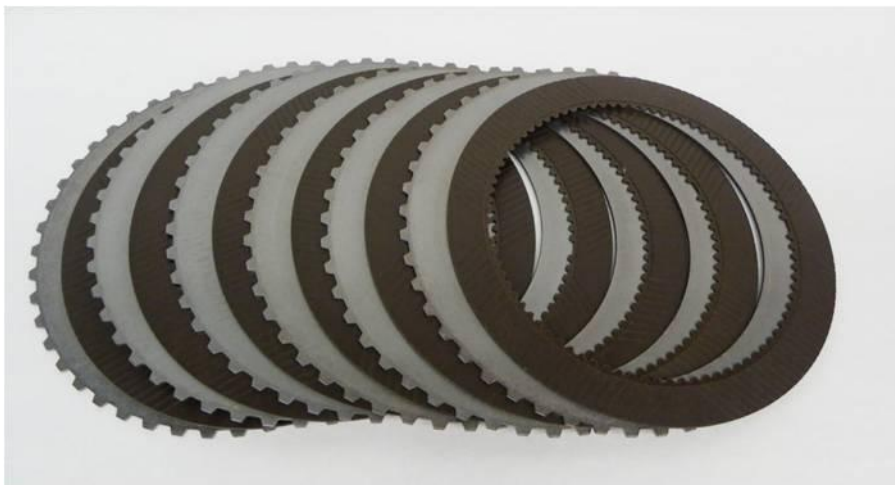
The C1 and C2 clutch assemblies for the TEST and CONTROL transmissions showed nearly identical condition upon removal. No discoloration or glazing was noted on the friction disks, and the reaction plates showed no unusual wear or signs of heat from excessive slipping. Figure 3 through Figure 6 show an overview photo of each C1 and C2 clutch assembly for the TEST and CONTROL units.

Figure 3. CONTROL Transmission C1 Clutch Assembly

Figure 4. TEST Transmission C1 Clutch Assembly

Figure 5. CONTROL Transmission C2 Clutch Assembly

Figure 6. TEST Transmission C2 Clutch Assembly

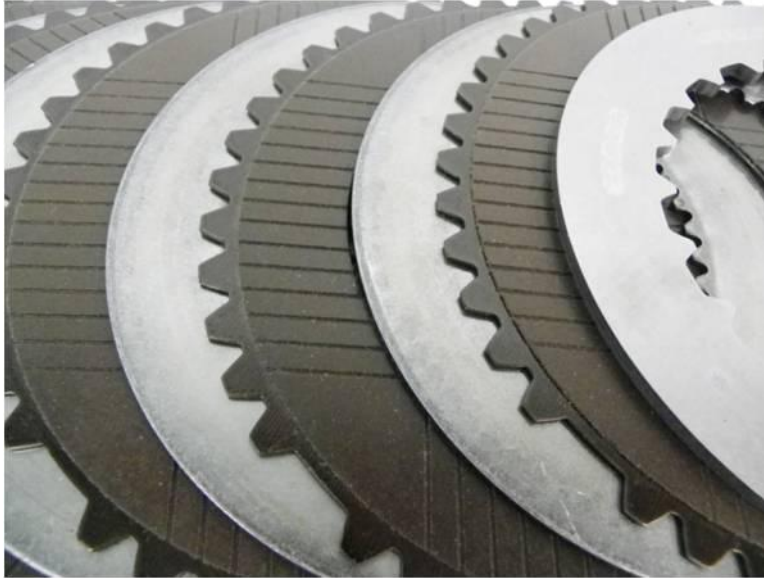
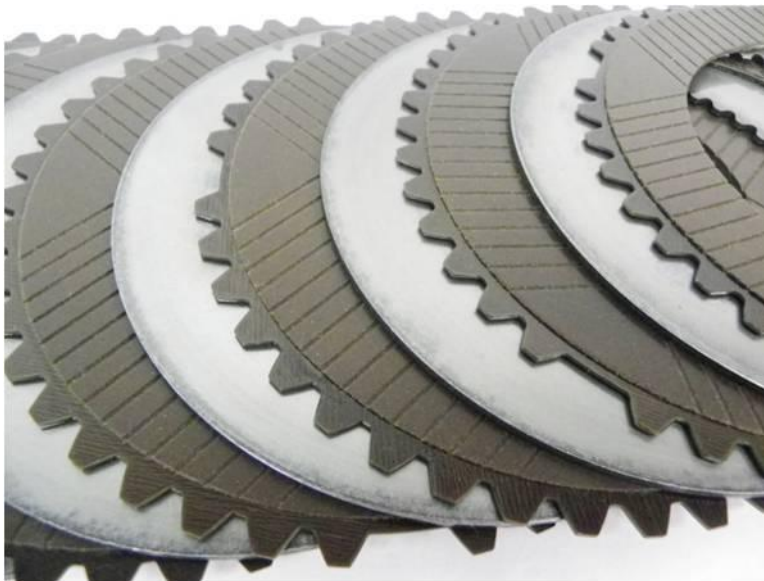
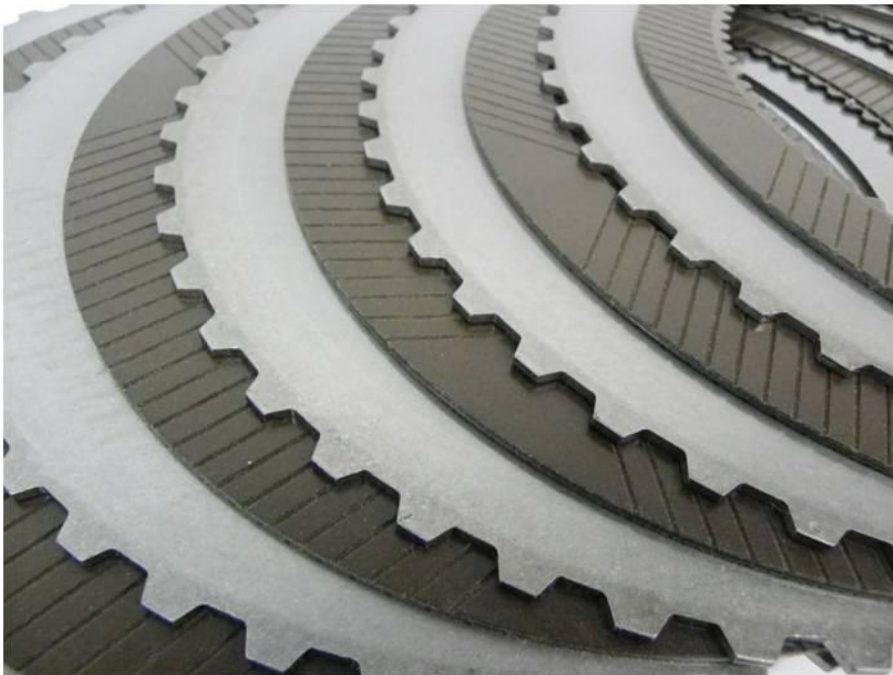
Figure 7 through Figure 10 show close up photos of the C1 and C2 clutch composition surfaces for both the TEST and CONTROL. As shown, both assemblies were found to be in excellent condition, without evidence of excessive heat, wear, or distress of the friction or steel reaction plate surfaces.

Figure 7. CONTROL Transmission C1 Clutch Assembly (Close-up)

Figure 8. TEST Transmission C1 Clutch Assembly (Close-up)

Figure 9. CONTROL Transmission C2 Clutch Assembly (Close-up)

Figure 10. TEST Transmission C2 Clutch Assembly (Close-up)

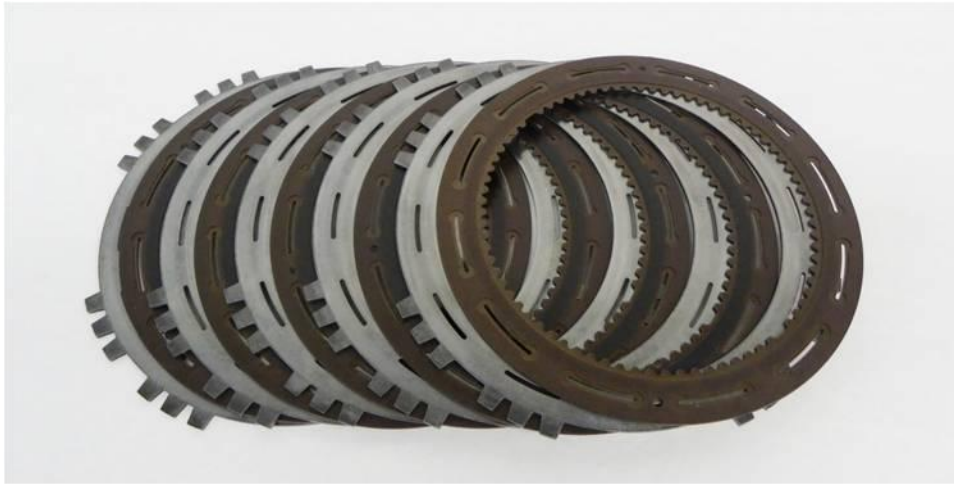
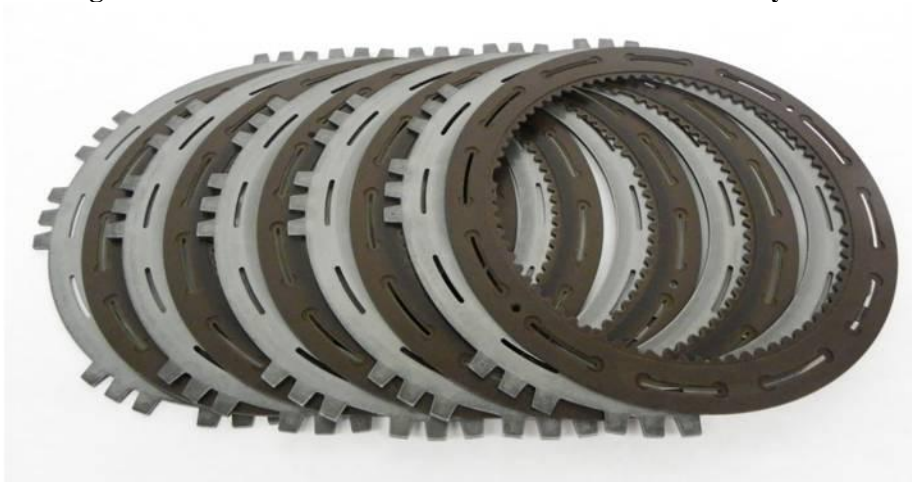
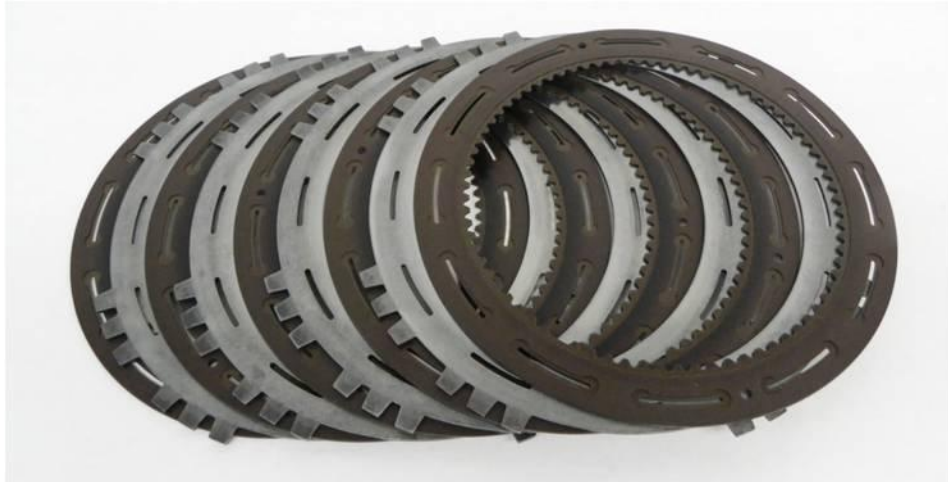
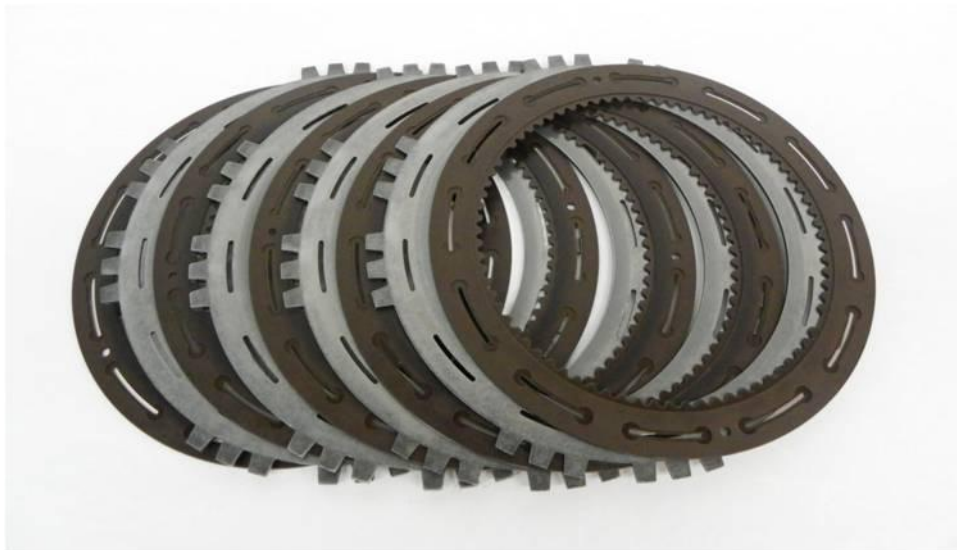
As previously mentioned, the C3 and C4 clutch assemblies for both transmissions did show some discoloration of the friction material. This was found to be relatively minor, and only occurred

on approximately 35-40% of the inner disk diameter on each clutch assembly. As would be expected, the steel reaction plates also showed some light grey discoloration from the additional heat, but results were functionally identical between both the TEST and CONTROL transmissions, suggesting that the SCPL demonstrated comparable performance to the commercial ATF. Figure 11 through Figure 14 show the C3 and C4 clutch assemblies for the TEST and CONTROL transmissions respectively.

Figure 11. CONTROL Transmission C3 Clutch Assembly

Figure 12. TEST Transmission C3 Clutch Assembly

Figure 13. CONTROL Transmission C4 Clutch Assembly

Figure 14. TEST Transmission C4 Clutch Assembly

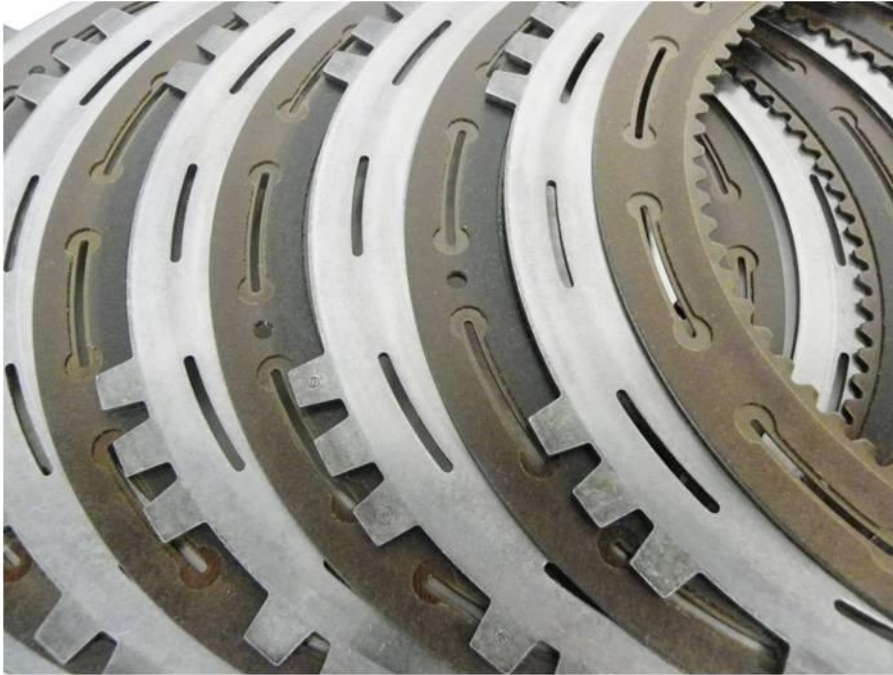
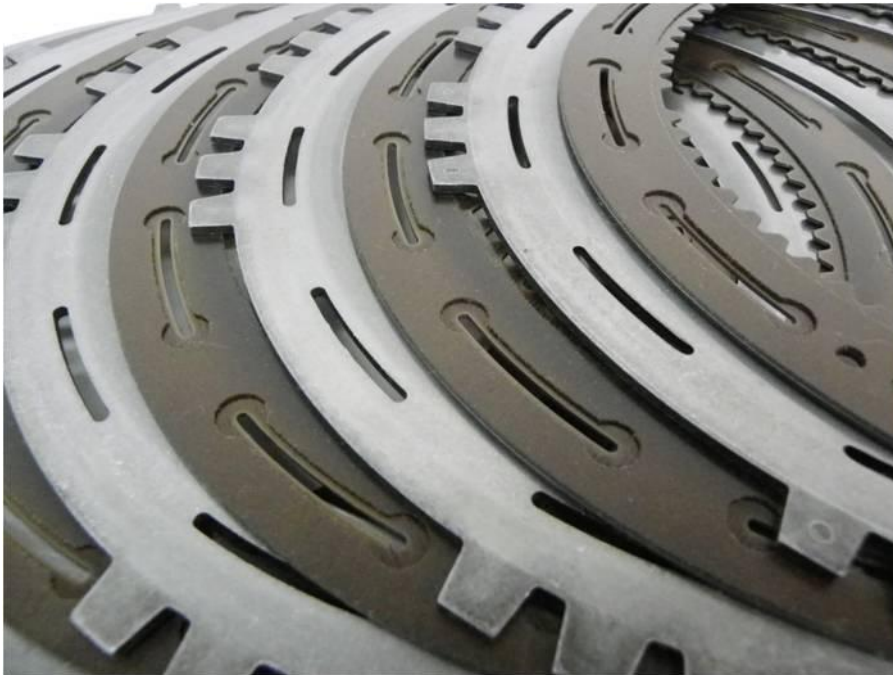
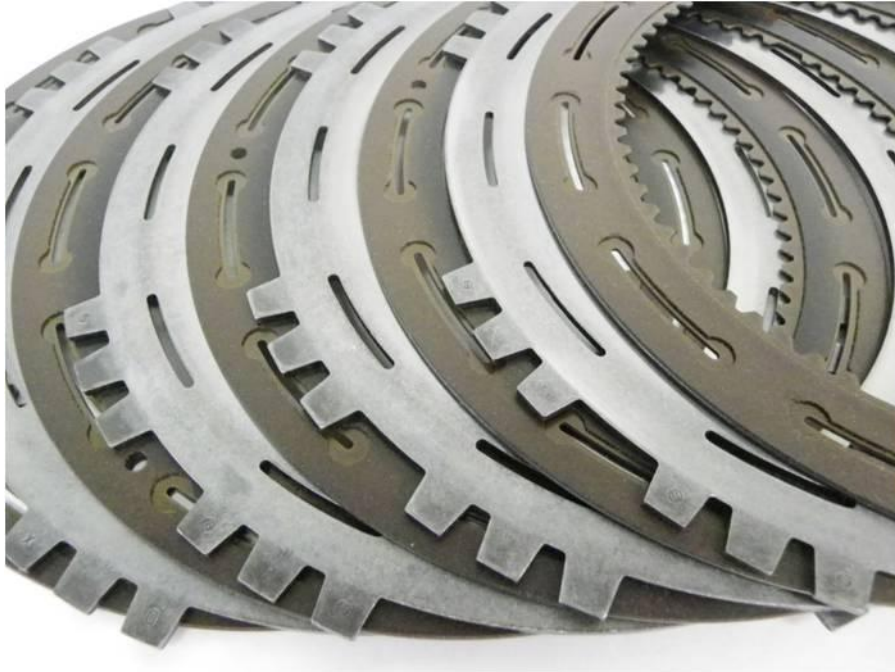
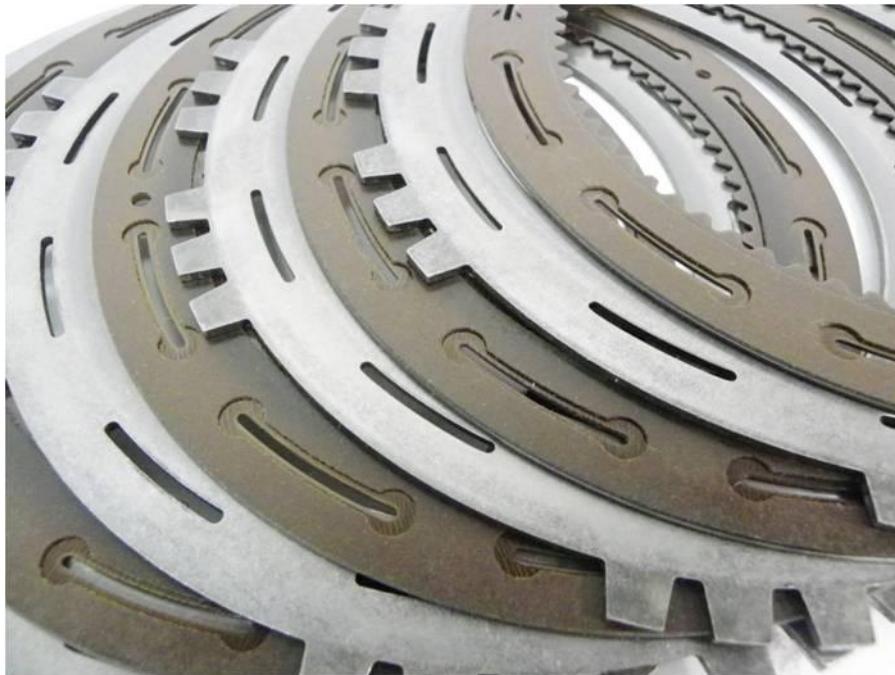
Figure 15 through Figure 18 (next 2 pages) show close up photos of the C3 and C4 clutch disks composition and reaction plates for both transmissions. This close-up shot better shows the discoloration present on the composition disks, but also conveys its overall minor nature.

Figure 15. CONTROL Transmission C3 Clutch Assembly (Close-up)

Figure 16. TEST Transmission C3 Clutch Assembly (Close-up)

Figure 17. CONTROL Transmission C4 Clutch Assembly (Close-up)

Figure 18. TEST Transmission C4 Clutch Assembly (Close-up)

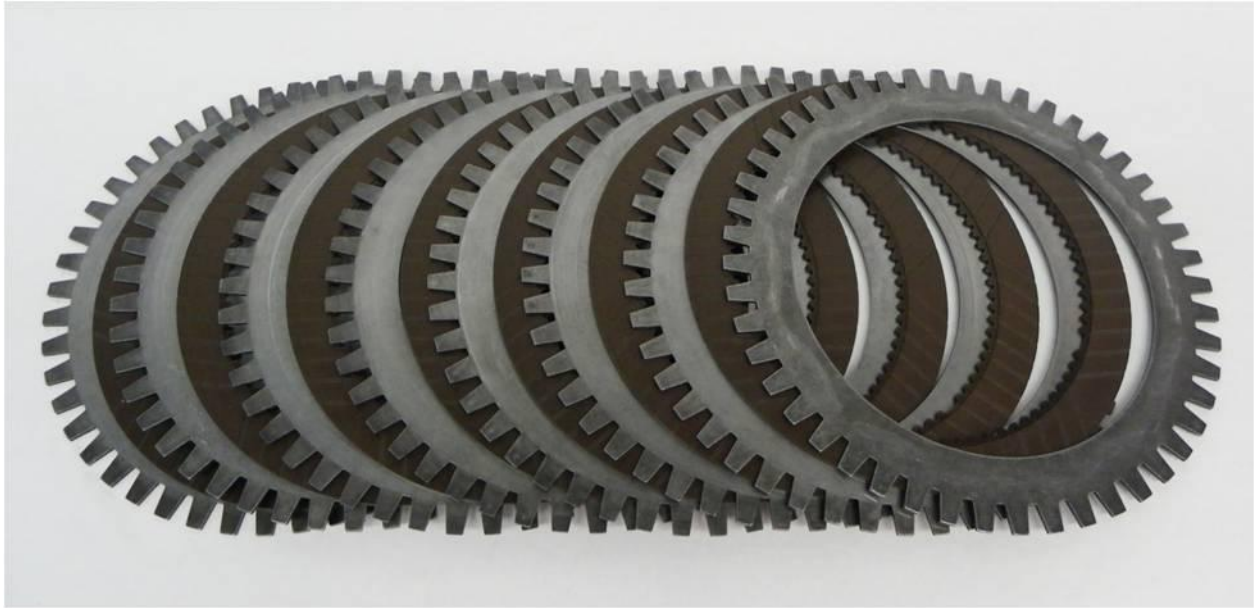
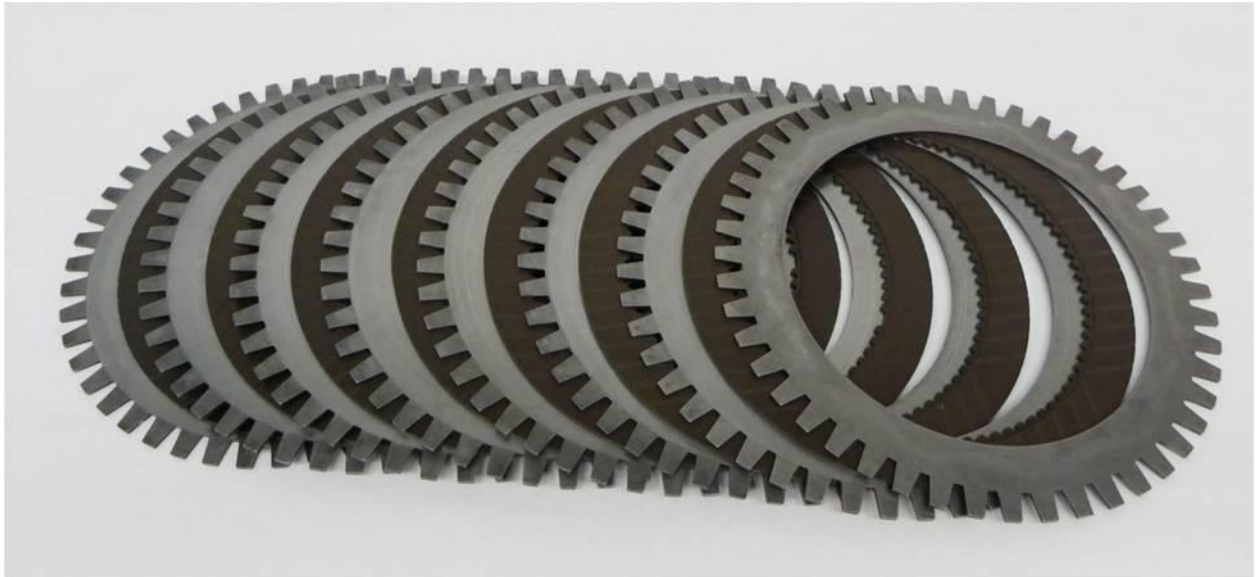
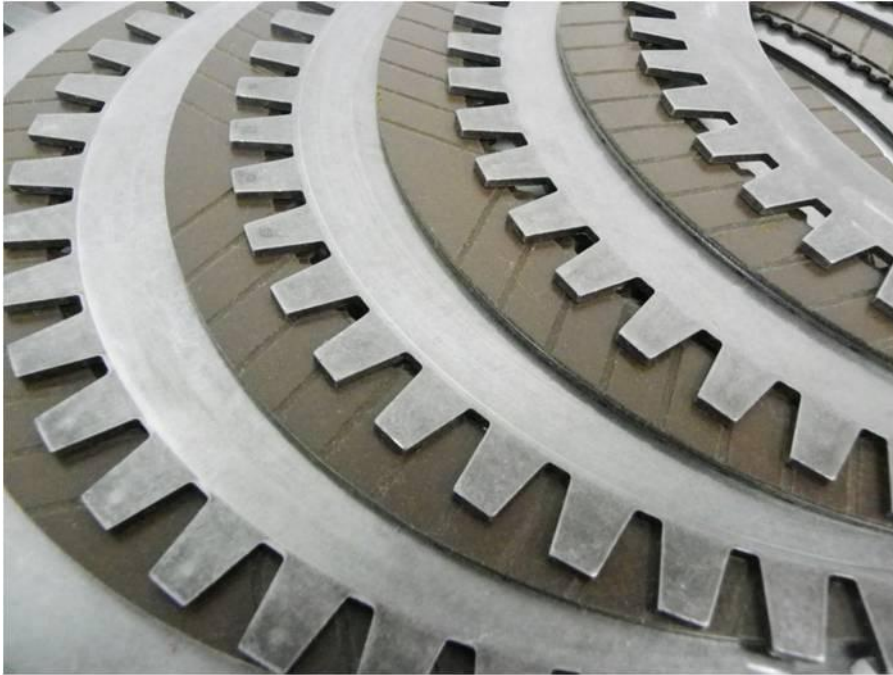
Figure 19 and Figure 20 show the C5 clutch assemblies. Like the C1 and C2 clutches, overall condition was found to be good, and both the TEST and CONTROL yielded similar component conditions. Figure 21 and Figure 22 (next page) show the close-up shots of the composition and reaction plates for the C5 assembly.

Figure 19. CONTROL Transmission C5 Clutch Assembly

Figure 20. TEST Transmission C5 Clutch Assembly

Figure 21. CONTROL Transmission C5 Clutch Assembly (Close-up)

Figure 22. TEST Transmission C5 Clutch Assembly (Close-up)

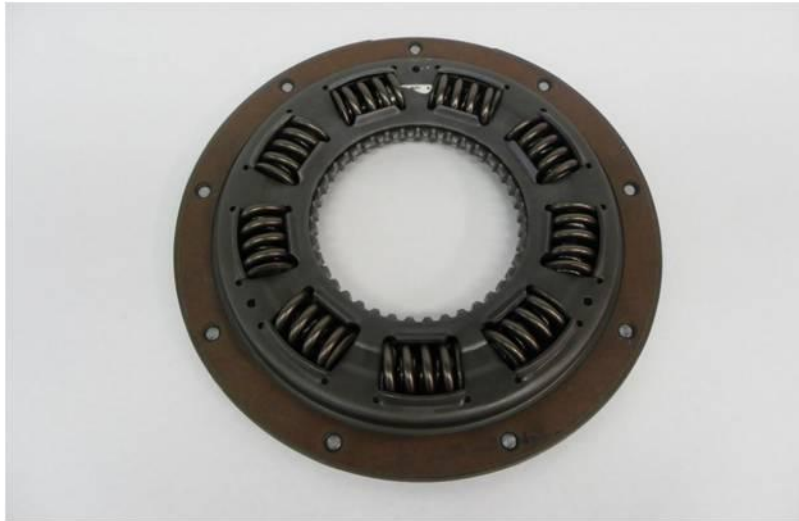
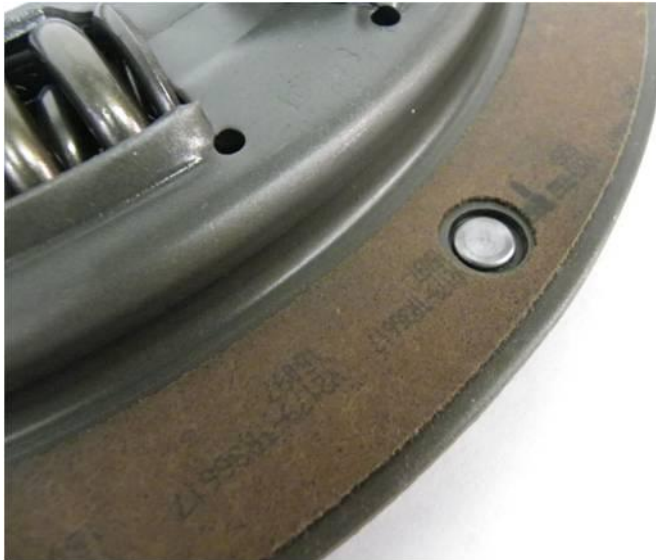
For the lockup clutch, neither of the assemblies showed excessive wear or signs of glazing consistent with results seen in all other clutch assemblies. Figure 23 and Figure 24 show the CONTROL transmission lockup clutch. As previously mentioned, factory markings can still be seen on the composition surface indicating little wear occurred to the composition material.

Figure 23. CONTROL Torque Converter Lockup Clutch

Figure 24. CONTROL Torque Converter Lockup Clutch (Close-up)

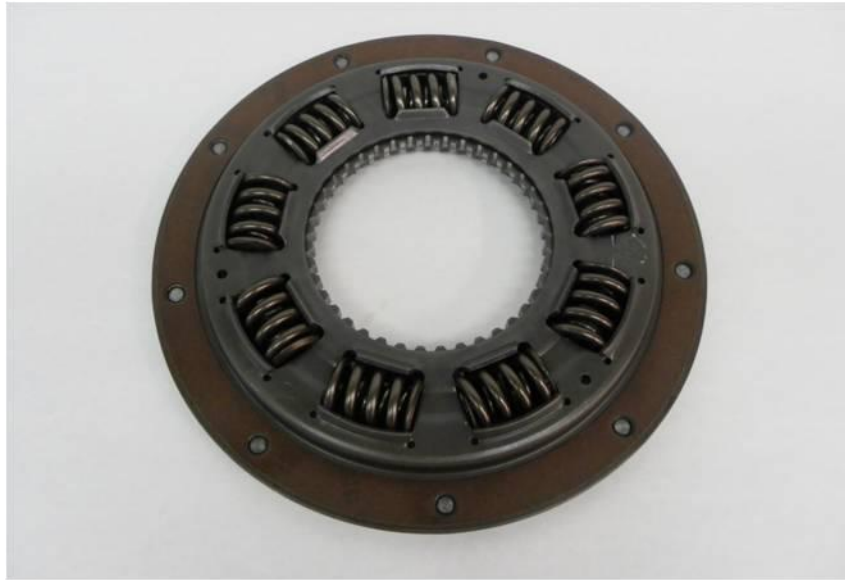
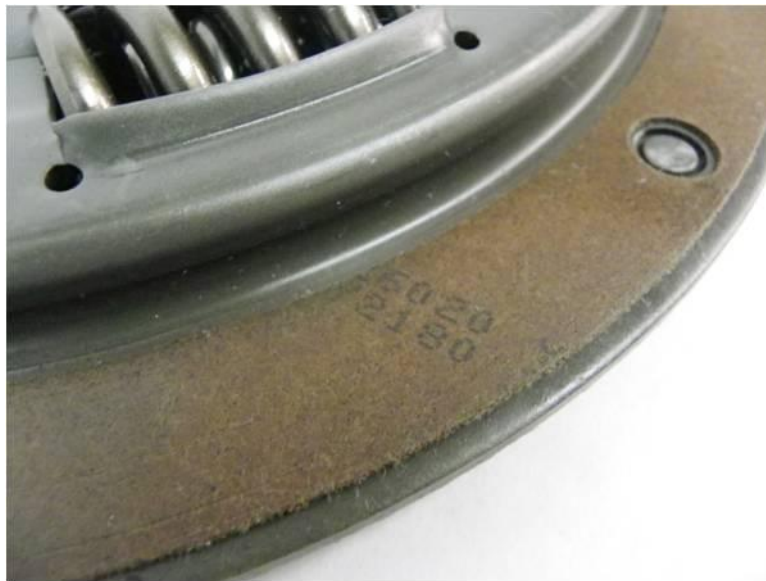
Figure 25 and Figure 26 show the lockup clutch photos for the TEST transmission. Like the CONTROL unit, factory markings can still be seen on its composition surface as well.

Figure 25. TEST Torque Converter Lockup Clutch

Figure 26. TEST Torque Converter Lockup Clutch (Close-up)

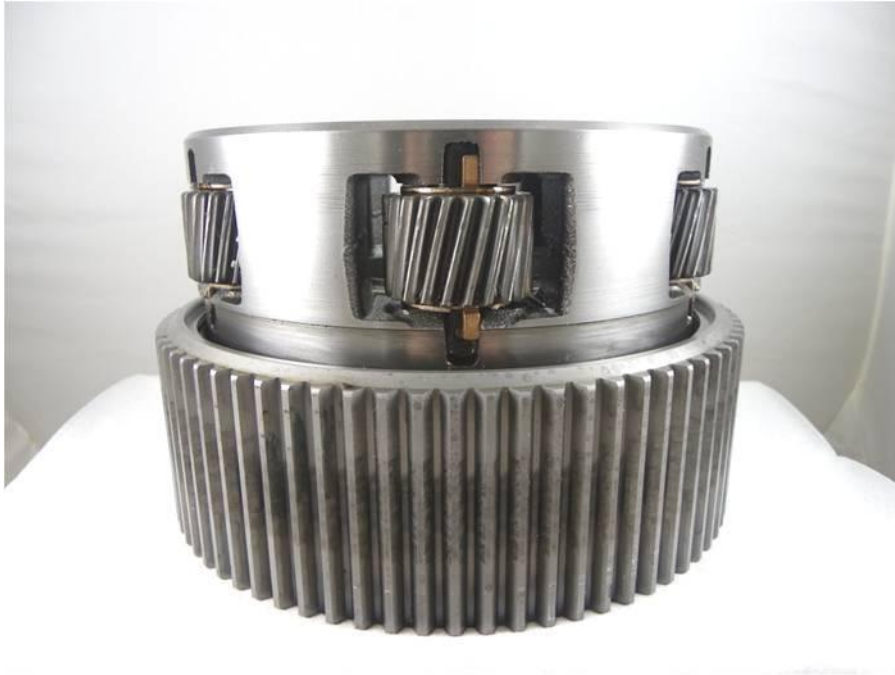
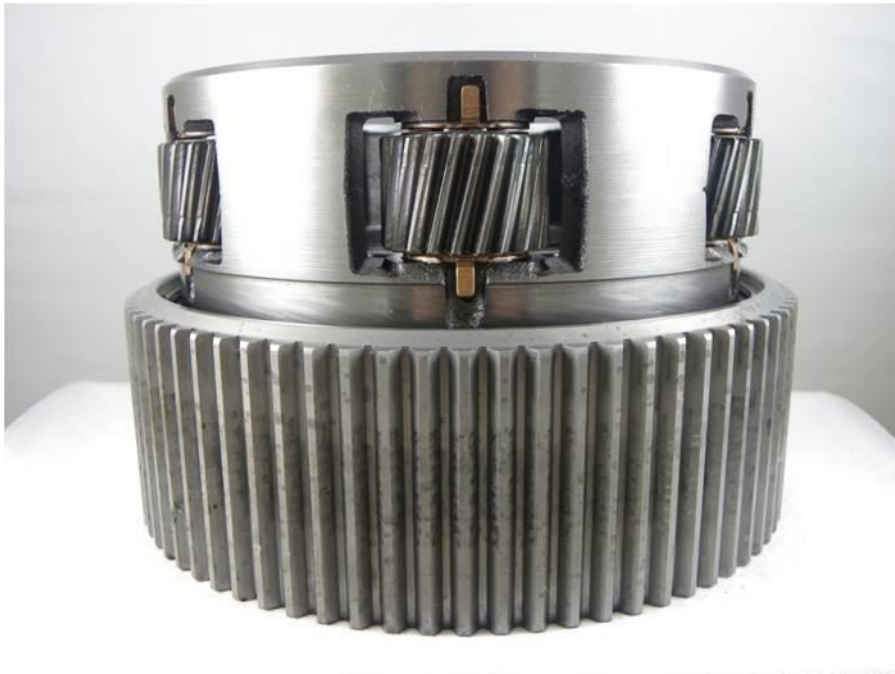
Consistent with all previous observations, inspection of the planetary gear sets also showed little discrimination between the two evaluated lubricants. All preliminary SCPL candidates had previously undergone standardized FZG gear wear testing during early lubricant development phases yielding positive results, so there was little expectation that the SCPL would show any unusual compatibility with the transmission gear sets themselves. Figure 27 and Figure 28 (next page) shows the P1 planetary module removed from the CONTROL and TEST transmissions, and confirm the SCPL provided adequate protection. As reporting in the ratings, both modules were noted to have normal polishing on the contact surfaces of the planetary gear teeth, but both were found void of any abnormal wear that would suggest lubrication issues. Likewise the outer ring gear of the P1 module which engages the internal splines of the C3 clutch assembly showed no abnormal wear, with only normal contact markings visible on the gear faces from engagement with the internal clutch disk teeth. These same general observations proved true for the P2 and P3 modules as well. All results suggest that the SCPL successfully provided adequate protection of the internal gear sets, and provided performance levels comparable to the specifically tailored commercial ATF. (Note - As a result of their unremarkable nature, photographs of the P2 and P3 modules were not included in reporting).

Figure 27. CONTROL P1 Planetary Gear Module

Figure 28. TEST P1 Planetary Gear Module

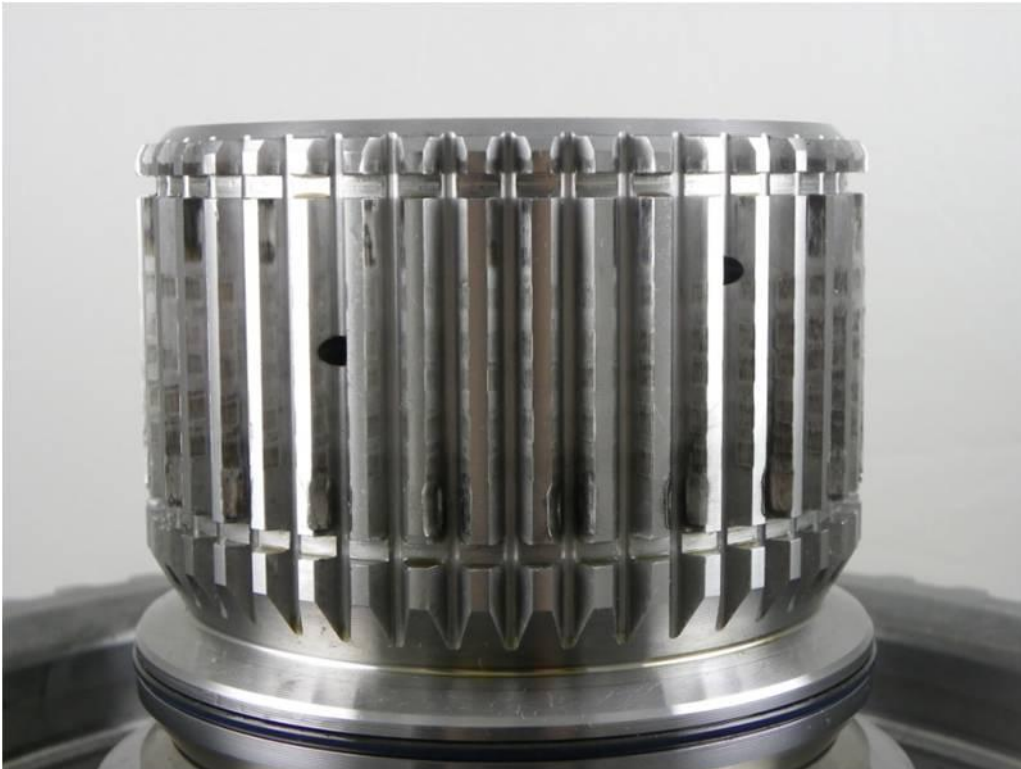
As previously mentioned, the main area that did stand out during inspection were signs that the TEST transmission had undergone some sort of previous service or rebuild. The primary support of this was wear noted on the splined shaft of the rotary clutch drum assembly. During its inspection, heavy contact wear was noted on every other spline on the shaft in the area where the balance piston rides and engages. This can be seen below in Figure 29, and again in a close up photo in Figure 30.

Figure 29. TEST Transmission Balance Shaft Spine Wear

Figure 30. TEST Transmission Balance Shaft Spline Wear (Close-up)

As shown, the wear was found present on every other spline tooth on the shaft, and is consistent with the skip tooth engagement of the balance piston that rides on the shaft and engages the splines (Figure 31).

This unusual wear discrepancy serves as the single biggest indicator that the TEST transmission had sometime in its history received major service/rebuild prior to the RAM-D testing. The balance piston, which is comprised of a relatively soft aluminum alloy, would have been expected to show significant corresponding wear to that seen on the harder splines if in fact the spline wear was a result of current testing. As the TEST transmission balance piston teeth appear to be virtually unworn, this indicates that the orientation of the balance piston upon installation was such that the piston teeth were NOT in contact with worn shaft splines, and had instead sometime previously been re-indexed during service to the unworn splines. As stated by the Allison transmission technicians, this is common practice in transmission overhaul, as the skip tooth engagement allows reinstallation of a new piston and reuse of the partially worn shaft by changing the engagement orientation to the unworn teeth. This type of action reduces the cost of an overhaul, as the rest of the balance shaft would still remain in usable condition apart from the localized wear that cannot be avoided. Since the balance piston removed from the RAM-D TEST transmission showed virtually no wear, it can only be surmised that the wear seen on the balance shaft splines was pre-existing. There was no evidence that the wear occurred as a result of SCPL use, and nothing was found to suggest that this issue could have biased the results of testing.

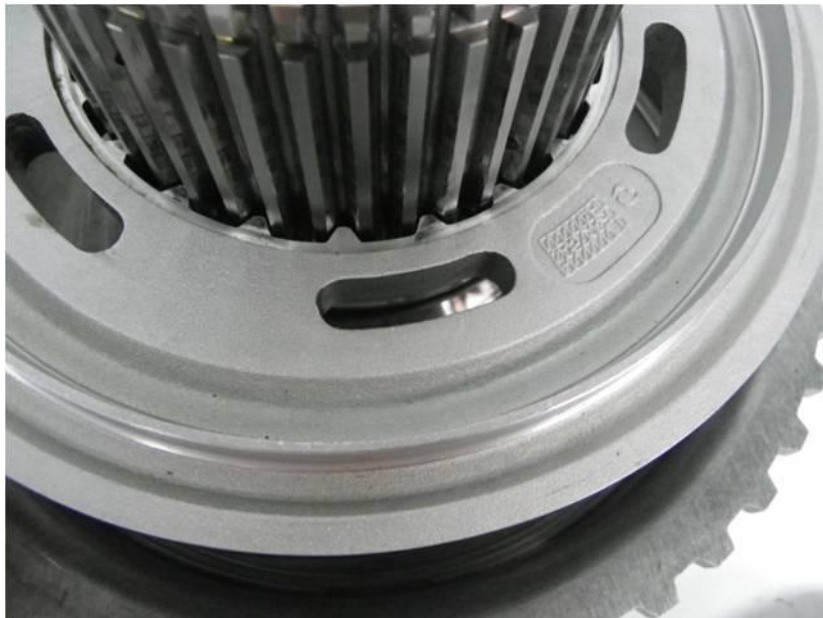
Figure 31. CONTROL Transmission Balance Shaft and Piston Engagement

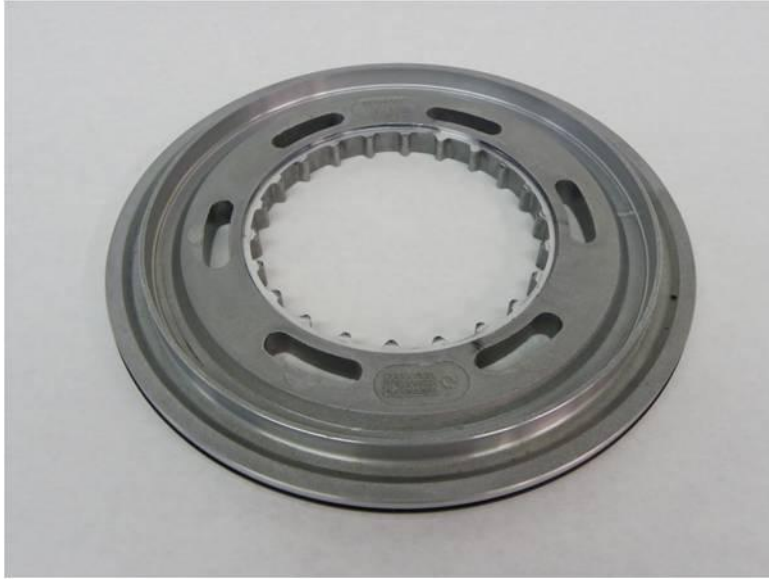
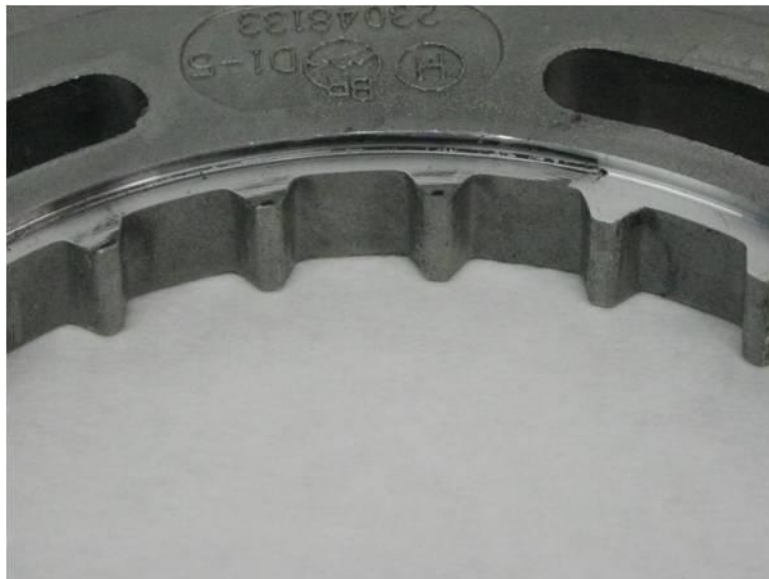
Despite the wear seen on the shaft splines, the engagement teeth of the TEST transmission balance piston (shown in Figure 32 and Figure 33) did not show corresponding damage when inspected. This is inconsistent with what would be expected based on the shaft spline wear.

Figure 32. TEST Transmission Balance Piston

Figure 33. TEST Transmission Balance Piston (Close-up)
