**BRAKE FLUID COMPATIBILITY STUDIES WITH  
ADVANCED BRAKE SYSTEMS**

**INTERIM REPORT  
TFLRF No. 473**

**By  
Douglas M. Yost  
Nigil Jeyashekar  
Edwin A. Frame**

**U.S. Army TARDEC Fuels and Lubricants Research Facility  
Southwest Research Institute<sup>®</sup> (SwRI<sup>®</sup>)  
San Antonio, TX**

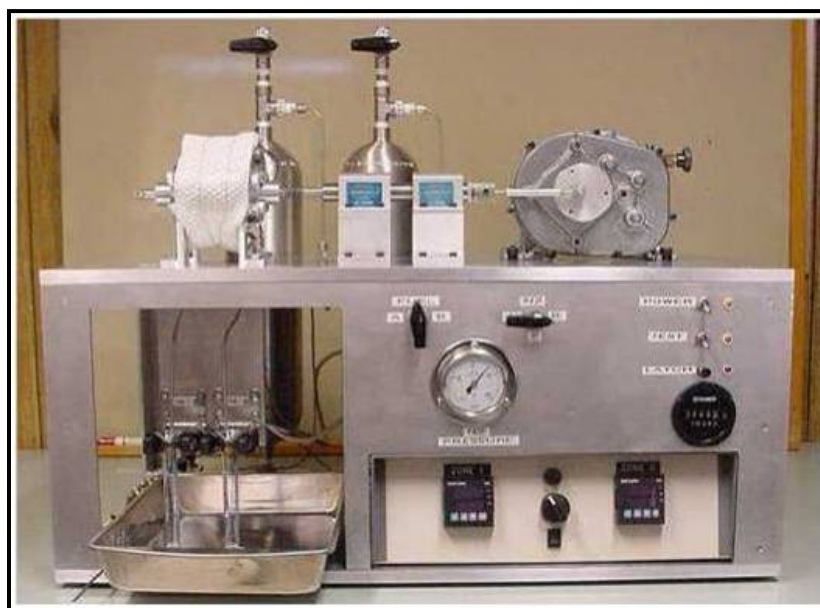
Figure 1. SwRI Dynamic Seal Tester

A detailed description of the dynamic seal test rig construction and operation was presented in TFLRF Report No. 371 [2]. Turbojet engine control systems employ sealing surfaces that move or slide over an elastomer sealing material. These seals are generally referred to as dynamic seals, and the usual configuration is an o-ring. SwRI designed and built a laboratory bench-top apparatus, which is shown in Figure 1. This apparatus, called the dynamic seal test rig, was used for the evaluation of elastomeric o-rings exposed to various fluids or fuels, on a reciprocating shaft, under dynamic conditions. The test rig was designed to simulate temperatures ranging from 15 °F to 300 °F. The dynamic tests were used to study the effect of brake fluids on properties and performance of elastomeric materials.

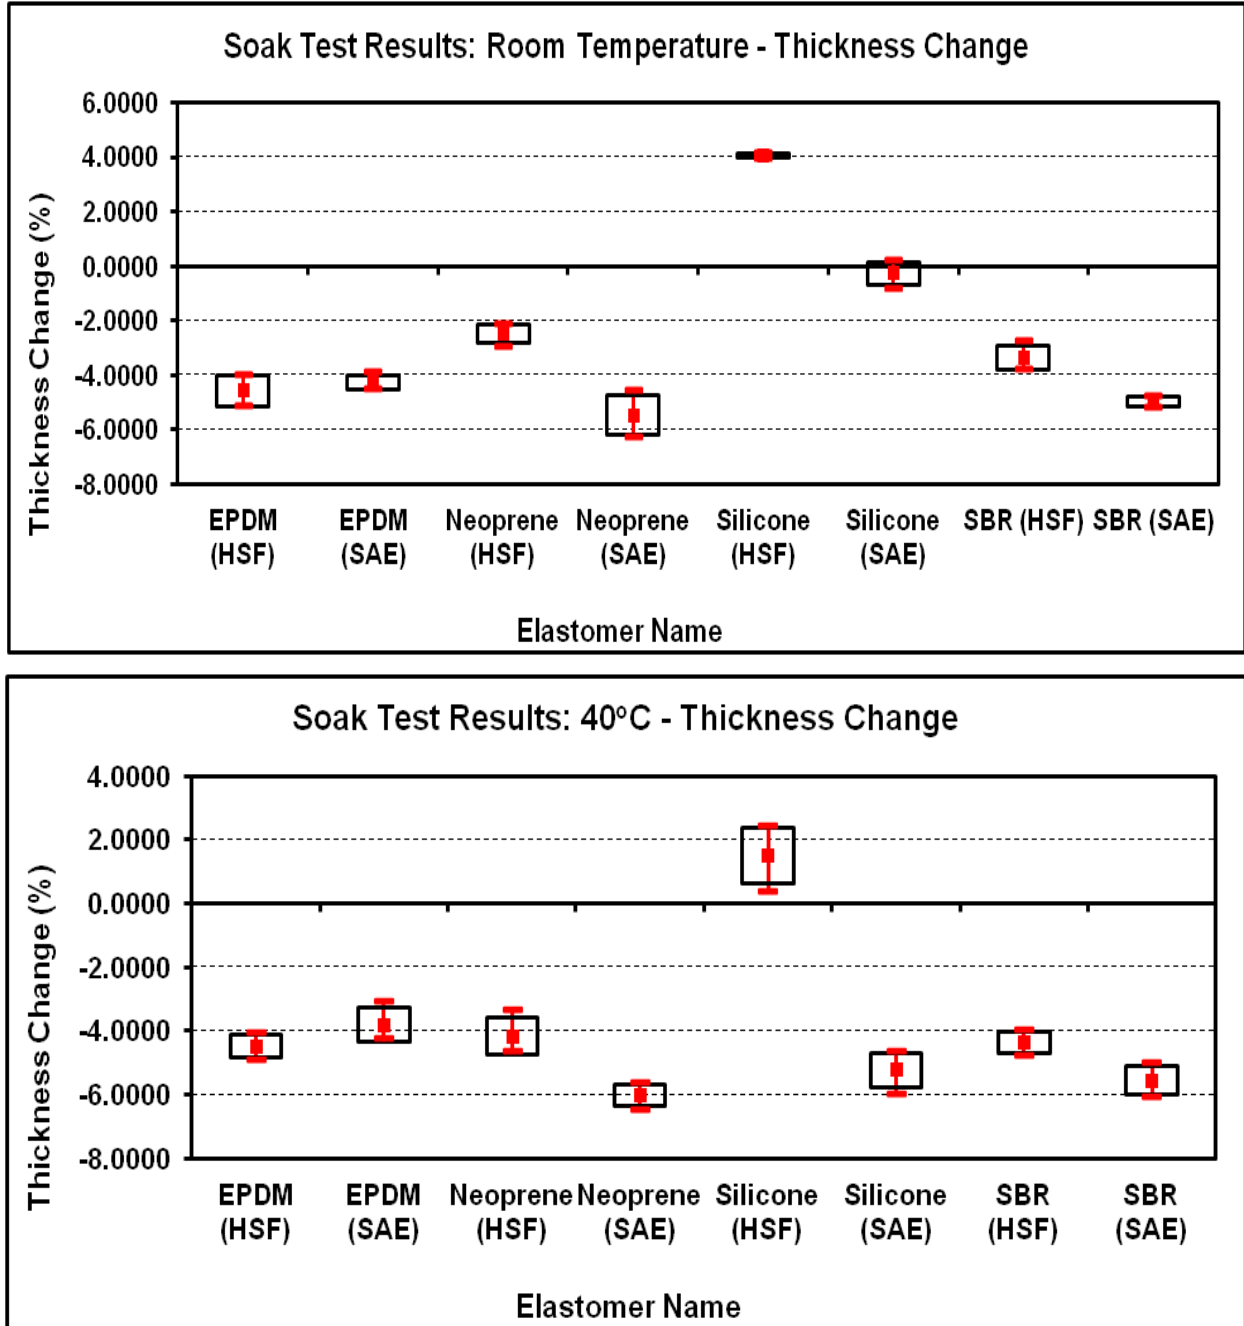
Figure 4. Soak Test Results – Elastomer Thickness Change at Room Temperature versus 40 °C

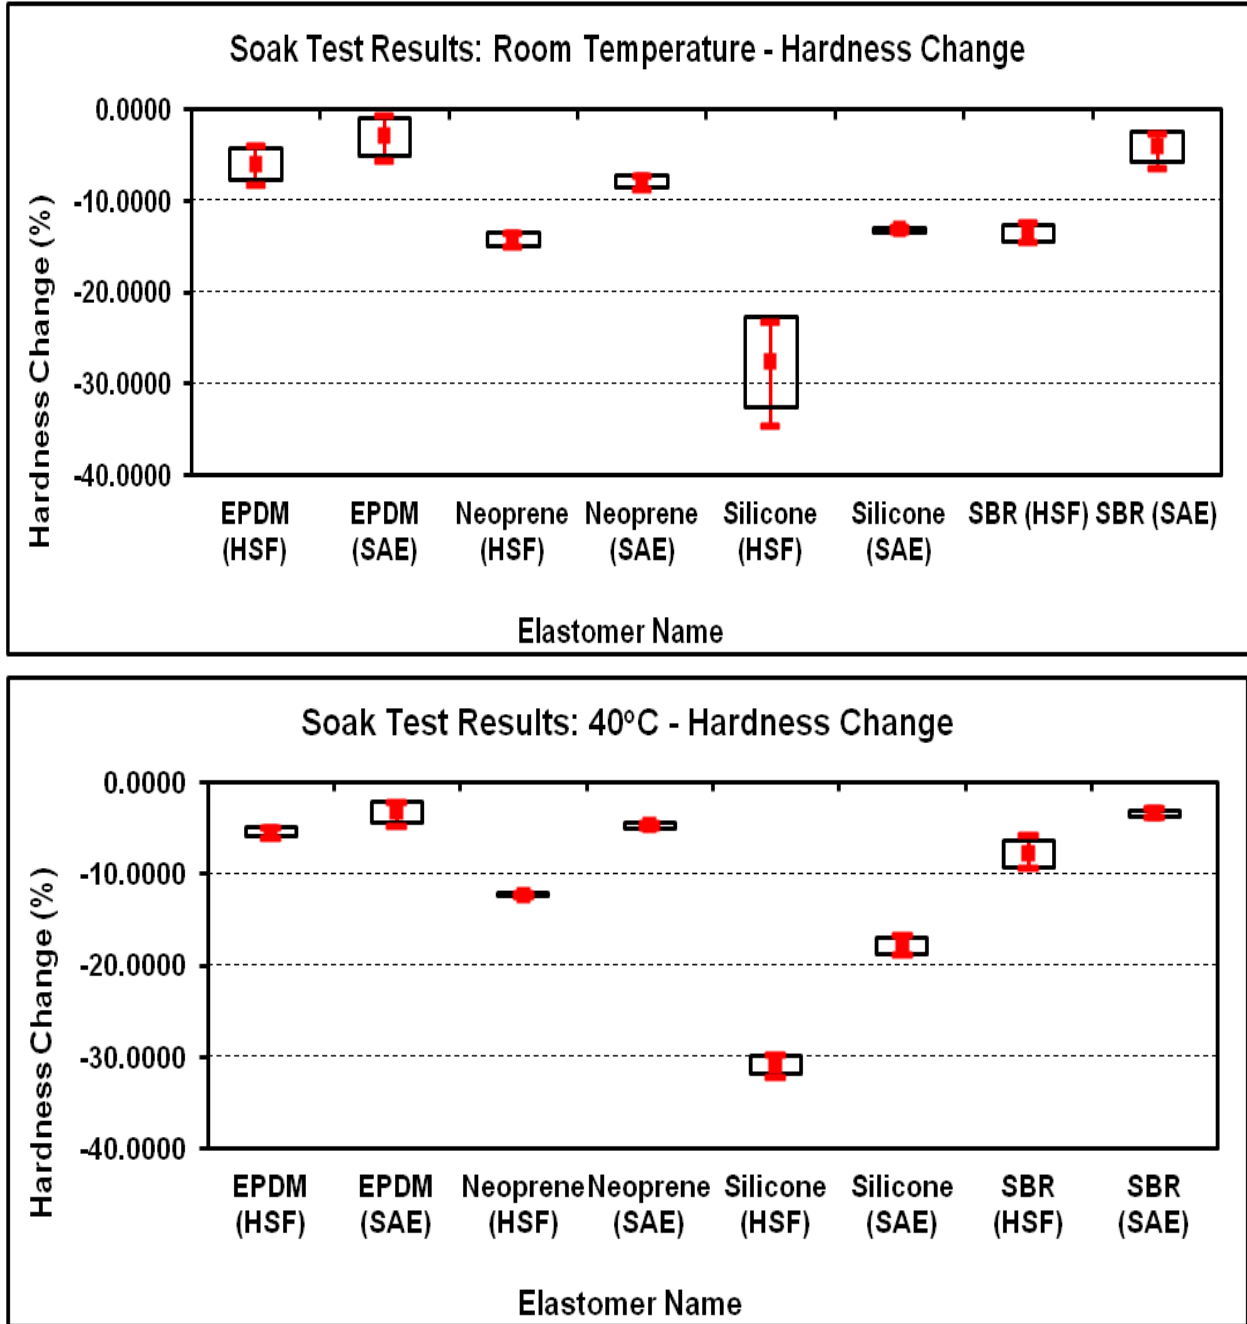
Figure 5. Soak Test Results – Elastomer Hardness Change at Room Temperature versus 40 °C

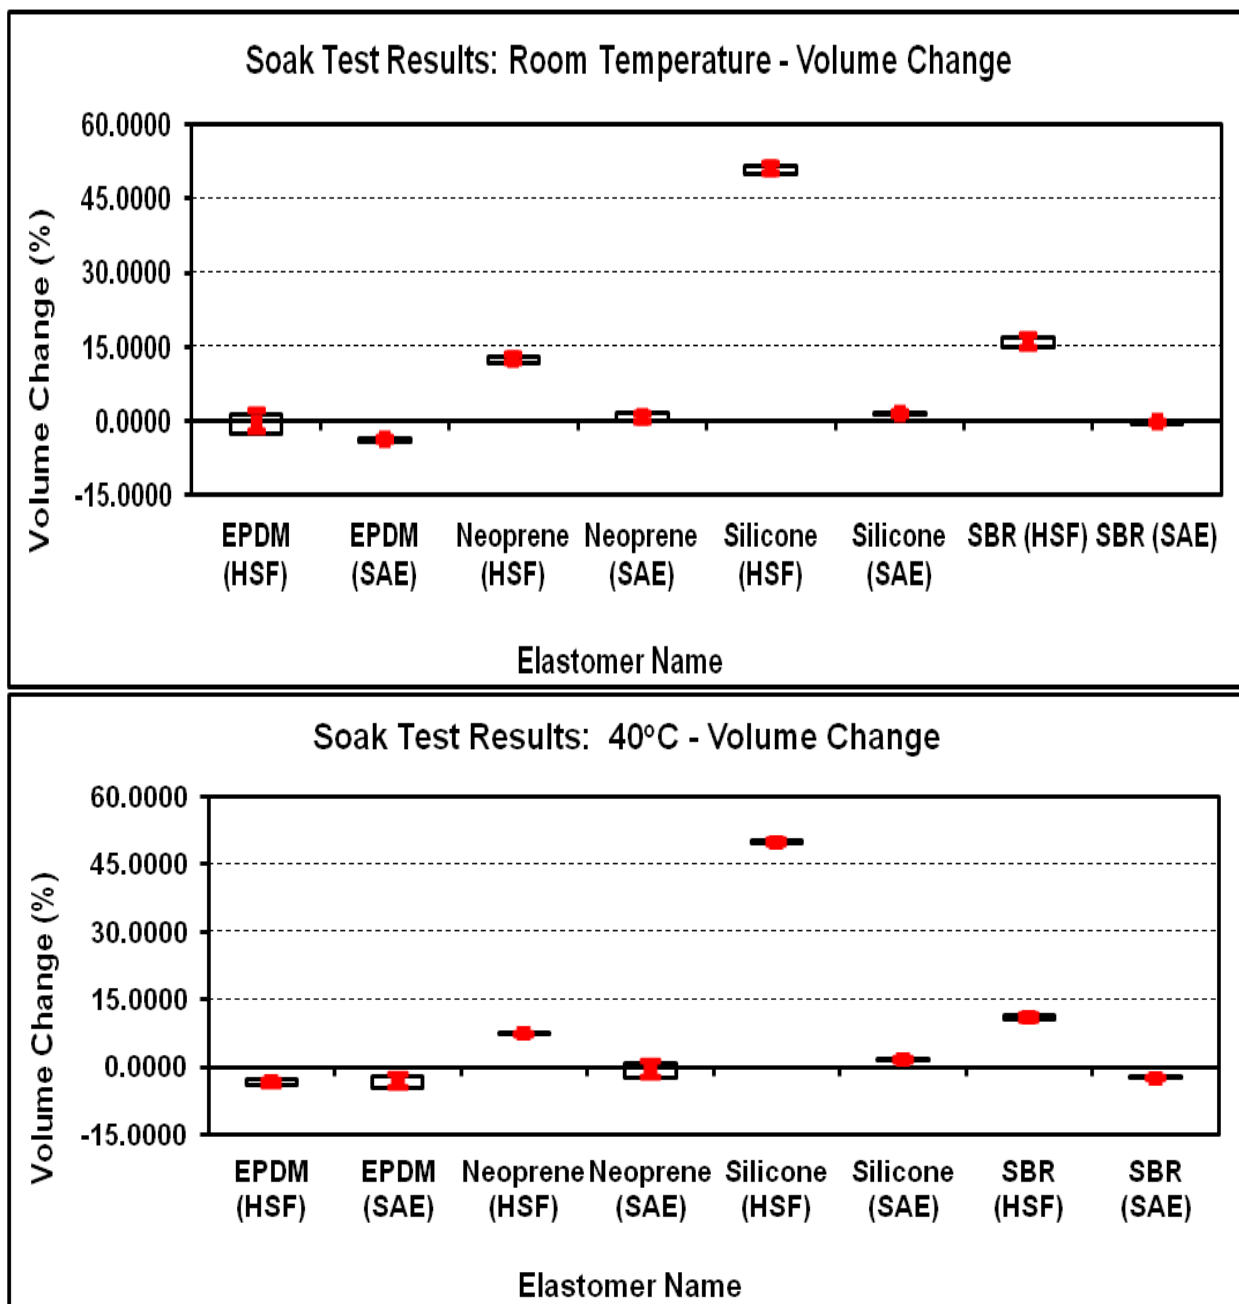
Figure 6. Soak Test Results – Elastomer Volume Change at Room Temperature versus 40 °C

temperature, whereas at 40 °C, EPDM samples showed volume shrinkage with silicone brake fluid.

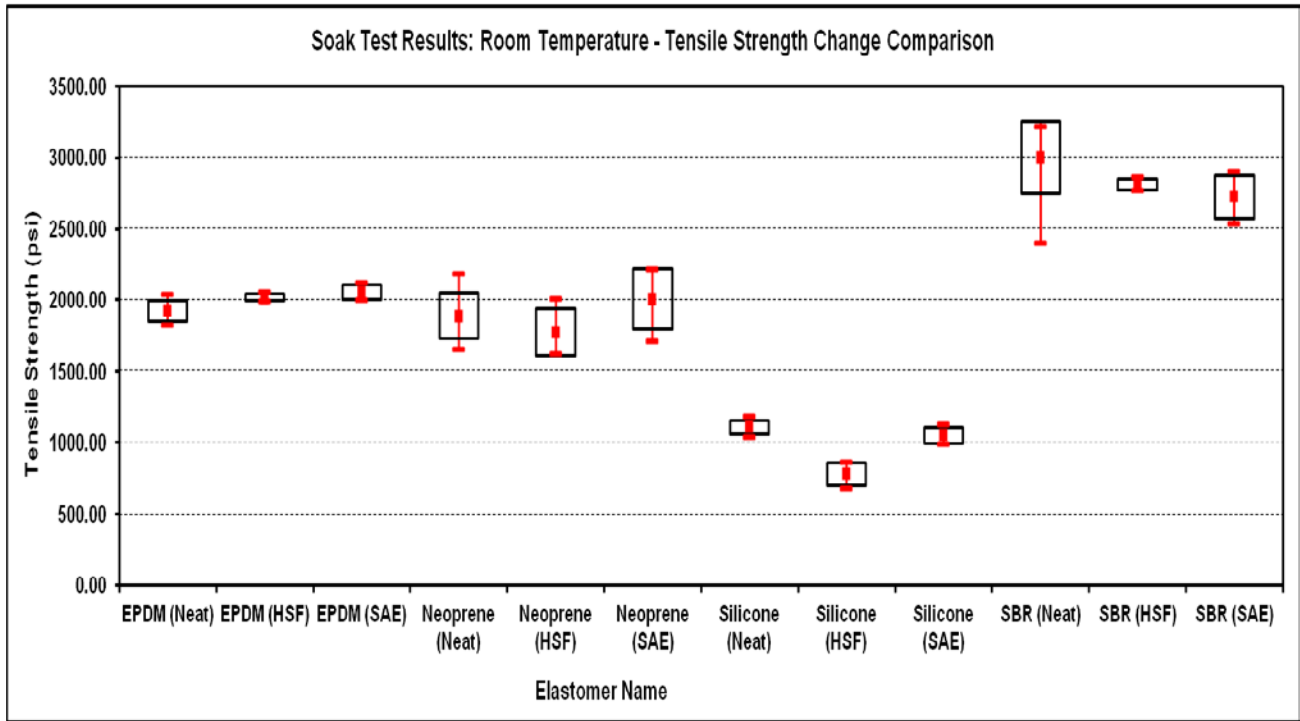
Figure 7. Soak Test Results – Tensile Strength Comparison at Room Temperature

- f. At ambient temperature, the tensile strength for EPDM elastomer was in the same ballpark for both brake fluids. The tensile strengths of Neoprene and SBR had overlapping ranges for both fluids and the comparison remains inconclusive. For Silicone elastomer, the silicone brake fluid decreased the tensile strength, at room temperature.
- g. At 40 °C, the tensile strengths of EPDM, Silicone and SBR decreased with silicone brake fluid relative to the SAE J1703 baseline brake fluid. For silicone elastomer, there was significant overlap between ranges and the results remain inconclusive.

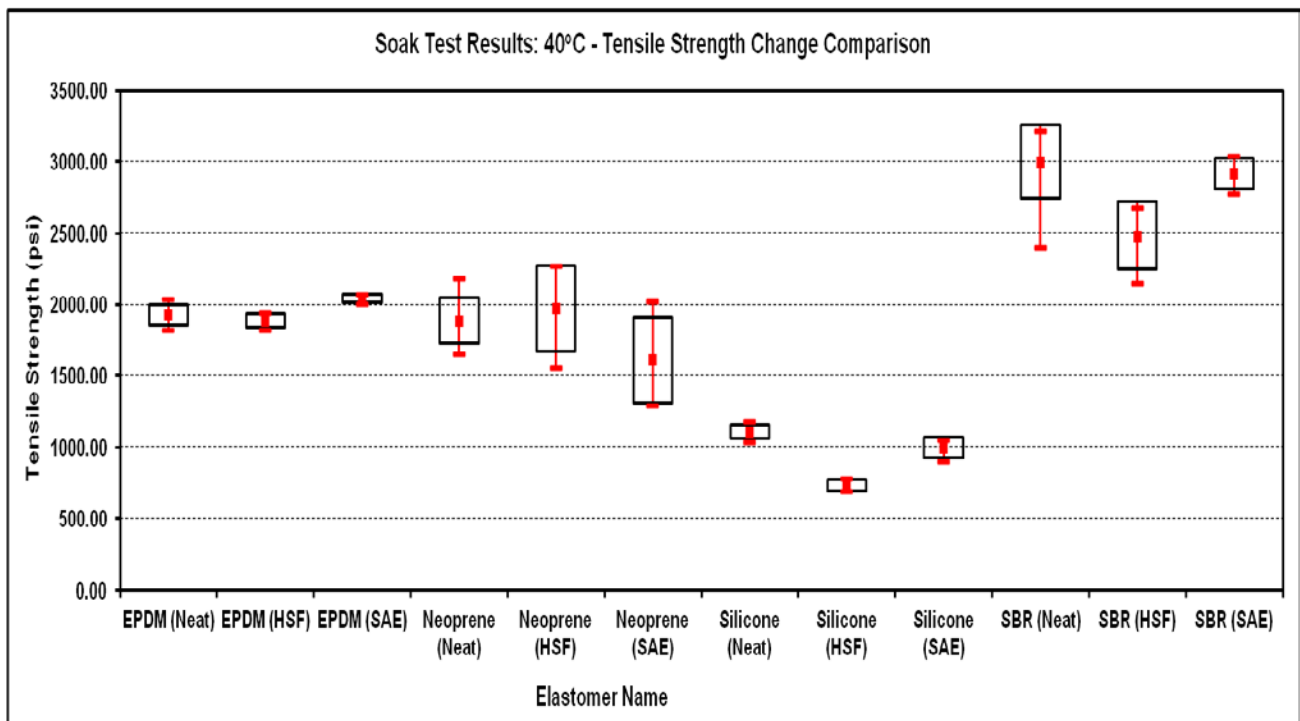
Figure 8. Soak Test Results – Tensile Strength Comparison at 40 °C

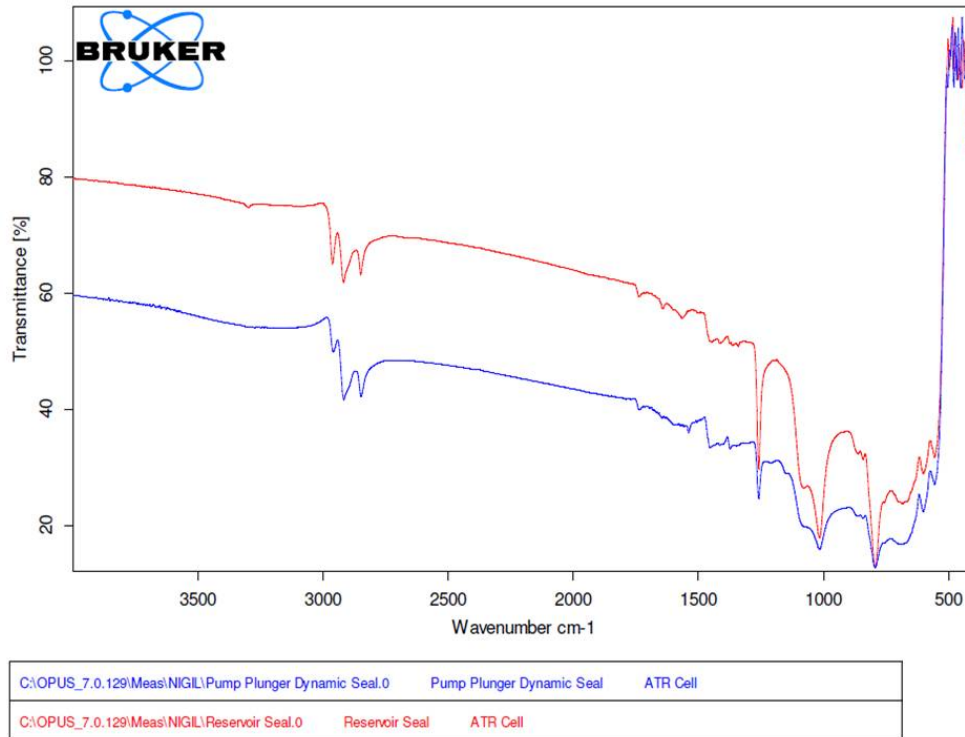
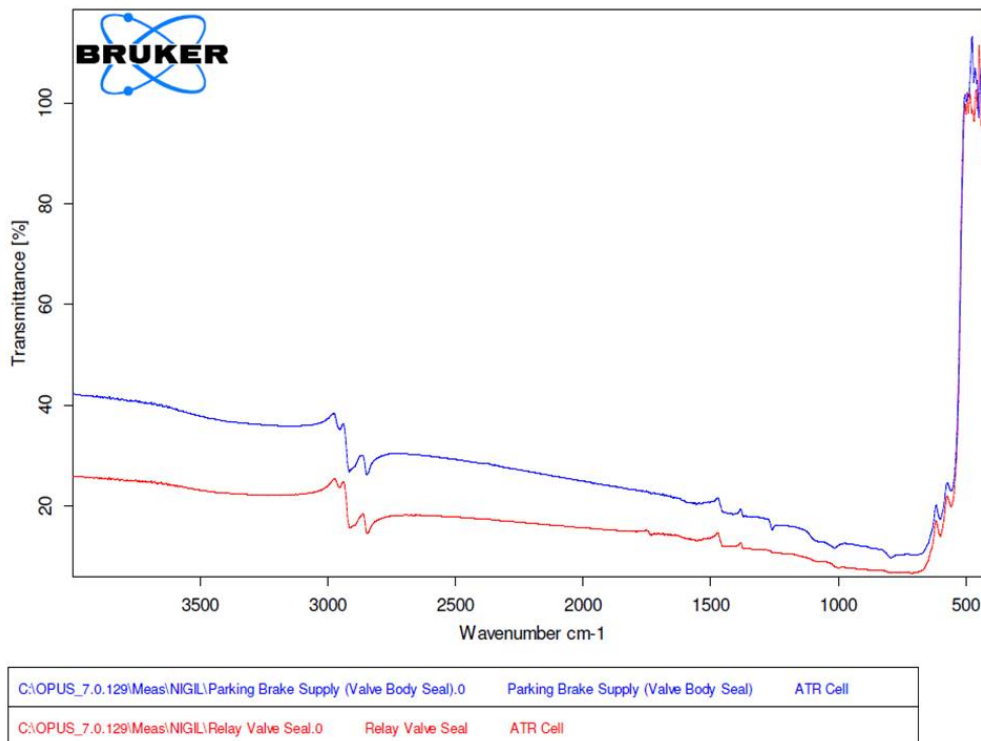
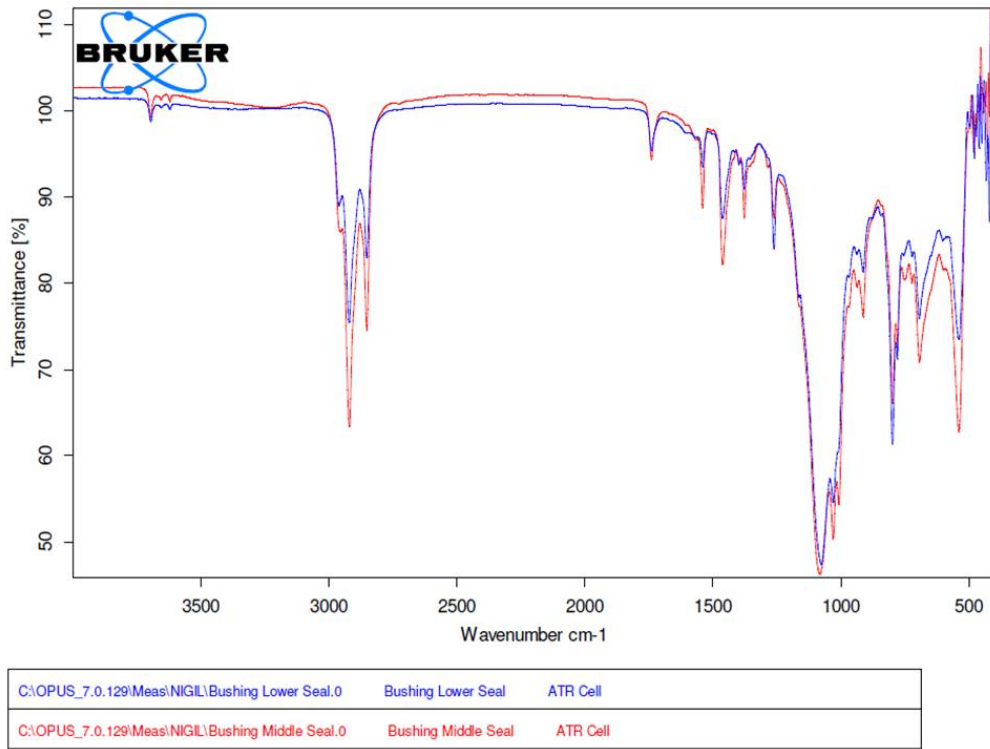
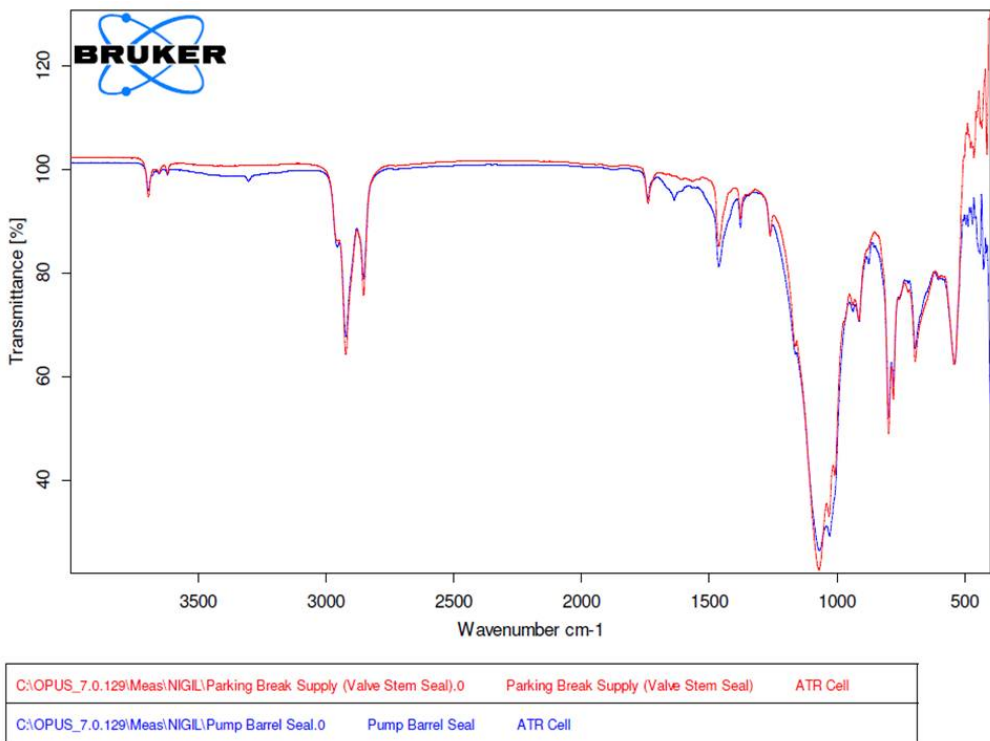
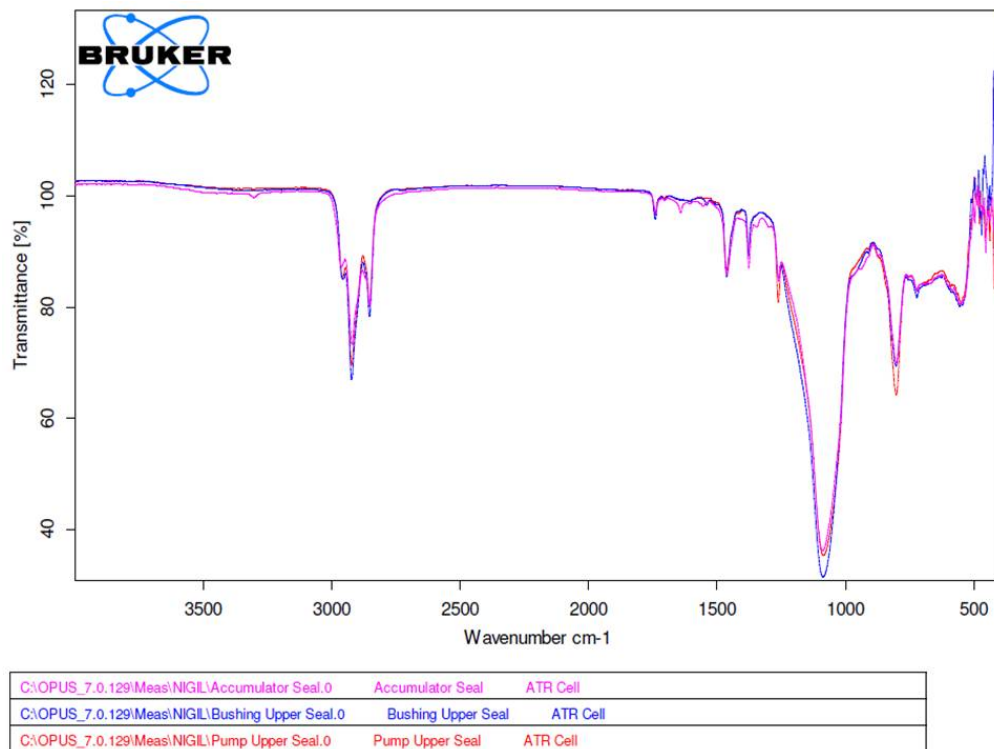
The FTIR spectra for the HPB components are shown from Figure 9 to Figure 13. The identity of Parking Brake Supply and Relay Valve Seal remains unclear due to proprietary nature of filler combinations used in the elastomer; it could be either EPDM or SBR. Similarly, Pump Plunger Dynamic Seal and Reservoir Seal could be Silicone or SBR elastomer. The remaining o-rings were determined to be a match for EPDM elastomer. The fillers (either silica or SiO<sub>2</sub>) are commonly used in the elastomer o-rings.

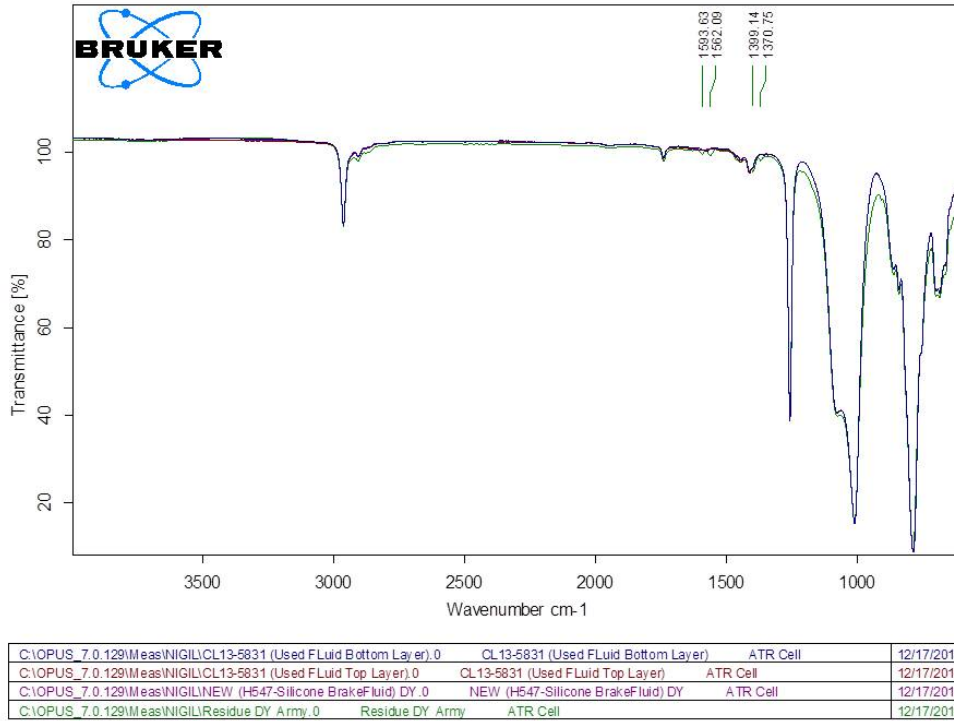
The above spectral bands likely points to the presence of Nitrile based compounds in the solid residue. However, FTIR spectra of elastomer seals from HBP components in Table 3, did not contain Nitrile based elastomers. Therefore, the spectral bands from FTIR spectra in Figure 14 and Figure 15, were not from Nitrile elastomers, rather could be an artifact of other constituents present in the fluid.

Figure 14. Overlaid FTIR Traces for New and Used Silicon Brake Fluids and Filter Residue

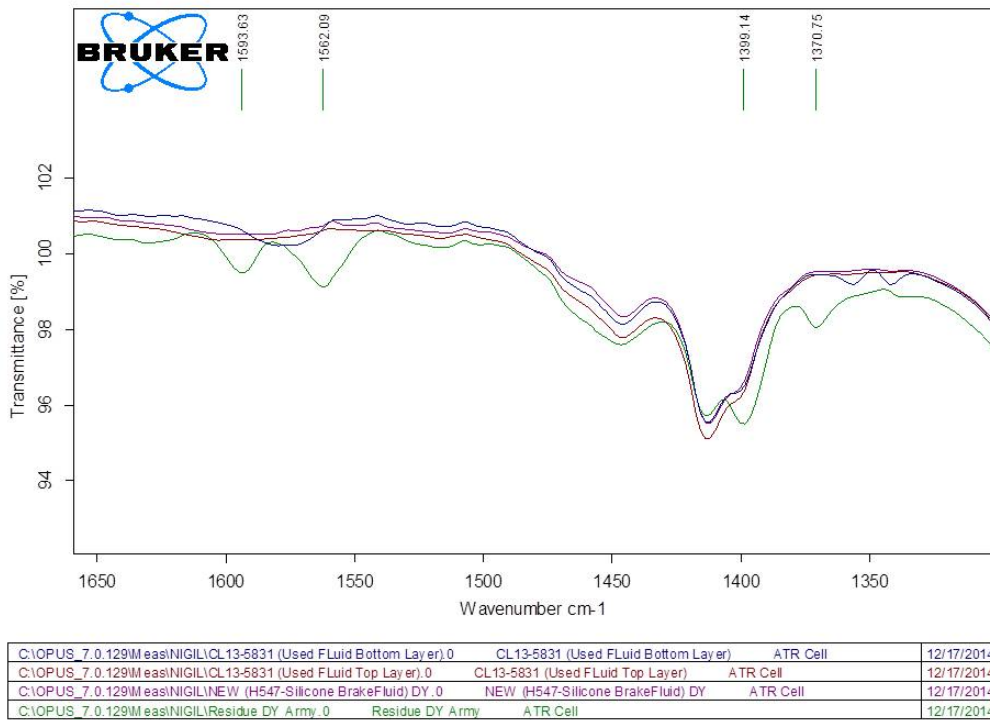
Figure 15. FTIR Region of Interest for Particulate Residue

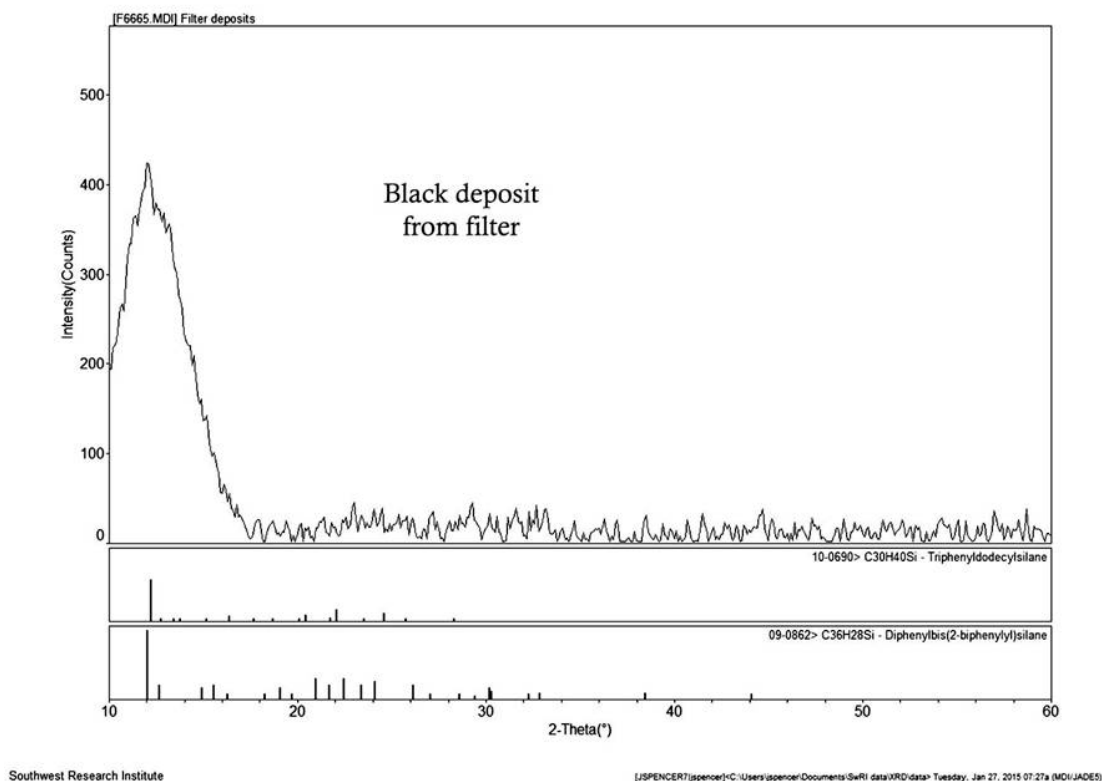
Since the exact identity of the deposit from the HPB filter could not be determined using FTIR technique the deposit sample was subjected to X-Ray Diffraction (XRD) and elemental analysis. The XRD and elemental analysis results for the black debris on the reservoir filter are shown in Figure 16 and Figure 17 respectively and Table 4.

Based on the XRD results, the deposit was identified as silane based compounds. Therefore, we can eliminate brake fluid polymerization as a possible cause since no siloxane based polymers were observed. However, the debris appeared to also contain a liquid that had a very low vapor pressure and did not evaporate in a vacuum. Therefore, it was not certain if the XRD analysis detected the residual silicone brake fluid or the deposit itself. This is also indicated by a strong Si peak in the elemental analysis result. Since there appeared to be no elastomeric compounds evident from the XRD analysis, we can simply state that the material could be either silicone grease and/or residual silicone brake fluid contained in the black residue.

**Figure 16. MIL-PRF-46176 Brake Fluid Filter Deposit**

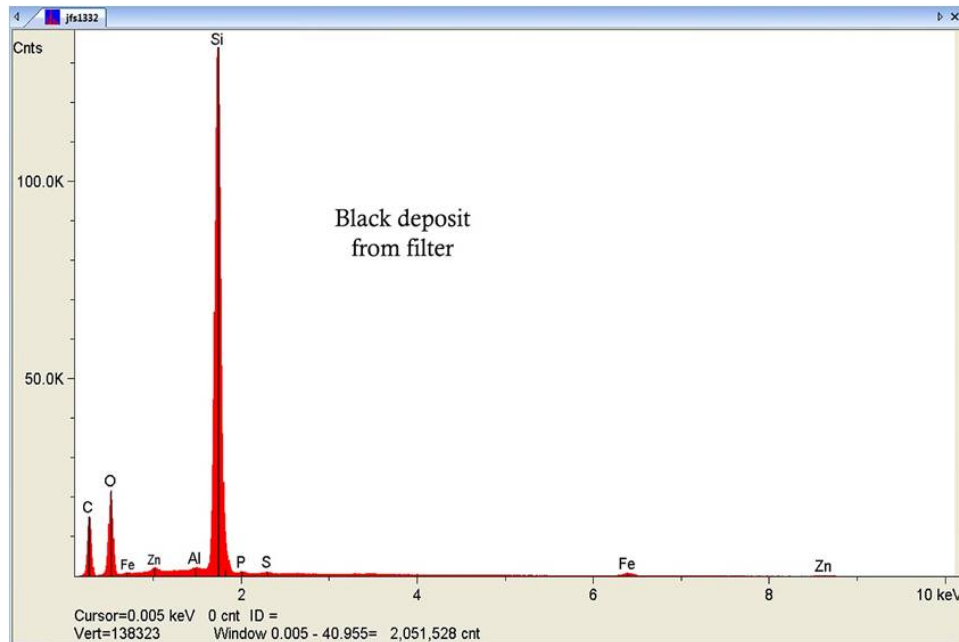
**Figure 17. Filter Debris Elemental Analysis**

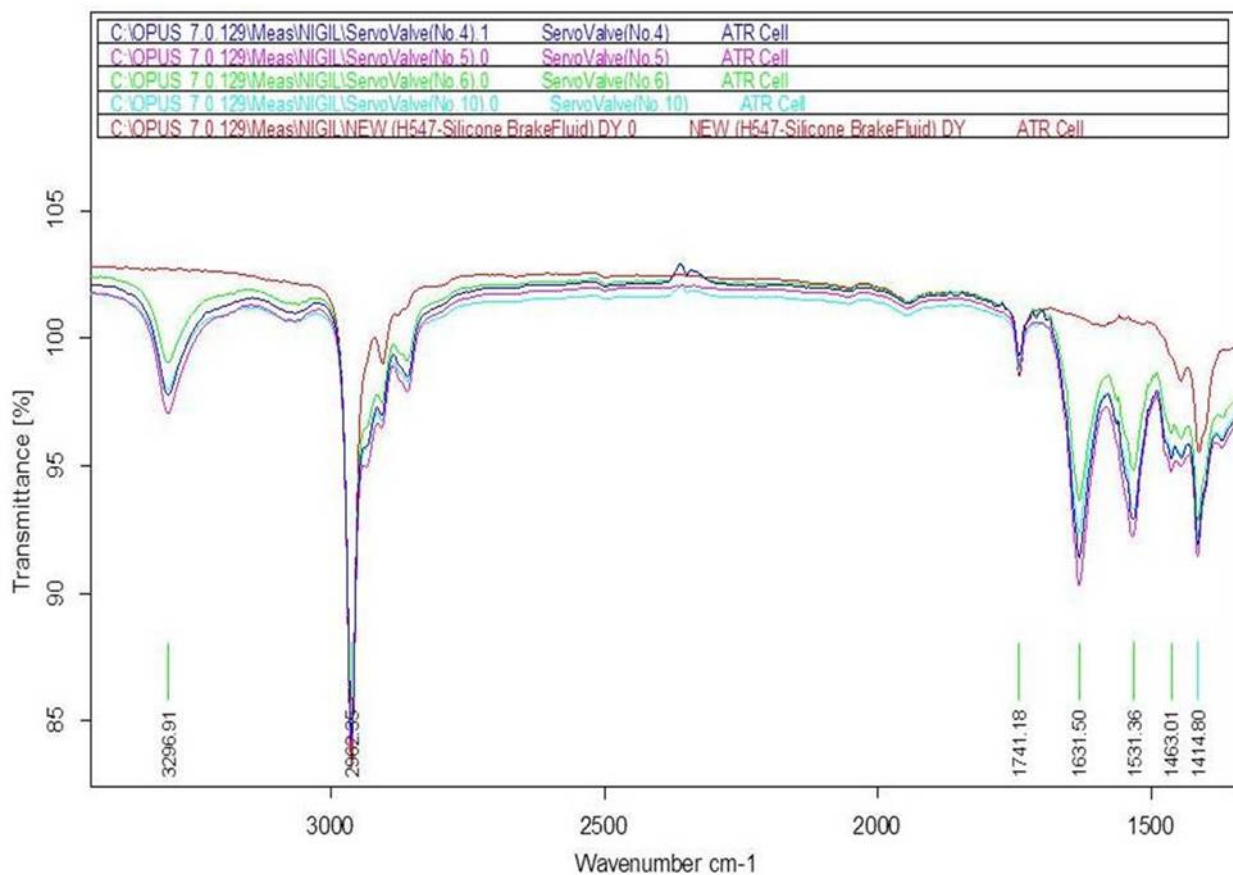
It can be observed in that the spectra from the servo valves were a match for the silicone brake fluid except, for the following peaks:  $3296.91\text{ cm}^{-1}$  indicate presence of O-H peak corresponding

In comparing with the identity of HBP elastomers in Table 3, it should be noted that these peaks indicate the probability of SBR elastomeric residue, where in, the C=C peak corresponding to alkenes point to butadiene chain, and C=C corresponding to aromatics point to phenyl group that matches styrene-butadiene (SBR) structure. Based on the FTIR spectra from these servo valves, there is potential evidence of SBR elastomeric residue on the servo valves. In order to confirm this inference, the used brake fluid from these servo valves have to be examined for the presence of SBR elastomeric residue. The subsequent section describes the used brake fluid analysis.

**Figure 18. FTIR Spectra of Four Servo Valve Filters and Fresh Silicone Brake Fluid**

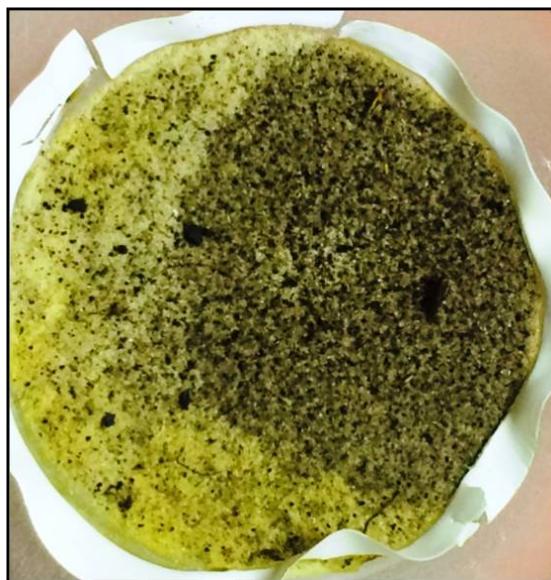
Figure 19 shows the used HSF fluid that was filtered for analysis. Elemental analysis of scraped material from this filter paper, shown in Figure 20 and Table 5 confirms a high amount of Si that could be potentially from the brake fluid. Therefore, in order to determine the presence of elastomer in the residue, the scraped material was subjected to SEM imaging which would confirm the physical presence of elastomers, followed by subjecting the residue to XRD which would confirm the actual chemical identity if the elastomer were present.

**Figure 19. Filtered Residue from Used HSF**

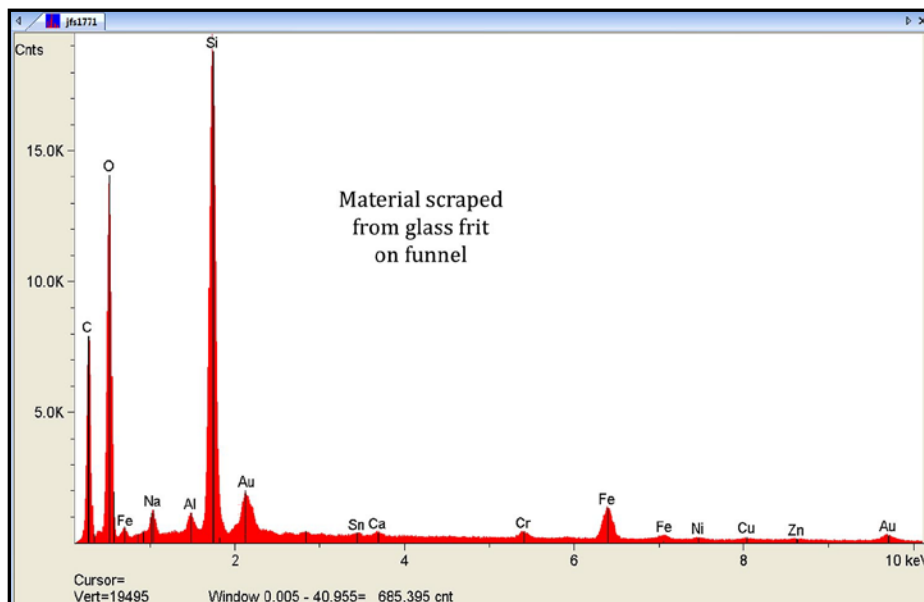
**Figure 20. Elemental Analysis of Filtered Residue from used HSF**

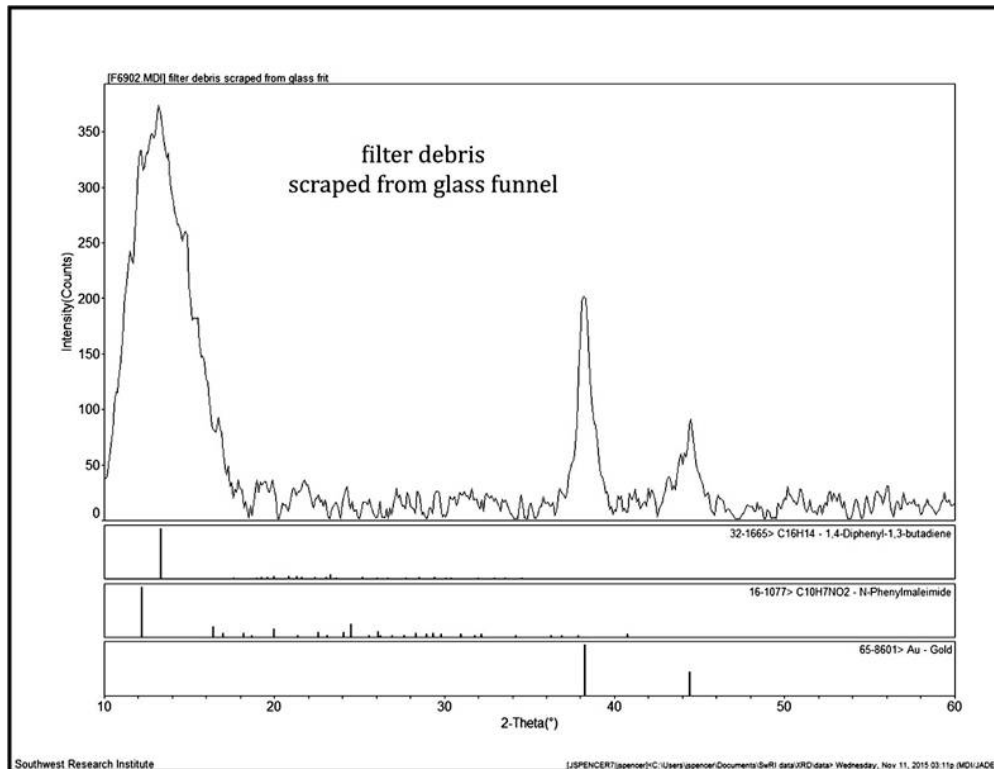
Based on the collective physical and chemical characterization, it can be inferred that there was SBR elastomer presence in the used silicone brake fluid residue and that there was a fine SBR elastomer layer coated on the surface of the servo valves. Based on FTIR characterization of elastomers and the above results, it can be concluded that the elastomers could have come from any of the following components: Parking Brake Supply (valve body seal), Relay Valve Seal, Pump Plunger Dynamic Seal or Reservoir Seal, with the pump plunger dynamic seal being the highly likely location from which SBR elastomer could have been leached into the brake fluid due to dynamic motion. For future work, it is recommended that Raman measurements be conducted on these elastomers and on residues, if feasible.

Figure 22. XRD Results of the Filtered Residue

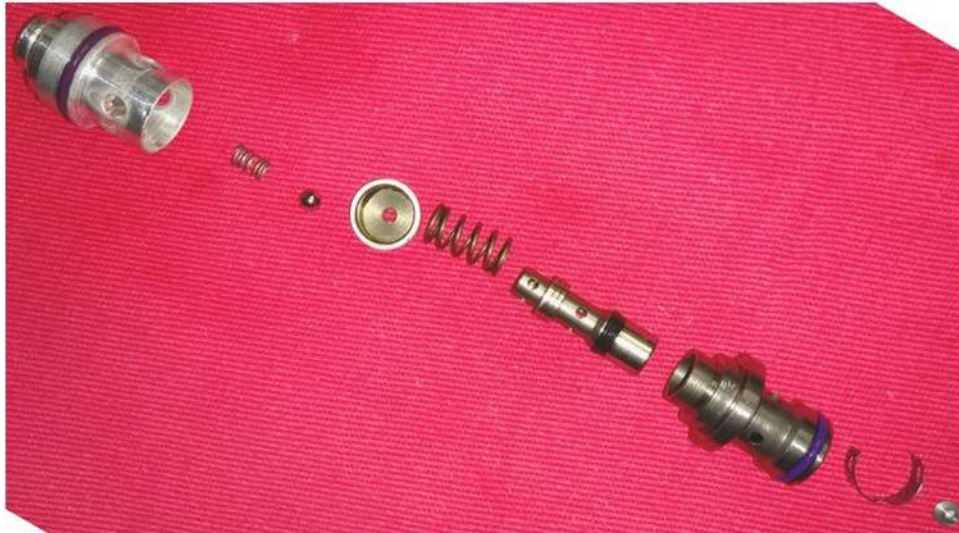
The two pumping elements from the HSF test article were disassembled and inspected for wear patterns. The disassembled components of a pumping element are shown in Figure 23. A close up image of the pumping element plunger is displayed in Figure 24. There appeared to be some polishing wear on the large diameter sections, some of which can be seen on the left side of the plunger. The wear on the right side of the plunger was diametrically opposite, to the right of the black seal.

**Figure 23. Disassembled Hydraulic Power Brake Pumping Element**

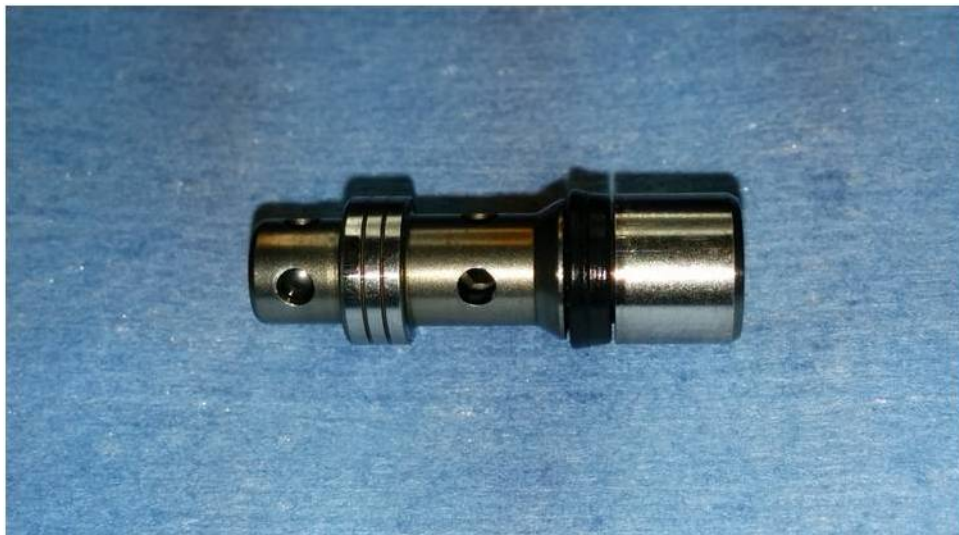
**Figure 24. Hydraulic Power Brake Pumping Plunger Detail**

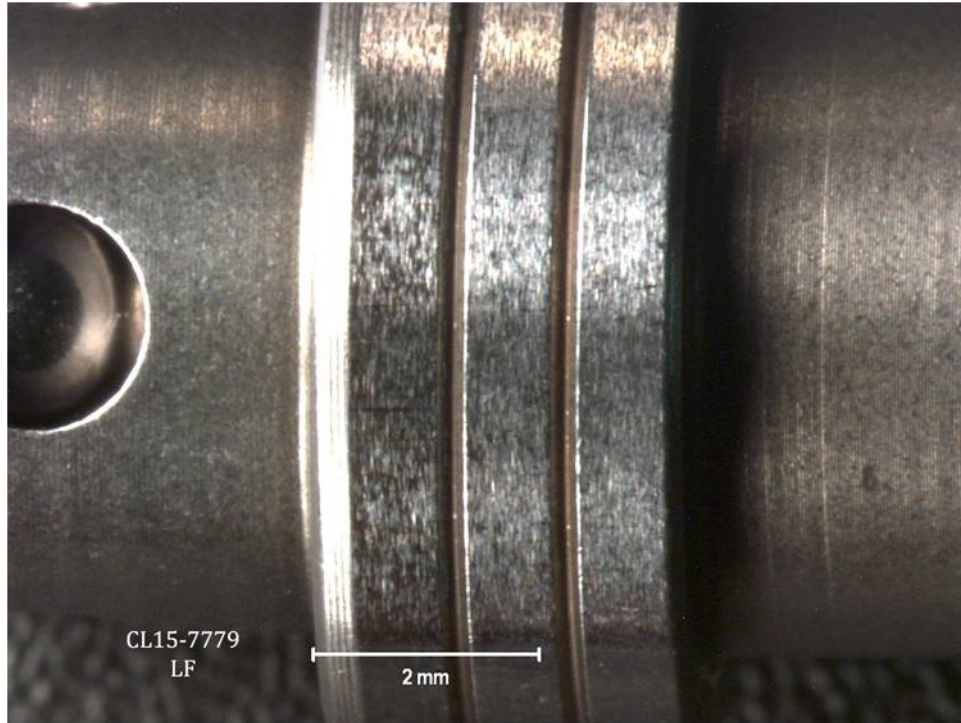
HSF LF plunger with wear seen on both the pumping (left) end and the follower (right) end. The baseline plunger condition is shown in Figure 26, each operated for 20,000 cycles. A closer image of the HSF plunger pumping section wear is shown as Figure 27 and the baseline plunger in Figure 28. There appeared to be less polish on the baseline LF plunger. Magnification of the HSF LF plunger follower wear is shown in Figure 29, where towards the left edge of the image, distress to the elastomeric seal was observed. The baseline LF plunger follower wear is shown in Figure 30, where towards the left edge of the image, very little distress to the elastomeric seal were observed. The area around the follower end is only lubricated by fluid that is wiped onto the barrel bore by the seal, as these sections were dry when disassembled.

Figure 28. Detail of the Baseline LF Plunger Pumping Section Polishing and Wear

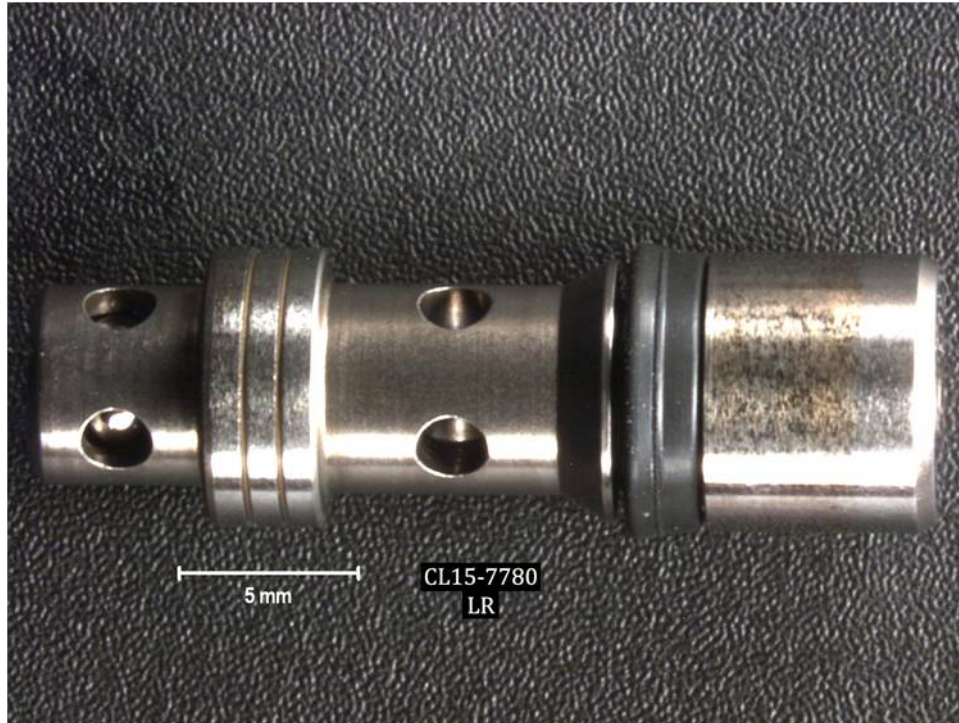
The overall condition of the HSF LR plunger is seen in Figure 35, with wear seen on both the pumping (left) end and the follower (right) end. More wear was evident on the LR plunger after HSF testing. The baseline LR plunger is shown in Figure 36 with very little polishing evident. A closer image of the HSF LR plunger pumping section wear is seen in Figure 37, and the similar baseline LR plunger section in Figure 38. Magnification of the HSF LR plunger follower wear is shown in Figure 39, where towards the left edge of the image distress to the elastomeric seal was also observed as before. The wear on the baseline LR plunger was minimal and the elastomer distress was also minimal as seen in Figure 40. More wear was evident on the LR plunger than the LF plunger, especially on the follower section, with the HSF brake fluid. Again it appeared the area around the follower end was only lubricated by fluid that was wiped onto the barrel bore surface by the seal. For the baseline fluid, the LR and LF plunger wear was similar. There was more overall plunger wear with the HSF fluid than the baseline fluid.

Figure 36. LR Plunger Overview from Baseline Testing

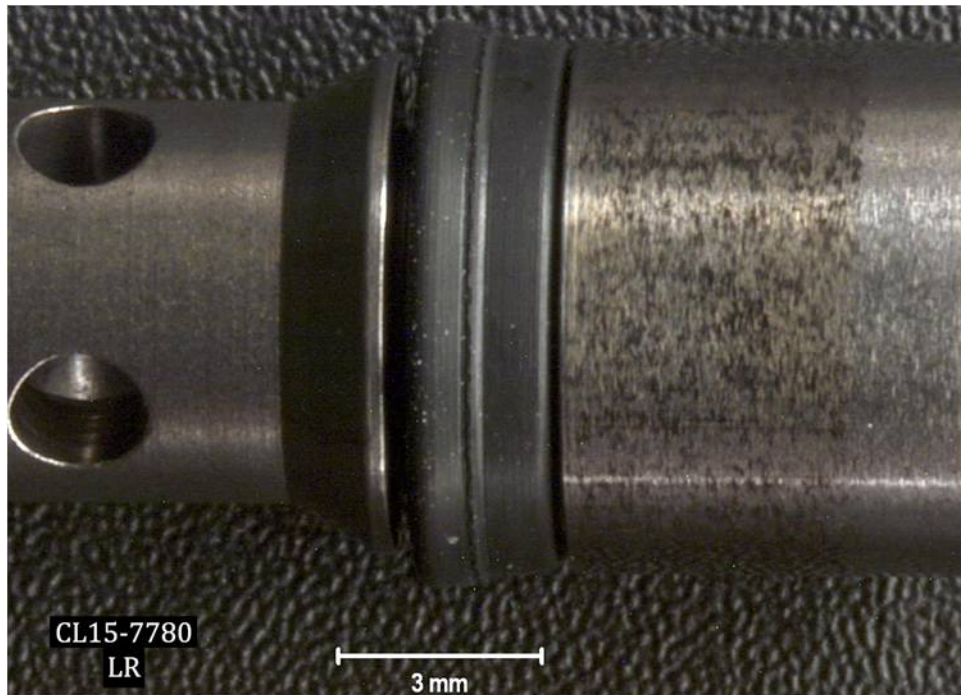
The LR pumping element barrel was also cross-sectioned using WEDM. The wear between the piston follower section and the barrel are shown in Figure 41 for the HSF fluid. Towards the left edge of the image for the LR pumping element barrel scuffing and material transfer was evident. The corresponding baseline LR barrel shows very little wear as seen in Figure 42. A closer view of the elastomer distress is shown in Figure 43. It appears evident debris from the barrel/plunger wear at the plunger follower section caused the elastomer distress. A closer view of the minimal LR plunger elastomer distress for the baseline fluid is shown in Figure 44.

Figure 44. Elastomer on LR Plunger from Baseline Testing
