**BRAKE FLUID COMPATIBILITY STUDIES WITH  
ADVANCED BRAKE SYSTEMS**

**INTERIM REPORT  
TFLRF No. 473**

**By  
Douglas M. Yost  
Nigil Jeyashekar  
Edwin A. Frame**

**U.S. Army TARDEC Fuels and Lubricants Research Facility  
Southwest Research Institute<sup>®</sup> (SwRI<sup>®</sup>)  
San Antonio, TX**

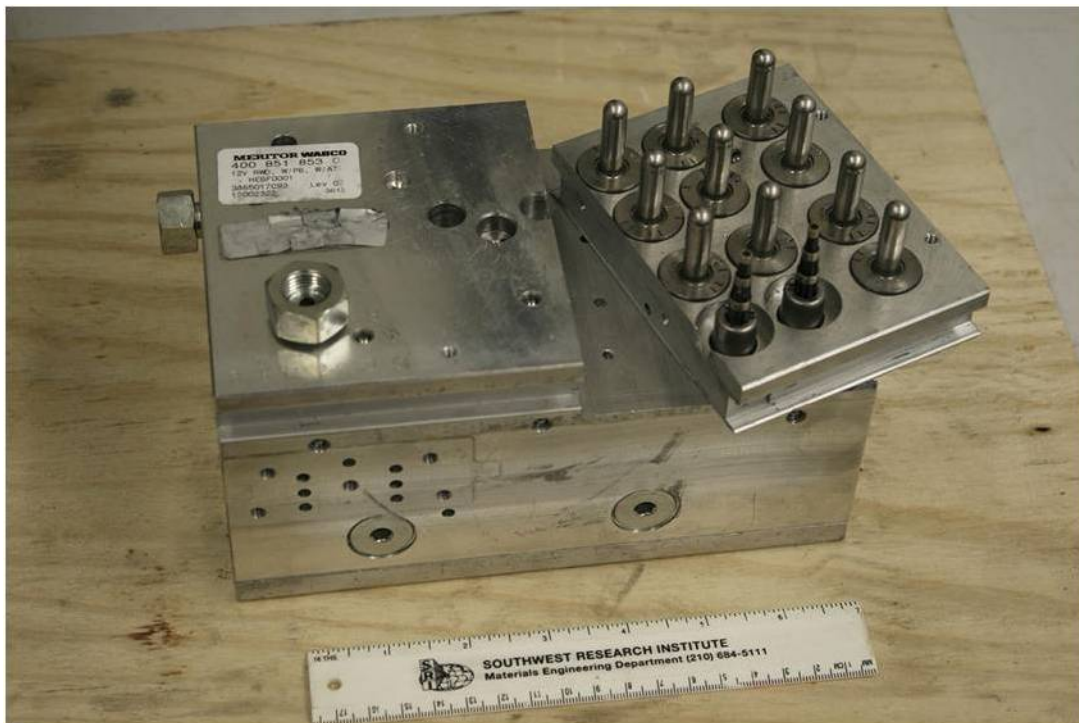
The following figures document how the servo valves and filters were removed from the HPB block. Figure 45 shows how the valve section was sliced off the HPB block with a band saw. The slice with the band saw was below the depth of the servo valve machining. The valves were numbered individually as shown in Figure 46, then parallel cuts were made between valve rows. Each valve was then isolated by making cuts perpendicular to the row cuts as shown in Figure 47.

Figure 45. Valves sliced from the main block using a band saw

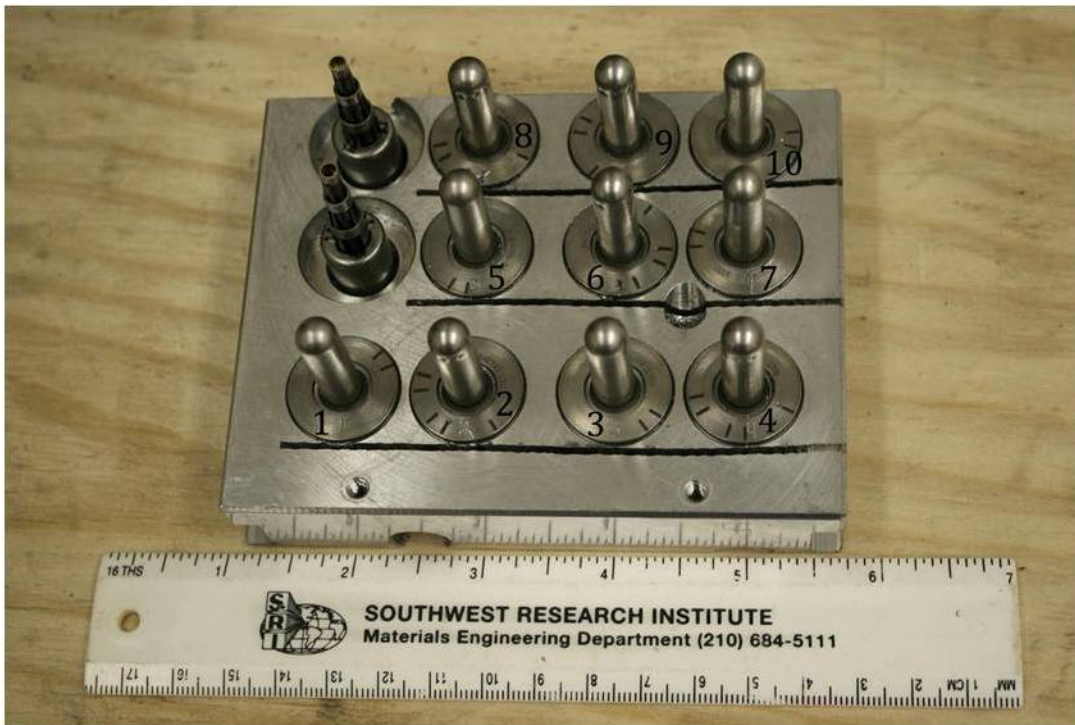
Figure 46. Parallel cuts were made along each row, with valves numbered as indicated

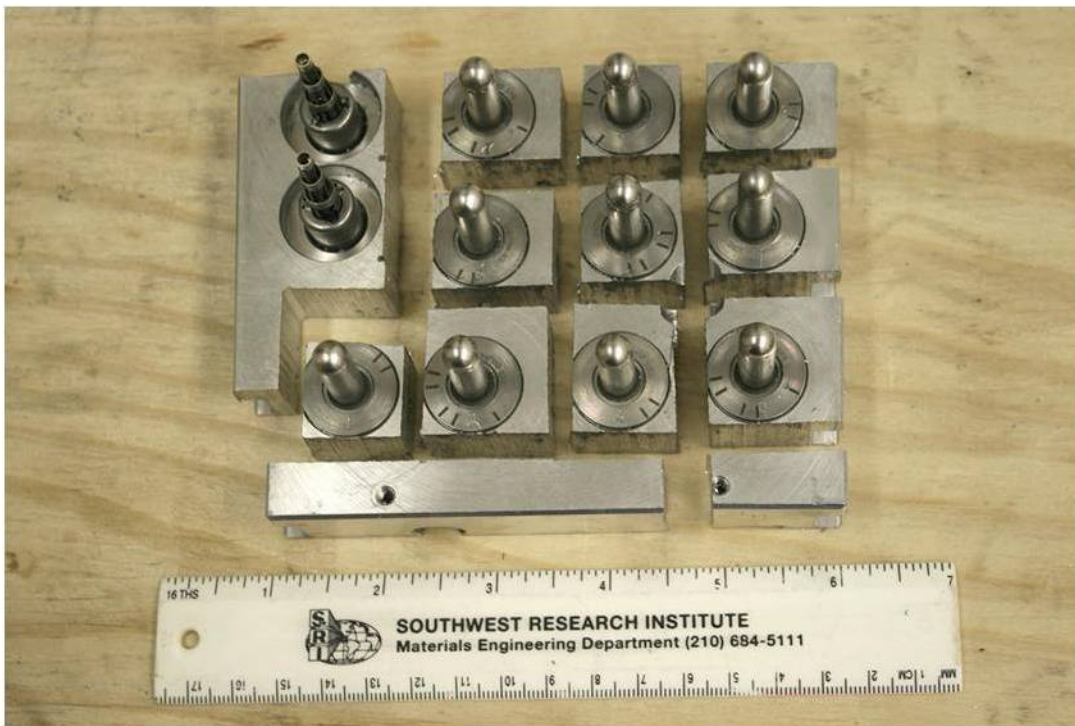
Figure 47. Cuts were then made perpendicular to the row cuts to isolate each valve and filter unit

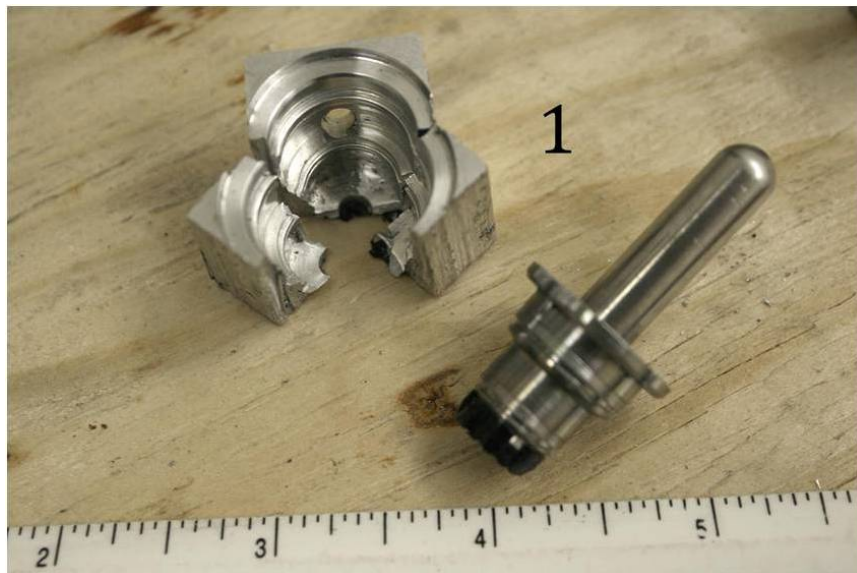
After each valve was isolated, three notches were made around each individual valve body, Figure 48, to assist with valve removal. A hammer and chisel was then used to separate the aluminum body from the valve as shown in Figure 49. The filters from servo valve bodies 4,5,6, and 10 bodies were analyzed using FTIR as discussed previously.

**Figure 49. A hammer and chisel was then used to crack open the case and the valve and filter were then removed**

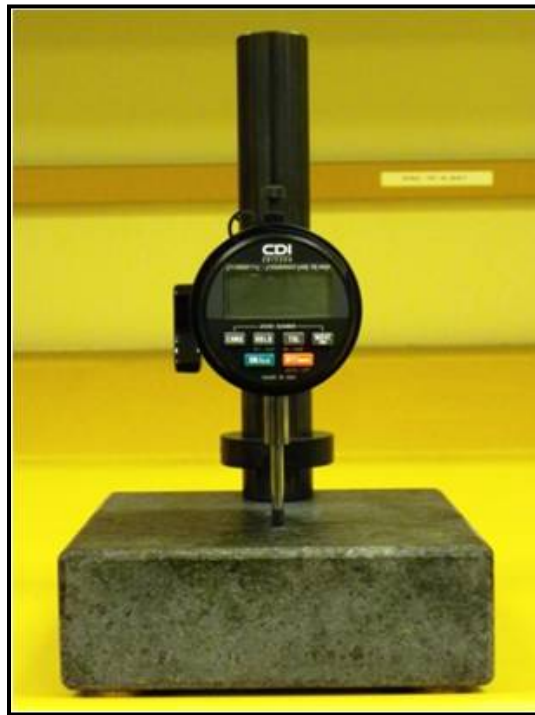
Thickness of the o-ring is measured using a CDI micrometer instrument (model LG2110), as shown in Figure A-1. The micrometer can measure o-rings that are up to one inch thick. The pressure foot is lifted using a lever mechanism and is positioned on the center of the o-ring. The pressure foot is lowered gradually until it comes into contact with the o-ring, and the digital reading is recorded as the thickness of the o-ring. Measurements are repeated in triplicates, and the average thickness measurement is recorded.

**Figure A-1. CDI Micrometer to Measure O-ring Thickness**

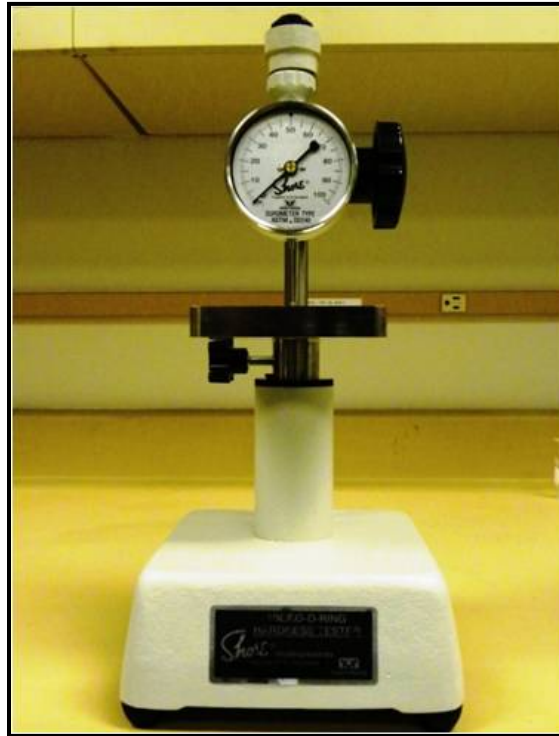
The hardness of the elastomer material is rated using Shore M hardness on a scale from 0 to 100. The hardness scale is indicative of the elastic modulus (Young's Modulus) of the o-ring and is a measure of the stiffness of the material. Hardness measurements are recorded using Shore M Durometer (model 714). The Shore M durometer (as shown in Figure A-2) is used to collect accurate, repeatable hardness readings on soft elastomers that are too thin or too irregular in shape for measurement with a standard durometer, such as small o-rings. It is used for cross-sections 1.25 mm – 7 mm.

**Figure A-2. Shore M Durometer to Measure O-ring Hardness**

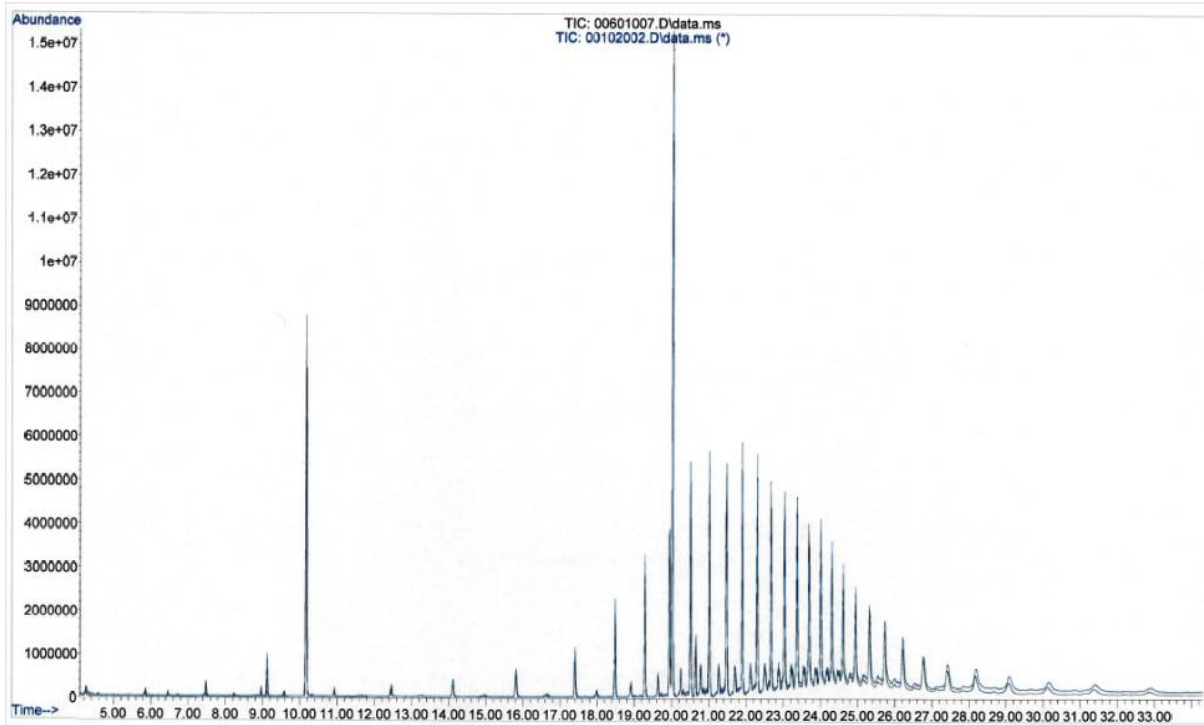
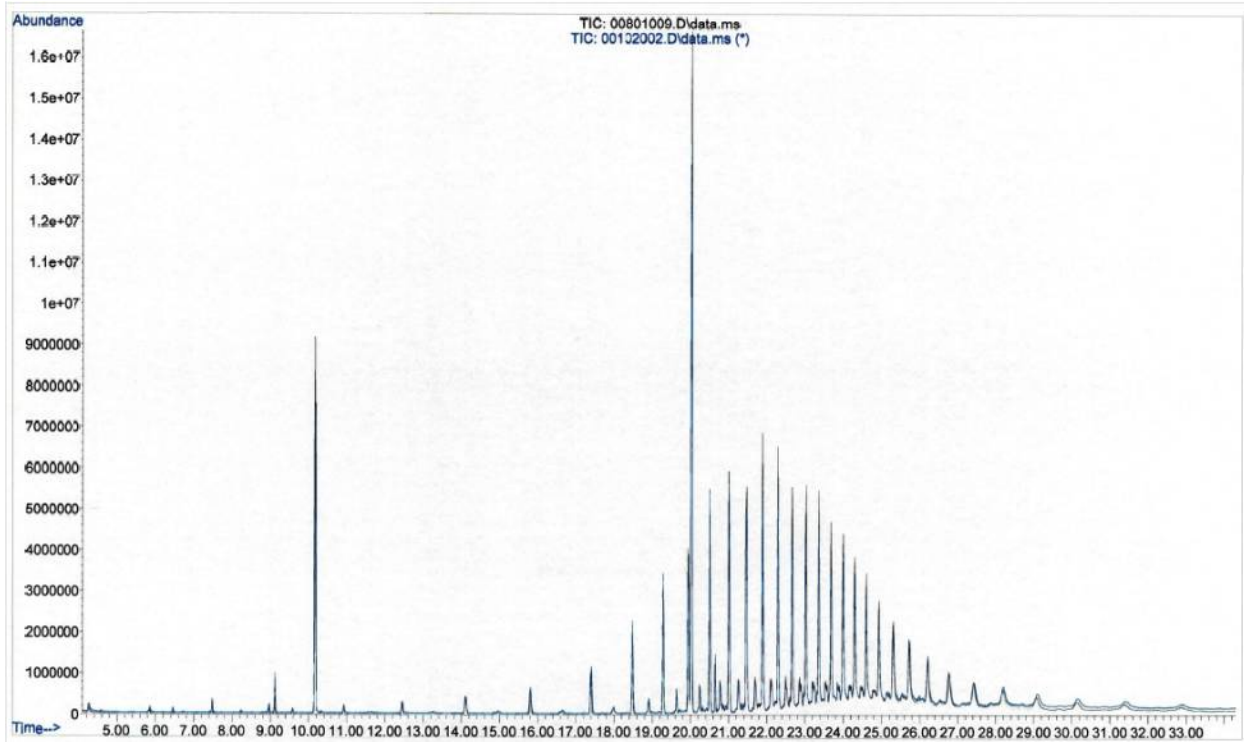
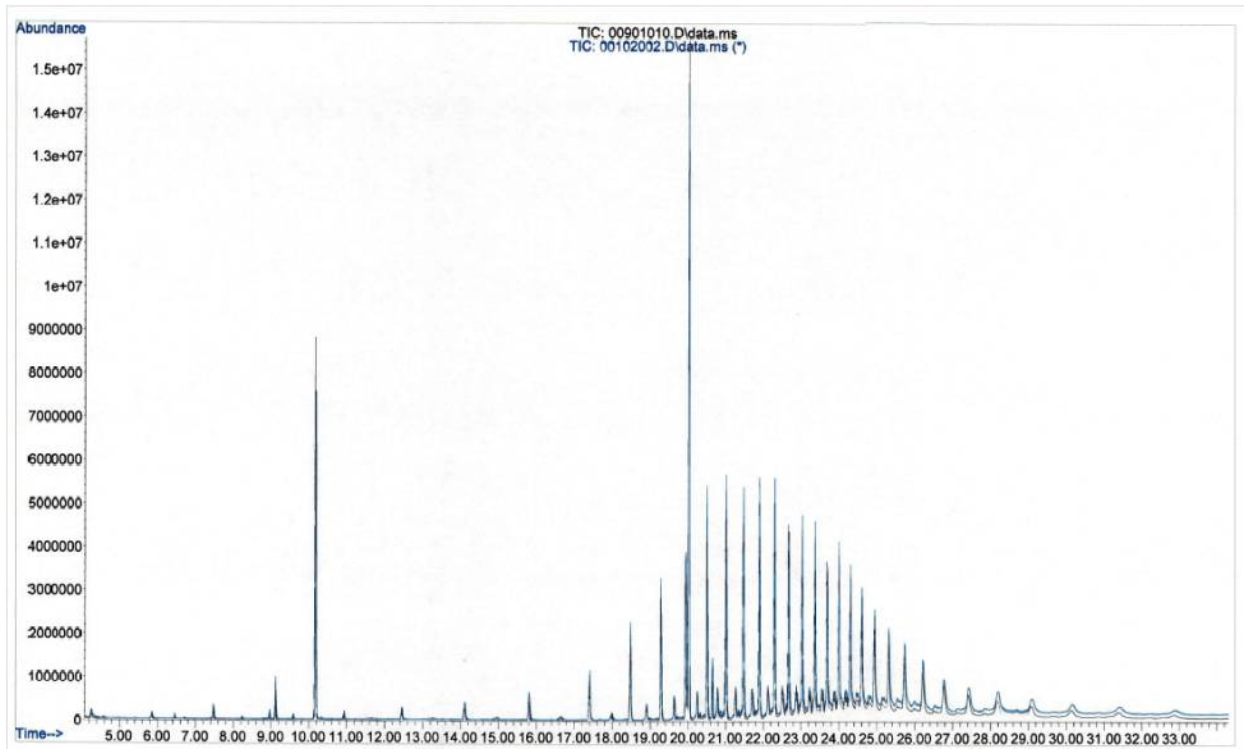
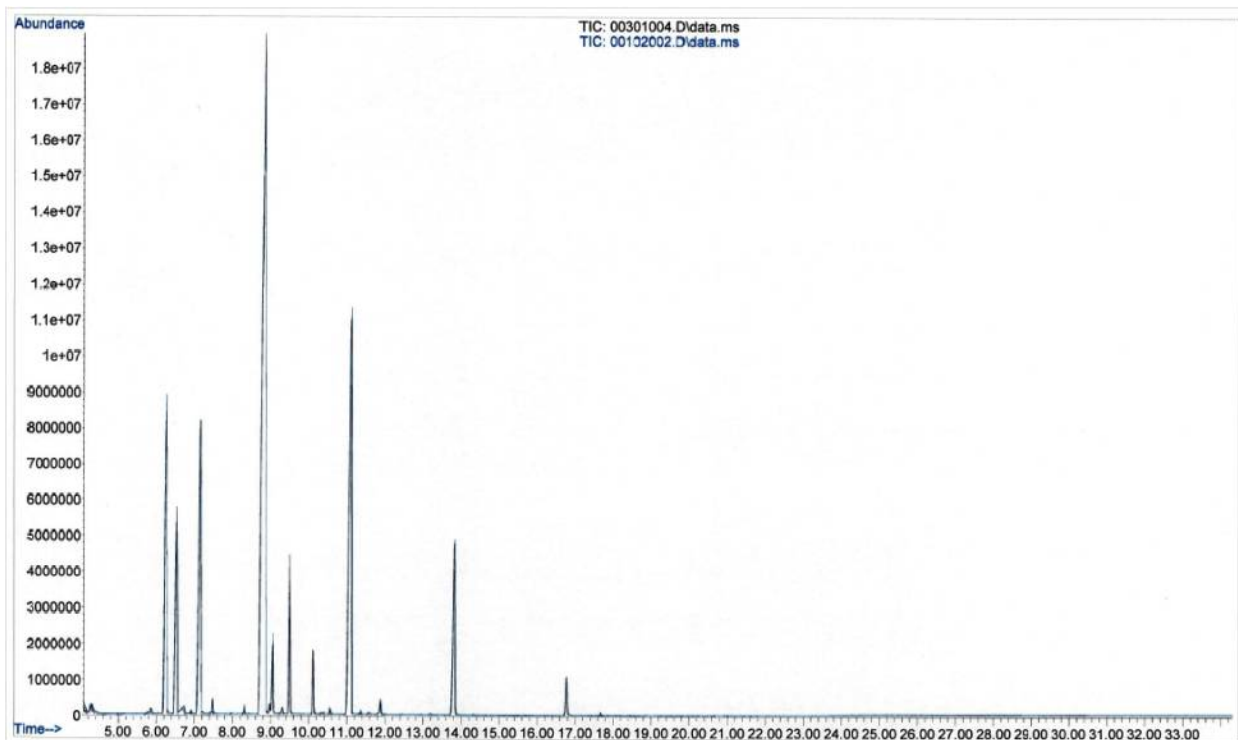
Figure B- 7. GC-MS Spectra for HSF containing EPDM at ambient conditions

Figure B- 8. GC-MS Spectra for HSF containing Neoprene at ambient conditions

Figure B- 9. GC-MS Spectra for HSF containing Silicone at ambient conditions

Figure B- 10. GC-MS Spectra for HSF containing SBR at ambient conditions

Figure B- 11. GC-MS Spectra for SAE J1703 fluid containing EPDM at 40 °C

Figure B- 12. GC-MS Spectra for SAE J1703 fluid containing Neoprene at 40 °C
