Field Demonstration of Propane  
Biosparging for *In Situ* Remediation  
of N-Nitrosodimethylamine (NDMA) in Groundwater

ESTCP Project ER-200828

DECEMBER 2015

Paul B. Hatzinger, Ph.D.  
David Lippincott, P.G.  
**CB&I Federal Services, LLC.**

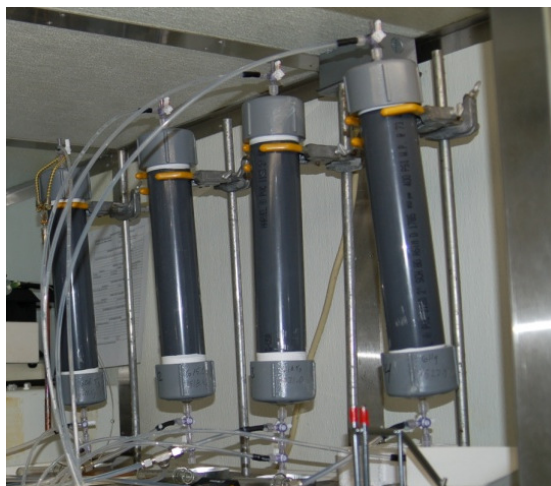
**Figure 5-6. Flow-through model aquifer columns used to evaluate NDMA biodegradation in site materials.**

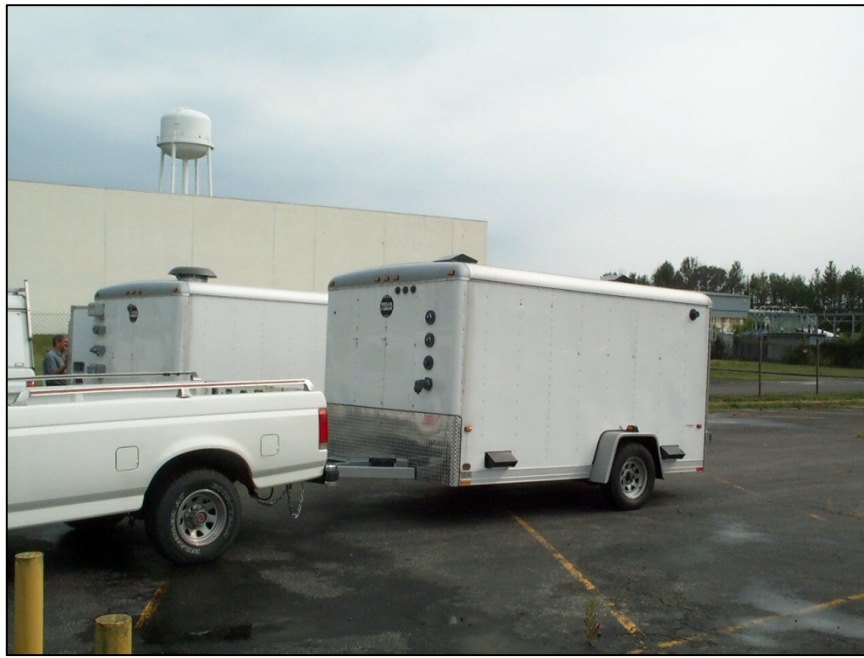
**Figure 5-18. Photograph of biosparge trailer units.**

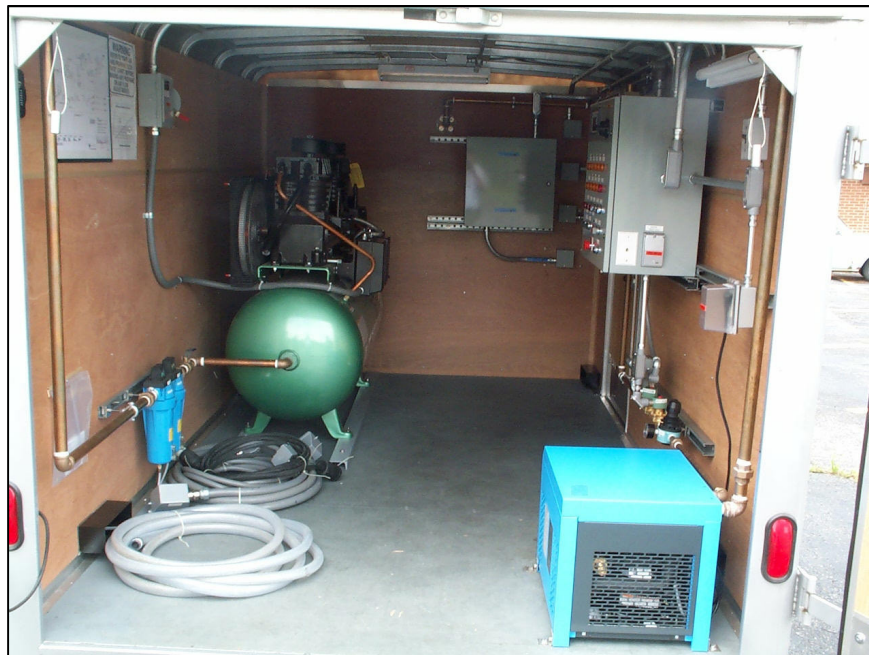
**Figure 5-19. Inside of Trailer #1 which houses the controls and air supply system.**

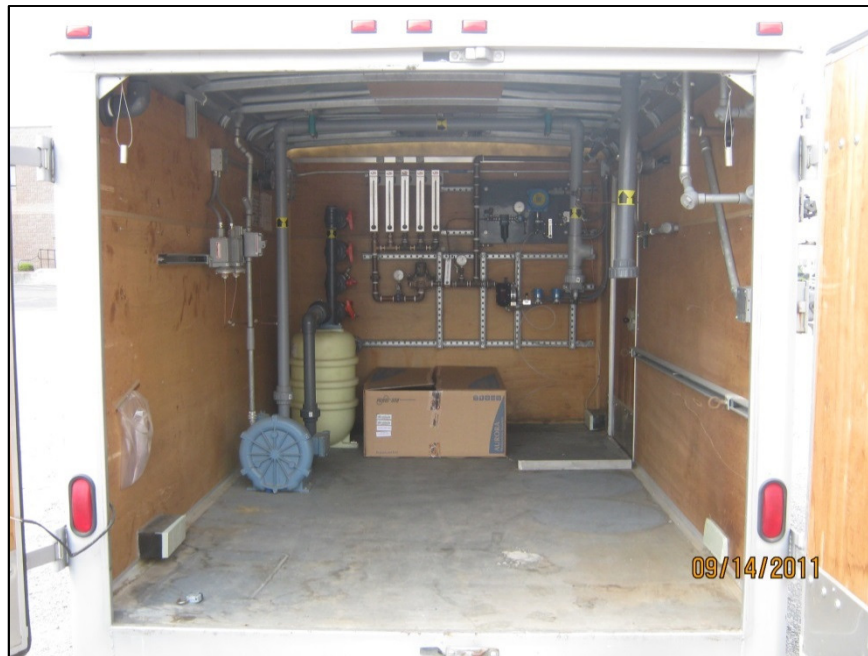
**Figure 5-20. Inside of Trailer # 2, which houses the propane feed and distribution as well as SVE equipment.**
