Determination of NRHP Eligibility for Buildings 28414, 32100, 33800, 36300, and 36302 at Fort Gordon, Georgia

Includes a Criteria Consideration G Evaluation of the 1988 Barracks Complex

Final Report

Under Project 450904, "NHPA Building Evaluations at Fort Gordon"

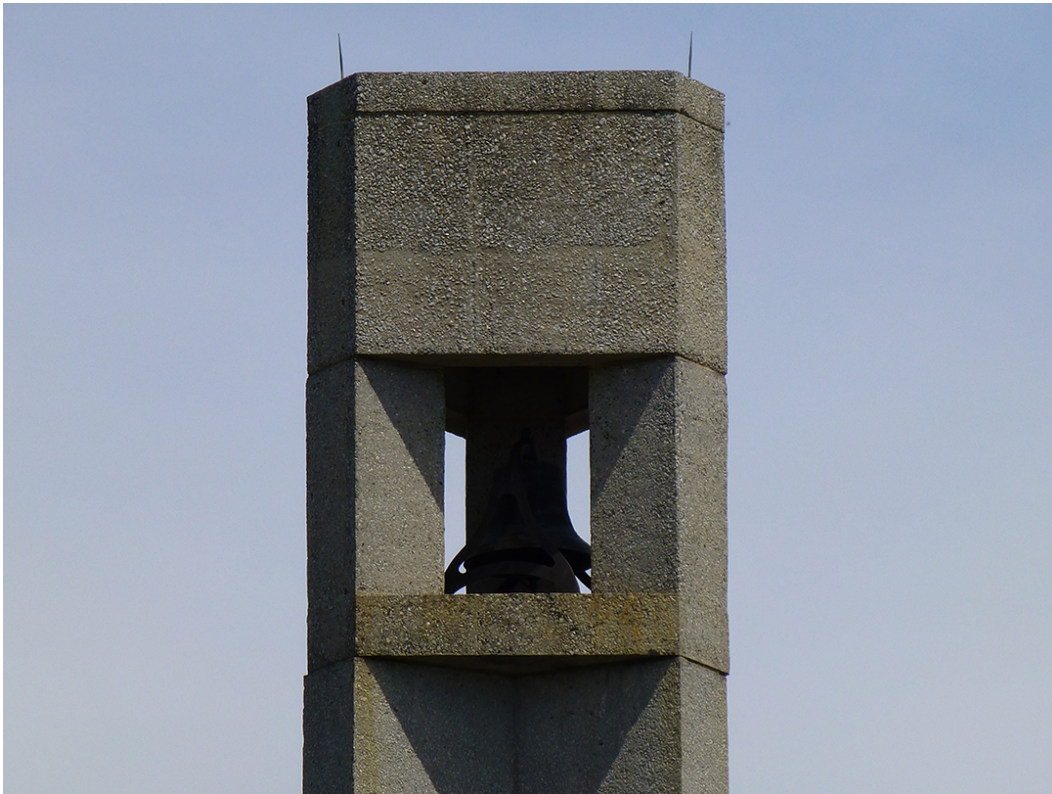
Figure 25. Detail of the top of the carillon tower on Building 28414 at Fort Gordon, GA (ERDC-CERL, 2015).

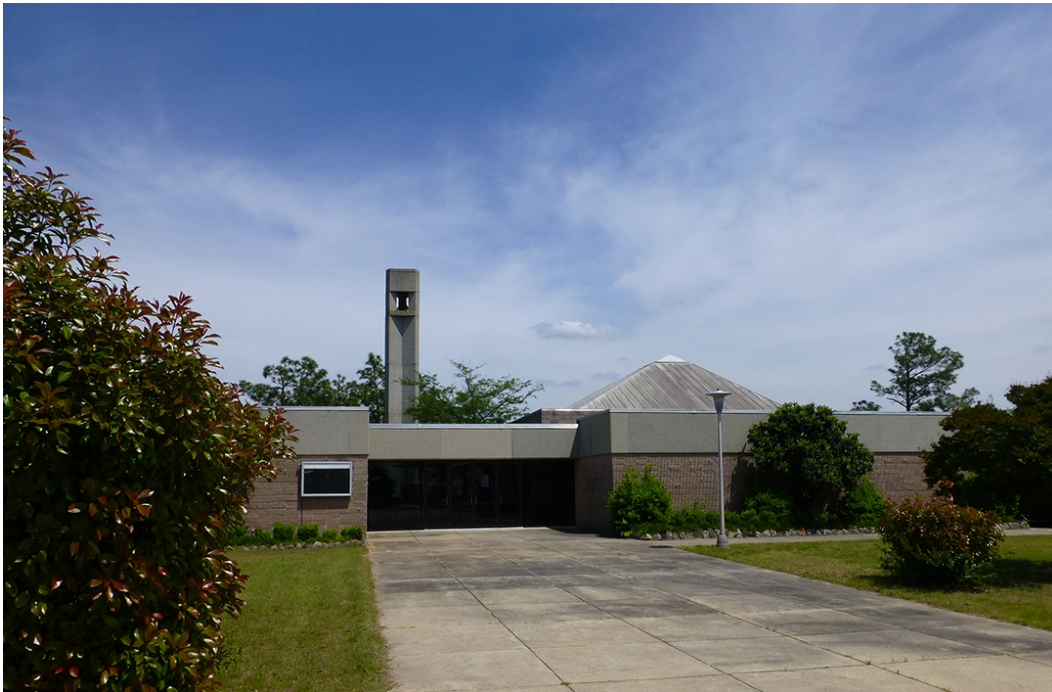
The west (front) elevation of the chapel faces 28th Street, and a wide concrete sidewalk leads to the main entry (Figure 26). The main entry bay is located near the left side of the elevation and is recessed from the left and right sides of elevation. The entry consists of a wall of replacement anodized-bronze aluminum and plate-glass doors and large fixed-pane sidelights. The split-rib concrete block wall has a bright-aluminum display case placed just to the left of the entry bay.

Figure 26. West (front) elevation of Building 28414 at Fort Gordon, GA (ERDC-CERL, 2015).

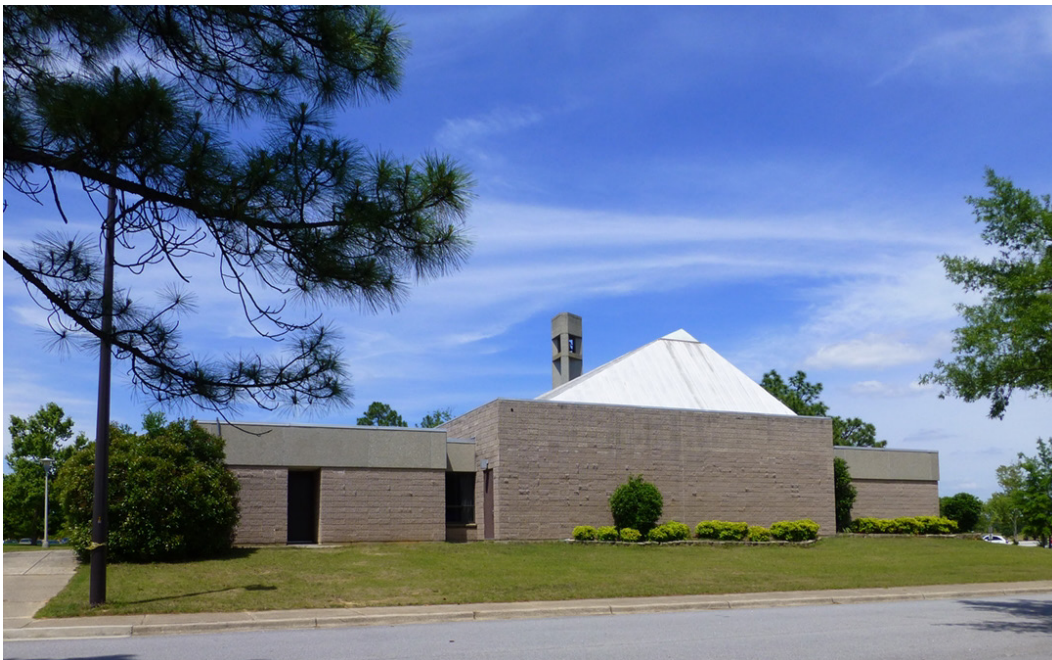
The south elevation faces a paved parking lot. The middle of the elevation projects outward slightly from the left and right sides of the building (Figure 27). There is a single-entry door and one window located on the left side of the elevation.

Figure 27. South elevation of Building 28414 at Fort Gordon, GA (ERDC-CERL, 2015).

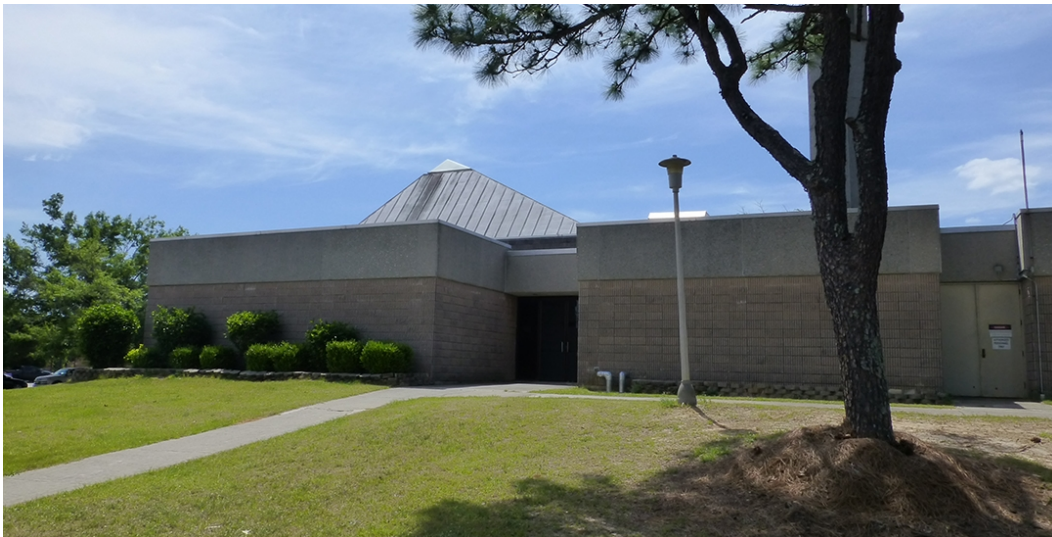
Figure 29. Northwest oblique of Building 28414 at Fort Gordon, GA (ERDC-CERL, 2015).

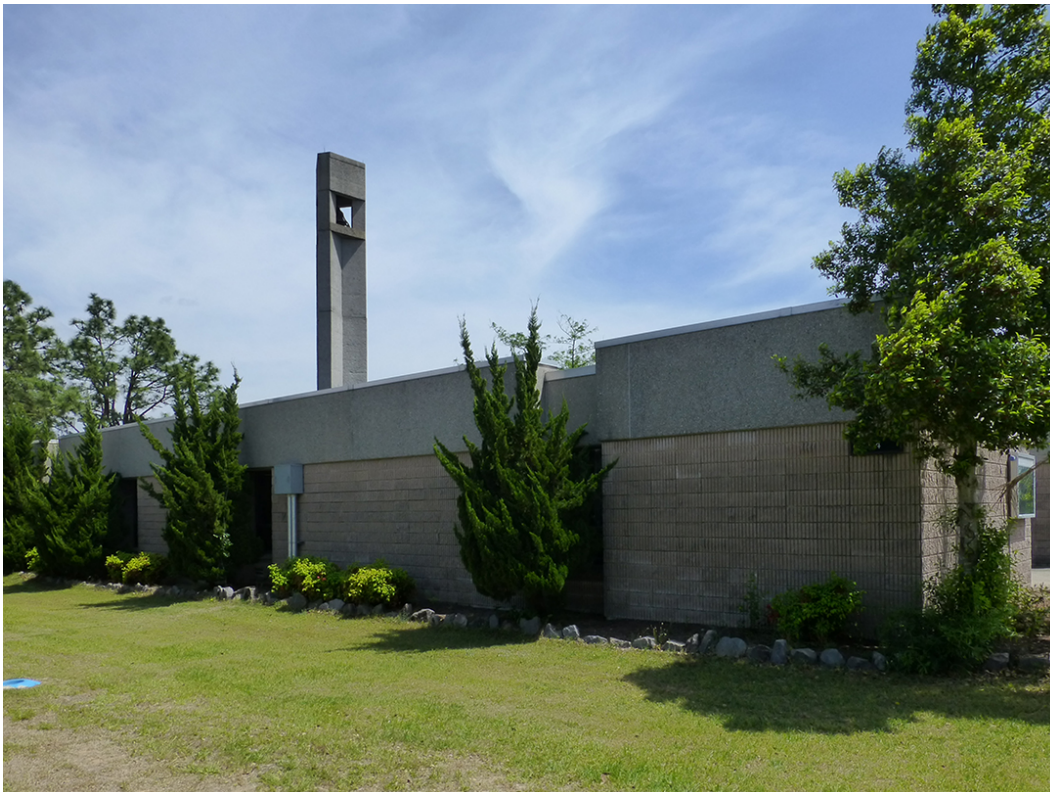
The chapel's north elevation faces Brainard Avenue. There are two recessed bays—one located on the left side and one on the right side of the elevation—that each have original bright-aluminum one-over-one awning windows (Figure 30). There are two more window bays located on this elevation that are flush with the concrete wall. These windows are replacement anodized-bronze aluminum-framed windows.

Figure 30. North elevation of Building 28414 at Fort Gordon, GA (ERDC-CERL, 2015).

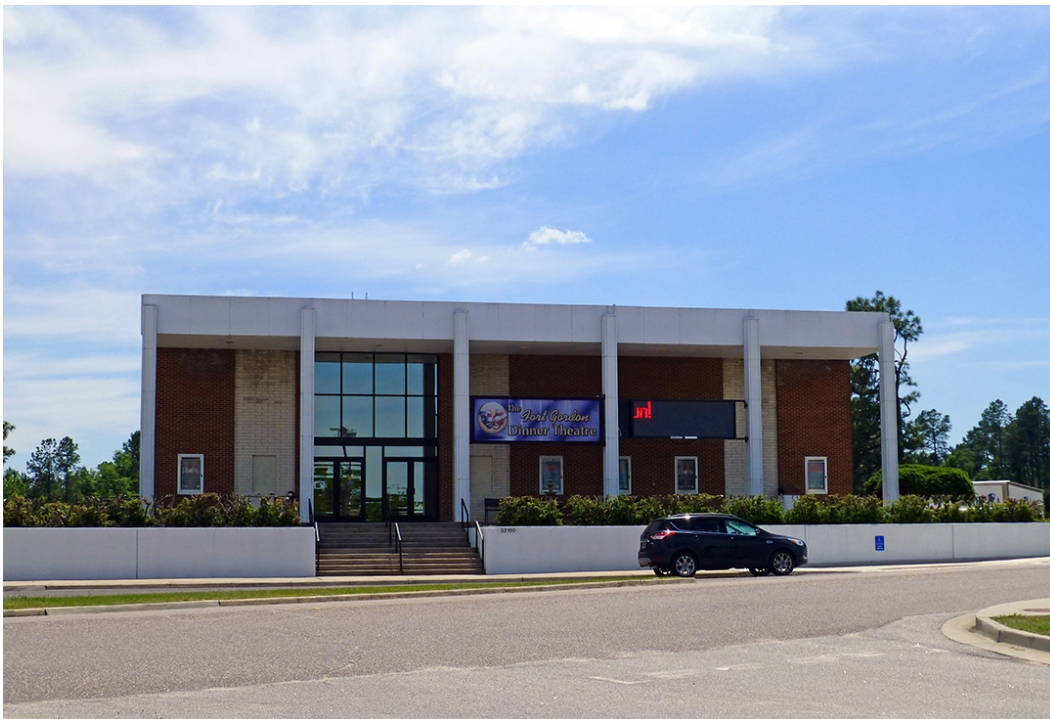
located in front of the building. The exterior wall of the front elevation is mostly red brick veneer; however, three large vertical sections of the wall are white brick laid in a running bond. Two of the vertical sections frame the entry, while the third is located on the right side of the elevation. Two sets of double-entry anodized-aluminum and plate-glass doors are located slightly to the left of center of the elevation (Figure 39). Above the doors are two large plate-glass windows. There are six poster display windows spaced across the front elevation (Figure 40). There are five original, round, light fixtures located on the underside of the portico.

Figure 36. Looking southwest at the front of Building 32100 at Fort Gordon, GA (ERDC-CERL, 2015).

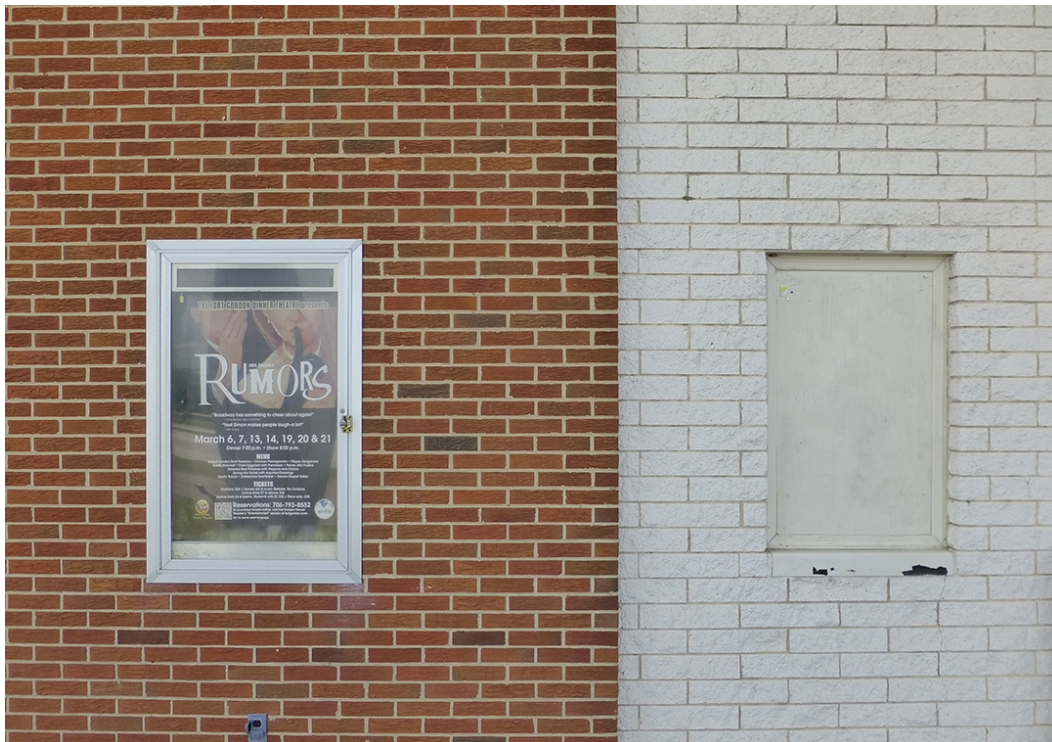
Figure 40. Detail of the different brick and the movie poster cases on the front of Building 32100 at Fort Gordon, GA (ERDC-CERL, 2015).

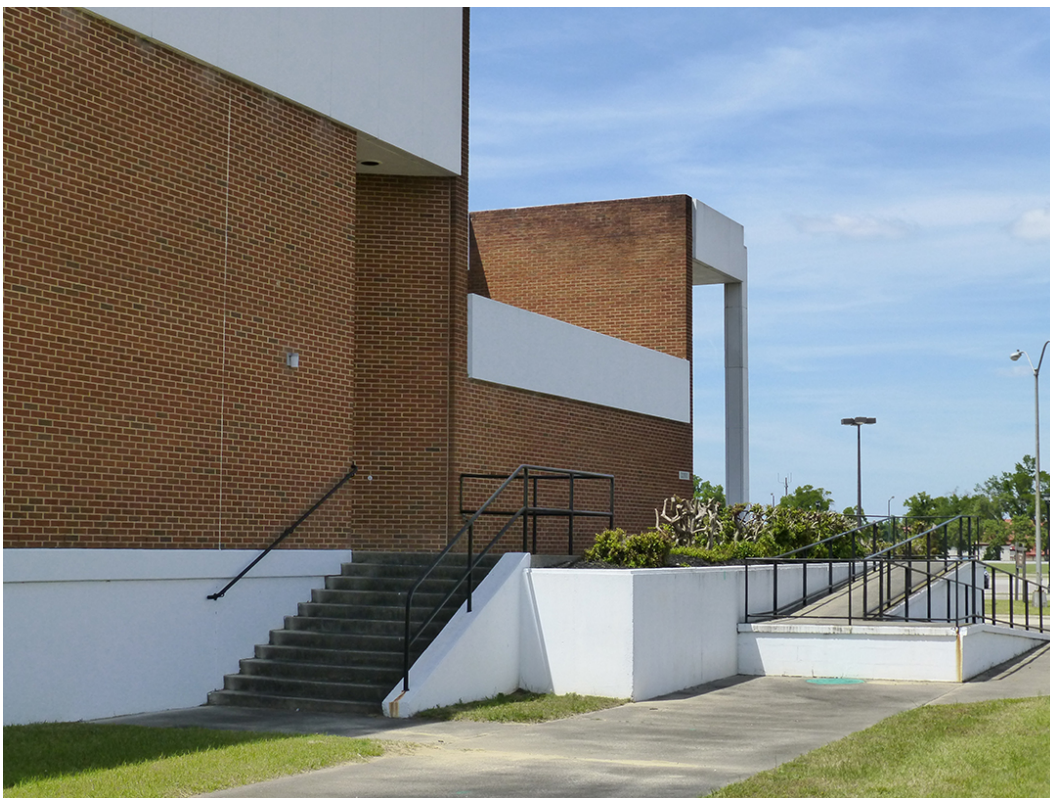
Figure 42. Looking southeast at Building 32100 at Fort Gordon, GA, with the lobby at left and auditorium on the right (ERDC-CERL, 2015).

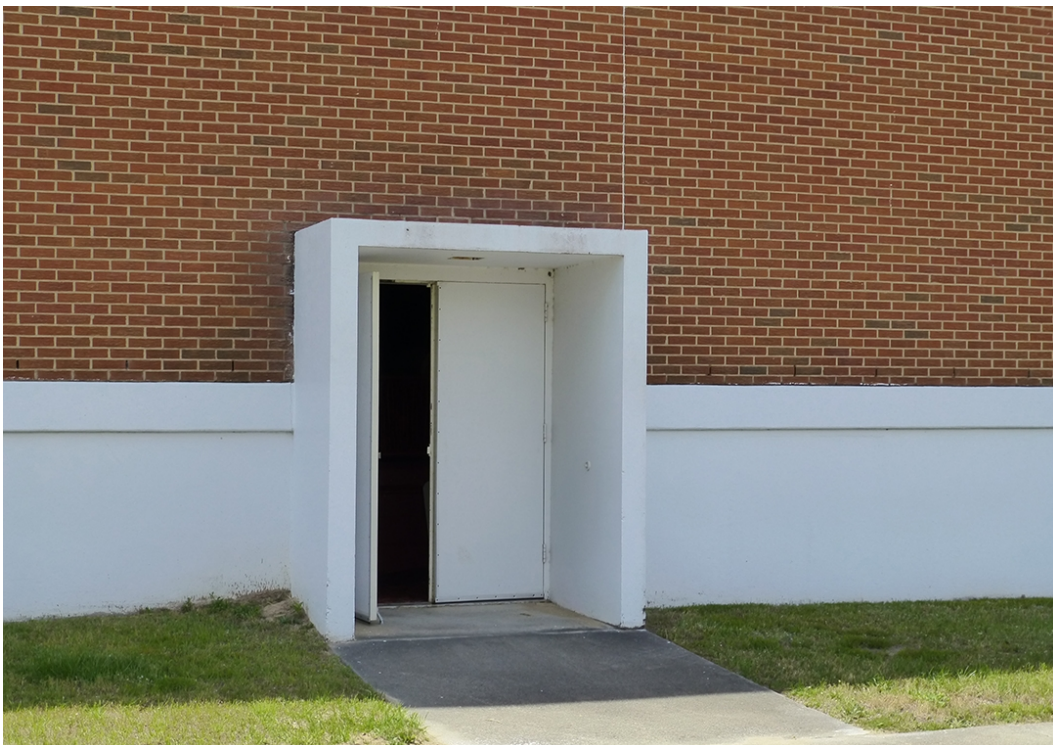
The northwest and southeast (side) elevations mirror each other. Neither elevation has windows. Two different roof heights define the side elevations. The portico area, located on the right side of the southeast elevation and the left side of the northwest elevation, is shorter in height than either of the roof heights. The architectural cast-stone panels are used as a parapet detail on the exterior of these two walls. Cast-in-place concrete planters are located on both elevations near the portico (Figure 41). The northwest and southeast elevations have two side entries each into the building. A large egress from the auditorium is on either side (Figure 42) that is inset into the brick wall. The other two exits are set within cast-in-place concrete wind protector walls located around replacement metal doors (Figure 43).

Figure 43. Emergency exit door from the auditorium on the southeast side of Building 32100 at Fort Gordon, GA (ERDC-CERL, 2015).

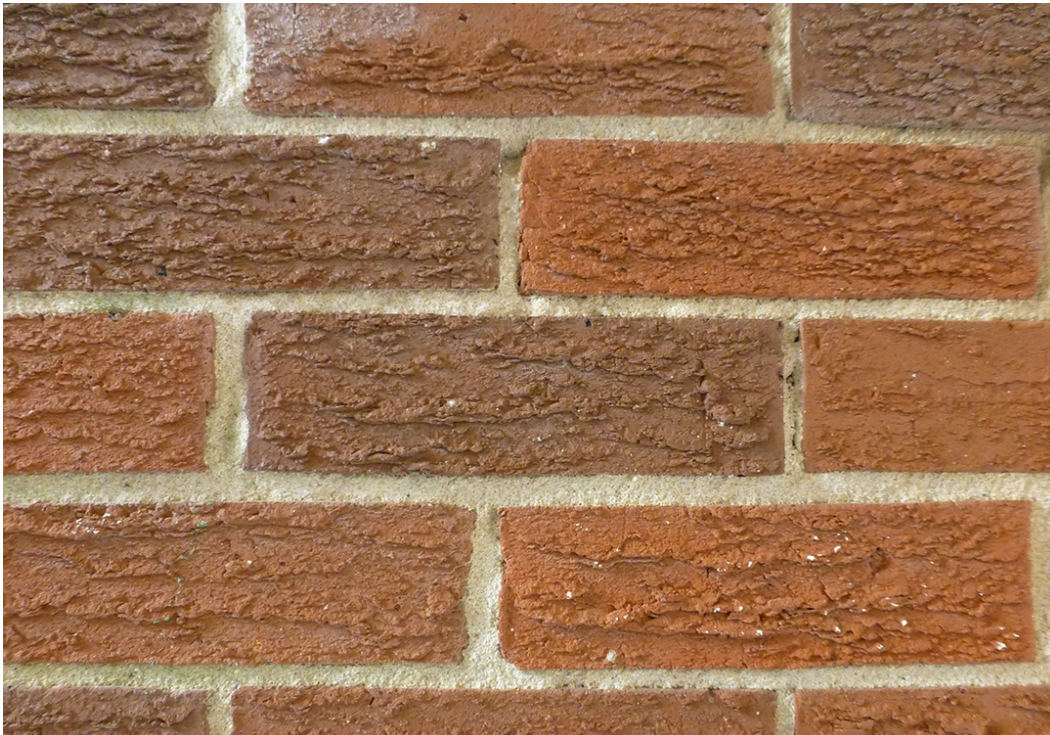
The overall footprint is complex, with a combination of two distinct L-shaped structures joined together. The north L-shaped structure is one-story in height, has a flat roof with a stucco panel fascia system, exterior walls clad with textured brick veneer (Figure 45), bright aluminum-framed windows with panel inserts, and bright-aluminum and plate-glass entry doors. The south L-shaped structure's design consists of a three-story mass designed in a Mid-Century Modern mundane style with three-story brick panels separated from three-story bright-aluminum window frames and stucco spandrels by an inset/projecting textured brick detail (Figure 46). A concrete sunshade projects out over the third floor windows (Figure 47). This part of the building has a flat roof with a parapet. The south and west wings have external concrete switchback staircases that have a brick supporting wall and a concrete shed roof over the top-floor opening. At some point, chain link fence panels were added to the openings between the concrete panels.

Figure 45. Detail of the textured red brick utilized on the exterior of Building 33800 at Fort Gordon, GA (ERDC-CERL, 2016).

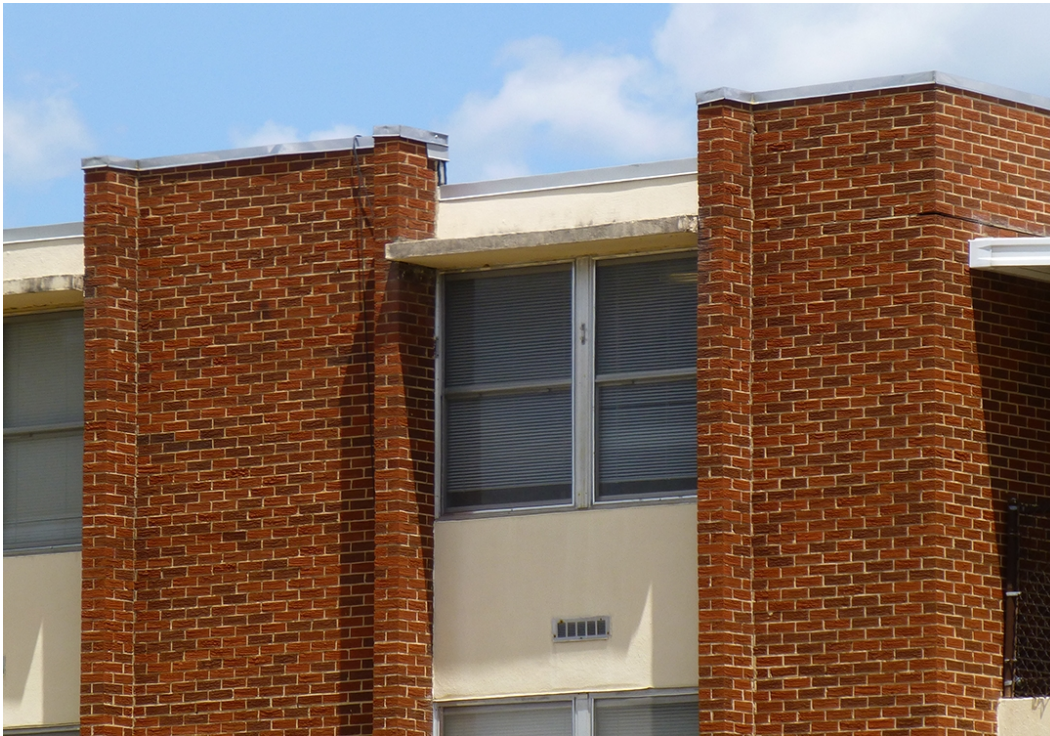
Figure 46. Detail of the bright-aluminum windows, stucco spandrels, and red brick detailing of Building 33800 at Fort Gordon, GA (ERDC-CERL, 2016).

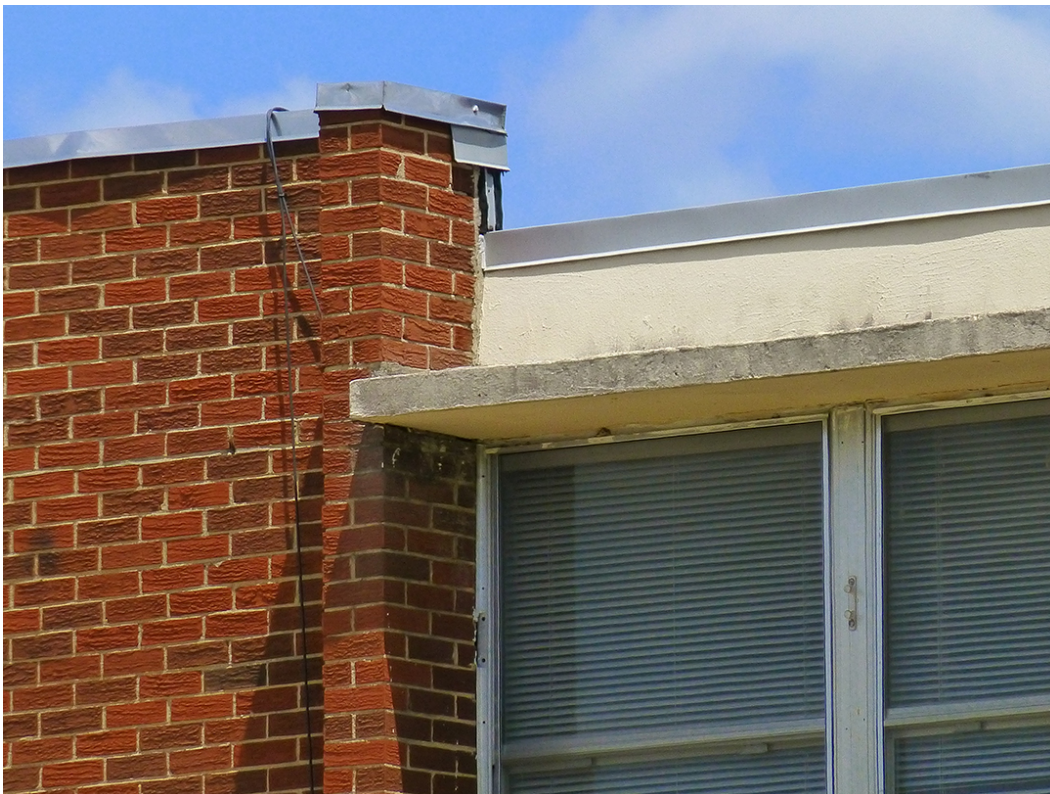
Figure 47. Detail of the concrete canopy above one of the third-floor windows on Building 33800 at Fort Gordon, GA (ERDC-CERL, 2016).

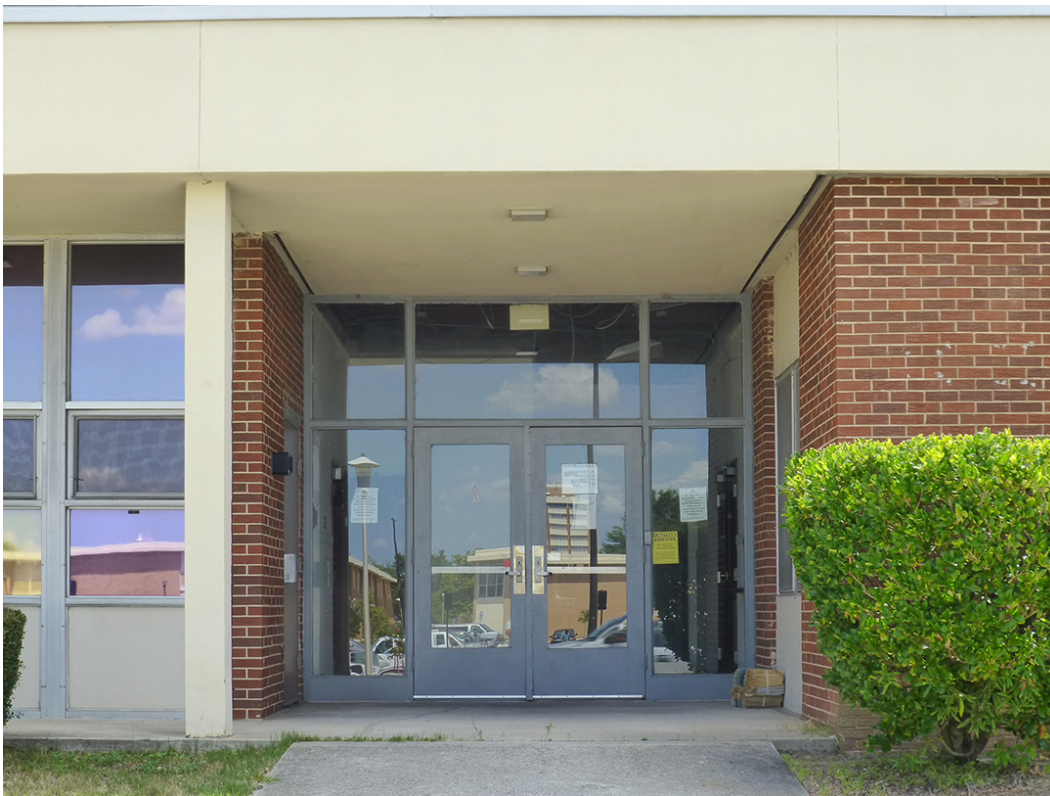
Figure 51. Looking at main entrance on the west side (front) of Building 33800 at Fort Gordon, GA (ERDC-CERL, 2016).

North L-shaped structure (one-story): The west (front) elevation faces 8th Street and is defined by a wall of bright aluminum-framed three-pane windows with panel inserts. This window bay is located in the middle of the elevation and is slightly recessed under the concrete fascia system overhang that is supported by concrete posts (Figure 48). This detail creates a colonnade along the west elevation that ends on the north at an original bright-aluminum and plate-glass door that leads into the former mess hall (Figure 49 and Figure 50). The main entry is recessed farther back than the window bay and consists of replacement steel and glass doors, sidelights, and transom (Figure 51). A bright-aluminum display case is located on the adjacent wall just to the right of the entry.

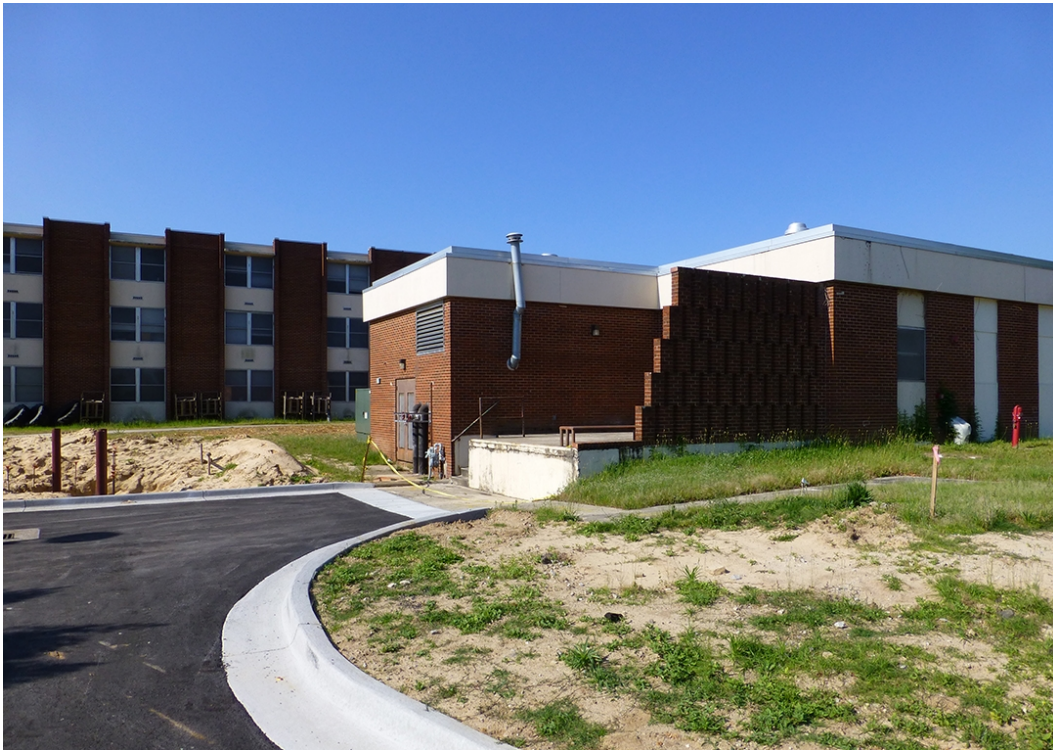
Figure 52. Looking at the loading dock and original perforated block wall on the north side of Building 33800 at Fort Gordon, GA (ERDC-CERL, 2015).

The north elevation of the north L-shape is defined by a repetitive pattern of narrow vertical strips of brick and stucco panels/bright-aluminum windows (Figure 52). The majority of the original windows have been removed and filled with stucco panels. There is an original bright-aluminum and plate-glass entry door flanked by an original window with panels that is located on the north elevation (Figure 54). The far left side of the elevation exhibits an original perforated brick wall that hides the concrete loading dock behind it (Figure 53).

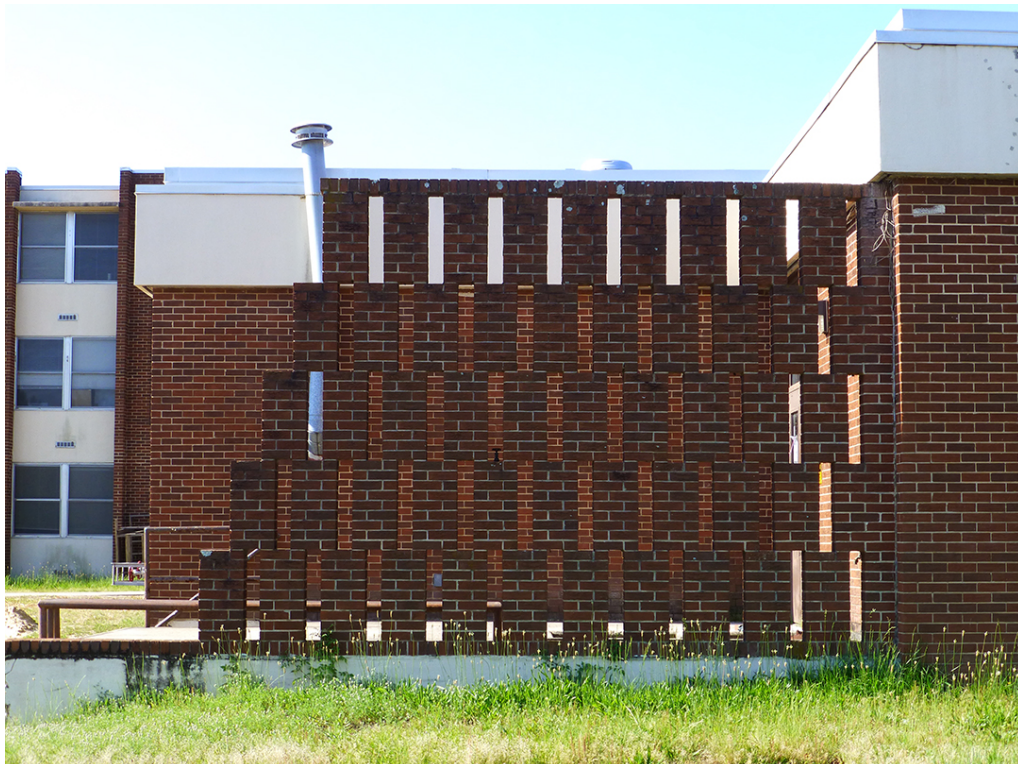
Figure 53. Close-up of original perforated block wall on the north side of Building 33800 at Fort Gordon, GA (ERDC-CERL, 2015).

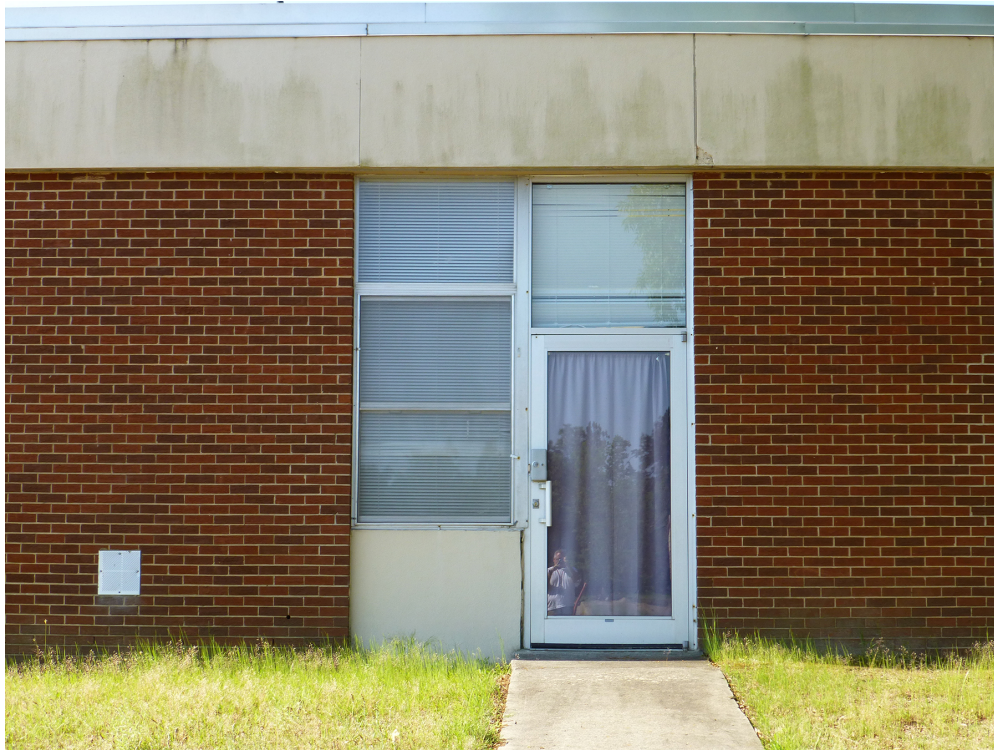
Figure 54. Original bright-aluminum plate-glass door on the north side of Building 33800 at Fort Gordon, GA (ERDC-CERL, 2015).

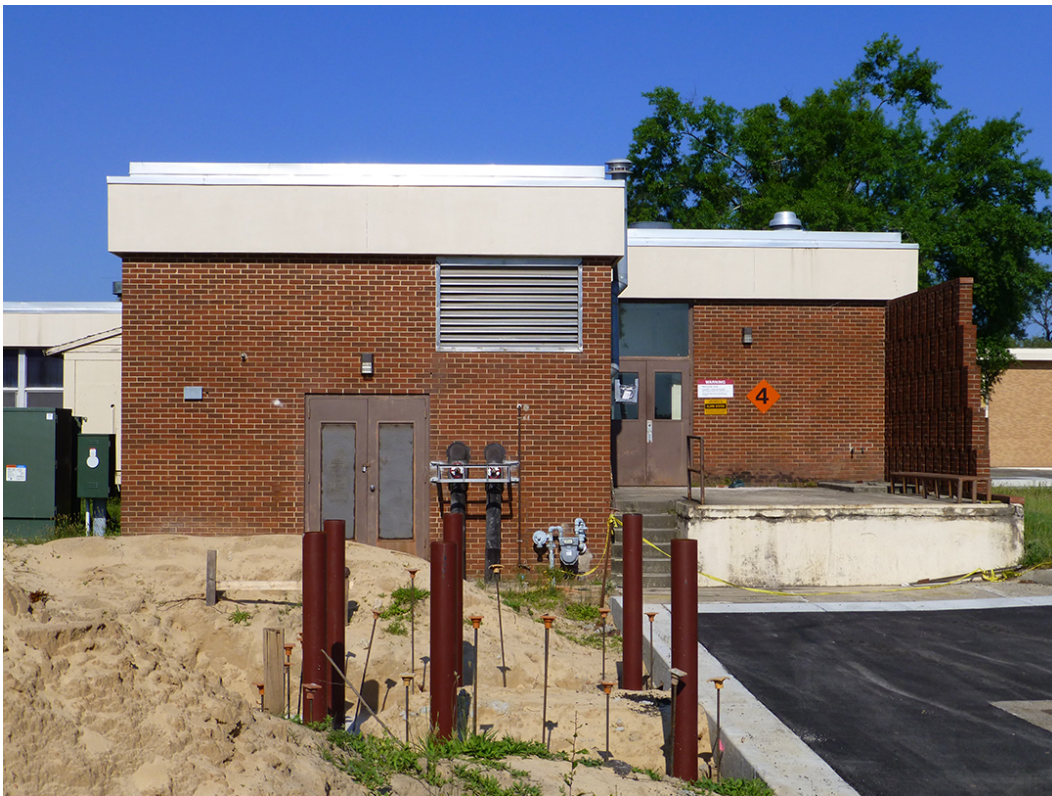
Figure 55. Close-up of loading dock on the east side of Building 33800 at Fort Gordon, GA (ERDC-CERL, 2015).

The east elevation of the north L-shape is two-part. The right side projects outward. A raised concrete loading dock is located on this part of the building (Figure 55). There are two sets of metal entry doors on this part of the elevation; one set is service doors with metal louvered vents located at ground level, the other is a set of metal doors with one light each and a transom above located at the loading dock level. The left side of the east elevation is defined by a curtain wall of original bright aluminum-framed three-pane windows and stucco panels (Figure 56 and Figure 57). A single-entry bright-aluminum door is located on the left side of this elevation near the junction where the two L-shapes join together.

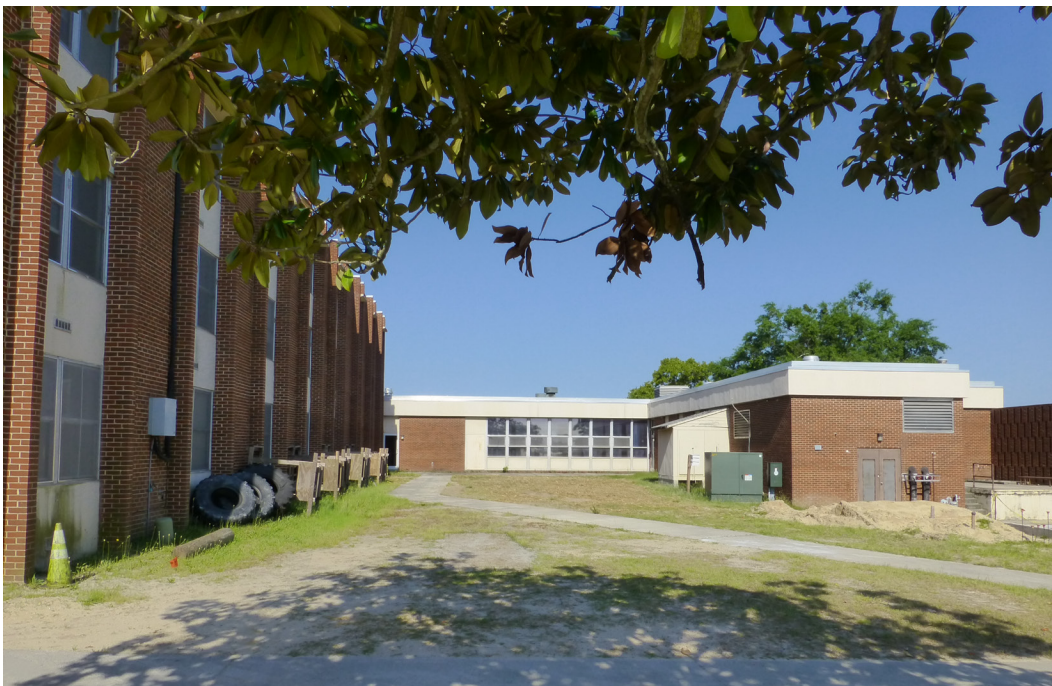
Figure 56. Looking at the east side of Building 33800 at Fort Gordon, GA (ERDC-CERL, 2015).

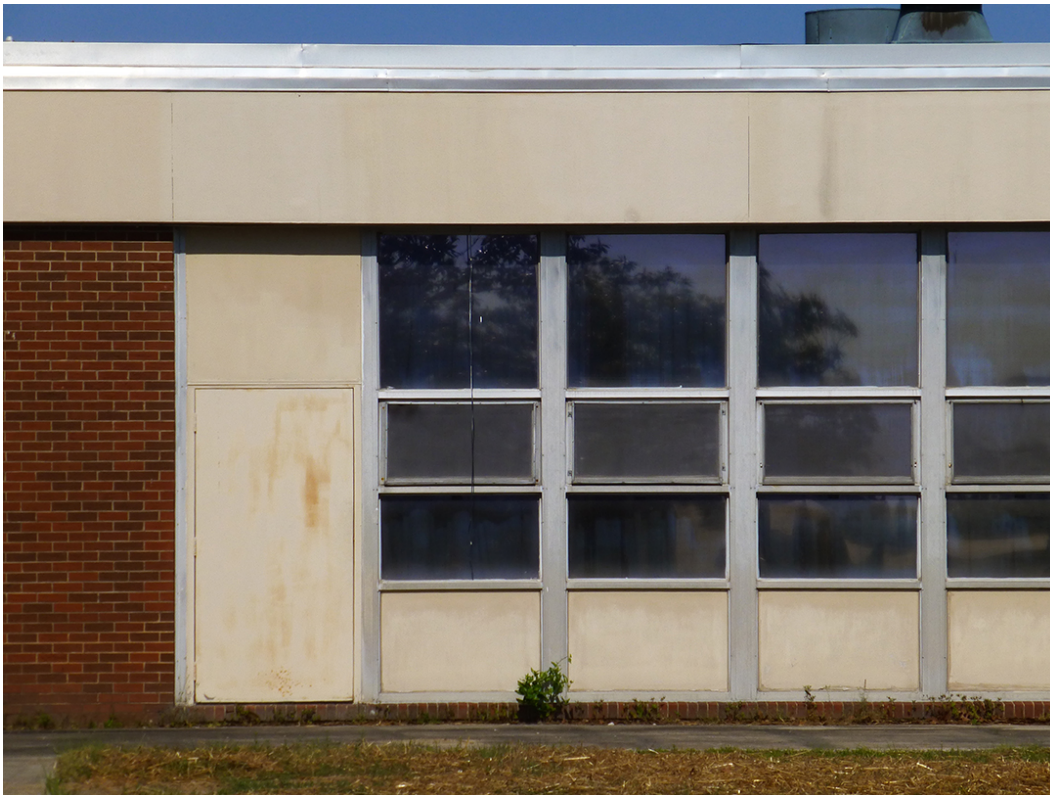
Figure 57. Looking at the original bright-aluminum window system on the east side of the old mess hall of Building 33800 at Fort Gordon, GA [the door on the left is not original] (ERDC-CERL, 2015).

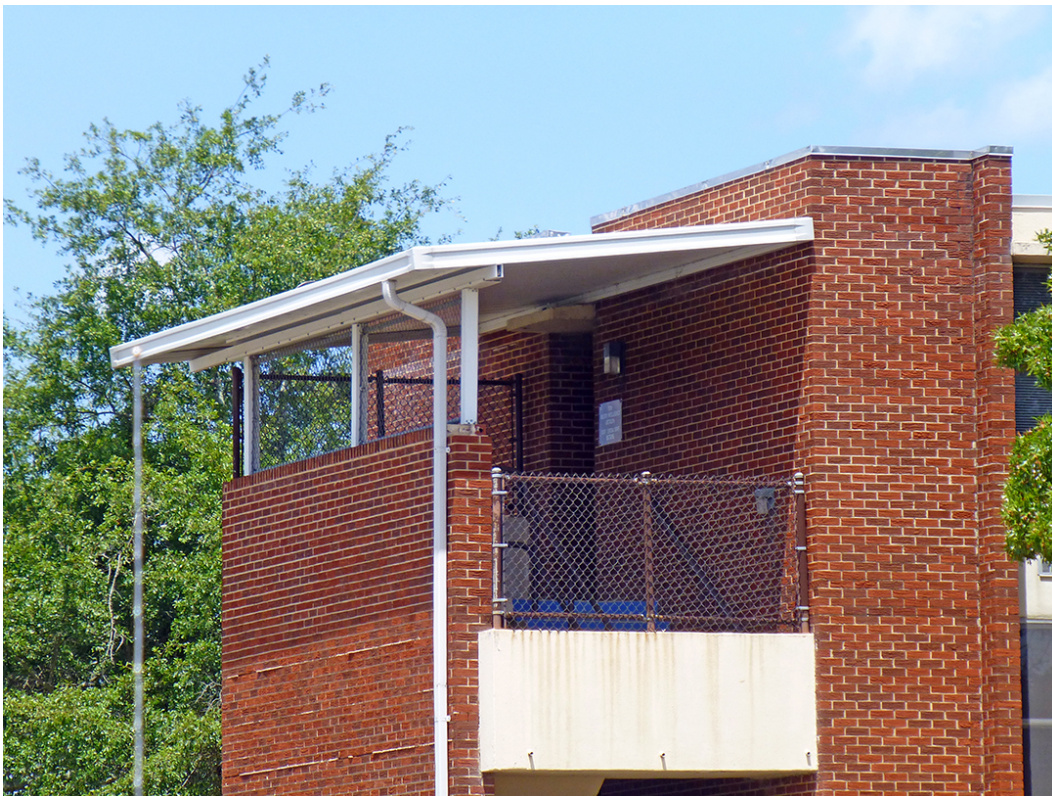
Figure 58. Detail of the external stair tower on the south side of Building 33800 at Fort Gordon, GA, showing the non-original roof and chain link (ERDC-CERL, 2016).

South L-shaped structure (three-stories): The west elevation faces 8th Street and has five narrow strips of single windows/stucco panels separated by the brick bay detail. The south elevation is two-part and faces a paved parking lot. The left side of the elevation projects outward and is where one of the two exterior staircases is located (Figure 58). The right side of the elevation has a repetitive pattern of tall vertical bays of six bays of brick and six bays of bright-aluminum windows/stucco panel combination (Figure 59). The windows are set in pairs on this elevation.

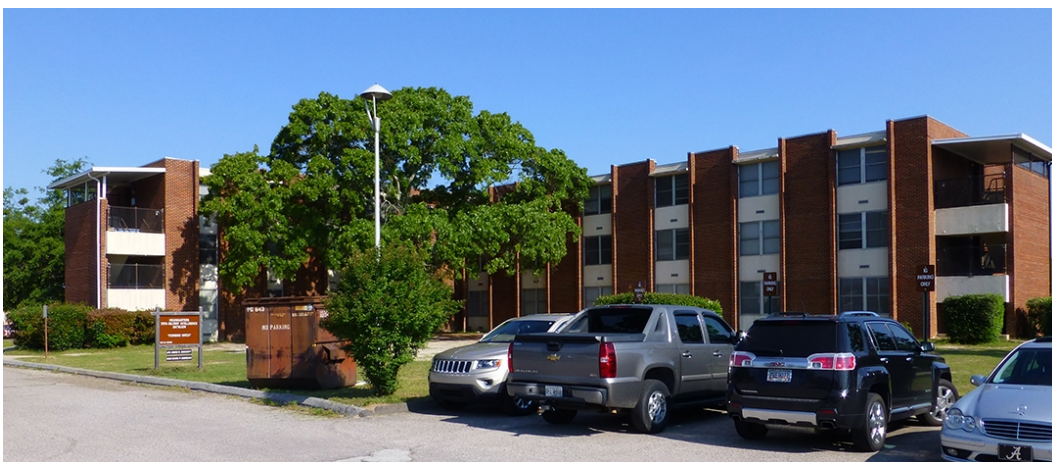
Figure 59. Southeast oblique of the three-story L-shaped leg of Building 33800 at Fort Gordon, GA (ERDC-CERL, 2015).

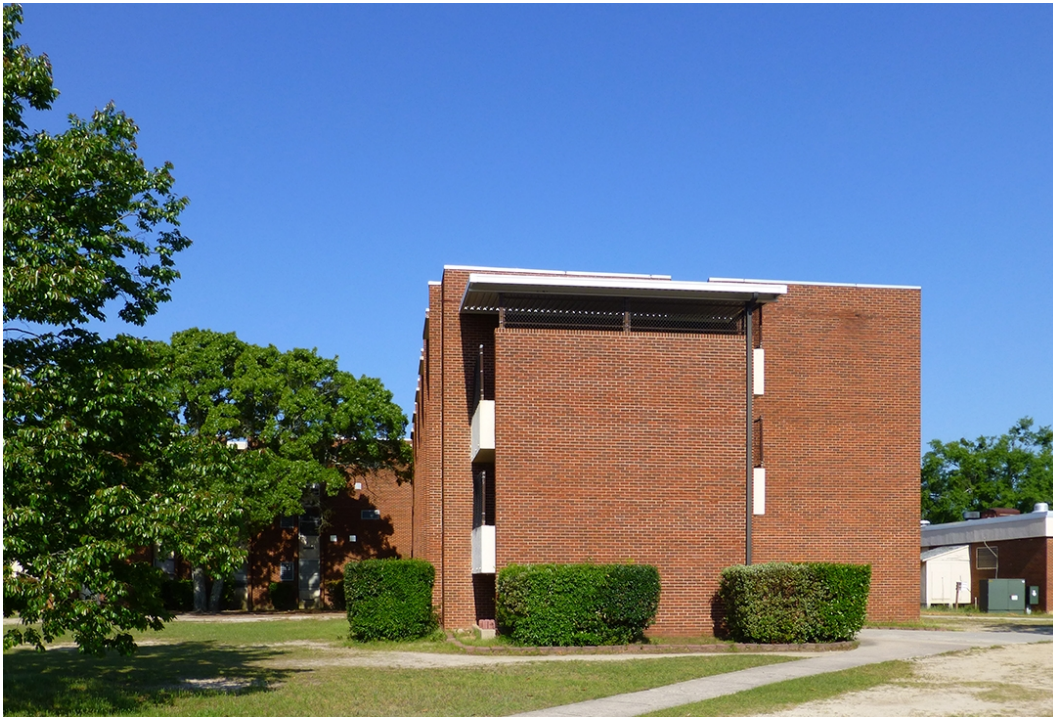
Figure 60. Looking at the external stair tower on the east side of Building 33800 at Fort Gordon, GA (ERDC-CERL, 2015).

The east elevation is two-part, with the left side recessed. This part of the elevation has five narrow strips of single windows/stucco panels separated by the brick bay detail. The right side of the elevation projects outward and is capped off with the second exterior staircase enclosure (Figure 60 and Figure 61).

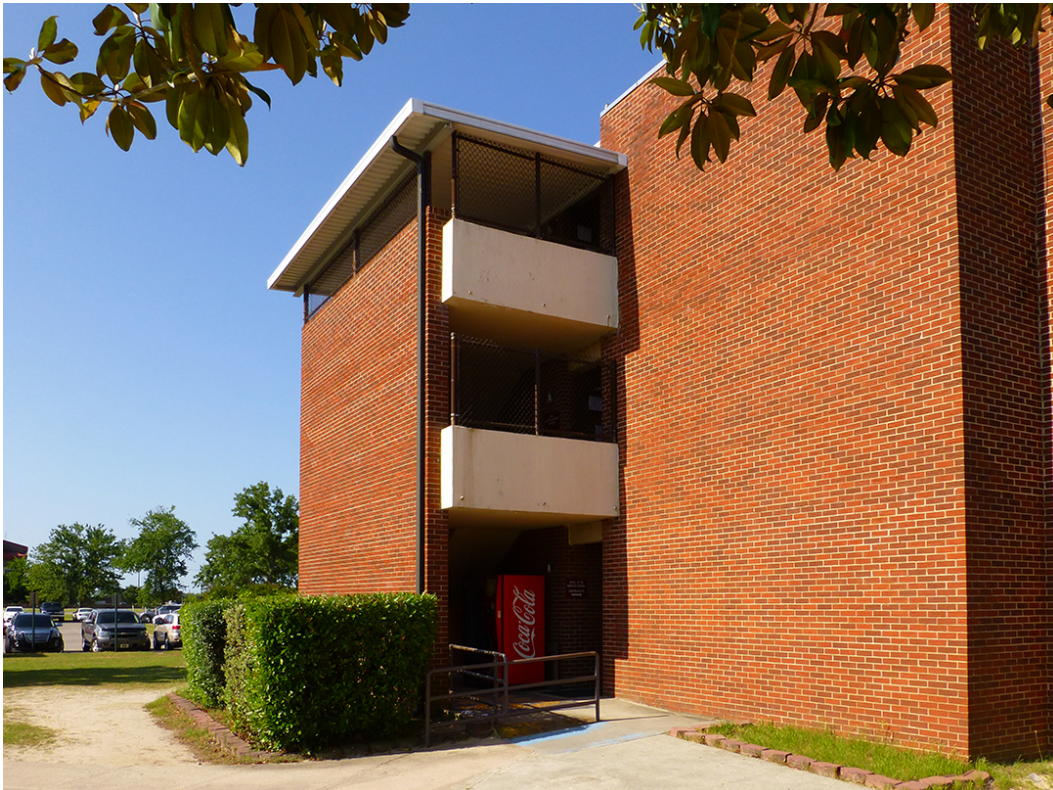
Figure 61. Detail of the external stair tower on the east side of Building 33800 at Fort Gordon, GA, showing the non-original roof and chain link (ERDC-CERL, 2015).

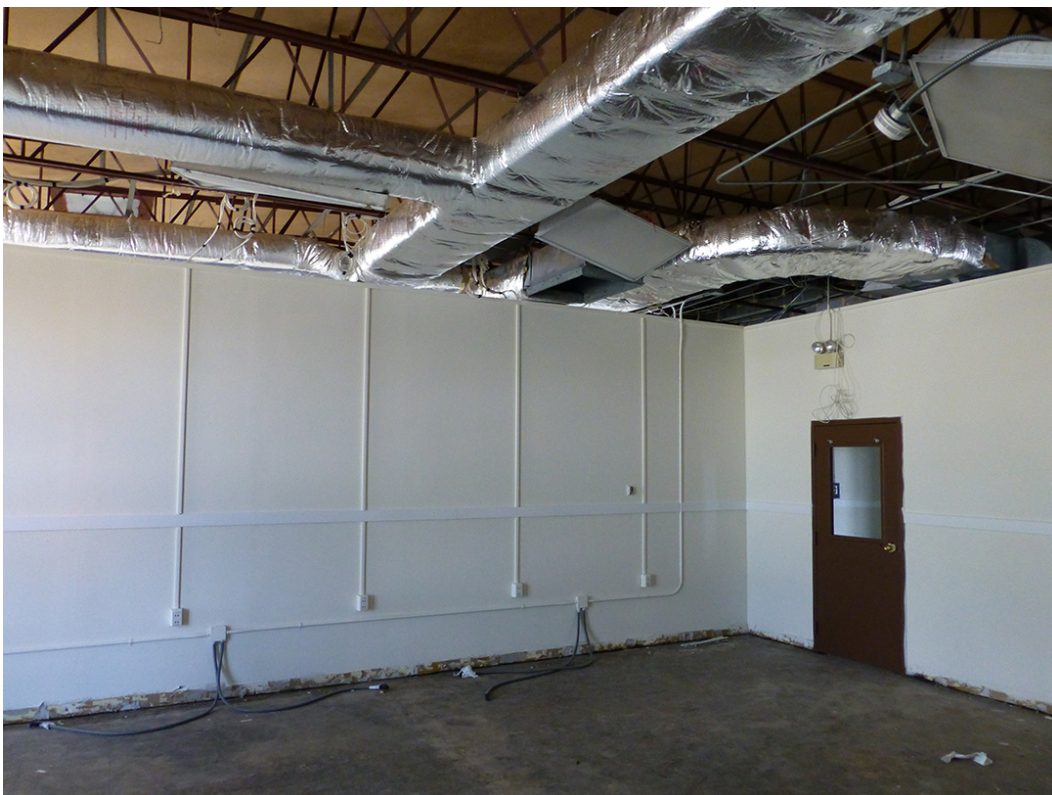
Figure 65. Example of the non-original walls inside the former mess hall of Building 33800 at Fort Gordon, GA (ERDC-CERL, 2016).

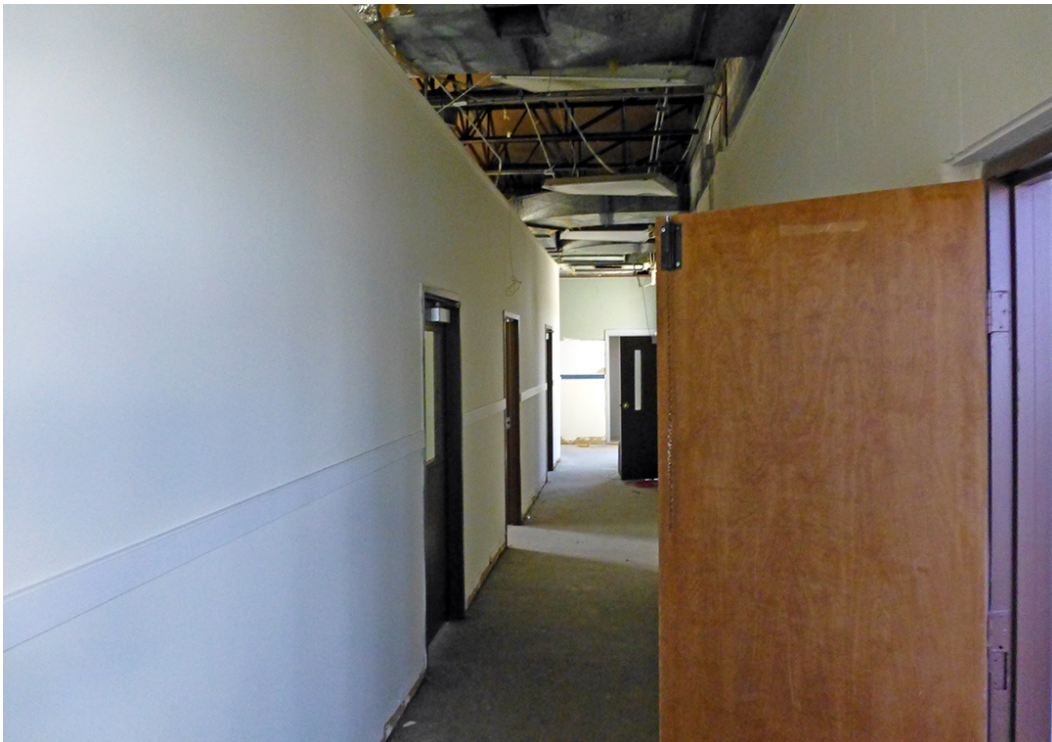
Figure 66. Example of the non-original walls inside the former mess hall of Building 33800 at Fort Gordon, GA (ERDC-CERL, 2016).

The mess hall for the enlisted women's barracks was on the west side of the building in a one-story wing. The front doors faced west. Inside the front doors was a lobby (Figure 62), with office space to the south (Figure 63) and a large lounge area to the north (Figure 64). Past the lounge was a mess hall (Figure 65) that was serviced by a kitchen on the east side. The interior was completely transformed in the 1980s when this portion of the building was converted into a childcare facility. None of the original open feeling of the two large rooms was left due to the addition of many drywall-covered walls (Figure 66). The kitchen equipment was removed and the space divided (Figure 67).
