Determination of NRHP Eligibility for Buildings 28414, 32100, 33800, 36300, and 36302 at Fort Gordon, Georgia

Includes a Criteria Consideration G Evaluation of the 1988 Barracks Complex

Final Report

Under Project 450904, "NHPA Building Evaluations at Fort Gordon"

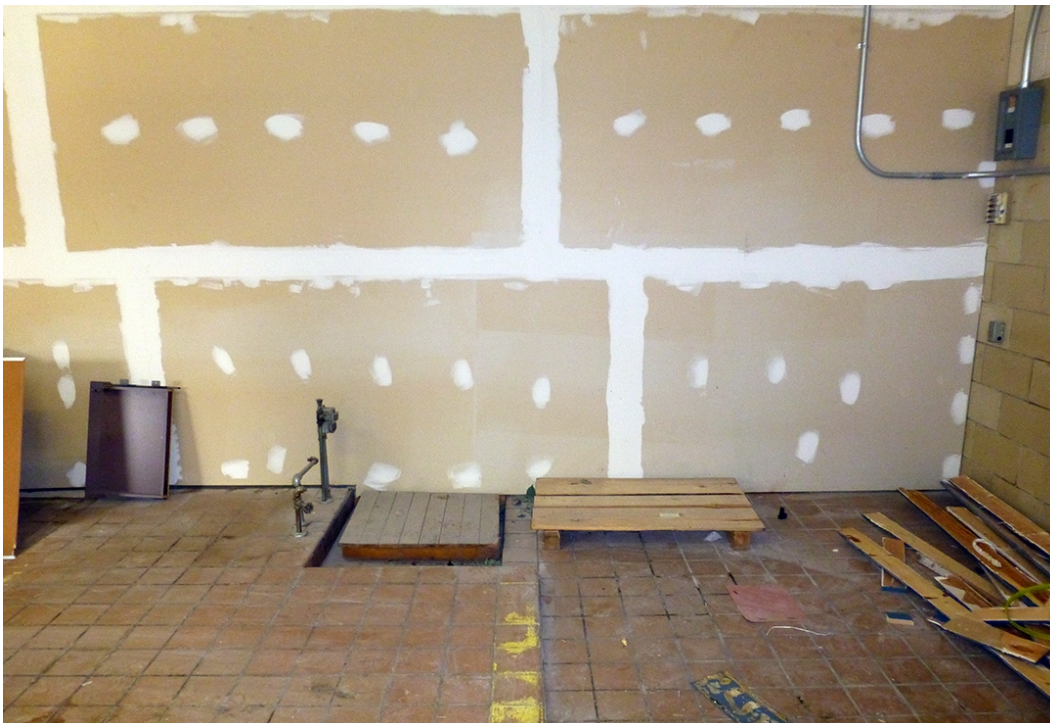
Figure 67. Example of the non-original walls inside the former kitchen of Building 33800 at Fort Gordon, GA (ERDC-CERL, 2016).

The mess hall for the enlisted women's barracks was on the west side of the building in a one-story wing. The front doors faced west. Inside the front doors was a lobby (Figure 62), with office space to the south (Figure 63) and a large lounge area to the north (Figure 64). Past the lounge was a mess hall (Figure 65) that was serviced by a kitchen on the east side. The interior was completely transformed in the 1980s when this portion of the building was converted into a childcare facility. None of the original open feeling of the two large rooms was left due to the addition of many drywall-covered walls (Figure 66). The kitchen equipment was removed and the space divided (Figure 67).

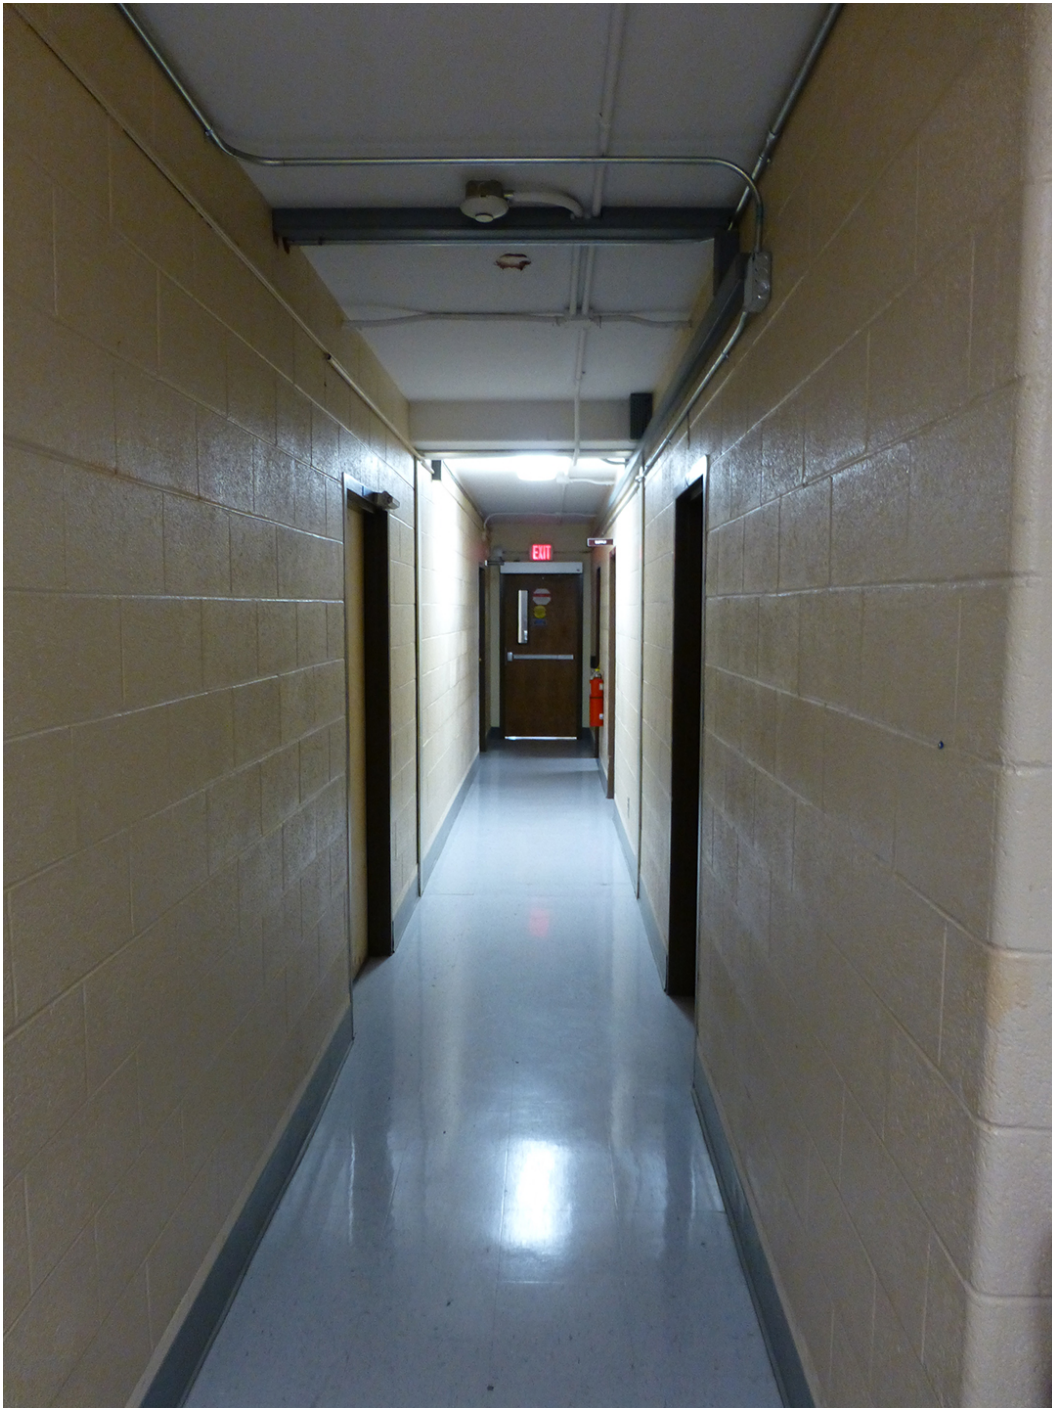
Figure 68. Example of one of the concrete-block hallways on the first floor of Building 33800 at Fort Gordon, GA (ERDC-CERL, 2016).

To the east of the mess hall and office space were the enlisted women's rooms, double-loaded off a central hallway (Figure 68). The walls between the rooms and the walls between the rooms and hallway were concrete block. The hallway had a telephone alcove (Figure 69).

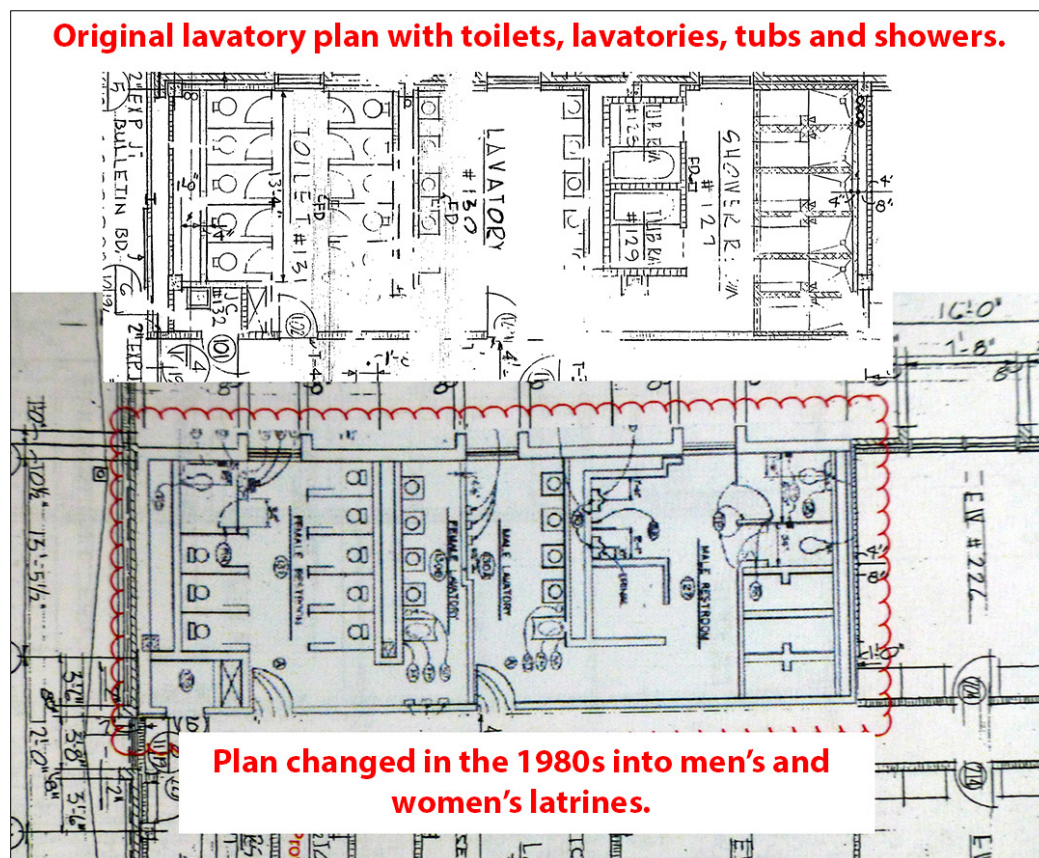
Figure 71. View of one the original tubs in the men's latrine on the first floor of Building 33800 at Fort Gordon, GA (ERDC-CERL, 2016).

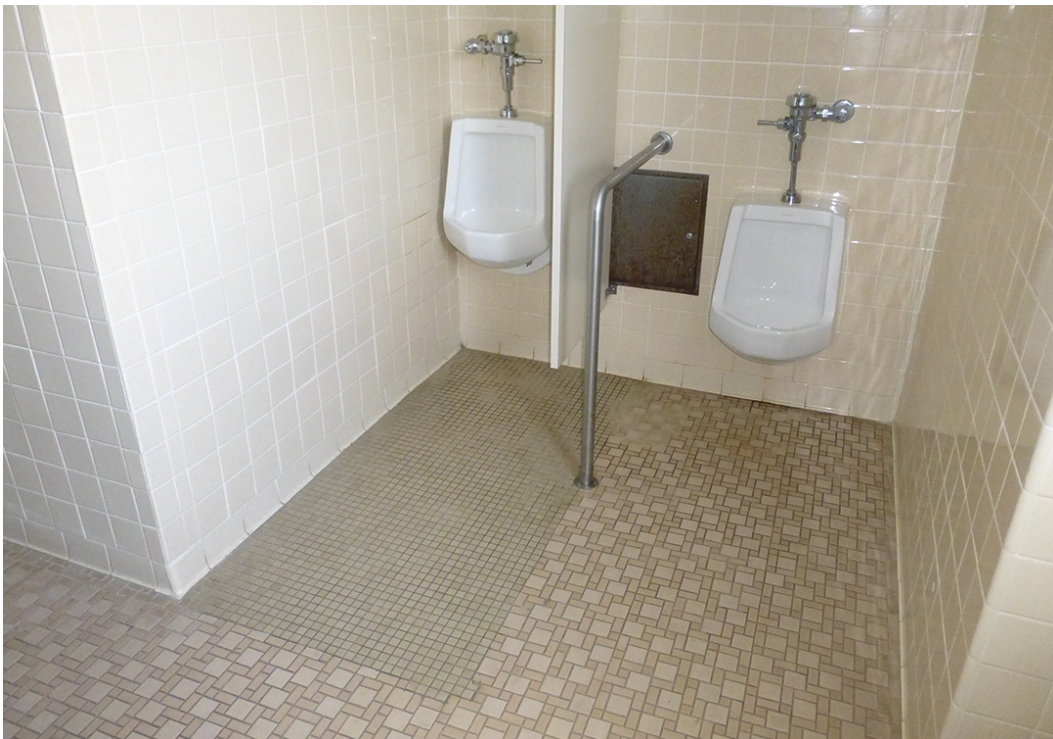
Figure 74. View of how the second tub area has been transformed with the removal of the tub and the addition of urinals in the men's latrine on the first floor of Building 33800 at Fort Gordon, GA (ERDC-CERL, 2016).

The men's and women's latrines on all three floors were originally large lavatory, toilet, and shower/bath rooms for the enlisted women (Figure 70). The toilet room had two banks of toilets; the lavatory had a large open area with a bank of sinks on either side; and the shower/tub room had six showers on one side and two tub alcoves (Figure 71 and Figure 72) on the other. In the 1980s conversion into a medical office building, the lavatory room was divided by a wall so that half the sinks and all of the toilets were in the women's latrine, while the other bank of sinks was in the men's latrine and half of the showers were converted over to toilets (Figure 73), and one of the tub alcoves was converted over for urinals (Figure 74). The walls in the lavatory and toilet rooms generally used glazed concrete block on the lower two-thirds of the walls and painted concrete block above, while square tiles were used in the shower/tub room. The floor tile is a mix of large squares, small, squares, and rectangular multicolored tile (Figure 76). The windows have soapstone windowsills (Figure 75), and the doors are blond stained wood (Figure 77).

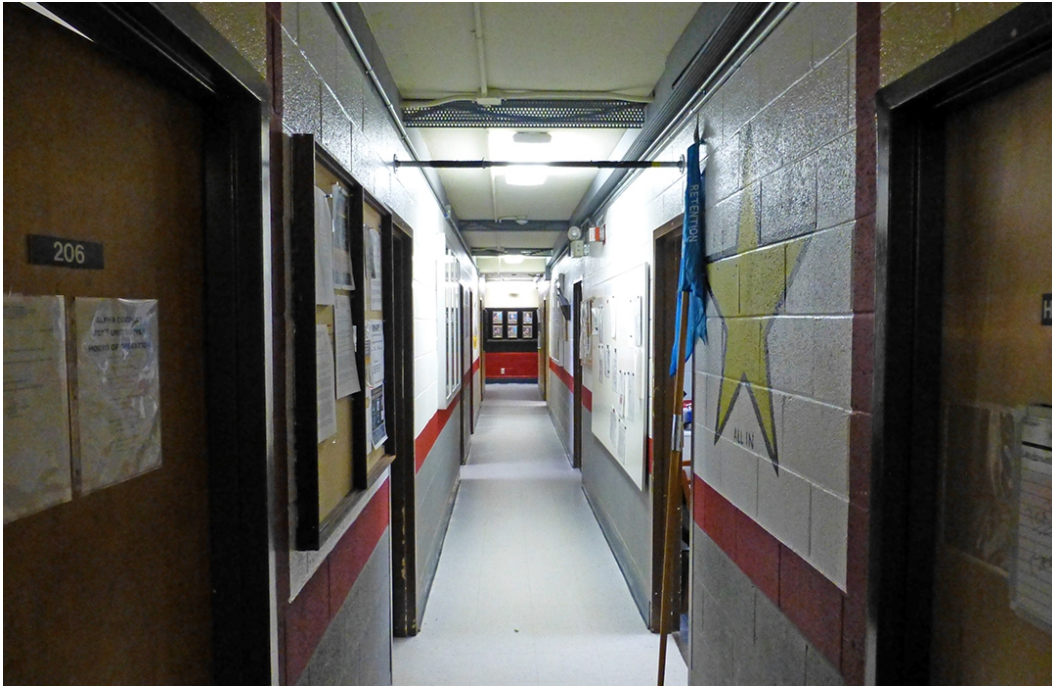
Figure 78. Example of one of the concrete-block hallways on the second floor of Building 33800 at Fort Gordon, GA (ERDC-CERL, 2016).

The second floor of the barracks rooms had the same configuration and construction as the first floor—in the shape of an “L” with the lavatory and laundry at the intersection. The walls were concrete block (Figure 78), and

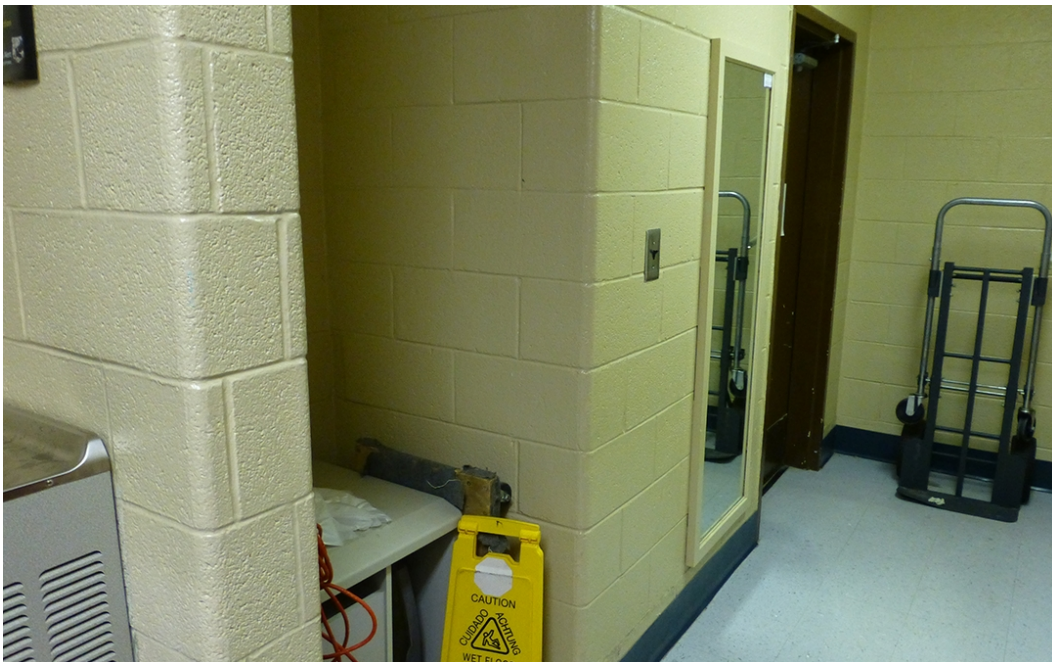
Figure 80. Detail of a replacement ceiling light fixture on the second floor of Building 33800 at Fort Gordon, GA (ERDC-CERL, 2016).

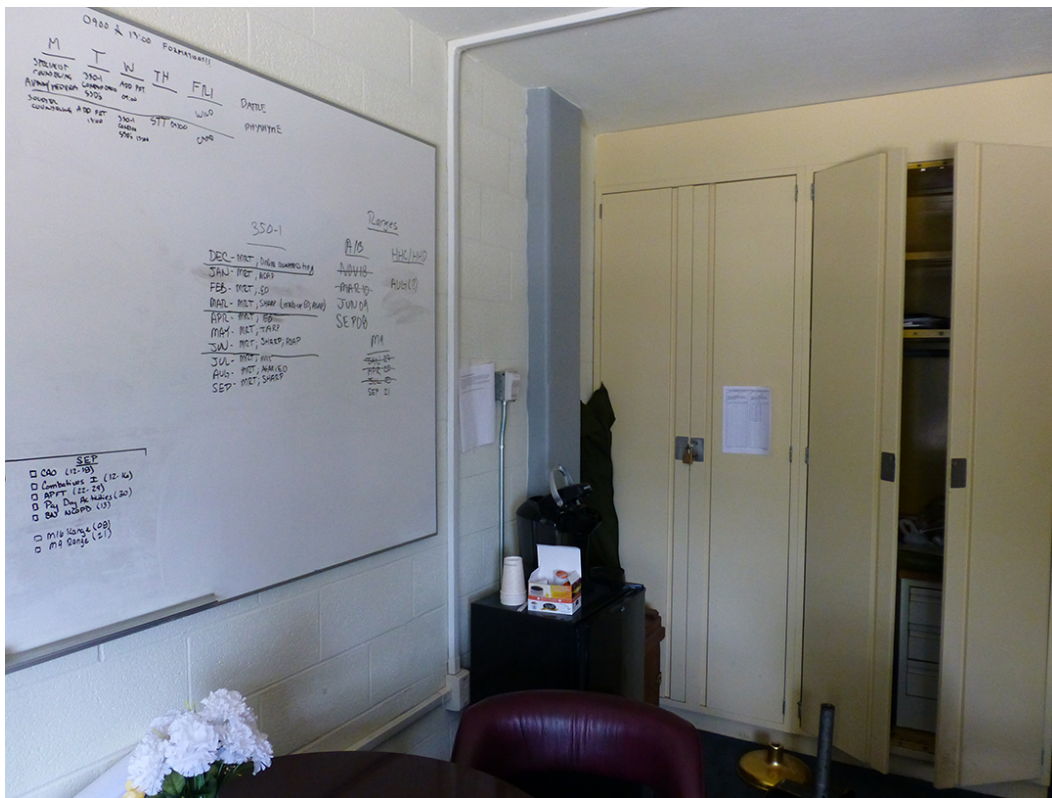
Figure 84. Example of one of the enlisted women's rooms where the original metal closets have been removed on the second floor of Building 33800 at Fort Gordon, GA (ERDC-CERL, 2016).

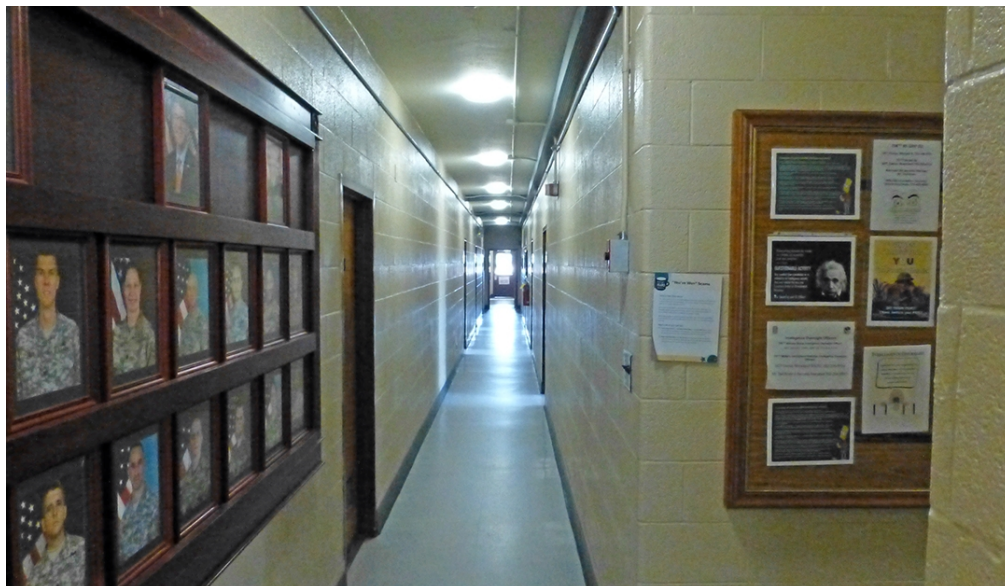
Figure 88. Example of one of the concrete-block hallways on the second floor of Building 33800 at Fort Gordon, GA (ERDC-CERL, 2016).

The third-floor hallway followed the same construction method as the first two floors, with concrete-block walls (Figure 88). The third-floor rooms had the same metal closets and bookshelves manufactured by KLN Products (Figure 89). The two latrines on the third floor had the same transformation as the ones on the first two floors (Figure 90). The original laundry room cabinets were changed out when the room was transformed into a staff lounge (Figure 91).

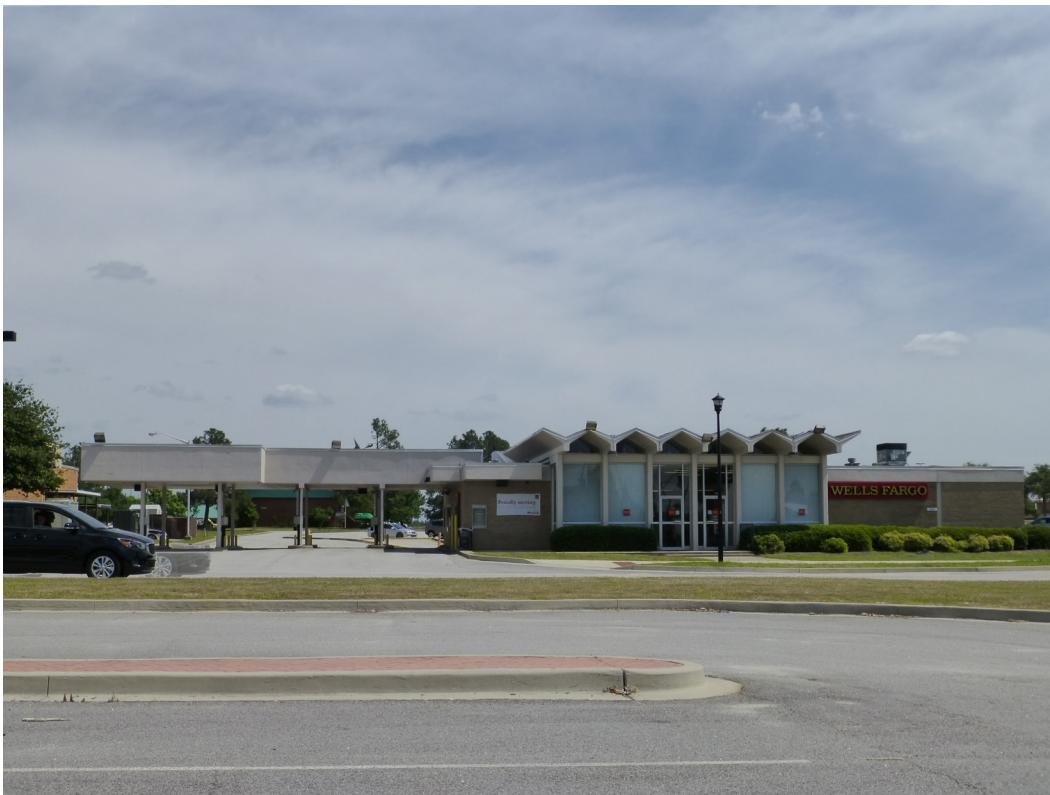
Figure 92. Northwest (front) elevation of Building 36300 at Fort Gordon, GA (ERDC-CERL, 2015).

The northwest (front) elevation is defined by the pre-cast concrete folded-plate roof and by bright-aluminum and plate-glass doors and windows framed by concrete columns (Figure 92). The main entry is six bays wide and divided by concrete columns that support the concrete folded roof (Figure 93). Four of the bays have large plate-glass windows and two of the bays have single-entry bright-aluminum and plate-glass doors with sidelights and transoms. Underneath the folds of the concrete folded roofing system is a unique triangular window (Figure 94). Just to the left of the middle entry bay and set within the brick wall is a metal night-deposit box. Between the original night-deposit box and the plate-glass window, tan brick was installed in the opening of the location of a walk-up teller window. The far left side of the northwest elevation has five drive-through banking bays covered by canopy that were added in 1995, while the right side has an addition to the one-story brick-faced wing added in the same year.

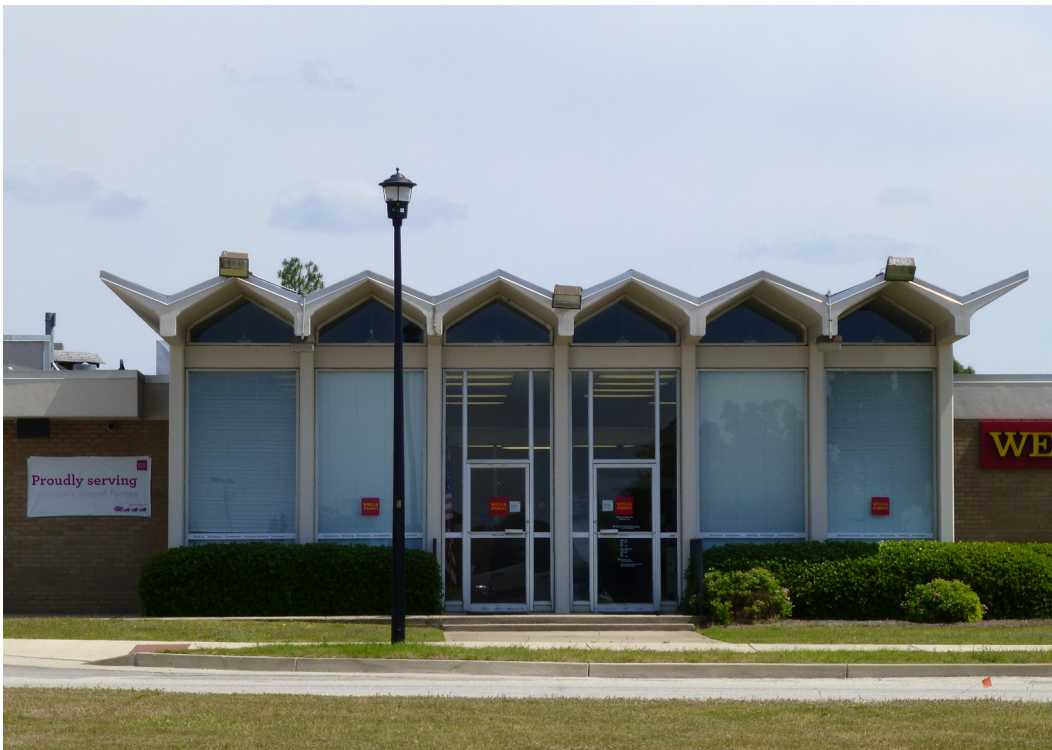
Figure 93. Main entry bay on the northwest (front) elevation of Building 36300 at Fort Gordon, GA (ERDC-CERL, 2015).

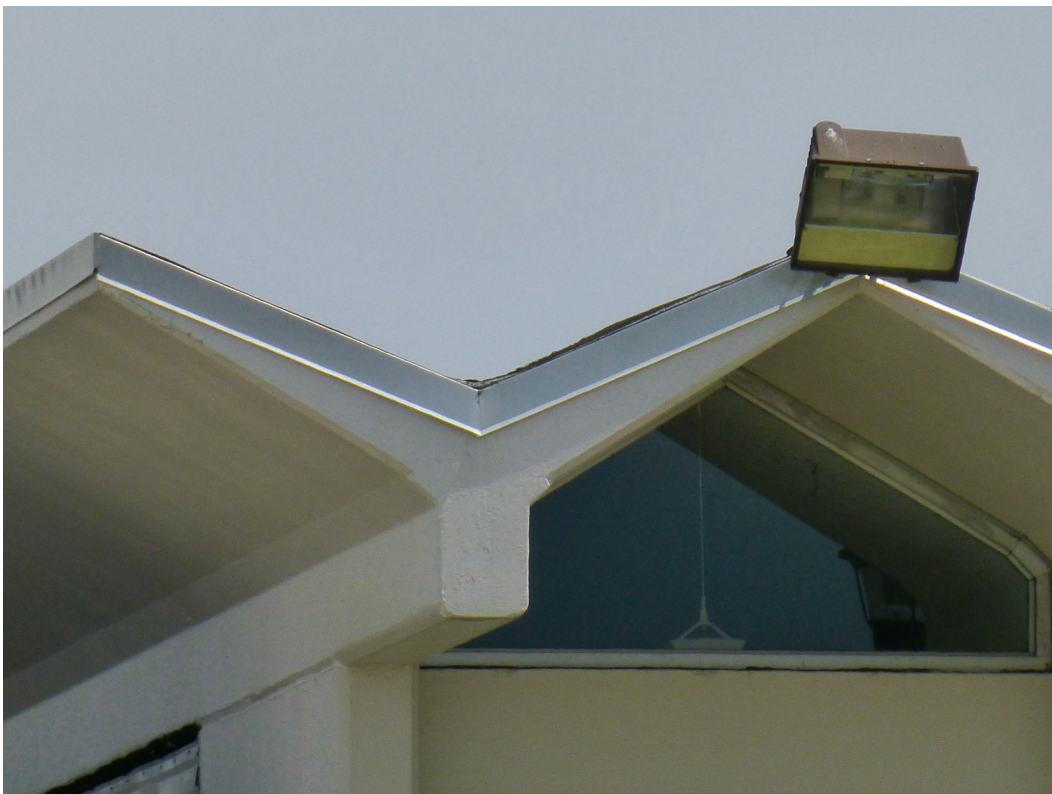
Figure 94. Detail of the pre-cast concrete folded-plate roof on Building 36300 at Fort Gordon, GA (ERDC-CERL, 2015).

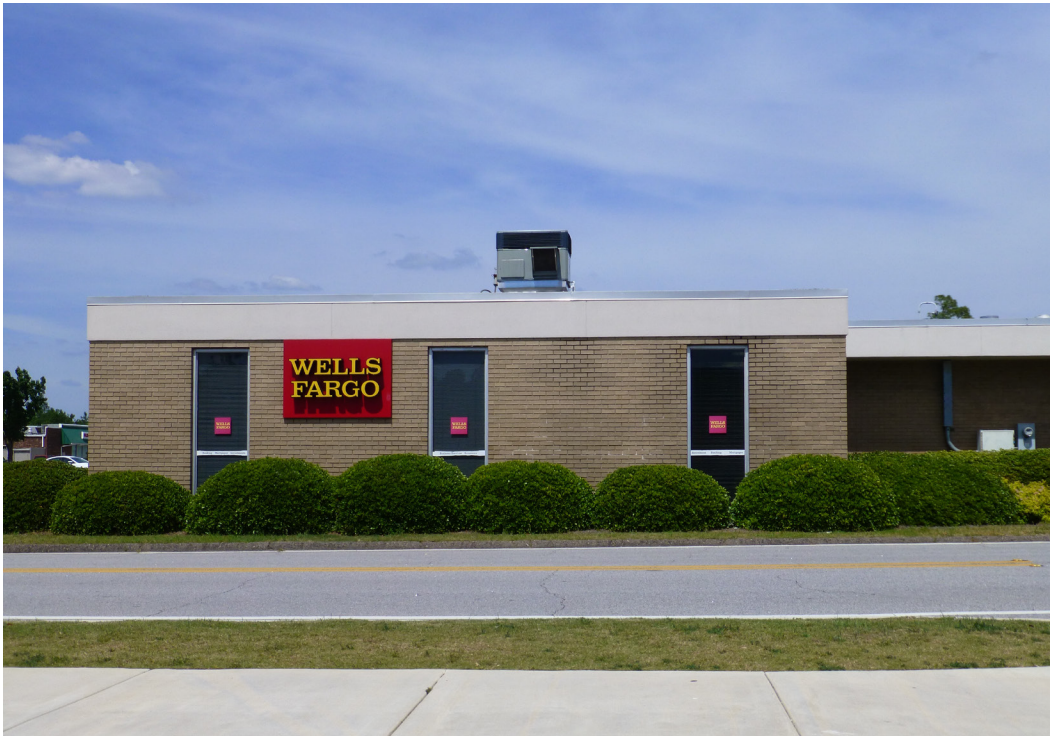
Figure 95. Left side of the southwest elevation of Building 36300 at Fort Gordon, GA (ERDC-CERL, 2015).

The southwest elevation faces 3rd Avenue. The left side of the elevation projects outward and has three tall narrow plate-glass windows set in bright-aluminum frames (Figure 95); these windows were relocated to this wall when the addition was constructed in 1995. A row of shrubs lines this side of the building.

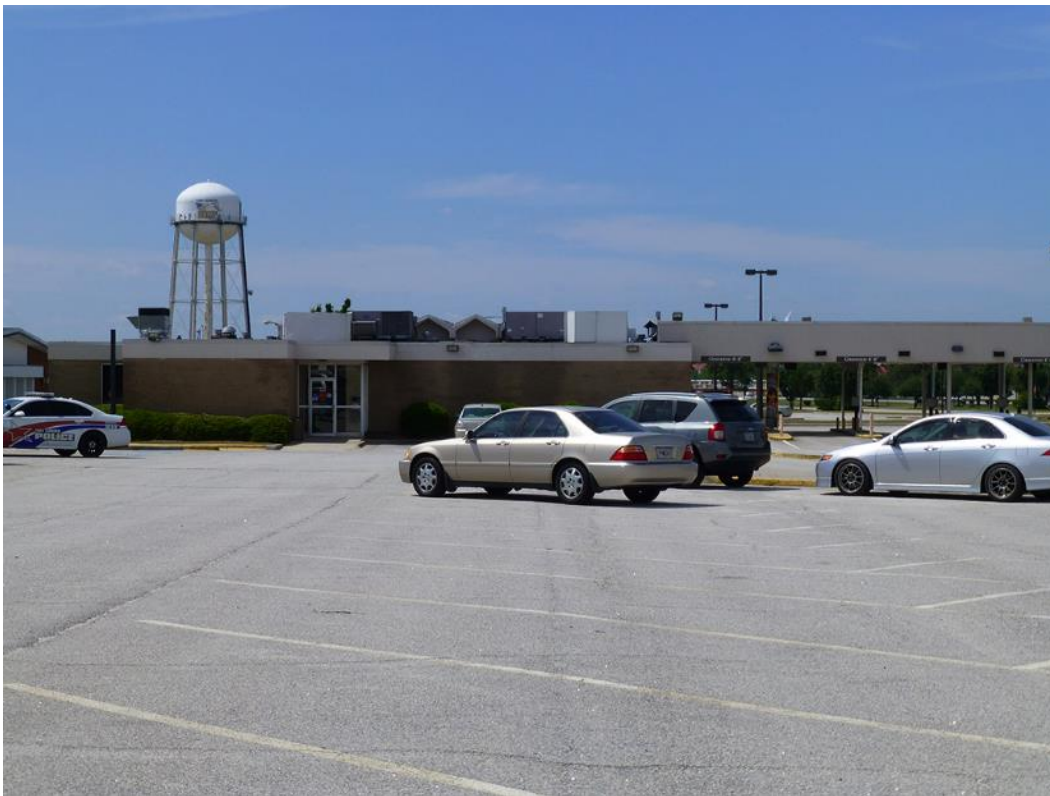
Figure 96. Southeast elevation of Building 36300 at Fort Gordon, GA (ERDC-CERL, 2015).

The southeast elevation faces a paved parking lot (Figure 96). The far left side of the elevation is the southwest addition, with one tall, narrow, plate-glass window. A secondary entry vestibule is located on this side of the building. The vestibule is defined by bright aluminum framing a plate-glass door, sidelights, and transom. The right side of the southeast elevation has five drive-through banking bays and a canopy that were added to the bank in 1995.

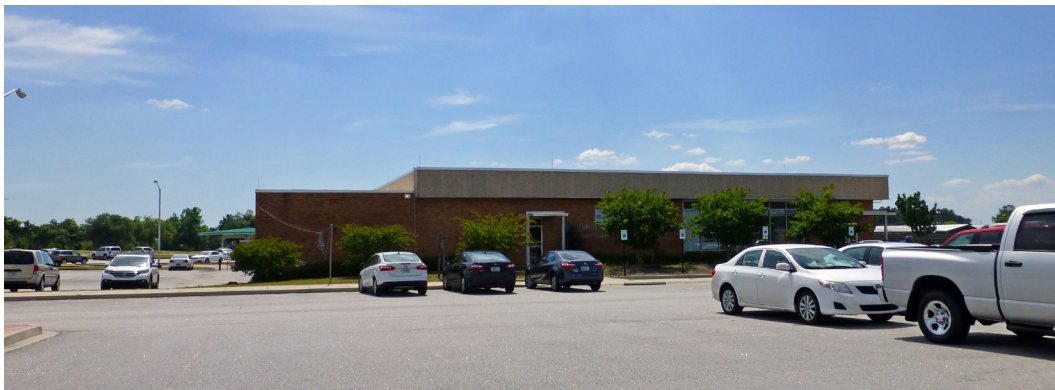
The northeast (front) elevation faces a paved parking lot (Figure 97). There are two main entries on this side of the building; the left entry is a single-entry door framed by metal details and a small metal awning above, the right entry consists of a set of doors with a transom framed by metal details and a metal canopy above (Figure 98). A poured-concrete ramp with metal handrails provides access to this entry. The majority of the northeast wall has a curtain wall of large plate-glass windows, and porcelain panels that are located at the top and bottom of each window. Cast-aluminum lettering is placed on the brick wall, spelling out “UNITED STATES POST OFFICE FORT GORDON.”

Figure 97. Northeast (front) elevation of Building 36302 at Fort Gordon, GA (ERDC-CERL, 2015).

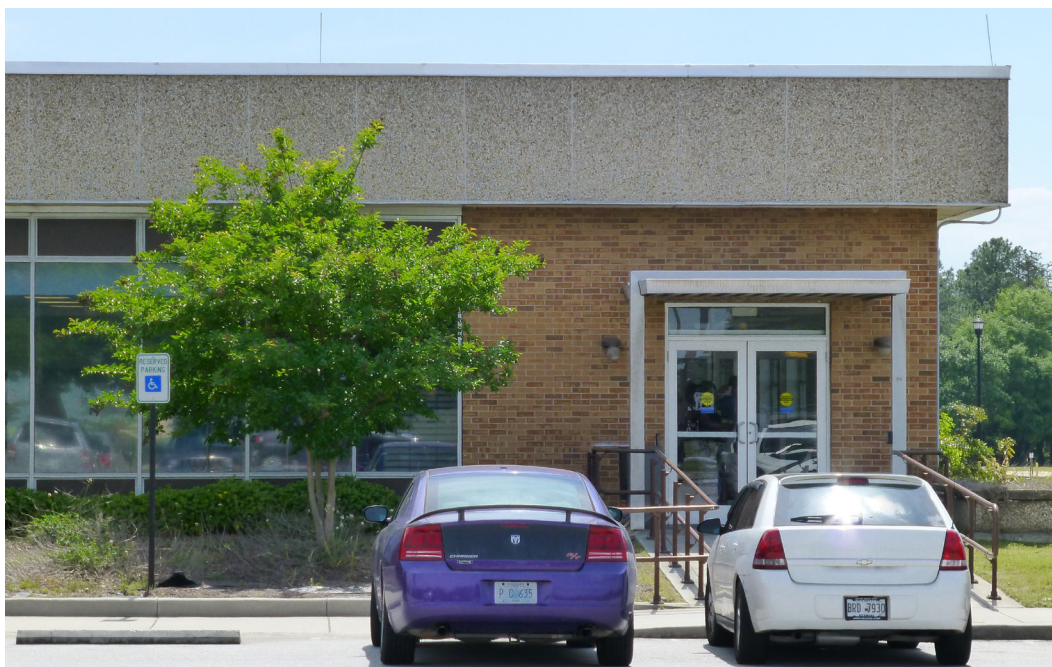
Figure 98. Detail of one of the entrance on the northeast side (front) of Building 36302 at Fort Gordon, GA (ERDC-CERL, 2015).

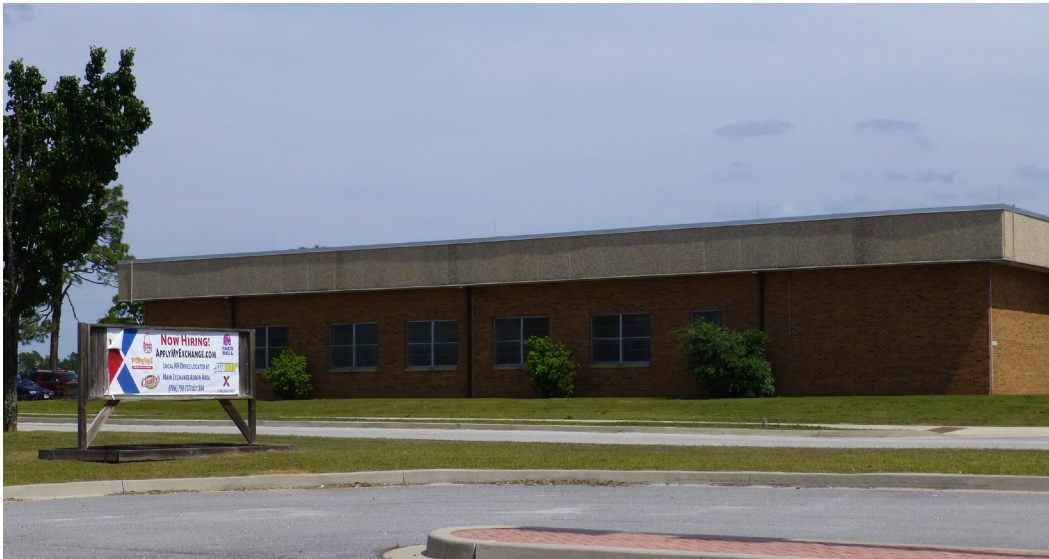
The northwest elevation faces 36th Street (Figure 99). There are five paired two-over-two windows and two single windows spaced across this side of the building (Figure 100).

Figure 99. Northwest elevation of Building 36302 at Fort Gordon, GA (ERDC-CERL, 2015).

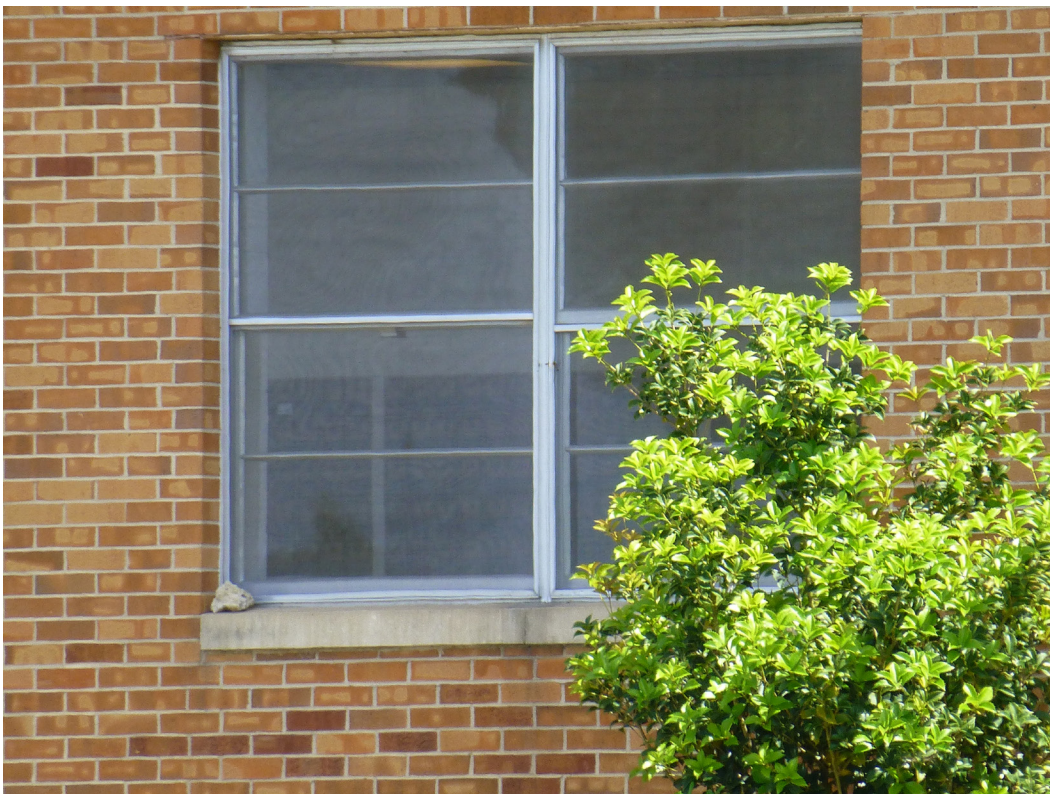
Figure 100. Detail of a paired two-over-two window on the northwest side of Building 36302 at Fort Gordon, GA (ERDC-CERL, 2015).

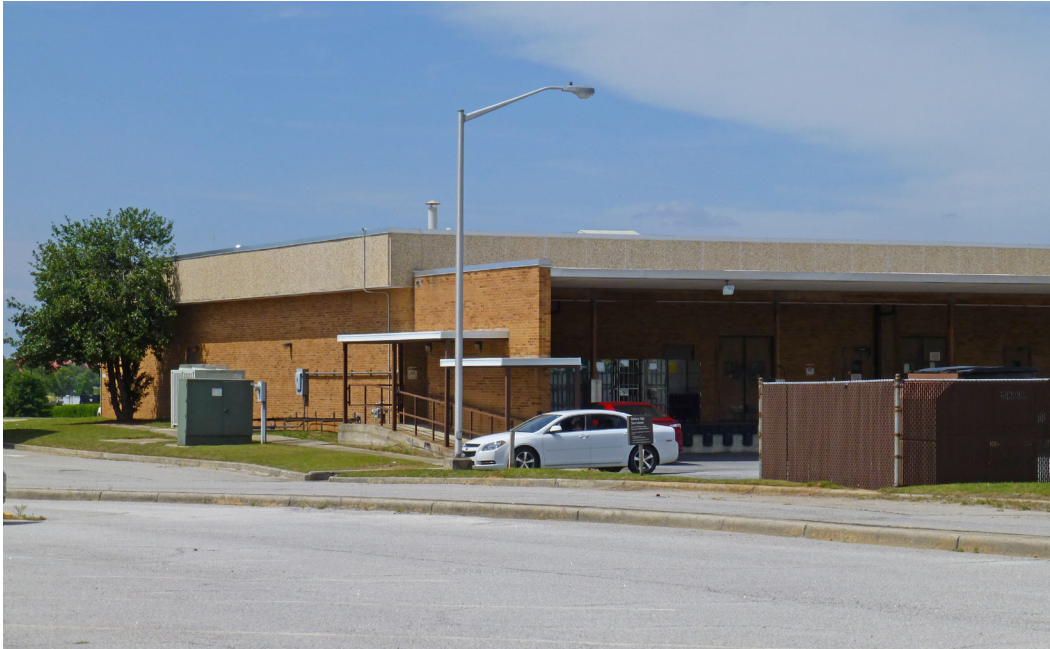
The southwest elevation faces Building 36300 (Bank). There are no windows on this side of the building. There is a single-entry metal door located on the right side of this elevation. A concrete ramp with metal-pipe handrails provides access to the elevated entry. Two flat, metal, canopy structures are located over the door and are part of the ramp (Figure 101).

Figure 101. South oblique of Building 36302 at Fort Gordon, GA (ERDC-CERL, 2015).

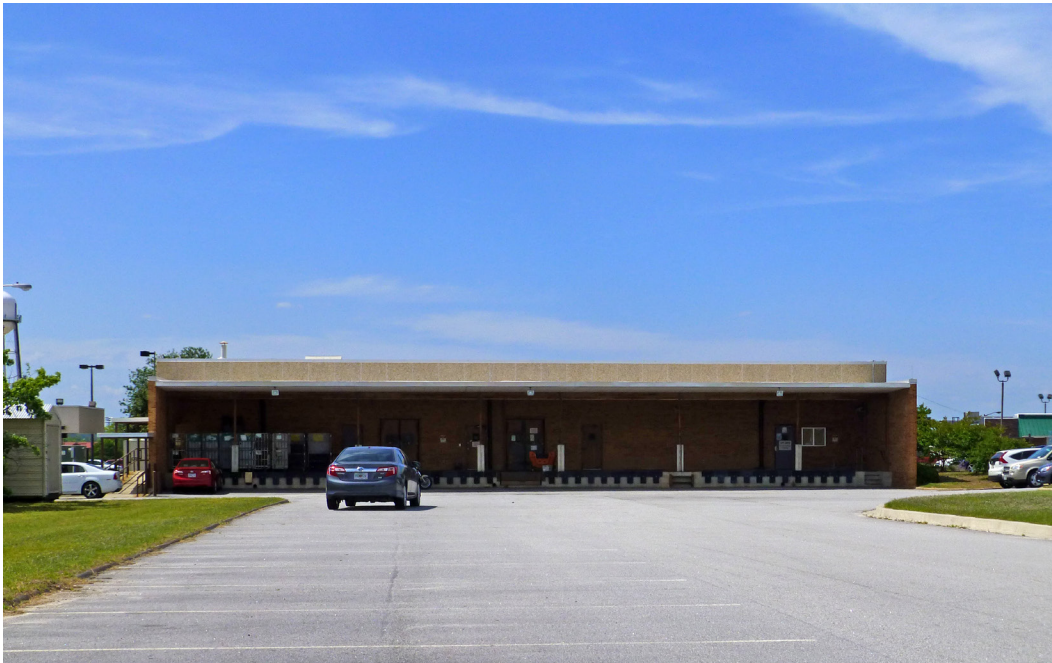
The southeast elevation faces a paved parking lot. This side of the building is where the loading dock is located (Figure 102). The roof of the loading dock area is shorter in height than that of the main building, has metal fascia, and projects out over the concrete platform that stretches across the entire elevation. There are two sets of metal doors, two single-entry metal doors, and a paired window located on this side of the building.

Figure 102. Southeast elevation of Building 36302 at Fort Gordon, GA, looking at the loading dock (ERDC-CERL, 2015).

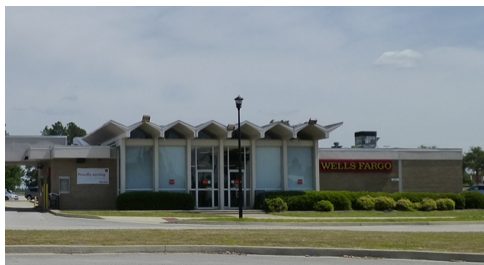
Figure 103. Examples of character-defining features for Building 36300 at Fort Gordon, GA (ERDC-CERL 2015).

Overall massing on the front.

Examples of character-defining features for Building 36300 are listed below and can be seen in Figure 103.

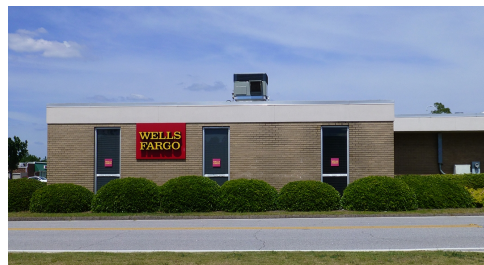
Rectangular massing on the southwest side.

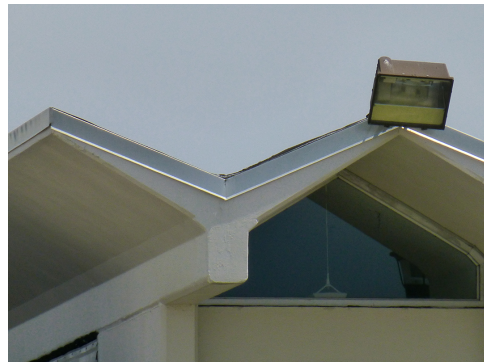
Detail of pre-cast concrete folded-plate roof.

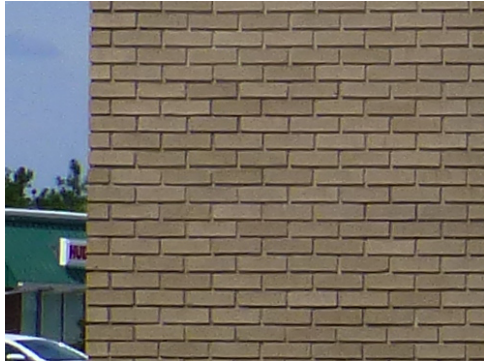
Tan-colored brick.

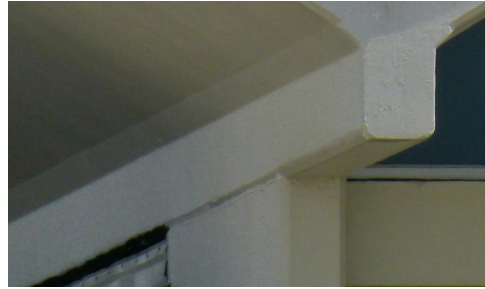
Painted concrete.

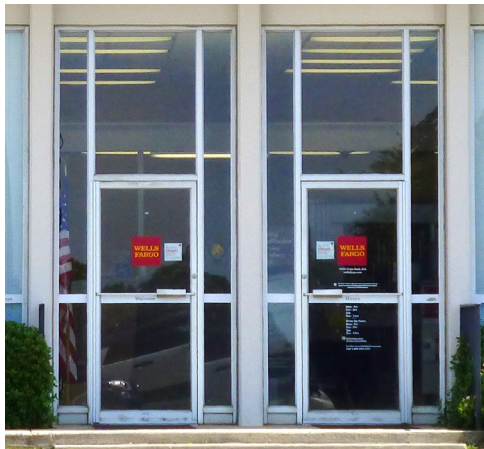
Bright-aluminum and plate-glass door frames.

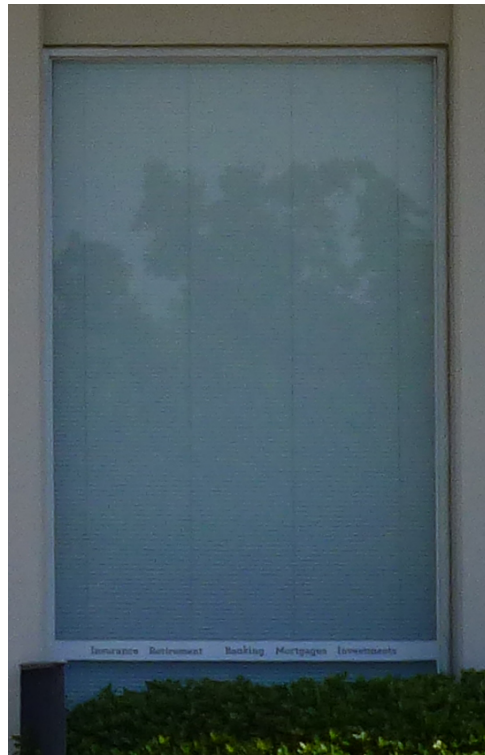
Bright-aluminum and plate-glass window frames.

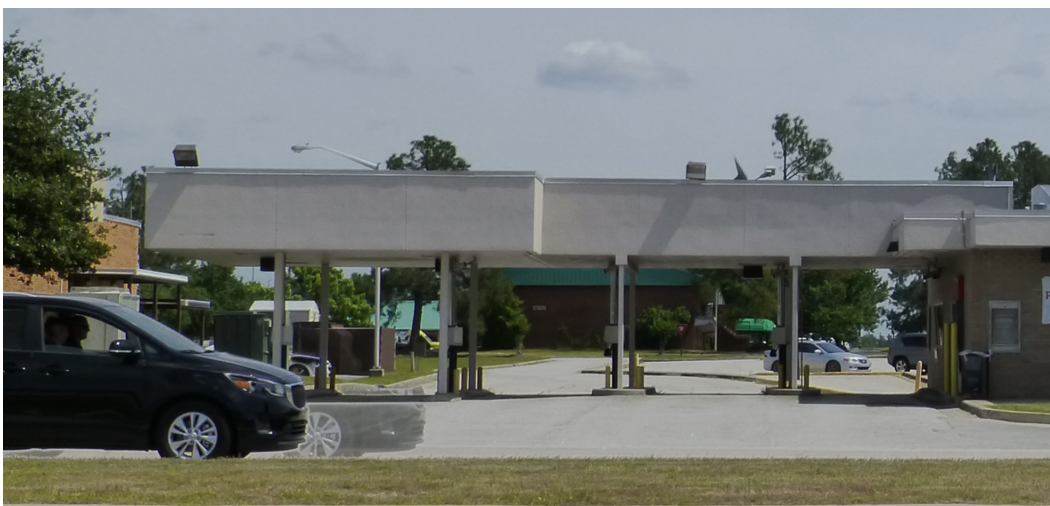
The five-bay drive-through structure and canopy is the only architectural structure that is not a character-defining feature for Building 36300 (Figure 104). The building's only other addition (on the southwest side of the original building) is in-scale and in keeping with the original design precepts; therefore it is a character-defining feature (Figure 103). The Wells Fargo sign is the only nonarchitectural feature for Building 36300 that is not character-defining (Figure 105).

Figure 104. Five-bay drive-through structure and canopy is a noncharacter-defining feature for Building 36300 at Fort Gordon, GA (ERDC-CERL, 2015).

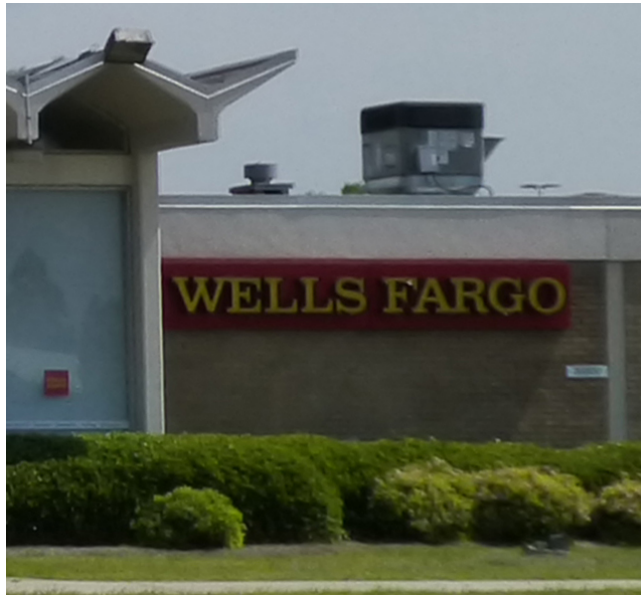
Figure 105. Wells Fargo sign is noncharacter-defining feature for Building 36300 at Fort Gordon, GA (ERDC-CERL, 2015).

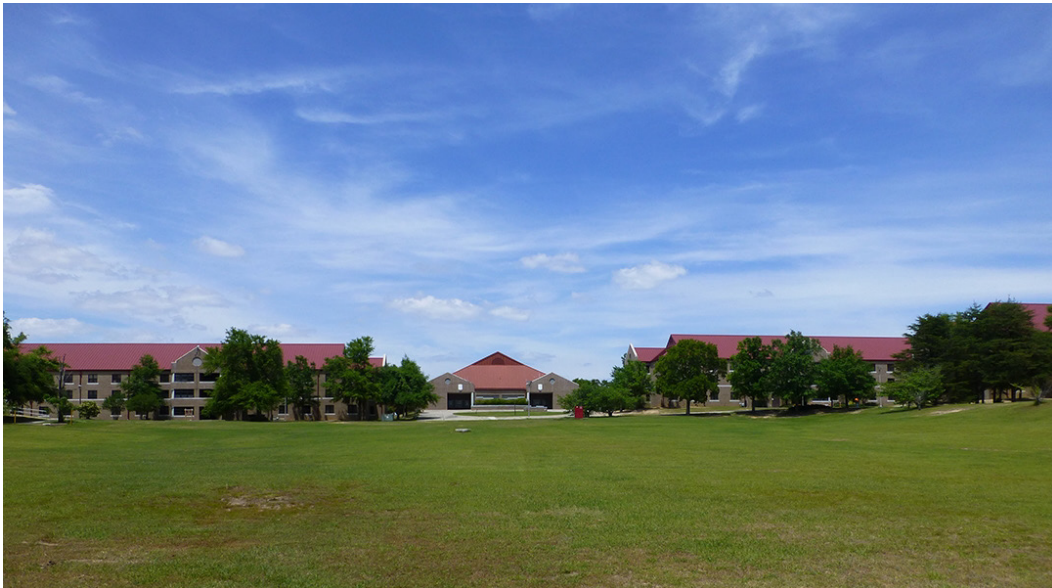
Photo 2. Overview of the 1988 barracks complex at Fort Gordon, GA, with the mess hall (Facility 24414) in the middle and barracks on either side (Facility 24407 on the left and Facility 24406 on the right), looking north (ERDC-CERL, 2015).

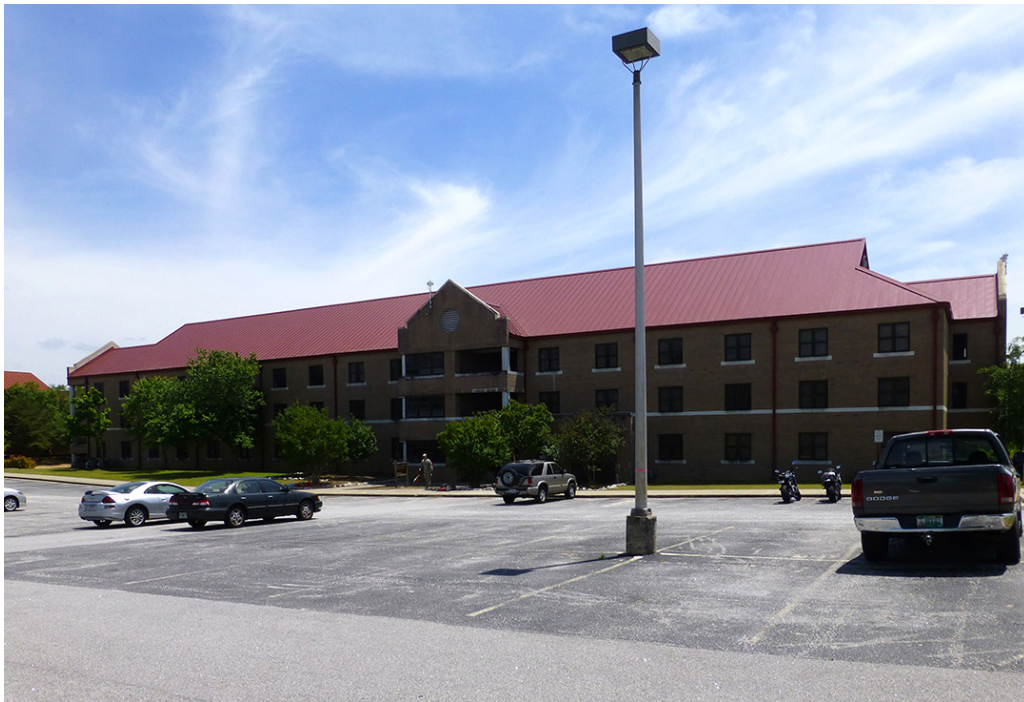
Photo 3. North side of Building 24413 at Fort Gordon, GA, showing the clipped gables, the cross gable, square window openings, precast-concrete belt course, and precast-concrete windowsills (ERDC-CERL, 2015).

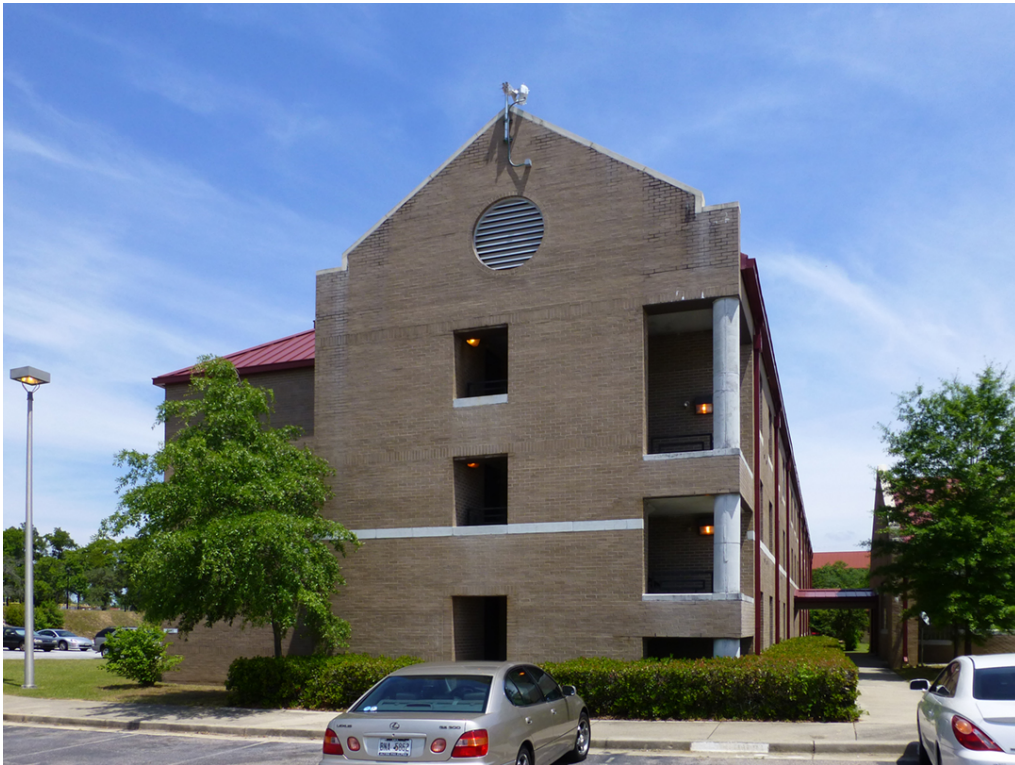
Photo 4. West side of Building 24413 at Fort Gordon, GA, showing gable end with open stair landings, precast-concrete columns, and precast-concrete belt course (ERDC-CERL, 2015).

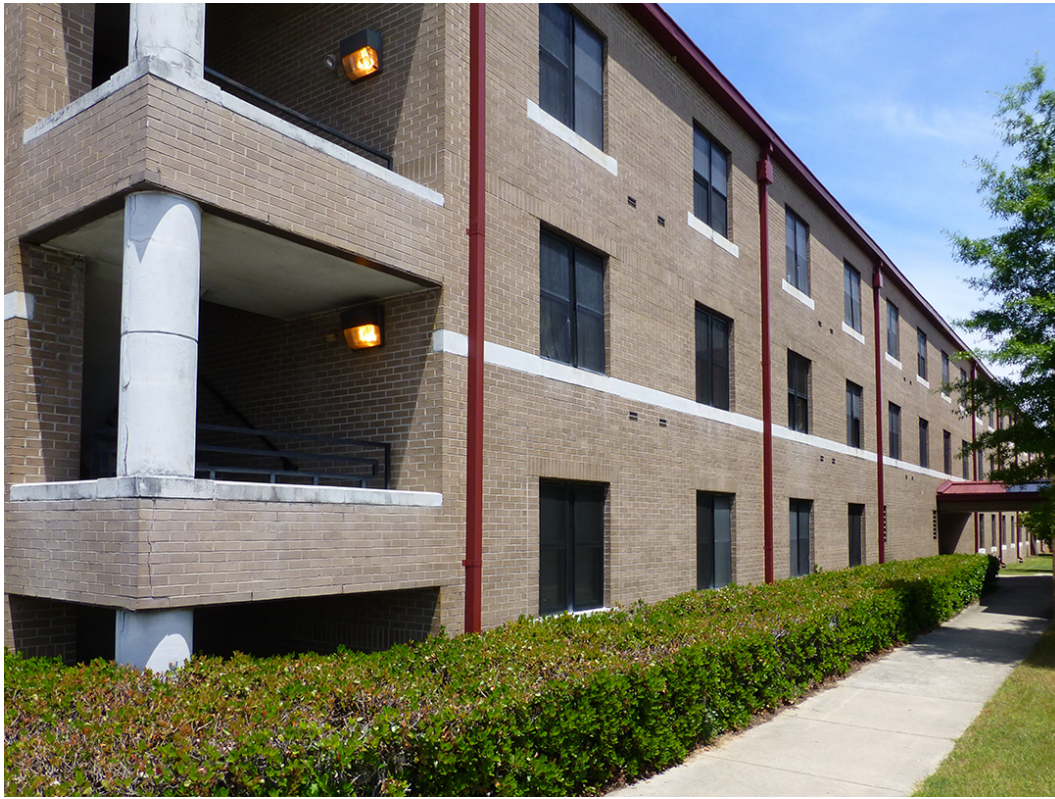
Photo 5. South side of Building 24413 at Fort Gordon, GA, showing open stair landings, precast-concrete columns, precast-concrete belt course, precast-concrete windowsills, and square window openings (ERDC-CERL, 2015).
