Determination of NRHP Eligibility for Buildings 28414, 32100, 33800, 36300, and 36302 at Fort Gordon, Georgia

Includes a Criteria Consideration G Evaluation of the 1988 Barracks Complex

Final Report

Under Project 450904, "NHPA Building Evaluations at Fort Gordon"

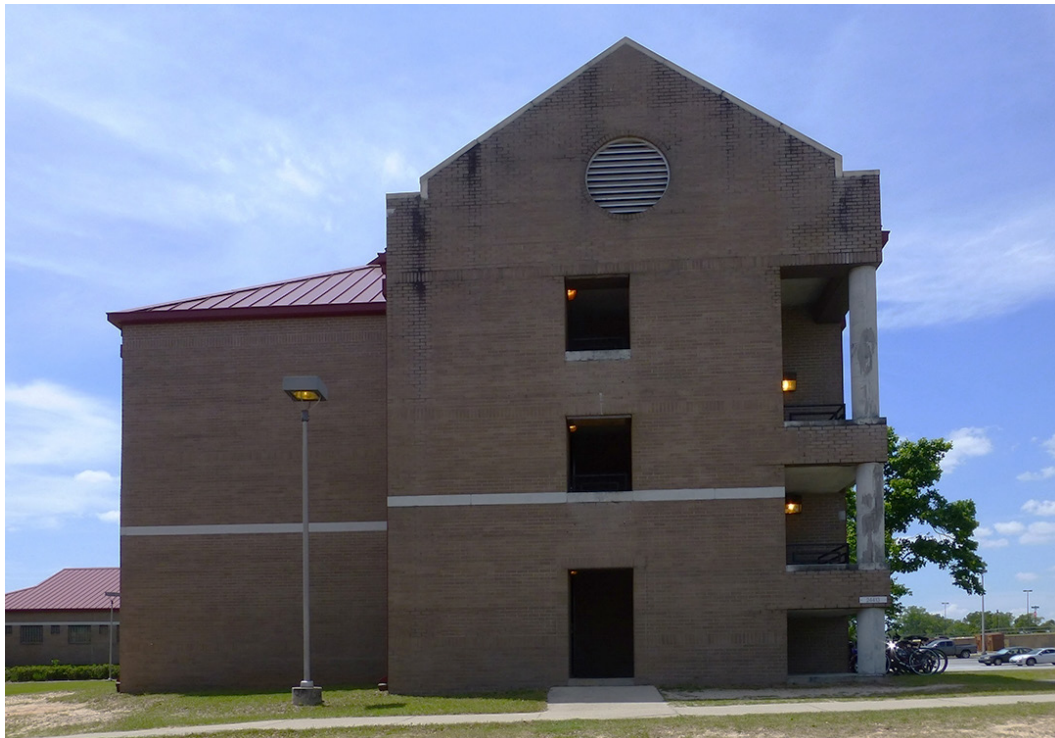
Photo 6. East side of Building 24413 at Fort Gordon, GA, showing gable end with open stair landings, precast-concrete columns, and precast-concrete belt course (ERDC-CERL, 2015).

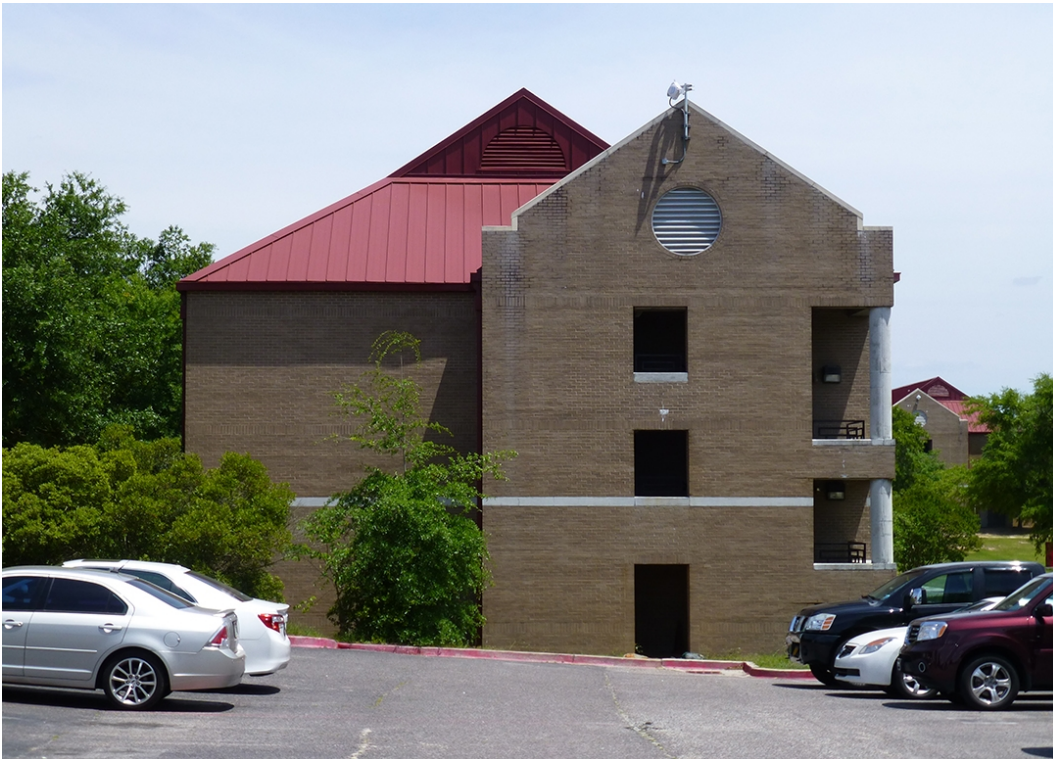
Photo 7. West side of Building 24407 at Fort Gordon, GA, showing gable end with open stair landings, precast-concrete columns, and precast-concrete belt course (ERDC-CERL, 2015).

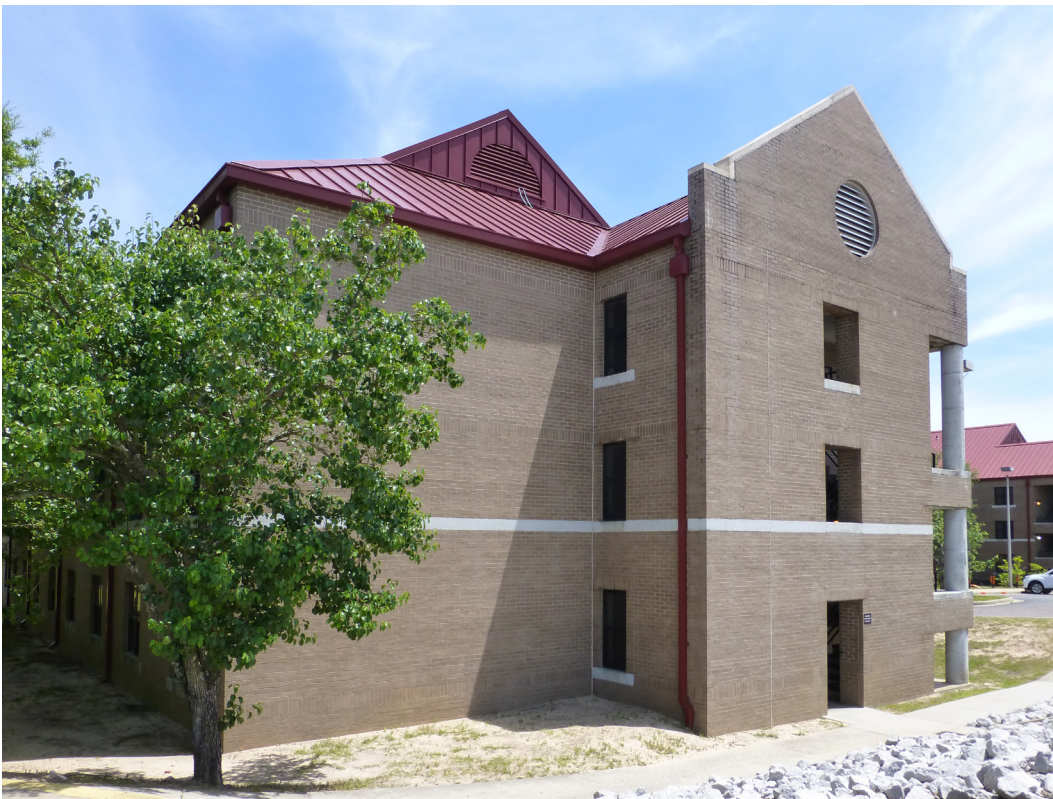
Photo 8. West side of Building 24405 at Fort Gordon, GA, showing gable end with open stair landings, precast-concrete columns, and precast-concrete belt course (ERDC-CERL, 2015).

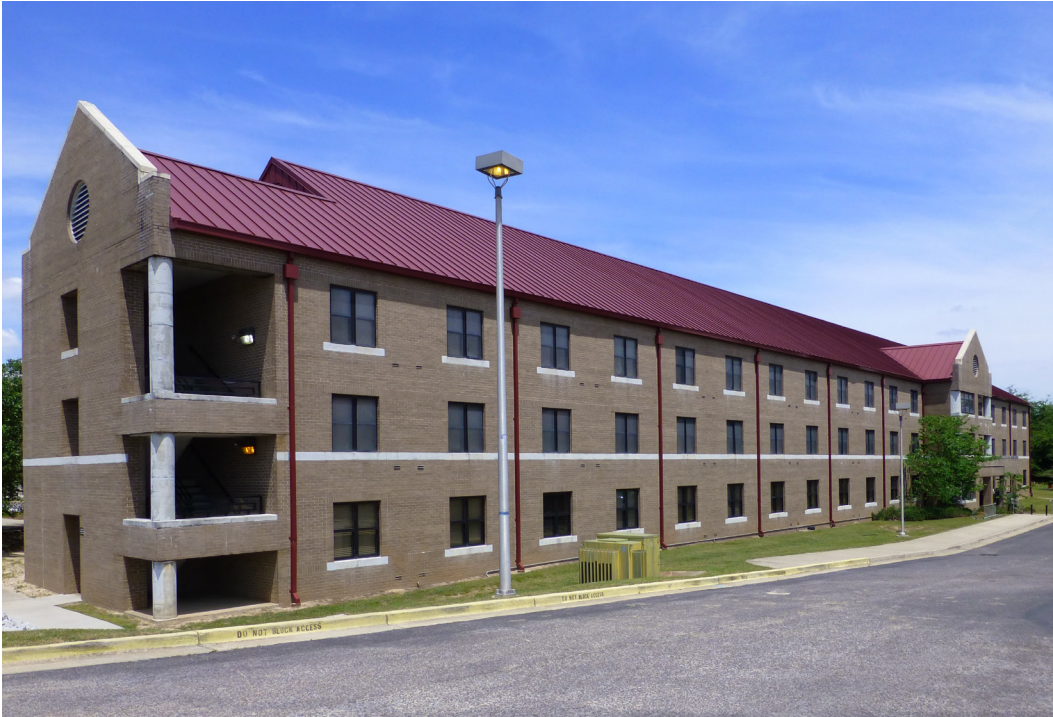
Photo 9. Southwest oblique of Building 24405 at Fort Gordon, GA, showing gable end with open stair landings, precast-concrete columns, and precast-concrete belt course (ERDC-CERL, 2015).

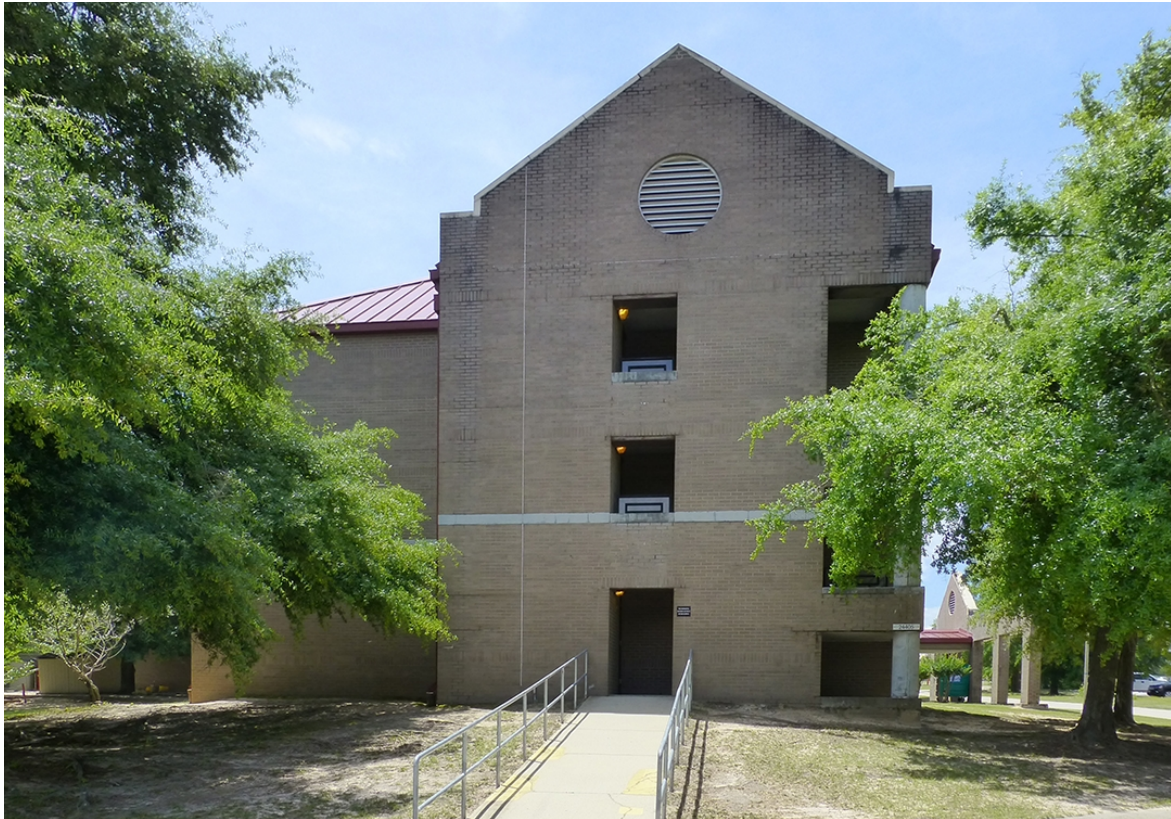
Photo 10. East side of Building 24405 at Fort Gordon, GA, showing gable end with open stair landings, precast-concrete columns, and precast-concrete belt course (ERDC-CERL, 2015).

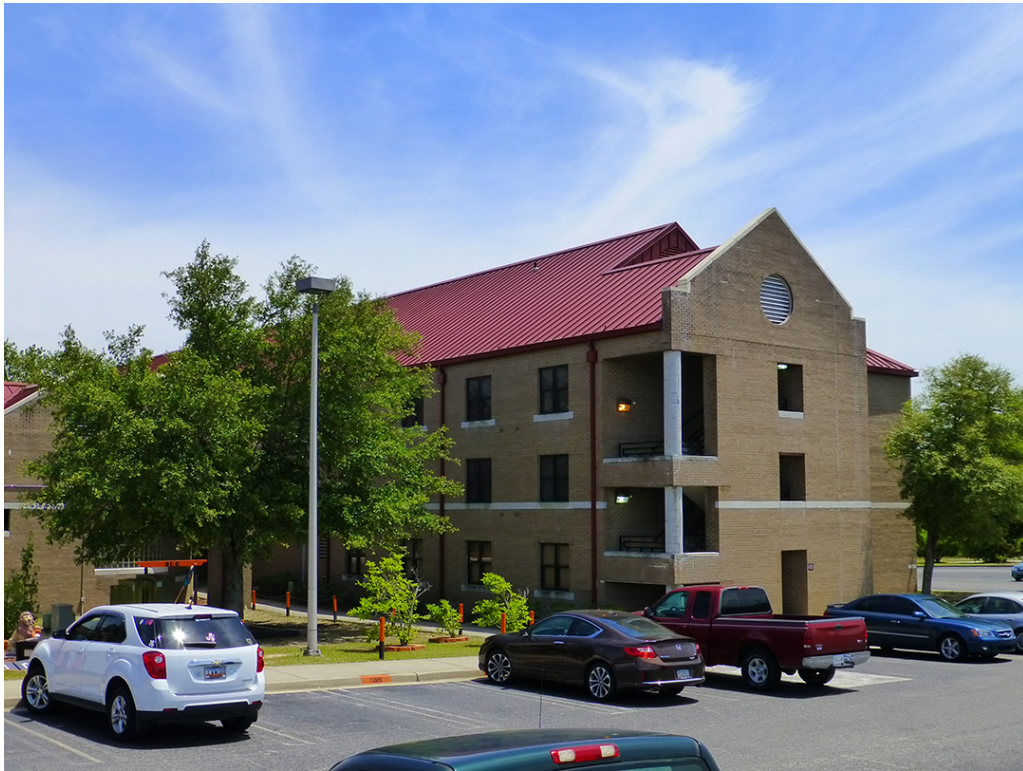
Photo 11. Northwest oblique of Building 24401 at Fort Gordon, GA, showing precast-concrete columns and open stair landings (ERDC-CERL, 2015).

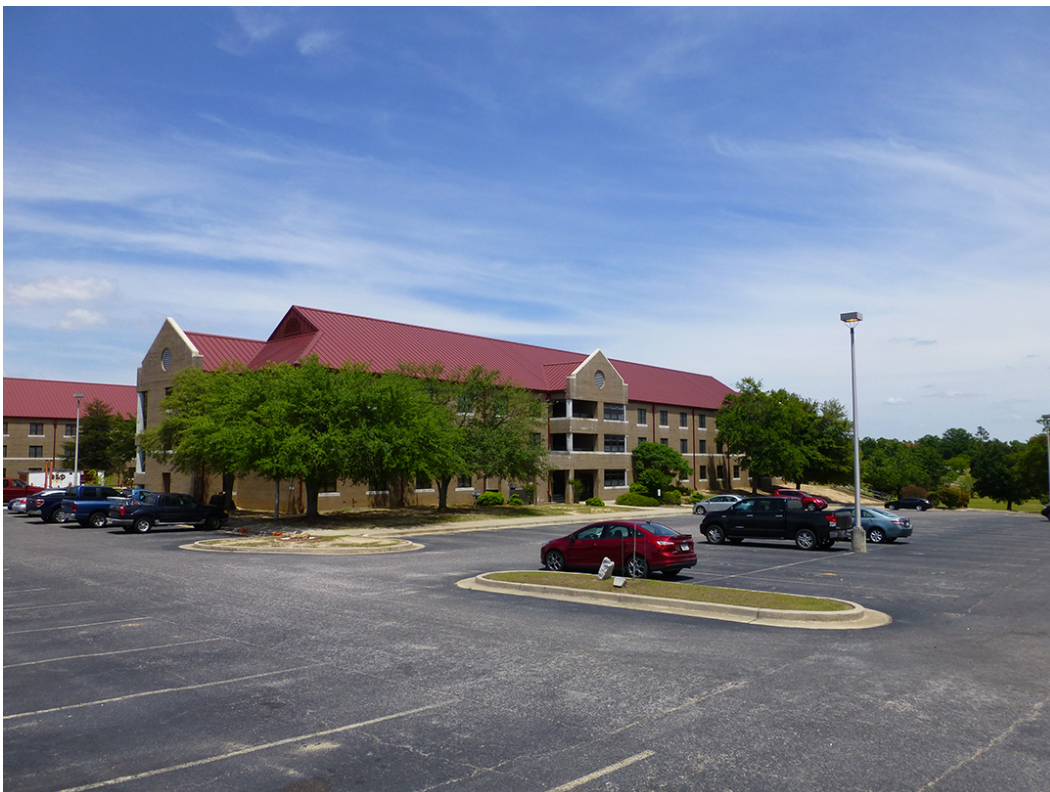
Photo 12. Southwest oblique of Building 24401 at Fort Gordon, GA, showing clipped gables and projecting entrance bay (ERDC-CERL, 2015).

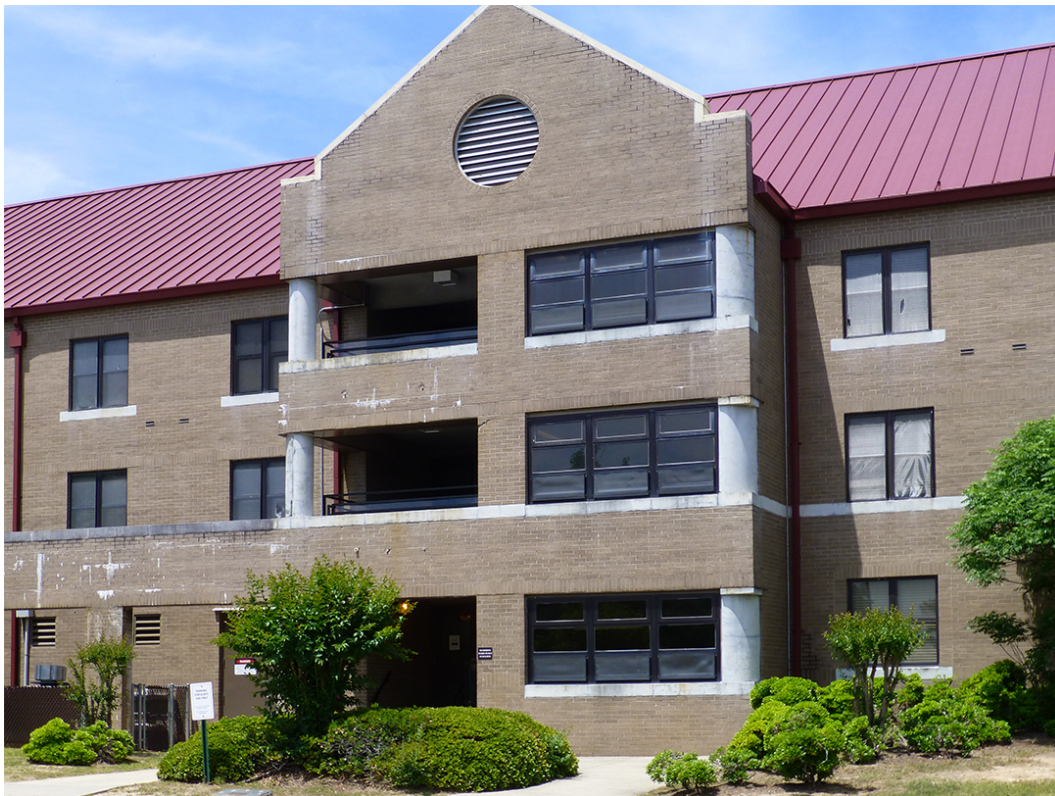
Photo 13. Detail of projecting entrance bay on southside of Building 24401 at Fort Gordon, GA, showing cross gable with balconies , precast-concrete columns, and precast-concrete belt course (ERDC-CERL, 2015).

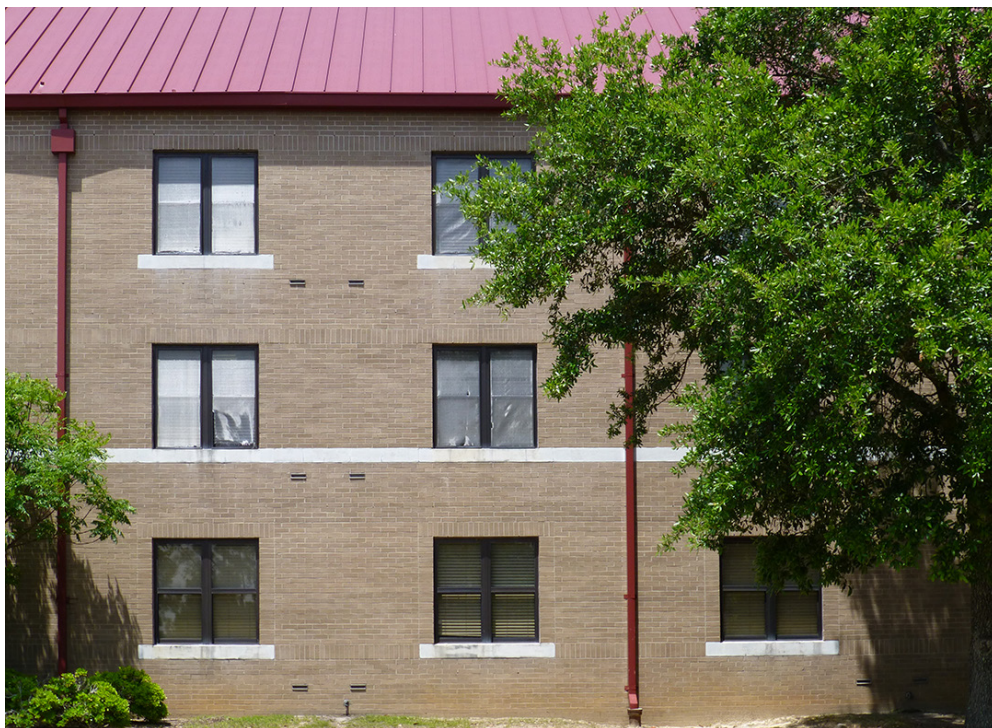
Photo 14. Detail of windows on southside of Building 24401 at Fort Gordon, GA, showing square window openings, precast-concrete belt course, and precast-concrete windowsills (ERDC-CERL, 2015).

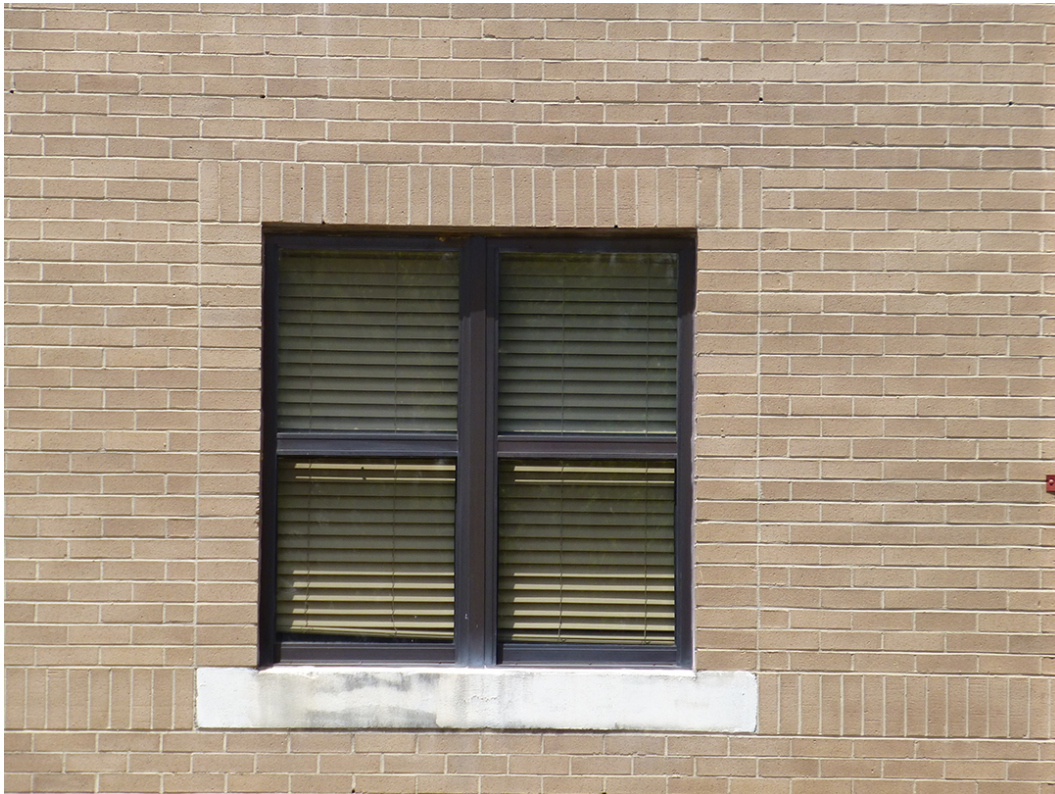
Photo 15. Detail of double window and precast-concrete windowsill on southside of Building 24401 at Fort Gordon, GA (ERDC-CERL, 2015).

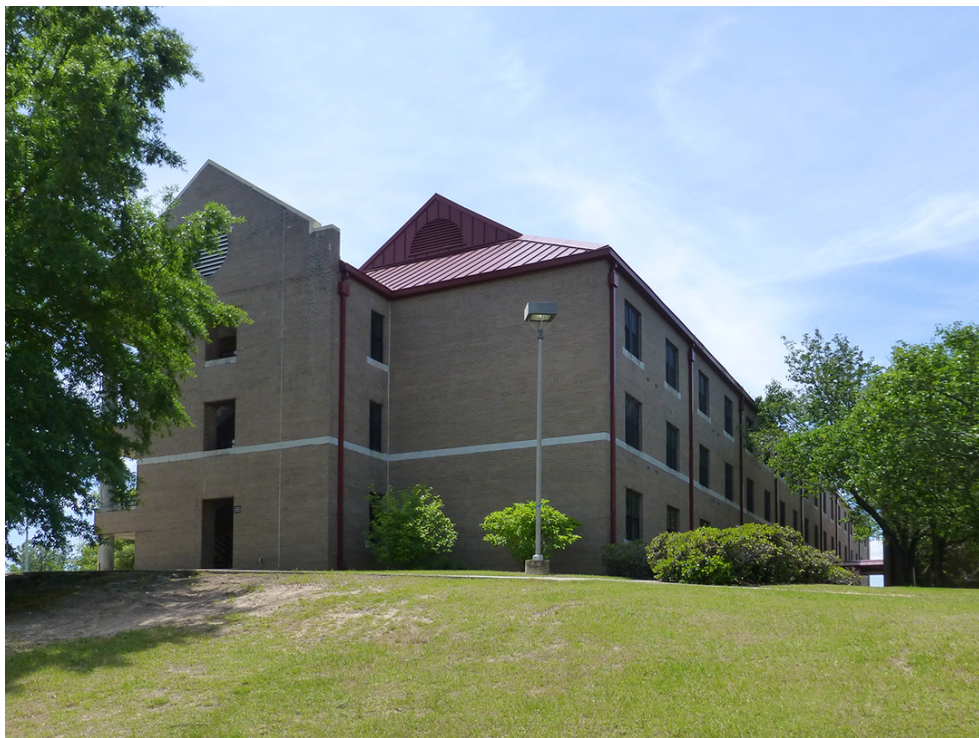
Photo 16. East side of Building 24401 at Fort Gordon, GA (ERDC-CERL, 2015).

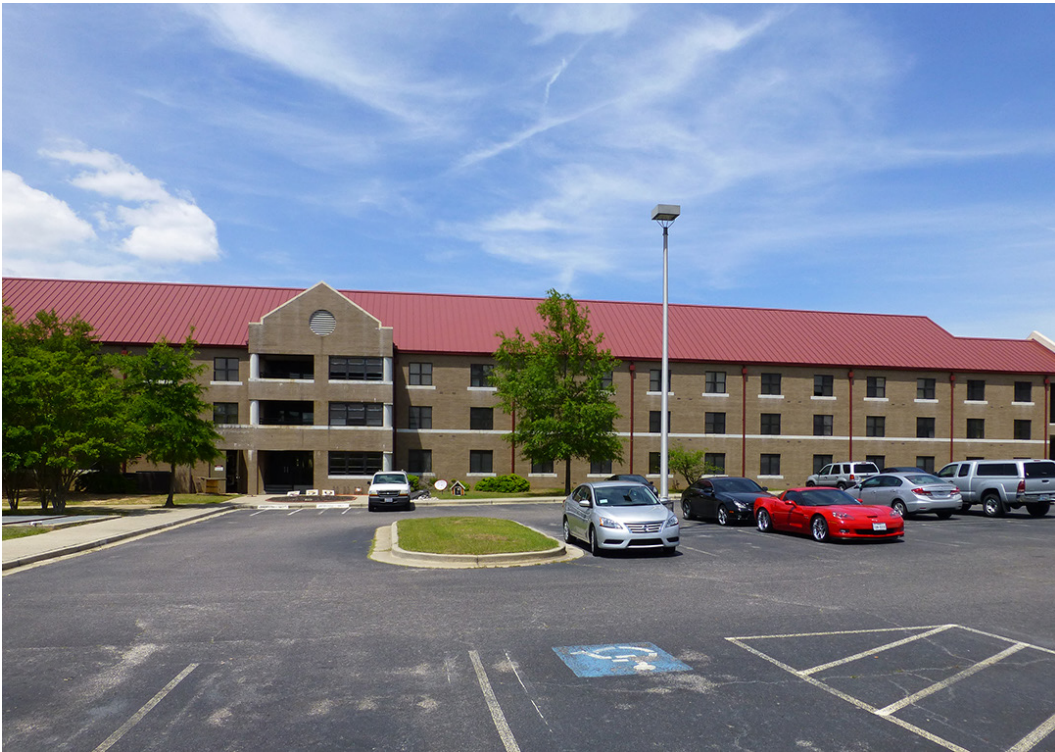
Photo 17. South side of Building 24404 at Fort Gordon, GA, showing projecting entrance bay (ERDC-CERL, 2015).

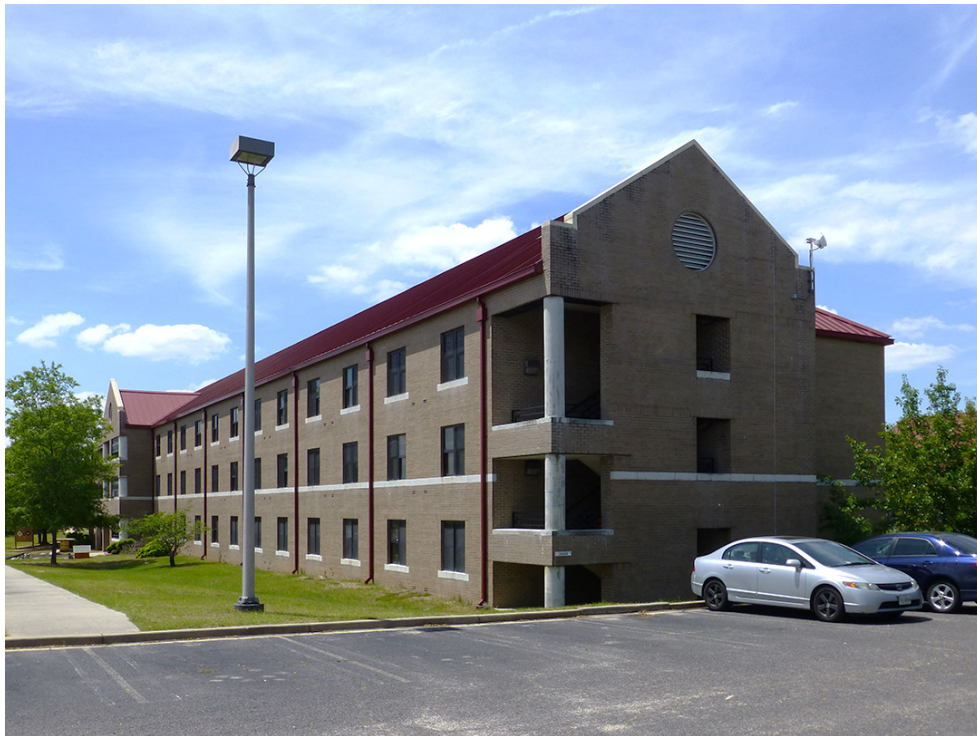
Photo 18. East side of Building 24404 at Fort Gordon, GA, with open stair landings and precast-concrete columns at the corner (ERDC-CERL, 2015).

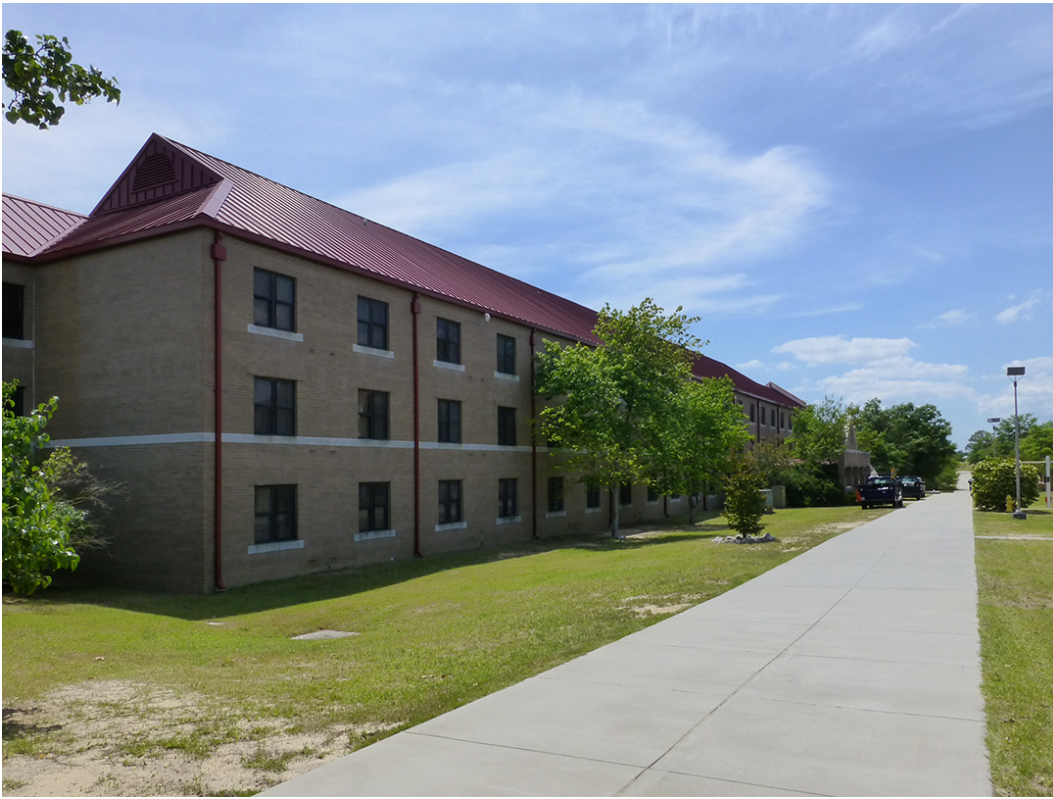
Photo 19. Northeast oblique of Building 24404 at Fort Gordon, GA, showing clipped gable (ERDC-CERL, 2015).

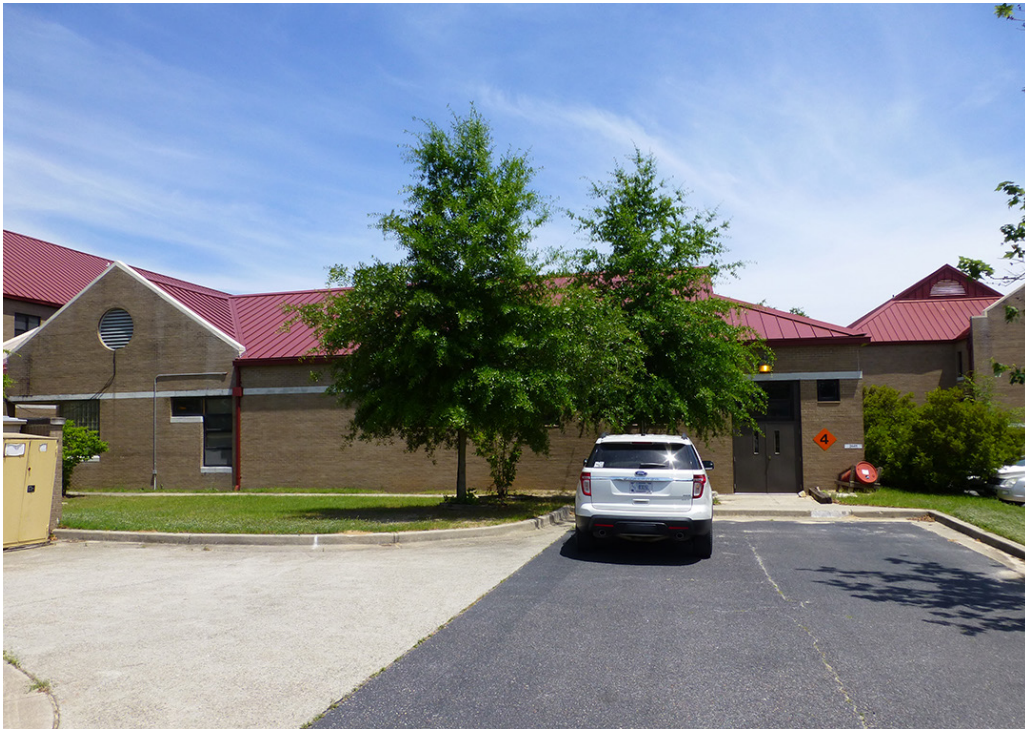
Photo 3. West side of 24411 at Fort Gordon, GA, showing cross gable on left and clipped gable on right (ERDC-CERL, 2015).

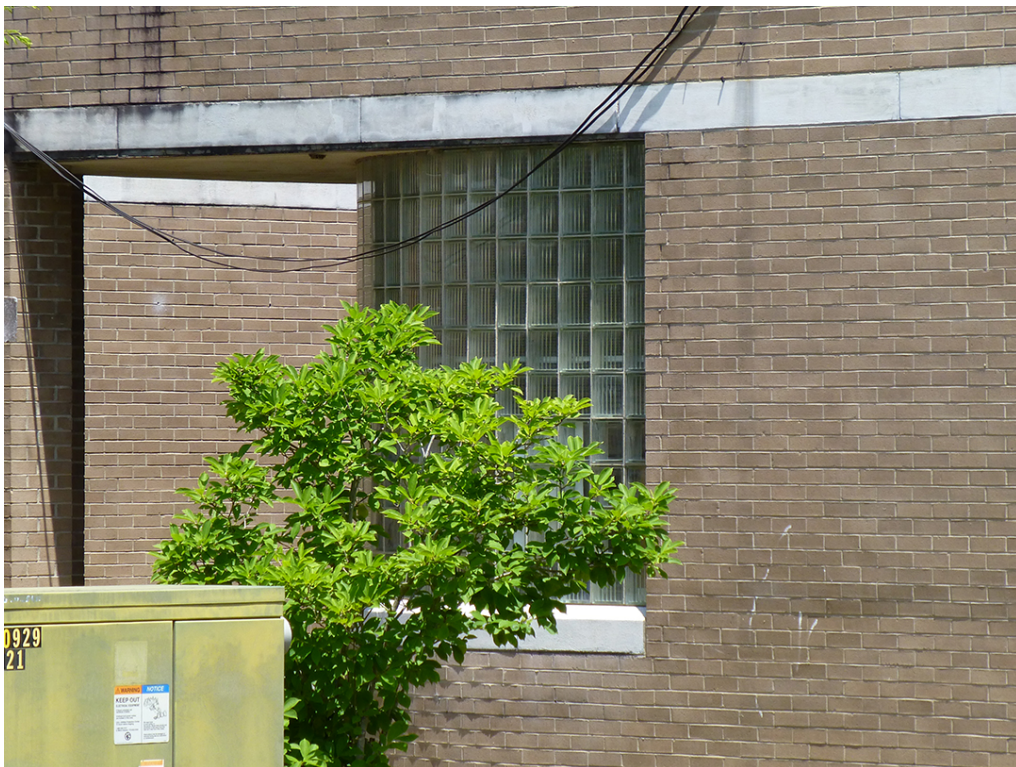
Photo 4. Northwest corner of 24411 at Fort Gordon, GA, showing curved glass block window, precast-concrete windowsill below, and precast-concrete belt course above (ERDC-CERL, 2015).

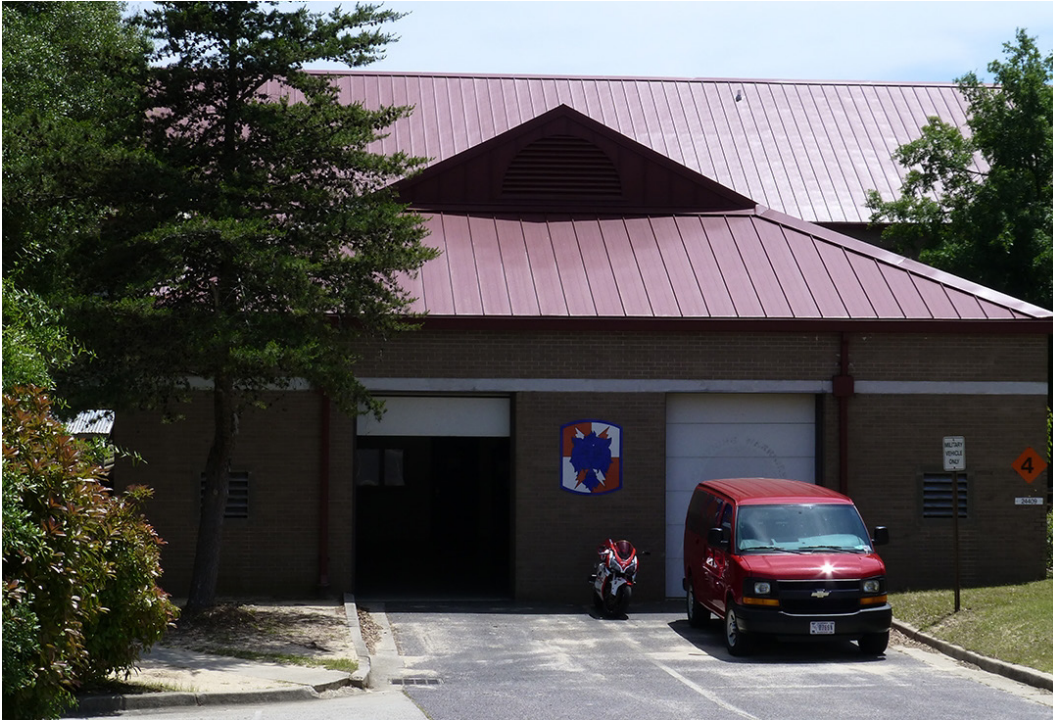
Photo 5. North side of 24409 at Fort Gordon, GA, showing clipped gable and two large openings with panel lift doors (ERDC-CERL, 2015).

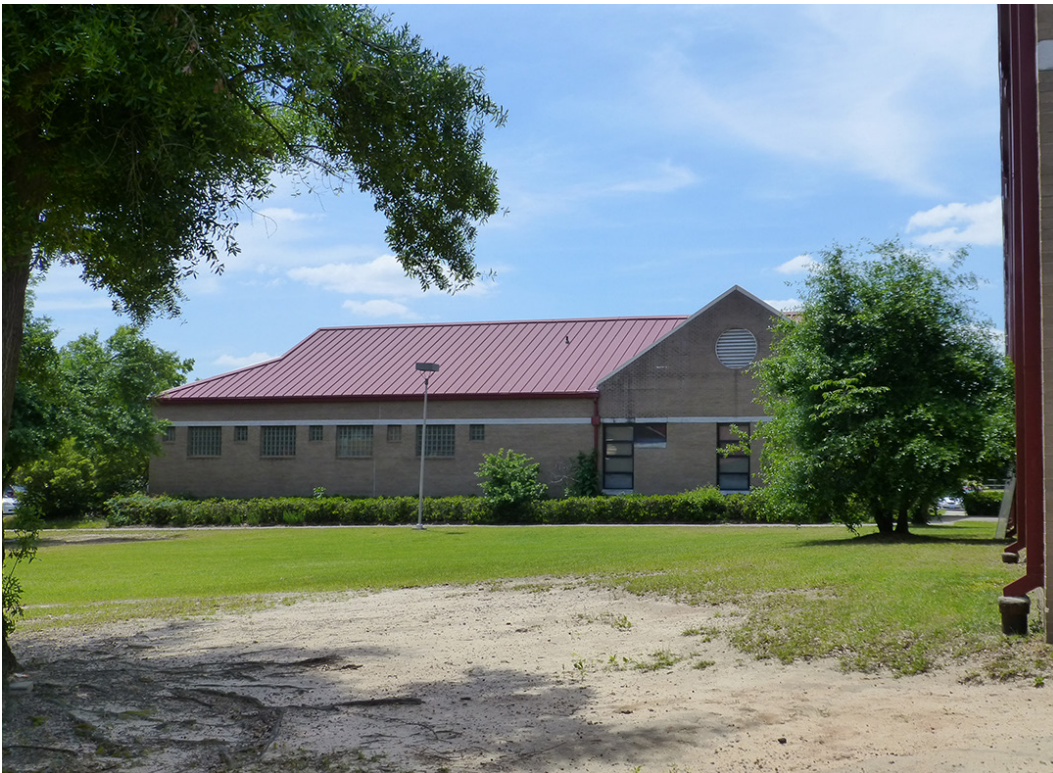
Photo 6. West side of 24411 at Fort Gordon, GA, showing clipped gable on left, cross gable on right, glass block windows, and precast-concrete belt course (ERDC-CERL, 2015).

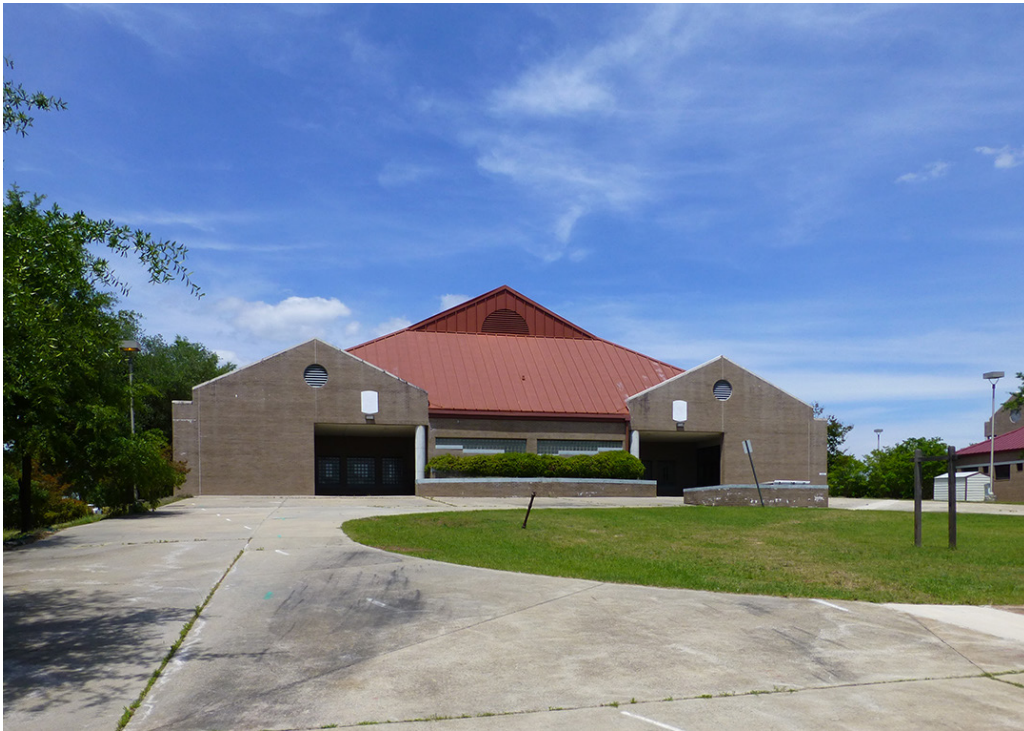
Photo 3. South side of 24414 at Fort Gordon, GA, showing large entrance plaza, clipped gable in the center, a cross gable over each entrance, precast-concrete columns, and glass-block window (ERDC-CERL, 2015).

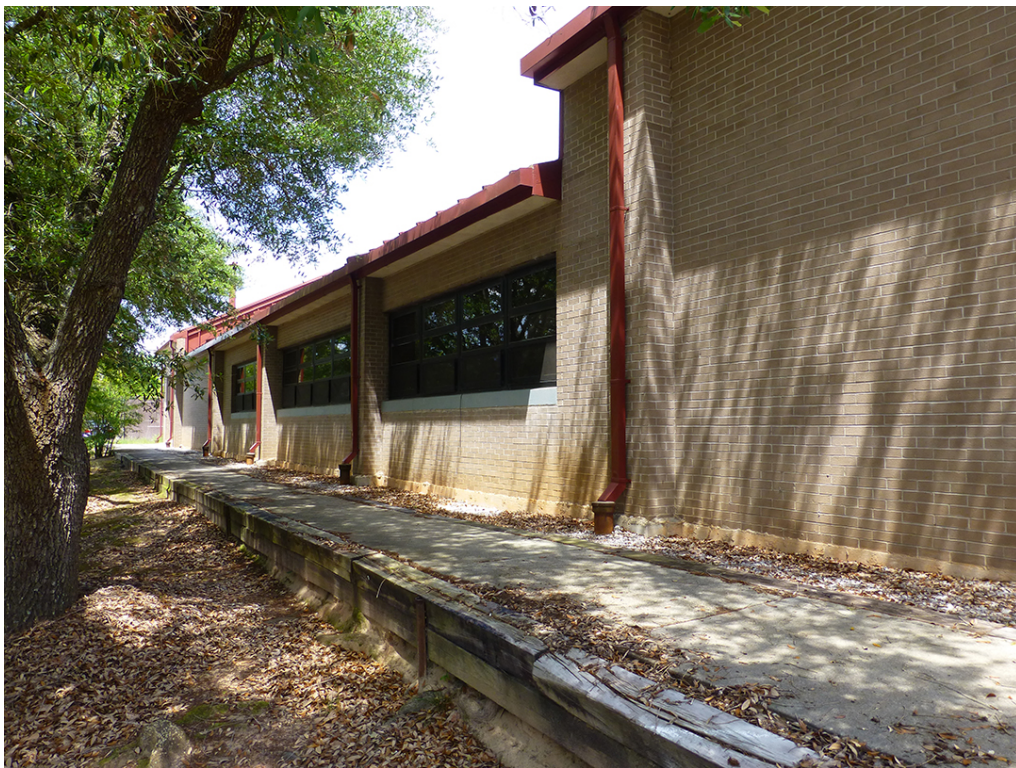
Photo 4. West side of Building 24414 at Fort Gordon, GA, showing tan brick, brick buttresses, and window openings (ERDC-CERL, 2015).

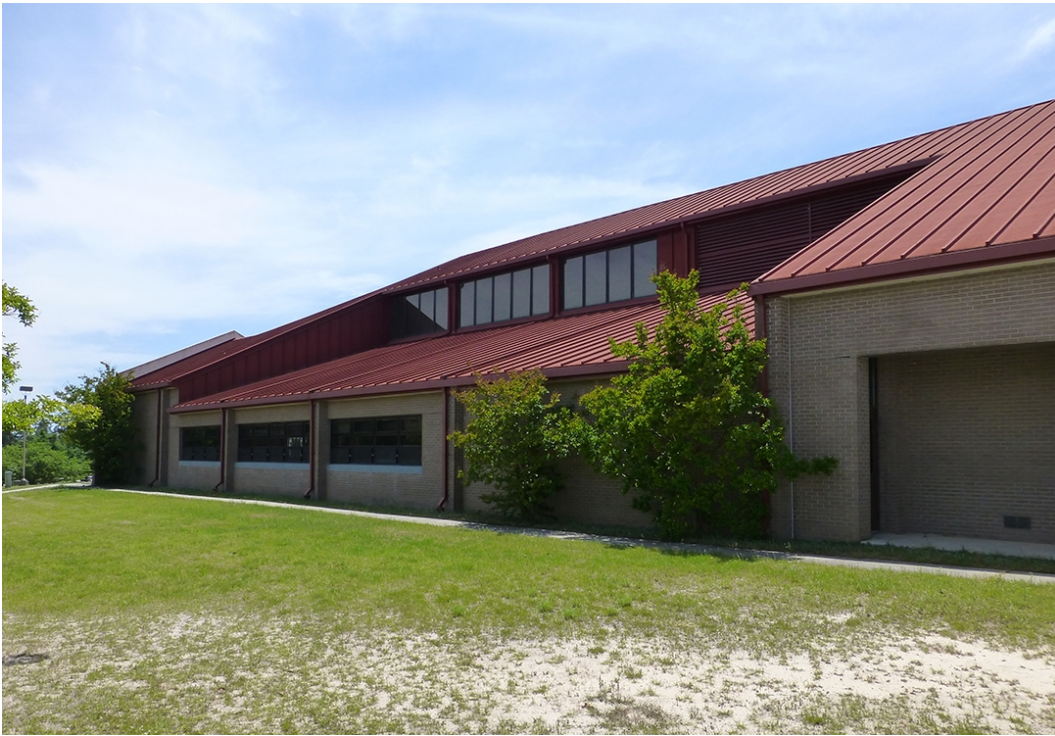
Photo 5. East side of Building 24414 at Fort Gordon, GA, showing red metal roof, high-height space, and clerestory windows (ERDC-CERL, 2015).

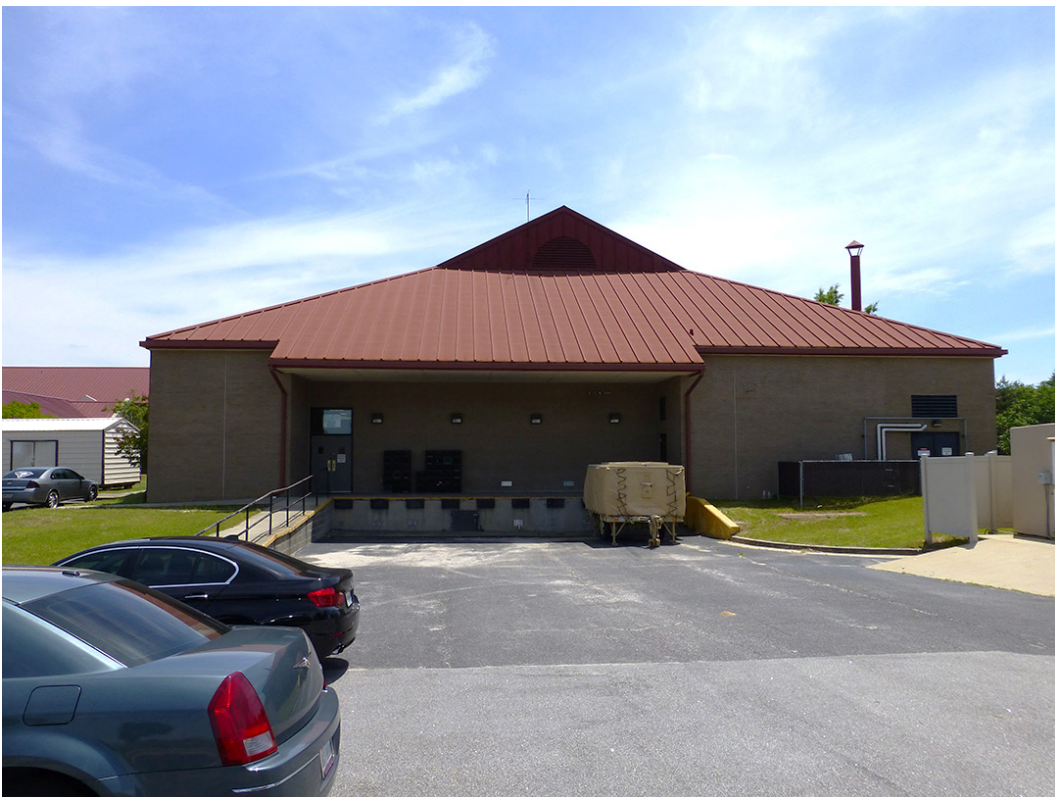
Photo 6. North side of Building 24414 at Fort Gordon, GA, showing clipped gable and loading dock (ERDC-CERL, 2015).

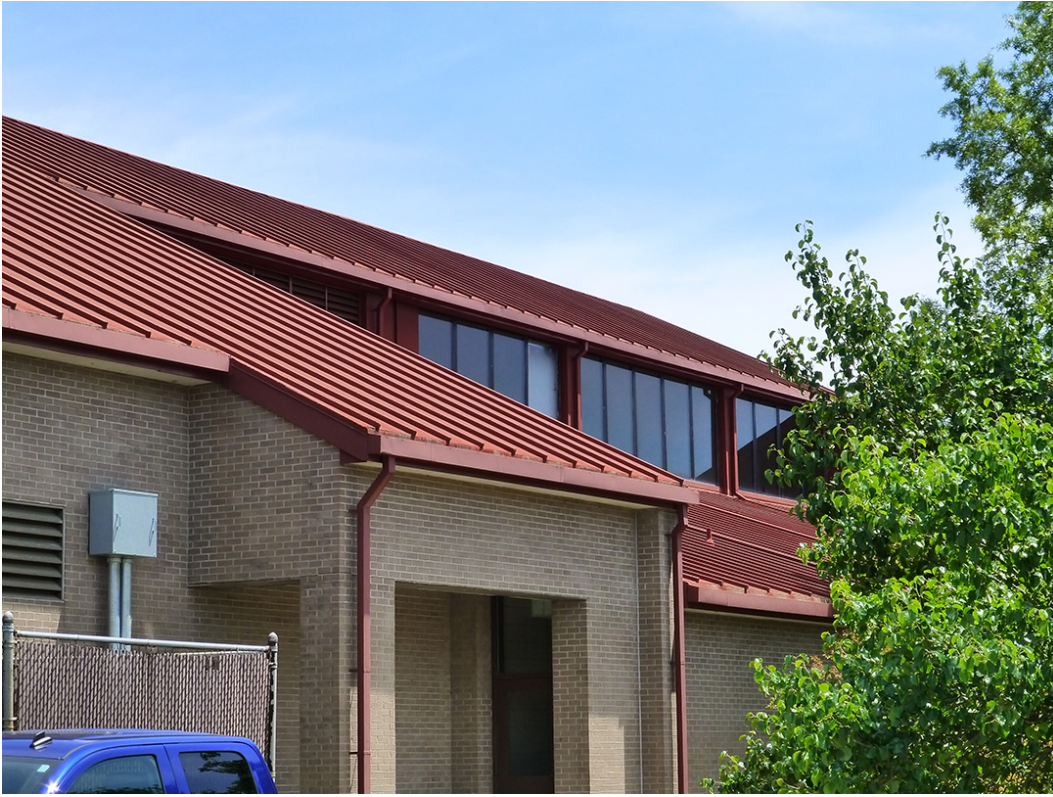
Photo 7. Detail of west side of Building 24414 at Fort Gordon, GA, showing west entrance, red metal roof, and clerestory windows (ERDC-CERL, 2015).

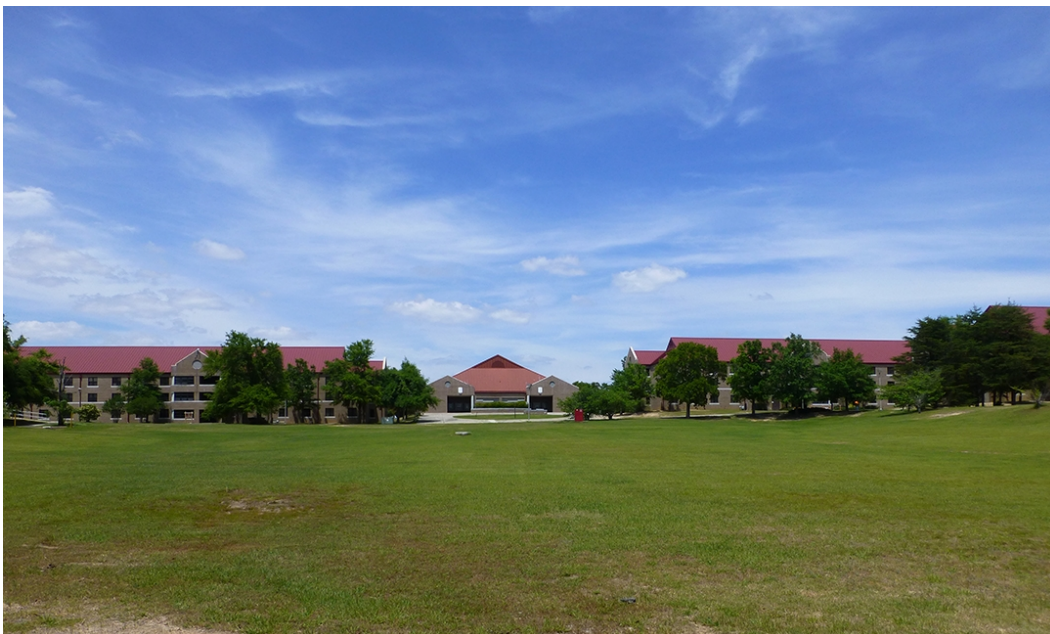
Photo 2. Overview of the 1988 barracks complex at Fort Gordon with the mess hall (Facility 24414) in the middle with barracks on either side (Facility 24407 on the left and Facility 24406 on the right), looking north (ERDC-CERL, 2015).

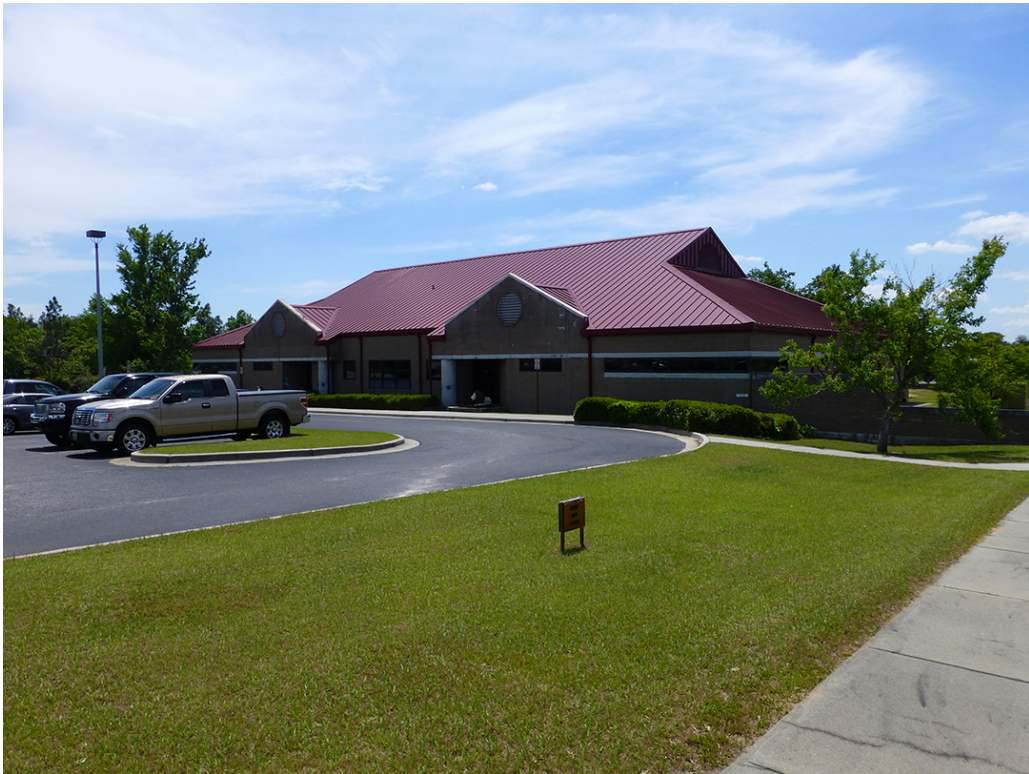
Photo 3. Northeast oblique of Building 24402 showing clipped gable, cross gables at entrances, precast-concrete columns, precast-concrete belt course, and precast-concrete windowsills (ERDC-CERL, 2015).

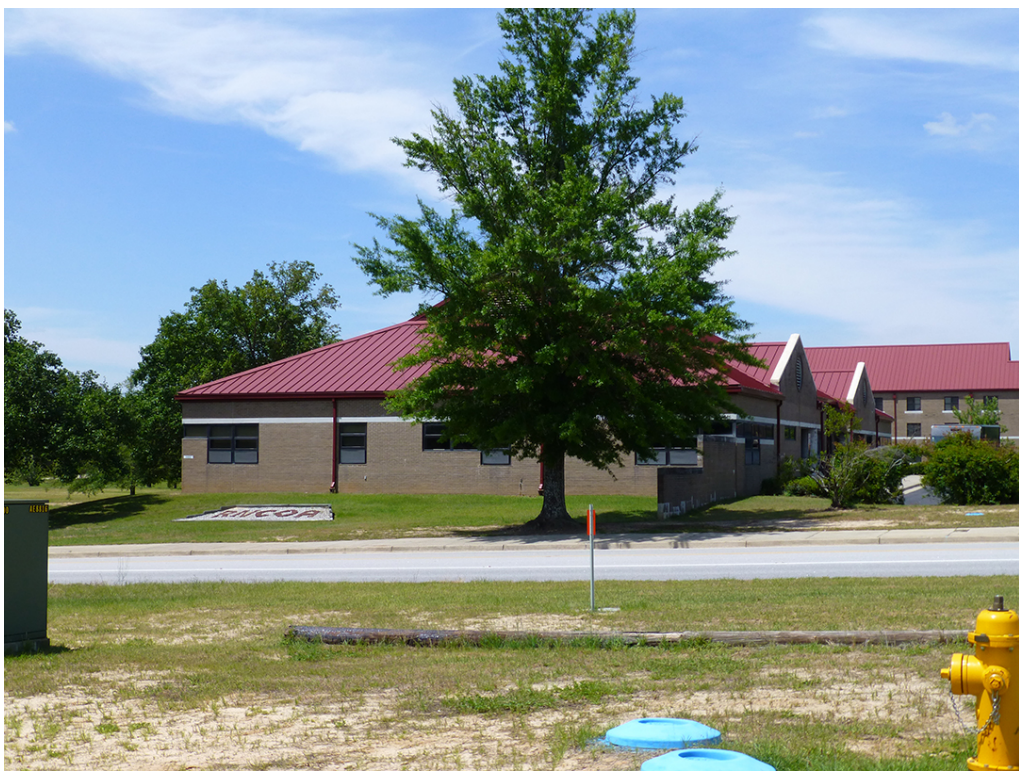
Photo 4. South side of Building 24402 showing cross gables and precast-concrete belt course (ERDC-CERL, 2015).
