**TECHNICAL REPORT**  
**TR-NAVFAC-EXWC-EV-1706**  
**DECEMBER 2016**

**Final Report : Innovative Acoustic Sensor Technologies for  
Leak Detection in Challenging Pipe Types**

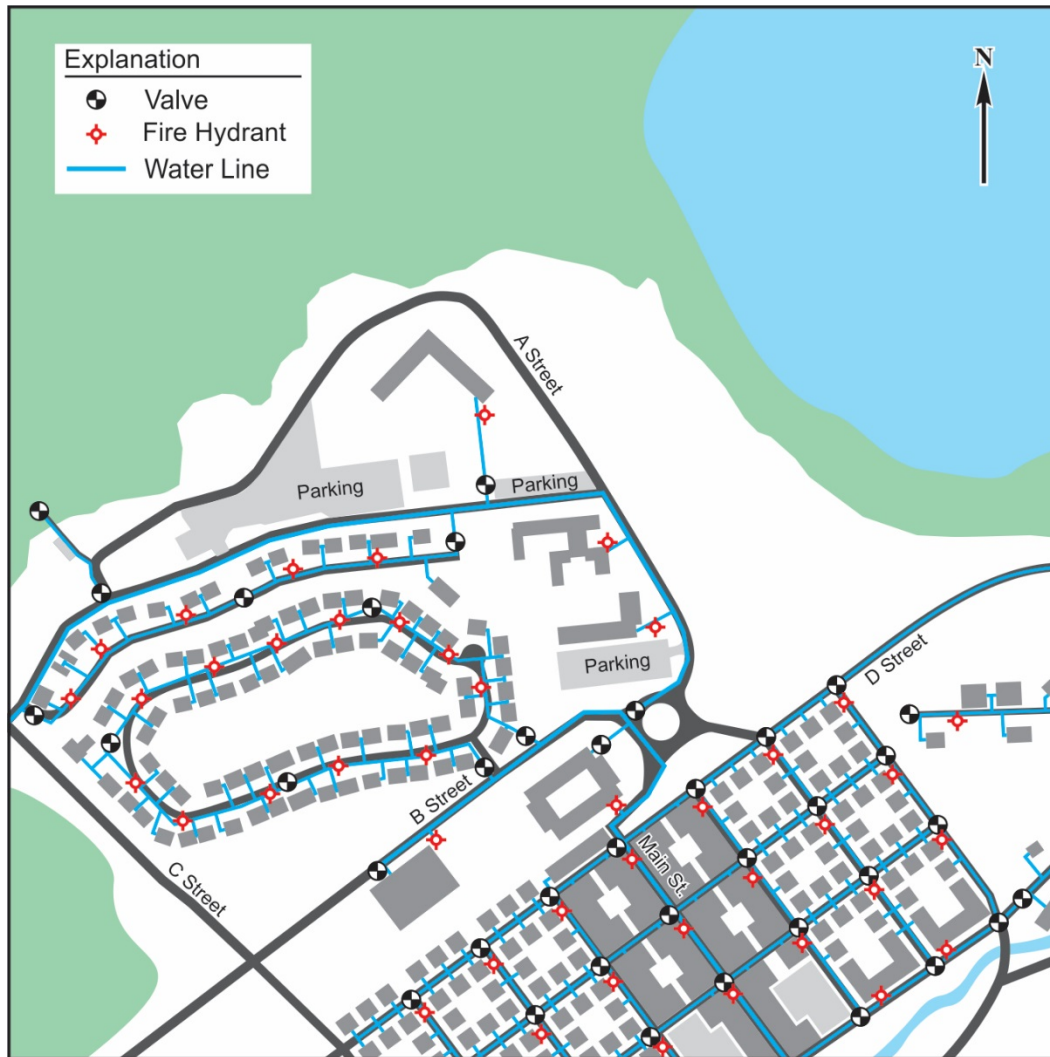
**Figure 1-1. Typical Water Distribution System Layout for a DoD Installation**

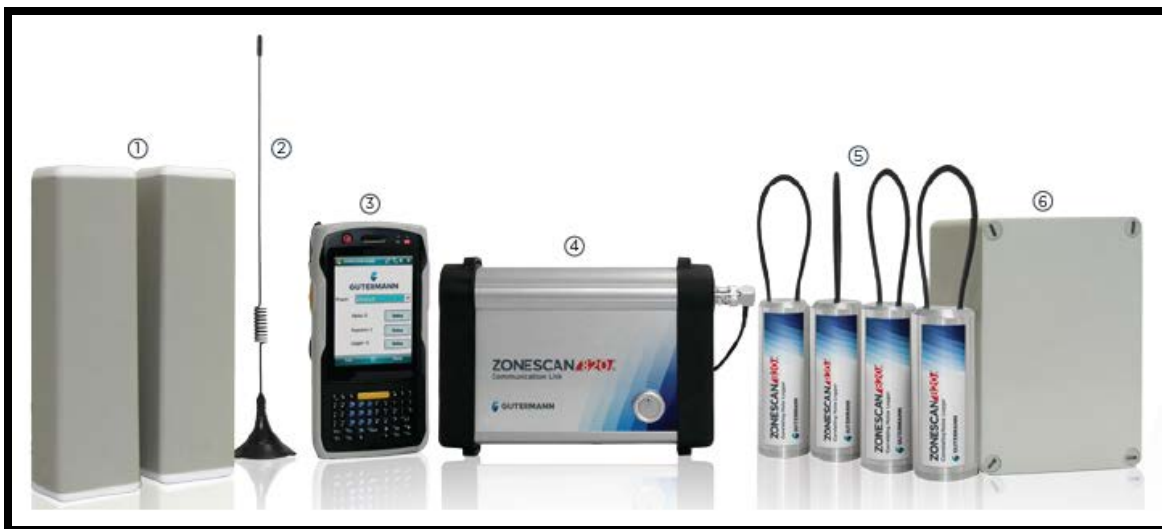
The ZoneScan Alpha acoustic logger sensor system for continuous monitoring is shown in Figure 2-2. Table 2-2 summarizes the primary components, along with their respective function. System components include: (1) radio repeater modules to send data to a centralized computer processing system; (2) extended antenna (optional to transmit data over longer distances); (3) personal data assistant (PDA) for system setup; (4) communication link for system setup; (5) ZoneScan acoustic sensors; and (6) ZoneScan Alpha Com Link. The system also relies on data management, processing and display capabilities provided by a personal computer system operated by the user and Gutermann's centralized server that provides data processing capability. The sensors are permanently or temporarily installed on valves or fire hydrants at targeted areas of the potable water distribution system. The sensors are easily attached via a magnet on the bottom of each sensor. The sensors can be connected via radio transmission or they can be integrated into an existing AMI network.

**Figure 2-2. ZoneScan Alpha System Components (Courtesy of Gutermann)**

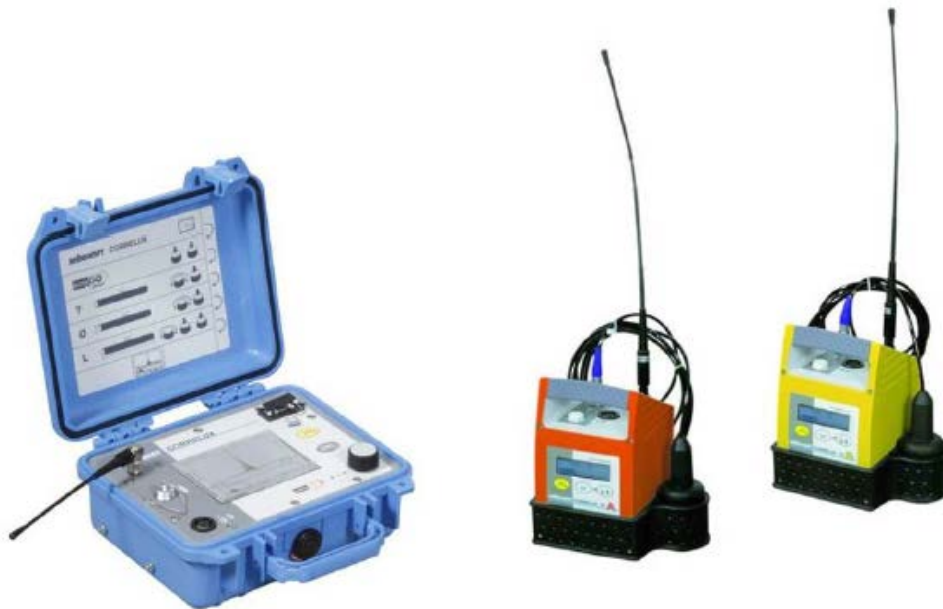
The Correlux HL6000X is a correlator system used for automatically pinpointing leaks in water pipes (see Figure 2-5). It consists of two radio transmitters that connect to piezo-ceramic accelerometers (transmitter A and B), the correlator (the user interface device), correlation software, and headphones. The correlator device can be connected to a personal computer for software updates, downloading data, and to printout results. The correlator device has enough memory to record data for up to 10 segments. It is powered by a battery with an operational life of 12 hours. Each radio transmitter is powered by an internal battery with an operational life of 15 hours. All devices can also be externally powered using a 12-volt direct current car adapter or 110-volt alternating current power supply.

**Figure 2-5. Correlux HL6000X System (Courtesy of Vivax-Metrotech)**

The correlator system works by placing the two accelerometers (sensors) at either end of a pipe section (on valves, exposed pipe sections, or hydrants as the local conditions dictates). Table 2-6 shows the recommended sensor spacing based upon pipe type. The sensor spacing must be accurately measured for input into the correlator if a leak is detected. No information was

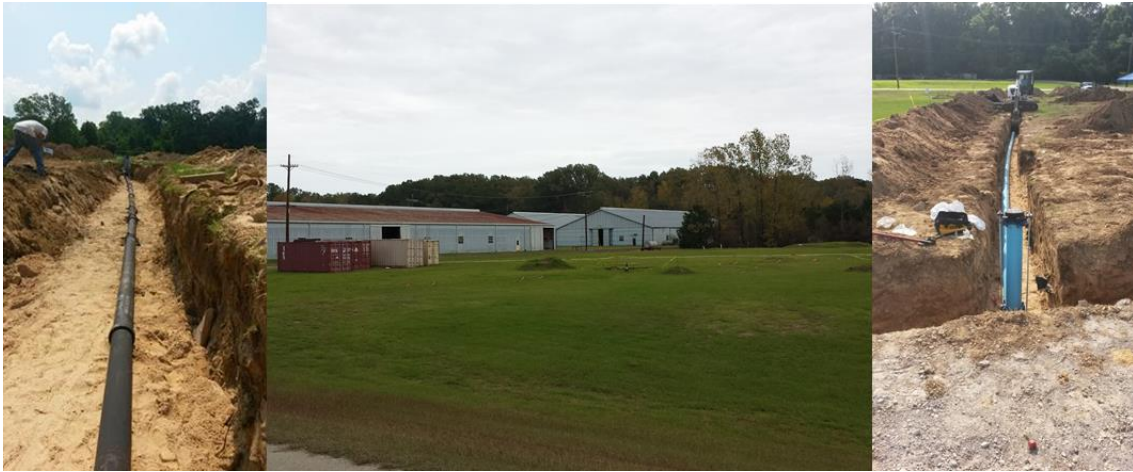
A 200-foot test bed was constructed for use in the project. The test bed consisted of 90 feet of 6-inch DI pipe and 110 feet of 6-inch PVC pipe. Risers were installed on the test sections to allow for the placement of the acoustic sensors including accelerometers and hydrophones. After test bed construction, 10 simulated leak locations were installed on the main line, along with one simulated leak on a nearby PVC lateral line. The 11 total simulated leaks were established using corporation valves and orifice plates with openings of various diameters (as discussed in Section

5.0). Several views of the test bed site are shown in Figure 4-4 from the installation process through final site restoration.

**Figure 4-4. Test Bed Installation and Configuration  
(From left: DI pipe, aboveground view, and PVC pipe)**

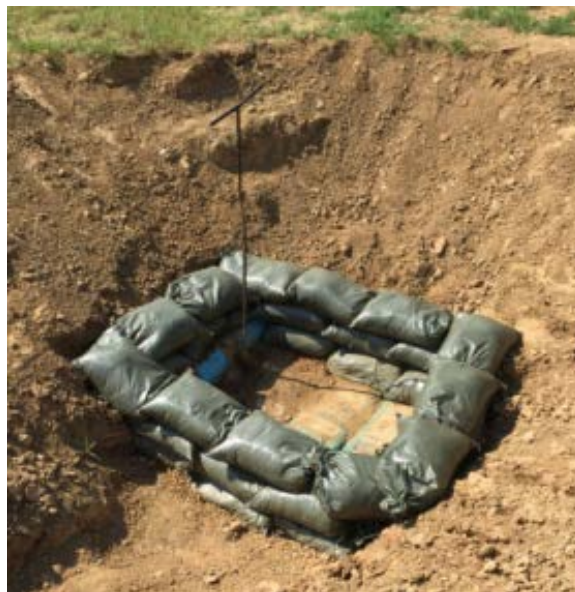
In addition to the installed test sections, a simulated leak was established on the nearby existing 6-inch PVC supply line that ran 205 feet in length. The purpose of this addition to the test bed configuration was to further evaluate the capabilities of the leak detection technologies on a longer PVC pipe segment. A corporation valve was installed to allow for the use of various sizes of orifice plates to simulate leaks (see Figure 4-5). The pit was subsequently backfilled with gravel and equipped with a sump pump.

**Figure 4-5. Long PVC Run Simulated Leak Pit**

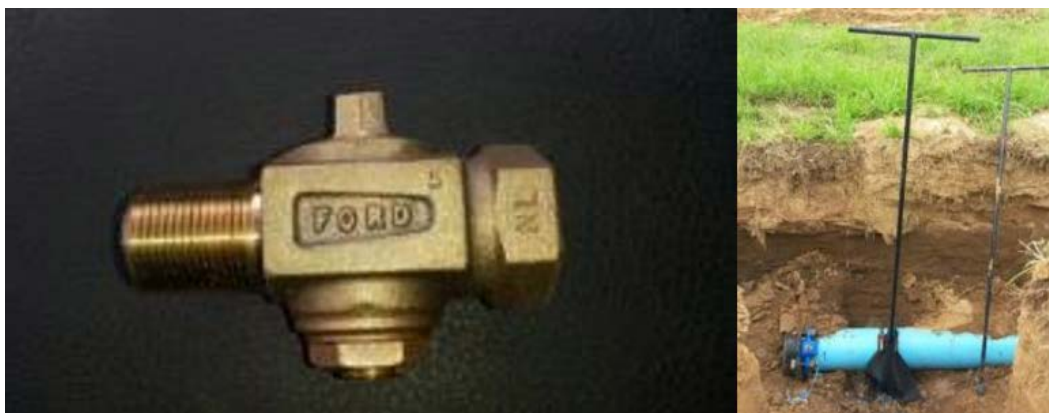
DI pipe. In addition, one leak was installed on a lateral "T" off of the test bed. To simulate pipeline leaks, corporation valves were installed with a  $\frac{3}{4}$ -inch internal threaded outlet port and a handle affixed to turn the valve on/off from the surface (see Figure 5-2). As shown in Table 5-1, the corporation valves were then fitted with  $\frac{3}{4}$ -inch brass orifice plates with drilled holes of various sizes to simulate a range of leak sizes. The flow through an orifice produces a high velocity jet and corresponding negative pressure wave characteristic of a leak signature. The negative pressure wave of a leak is transmitted through the pipe wall and fluid medium. Although not exact, the orifice creates an acoustical signal similar to pressure waves generated from small openings in pipe faults (e.g., pinhole leaks). The estimated flow rate through each orifice was calculated based on the pipeline pressure and Greeley's formula assuming a circular opening (AWWA, 2009). The flow rates ranged from approximately 1 to 8 gpm based on the average 93 psi pipeline pressure at ERDC. Calibration of the leakage rates was conducted in the field as discussed in Sections 5.2 and 5.5. In general, leaks through cracks and joints at the same water line pressure would yield a slightly lower flow rate compared to a circular hole of comparable size based on Greeley's formula (AWWA, 2009). However, varying leak shapes were not studied as part of this demonstration.

**Figure 5-2. Simulated Leak Configuration Using Corporation Valves**

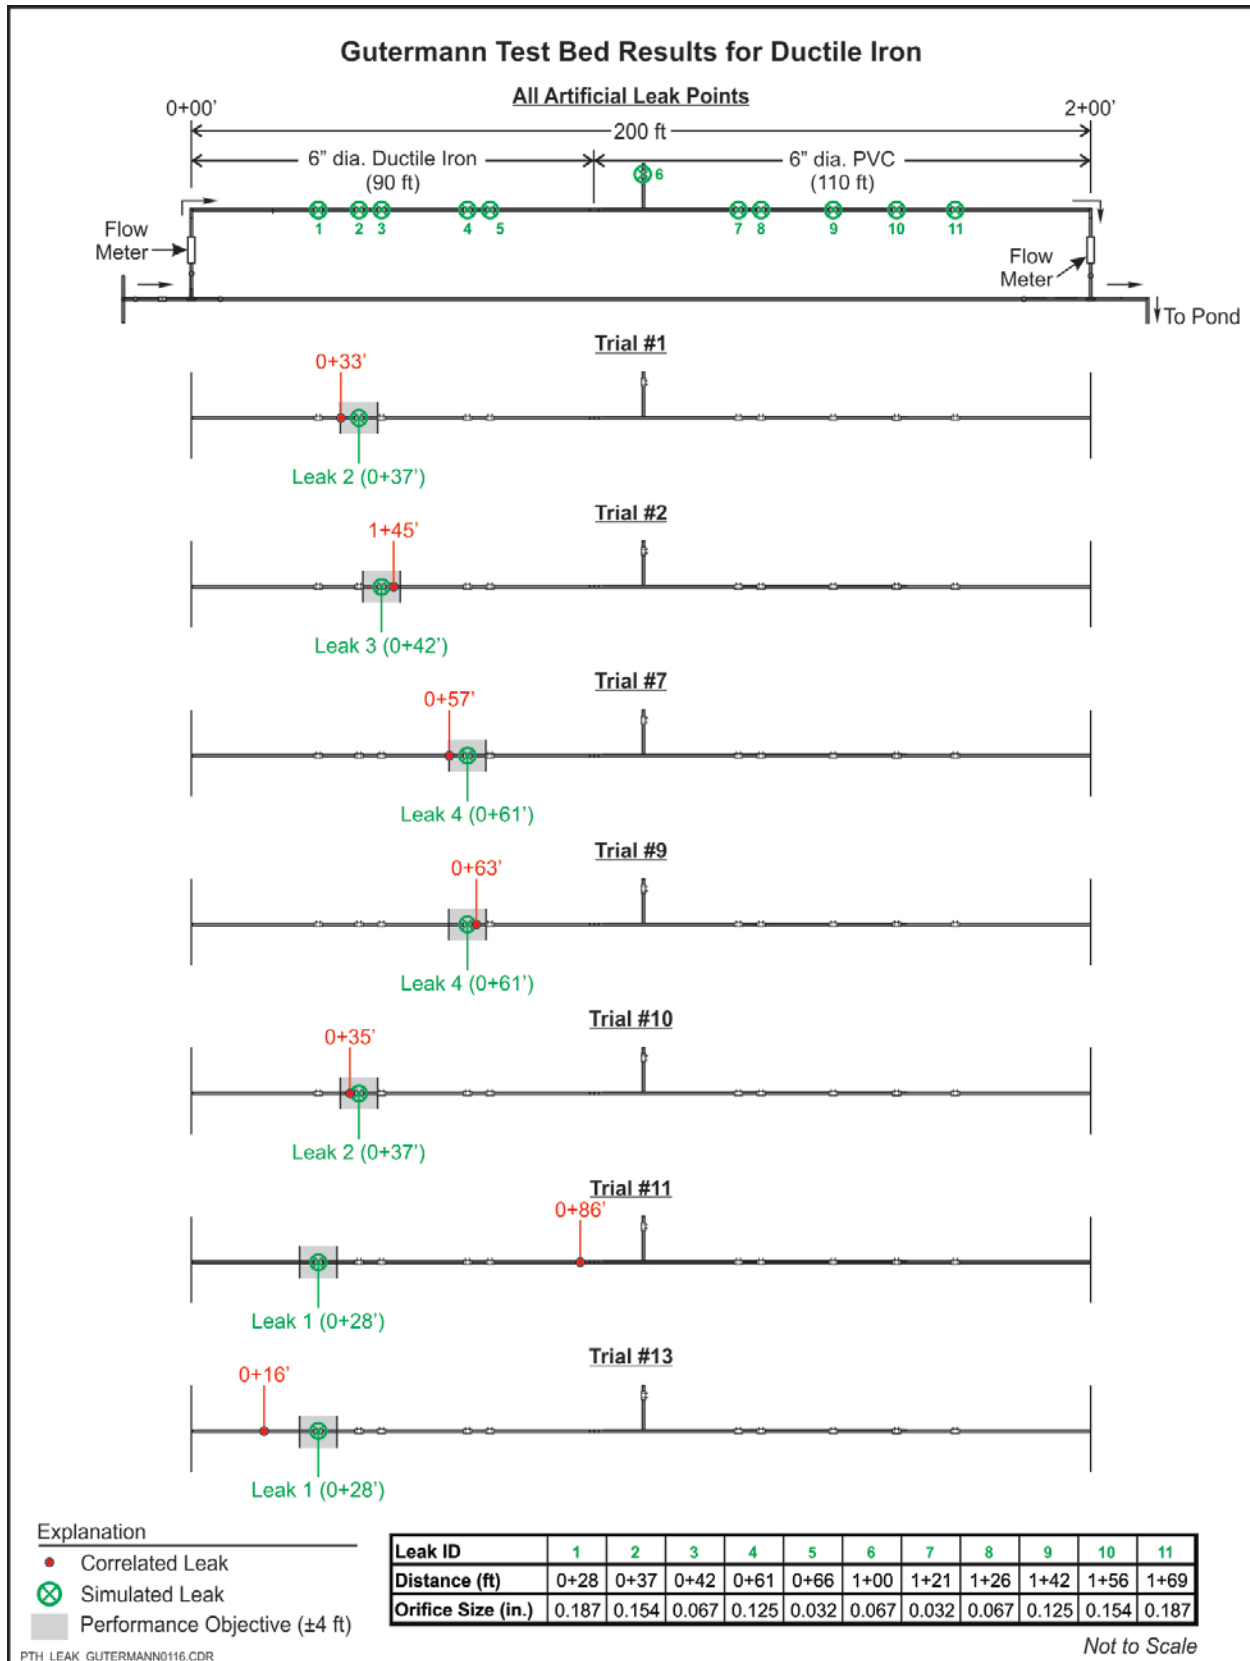
**Figure 6-2. ZoneScan Alpha Test Bed Leak Location Results for DI Pipe**

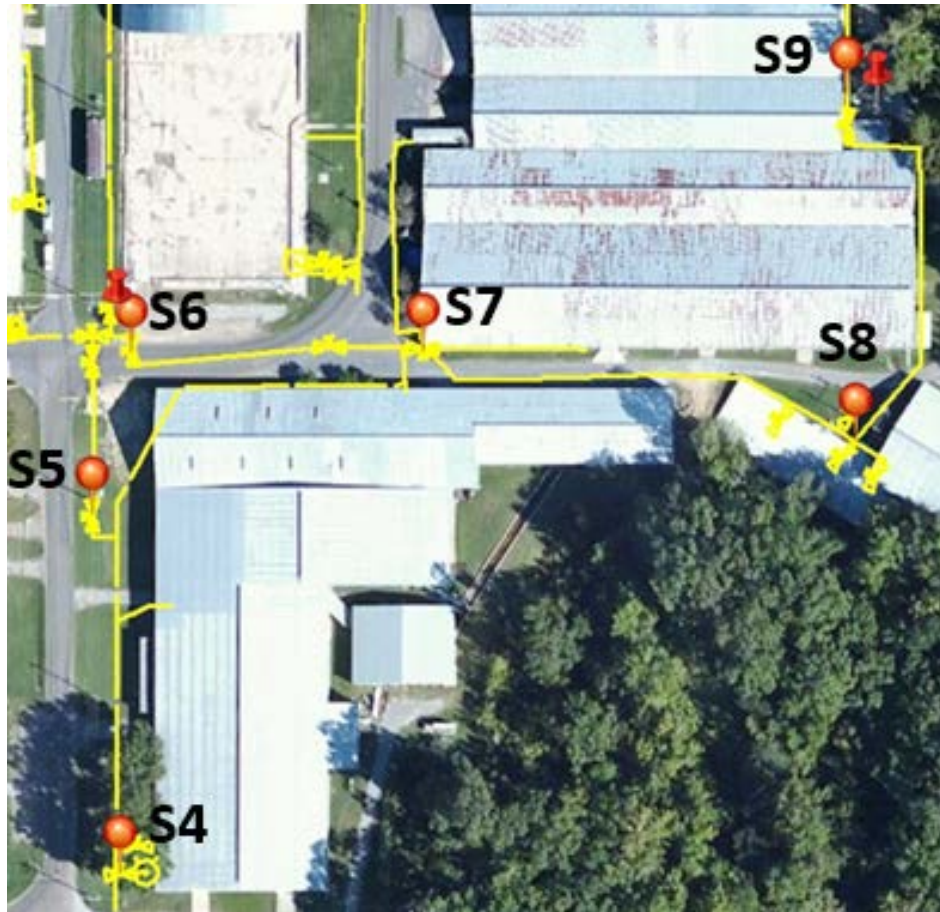
**Figure 6-3. Map of Area B ZoneScan Alpha Sensors (from ESRI ArcGIS, 2015)**

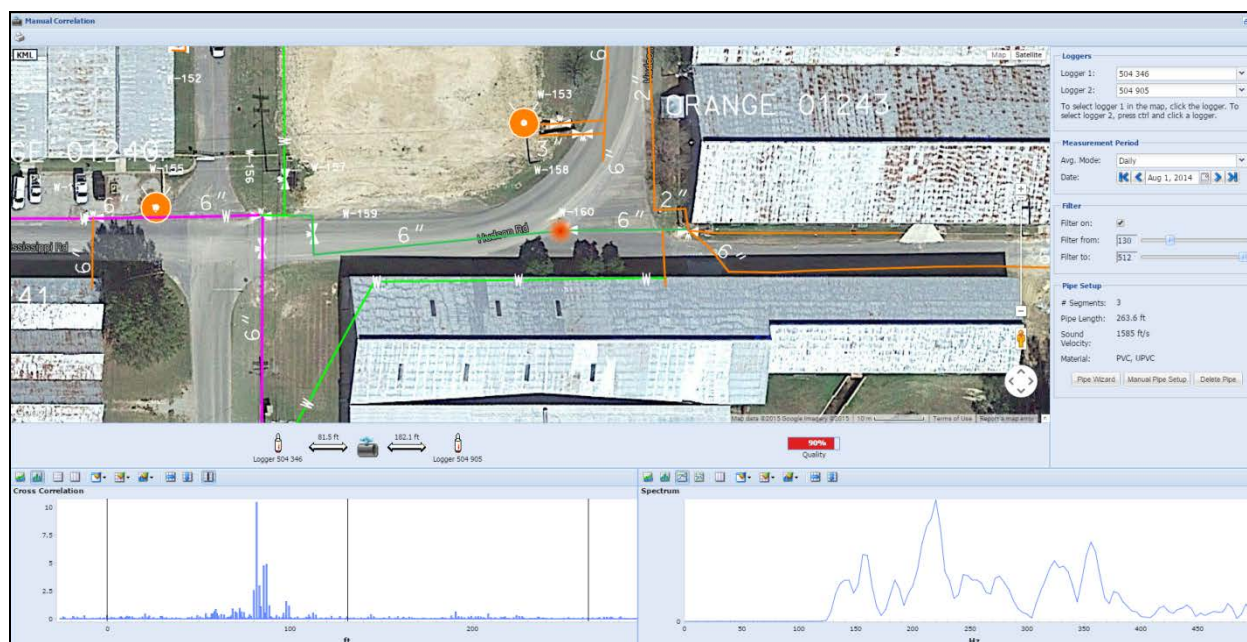
**Figure 6-4. Manual Correlation between Sensors 6 and 7 in Area B on August 1, 2014**

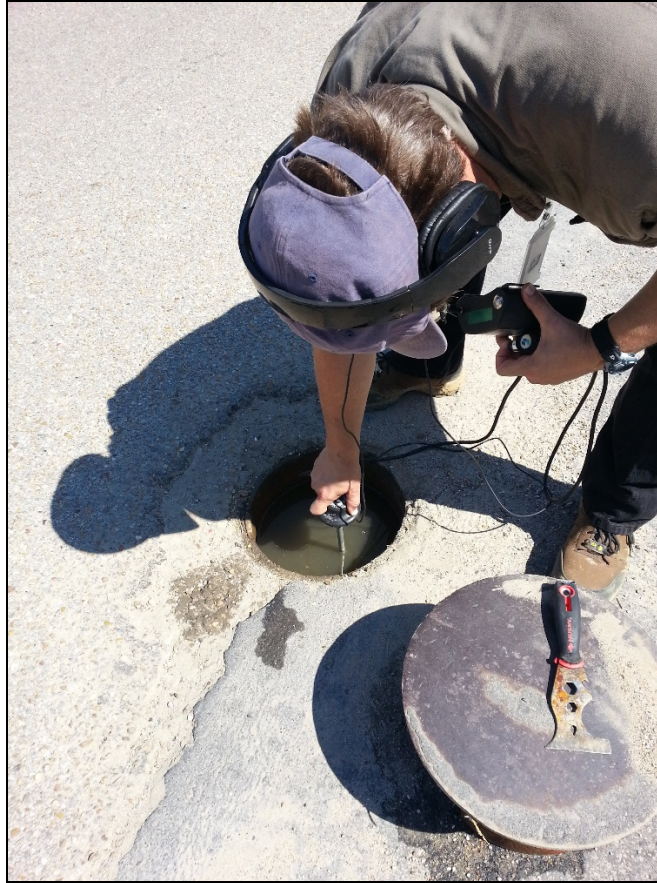
**Figure 6-5. Water-filled Valve Box in Vicinity of Leak Detected by ZoneScan Alpha System**

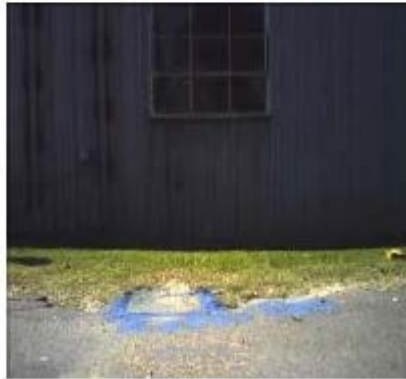
Date	July 30, 2014	Leak No	1	Crew	MA/KS
Address	3281 MISSISSIPPI RD				
Leak Code	WMLK	Leak Class	C	Leak Visible	No
Leak At	Main Leak	Est Water Loss in GPM	11	Map Area	Area B
Pipe Material	Steel	Pipe Size	6	GPSID	1
Latitude:	32.1758318	Longitude:	90.5147414		
Leak Photo

**Figure 6-10. LeakFinderRT Results for POI Identified at ERDC**

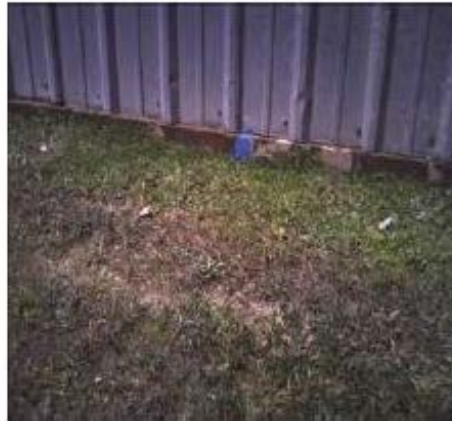
Date	July 30, 2014	Leak No	2	Crew	MA/KS
Address	3281 MISSISSIPPI RD				
Leak Code	WMLK	Leak Class	B	Leak Visible	Yes
Leak At	Main Leak	Est Water Loss in GPM	59	Map Area	Area B
Pipe Material	CI	Pipe Size	6	GPSID	2
Latitude:	32.1759883	Longitude:	90.5142515

**Figure 6-11. LeakFinderRT Results for Large Leak Identified at ERDC**

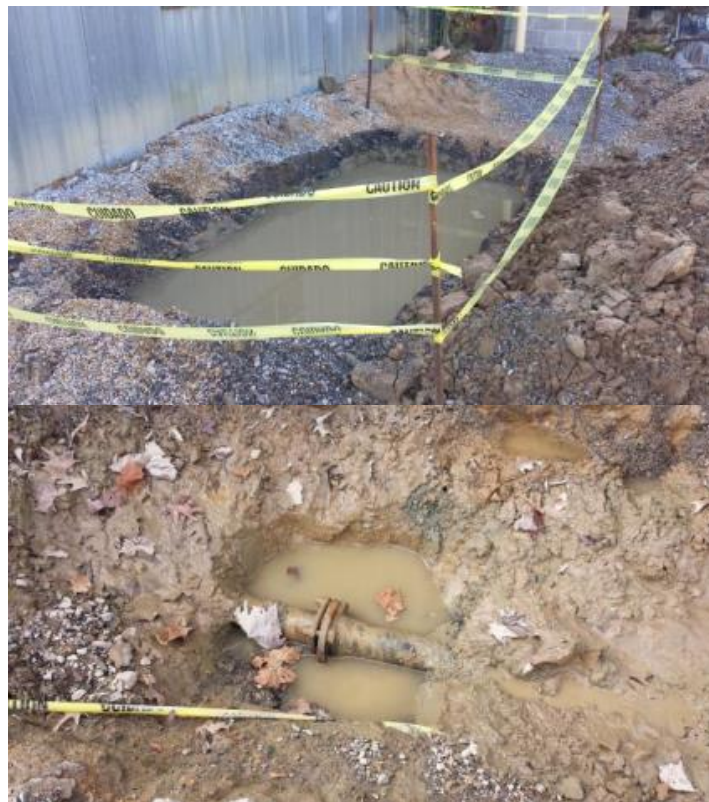
**Figure 6-13. Excavation of the Large Leak Identified at ERDC**
