## **Corrosion Immersion Testing of 13-mm-Diameter Grade-10.9 Bolts for Bolt-on Armor**

**ARL-CR-654**

**July 2010**

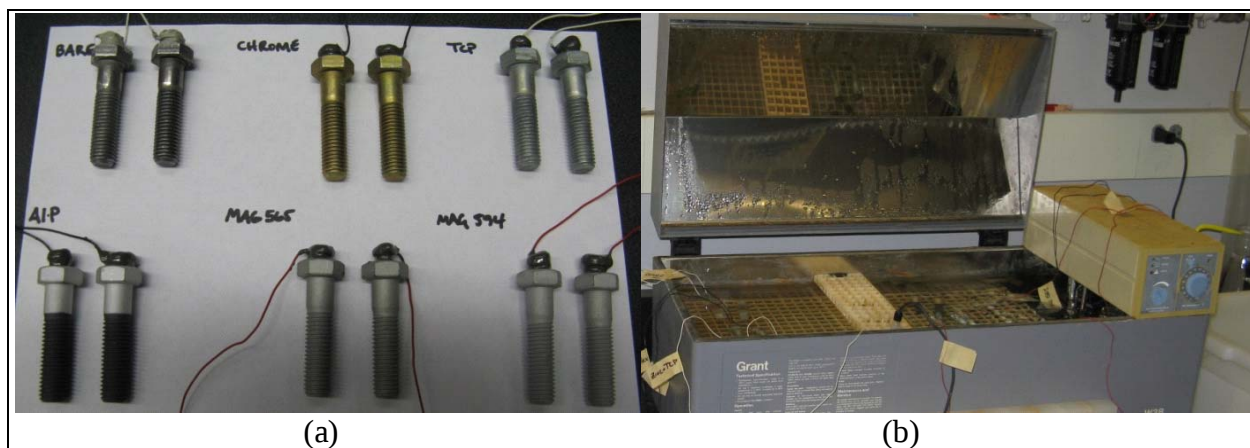
Figure 2. (a) Prepared bolts prior to immersion and (b) immersion bath setup.

1. Each bolt had a 1/8-in hole bored into the center of its head (see figure 1).
2. A Zn-plated steel screw, wrapped with wire, was fixed in place using this hole.
3. Polysulfide sealant was used to insulate and seal the wire/screw assembly to the bolt to prevent contamination (see figure 2 for full assembly).
4. A thermostatic circulated bath was filled with a 5% NaCl solution and heated to 75 °F. Solution temperature was maintained for the duration of the experiment, and the water was continually agitated.
5. Two of each specimen were immersed in the bath for 500 h. Open circuit potential measurements and visual inspections were taken after 1, 2, 4, 8, and 24 h, and every 24 h thereafter.

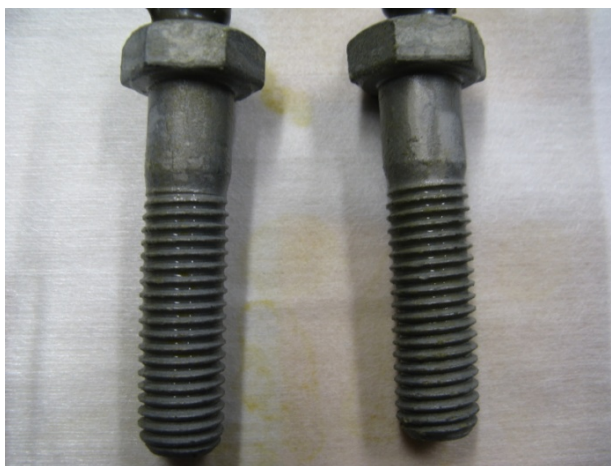
Figure 10. MagniPlate 594 immediately after immersion.

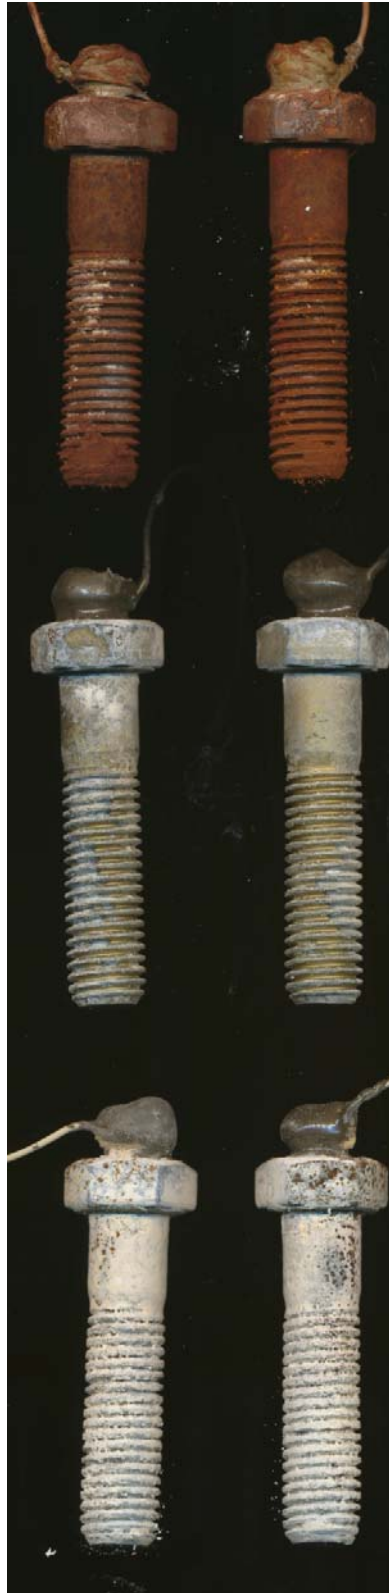
Figure 11. Bare steel, hexavalent chrome/zinc, and TCP/zinc after drying.

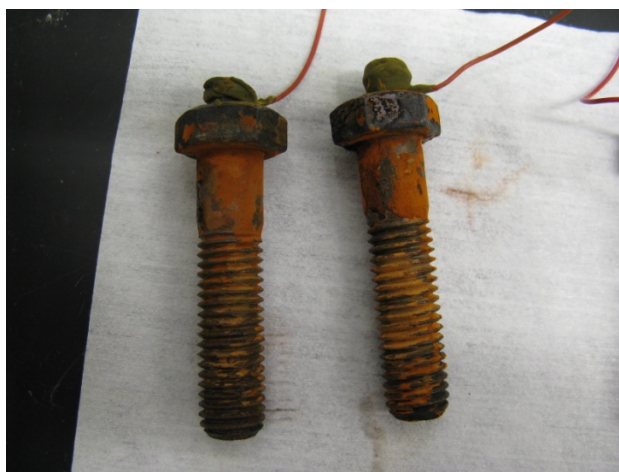
Figure 15. Bare bolts immediately after immersion in supplementary experiment.
