**ROTARY FUEL INJECTION PUMP WEAR TESTING  
USING A 30%/70% ATJ/F-24 FUEL BLEND**

**INTERIM REPORT  
TFLRF No. 488**

**U.S. Army TARDEC Fuels and Lubricants Research Facility  
Southwest Research Institute® (SwRI®)  
San Antonio, TX**

**Contract No. W56HZV-15-C-0030 (WD12 Task 2.2)**

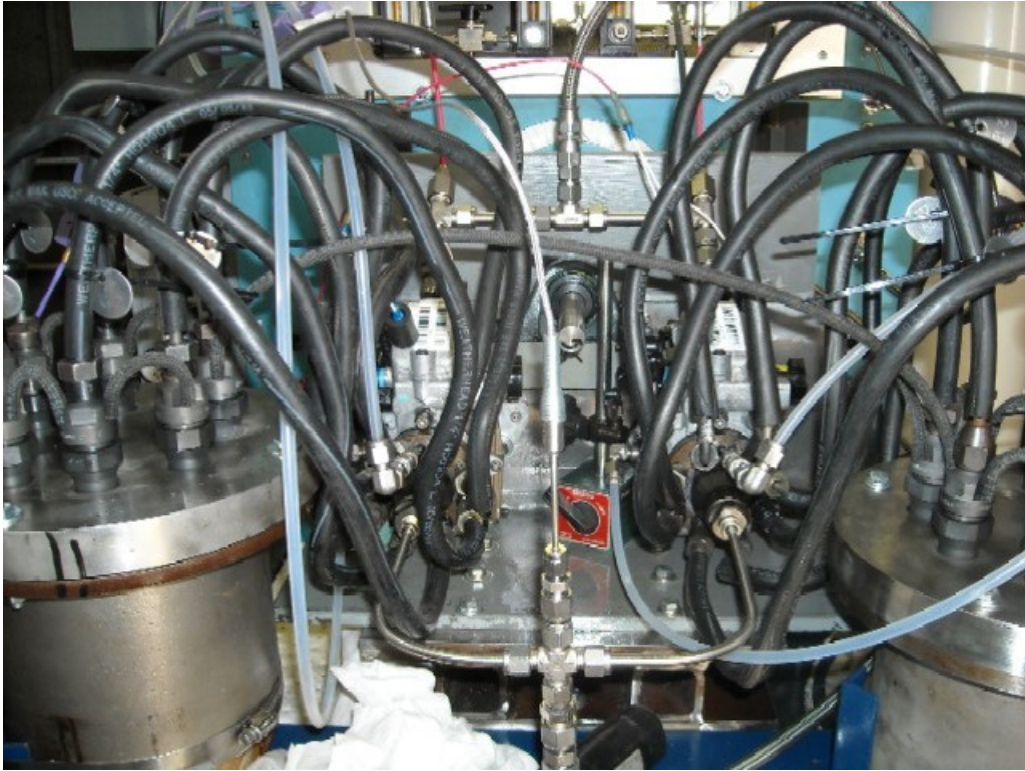
The high-pressure outlets from the pumps were connected to eight Bosch Model O432217276 fuel injectors for a 6.5LT engine and assembled in a collection canister. Fuel from both canisters was then returned to the 55-gallon drum. A separate line was used to return excess fuel from the governor housing to the fuel supply. Fuel-to-water heat exchangers on both the return lines from the injector canisters and the governor housing were used to cool the fuel. The test stand with pumps mounted is shown in Figure 3.

**Figure 3. Dual Stanadyne Rotary Fuel Injection Pumps Mounted on Stand with Fuel Injectors**

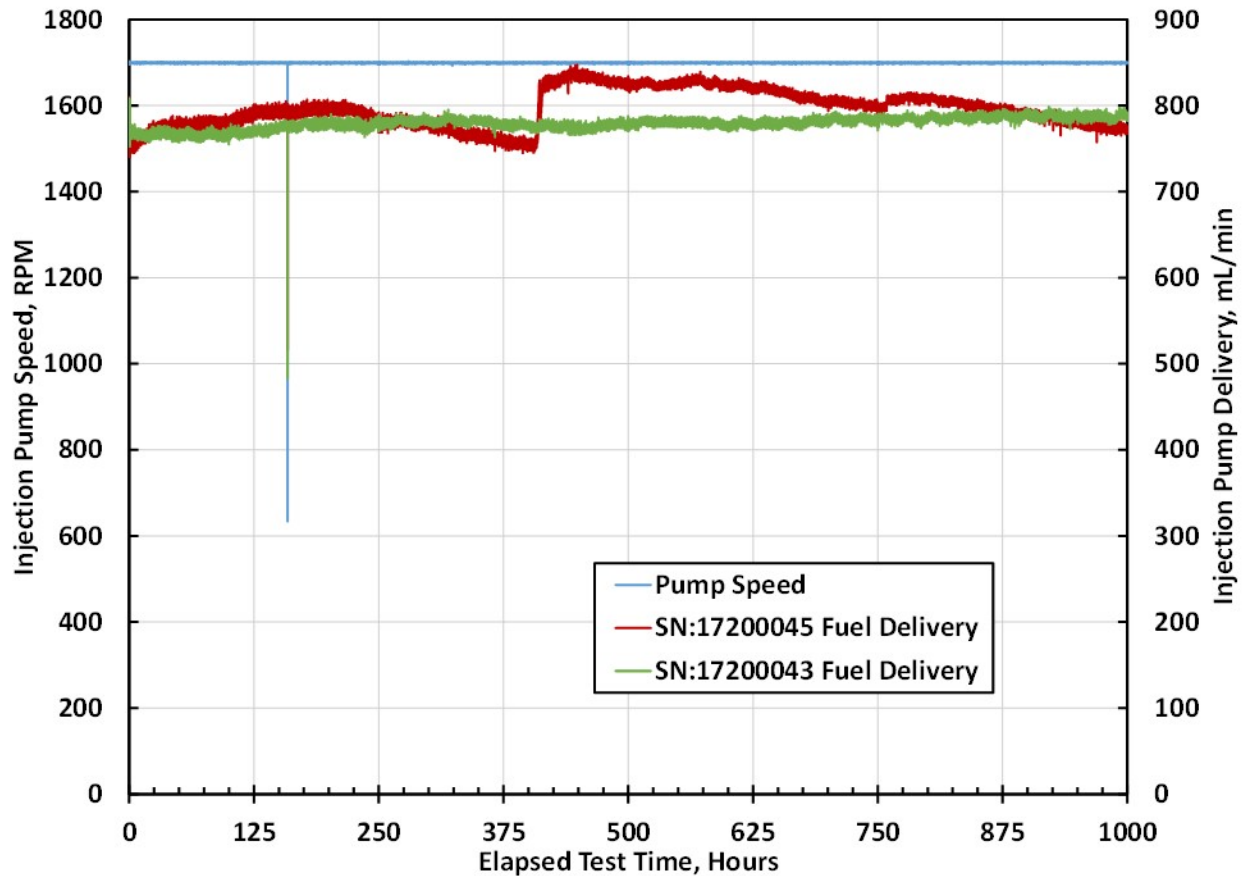
backlash due to drive tang wear. The pump drive speed was very consistent throughout the test, indicating very little governor wear and delivery interaction. The sole deviation of the pump speed and delivery in Figure 4 was due to a power failure.

**Figure 4. Injection Pump Delivery Histories for 30/70 ATJ/F-24 with 24-ppm CI/LI Fuel at 77 °C Elevated Temperature**

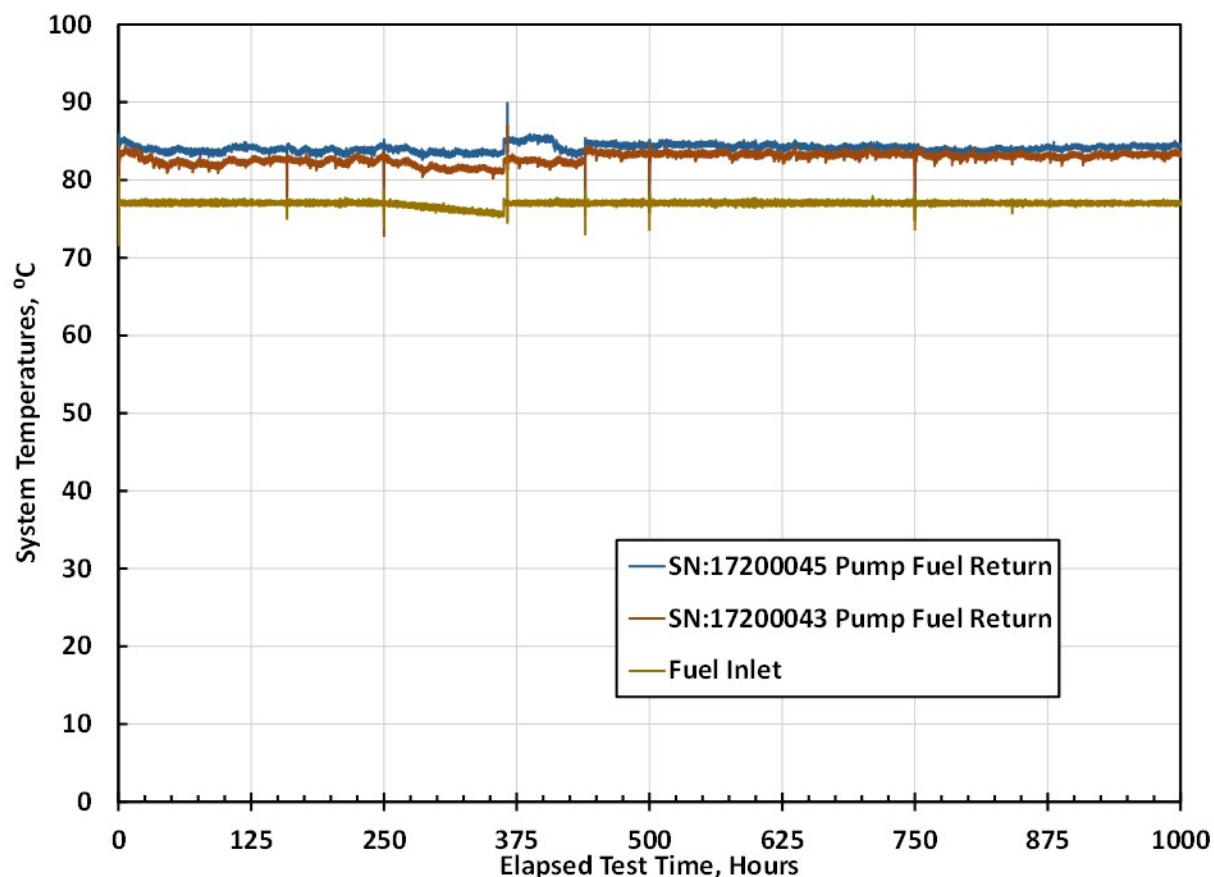
The fuel injection pump temperature histories are shown in Figure 5 for both fuel injection pumps for operation on ATJ/F-24 fuel with 24-ppm CI/LI at 77 °C fuel inlet temperature. Prior to test completion with either fuel injection pump, the housing fuel return temperatures are seen to increase at various times, due to increased internal friction in the fuel injection pumps. Pump SN:17200045 had higher return temperatures, possibly related to the more erratic delivery characteristics

**Figure 5. Fuel Inlet and Fuel Housing Return Temperatures for 30/70 ATJ/F-24 with 24-ppm CI/LI Fuel at 77 °C Elevated Temperature**

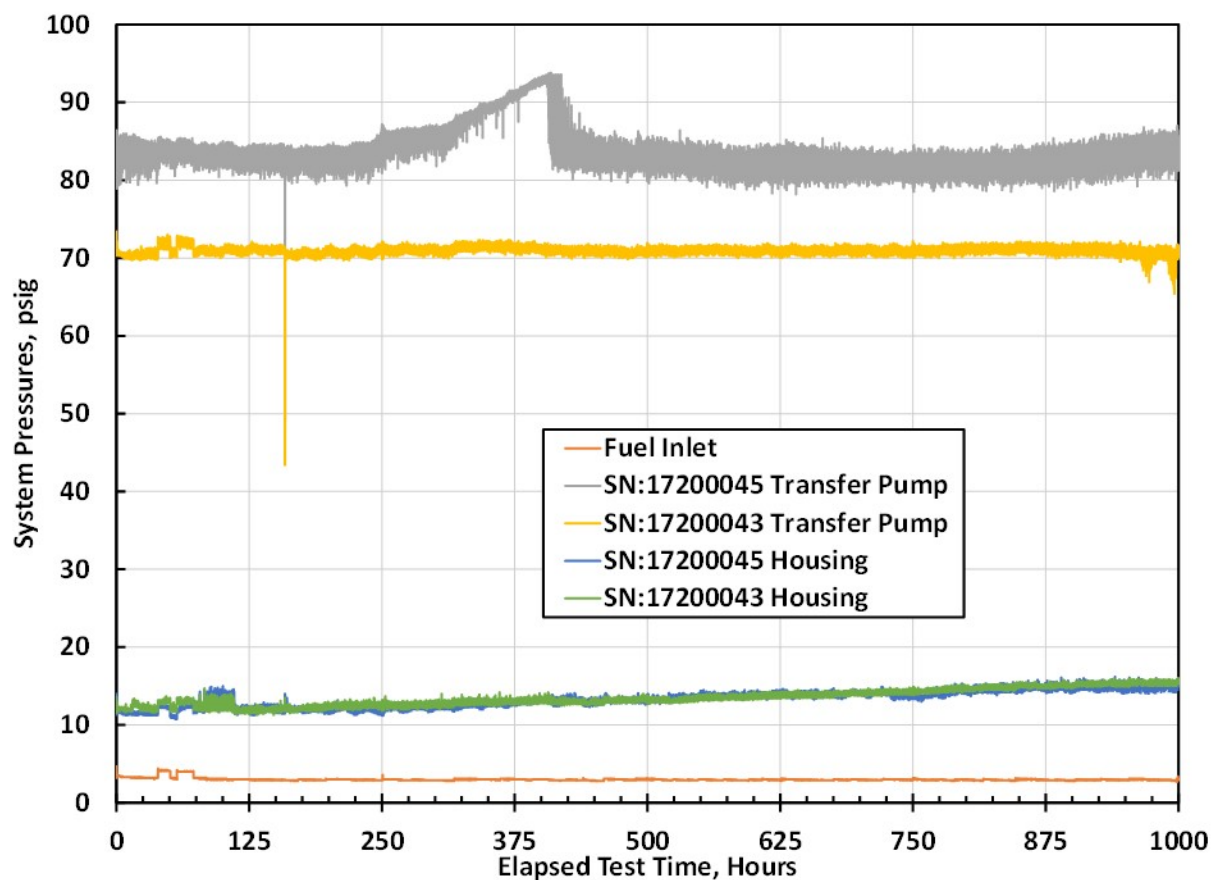
**Figure 6. Fuel Inlet, Fuel Transfer Pump, and Housing Pressure Histories for 30/70 ATJ/F-24 with 24-ppm CI/LI Fuel at 77 °C Elevated Temperature**

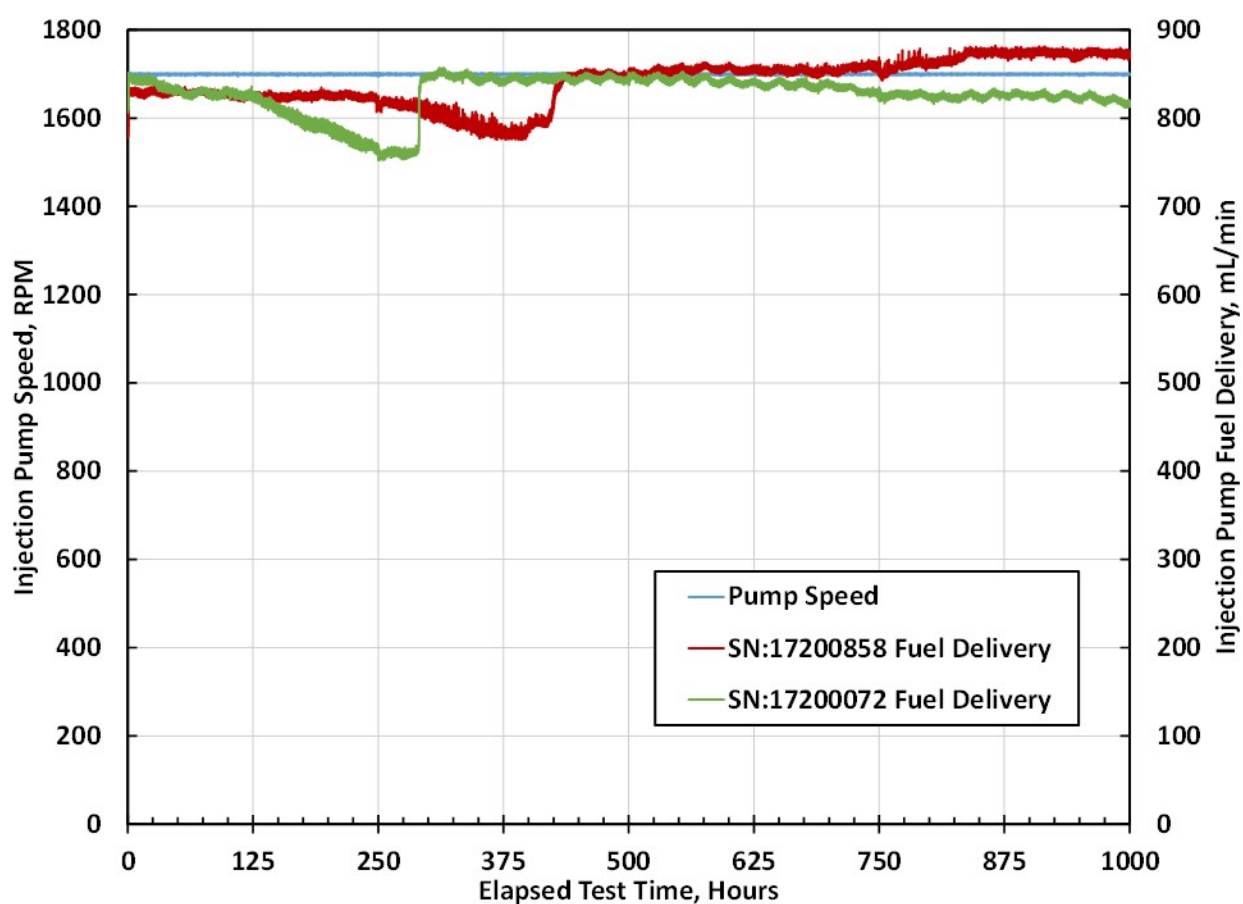
pumps exhibited a slight decrease in fuel delivery, followed by a steady delivery decline, then a rapid delivery recovery. Pump SN:17200858 increased injected delivery fairly steadily till the end of operation after the rapid delivery recovery. Pump SN:17200072 exhibited fairly steady after the delivery recovery, then a slight decline during the last several hundreds of hours of testing. Pump drive speed was very consistent throughout testing indicating wear was not occurring in the governor or drive tang sections of the pump. However both fuel injection pumps appeared to be functioning on the ATJ/F-24 blend with 24-ppm CI/LI at the conclusion of the 1000-hours of operation at 40 °C fuel inlet temperature.

**Figure 9. Injection Pump Delivery Histories for 30/70 ATJ/F-24 with 24-ppm CI/LI Fuel Evaluation at 40 °C**

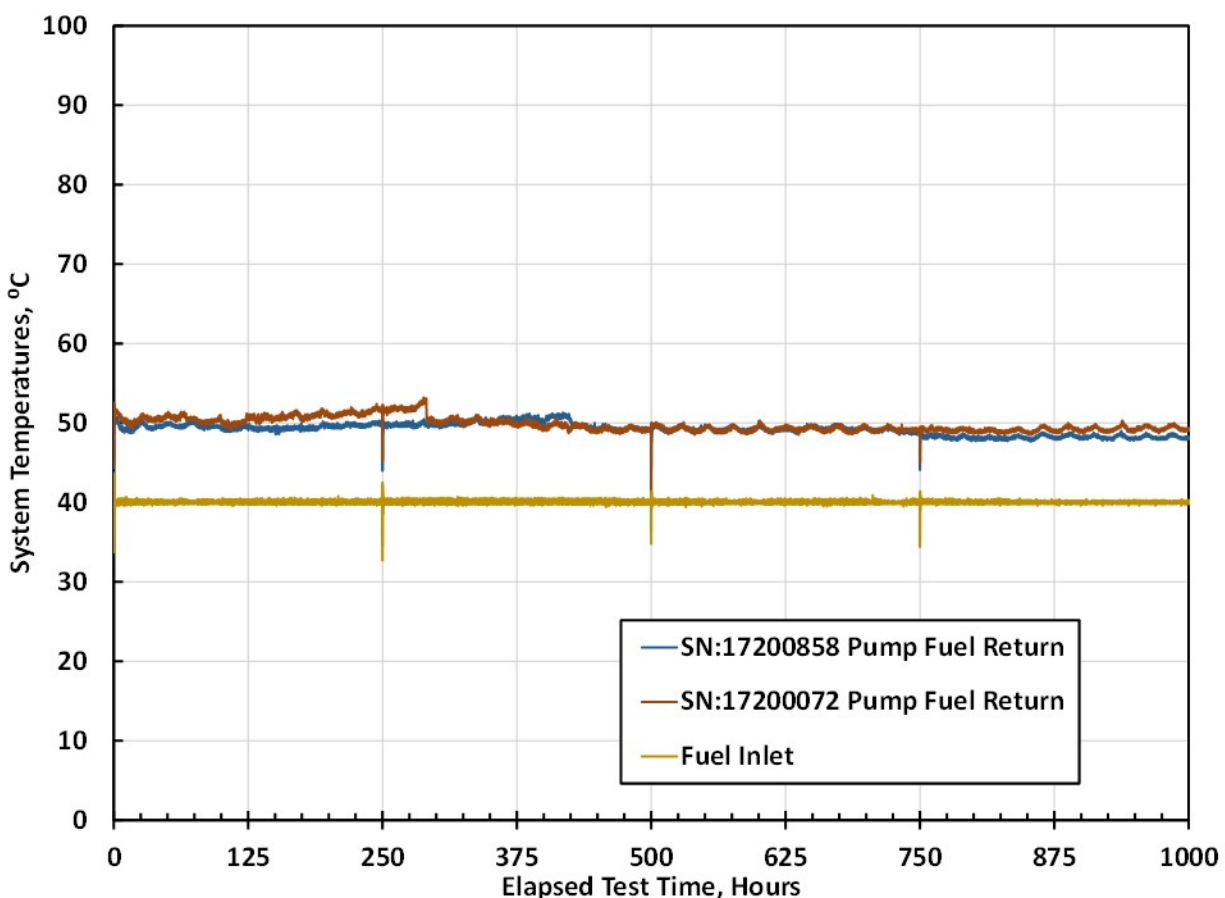
friction, then decreased gradually towards end of testing. Pump SN:17200858 exhibited steady initial fuel return temperature that increased until before mid-test, then gradually decreased towards test conclusion. Unusual wear in the pumps usually result in increases and variability of the fuel return temperatures. The fuel inlet temperature to both pumps was very consistent throughout testing.

**Figure 10. Injection Pump Temperature Histories for 30/70 ATJ/F-24 with 24-ppm CI/LI Fuel Evaluation at 40 °C**

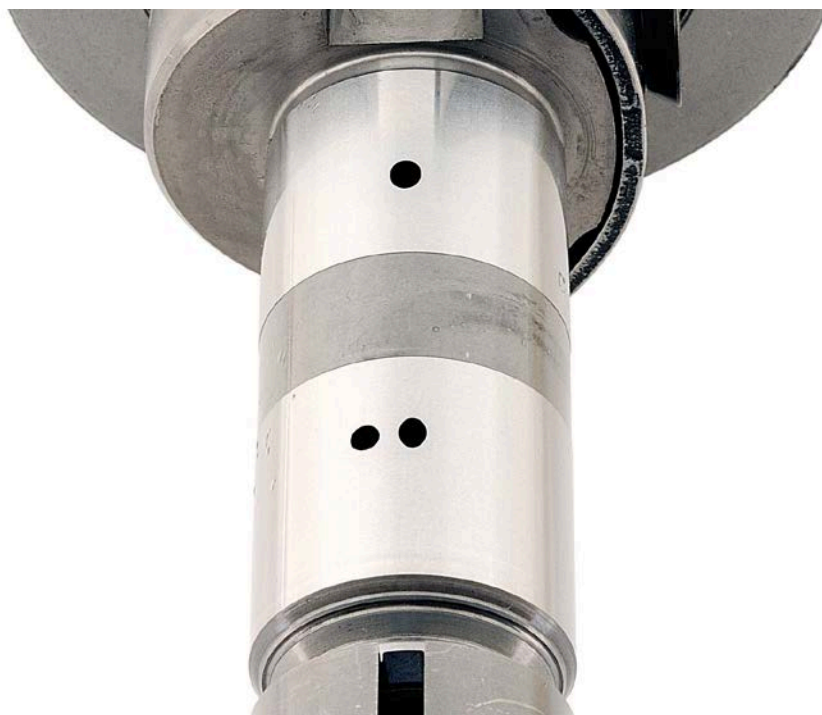
**Figure 14. Pump SN:17200043 Distributor Rotor before Testing with 30/70 ATJ/F-24 with 24-ppm CI/LI Fuel at 77 °C**

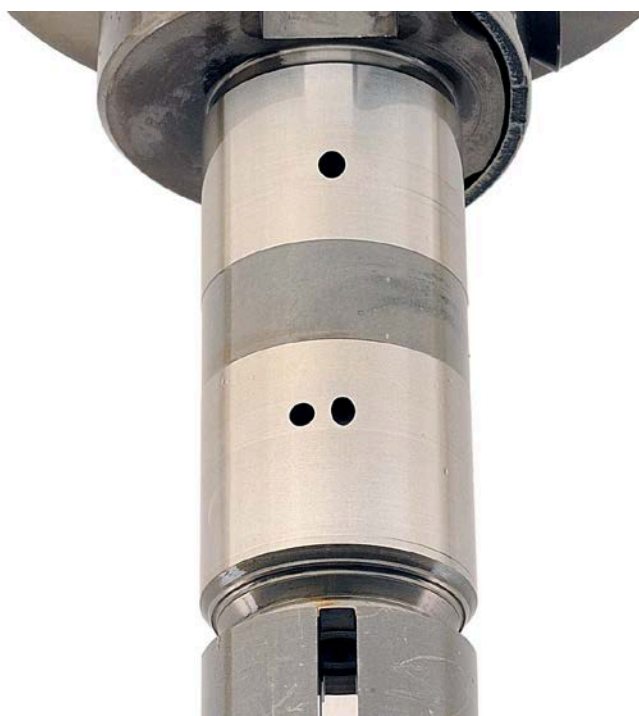
**Figure 15. Pump SN:17200043 Distributor Rotor with 1000-Hours Testing with 30/70 ATJ/F-24 with 24-ppm CI/LI Fuel at 77 °C**

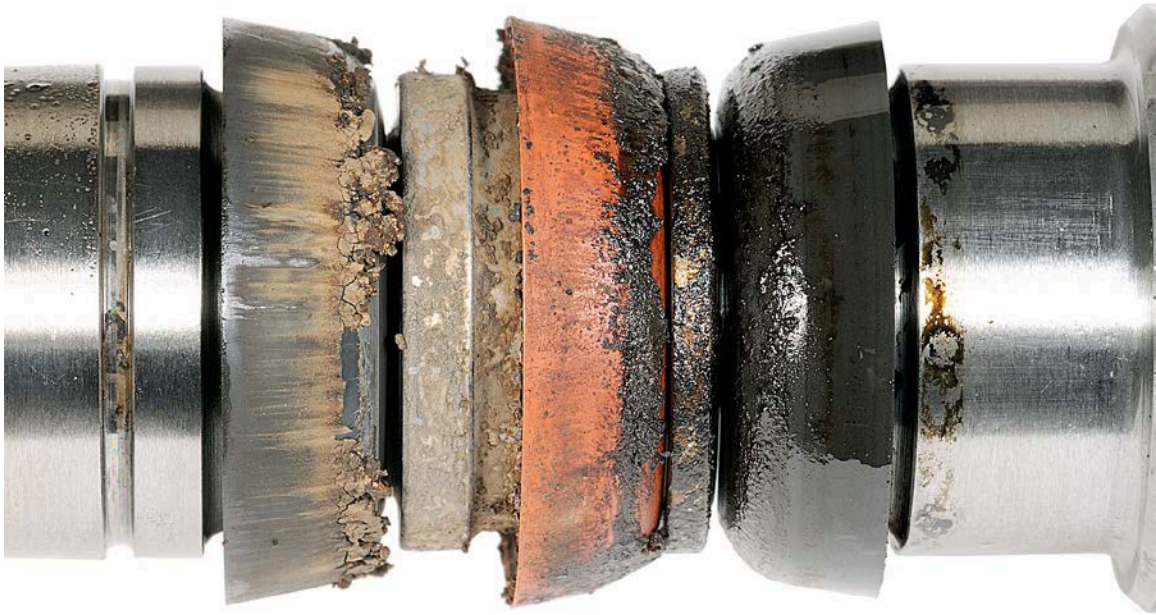
**Figure 16. Pump SN:17200043 Driveshaft Seal Deposits with 1000-Hours Testing with 30/70 ATJ/F-24 with 24-ppm CI/LI Fuel at 77 °C**

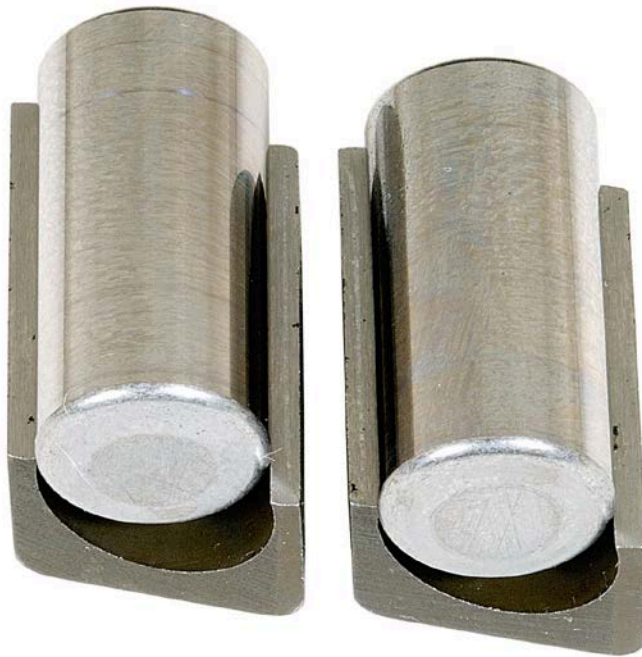
**Figure 18. Pump SN:17200043 Rollers and Shoe before Testing with 30/70 ATJ/F-24 with 24-ppm CI/LI Fuel at 77 °C**

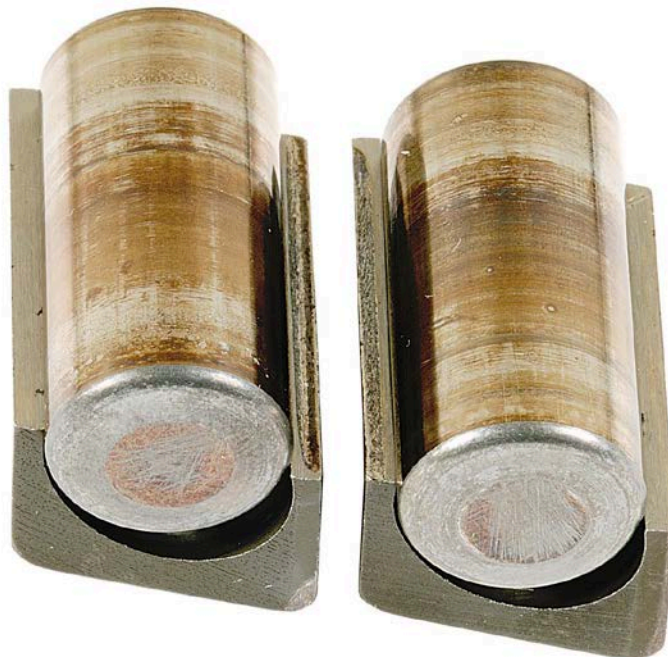
**Figure 19. Pump SN:17200043 Rollers and Shoe with 1000-Hours Testing with 30/70 ATJ/F-24 with 24-ppm CI/LI Fuel at 77 °C**

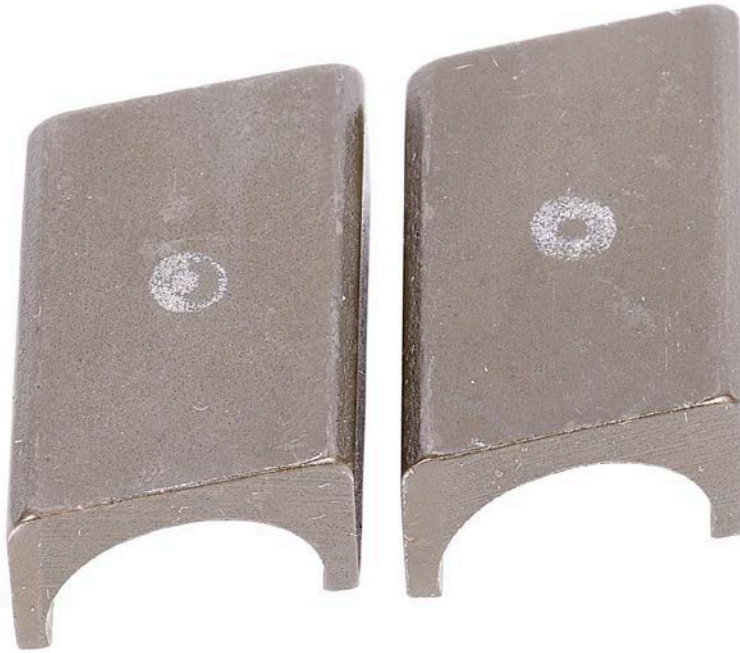
**Figure 20. Pump SN:17200043 Roller Shoe before Testing with 30/70 ATJ/F-24 with 24-ppm CI/LI Fuel at 77 °C**

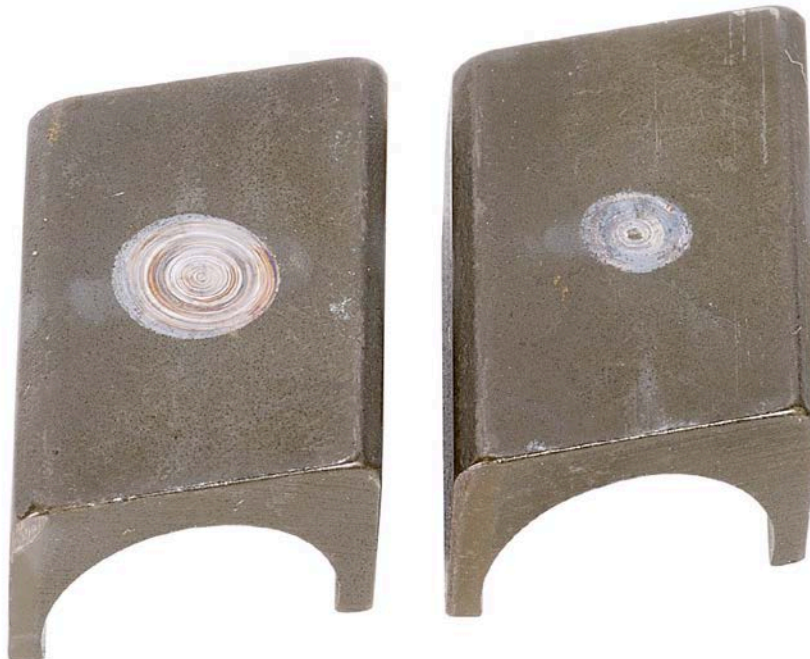
**Figure 21. Pump SN:17200043 Roller Shoe with 1000-Hours Testing with 30/70 ATJ/F-24 with 24-ppm CI/LI Fuel at 77 °C**

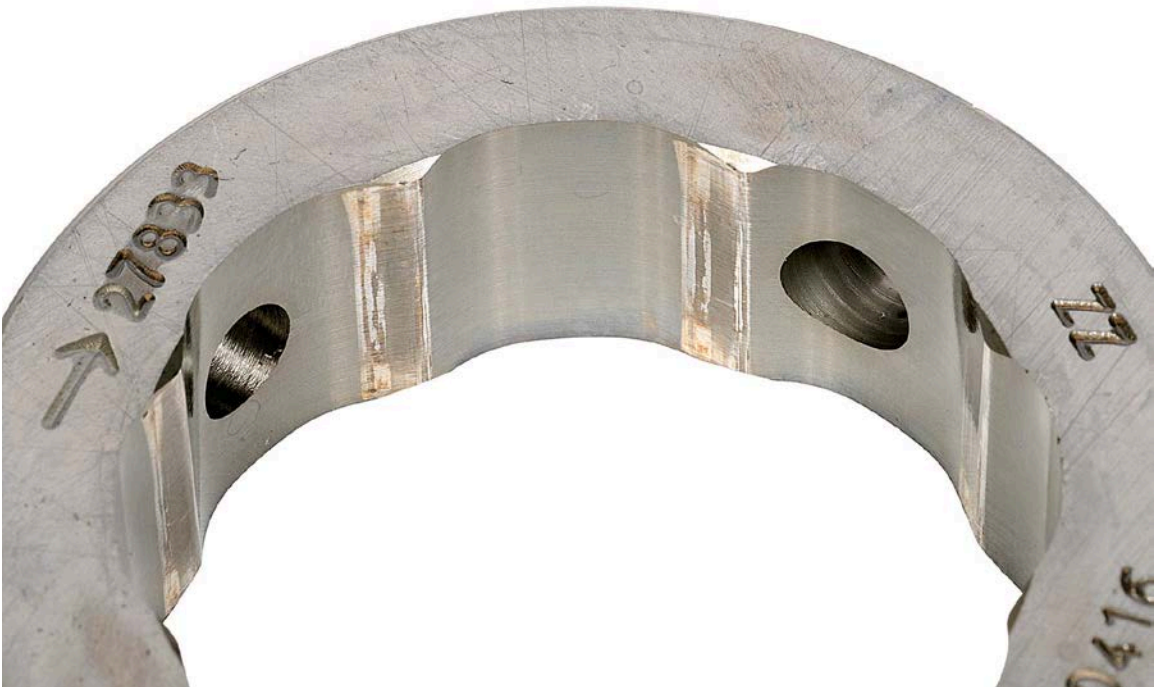
**Figure 23. Pump SN:17200043 Cam Ring with 1000-Hours Testing with 30/70 ATJ/F-24 with 24-ppm CI/LI Fuel at 77 °C**

The injection pump cam ring shown in Figure 22 and Figure 23 reveals moderate distress, with evidence of sliding contact, and moderate lobe wear from 1000-hours of operation with the 30%

ATJ/F-24 fuel with 24-ppm CI/LI at elevated temperature. The level cam lobe wear is consistent with the wear seen on the rollers.

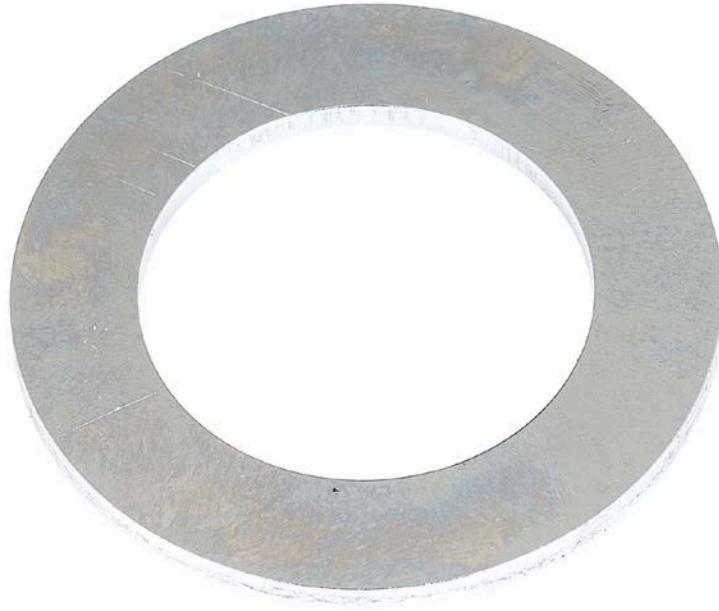
**Figure 24. Pump SN:17200043 Thrust Washer before Testing with 30/70 ATJ/F-24 with 24-ppm CI/LI Fuel at 77 °C**

The governor thrust washer condition before and after 1000-hours are shown in Figure 24 and Figure 25. The polishing wear seen on the thrust washer in Figure 25 seems lighter than normal for 1000-hours of injection pump operation. Light polishing seen on the advance piston suggests low fluctuating fuel pressures in that area of the fuel injection pump housing. The metering valve regulates the pressure to the rotor fill ports. The pressure is regulated by the action of the helix changing the outlet area of an orifice. Due to WOT operation a lightly polished area shows at one location on the helix. The wear on these components is normal considering the 1000-hour duration of testing. The wear on the thrust washer, the advance piston wear, and the metering valve may have affected fuel injection pump operation.

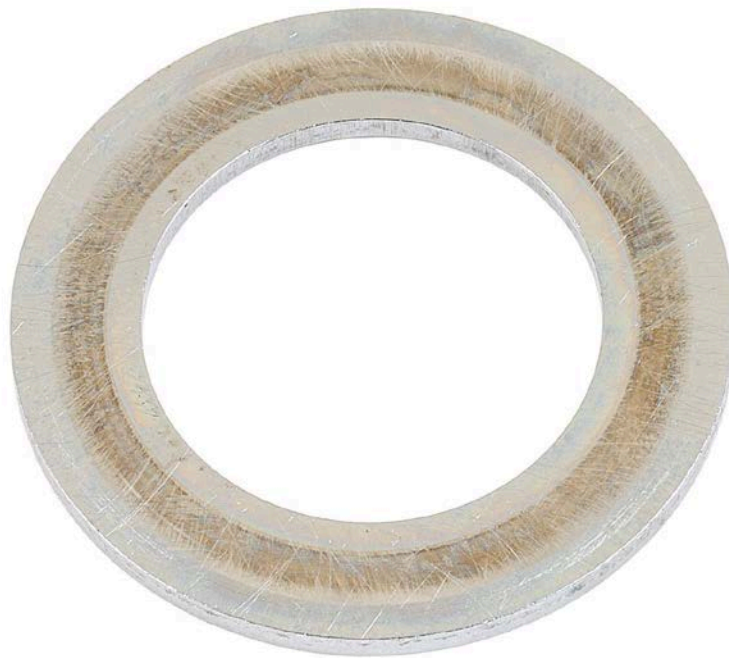
**Figure 25. Pump SN:17200043 Thrust Washer with 1000-Hours Testing with 30/70 ATJ/F-24 with 24-ppm CI/LI Fuel at 77 °C**

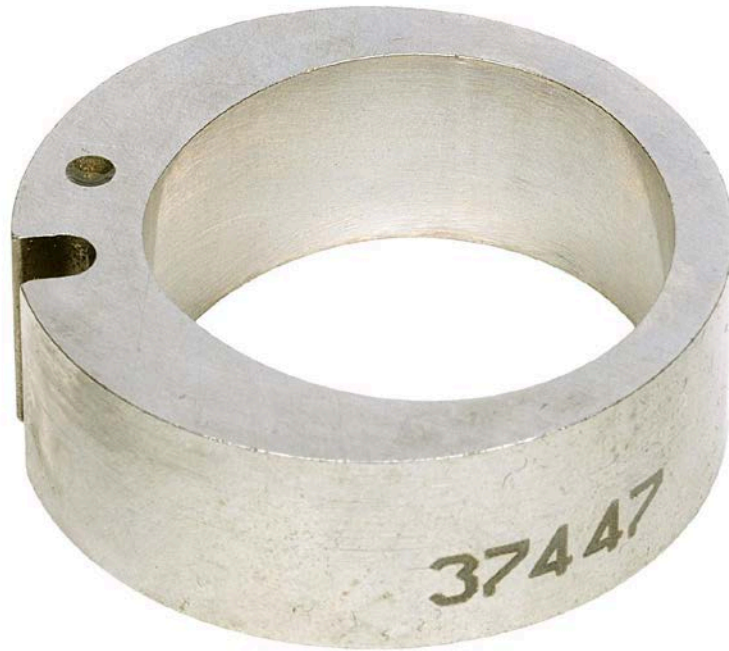
**Figure 26. Pump SN:17200043 Transfer Pump Liner before Testing with 30/70 ATJ/F-24 with 24-ppm CI/LI Fuel at 77 °C**

Figure 26 and Figure 27 illustrate the level of wear seen in the transfer pump section of fuel injection pump SN:17200043. Figure 26 shows the surface condition of the transfer pump liner prior to testing and Figure 27 shows the surface with scarring seen on 90% of the area after 1000-hours of operation on the ATJ/F-24 fuel with 24-ppm CI/LI at elevated temperature. Also illustrative of the transfer pump section wear are the transfer pump blade conditions shown in Figure 28 through Figure 31. The edge wear shown in Figure 28 and Figure 29 corresponds to the surface on the transfer pump blades that contact and slide on the transfer pump liner, separated by a film of fuel. The blade edge conditions in Figure 29 reflect the wear seen on the transfer pump liner. The side polishing shown in Figure 30 and Figure 31 reflect wear from the transfer pump blade slots on the injection pump rotor, and is relatively mild with some fuel deposition. The wear seen on the transfer pump components seems consistent with the 1000-hour testing duration for pump SN:17200043.

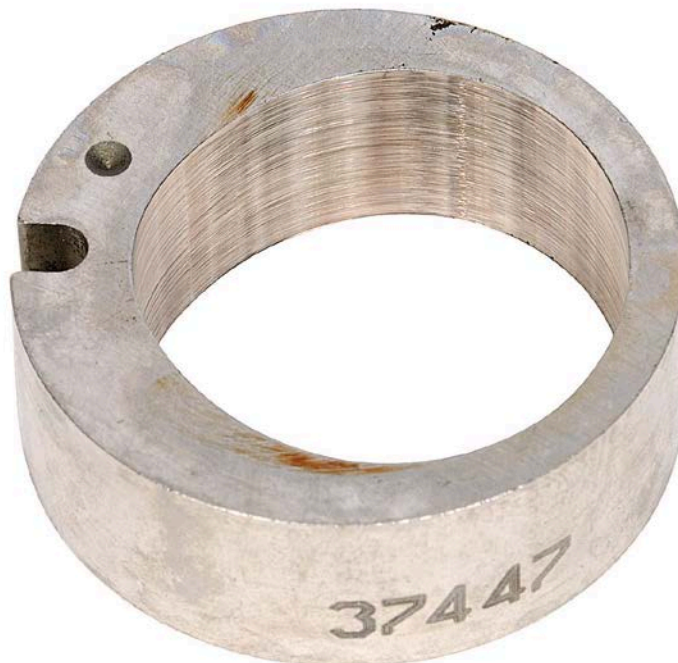
**Figure 27. Pump SN:17200043 Transfer Pump Liner with 1000-Hours Testing with 30/70 ATJ/F-24 with 24-ppm CI/LI Fuel at 77 °C**

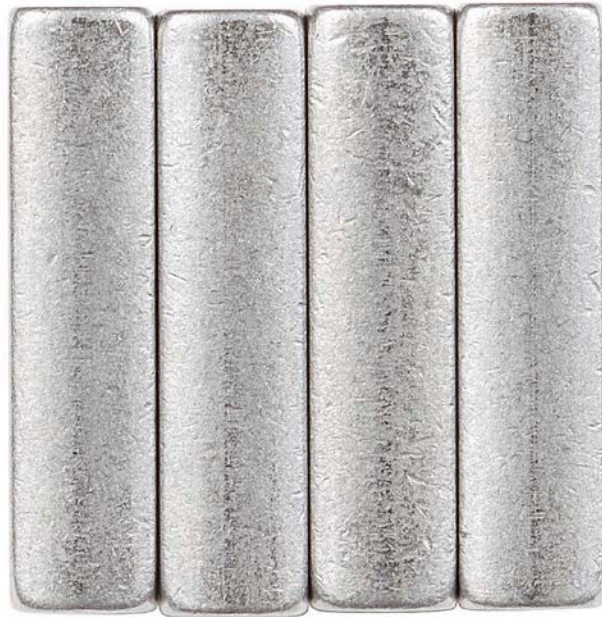
**Figure 28. Pump SN:17200043 Transfer Pump Blade Edges before Testing with 30/70 ATJ/F-24 with 24-ppm CI/LI Fuel at 77 °C**

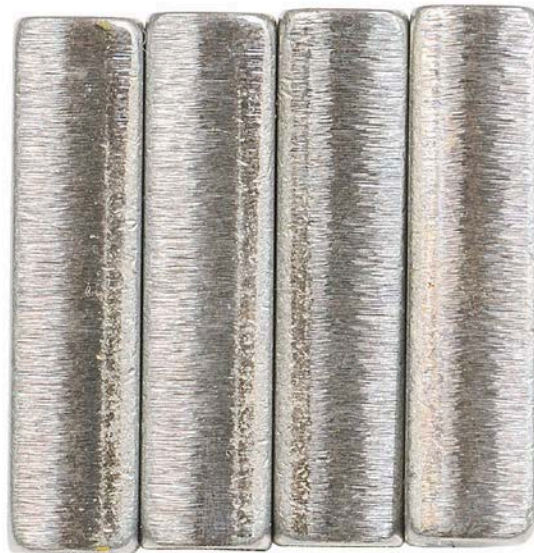
**Figure 29. Pump SN:17200043 Transfer Pump Blade Edges with 1000-Hours Testing with 30/70 ATJ/F-24 with 24-ppm CI/LI Fuel at 77 °C**

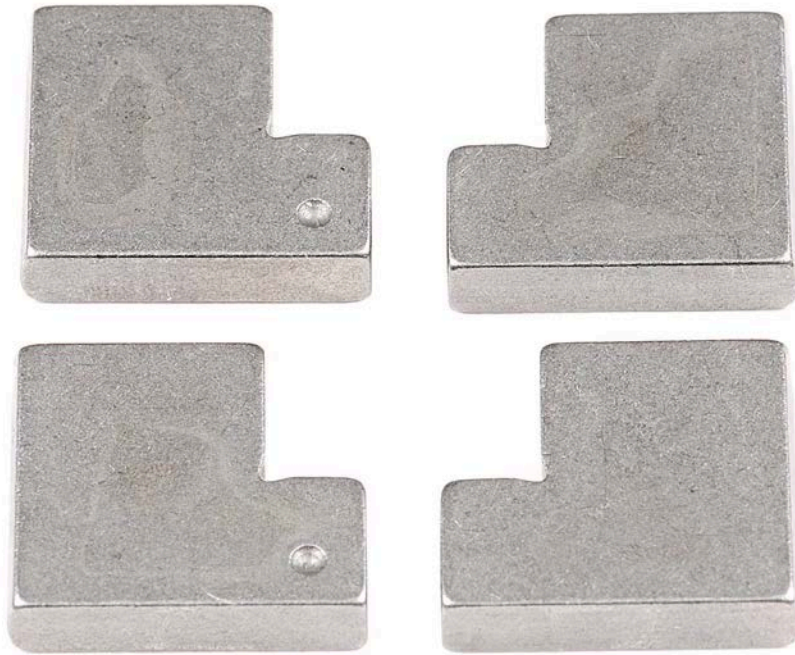
**Figure 30. Pump SN:17200043 Transfer Pump Blade Sides before Testing with 30/70 ATJ/F-24 with 24-ppm CI/LI Fuel at 77 °C**

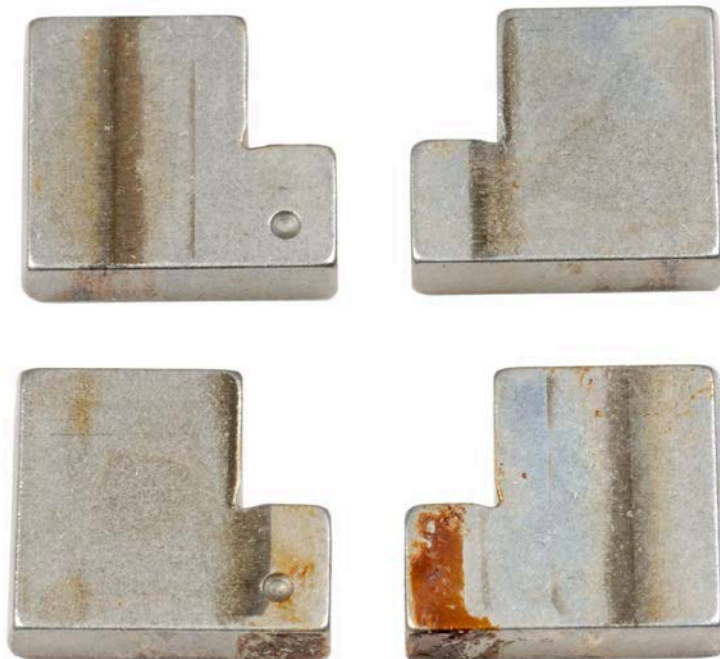
**Figure 31. Pump SN:17200043 Transfer Pump Blade Sides with 1000-Hours Testing with 30/70 ATJ/F-24 with 24-ppm CI/LI Fuel at 77 °C**

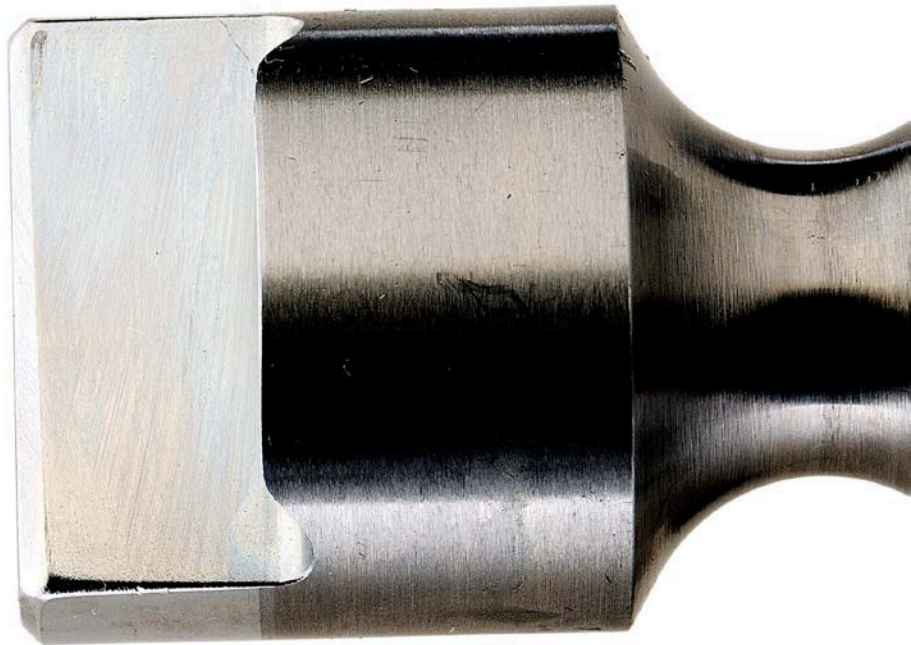
**Figure 32. Pump SN:17200043 Driveshaft Drive Tang before Testing with 30/70 ATJ/F-24 with 24-ppm CI/LI Fuel at 77 °C**

Figure 32 and Figure 33 show the condition of the injection pump drive shaft drive tang that transmits torque to the hydraulic section of the pump from the engine. Figure 32 and Figure 33 reveal only minor wear scars that indicates backlash and timing were not affected with the ATJ/F-24 fuel with 24-ppm CI/LI at elevated temperature after 1000-hours.

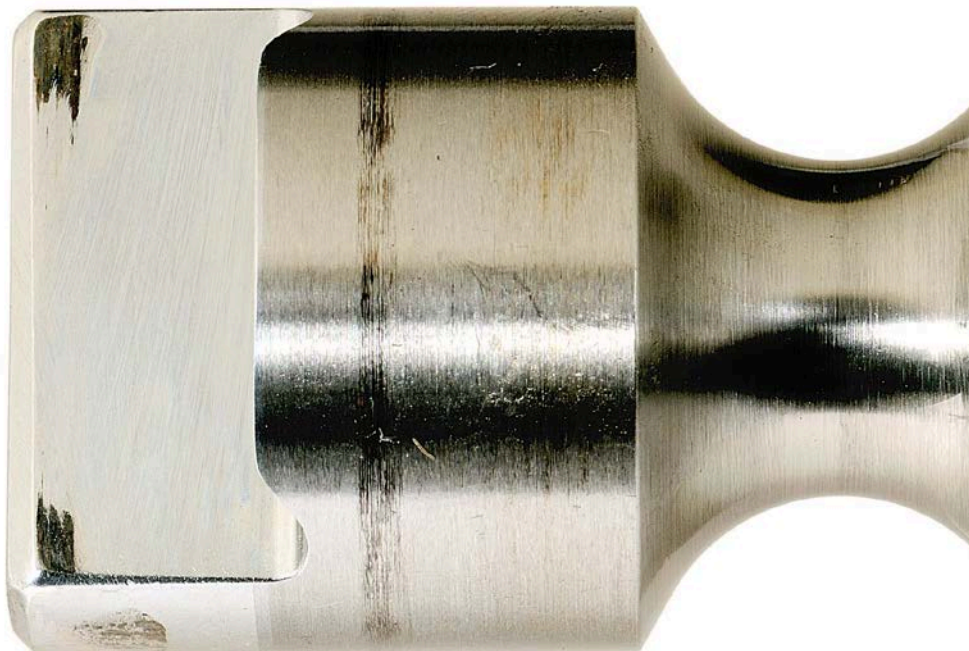
**Figure 33. Pump SN:17200043 Driveshaft Drive Tang with 1000-Hours Testing with 30/70 ATJ/F-24 with 24-ppm CI/LI Fuel at 77 °C**

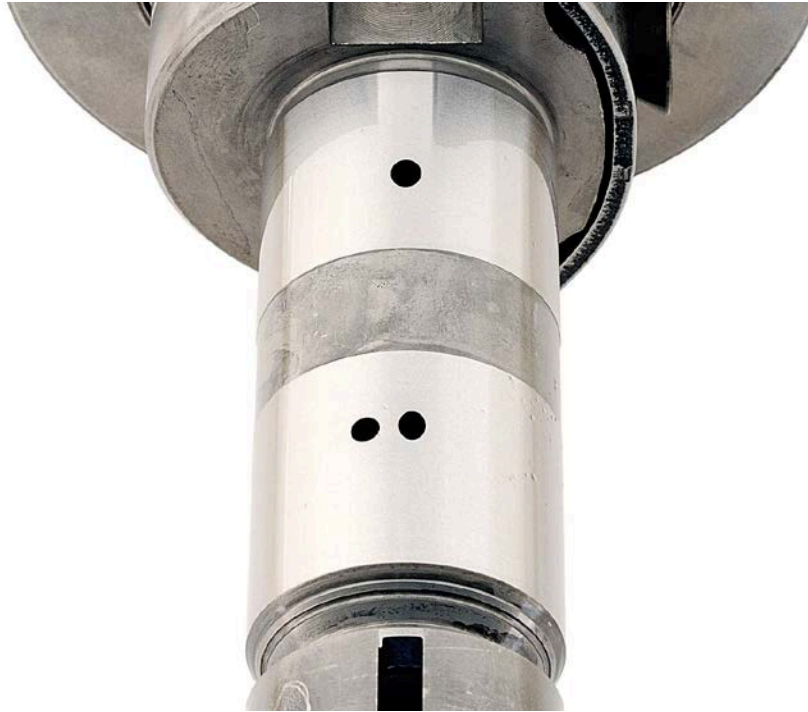
**Figure 34. Pump SN:17200045 Distributor Rotor before Testing with 30/70 ATJ/F-24 with 24-ppm CI/LI Fuel at 77 °C**

The parts conditions and subjective wear ratings for fuel injection pump SN:17200045 are summarized in Table 18. Images of the wear seen on the components of fuel injection pump SN:17200045 are shown in Figure 34 through Figure 53. Figure 34 and Figure 35 show the condition of the injection pump rotor that carries the plungers and distributes the compressed fuel. Figure 35 reveal the circumferential light scratches at the rotor discharge ports, usually from wear debris, after the 1000-hours.

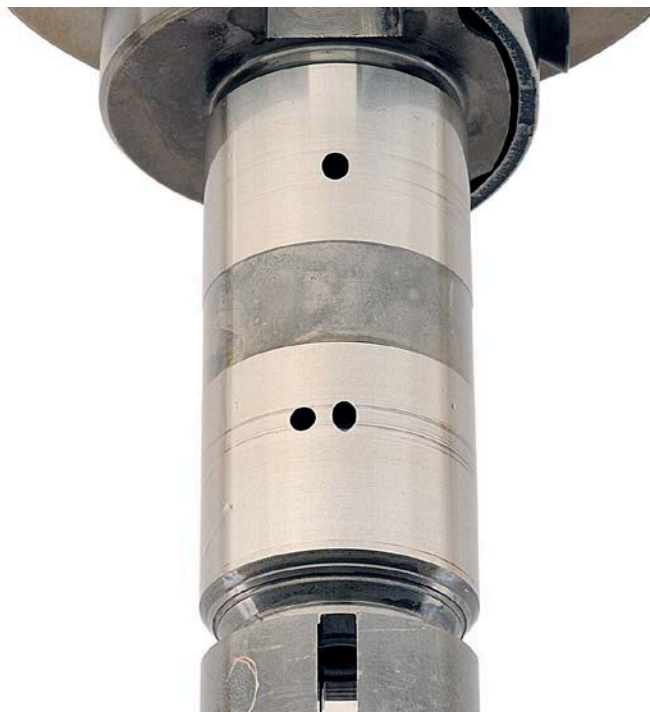
**Figure 35. Pump SN:17200045 Distributor Rotor with 1000-Hours Testing with 30/70 ATJ/F-24 with 24-ppm CI/LI Fuel at 77 °C**

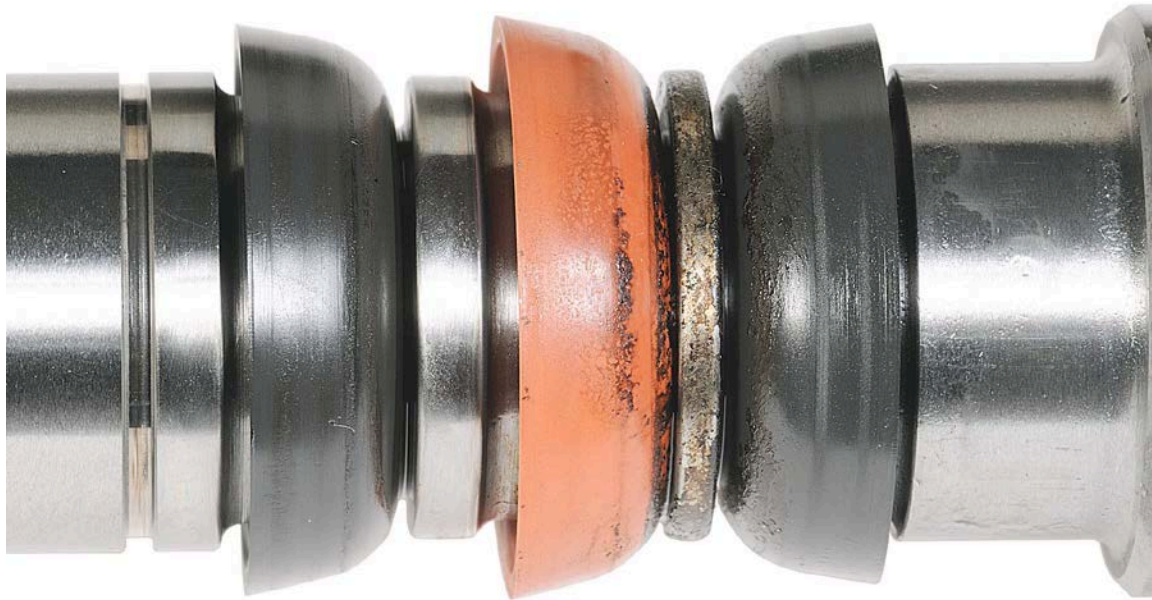
**Figure 36. Pump SN:17200045 Driveshaft Seal Deposits with 1000-Hours Testing with 30/70 ATJ/F-24 with 24-ppm CI/LI Fuel at 77 °C**

The driveshaft seal deposition shown in Figure 36 is very light for the 1000-hours of pump operation. The two left seals are for keeping fuel in the housing, the rightmost seal is for keeping engine oil out of the pump. The governor fork shown in Figure 37 reveals wear on the fork tines and on the thermal compensation tab. The tab is a bimetallic material that provides some governor compensation from thermal deviations.

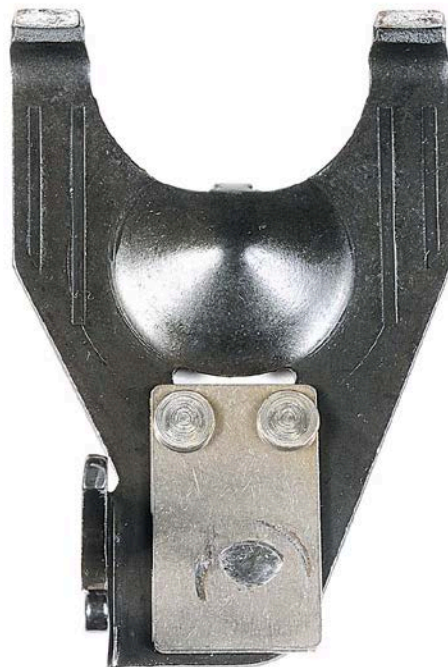
**Figure 37. Pump SN:17200045 Governor Fork Wear on Tines and Tab with 1000-Hours Testing with 30/70 ATJ/F-24 with 24-ppm CI/LI Fuel at 77 °C**

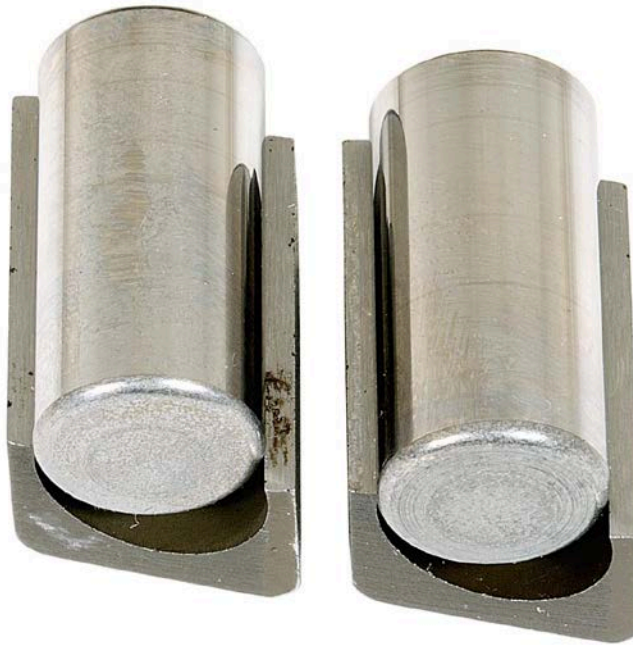
**Figure 38. Pump SN:17200045 Rollers and Shoe Condition before Testing with 30/70 ATJ/F-24 with 24-ppm CI/LI Fuel at 77 °C**

Figure 38 and Figure 39 are the Pre-Test and Post-Test conditions of the fuel injection pump SN:17200045 roller shoe and roller conditions. Of note is the lack of a wear scar at the roller shoe leaf spring contact and the shiny, bright rollers shown in Figure 38. Figure 39 reveals only light polishing wear on the roller shoe from the leaf spring contact. Figure 39 shows the Rollers and Roller Shoes with roller discoloration due to heavy burnishing on one roller and moderate burnishing and roller scratching on the other. Figure 40 and Figure 41 show the moderate wear scars due to 1000-hours operation on the roller shoe plunger contact area. The injection pump cam ring conditions are shown in Figure 42 and Figure 43. The cam ring the rollers ride on exhibited flattened cam lobes towards the edges as seen in Figure 43, and appear to reflect the wear seen on the rollers.

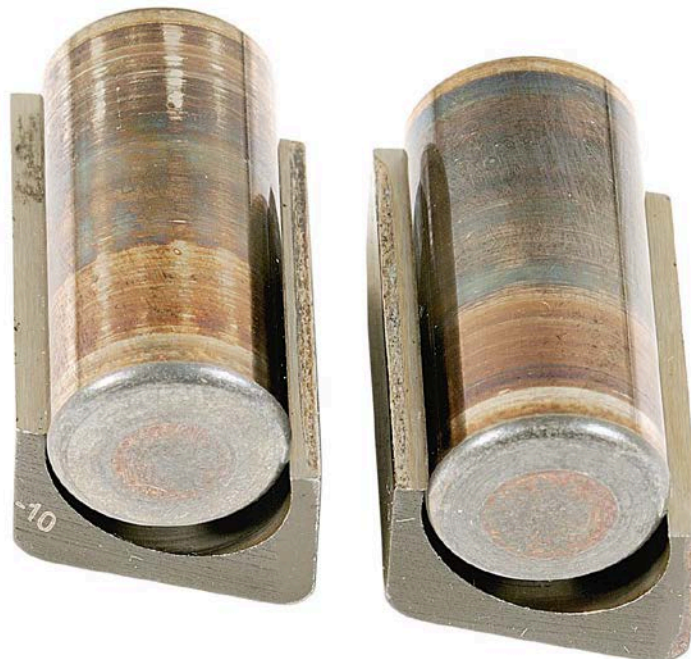
**Figure 39. Pump SN:17200045 Rollers and Shoe with 1000-Hours Testing with 30/70 ATJ/F-24 with 24-ppm CI/LI Fuel at 77 °C**

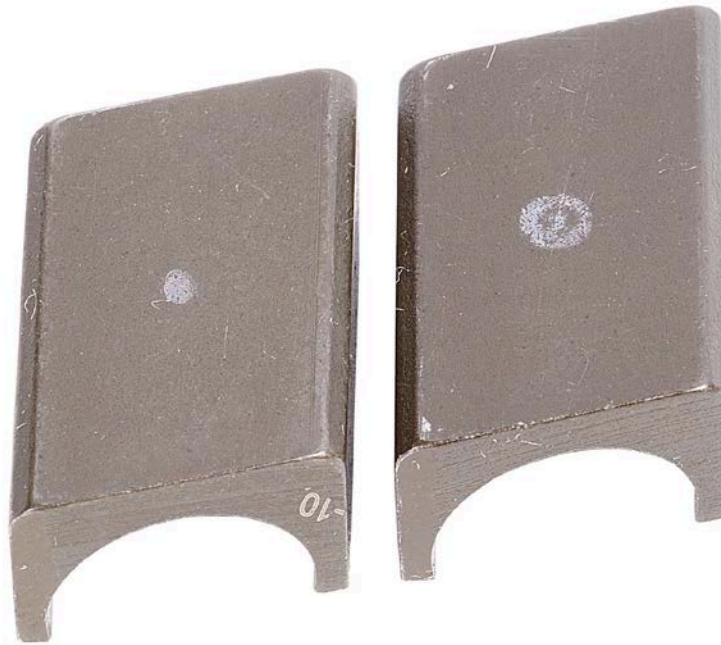
**Figure 40. Pump SN:17200045 Roller Shoe Condition before Testing with 30/70 ATJ/F-24 with 24-ppm CI/LI Fuel at 77 °C**

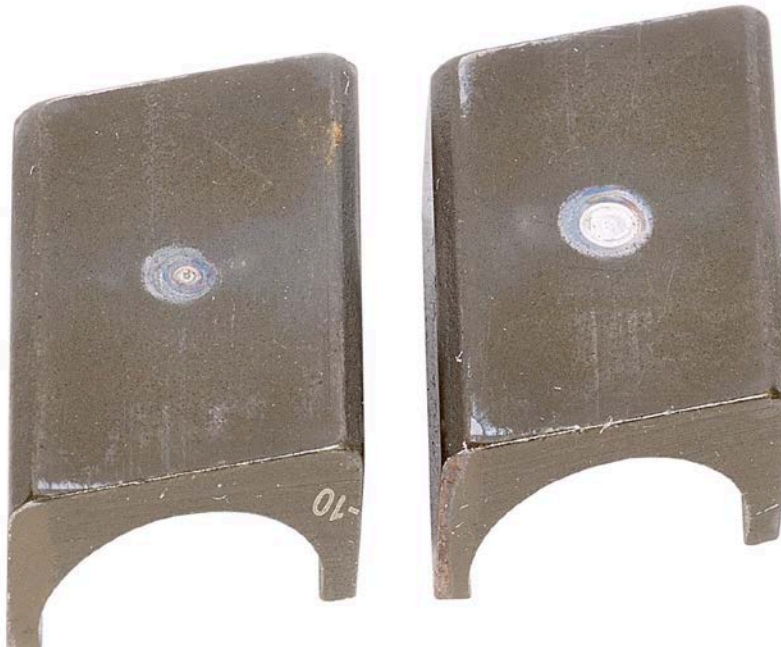
**Figure 41. Pump SN:17200045 Roller Shoe with 1000-Hours Testing with 30/70 ATJ/F-24 with 24-ppm CI/LI Fuel at 77 °C**
