**ROTARY FUEL INJECTION PUMP WEAR TESTING  
USING A 30%/70% ATJ/F-24 FUEL BLEND**

**INTERIM REPORT  
TFLRF No. 488**

**U.S. Army TARDEC Fuels and Lubricants Research Facility  
Southwest Research Institute® (SwRI®)  
San Antonio, TX**

**Contract No. W56HZV-15-C-0030 (WD12 Task 2.2)**

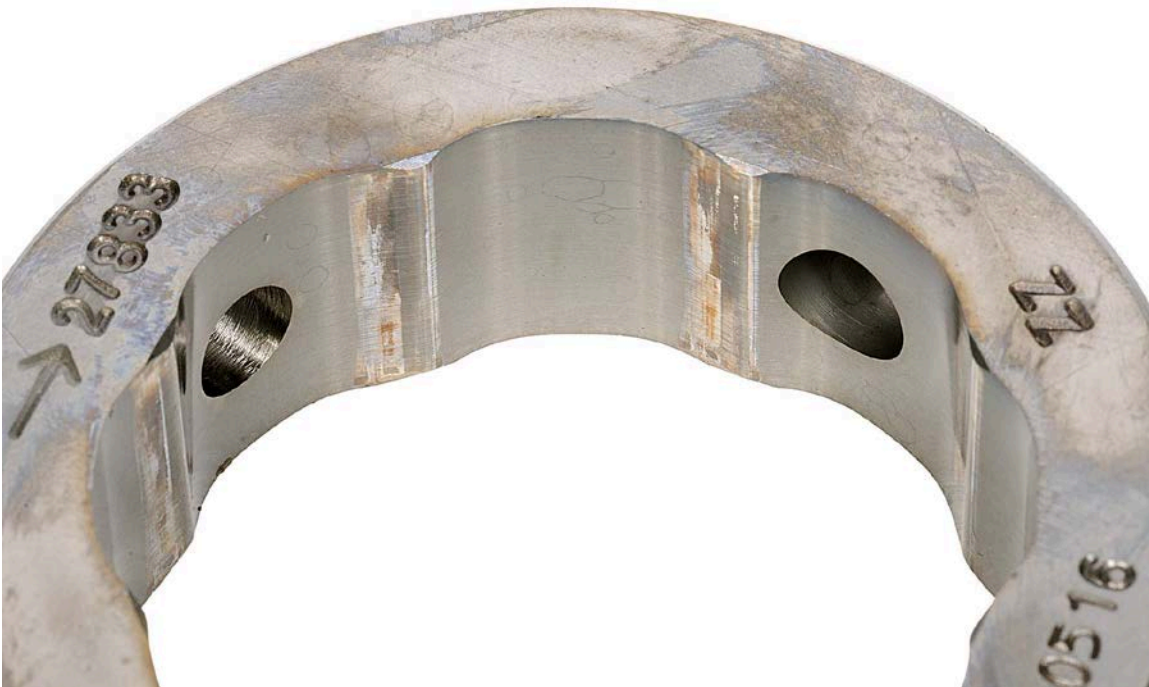
**Figure 43. Pump SN:17200045 Cam Ring with 1000-Hours Testing with 30/70 ATJ/F-24 with 24-ppm CI/LI Fuel at 77 °C**

Figure 38 and Figure 39 are the Pre-Test and Post-Test conditions of the fuel injection pump SN:17200045 roller shoe and roller conditions. Of note is the lack of a wear scar at the roller shoe leaf spring contact and the shiny, bright rollers shown in Figure 38. Figure 39 reveals only light polishing wear on the roller shoe from the leaf spring contact. Figure 39 shows the Rollers and Roller Shoes with roller discoloration due to heavy burnishing on one roller and moderate burnishing and roller scratching on the other. Figure 40 and Figure 41 show the moderate wear scars due to 1000-hours operation on the roller shoe plunger contact area. The injection pump cam ring conditions are shown in Figure 42 and Figure 43. The cam ring the rollers ride on exhibited flattened cam lobes towards the edges as seen in Figure 43, and appear to reflect the wear seen on the rollers.

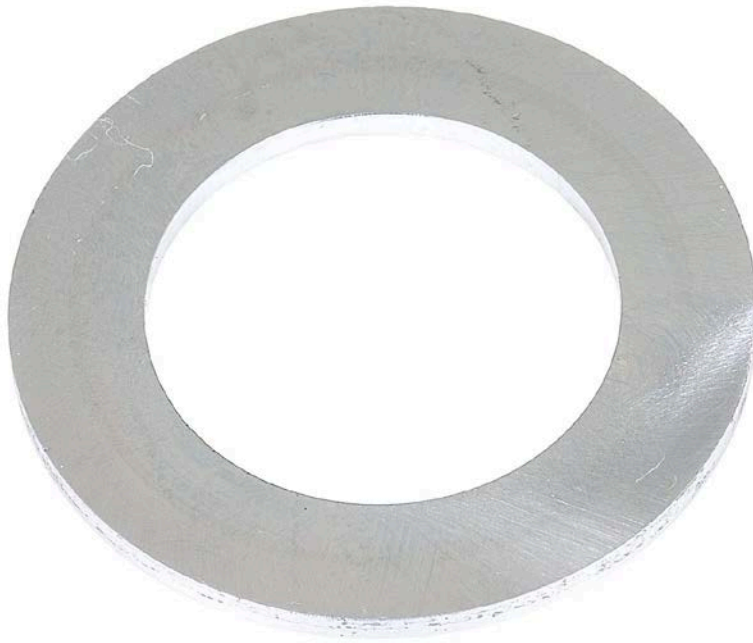
**Figure 44. Pump SN:17200045 Thrust Washer Before Testing with 30/70 ATJ/F-24 with 24-ppm CI/LI Fuel at 77 °C**

The governor thrust washer condition before and after 1000-hours is seen in Figure 44 and Figure 45. The polishing wear seen on the thrust washer in Figure 45 is mild for 1000-hours of injection pump operation. Light polishing and fretting seen on the advance piston suggests fluctuating fuel pressure in that region of the fuel injection pump housing. The metering valve regulates the pressure to the rotor fill ports. The pressure is regulated by the action of the helix changing the outlet area of an orifice. Due to WOT operation a lightly polished area shows at one location on the helix. The wear on these components appear normal for the 1000-hour duration of testing. The wear on the thrust washer, the advance piston wear, and the metering valve likely did not affect pump operation.

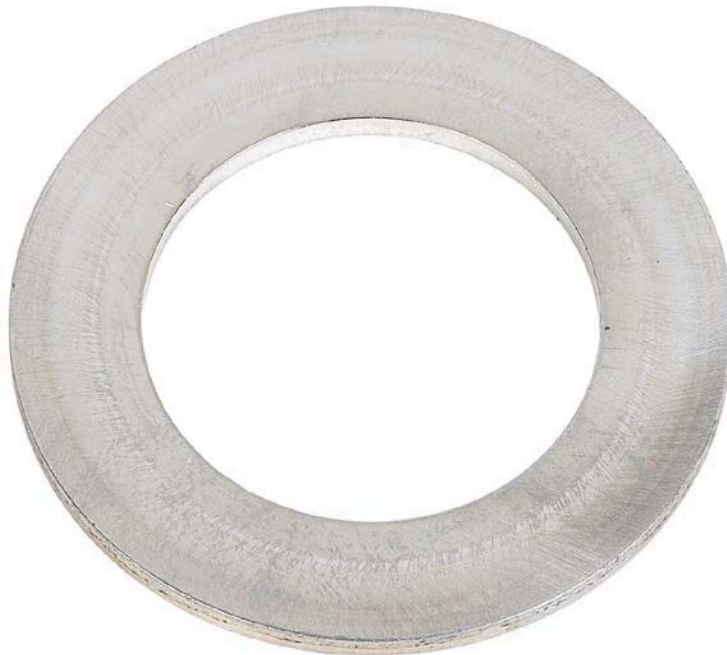
**Figure 45. Pump SN:17200045 Thrust Washer with 1000-Hours Testing with 30/70 ATJ/F-24 with 24-ppm CI/LI Fuel at 77 °C**

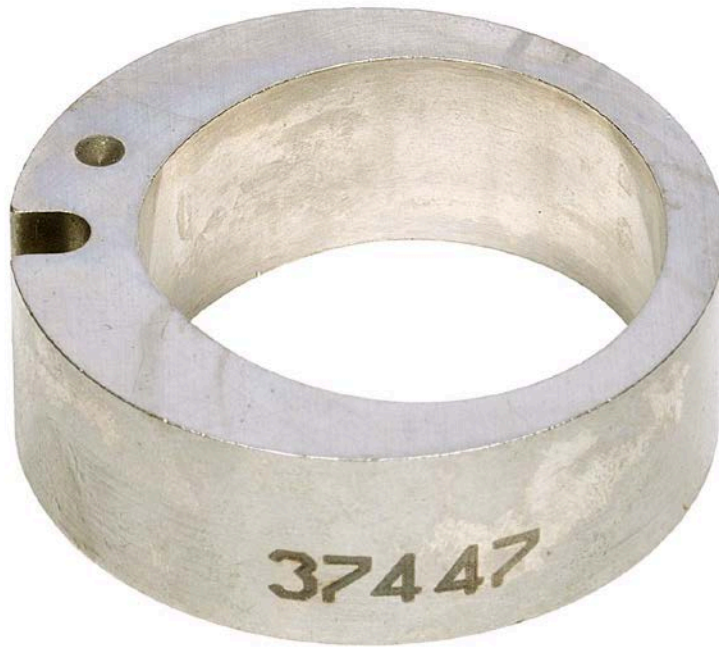
**Figure 46. Pump SN:17200045 Transfer Pump Liner before Testing with 30/70 ATJ/F-24 with 24-ppm CI/LI Fuel at 77 °C**

Figure 46 and Figure 47 illustrates the level of wear seen in the transfer pump section of fuel injection pump SN:17200045. Figure 46 shows the surface condition of the transfer pump liner prior to testing and Figure 47 shows the surface with 85% surface area scored after 1000-hours of operation on the elevated temperature ATJ/F-24 fuel with 24-ppm CI/LI. Also illustrative of wear in the transfer pump section are the transfer pump blade conditions shown in Figure 48 through Figure 51. The edge wear shown in Figure 48 and Figure 49 corresponds to the surface on the transfer pump blades that contact the transfer pump liner. The blade edge conditions in Figure 49 reflect the scoring seen on the transfer pump liner, and appear typical for 1000-hours operation with moderate lubricity fuel at elevated temperature. The side polishing shown in Figure 50 and Figure 51 reflect wear from the transfer pump blade slots on the injection pump rotor. The wear seen on the transfer pump components seems consistent with the testing duration for pump SN:17200045.

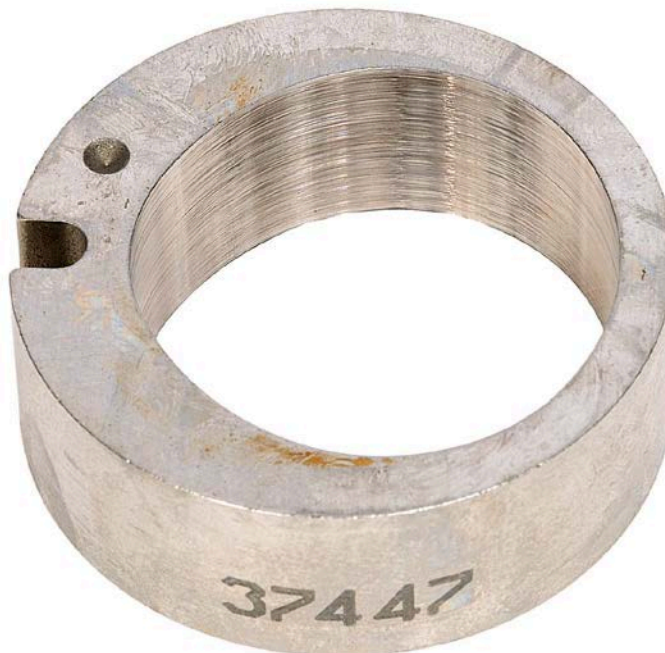
**Figure 47. Pump SN:17200045 Transfer Pump Liner with 1000-Hours Testing with 30/70 ATJ/F-24 with 24-ppm CI/LI Fuel at 77 °C**

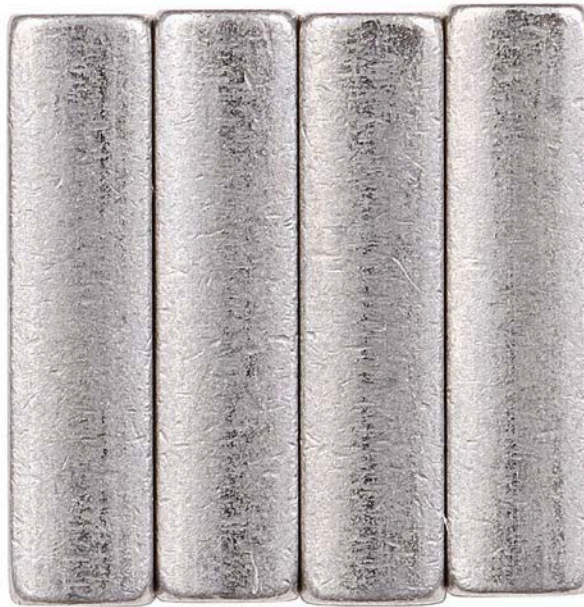
**Figure 48. Pump SN:17200045 Transfer Pump Blade Edges before Testing with 30/70 ATJ/F-24 with 24-ppm CI/LI Fuel at 77 °C**

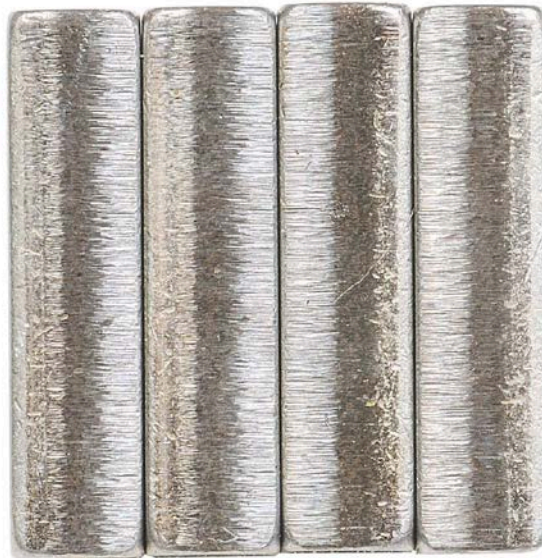
**Figure 49. Pump SN:17200045 Transfer Pump Blade Edges with 1000-Hours Testing with 30/70 ATJ/F-24 with 24-ppm CI/LI Fuel at 77 °C**

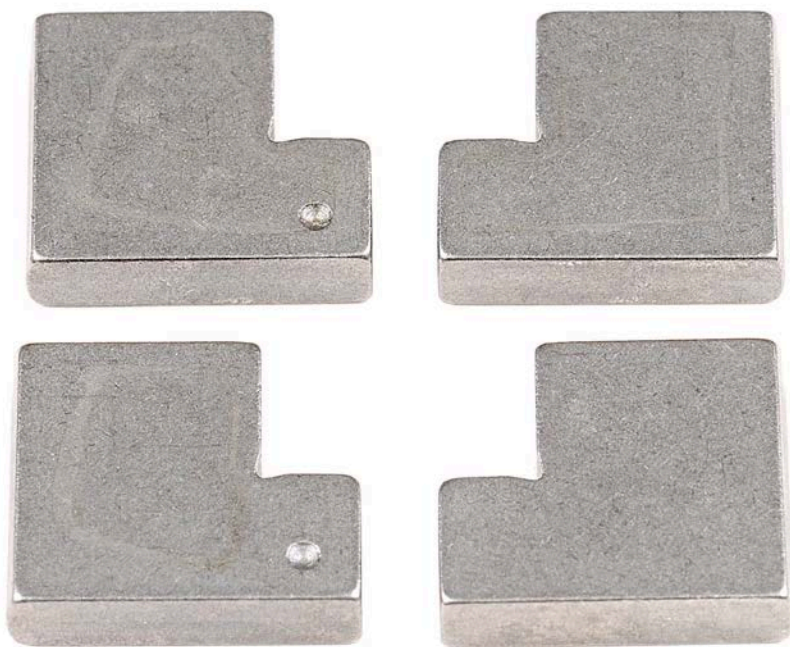
**Figure 50. Pump SN:17200045 Transfer Pump Blade Sides before Testing with 30/70 ATJ/F-24 with 24-ppm CI/LI Fuel at 77 °C**

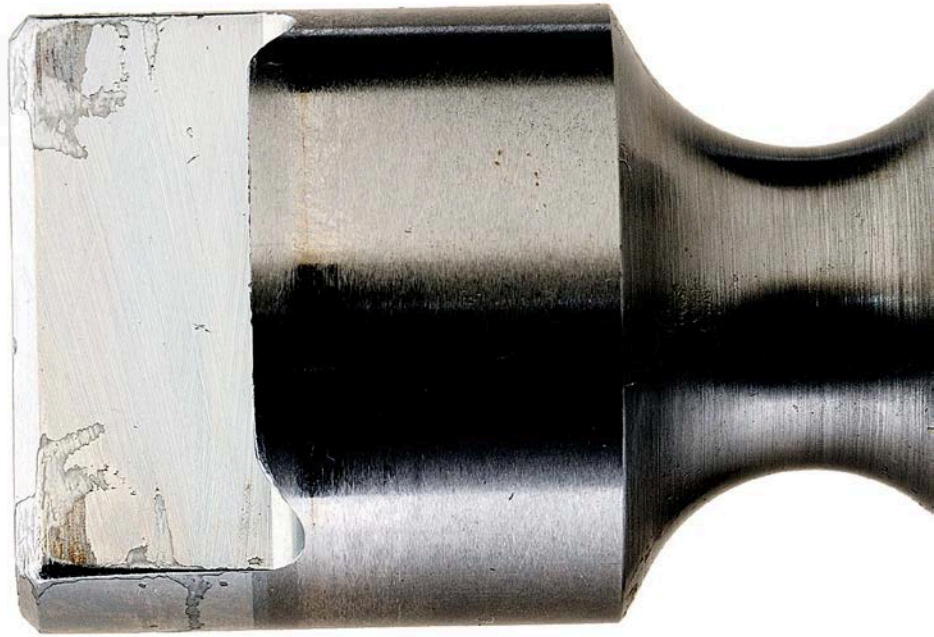
Figure 52 and Figure 53 show the condition of the injection pump drive shaft drive tang that transmits torque to the hydraulic section of the pump from the engine. Of interest is the new drive tang in Figure 52 reveals unusual surface conditions for a new part. Figure 53 reveals a moderate wear scar that indicates some backlash was occurring. For both pumps the cumulative effect of all the worn components contributed to the performance degradation with the ATJ/F-24 fuel with 24-ppm CI/LI at 77 °C fuel inlet temperature.

**Figure 53. Pump SN:17200045 Driveshaft Drive Tang with 1000-Hours Testing with 30/70 ATJ/F-24 with 24-ppm CI/LI Fuel at 77 °C**

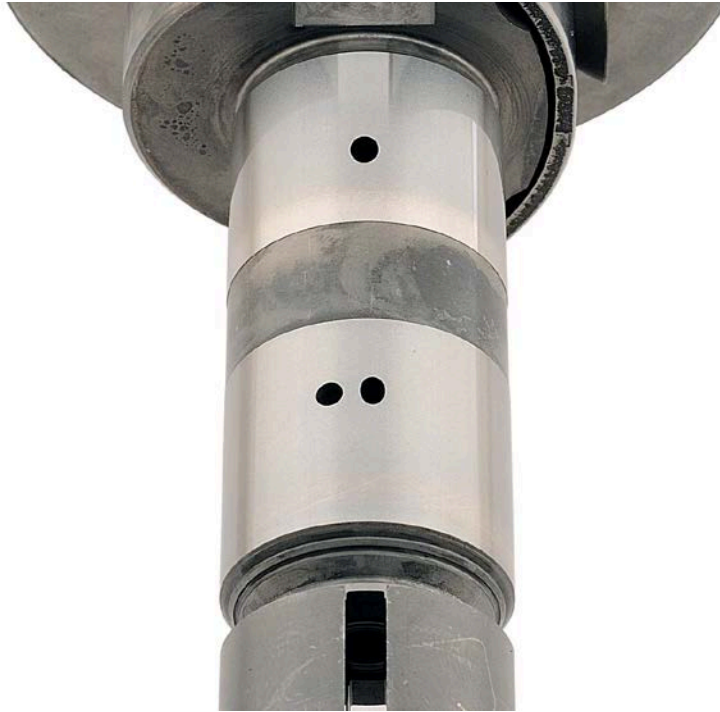
**Figure 54. Pump SN:17200072 Distributor Rotor before Testing with 30/70 ATJ/F-24 with 24-ppm CI/LI Fuel at 40 °C**

The parts conditions and subjective wear ratings for fuel injection pump SN:17200072 are summarized in Table 19. Images of the wear seen on the components of fuel injection pump SN:17200072 are shown in Figure 54 through Figure 71. Figure 54 and Figure 55 show the condition of the injection pump rotor that carries the plungers and distributes the compressed fuel. Figure 55 shows the discharge ports and rotor are in good condition, with very little distress evident after 1000-hours with ATJ/F-24 fuel with 24-ppm CI/LI at 40 °C fuel inlet temperature.

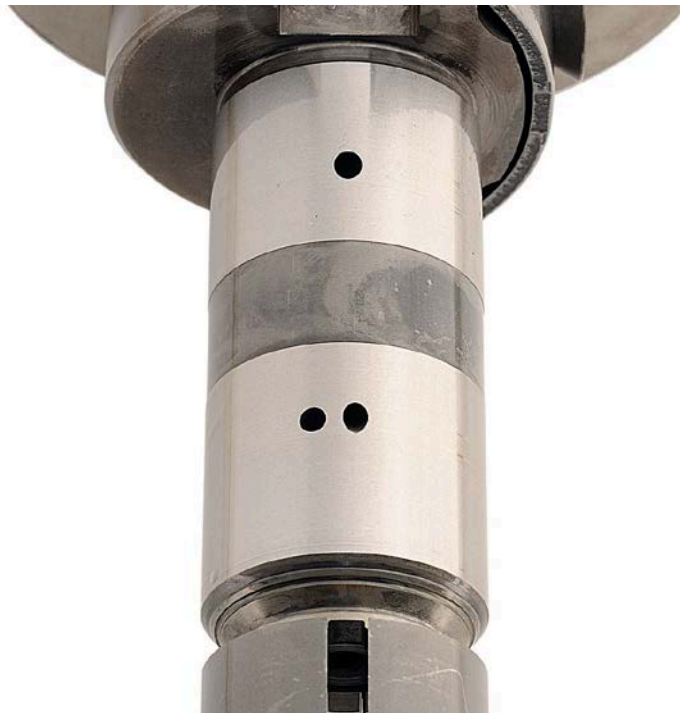
**Figure 55. Pump SN:17200072 Distributor Rotor with 1000-Hours Testing with 30/70 ATJ/F-24 with 24-ppm CI/LI Fuel at 40 °C**

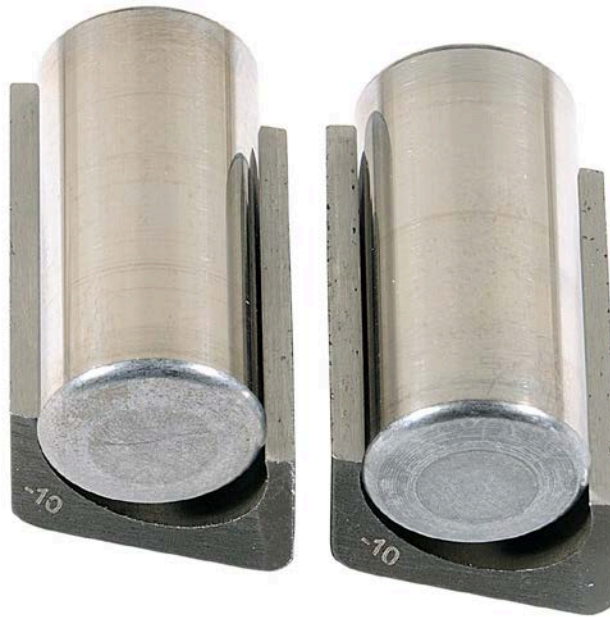
**Figure 56. Pump SN:17200072 Rollers and Shoe before Testing with 30/70 ATJ/F-24 with 24-ppm CI/LI Fuel at 40 °C**

Figure 56 and Figure 57 is the Pre-Test and Post-Test conditions of the fuel injection pump SN:17200072 roller shoe and roller conditions. Of note is the lack of a wear scar at the roller shoe leaf spring contact and the shiny, bright rollers shown in Figure 56. Figure 57 reveals mild wear scars on the roller shoe from the leaf spring contact, light burnishing of the rollers, and no evidence of scoring on the rollers. The rollers tend to discolor when combination rolling-sliding action occurs as the rollers follow the injection cam profile. Figure 58 and Figure 59 show the relatively mild wear scars due to 1000-hours operation on the roller shoe plunger contact. The injection pump cam ring shown in Figure 60 and Figure 61 reveals light polishing on the cam lobes with the 30/70 ATJ/F-24 with 24-ppm CI/LI Fuel blend.

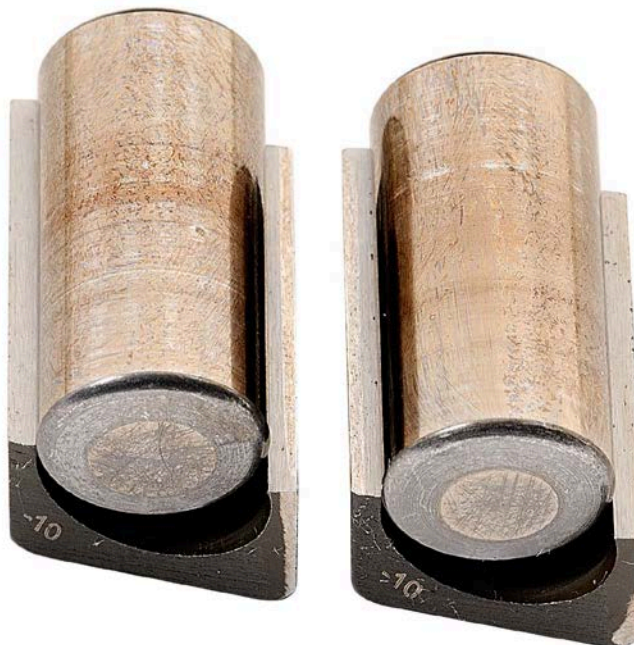
**Figure 57. Pump SN:17200072 Rollers and Shoe with 1000-Hours Testing with 30/70 ATJ/F-24 with 24-ppm CI/LI Fuel at 40 °C**

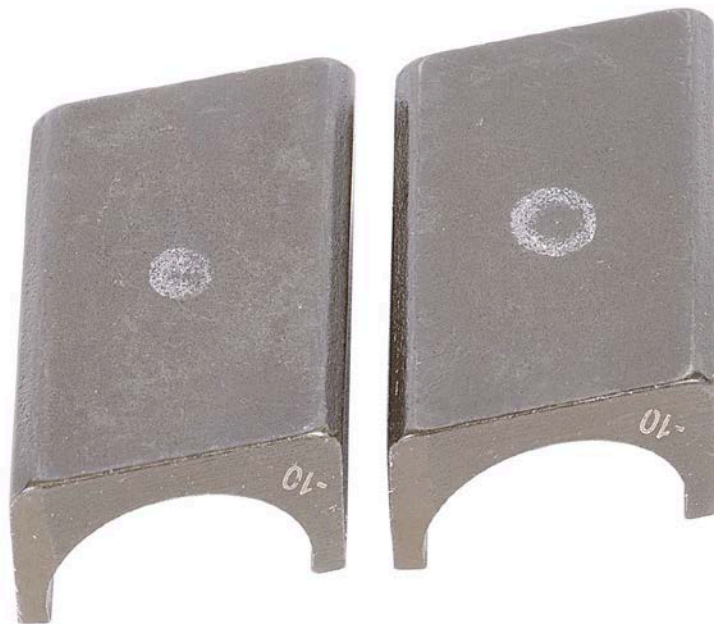
**Figure 58. Pump SN:17200072 Roller Shoe before Testing with 30/70 ATJ/F-24 with 24-ppm CI/LI Fuel at 40 °C**

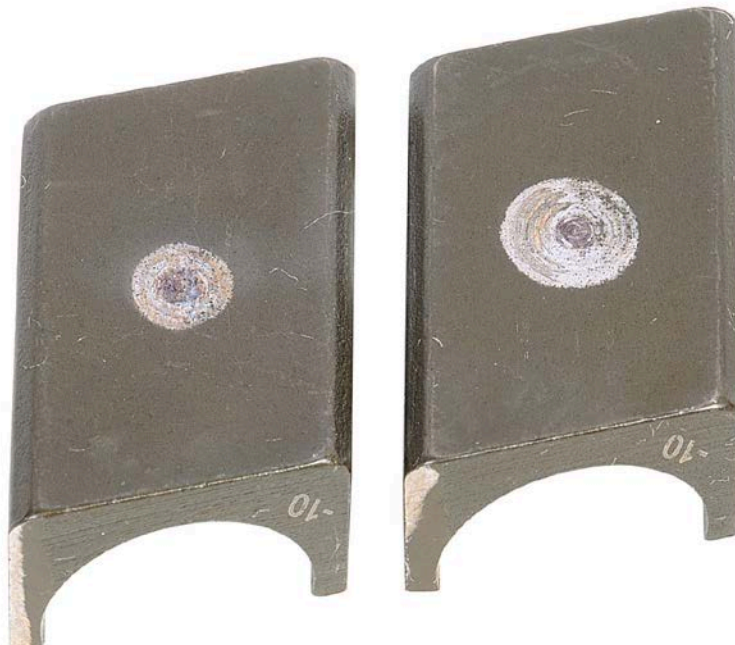
**Figure 59. Pump SN:17200072 Roller Shoe with 1000-Hours Testing with 30/70 ATJ/F-24 with 24-ppm CI/LI Fuel at 40 °C**

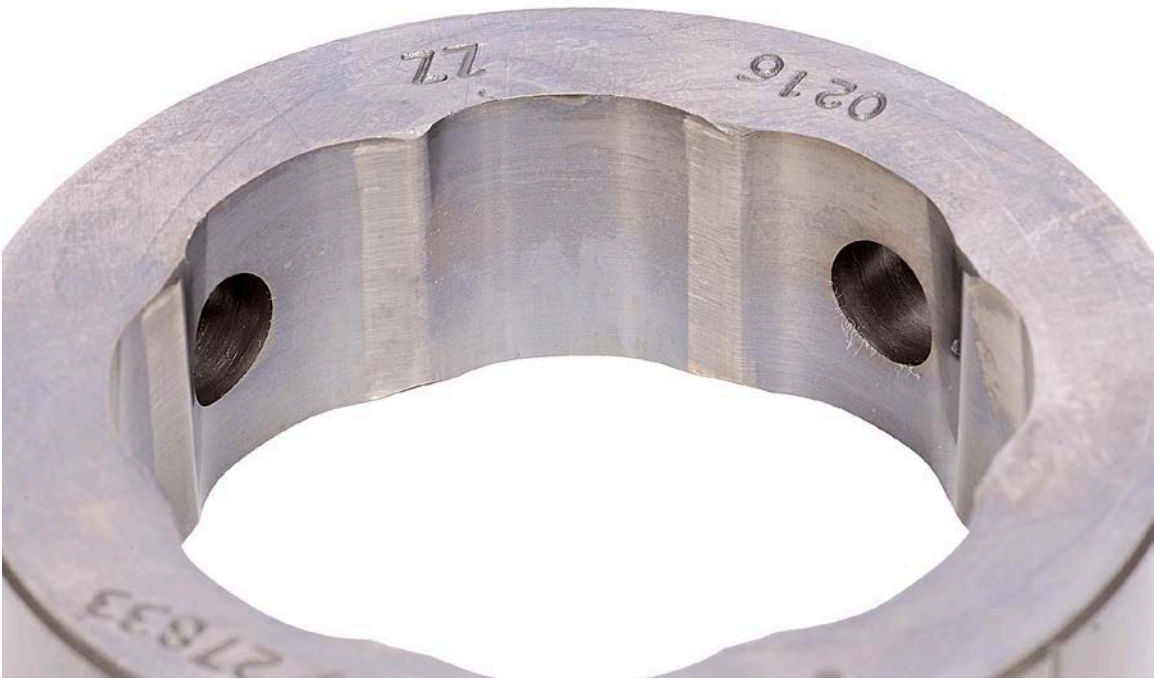
**Figure 60. Pump SN:17200072 Cam Ring before Testing with 30/70 ATJ/F-24 with 24-ppm CI/LI Fuel at 40 °C**

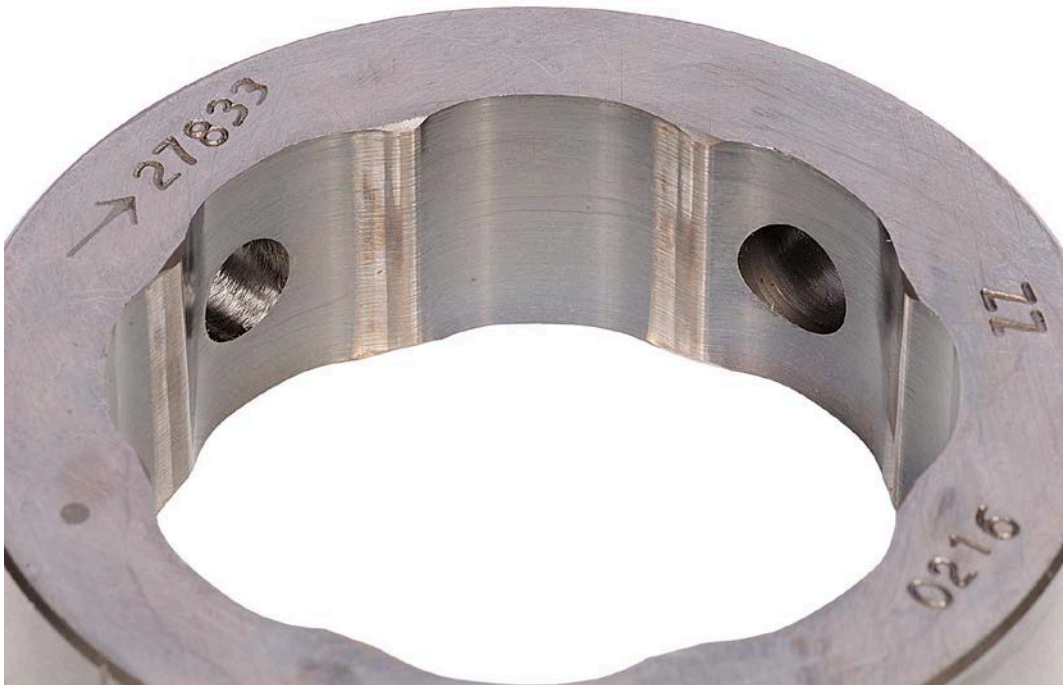
**Figure 61. Pump SN:17200072 Cam Ring with 1000-Hours Testing with 30/70 ATJ/F-24 with 24-ppm CI/LI Fuel at 40 °C**

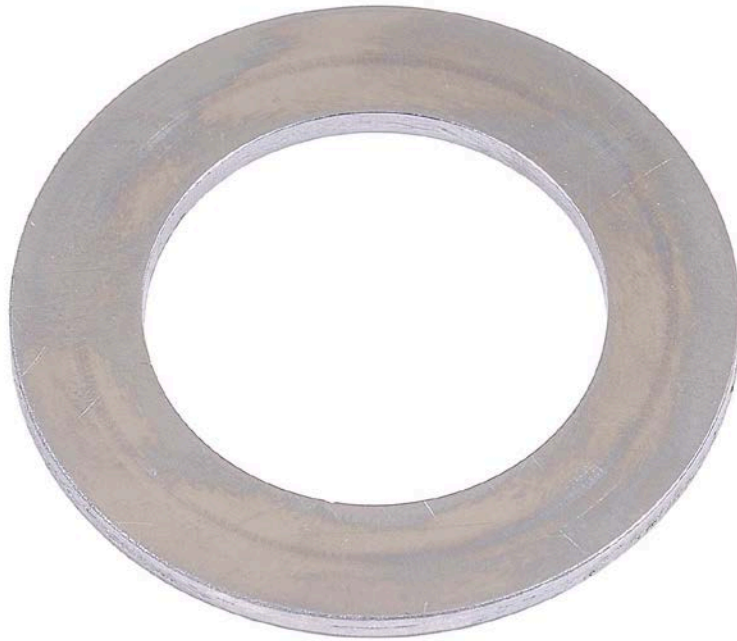
**Figure 62. Pump SN:17200072 Thrust Washer before Testing with 30/70 ATJ/F-24 with 24-ppm CI/LI Fuel at 40 °C**

The governor thrust washer condition before and after 1000-hours is seen in Figure 62 and Figure 63. The polishing wear seen on the thrust washer in Figure 63 is typical for the 1000-hour operating interval. Polishing and light fretting seen on the advance piston suggests the fuel pressure fluctuates in that area of the fuel injection pump housing. The metering valve regulates the pressure to the rotor fill ports. The pressure is regulated by the action of the helix changing the outlet area of an orifice. Due to WOT operation a lightly polished area shows at one location on the helix. The light wear on these components is normal considering the 1000-hour duration of testing. The wear on the thrust washer and the advance piston wear likely did not have an effect on pump operation. The metering valve wear may have affected the governor cut-off operation.

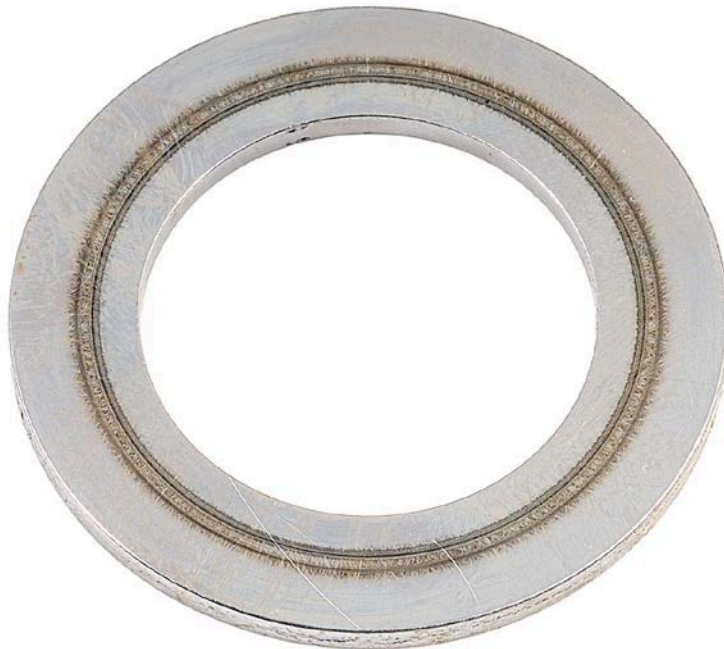
**Figure 63. Pump SN:17200072 Thrust Washer with 1000-Hours Testing with 30/70 ATJ/F-24 with 24-ppm CI/LI Fuel at 40 °C**

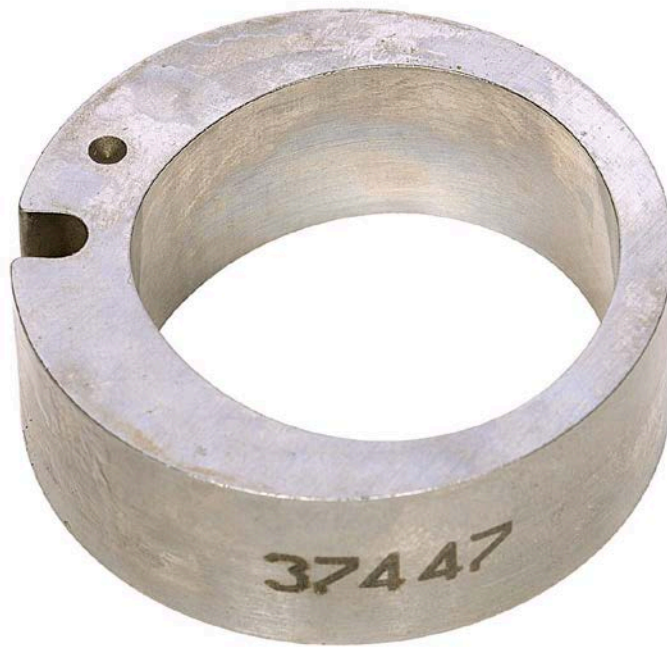
**Figure 64. Pump SN:17200072 Transfer Pump Liner before Testing with 30/70 ATJ/F-24 with 24-ppm CI/LI Fuel at 40 °C**

Figure 64 and Figure 65 illustrates the level of wear seen in the transfer pump section of fuel injection pump SN:17200072. Figure 64 shows the surface condition of the transfer pump liner prior to testing and Figure 65 shows the surface with moderate 85% circumferential scarring after

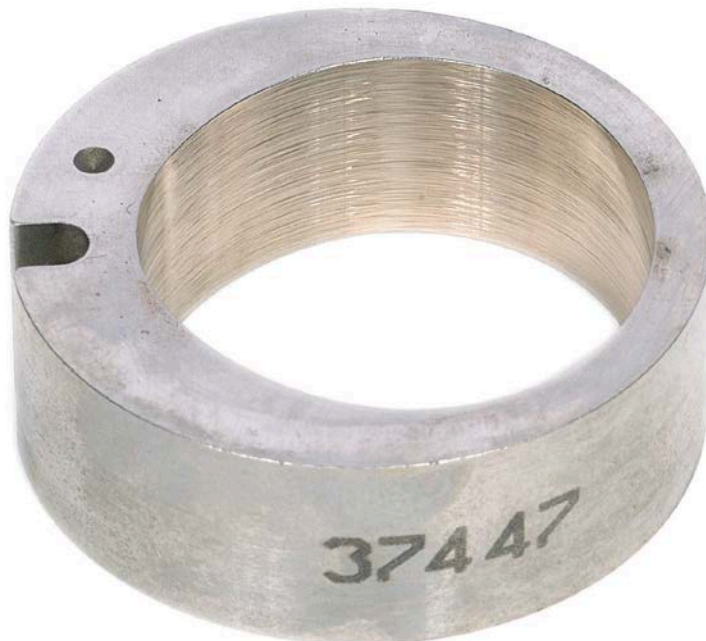
**Figure 65. Pump SN:17200072 Transfer Pump Liner with 1000-Hours Testing with 30/70 ATJ/F-24 with 24-ppm CI/LI Fuel at 40 °C**

1000-hours of operation on the 30/70 ATJ/F-24 with 24-ppm CI/LI Fuel. Also illustrative of the transfer pump section wear are the transfer pump blade conditions shown in Figure 66 through Figure 69. The edge wear shown in Figure 66 and Figure 67 corresponds to the surface on the transfer pump blades that contact the transfer pump liner, and they reveal moderate scoring. Pump SN:17200072 had a broken blade spring that could have affected transfer pump component wear. The side polishing shown in Figure 68 and Figure 69 reflect wear from the transfer pump blade slots on the injection pump rotor. The transfer pump component conditions suggest the test fuel has marginal fuel lubricity.

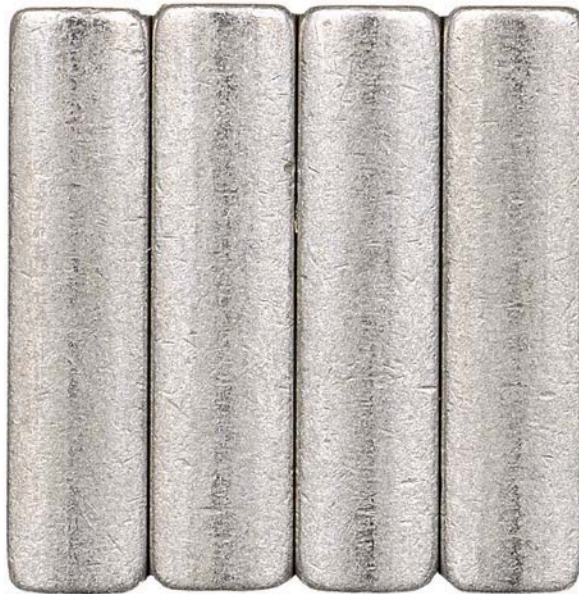
**Figure 66. Pump SN:17200072 Transfer Pump Blade Edges before Testing with 30/70 ATJ/F-24 with 24-ppm CI/LI Fuel at 40 °C**

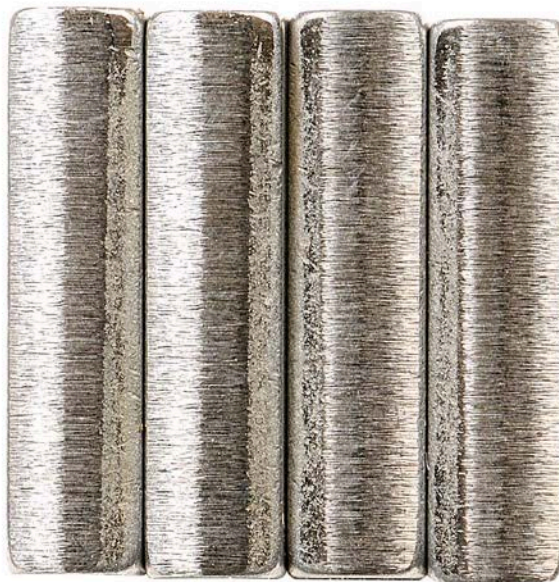
**Figure 67. Pump SN:17200072 Transfer Pump Blade Edges with 1000-Hours Testing with 30/70 ATJ/F-24 with 24-ppm CI/LI Fuel at 40 °C**

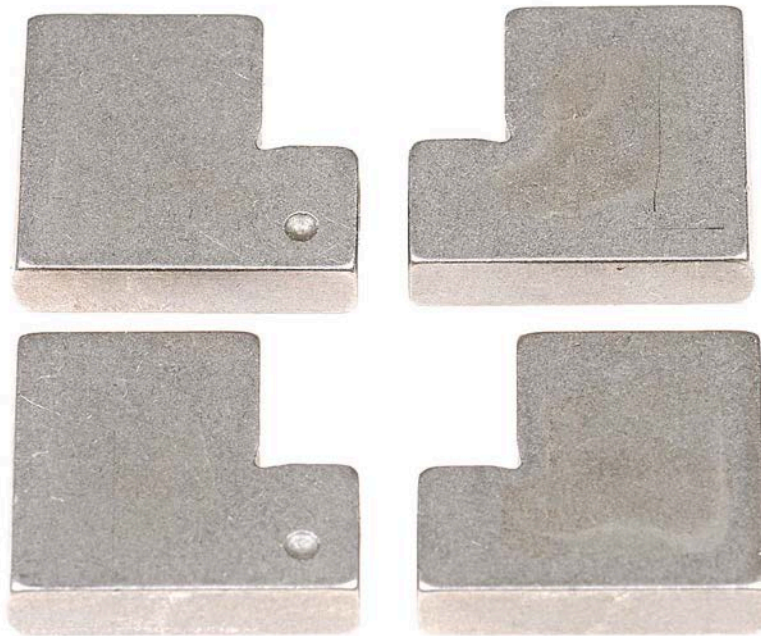
**Figure 68. Pump SN:17200072 Transfer Pump Blade Sides before Testing with 30/70 ATJ/F-24 with 24-ppm CI/LI Fuel at 40 °C**

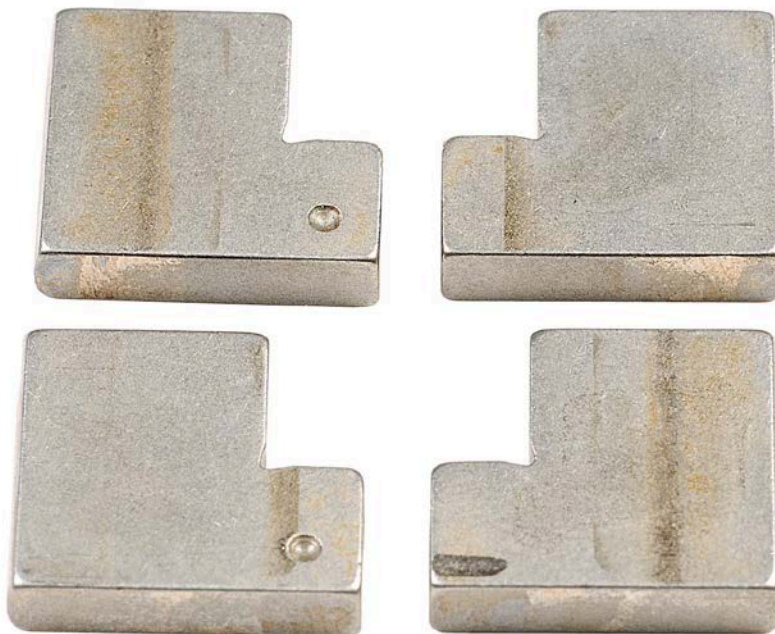
**Figure 69. Pump SN:17200072 Transfer Pump Blade Sides with 1000-Hours Testing with 30/70 ATJ/F-24 with 24-ppm CI/LI Fuel at 40 °C**

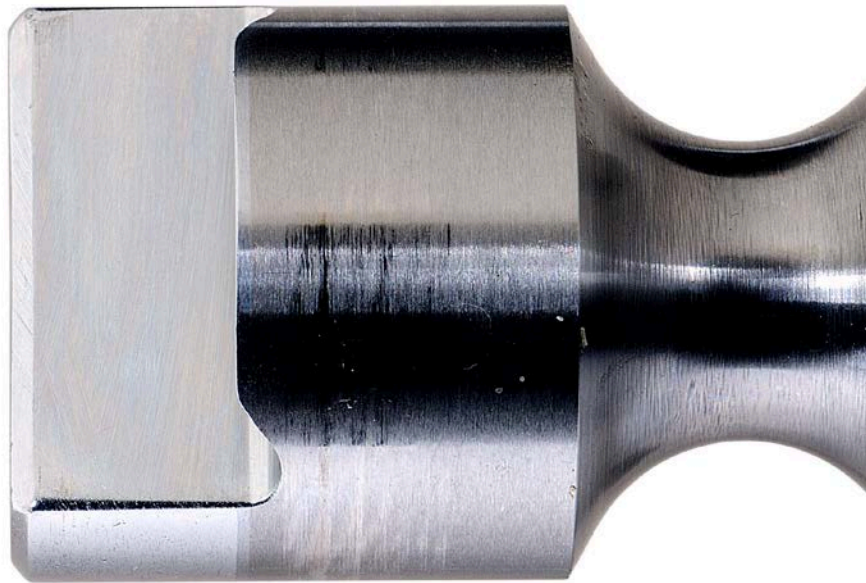
**Figure 70. Pump SN:17200072 Driveshaft Drive Tang Sides before Testing with 30/70 ATJ/F-24 with 24-ppm CI/LI Fuel at 40 °C**

Figure 70 and Figure 71 show the condition of the injection pump drive shaft drive tang that transmits torque to the hydraulic section of the pump from the engine. Figure 71 reveals a wear scar that indicates minor backlash was occurring with the 30/70 ATJ/F-24 with 24-ppm CI/LI Fuel blend after 1000-hours at elevated 40 °C fuel inlet temperature. Post-test specification checks did indicate a slight base timing change, possibly due to the drive tang wear.

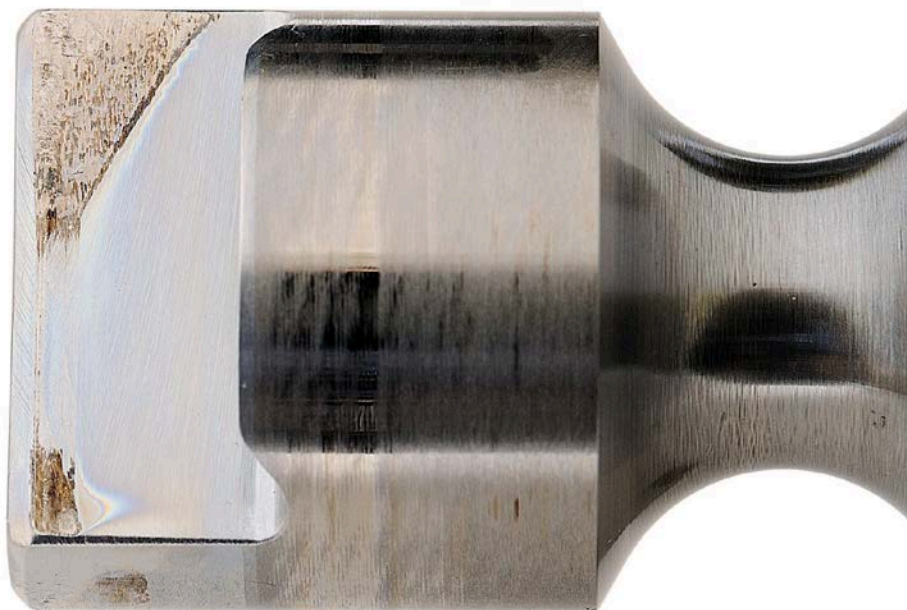
**Figure 71. Pump SN:17200072 Driveshaft Drive Tang with 1000-Hours Testing with 30/70 ATJ/F-24 with 24-ppm CI/LI Fuel at 40 °C**

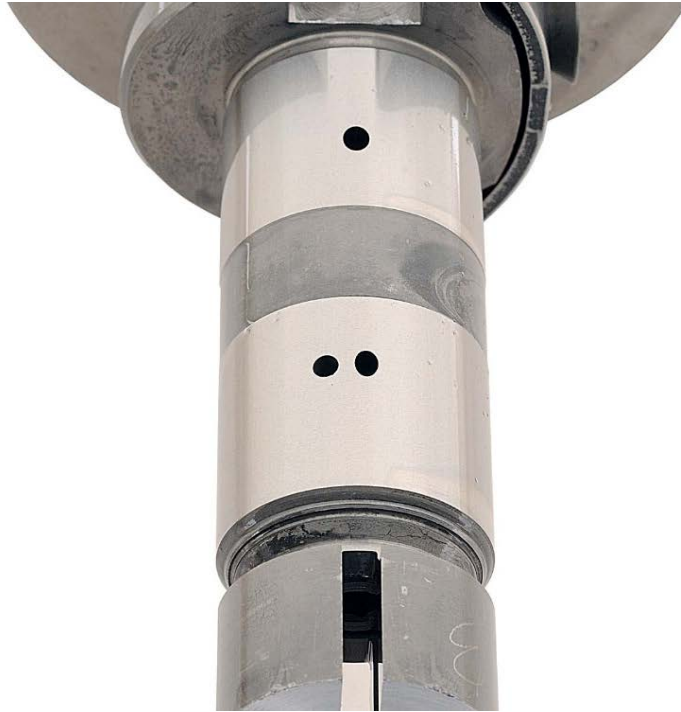
**Figure 72. Pump SN:17200858 Distributor Rotor before Testing with 30/70 ATJ/F-24 with 24-ppm CI/LI Fuel at 40 °C**

The parts conditions and subjective wear ratings for fuel injection pump SN:17200858 are summarized in Table 20. Images of the wear seen on the components of fuel injection pump SN:17200858 are shown in Figure 72 through Figure 89. Figure 72 and Figure 73 show the condition of the injection pump rotor that carries the plungers and distributes the compressed fuel. Figure 73 shows the discharge ports and rotor with minimal distress on the rotor or near the rotor discharge ports after the 1000-hours of operation. The rotor conditions with the ATJ/F-24 blend with 24-ppm CI/LI at 40 °C has less distress than the rotor conditions seen as a result of 1000-hours at the elevated 77 °C temperature.

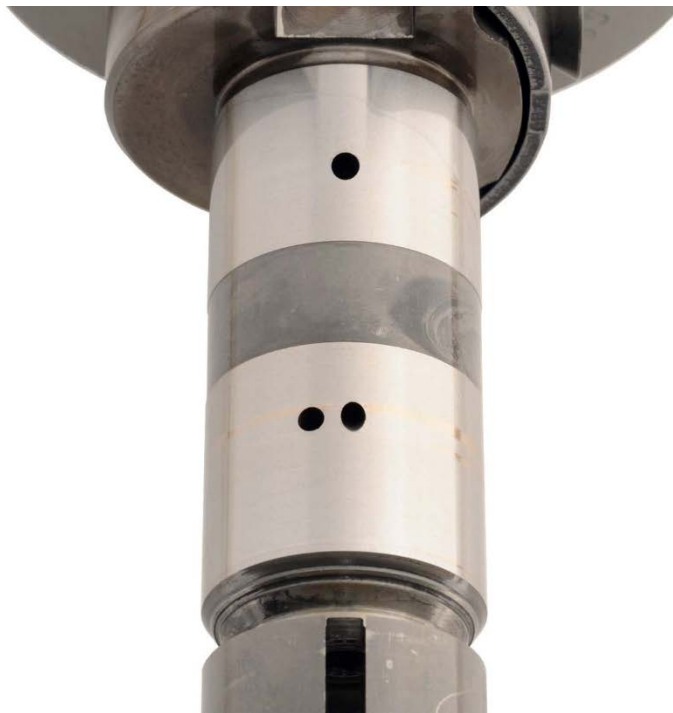
**Figure 73. Pump SN:17200858 Distributor Rotor with 1000-Hours Testing with 30/70 ATJ/F-24 with 24-ppm CI/LI Fuel at 40 °C**

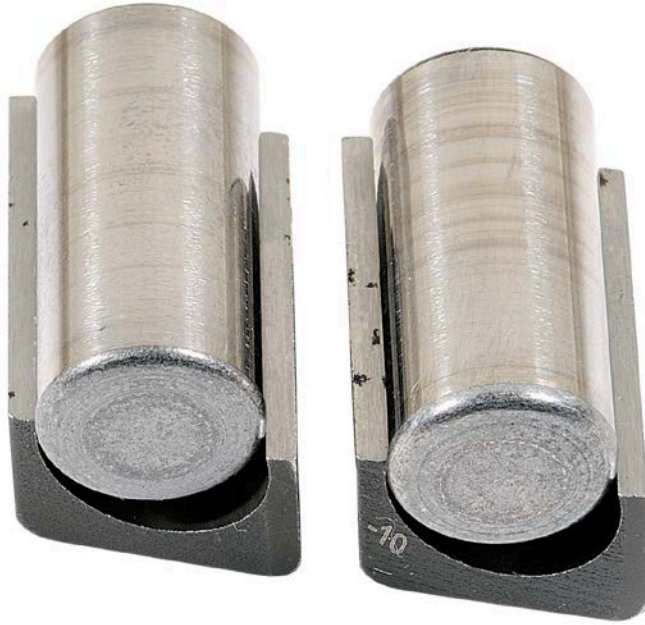
**Figure 74. Pump SN:17200858 Rollers and Shoe before Testing with 30/70 ATJ/F-24 with 24-ppm CI/LI Fuel at 40 °C**

Figure 74 and Figure 75 is the Pre-Test and Post-Test conditions of fuel injection pump SN:17200858 roller shoe and roller conditions. Of note is the lack of a wear scar at the roller shoe leaf spring contact and the shiny, bright rollers shown in Figure 74. Figure 75 reveals very light wear scars on the roller shoe from the leaf spring contact and light burnishing of the rollers. The rollers tend to discolor when combination rolling-sliding action occurs as the rollers follow the injection cam profile. Figure 76 and Figure 77 show the relatively moderate wear scar due to 1000-hours operation at the roller shoe plunger contact. The injection pump cam ring shown in Figure 78 and Figure 79 reveals minimal polishing and wear on the cam lobes from 1000-hours operation with the ATJ/F-24 fuel blend. The roller and cam distress with the ATJ/F-24 blend at 40 °C is much less severe than the distress previously seen with the 30% ATJ/F-24 blend with 24-ppm CI/LI after 1000-hours at 77°C fuel inlet temperature.

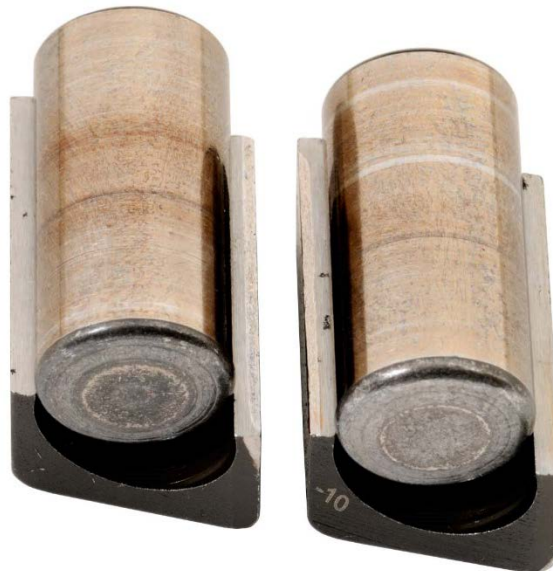
**Figure 75 Pump SN:17200858 Rollers and Shoe with 1000-Hours Testing with 30/70 ATJ/F-24 with 24-ppm CI/LI Fuel at 40 °C**

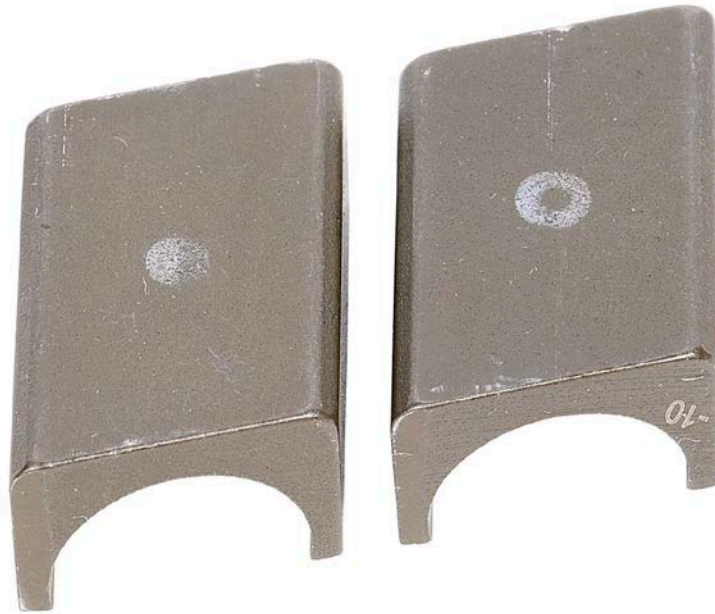
**Figure 76. Pump SN:17200858 Roller Shoe before Testing with 30/70 ATJ/F-24 with 24-ppm CI/LI Fuel at 40 °C**

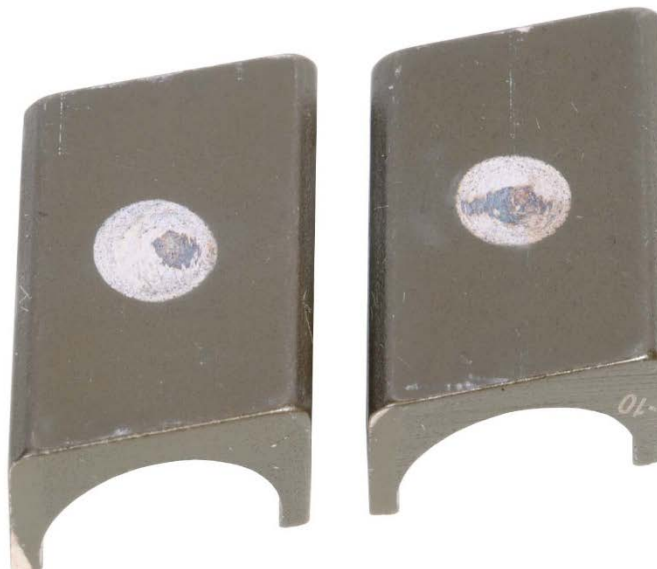
**Figure 77. Pump SN:17200858 Roller Shoe with 1000-Hours Testing with 30/70 ATJ/F-24 with 24-ppm CI/LI Fuel at 40 °C**

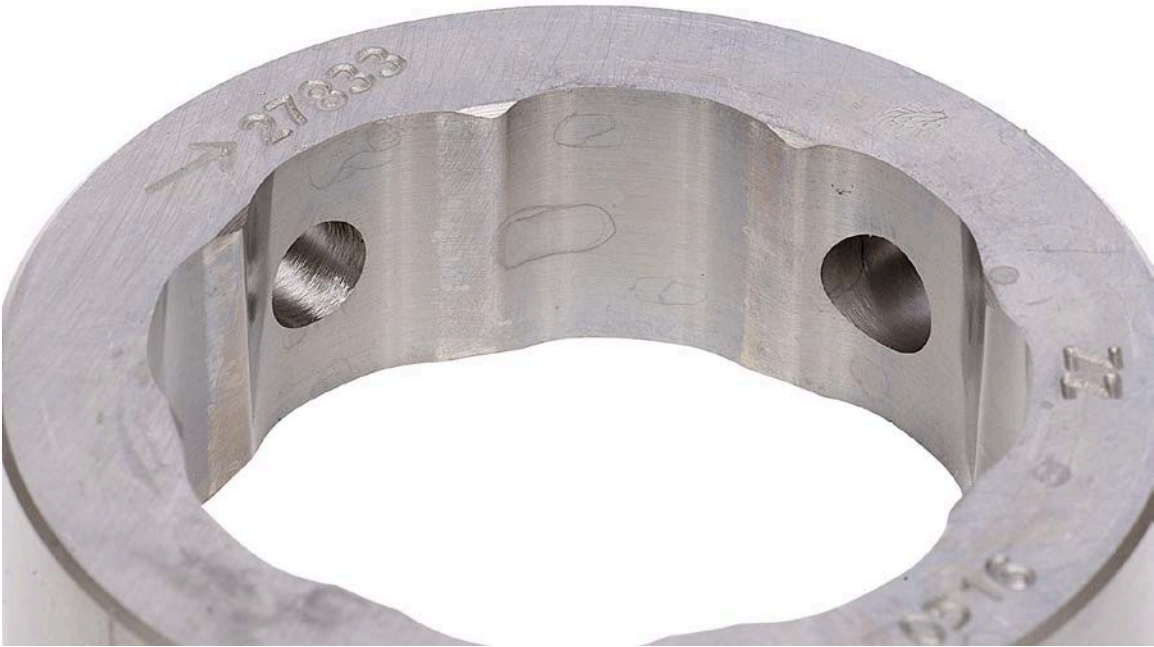
**Figure 78. Pump SN:17200858 Cam Ring before Testing with 30/70 ATJ/F-24 with 24-ppm CI/LI Fuel at 40 °C**

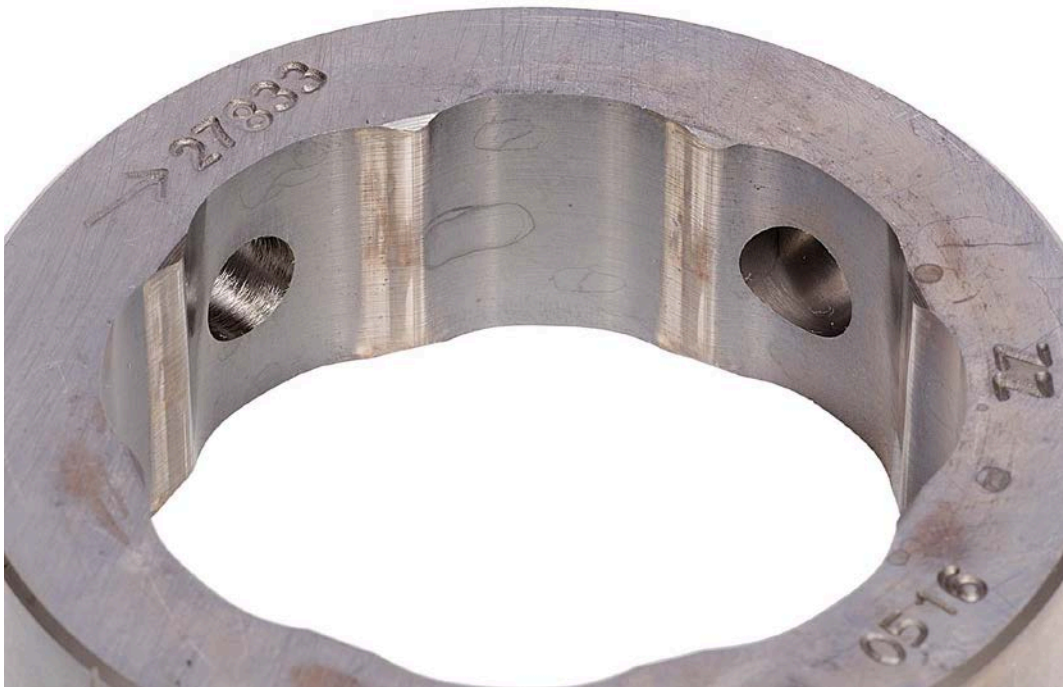
**Figure 79. Pump SN:17200858 Cam Ring with 1000-Hours Testing with 30/70 ATJ/F-24 with 24-ppm CI/LI Fuel at 40 °C**

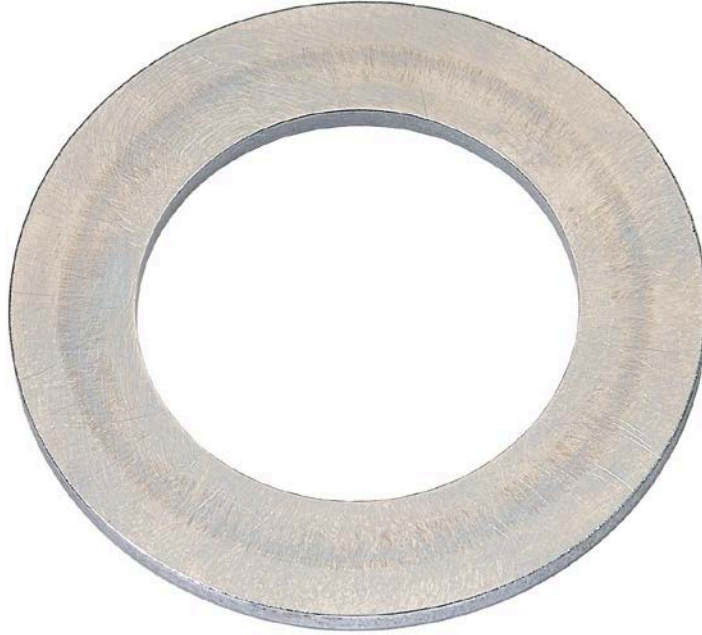
**Figure 80. Pump SN:17200858 Thrust Washer before Testing with 30/70 ATJ/F-24 with 24-ppm CI/LI Fuel at 40 °C**

The governor thrust washer conditions before and after 1000-hours are seen in Figure 80 and Figure 81. The polishing wear seen on the thrust washer in Figure 81 appears less severe than typical for a 1000-hour operation with a nominal lubricity fuel. Polishing and light fretting seen on the advance piston suggests the fuel pressure fluctuations in the fuel injection pump housing advance section. The metering valve regulates the pressure to the rotor fill ports. The pressure is regulated by the action of the helix changing the outlet area of an orifice. Due to WOT operation a lightly polished area shows at one location on the helix. The light wear on these components is normal considering the 1000-hour duration of testing. The wear on the thrust washer and the

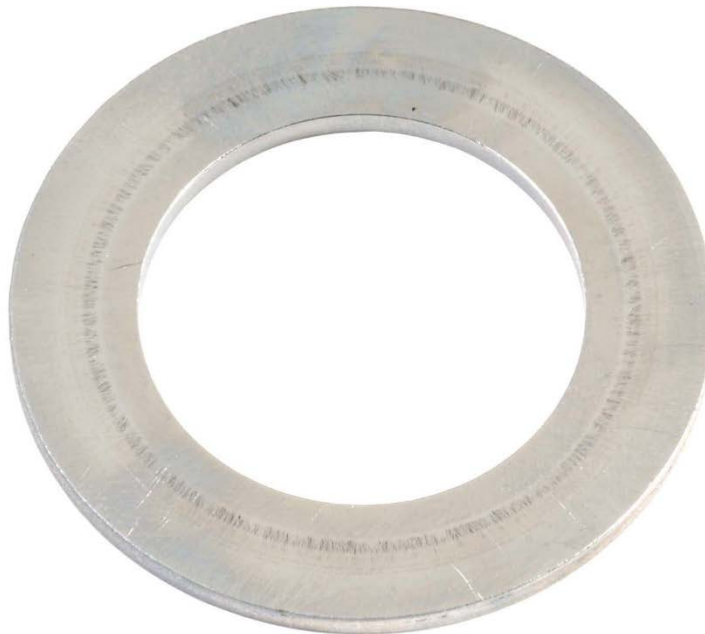
**Figure 81. Pump SN:17200858 Thrust Washer with 1000-Hours Testing with 30/70 ATJ/F-24 with 24-ppm CI/LI Fuel at 40 °C**

advance piston wear likely did not affect the governor cut-off operation. The metering valve wear could have contributed to the compromised governor operation.

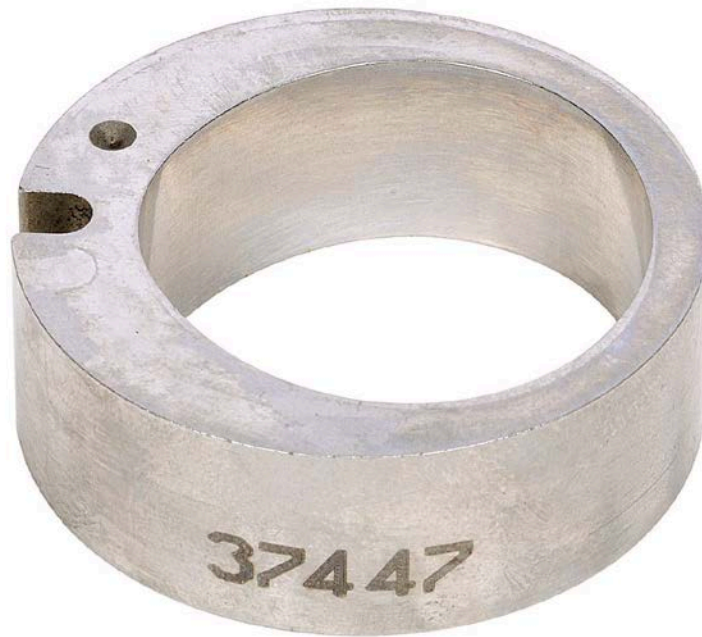
**Figure 82. Pump SN:17200858 Transfer Pump Liner before Testing with 30/70 ATJ/F-24 with 24-ppm CI/LI Fuel at 40 °C**

Figure 82 through Figure 87 illustrate the level of wear seen in the transfer pump section of fuel injection pump SN:17200858. Figure 82 shows the surface condition of the transfer pump liner prior to testing and Figure 83 shows the surface with 85% circumferential scoring after 1000-hours of operation on the ATJ/F-24 fuel with 24-ppm CI/LI. Also illustrative of the transfer pump section wear are the transfer pump blade conditions shown in Figure 84 through Figure 87. The edge wear shown in Figure 84 and Figure 85 corresponds to the surface on the transfer pump blades that contact the transfer pump liner and are typical for 1000-hours operation with a marginal to low lubricity fuel. Pump SN:17200858 had a broken blade spring that could have affected transfer pump component wear. The side polishing shown in Figure 86 and Figure 87 is light and reflects wear from the transfer pump blade slots on the injection pump rotor. The wear seen on the transfer pump components of pump SN:17200858 are less severe than the elevated temperature 30% ATJ/F-24 test. The transfer pump component conditions suggest the test fuel has moderate fuel lubricity, also evidenced by the variation of transfer pump pressures noted during testing.
