**ROTARY FUEL INJECTION PUMP WEAR TESTING  
USING A 30%/70% ATJ/F-24 FUEL BLEND**

**INTERIM REPORT  
TFLRF No. 488**

**U.S. Army TARDEC Fuels and Lubricants Research Facility  
Southwest Research Institute® (SwRI®)  
San Antonio, TX**

**Contract No. W56HZV-15-C-0030 (WD12 Task 2.2)**

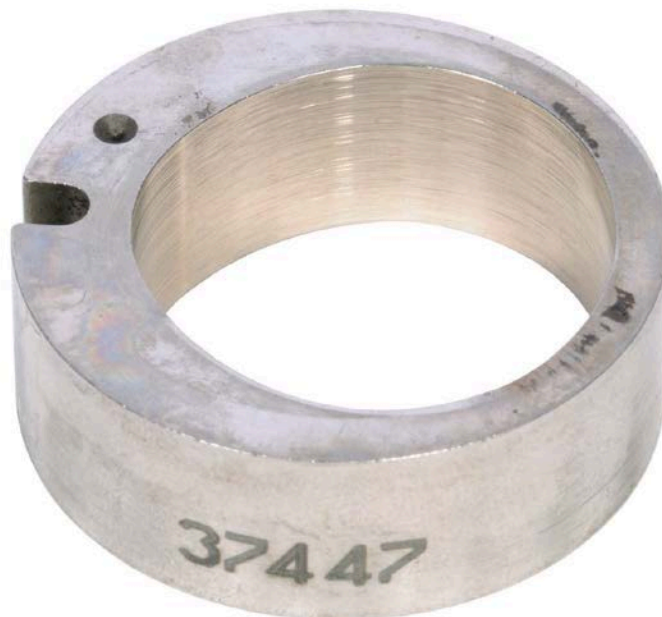
**Figure 83. Pump SN:17200858 Transfer Pump Liner with 1000-Hours Testing with 30/70 ATJ/F-24 with 24-ppm CI/LI Fuel at 40 °C**

Figure 82 through Figure 87 illustrate the level of wear seen in the transfer pump section of fuel injection pump SN:17200858. Figure 82 shows the surface condition of the transfer pump liner prior to testing and Figure 83 shows the surface with 85% circumferential scoring after 1000-hours of operation on the ATJ/F-24 fuel with 24-ppm CI/LI. Also illustrative of the transfer pump section wear are the transfer pump blade conditions shown in Figure 84 through Figure 87. The edge wear shown in Figure 84 and Figure 85 corresponds to the surface on the transfer pump blades that contact the transfer pump liner and are typical for 1000-hours operation with a marginal to low lubricity fuel. Pump SN:17200858 had a broken blade spring that could have affected transfer pump component wear. The side polishing shown in Figure 86 and Figure 87 is light and reflects wear from the transfer pump blade slots on the injection pump rotor. The wear seen on the transfer pump components of pump SN:17200858 are less severe than the elevated temperature 30% ATJ/F-24 test. The transfer pump component conditions suggest the test fuel has moderate fuel lubricity, also evidenced by the variation of transfer pump pressures noted during testing.

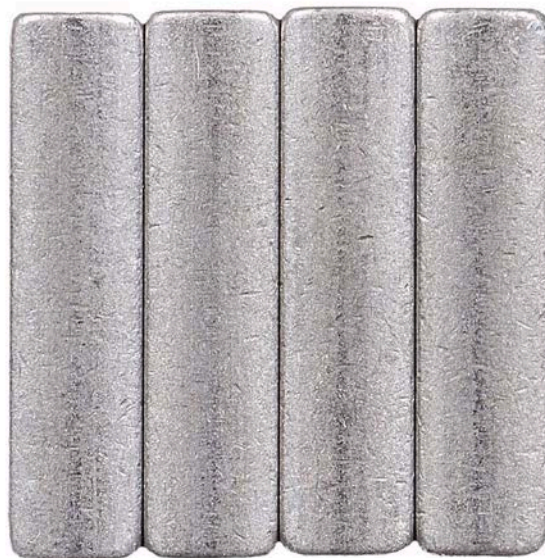
**Figure 84. Pump SN:17200858 Transfer Pump Blade Edges before Testing with 30/70 ATJ/F-24 with 24-ppm CI/LI Fuel at 40 °C**

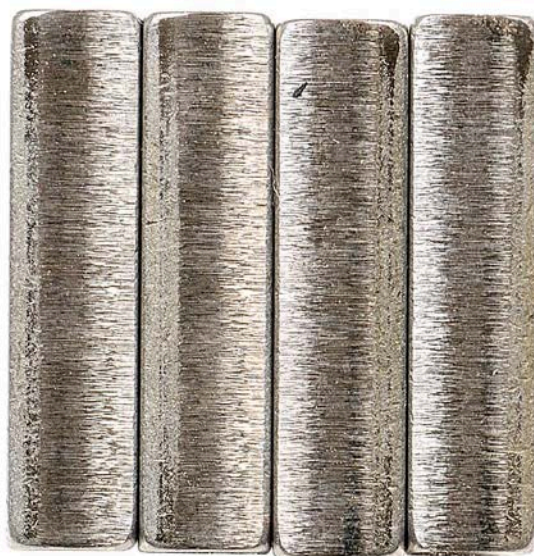
**Figure 85. Pump SN:17200858 Transfer Pump Blade Edges with 1000-Hours Testing with 30/70 ATJ/F-24 with 24-ppm CI/LI Fuel at 40 °C**

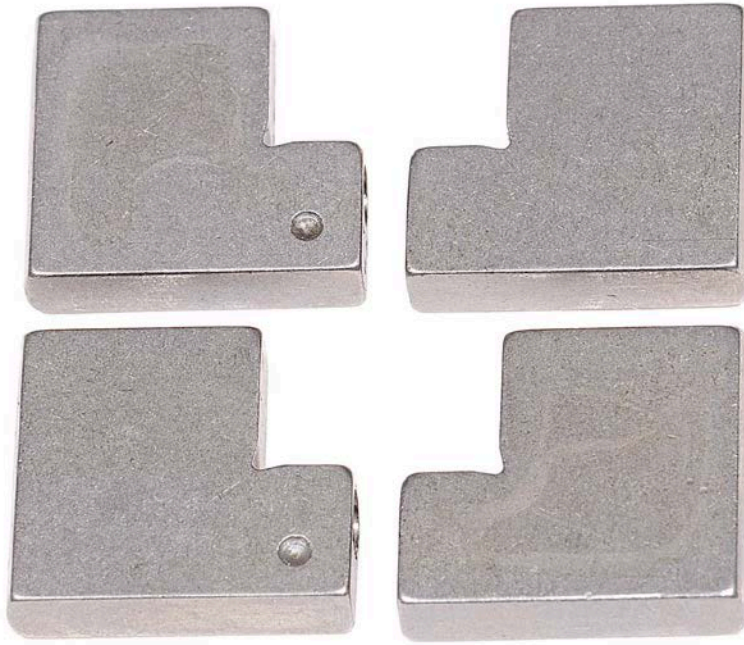
**Figure 86. Pump SN:17200858 Transfer Pump Blade Sides before Testing with 30/70 ATJ/F-24 with 24-ppm CI/LI Fuel at 40 °C**

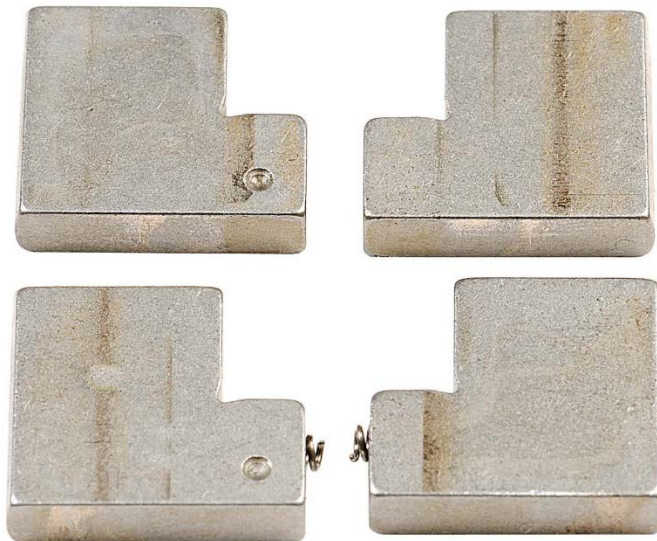
**Figure 87. Pump SN:17200858 Transfer Pump Blade Sides with 1000-Hours Testing with 30/70 ATJ/F-24 with 24-ppm CI/LI Fuel at 40 °C**

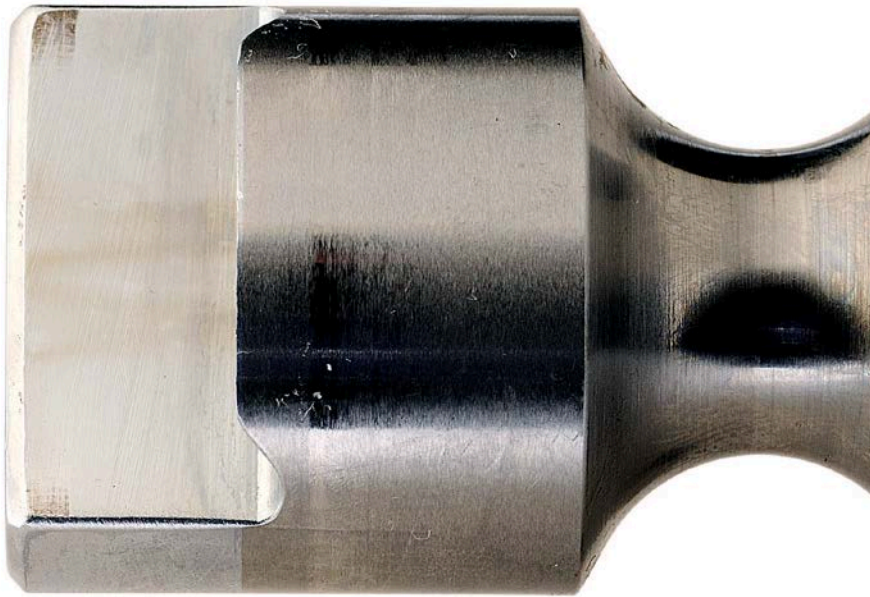
**Figure 88. Pump SN:17200858 Driveshaft Drive Tang before Testing with 30/70 ATJ/F-24 with 24-ppm CI/LI Fuel at 40 °C**

Figure 88 and Figure 89 show the condition of the injection pump drive shaft drive tang that transmits torque to the hydraulic section of the pump from the engine. Figure 89 reveals a wear scar that indicates backlash may have altered with the 30% ATJ/F-24 fuel with 24-ppm CI/LI after 1000-hours. For both pumps operated at 40 °C fuel temperature and utilized the ATJ/F-24 with 24-ppm CI/LI fuel, there were not any significantly worn components. The impacted injection pump performance was likely due to the accumulation of mild wear in multiple sections of the pumps.

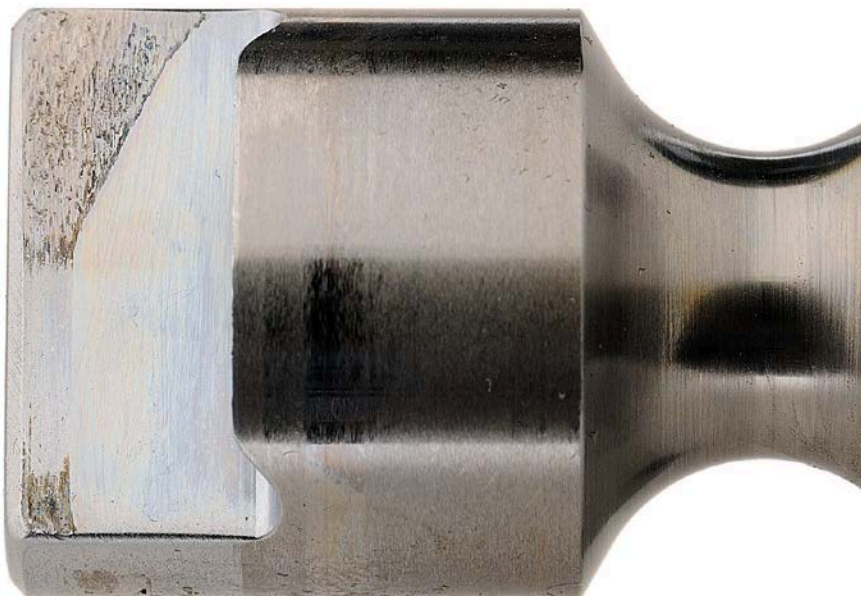
**Figure 89. Pump SN:17200858 Driveshaft Drive Tang with 1000-Hours Testing with 30/70 ATJ/F-24 with 24-ppm CI/LI Fuel at 40 °C**
