## **Demonstration and Validation of Advanced Rebar Materials in Salt-Exposure Applications**

Final Report on Project F09-AR13

Under Project F09-AR13, "Evaluation of State-of-the-Art Rebar Concrete Structures in  
Salt Environments at Fort Knox, KY"

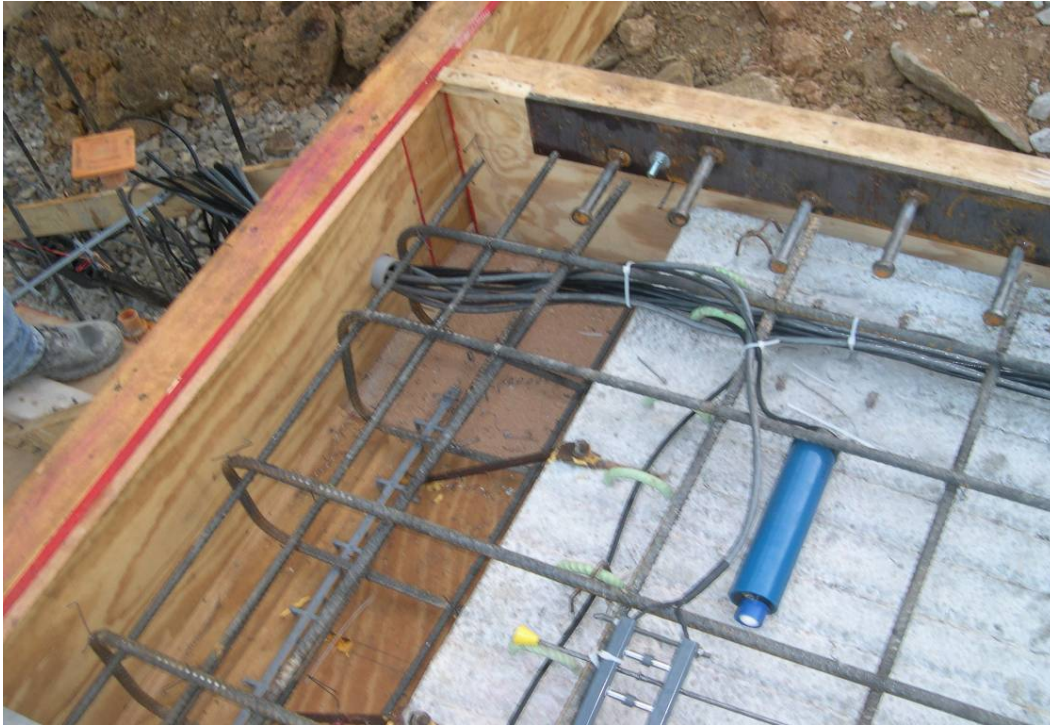
Figure 2. Corrosion potential reference electrodes (blue).

To measure corrosion potential, Stelth 7 silver/silver chloride reference electrodes\* were placed at strategic locations across the structure. Potential measurements could then be obtained and monitored for corrosion activity over a stated period of time. The reference electrodes were attached directly to the rebar and mounted as shown in Figure 2.

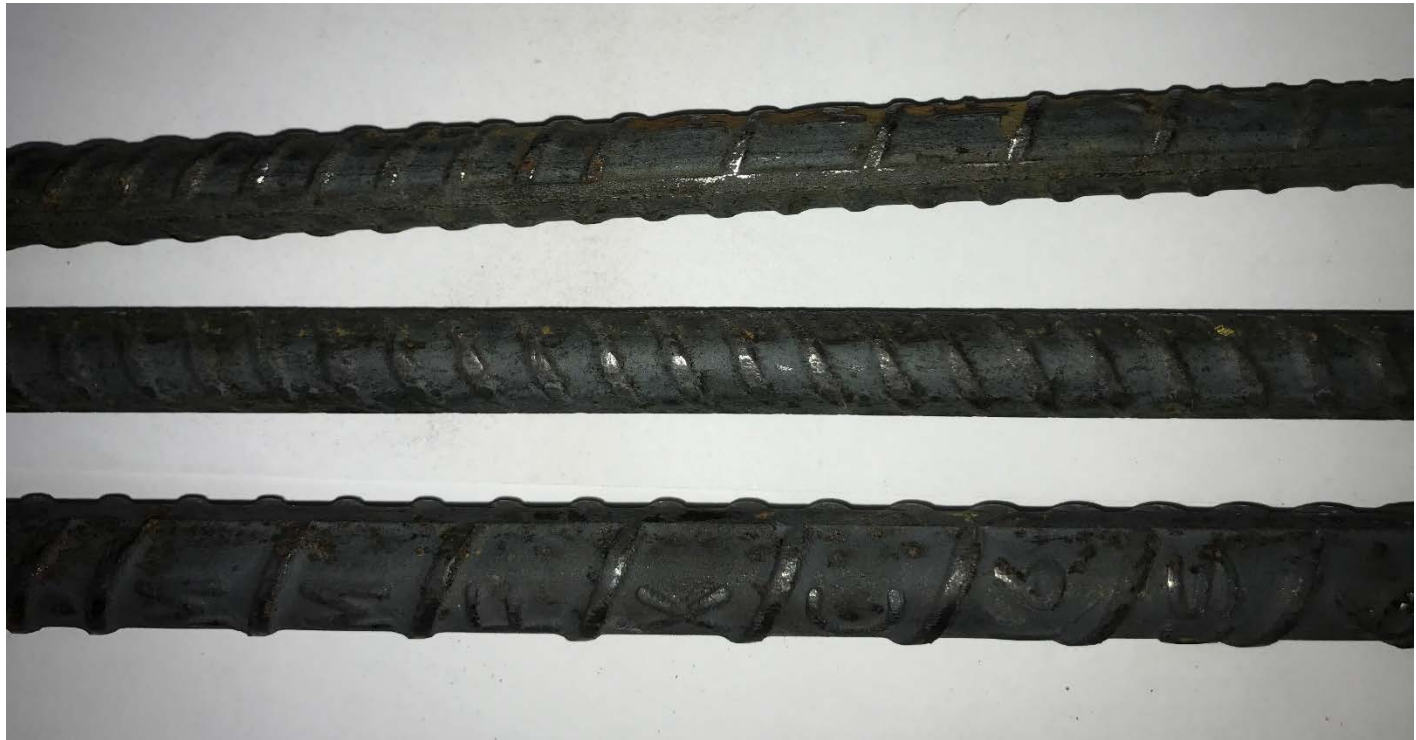
Figure 4. Samples of MMFX2 rebar installed at Bridge 9.

As previously stated, one material tested was MMFX2 rebar (Figure 4). This material was installed in Bridge 9, a conventional steel beam structure with a poured concrete cap. However, the replacement bridge used precast, reinforced, stressed beams with a concrete deck cap that was constructed using the MMFX rebar (Figure 5). Sensors were installed in the deck cap at five locations. A deck cap's thickness varied from 4 to 7 in. and had a brushed concrete veneer.

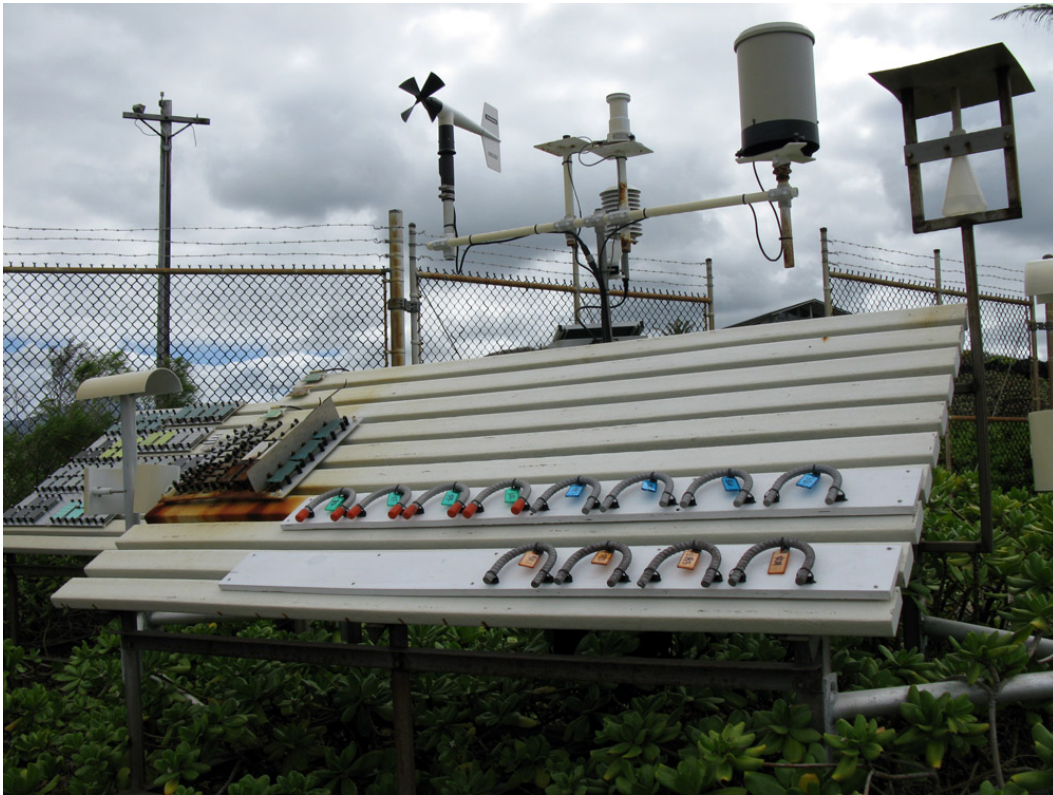
Figure 14. Sample rebar on test rack at MCBH.

A nonstandard exposure test was performed on samples of each rebar used in the demonstration project. The test's purpose was to subjectively evaluate the relative corrosion resistance between the materials, as well as to see if bending the materials had an adverse effect on their corrosion resistance. Approximately 1-foot long sections of size #5 bars were bent into a U shape with an approximate 2-inch radius. These samples were then placed on an exposure rack operated by the University of Hawaii on the north shore of the Oahu, Hawaii, at Marine Corp Base Hawaii (MCBH). The samples remained on the rack for 1,174 days, at which time the samples were removed, sealed in plastic bags, and shipped to ERDC CERL. The samples placed on the test rack are shown in Figure 14. In the figure, the SSC bar has the green tags, the MMFX2 samples the blue tag, and the plain rebar the orange tags.
