## **Evaluation of Insulated Pavements to Prevent Frost Damage**

Marissa J. Torres, Alexander R. Stott, and  
Marina I. Reilly-Collette

December 2018

Final report

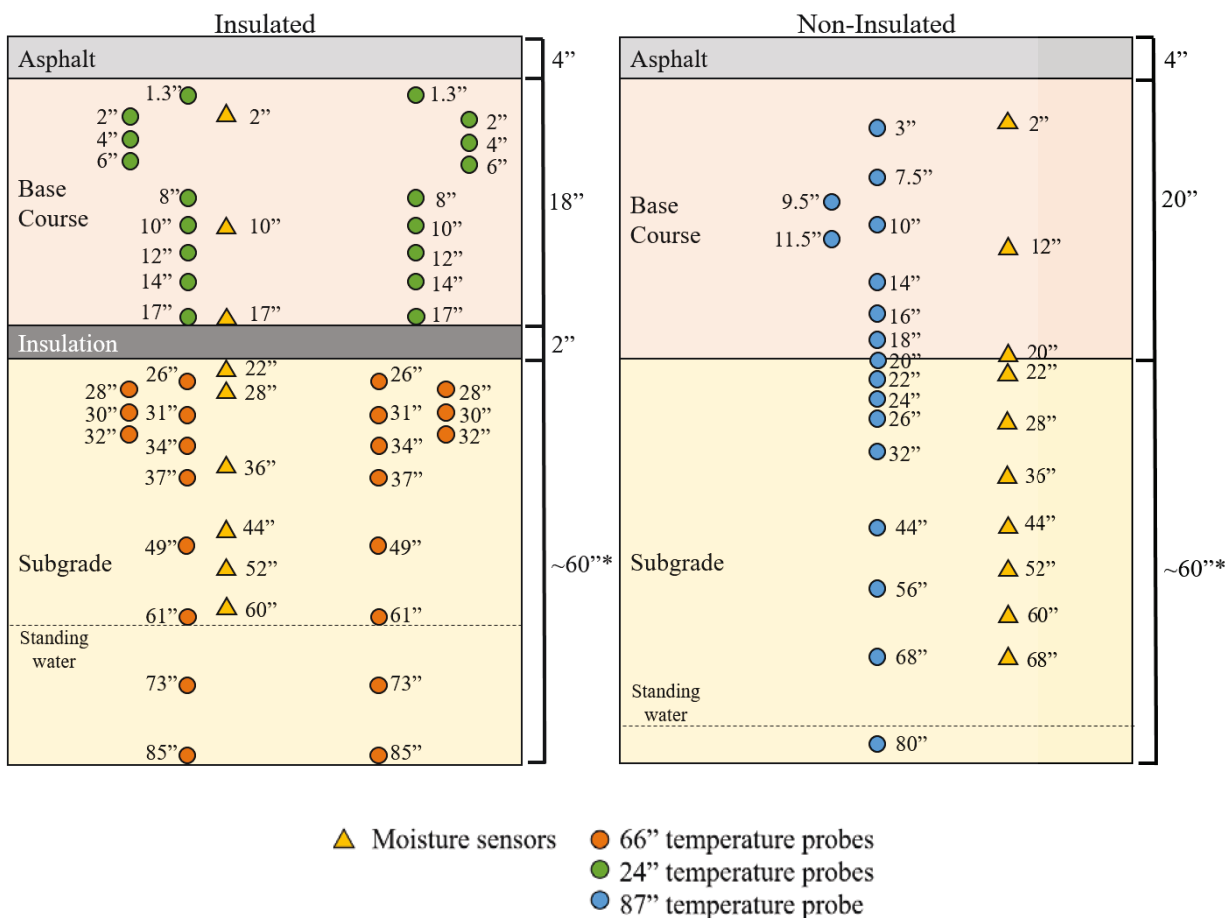
Figure 2. Vertical depth profile of the insulated (left) and non-insulated (right) pavement sections at the test site in Fort McCoy, WI. Sensor depths measured from bottom of asphalt layer; approximate depth of standing water is noted in each diagram.

The vertical profiles of the insulated and non-insulated pavement sections consisted of three primary layers: asphalt, base course, and subgrade (Figure 2). Each section had 4 in. of asphalt and 60 in. or more of subgrade material. In between, the insulated pavement had 18 in. of base course and up to 2 in. of XPS, while the non-insulated pavement had only 20 in. of base course material. When installing the temperature probes in the subgrade, standing water was visible approximately 38 in. below the subgrade surface in the insulated section, and 54 in. in the non-insulated section. The height of the water table was not known prior to beginning installation. The deepest temperature sensors were placed in the standing water and no moisture sensors were placed directly in the standing water.

The vertical thermal gradients of the insulated and non-insulated pavement sections were recorded using three different length temperature probes from Campbell Scientific (model CS230) – (2) 24 in. probes above the insulating layer, (2) 66 in. probes below the insulation layer, and (1) 87 in. probe in the control section. Each temperature probe contains a number of internal sensors along its length, as well as three external sensors with varying cord length placed near the top of the soil layer (Figure 2). The temperature probes above the insulating layer were laterally offset from the probes below the insulating layer by 1 ft (Figure 1b). The offset was applied as result of having to puncture through the insulation in order to fit the 24 in. probe in the 18 in. depth of the base layer, avoiding the asphalt. Spray foam insulation was used to fill the gaps in the XPS created during this process.

A number of Decagon ECH<sub>2</sub>O moisture sensors were positioned at varying depths in the insulated and non-insulated pavement sections to record the volumetric water content of the base course and subgrade layers throughout the winter freeze and spring thaw cycles. The vertical profile of the soil moisture provided a baseline of the natural water content in the test area, as well as insight into how the soil moisture behaved with changing temperatures. This information was further used to determine whether the insulating layer was effective in preventing moisture from reaching the frost-susceptible subgrade and if freezing occurred.

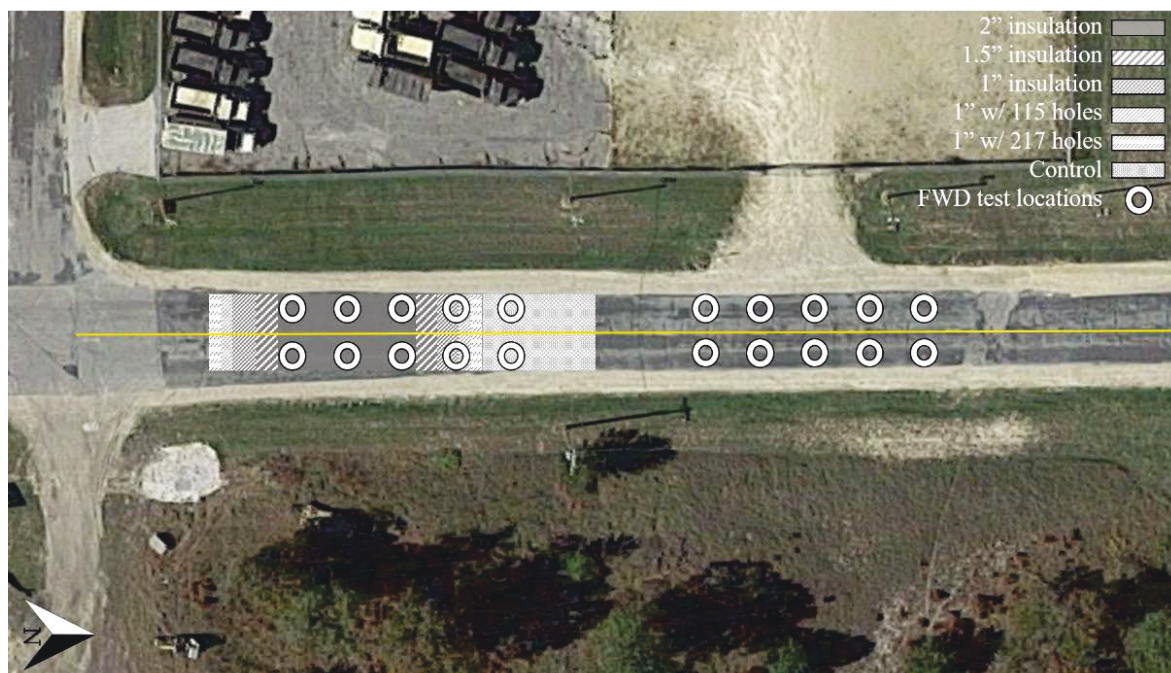
Figure 3. Approximate locations of the falling weight deflectometer (FWD) tests performed on East South Street at Fort McCoy.

Additionally, several FWD tests were performed on the road over the course of the winter season and spring thaw to gauge how the road's structural properties changed during the spring thaw cycle. Figure 3 shows the approximate locations of each FWD drop site. Four loading forces of increasing weight were applied at each test site, ranging from 5500 lbs to 15,000 lbs. Four drops per loading force were conducted, totaling 16 drops at each site. Back calculations of the elastic moduli for each pavement layer were completed for a loading force around 9,000 lbs using the MODULUS 7 software. The program was configured as a three-layer system with a semi-infinite subgrade layer defined as silty sand and pavement surface temperature defined by the closest installed temperature probe.

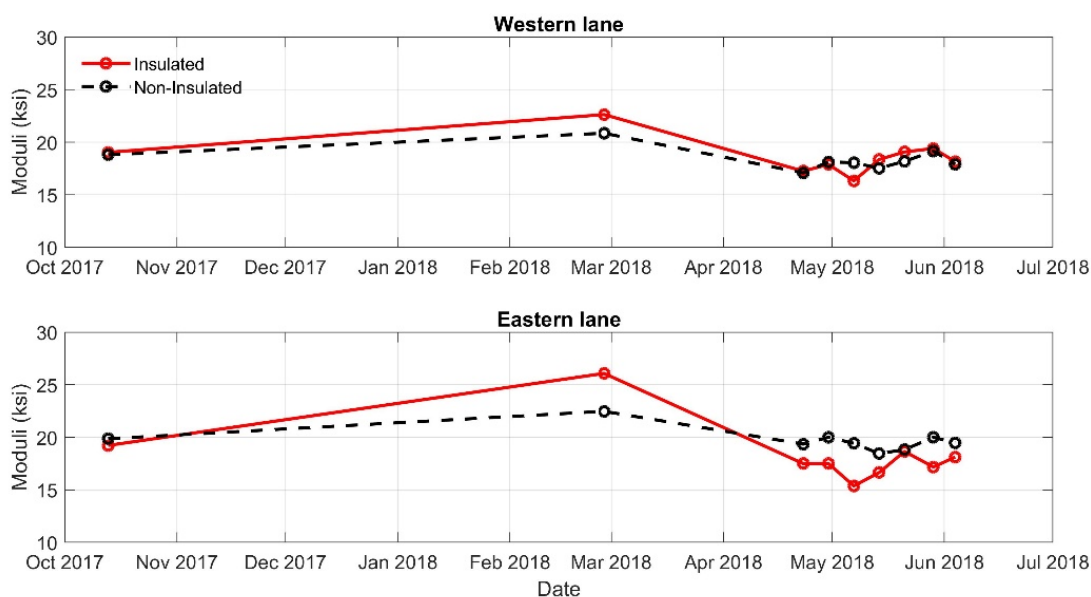
**Figure 5. Back calculated elastic moduli in ksi of the subgrade layer (frost susceptible soil) in the insulated and non-insulated pavement section in the western and eastern lanes of East South Street.**

Results from the FWD tests indicate there was no significant difference in elastic modulus of the subgrade between the insulated and non-insulated pavement sections (Figure 5). The moduli increased in the winter and fluctuated slightly during the spring thaw. The subgrade was hardest during the harshest winter months, returning to its autumnal values over the course of the spring thaw. Most notable is the difference between the western and eastern lanes of the insulated pavement. The moduli in the winter is 4 ksi stronger in the eastern lane than in the western lane; and during spring, the moduli is consistently 1 ksi lower in the eastern lane. The western lane of East South Street contained the temperature and moisture instrumentation. The installment of these sensors could have impacted the

strength of the subgrade during the test period (e.g., water penetration along the edges of the temperature probes or cables).
