ERDC TR-19-6

Improved Levee Resilience Through Soil Application of a Natural Organic Polymer

Field Study: Kaufman Levee No. 1

June 2019

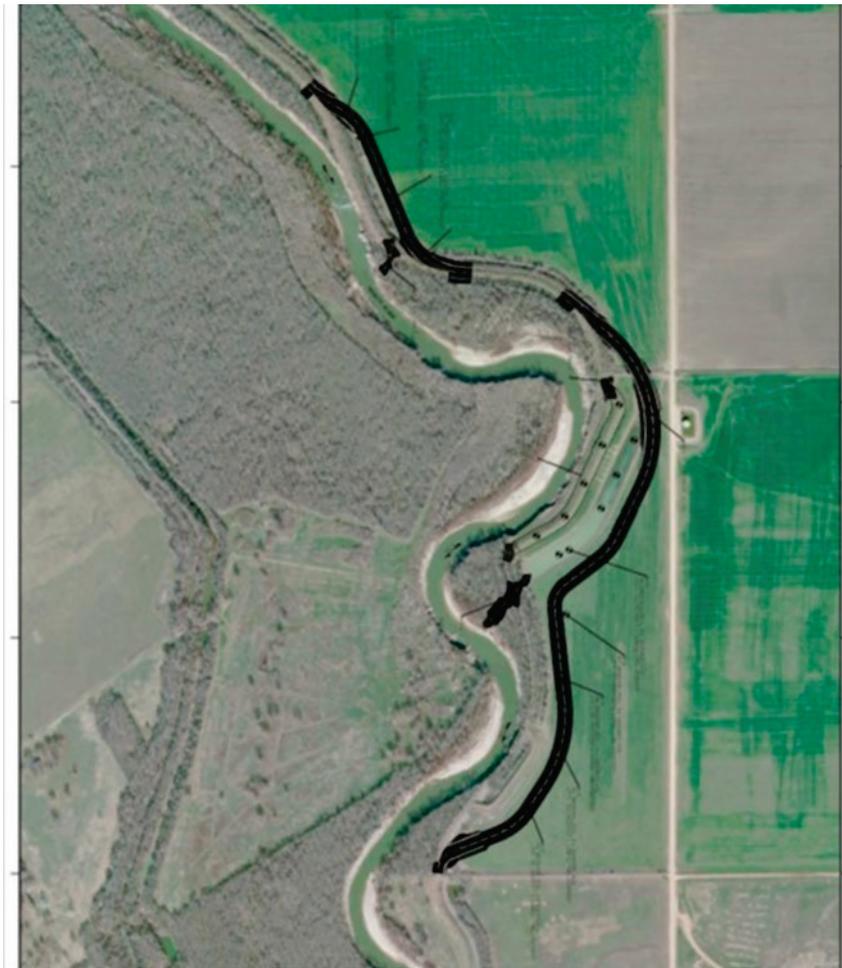
Figure 2. Overview of the levee setback placement and new borrow site (drawing provided by Fort Worth District).

plasticity clays down to a depth of at least 15 feet (ft) (information supplied by Fort Worth District). The high-water flows in 2009 and 2010 undercut the levee bank and resulted in the numerous bank failures that eventually made the levee road narrow and impassable in some places. Local farmers attempted to repair part of the levee in one of the southern-most affected areas during 2013 (Figure 2). The emergency repair plan made by the USACE Fort Worth District defined two new setback levees to be placed behind the existing levee (Figure 2). Materials for this construction project came from the existing levee when it was deconstructed. Additional borrow materials (primarily clays) were provided by Trinity Materials, Inc. located south of the levee construction site. Fort Worth District also completed bank stabilization using two bendway weirs as well as the two setback levees.

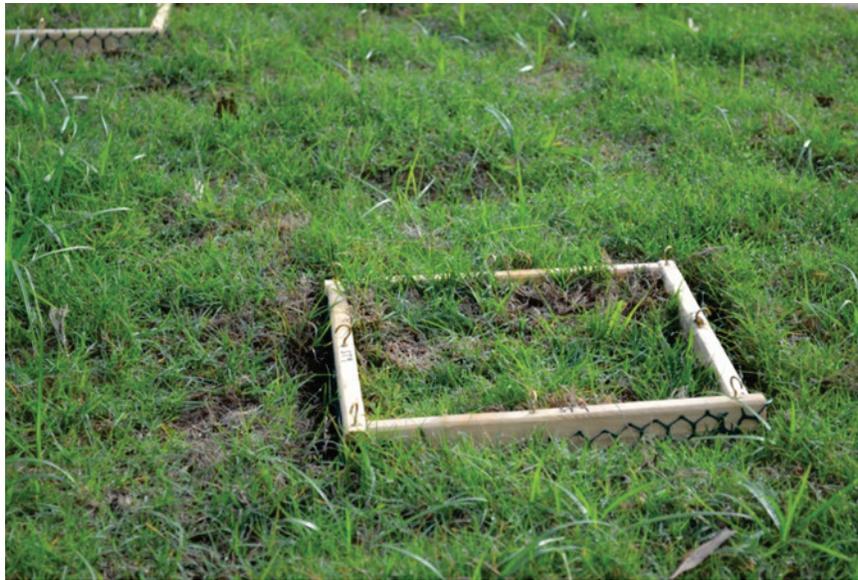
Figure 4. Pull box designed and placed in the field under sod.

A sod “pull-box” system was designed and constructed to evaluate the degree to which sod grass expanded roots and became integrated into the underlayer of soil (Figure 4). Each pull-box held one section of sod. The pull-boxes were placed under randomly selected pieces of sod in each soil plot (three sod units x four treatments). The bottom of the box was composed of stiff plastic netting to allow unimpaired root growth from the sod into the soil.

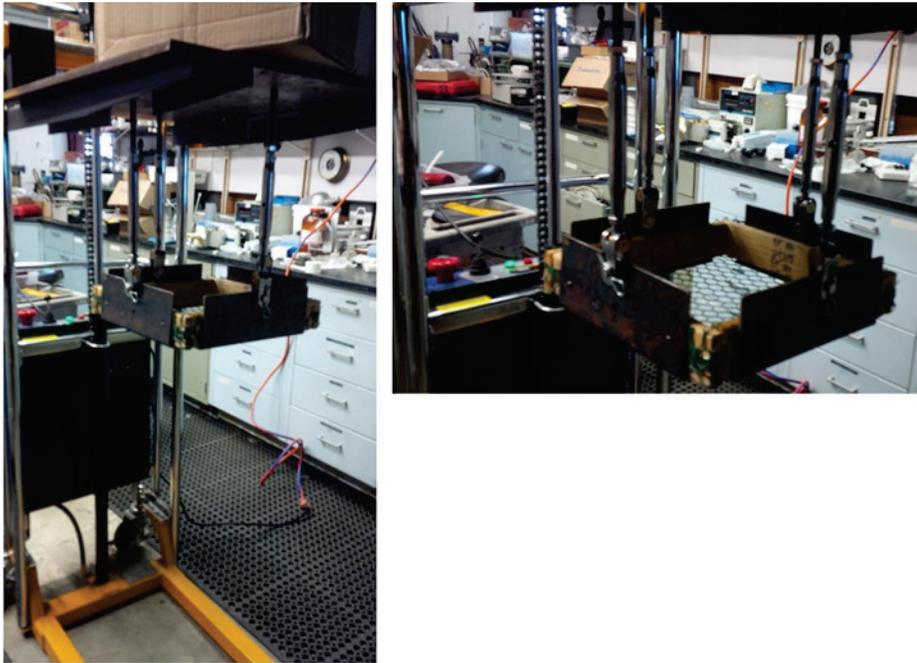
Figure 5. Field tensiometer designed and constructed to evaluate root establishment of sod in soils treated with an organic polymer. Note the flexible webbing that allowed root growth from the sod to the soil.

A “pull system” was designed with a center tensiometer to measure the pressure required for a direct lift of the sod (Figure 5). The system’s design was based on the hypothesis that as the sod roots grew into the soil, the amount of tension required to lift the sod would increase. The soil removed with the sod was used to determine the mass of root-adhered soil (RAS) using the method of Alami et al. (2000). The RAS, being an integral part of the rhizosphere, is considered a functional soil unit. The RAS contains the greatest number of rhizosphere microorganisms and the associated enzymes and root exudates (Angle et al. 1996).

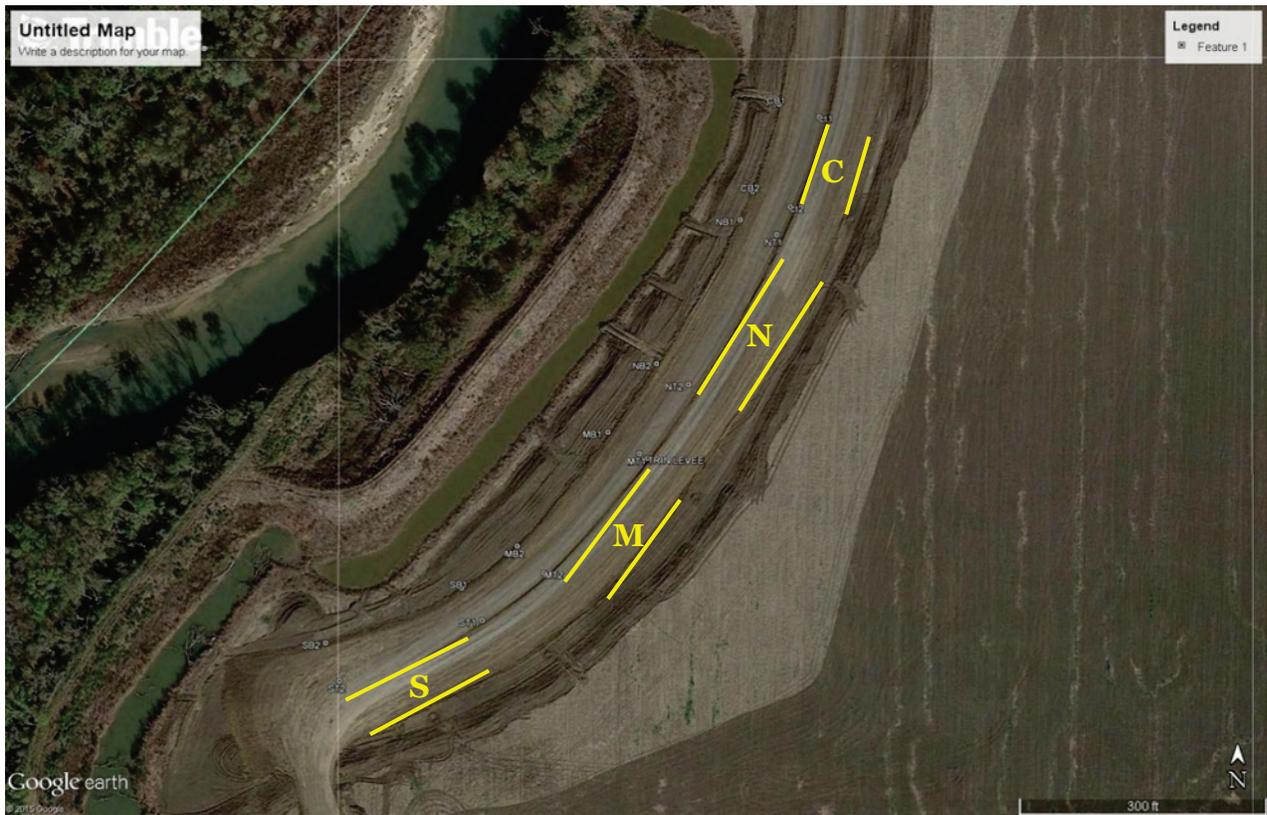
Figure 6. Satellite image of Kaufman Levee No.1 showing GPS coordinates and upper and lower boundaries of test and control areas: C=Control, N=North, M=Middle, S=South.

The setback levees, referred to as Kaufman Levee No.1, were constructed using material from the original, failed levee along with fill material purchased from Trinity Materials, Inc. The ERDC-EL worked with the contractor and USACE Fort Worth District to perform the field demonstration seeding on Kaufman Levee No.1. Three test areas and a control area (not treated with biopolymer) were selected along the levee, identified by their Global Positioning System (GPS) coordinates, and physically marked with stakes at the corners (Figure 6). Seeding was performed during the spring of 2014, using a standard hydroseeding mixture with the addition of a hydromulch (Figure 7).

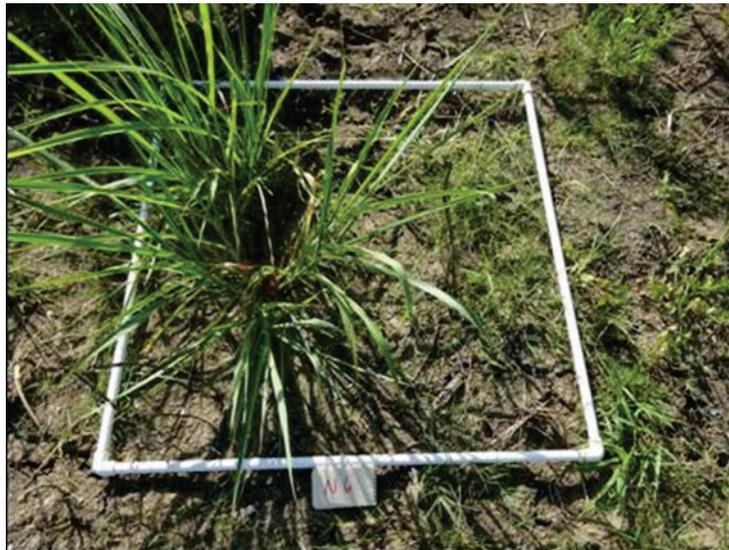
Figure 8. The sampling grid employed to establish plant density and species diversity in the treatment areas on Kaufman Levee.

Several techniques were used in order to evaluate establishment of Bermuda grass on the one-year-old levee repair. Sampling for plant density and species diversity was accomplished using a 1 m x 1 m polyvinyl chloride (PVC) grid (Figure 8). Six points were selected randomly from within each section for grid sampling. Visual identification of species and estimates of species coverage were made by walking the area immediately above the water line.

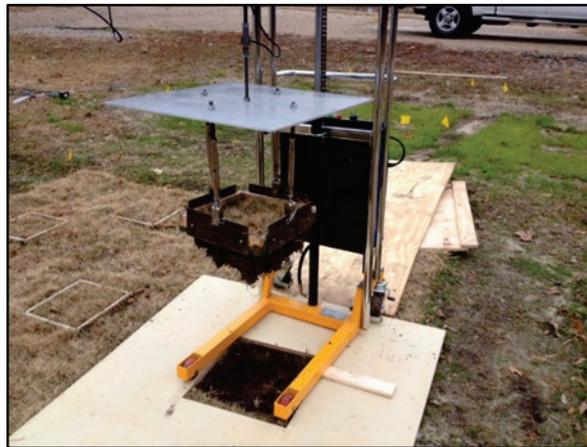
Figure 9. Sod pull-box system with tensiometer in use in the pilot demonstration.

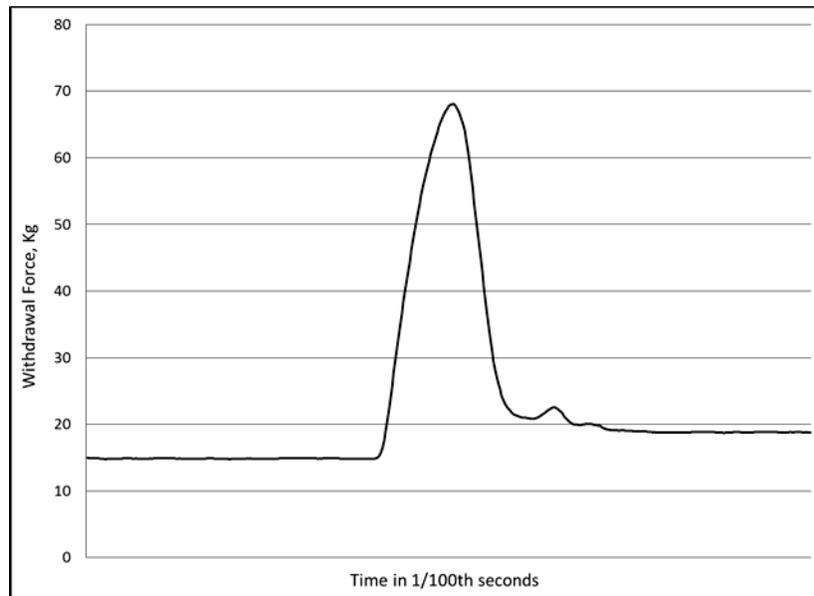
Figure 10. Example of tensiometer data from sod “pulls,” measured as withdrawal force vs. time.

An example of tensiometer data obtained from the soil pulls is shown in Figure 10. The data are reported as the average withdrawal force in kg. Three replicates were pulled from each experimental plot of the two soil types. The withdrawal force was exerted on the soil square over a short time (approximately $\frac{1}{4}$ of a second), and maximum withdrawal forces ranged from 60 to 120 kg. In the example below, the large, initial pull force can be seen as the large peak. Two, much smaller “bounces” can be observed, represented by small peaks visible following the main peak.

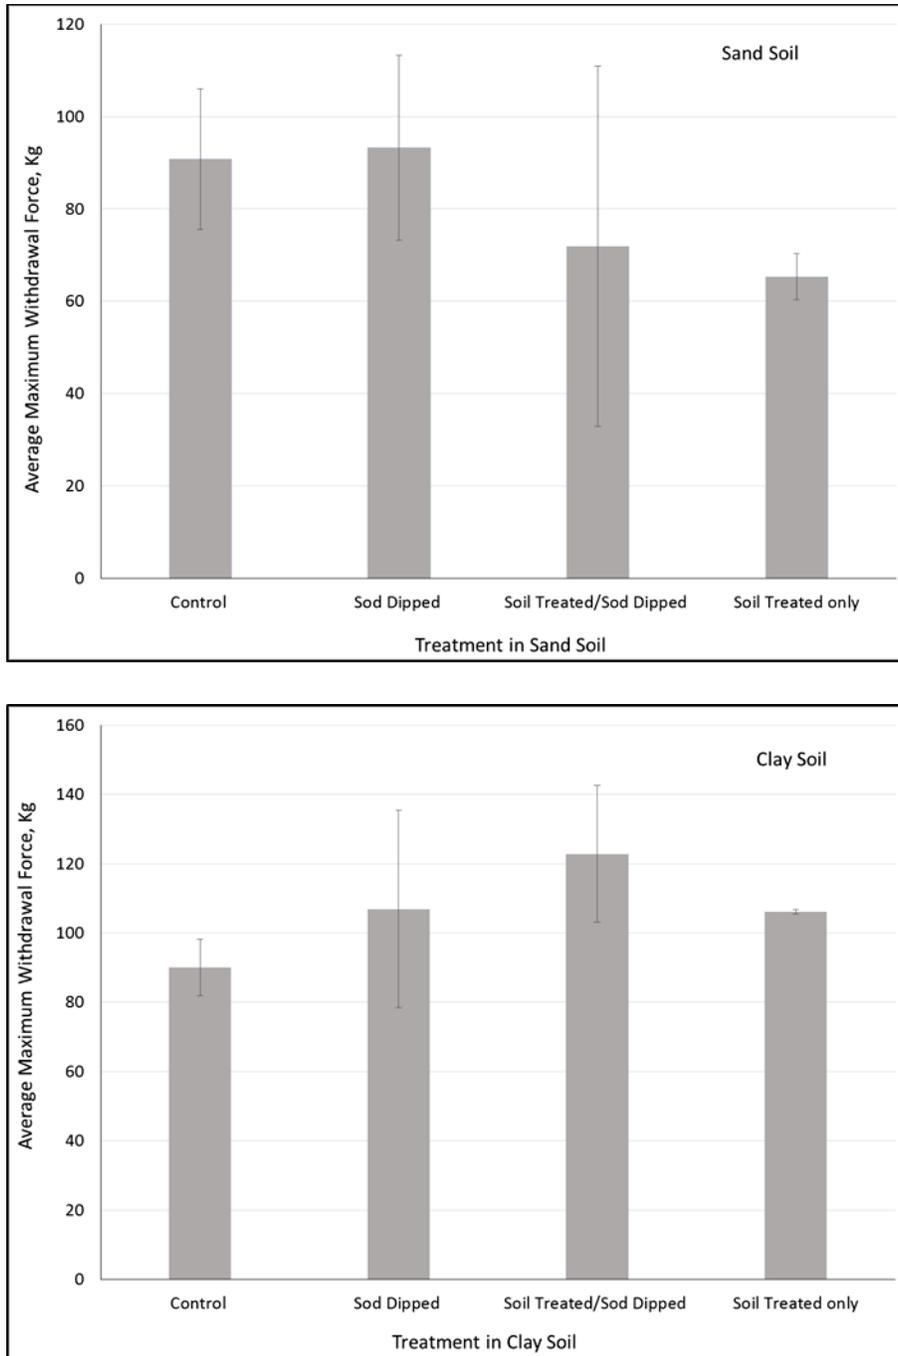
Figure 11. Average maximum withdrawal force (kg) required to remove sod section from the surrounding soil in control and biopolymer-treated experimental plots after 10 weeks. Top. Sand-soil type. Bottom. Clay-soil type.

As can be seen in Figure 11, the large error bars extending beyond the average maximum withdrawal force in both the sand and the clay overlap sufficiently that no clear trend is noted. This high degree of variability is most likely a result of uncontrolled environmental factors, such as

localized soil moisture content, inability to achieve perfect levelling of the device, or a less-than-vertical orientation of the pull box.

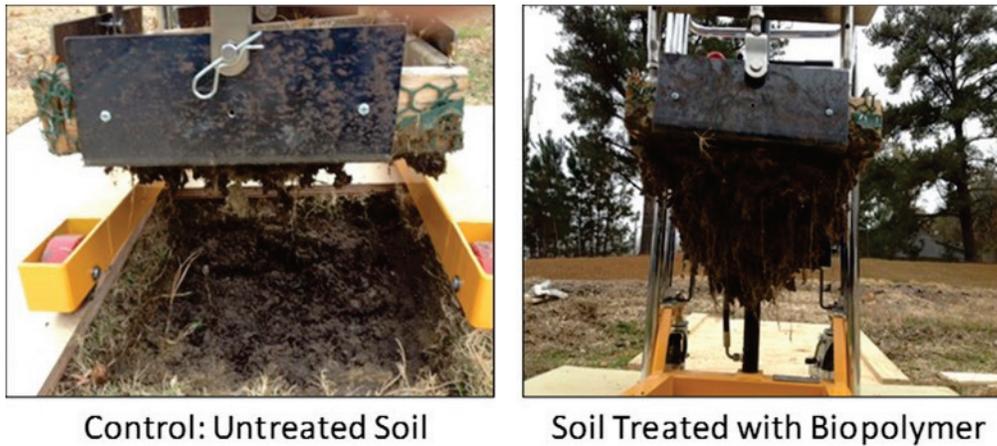
Figure 12. Comparison of root development in overwintered Bermuda grass sod when left untreated (Control – left) or treated with biopolymer (right).

While the withdrawal force results were not beneficial with regards to understanding the integration of sod roots into the soil, the measurement of the mass of soil retained when the pull boxes were removed was beneficial. Differences in the mass of soil adhering to the roots following removal was noted during the pulls. Figure 12 is a photographic comparison of the difference in root mass between the untreated sod and a section of sod grown with biopolymer treatment in the Sand plots.

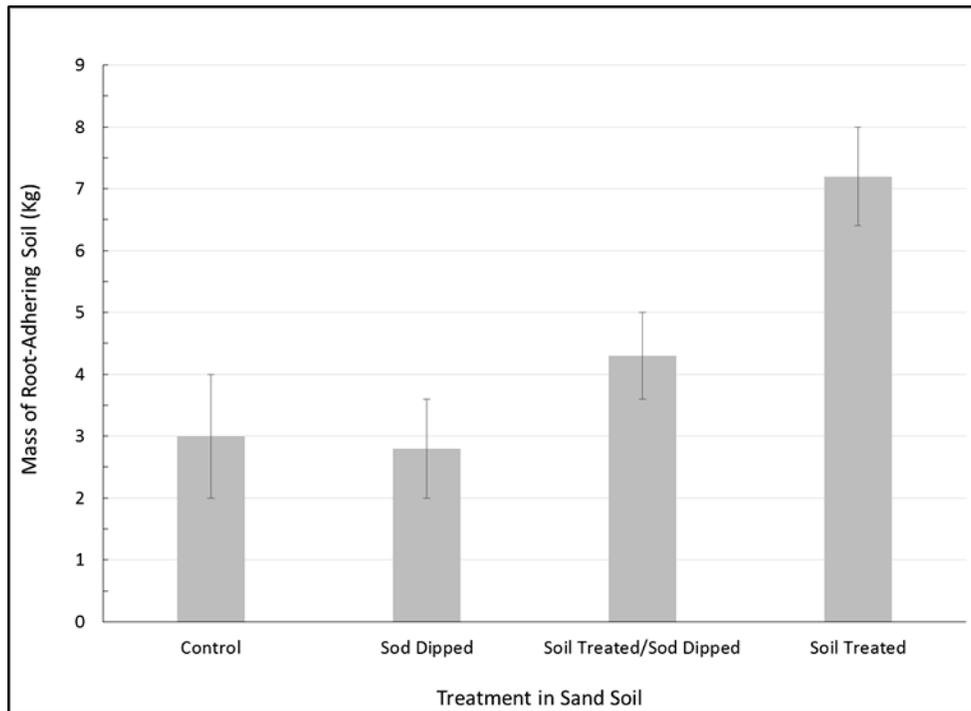
Figure 13. Root-adhering soil mass (kg) of sod pulls by experimental treatment in Sand soil.

Masses were obtained for the RAS from the Sand-soil experimental treatments. These are shown in Figure 13. The averages and standard deviations of the RAS results indicate a clear trend with regard to the effect of biopolymer soil amendment on production of a biogeotextile. RAS determination proved to be a more accurate determinant of root/soil integration than the tensiometer.

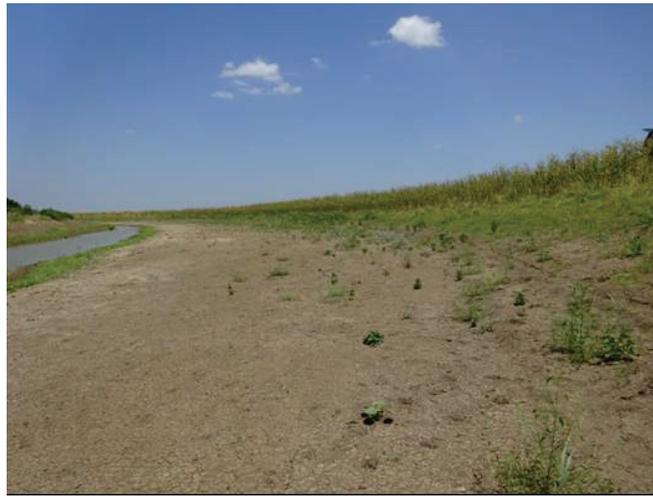
Figure 15. Effect of flooding on vegetation growth on the lower Kaufman Levee.

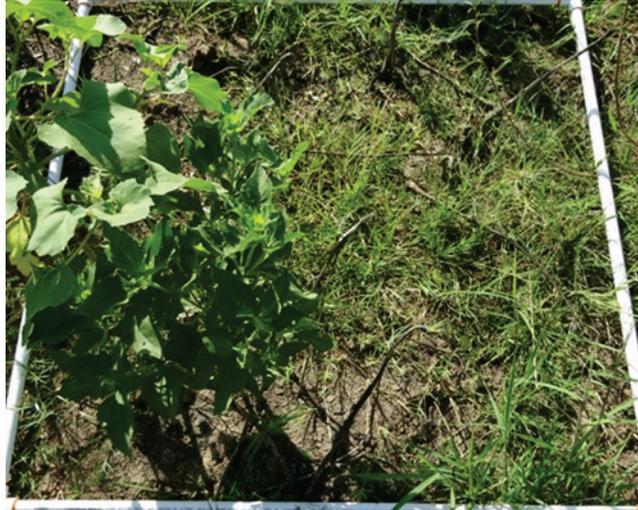
Figure 16. Digital image of one m² sampling plot from Kaufman levee.

The Easy Leaf Area image analysis software uses pixel color and connectivity analysis to evaluate vegetation and calculate species diversity and plant density. As an example, Figure 16 is a digital photograph of one of the m² sampling plots. The edges of the white plastic square are just visible. Figure 17 illustrates the vegetation in the same plot as Figure 16 separated from the background by the Easy Leaf Area image analysis. The Leaf Area filter then identifies Bermuda grass leaves in black and shows the unwanted plants in green, providing coverage areas for both selections.

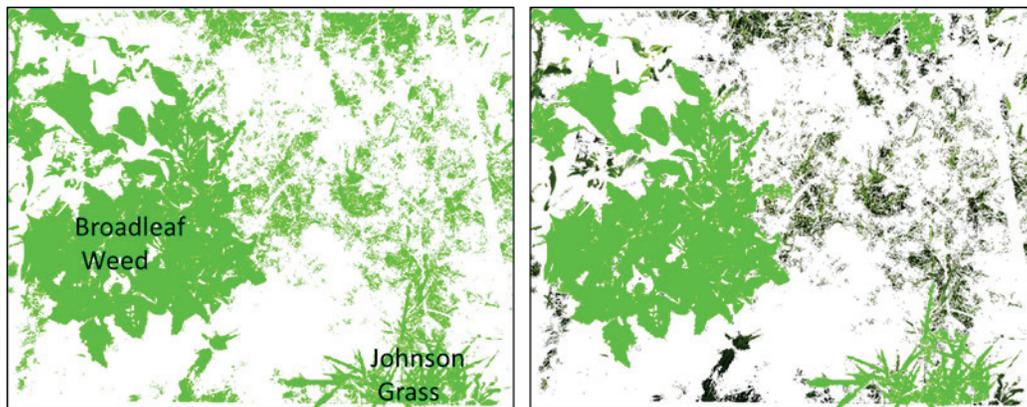
Figure 17. Easy Leaf Area digital image of the sample plot shown in Figure 16, with filters applied, allowing separation of plants from background and selection of specific plants. Black in the image on the right indicates Bermuda grass.

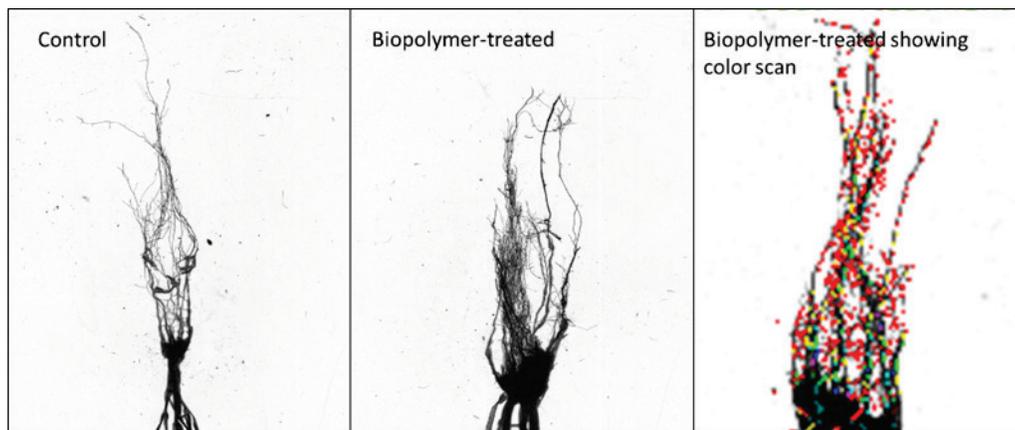
Figure 19. Example of root scans performed by WinRHIZO™ image analysis software: in this case, scans of roots grown with and without biopolymer addition to the soil.

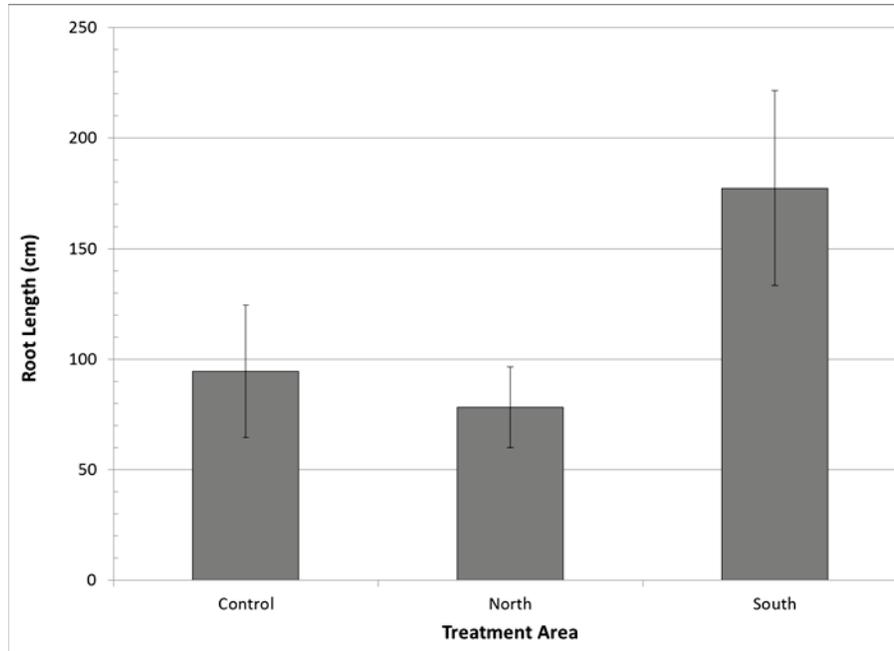
Figure 20. Comparison of average root length between plants grown with no biopolymer to those grown in biopolymer-treated soil (North and South Treatment Areas).

Image analysis, performed as it is with clean roots in water, often underestimates root length due to damage during cleaning and root overlap in the image area (Judd et al. 2015). However, the average total root length (Figure 20) observed in plants grown in the field

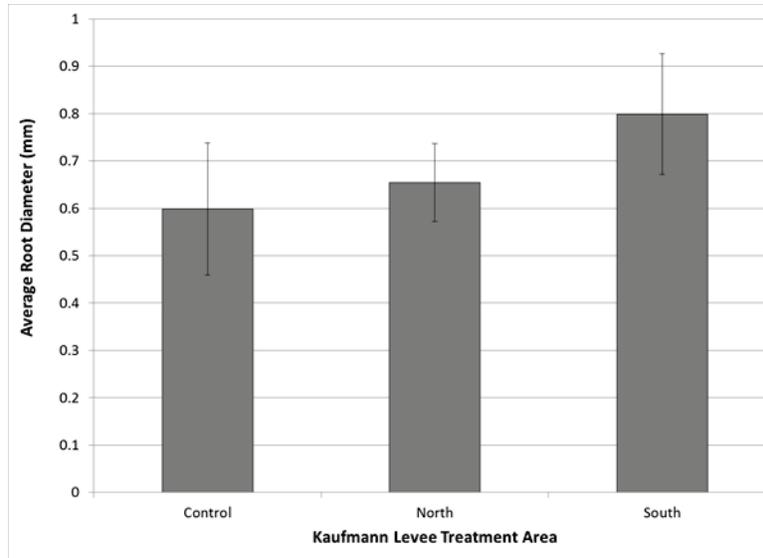
Figure 21. Comparison of average root diameter between plants grown with no biopolymer to those grown in biopolymer-treated soil (North and South Treatment Areas).

Root diameter can be used to assess what the root and the plant experience in the surrounding environment (Judd et al. 2015). Root diameter affects the length of the root that the plant can produce for resource input to the whole plant system (Fitter 1996). Root diameter also seems to be a good predictor of the effect of mechanical impedance and soil/substrate pore size (Goss 1997, Gregory 2006). Root diameter of plants analyzed from the field demonstration site (Figure 21) show a trend of increased diameter with biopolymer concentration. This may be a preliminary indication of the presence of additional nutrient bioavailability or the decrease in mechanical impedance for roots grown in biopolymer-treated soils.

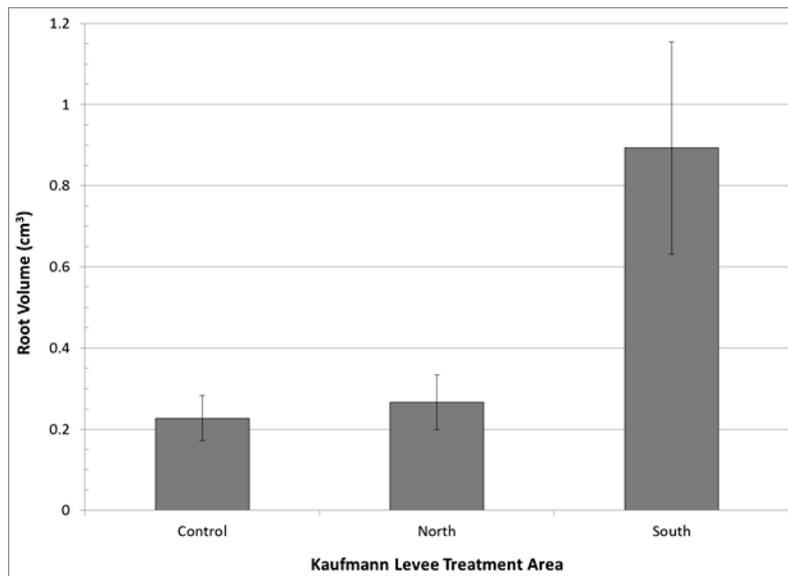
Figure 22. Comparison of root volume (cm³) between plants grown with no biopolymer to those grown in biopolymer-treated soil (North and South Treatment Areas).

The positive effect of biopolymer soil amendment is clear in the significantly greater value for root volume occurring with the highest level of biopolymer amendment (Figure 22). Volume, being dependent on the radius of the roots examined and their length, is a secondary index of growth and development. It demonstrates the combined effect of greater diameter and greater root length that was not as apparent with the other measurements.

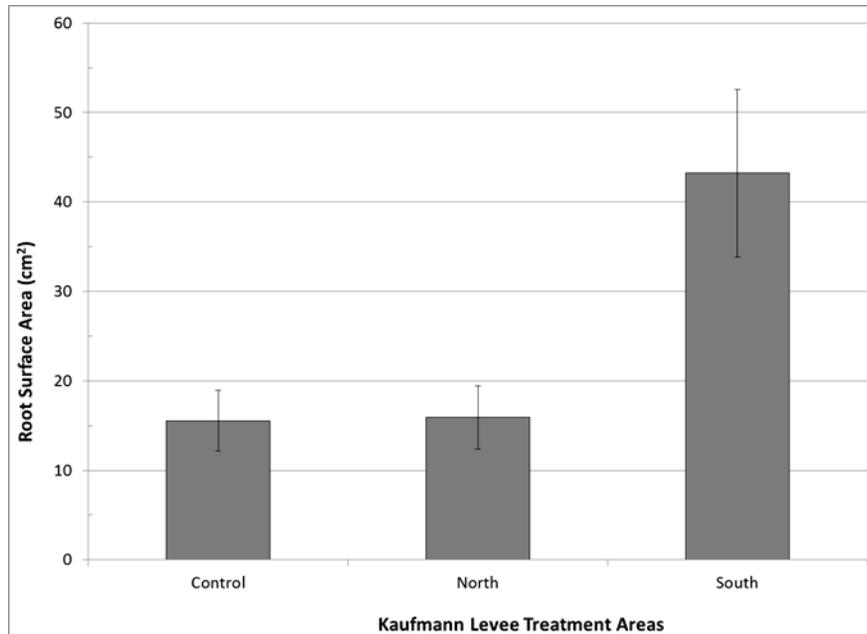
Figure 23. Comparison of root surface area (cm²) between plants grown with no biopolymer to those grown in biopolymer-treated soil (North and South Treatment Areas).

Root surface area includes the fine root hairs (Figure 23). At the highest level of biopolymer soil amendment, the observed plants demonstrated the highest root surface area.

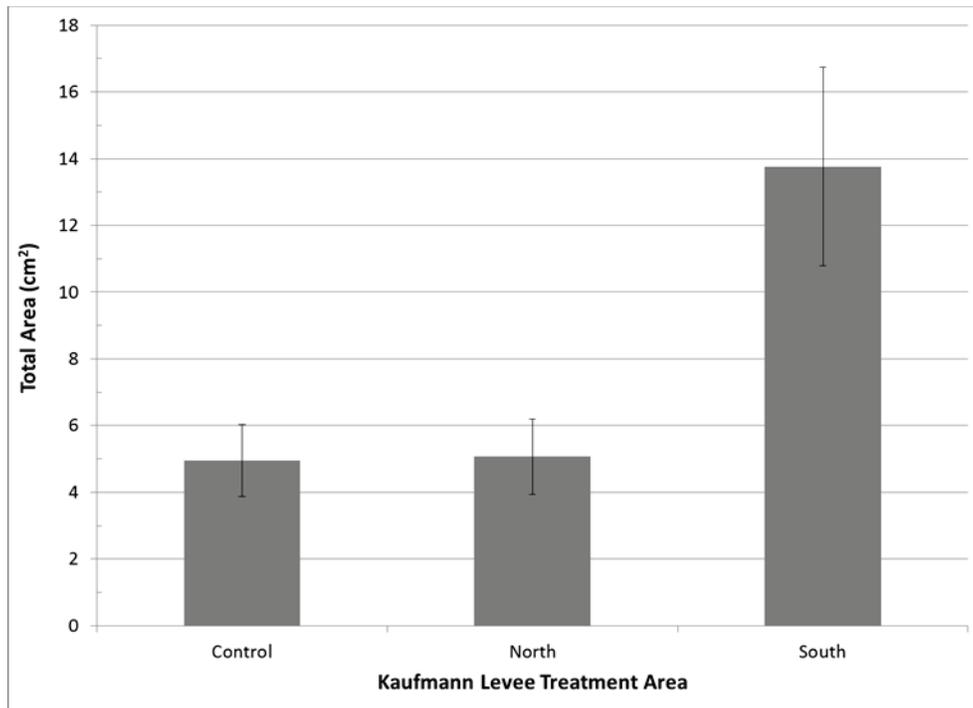
Figure 24. Comparison of total root area (cm²) between plants grown with no biopolymer to those grown in biopolymer-treated soil (North and South Treatment Areas).

Root area, on the other hand (Figure 24), does not include the fine root hairs, and is considered an environmental morphological index reflective of soil conditions, not plant growth (Lõhmus et al. 1989). Small, flexible roots increase the soil-fiber strength (Gray and Leiser 1982). Larger roots that intersect the shear plane of the slope act as individual anchors (Coppin and Richards 2007). Root area, therefore, has a direct influence on soil slope stability, which can be quantified as the root area ratio (RAR) (Bischetti et al. 2005). The RAR is the ratio between the area occupied by the roots in a unit area of soil, which will vary by depth. Although the unit area of soil was not calculated for plants observed during the field demonstration, the greater total root area, observed in plants grown with the highest level of biopolymer amendment, would seem to indicate a higher RAR and therefore a higher tensile strength of the soil. The higher tensile strength would contribute to decreased soil erodibility and an increase in soil stability.
