Environmental Security Technology Certification Program (ESTCP)

Systems Approach to Improved Facility Energy Performance

February 2019

Final Report

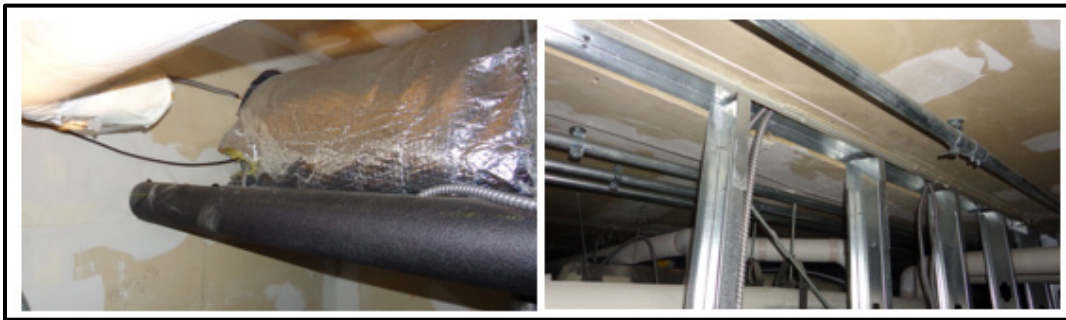
Figure 3-1. Leakage sources at pipe penetrations and at framing systems.

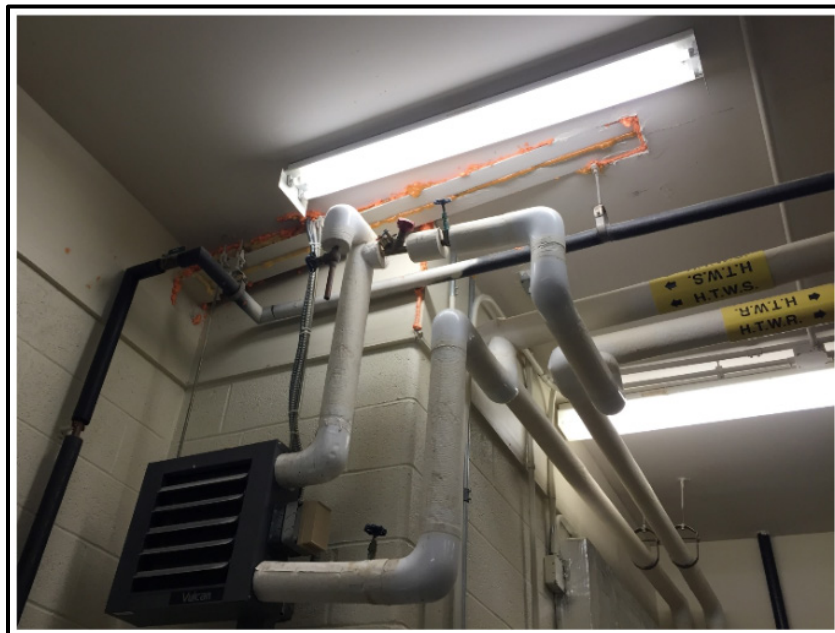
Figure 3-2. Leaks sealed at pipe hangers in “heated-only” portion of Bldg 1540A.

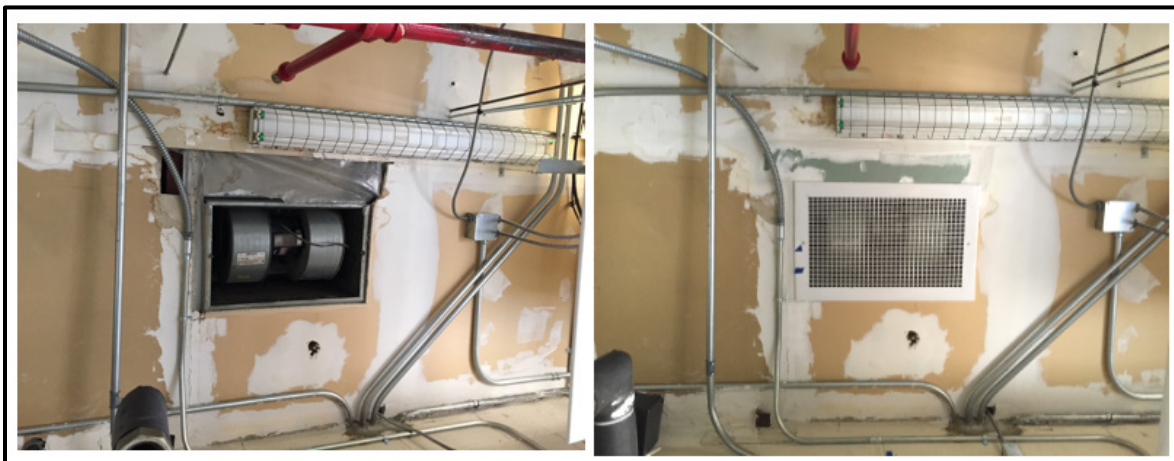
Figure 3-4. Sealing of leaks around an exhaust fan in the mechanical room.

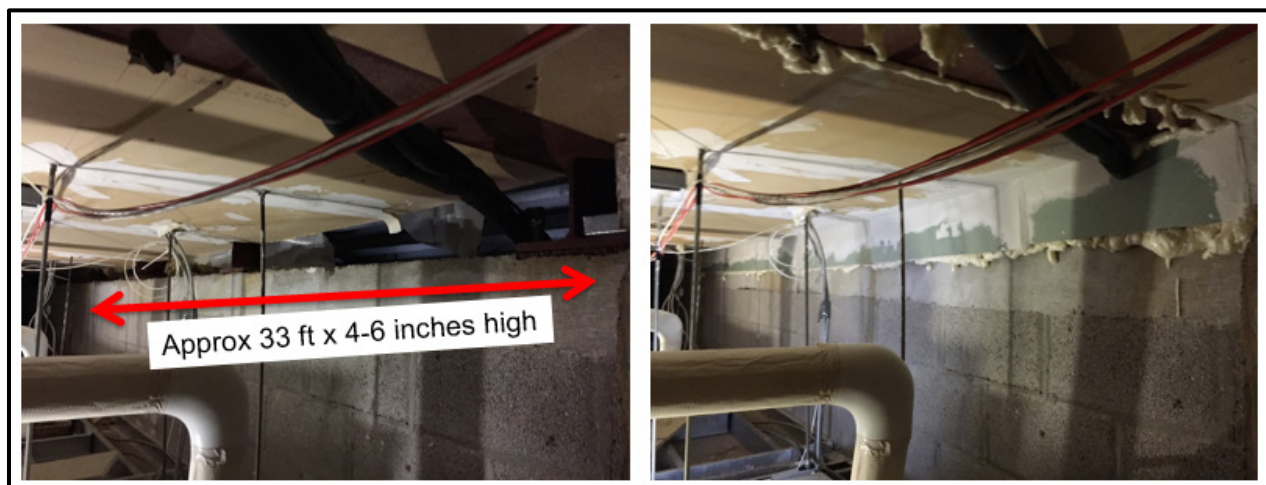
Figure 3-5. Sealing of a major opening above the hard ceiling above the men's latrine.

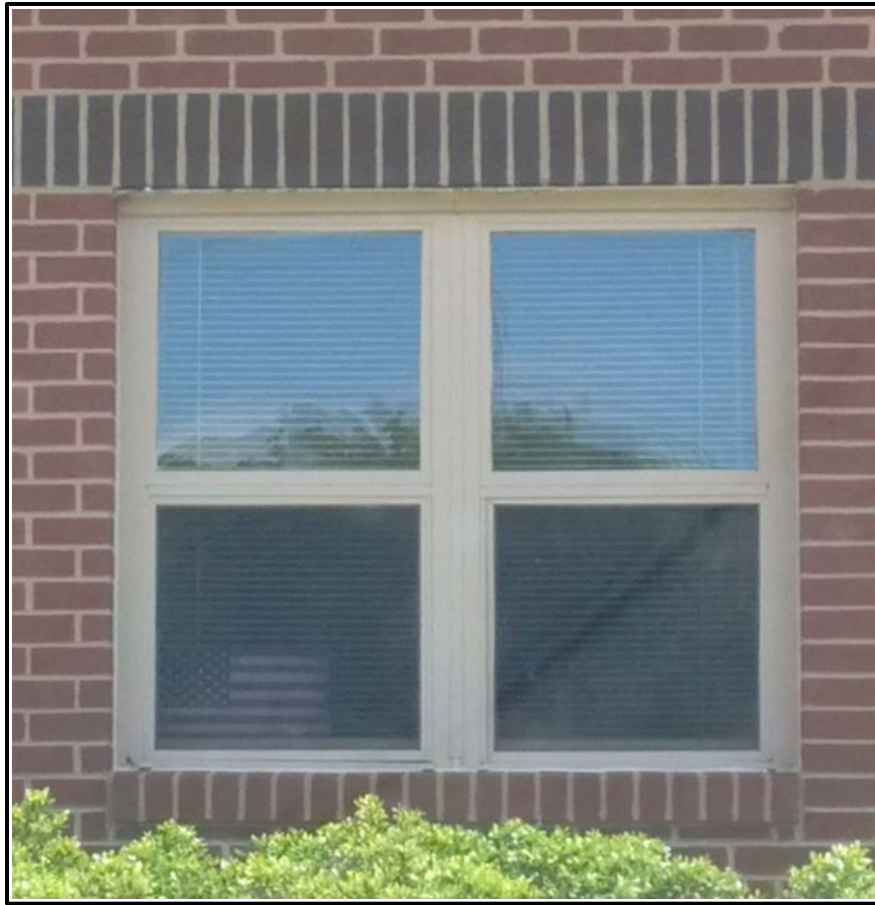
Figure 3-6. Single hung window (4x4-ft) in Bldg 1540A (typical of 10).

Current best practice is to tape the gap between the interior side of the window frame and the interior air barrier with a high quality, long lasting sealing tape. On the exterior side, windows should be sealed per the manufacturer's instructions. In order to seal these windows in accordance with current best practice would have involved major disruptive repair work on the interior and possibly the exterior sides of the windows.

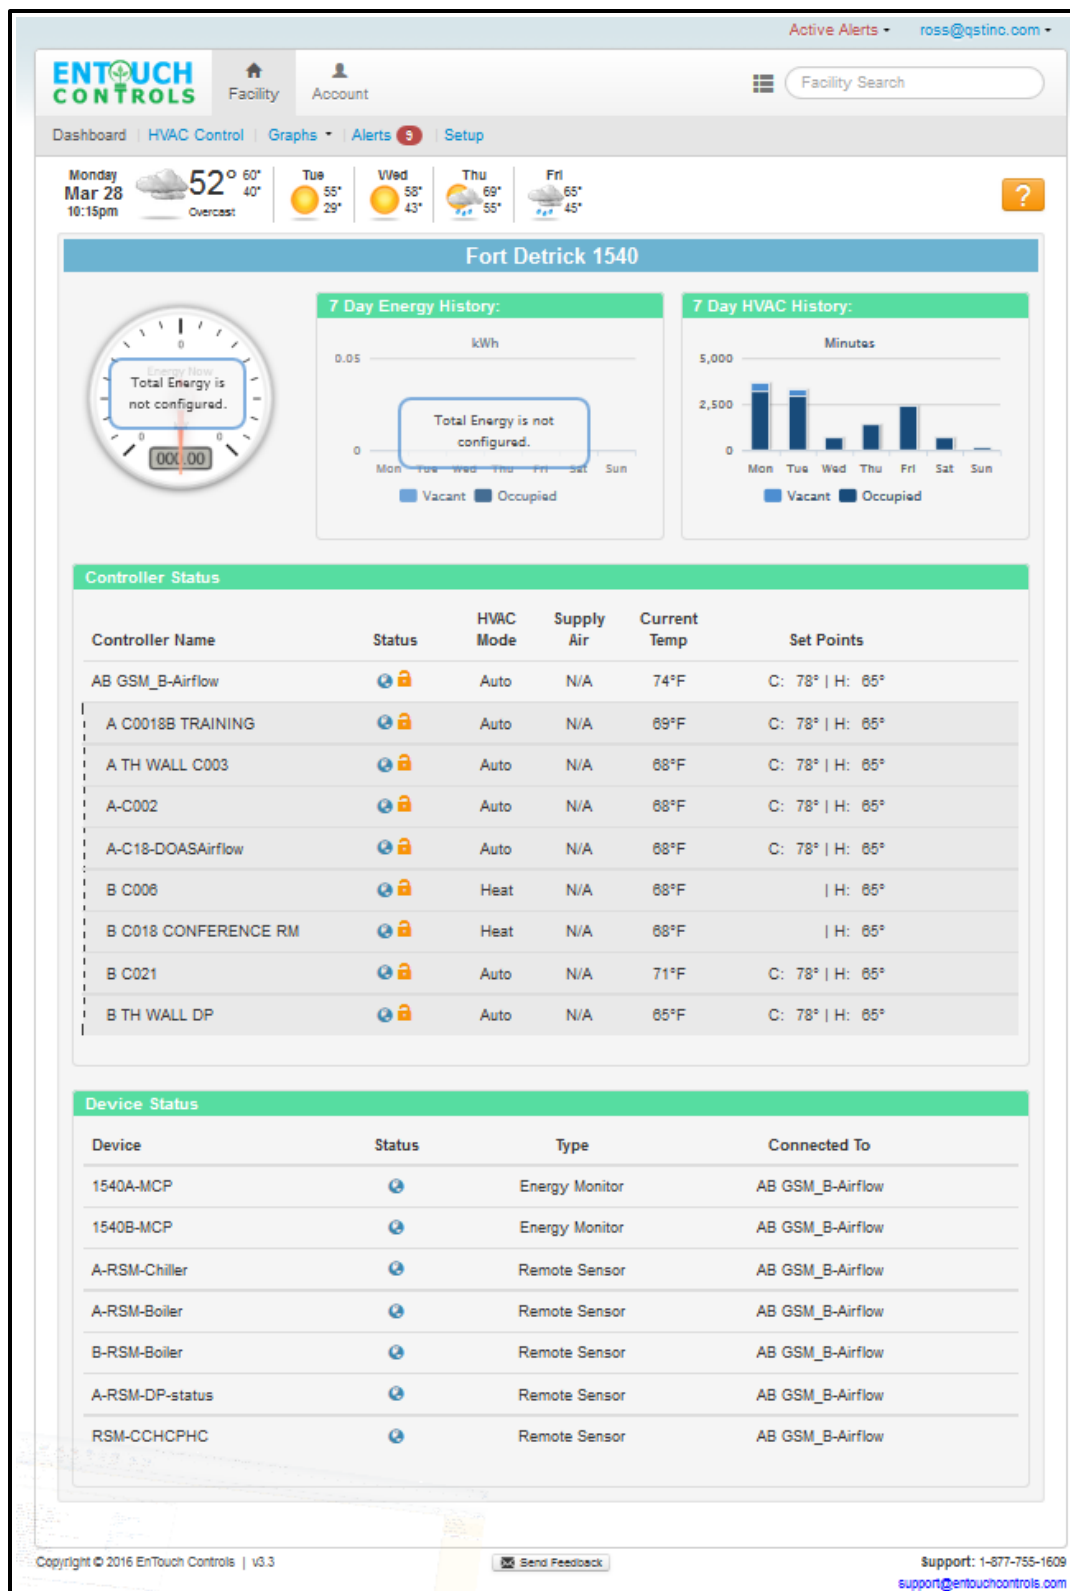
Figure 4-4. Screen capture of the online EnTouch energy management system platform for Bldg 1540.

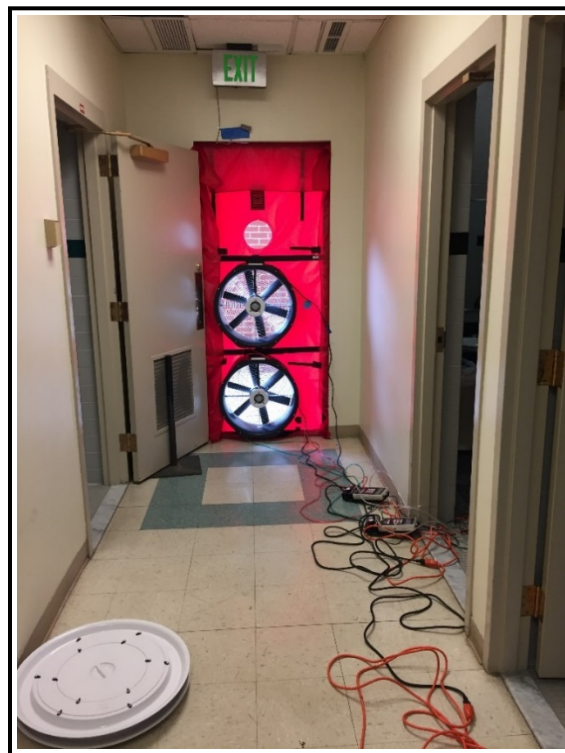
Figure 5-1. Air barrier testing apparatus.

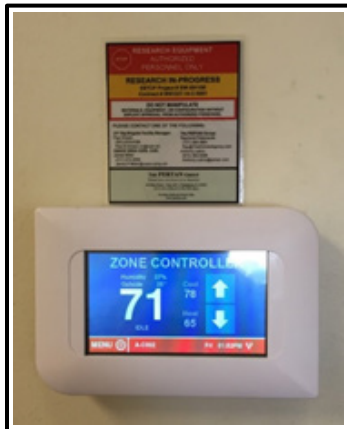
Figure 5-2. Typical EnTouch EMS zone thermostat and temperature/humidity logger.

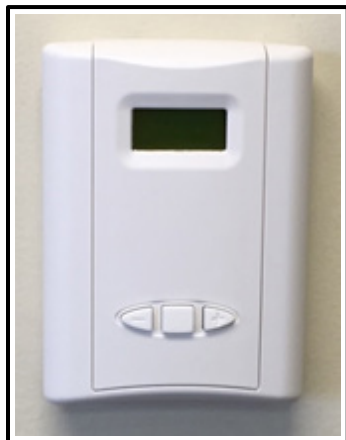
Figure 5-4. Typical room thermostat and RH sensor.

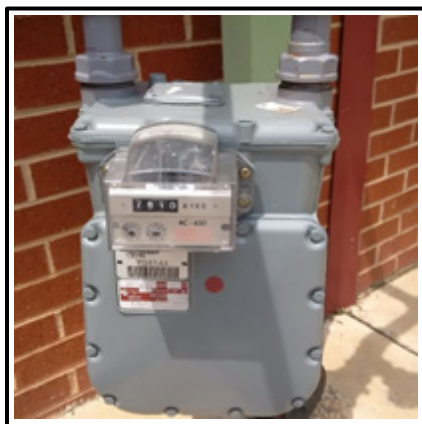
Figure 5-6. Existing utility gas meter for Bldg 1540B.

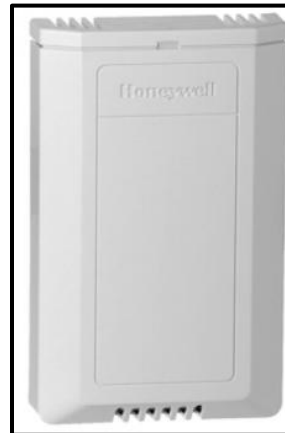
Figure 5-3. Typical temperature and RH dataloggers.

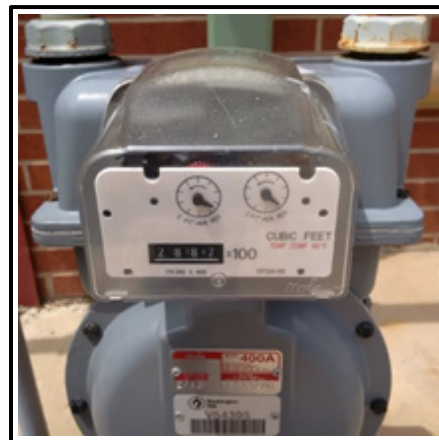
Figure 5-5. Existing utility gas meter for Bldg 1540A.

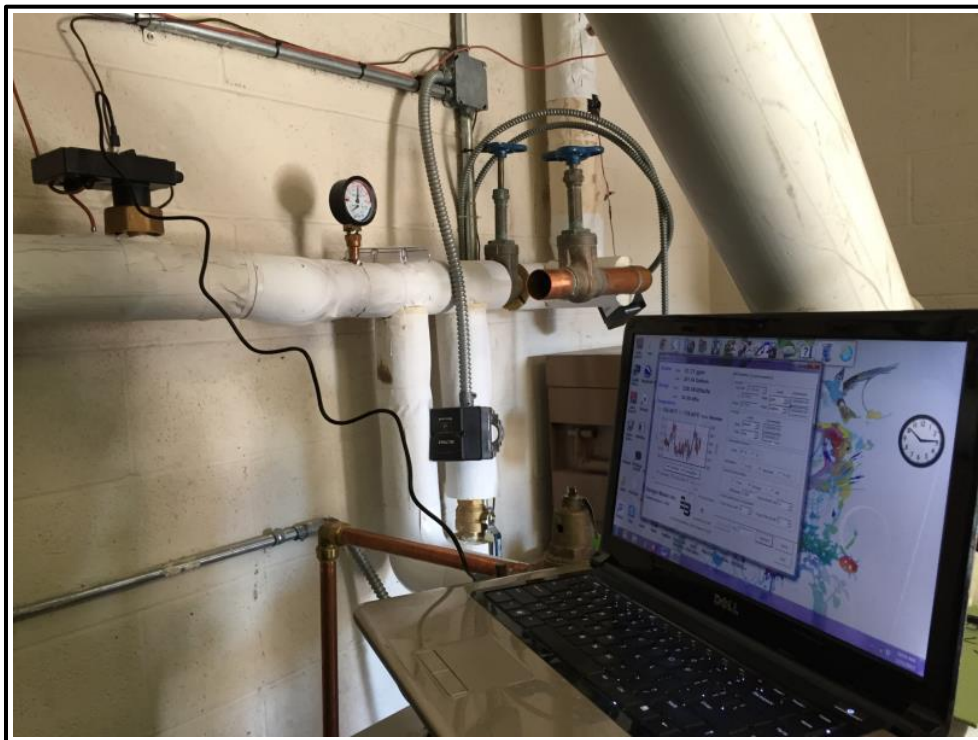
Figure 5-14. Boiler BTU meter connected to programming software.

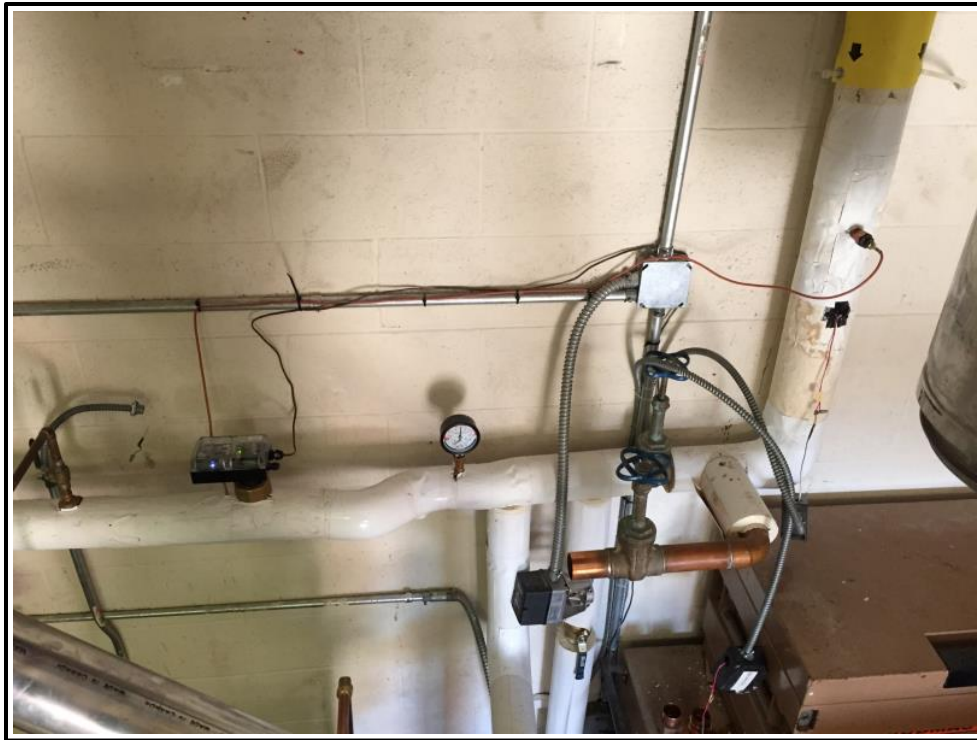
Figure 5-15. Boiler BTU meter as installed.

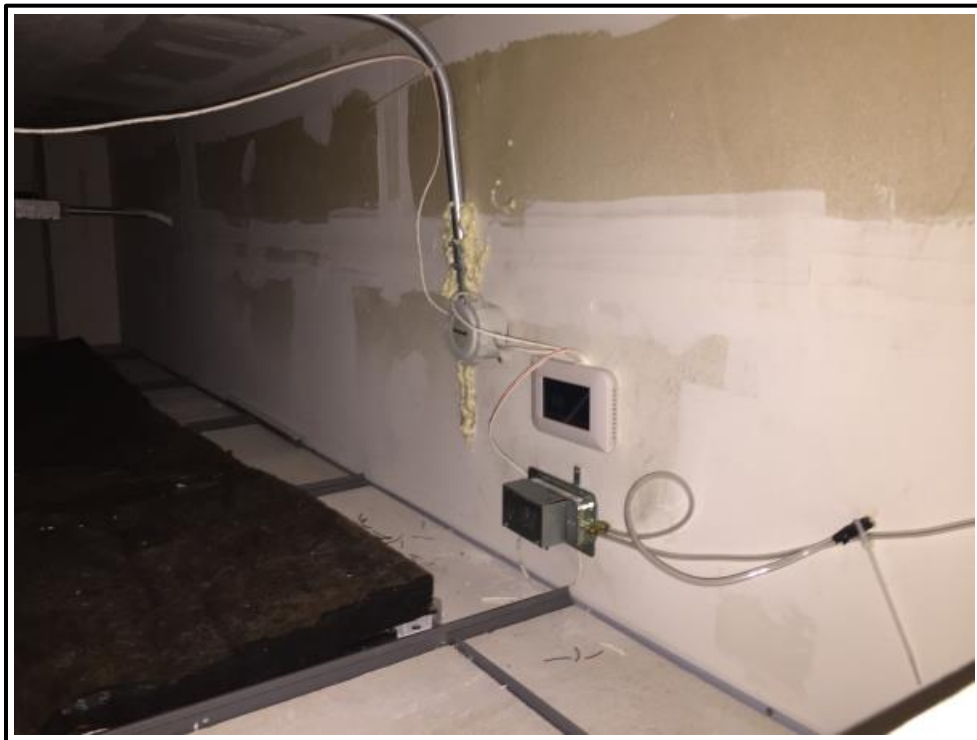
Figure 5-16. Building envelope DP sensor and wall temperature/RH sensors installed above office C003.

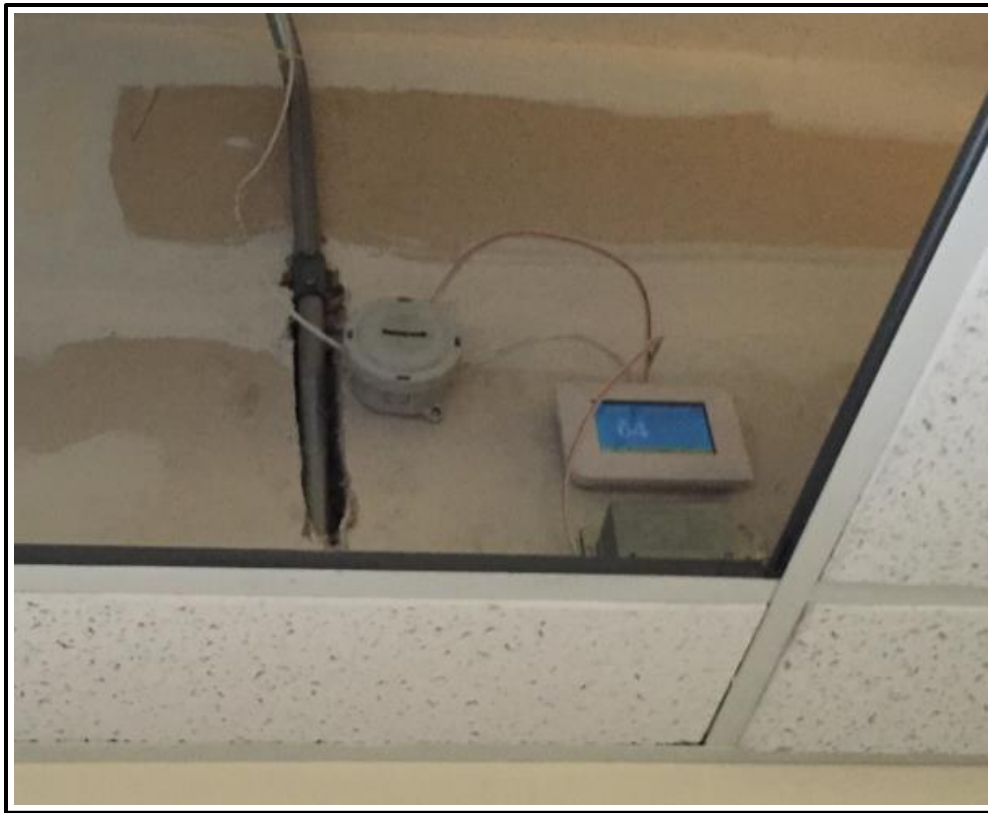
Figure 5-17. Building envelope DP sensor (high side inside room, low side outside building) and wall temperature/RH sensor installed above office C003.

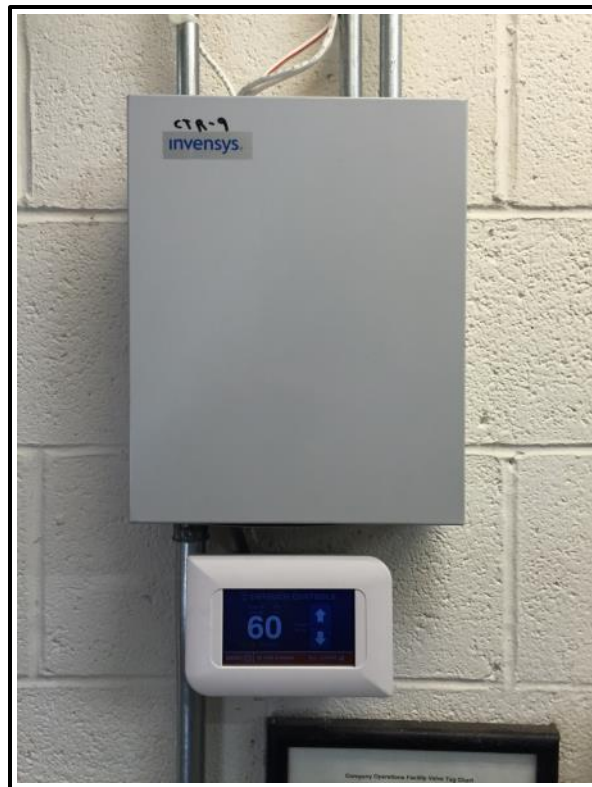
Figure 5-18. EMS master monitoring device with Global System for Mobile Communications (GSM) communication device.

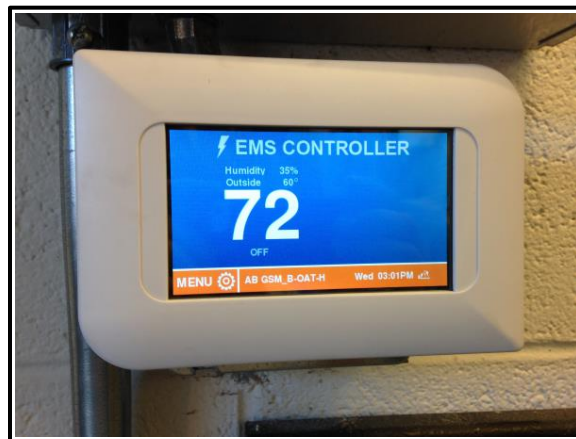
Figure 5-19. EMS Controller.

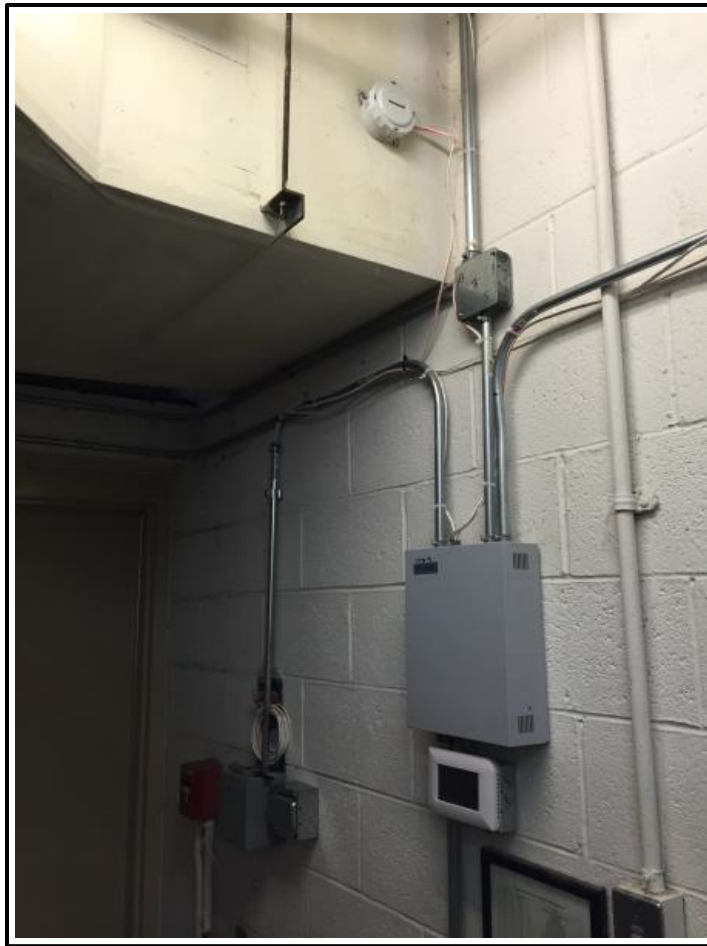
Figure 5-20. EMS installation within the Bldg 1540B mechanical room, showing EMS controller and outside air (OA) temperature sensor.

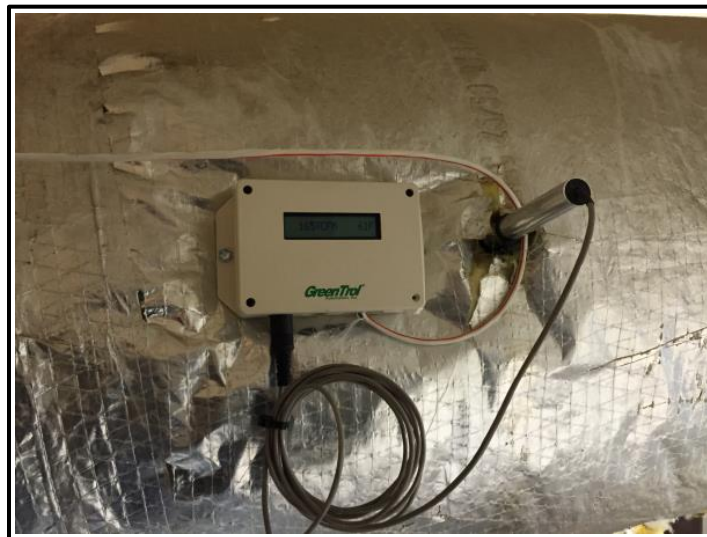
Figure 5-21. Air flow sensor located in AHU-4 supply air.

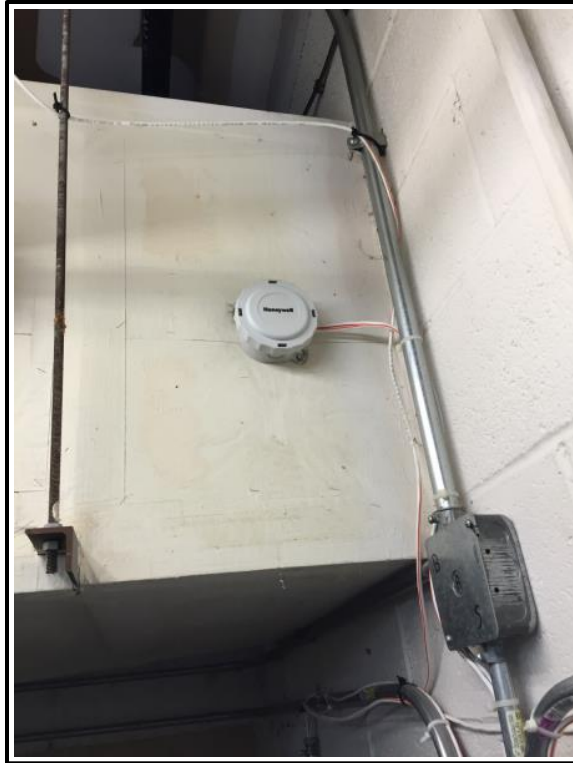
Figure 5-22. Outside air temperature sensor.

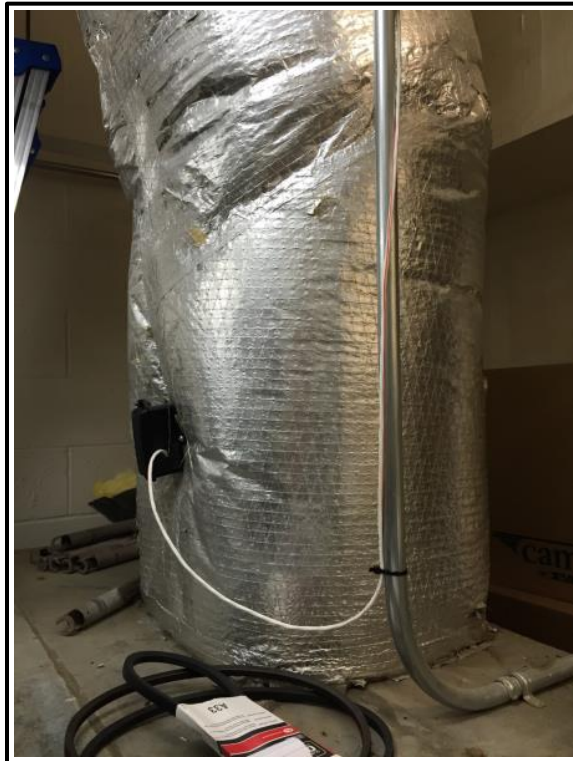
Figure 5-23. Supply air temperature AHU-4 duct sensor.

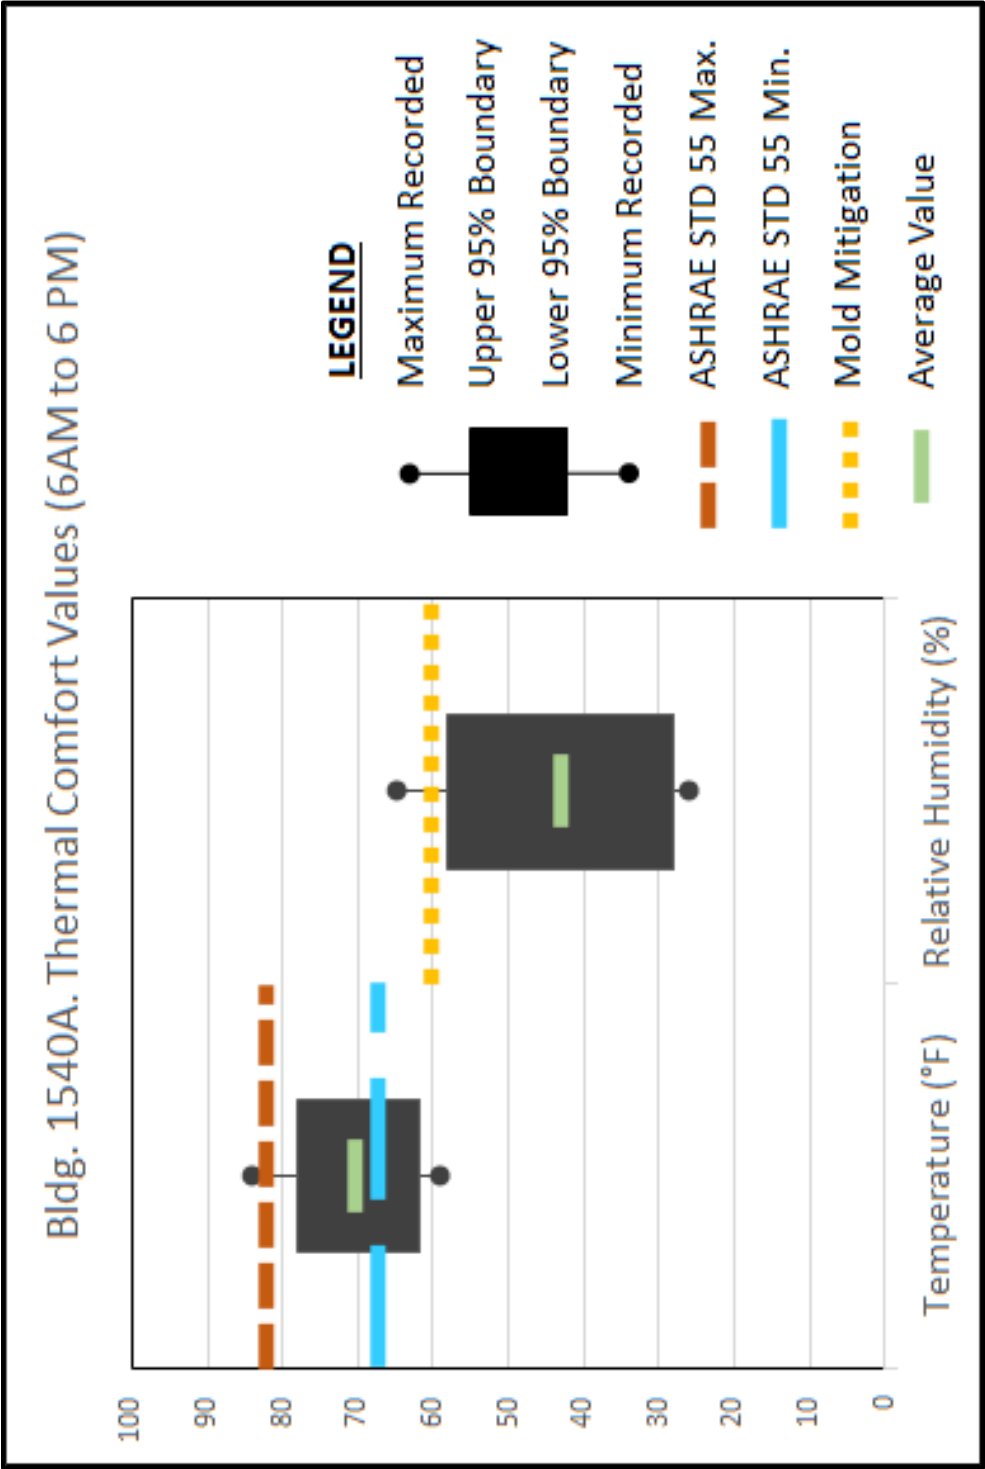
Figure 6-3. Thermal comfort values for Bldg 1540 during occupied hours (6 a.m. to 6 p.m.).

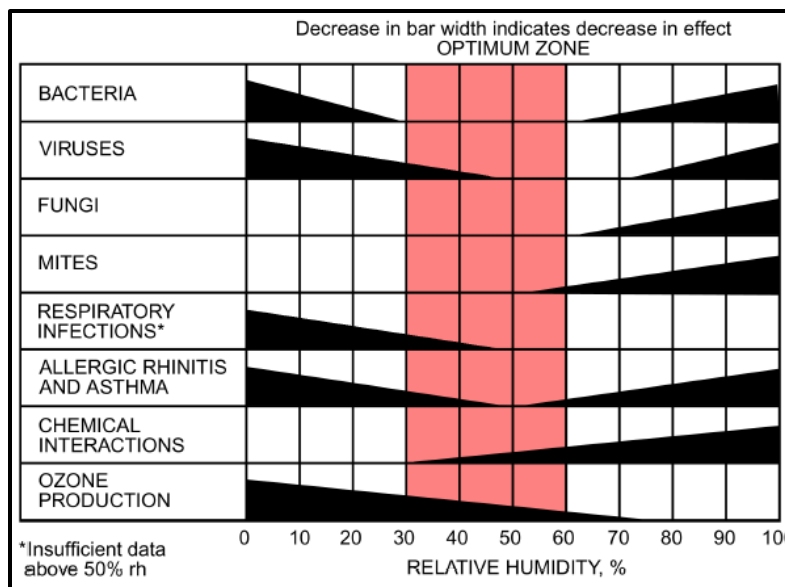
Figure 6-5. The optimum humidity range for human comfort and health (30 to 60%), as published in the 2012 *ASHRAE Handbook on HVAC Systems and Equipment*.
