## **Determination of NRHP Eligibility for 26 Buildings at Fort McCoy, Wisconsin**

Adam D. Smith and Sunny E. Adams

December 2018

Under Project 474178, "NRHP Integrity Analysis – Fort McCoy"

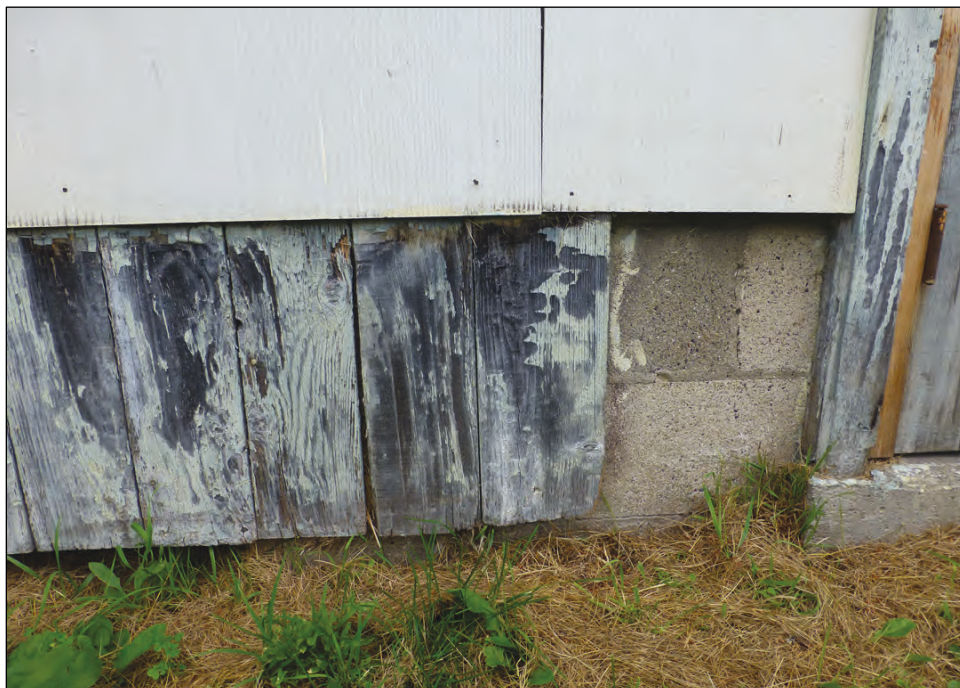
**Foundation skirting – wood (Figure 18).**

Figure 18. Wood foundation skirting on Building 849 (ERDC-CERL, 2018).

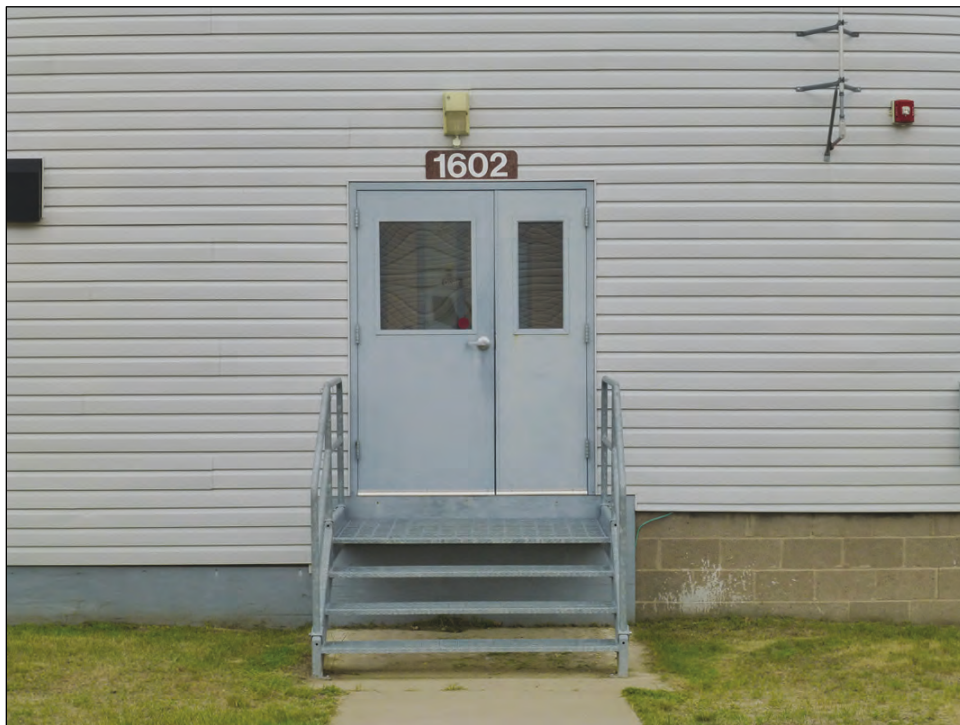
Figure 62. Main barracks entrance with metal door and metal steps on Building 1602 (ERDC-CERL, 2018).

The exterior of the barracks (Figure 54–Figure 64) have no original character-defining features from the period of significance except their overall mass. Two of the four doors on the opposite side from each building's entrance were removed, and the wood platform and ladders were replaced with a steel staircase and platform (Figure 69–Figure 82).

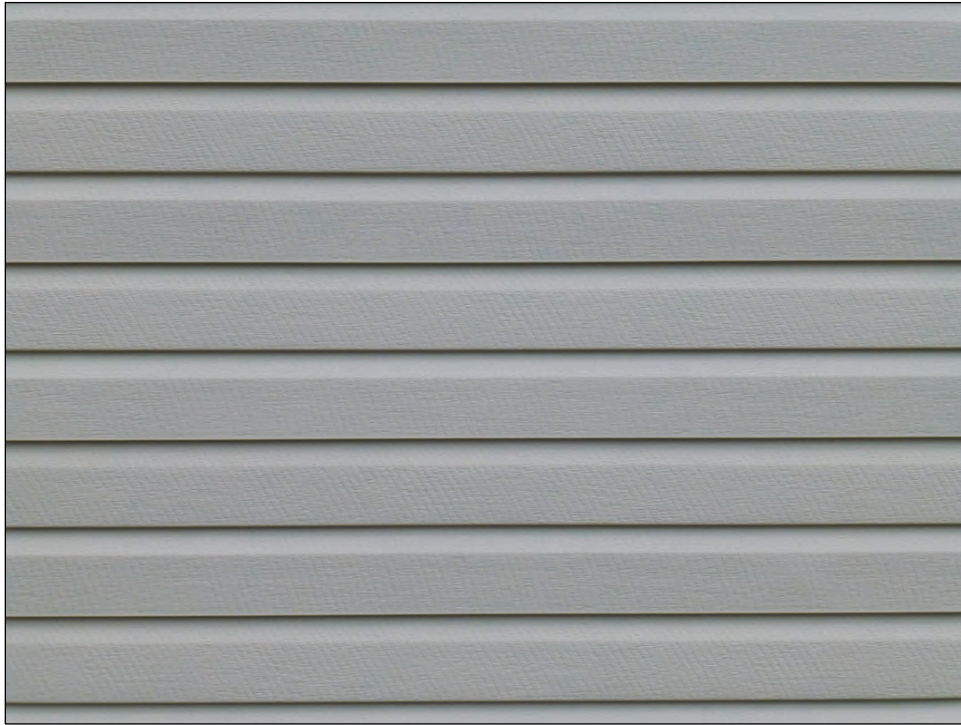
Figure 63. Replacement siding on Building 1602 (ERDC-CERL, 2018).

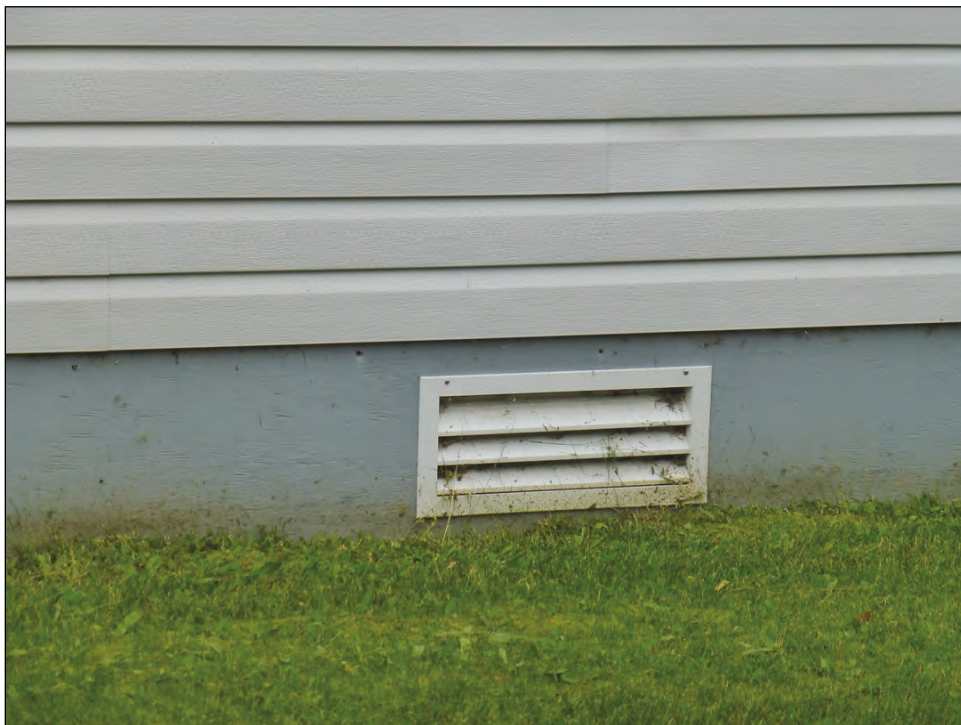
Figure 64. Replacement siding, foundation covering, and vent on Building 1602 (ERDC-CERL, 2018).

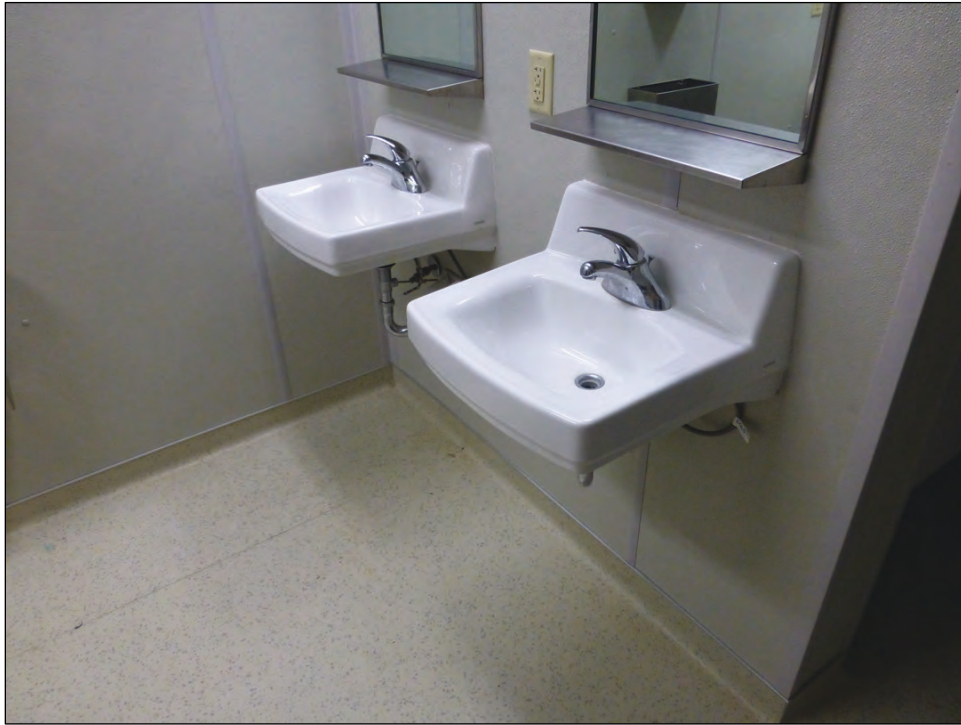
Figure 67. Renovated latrine in Building 1602 (ERDC-CERL, 2018).

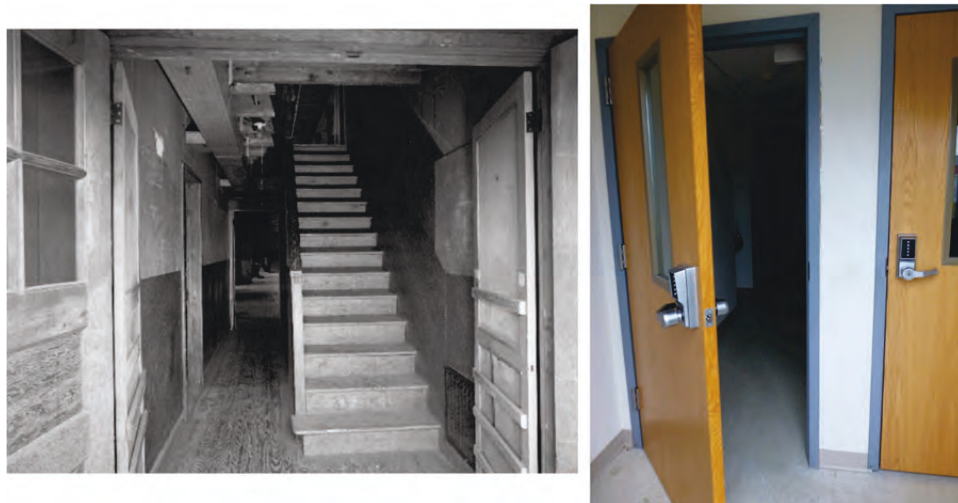
Figure 134. Interior view of the original open-bay entry vestibule with wood screen doors leading to the first floor and to the staircase (left) compared to the modified entry vestibule with partition wall and replacement interior wood door (right) (left: Library of Congress, HABS; right: ERDC-CERL).

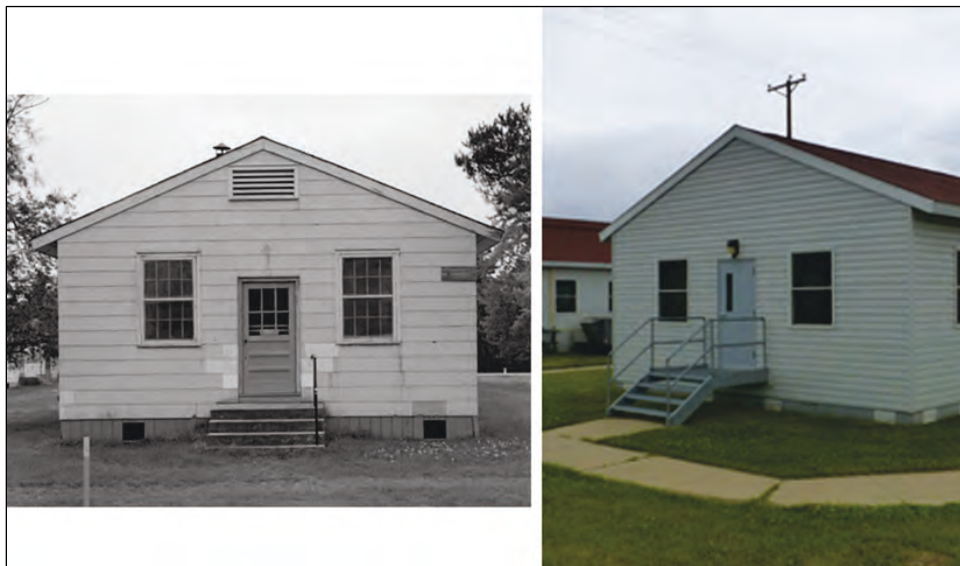
Figure 145. Entry into dining room of a mess hall. Building 635 (left) with original design and materials compared to the current condition of Buildings 1616, 1617, 1626, and 1627 (right) (left: Library of Congress; right: ERDC-CERL).

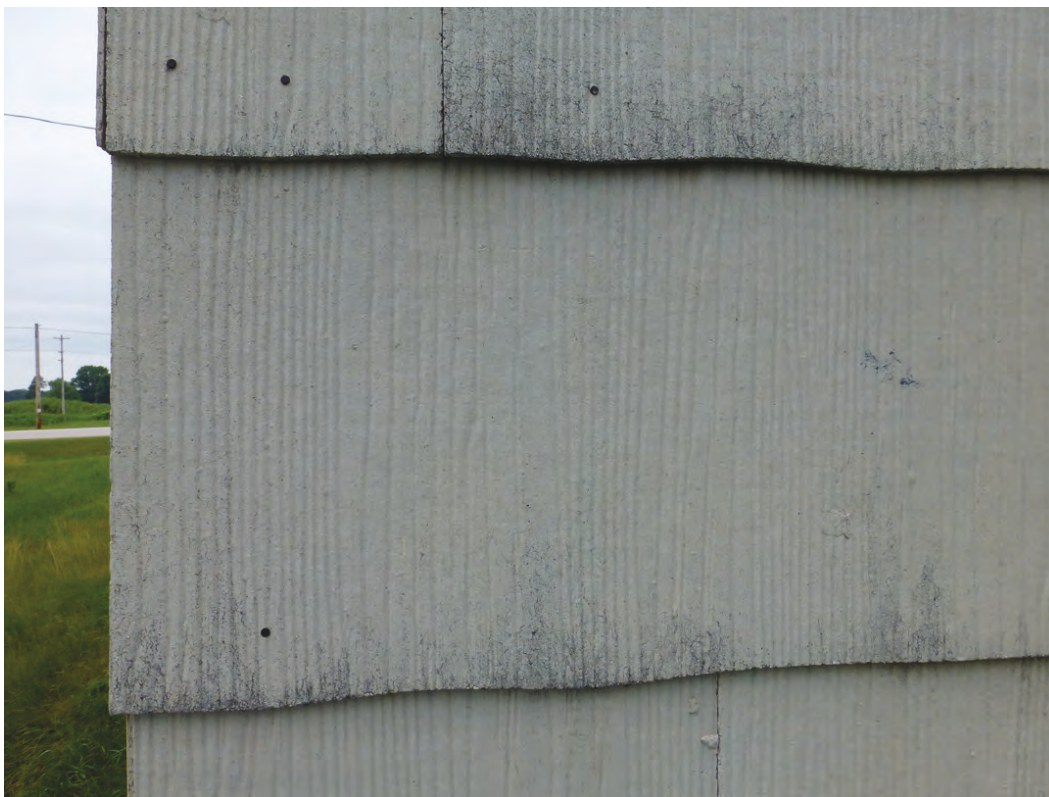
**Photo 7. Close-up of the asbestos cement siding, wood trim around door openings, missing light fixture, and replacement metal soffit on Building 550 (ERDC-CERL, 2018).**

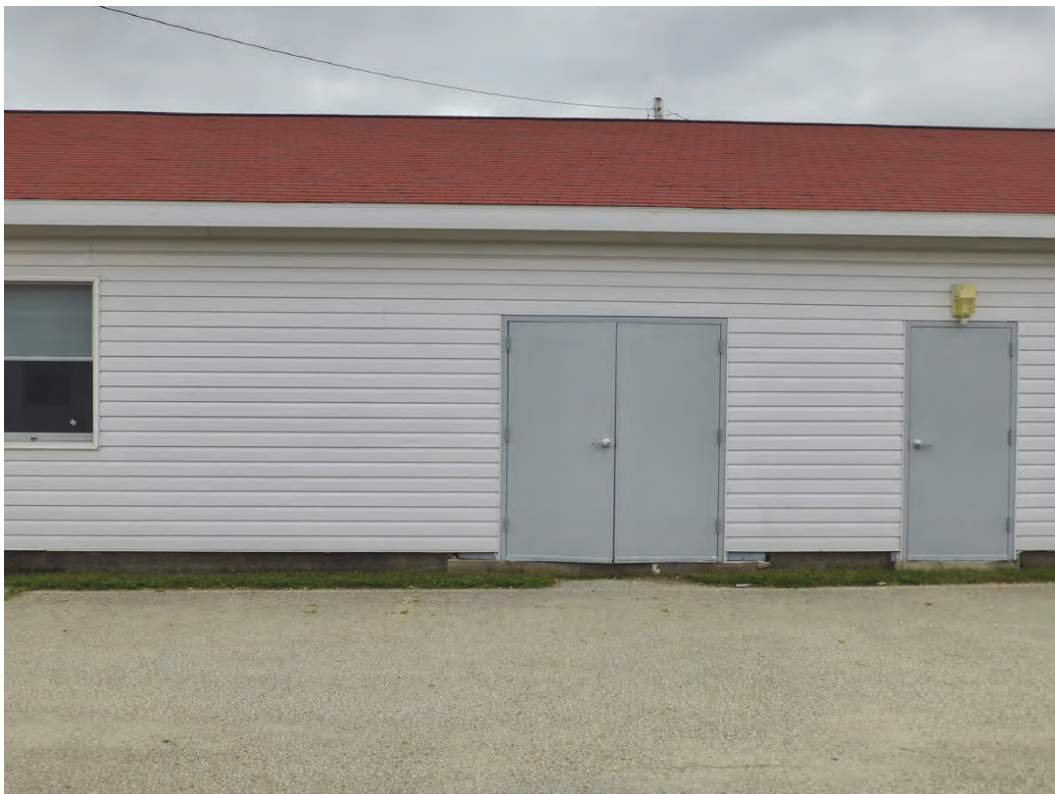
**Photo 10. Replacement metal doors on the east elevation of Building 1621 (ERDC-CERL, 2018).**

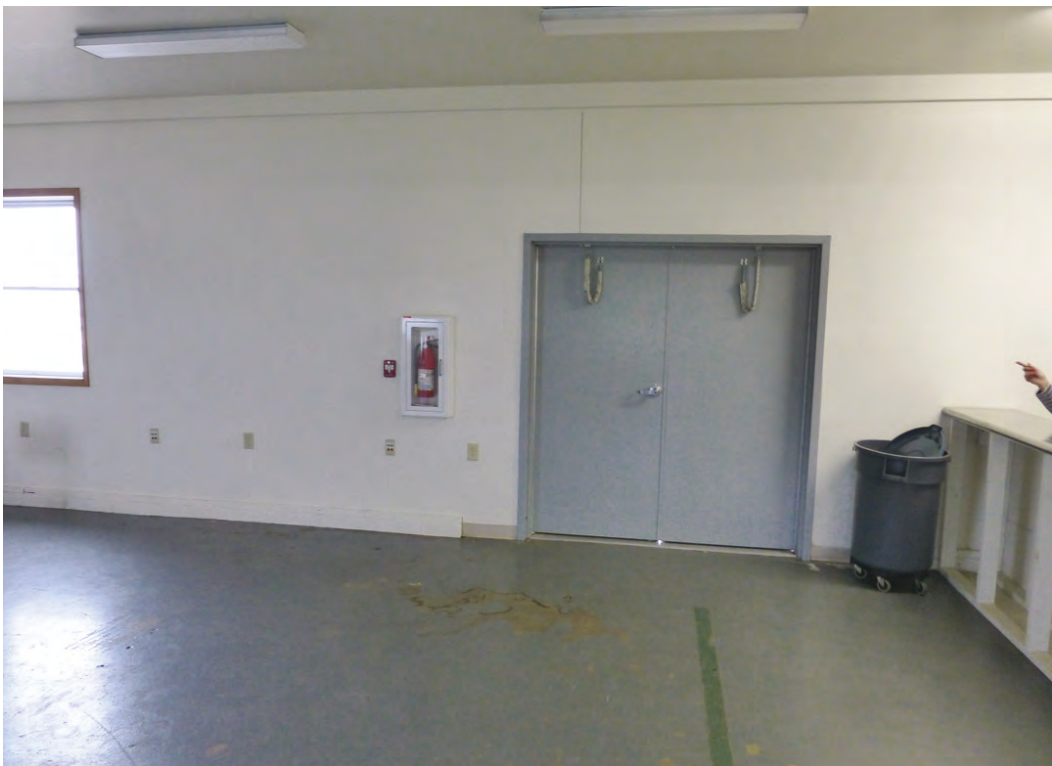
**Photo 22. New metal doors replace the original wood sliding door on the east wall of the former storehouse/administration portion of Building 1621 (ERDC-CERL, 2018).**

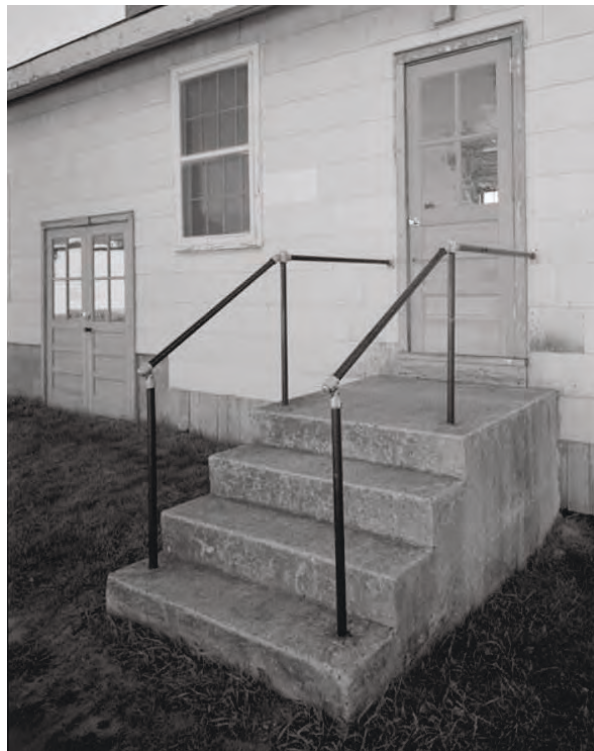
Close-up detail of concrete stoop, cast-iron metal handrails, wood panel and divided light doors, and multi-pane wood window and screen on Building 801, Company Storehouse/Administration and Recreation Building, September 1988 (Library of Congress HABS WIS, 41-SPAR.V, 1-B—5). The original WWII wood steps and handrails were replaced across Fort McCoy between 1965 and 1975.

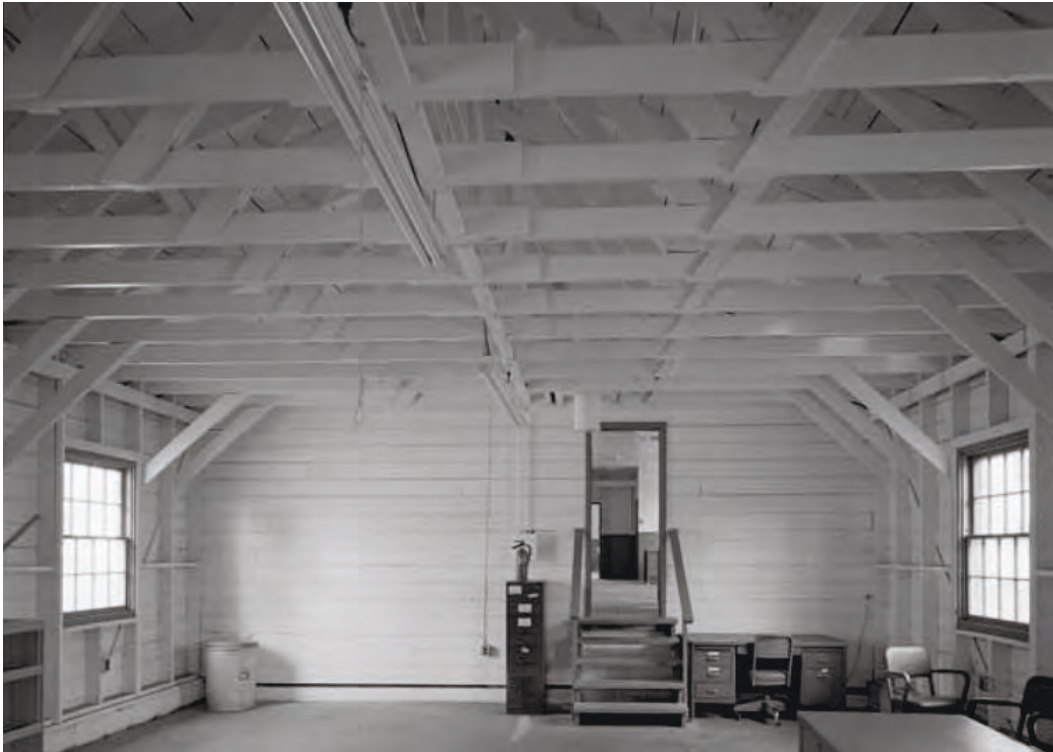
Building 801, interior view of storeroom showing roof trusses and north wall stairs into the recreation area, September 1988 (Library of Congress, HABS WIS, 41-SPAR.V, 1-B—6).

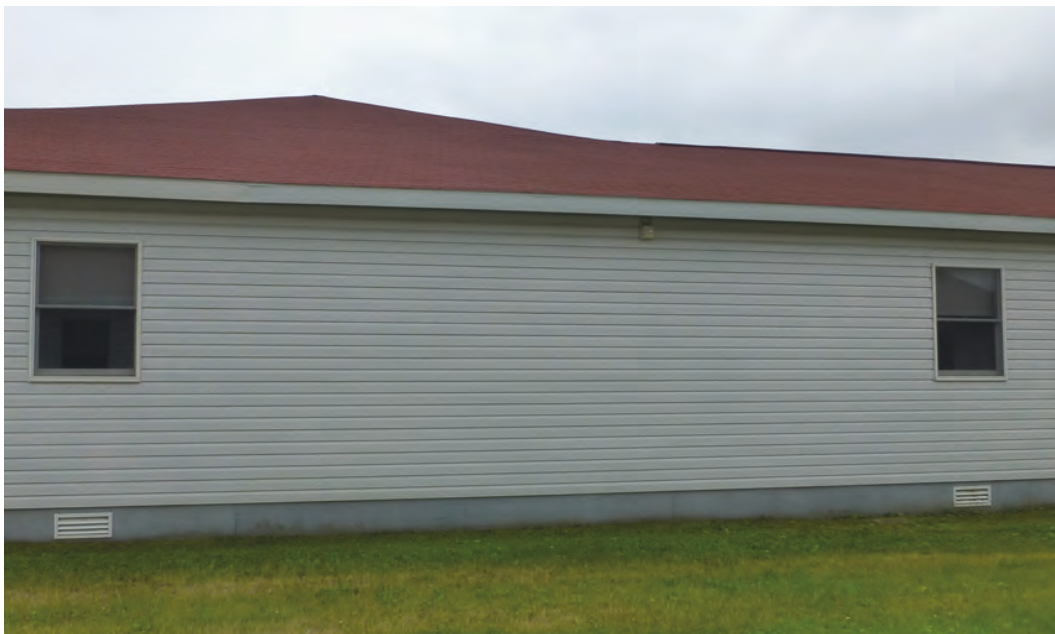
**Photo 9. Close-up of replacement one-over-one vinyl windows, vinyl siding, and replacement wood foundation skirting (ERDC-CERL, 2018).**

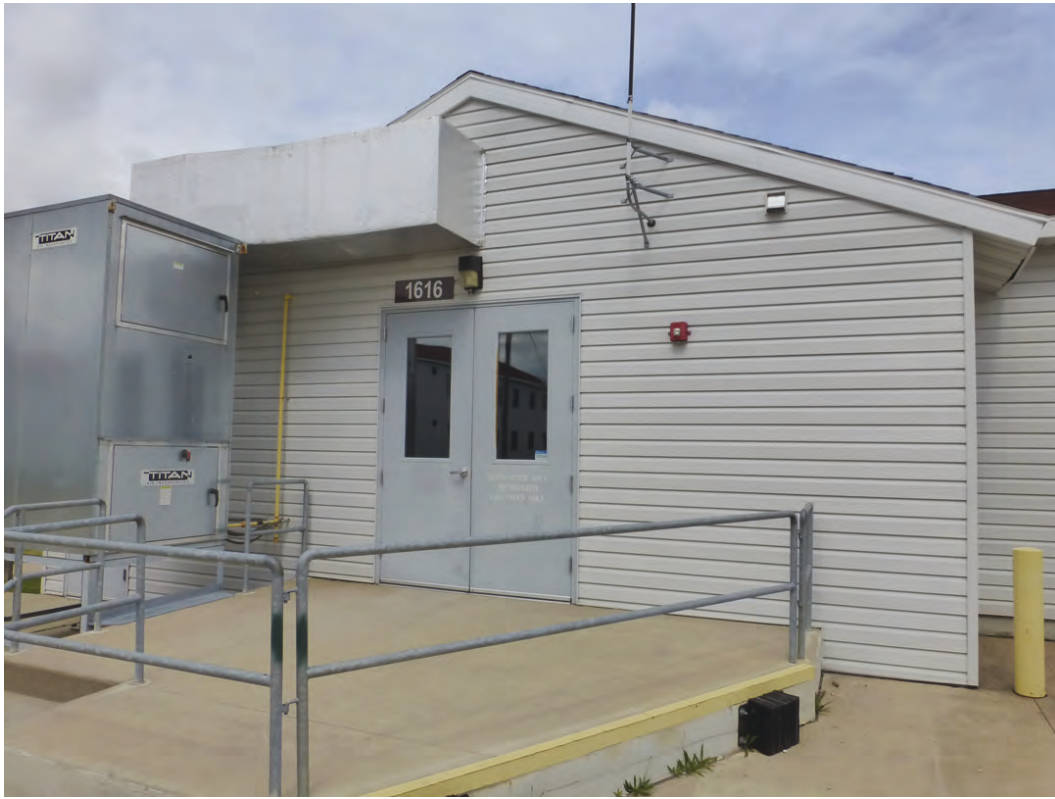
**Photo 10. Close-up of replacement metal and glass entry doors and newer poured concrete ramp/steps with metal handrails used on both Buildings 1616 and 1617 (ERDC-CERL, 2018).**

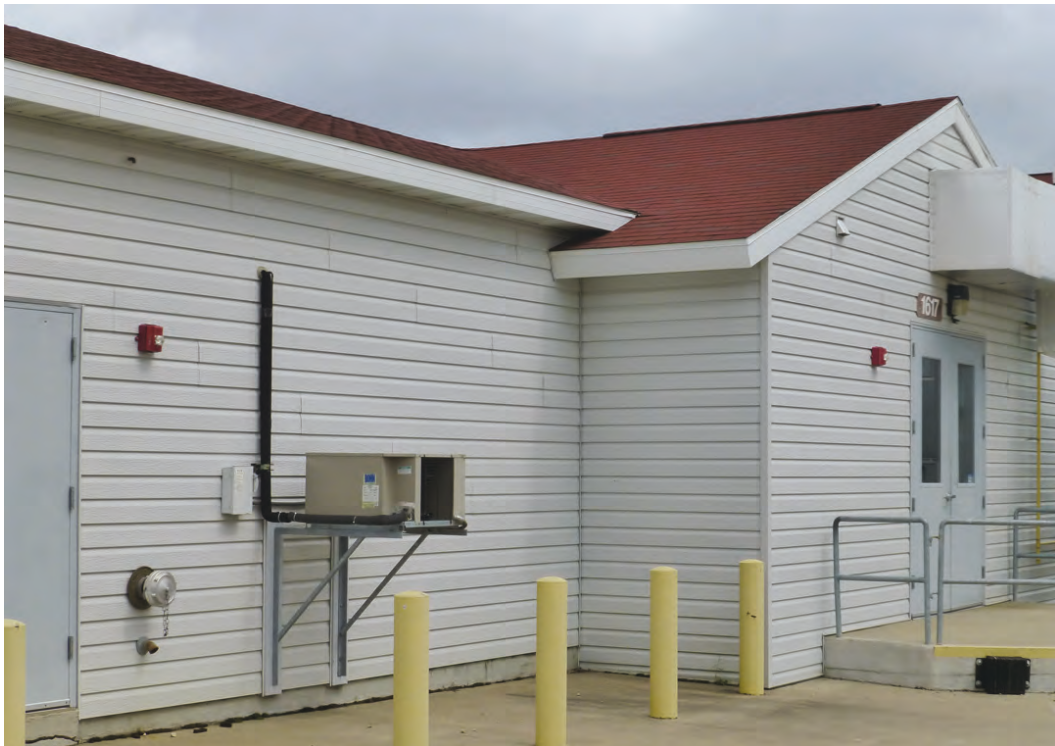
**Photo 11. Close-up of the connection between Building 1617 (right) and the hyphen to connect Building 1617 to Building 1616 (ERDC-CERL, 2018).**

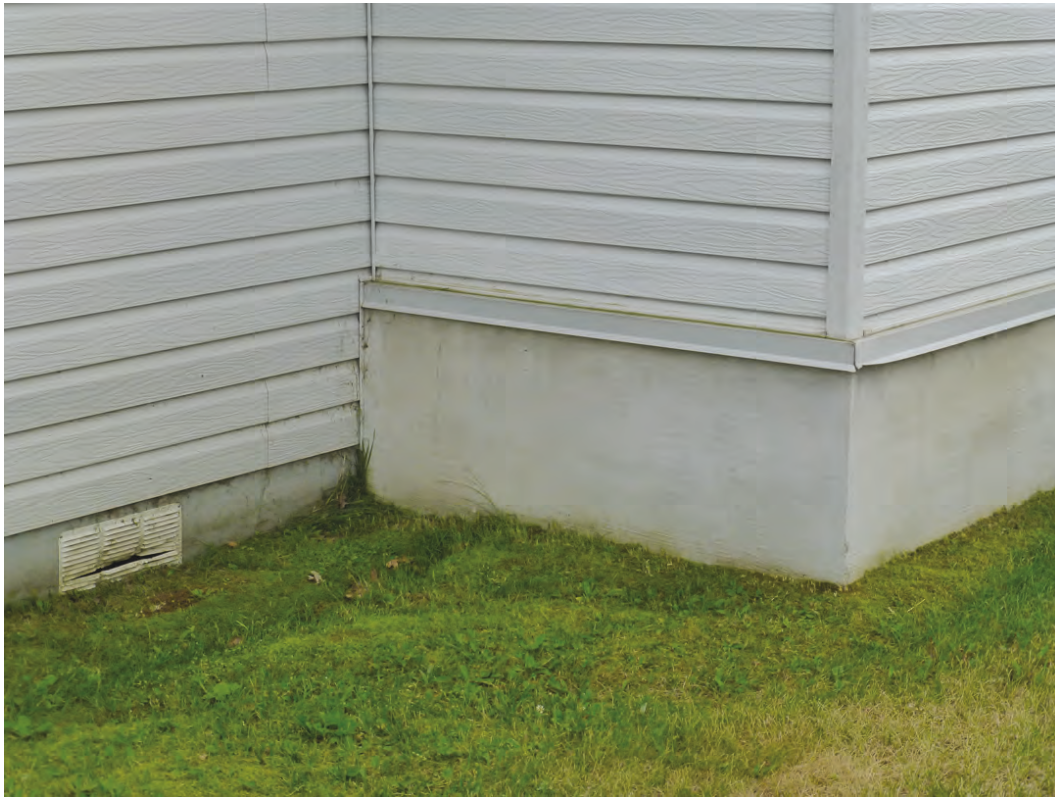
**Photo 12. Close-up of foundation skirting on original part of the structure (left) compared to the poured concrete foundation of an appendage that was constructed at a later date (right) (ERDC-CERL, 2018).**

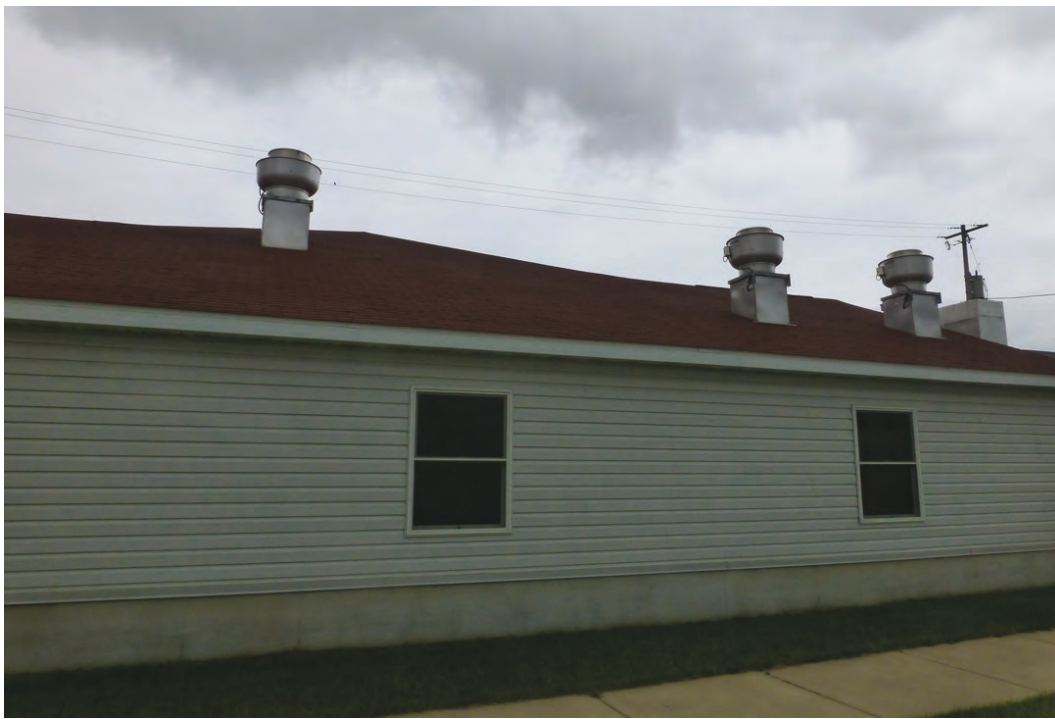
**Photo 13. Close-up of replacement windows, vinyl siding, and newer roof ventilators (ERDC-CERL, 2018).**

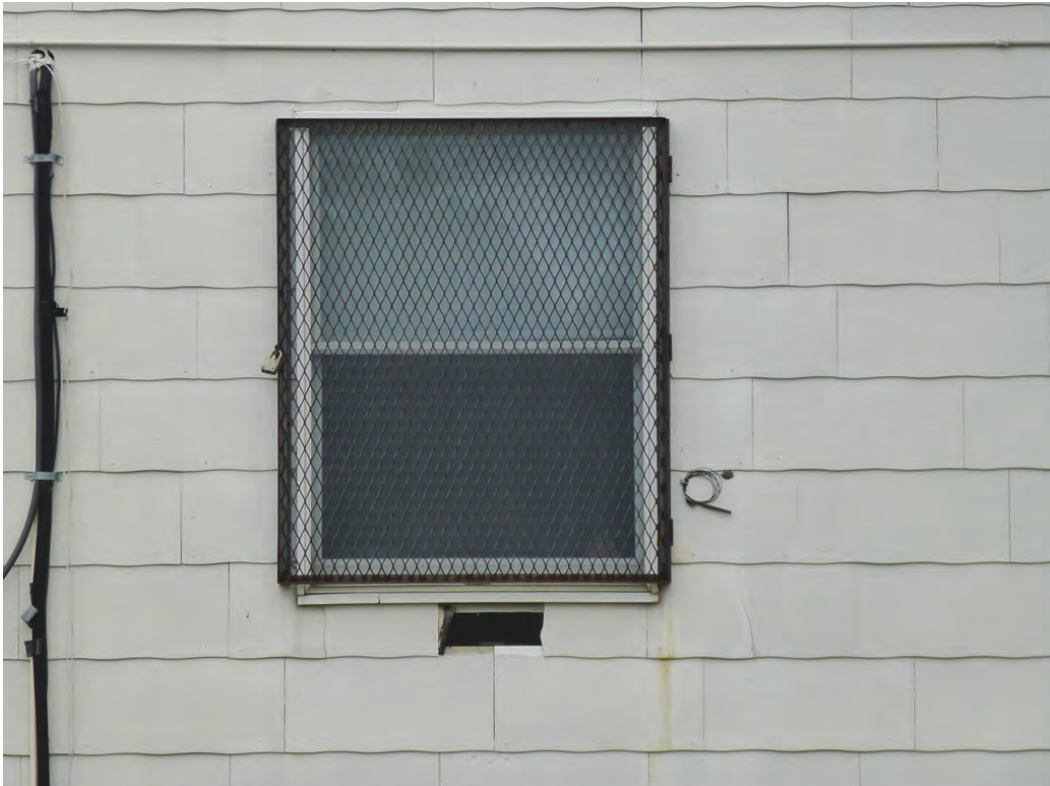
**Photo 17. Close-up of replacement one-over-one vinyl window with new metal security screen and close-up of original cement asbestos siding of Building 2000 (ERDC-CERL, 2018).**

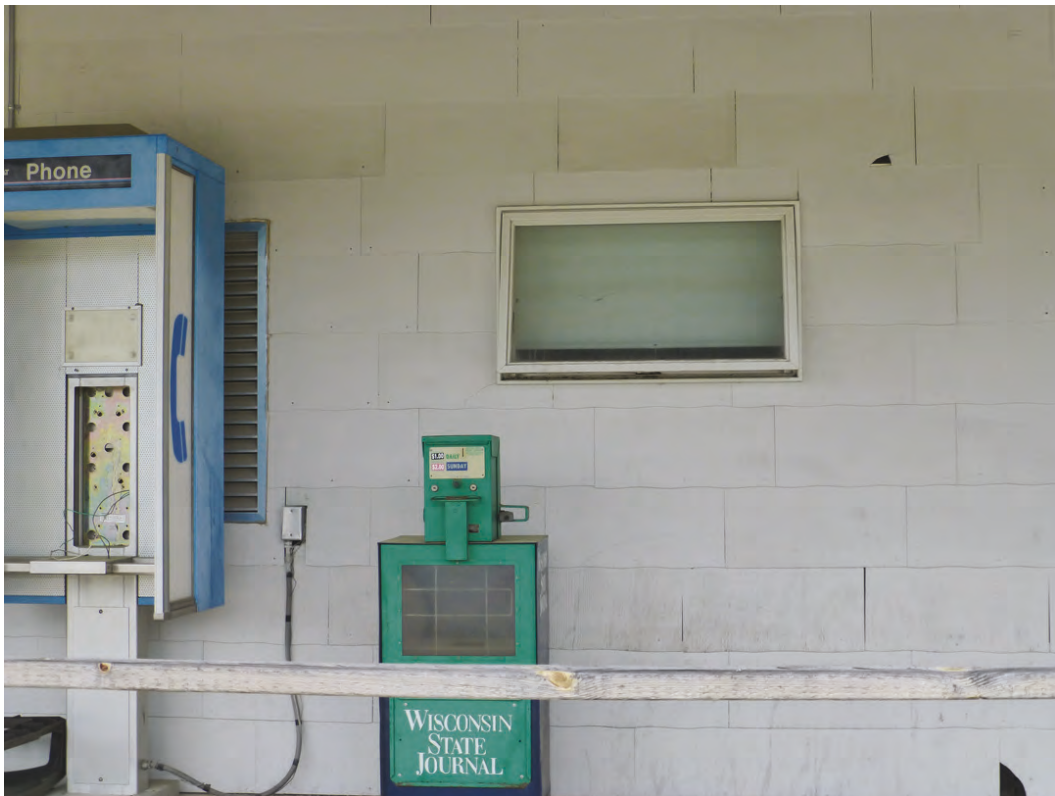
**Photo 18. Small replacement one-pane window on the south (front) elevation of Building 2000 (ERDC-CERL, 2018).**

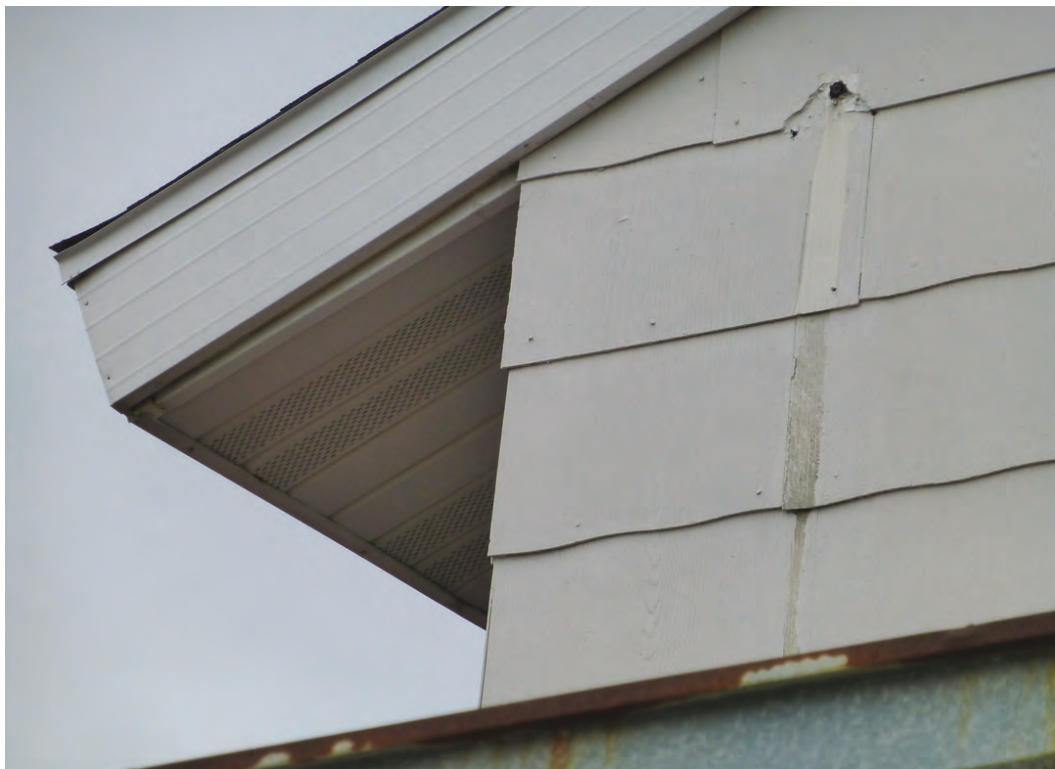
**Photo 19. Close-up of modified roof overhang with replacement metal soffit and fascia on Building 2000 (ERDC-CERL, 2018).**

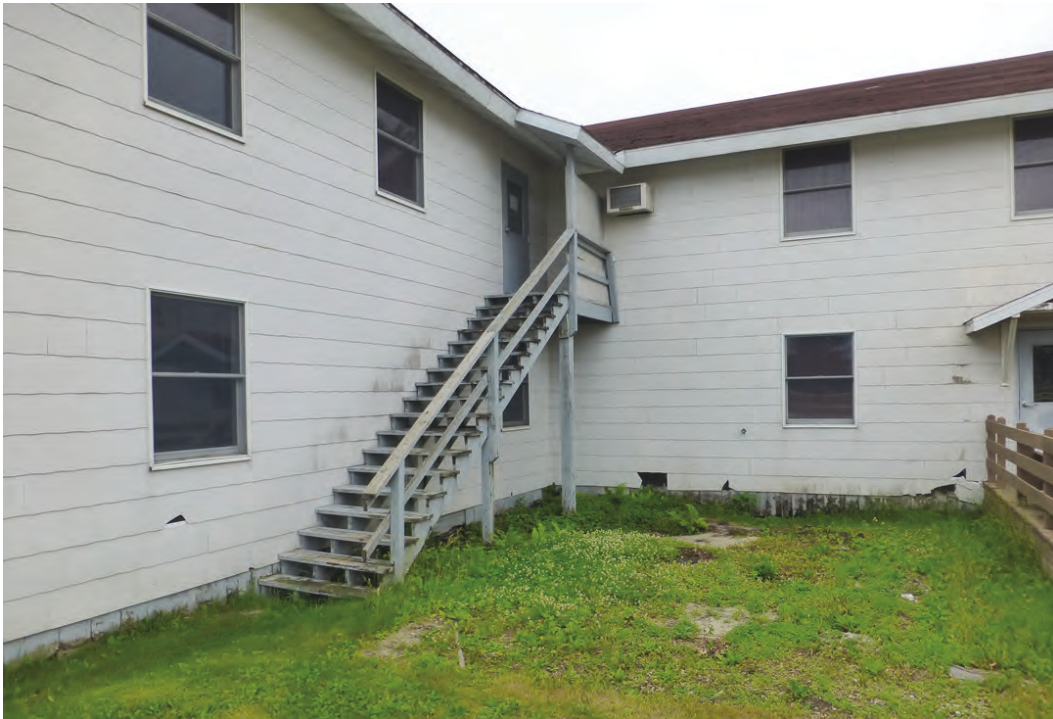
**Photo 20. Connection between the east wing (left) and north wing (right) of Building 2000, with replacement windows, replacement fire escape door, and original wood fire escape stairs (ERDC-CERL, 2018).**

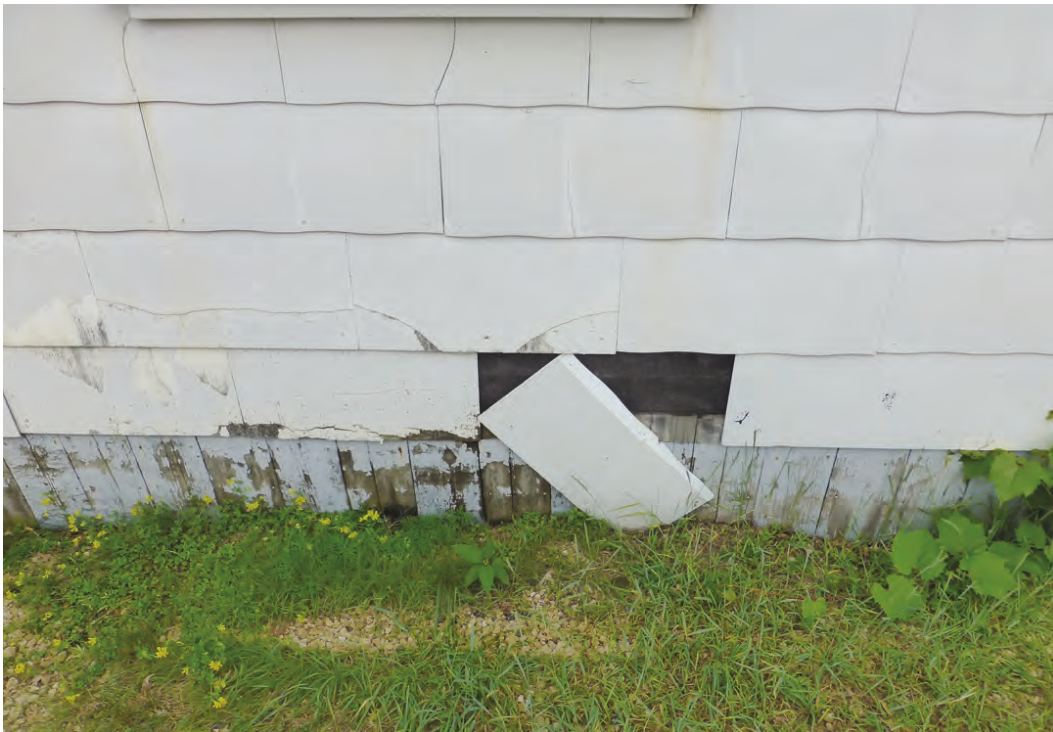
**Photo 21. Close-up of original cement asbestos siding with scalloped bottom edge detail and original wood foundation skirting on Building 2000 (ERDC-CERL, 2018).**

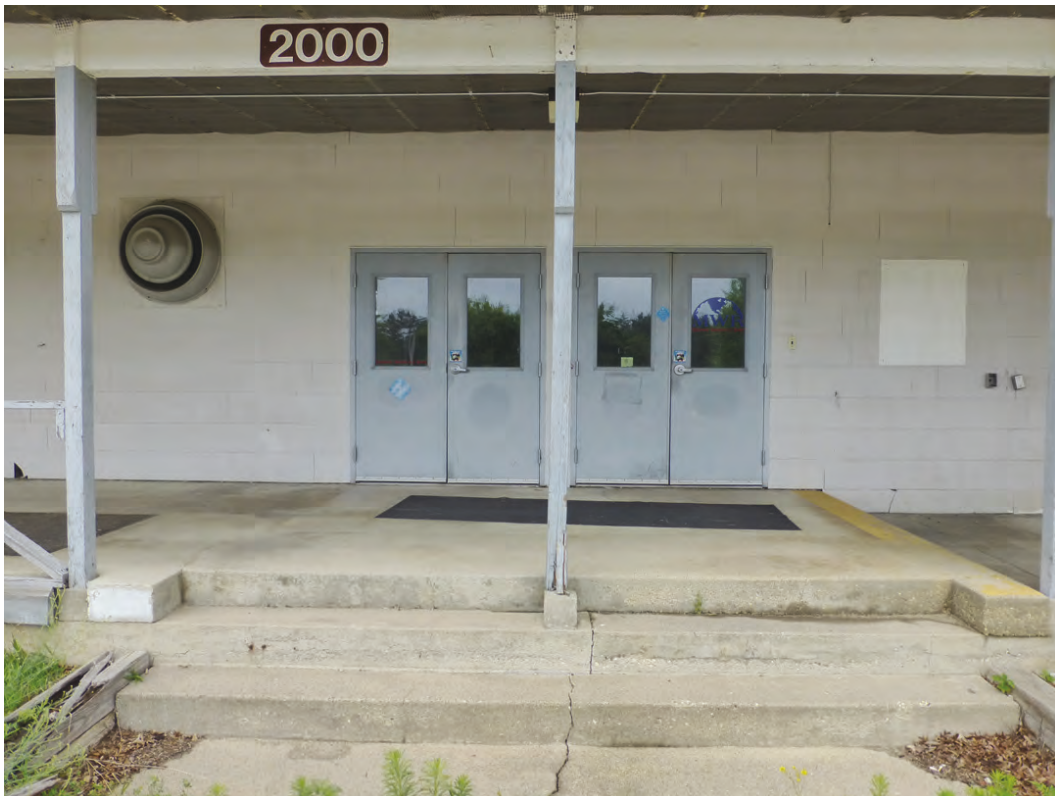
**Photo 22. Two sets of main entry replacement metal and glass doors on the south (front) elevation of Building 2000 (ERDC-CERL, 2018).**

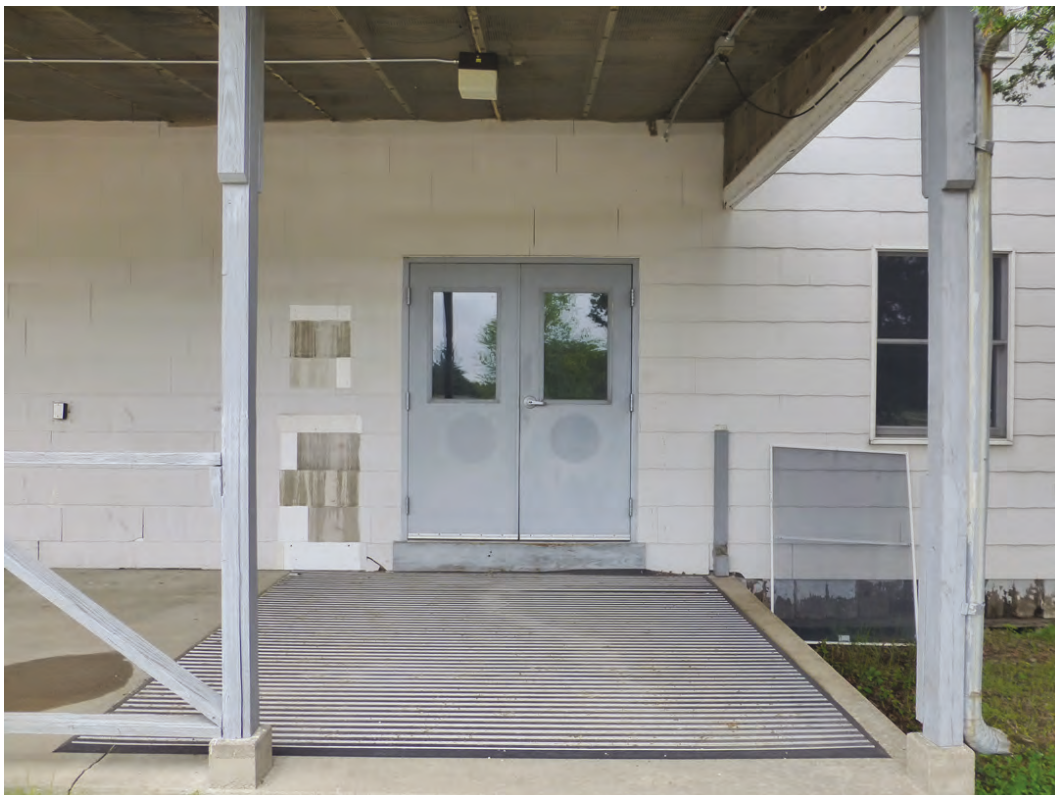
**Photo 23. Typical replacement metal door with large pane on Building 2000 (ERDC-CERL, 2018).**

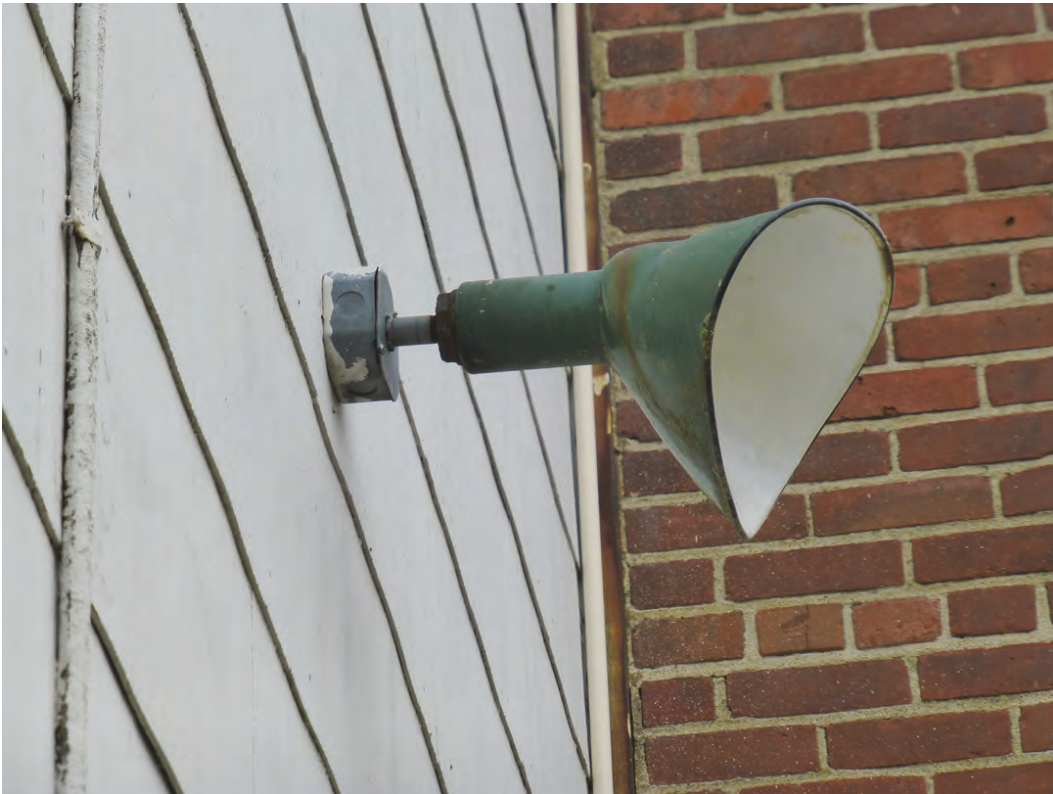
**Photo 26. Original exterior light fixture located on the north elevation of the north wing of Building 2000, near the chimney (ERDC-CERL, 2018).**

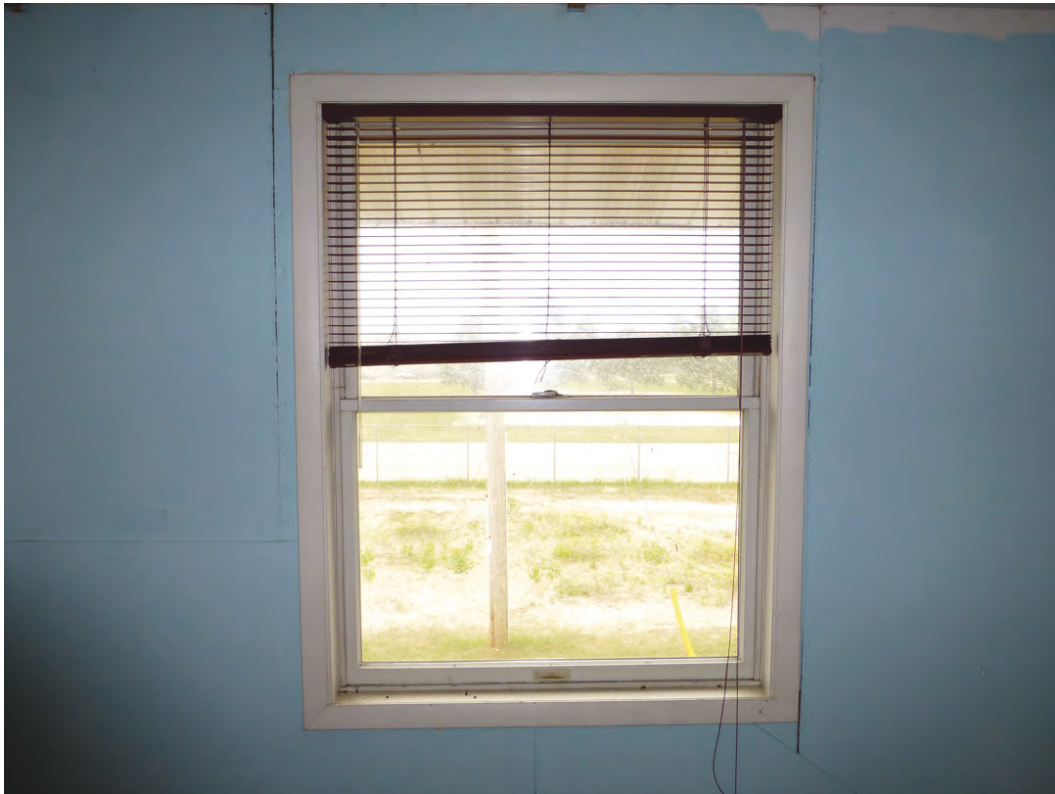
**Photo 54. Replacement wood window trim in Building 2000 (ERDC-CERL, 2018).**

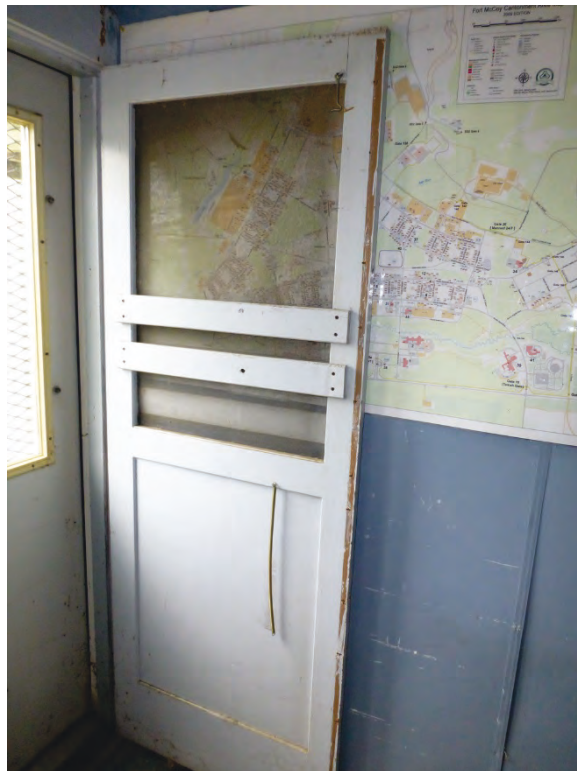
**Photo 55. Original wood screen door on the south wall of the 1943 addition to Building 2000 (ERDC-CERL, 2018).**

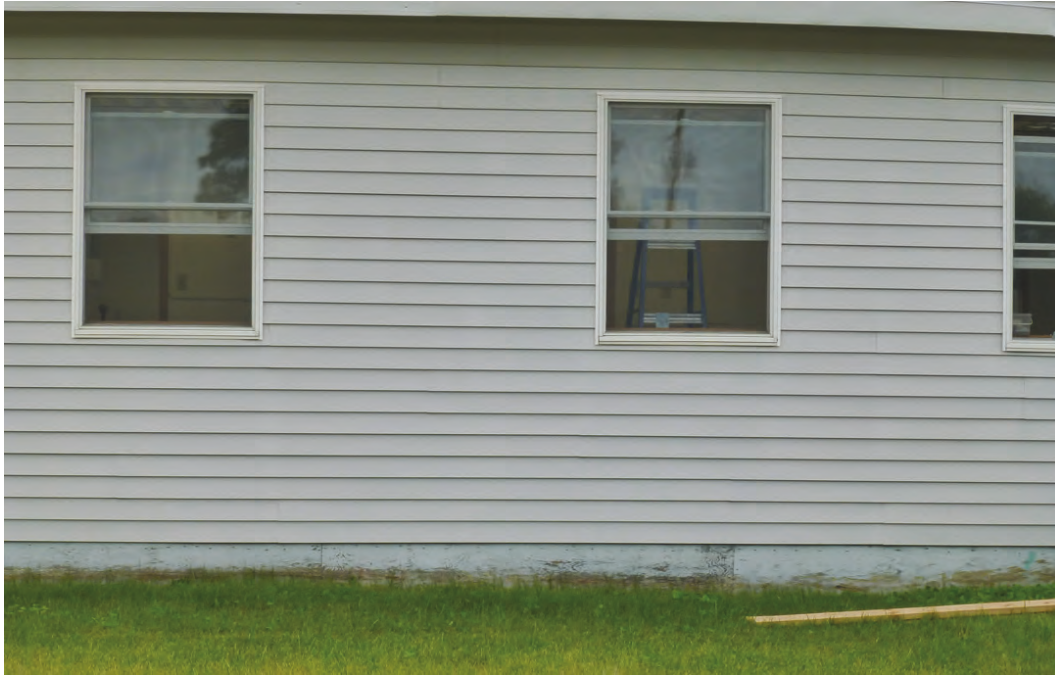
**Photo 3.** Close-up of the new vinyl siding, new wood foundation skirting, and replacement windows of Building 2668 (ERDC-CERL, 2018).

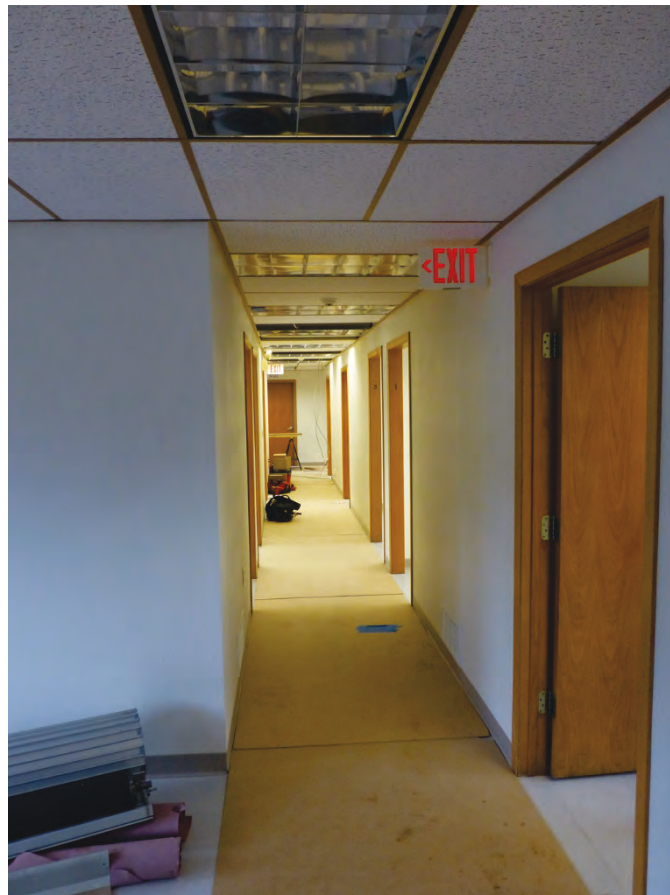
**Photo 4.** View of the modified interior spaces of Building 2668 with new partition walls, ceiling, floors, and doors (ERDC-CERL, 2018).
