ARMY PRELIMINARY EVALUATION I.
RV-1D/QUICK LOOK II AIRCRAFT

Army Aviation Engineering Flight Activity
Edwards Air Force Base, California

August 1974

4. TITLE (and Subtitle) ARMY PRELIMINARY EVALUATION I RV-1D/QUICK LOOK II AIRCRAFT		5. TYPE OF REPORT & PERIOD COVERED FINAL REPORT 16 - 17 July 1974
		6. PERFORMING ORG. REPORT NUMBER USAAEFA PROJECT NO. 74-36

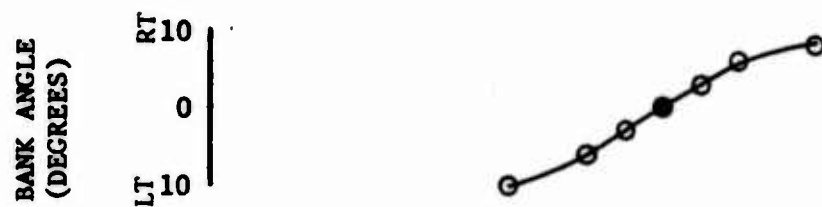
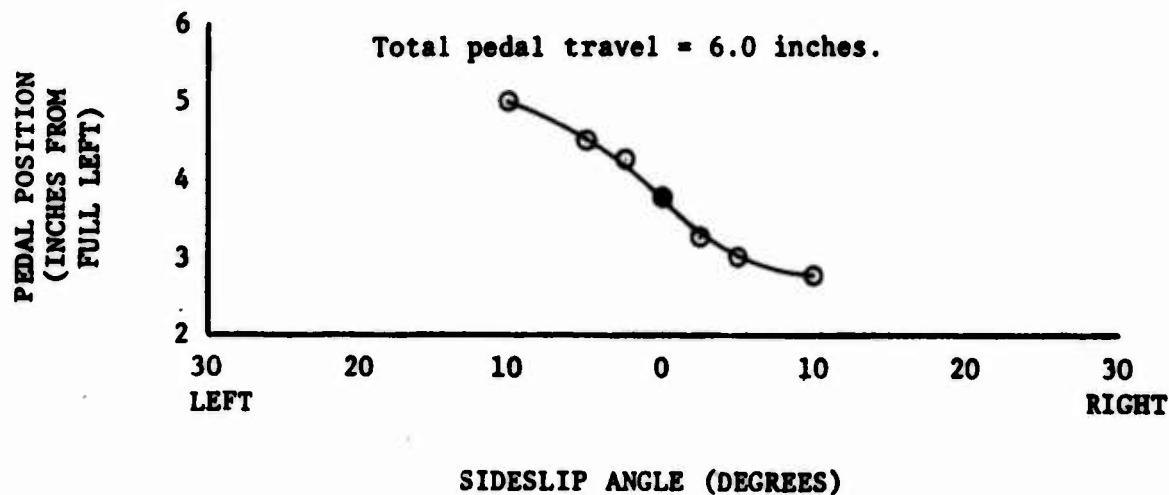
FIGURE 4
STATIC LATERAL-DIRECTIONAL STABILITY
RV-1D/QUICK LOOK II
USA S/N 67-18905

AVG GROSS WEIGHT (lb)	AVG CG LOCATION (% MAC)	AVG PRESSURE ALTITUDE (ft)	OUTSIDE AIR TEMP (°C)	TRIM CALIB. AIRSPEED (KT)	CONFIGURATION
16170	28.8(AFT)	8000	6	108	PAI

NOTE: Shaded symbols denote trim.

Total lateral control travel = 11.5 inches.

Total pedal travel = 6.0 inches.

13. The static lateral-directional stability characteristics were evaluated at the conditions presented in table 1. The aircraft was initially trimmed for steady-heading, coordinated level flight at the desired trim airspeed. The heading was then incrementally varied while maintaining trim airspeed, constant ground track, and constant power. In each case, the maximum sideslip angle obtained was limited by the pedal force required. Test results are presented in figures 2 through 4, appendix C.

14. The side-force characteristics, as indicated by the variation of bank angle with sideslip angle, were positive and essentially linear. Dihedral effect, as indicated by the variation of aileron control displacement with sideslip angle, was positive. The static directional stability, as indicated by the variation of sideslip angle with rudder pedal deflection and rudder pedal force, was positive for the conditions tested. A nonlinear variation of rudder pedal deflection with sideslip was present in the PA1 configuration at 108 KCAS, but was not objectionable. Within the scope of this test, the static lateral-directional stability characteristics of the RV-1D/Quick Look II aircraft are satisfactory.

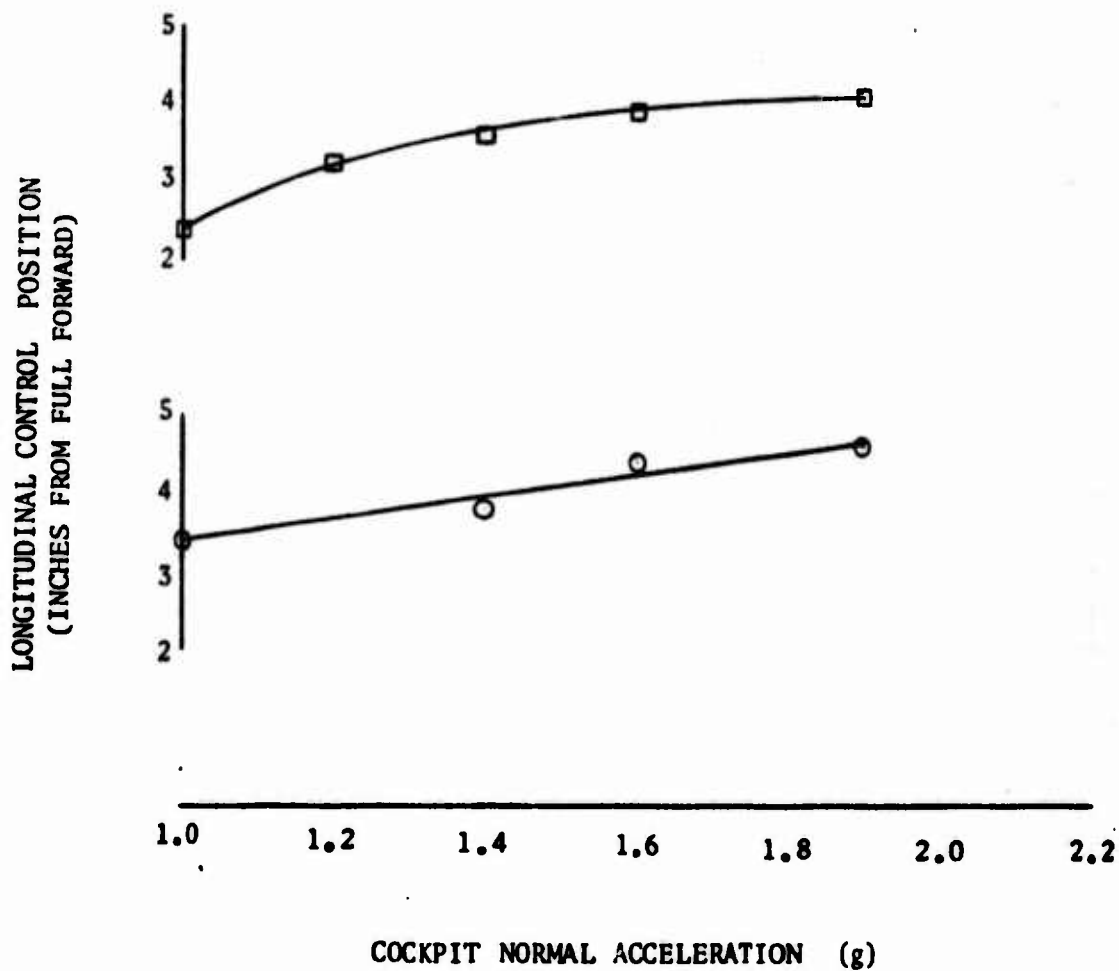
FIGURE 5
MANEUVERING STABILITY
RV-1D/QUICK LOOK II
USA S/N 67-18905

AVG GROSS WEIGHT (1b)	AVG CG LOCATION (% MAC)	AVG PRESSURE ALTITUDE (ft)	OUTSIDE AIR TEMP (°C)	TRIM CALIB AIRSPEED (KT)
16090	28.8 (AFT)	8000	6°	140

- NOTES: 1. Circles denote CR configuration.
 2. Squares denote PAI configuration.
 3. Full longitudinal control travel = 11.6 inches.

15. The maneuvering stability characteristics were evaluated at the conditions shown in table 1. The airplane was trimmed in wings-level flight at 140 KIAS. The trim airspeed and power setting were maintained constant as the bank angle was gradually increased until the desired normal load factor was reached. Stick-fixed maneuvering stability data are presented in figure 5, appendix C. The control position versus normal acceleration gradients were positive for CR and PA1 configurations. The stick-free maneuvering stability was qualitatively evaluated to be positive (increasing aft control force with increasing normal acceleration) for the conditions tested. A decreasing position gradient with increasing load factor was apparent in the PA1 configuration; however, it was not objectionable. The increasing aft control force required provided sufficient pilot cues of increasing load factor during steady-state maneuvering. However, during qualitative tests involving rapid left and right rolling maneuvers at airspeeds less than 140 KIAS, insufficient control position and force cues were present to warn the pilot of

increasing load factor. As discussed in paragraph 21, the high lateral control forces are not compatible with the relatively light longitudinal forces. During these tests, the pilot was required to closely monitor the load factor indicator to avoid exceeding the flight envelope. A normal load factor indicator is therefore required to prevent unintentionally exceeding the flight envelope during rapid rolls at airspeeds less than 140 KIAS. Except during rapid rolling maneuvers at low airspeeds, maneuvering stability of the RV-1D/Quick Look II aircraft is satisfactory.
