Mechanical, Corrosion, and Fatigue Properties of 15-5 PH,  
Inconel 718, and René 41 Weldments

Report 4528

# NAVAL SHIP RESEARCH AND DEVELOPMENT CENTER

May 1975

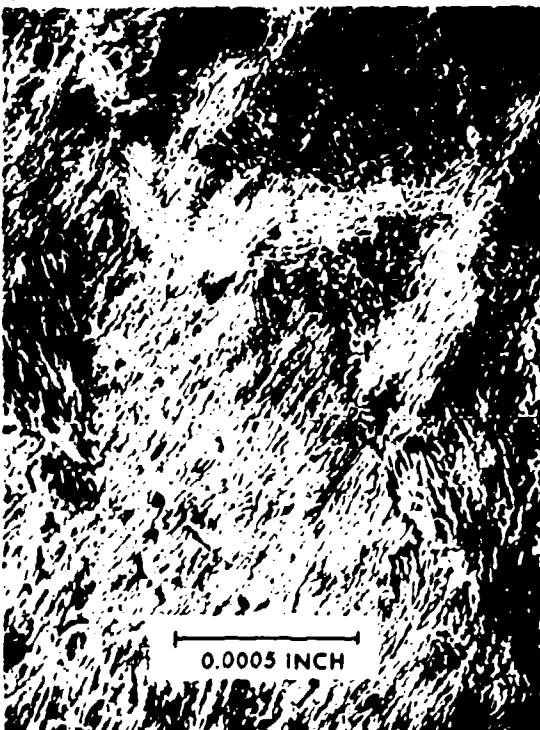
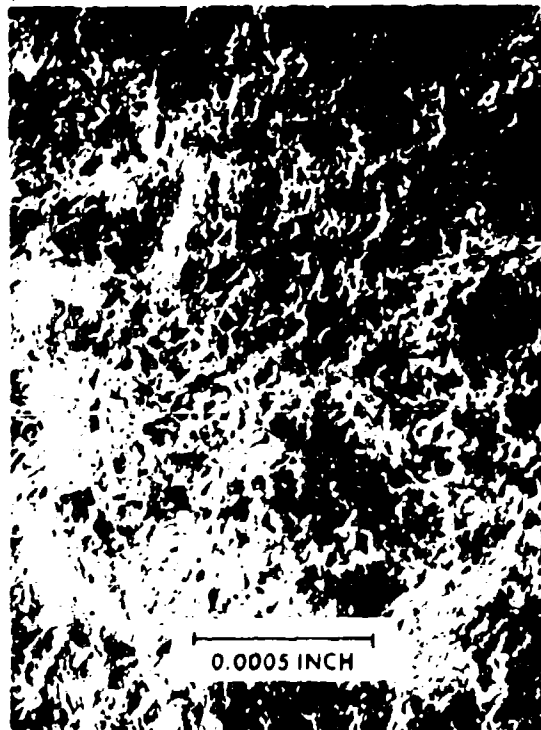
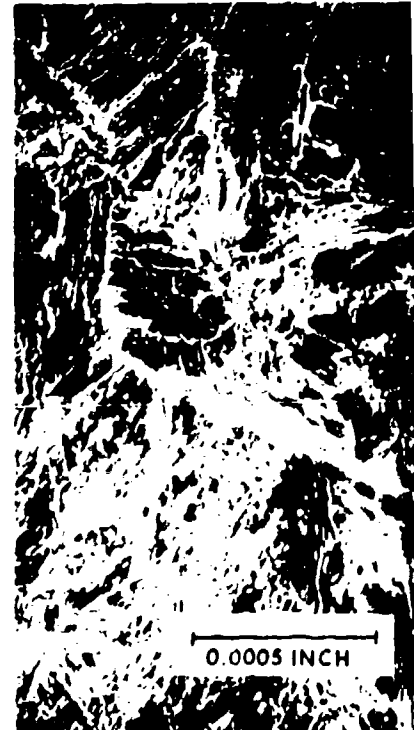
Figure 10  
Metallurgical Structure of 15-7 PH  
in the WELD HAZ (Fillet's Reagent)

Four high-magnification scanning electron photomicrographs of selected areas of the microstructure compose the lower portion of figure 10. The left-hand photo shows the fine dendritic structure existing in the weld metal. The next photo shows a fine, equiaxed structure with acicular regions existing in the middle temperature heat-affected zone, resulting from the heat of welding. Between these two areas is a region within the high-temperature, heat-affected zone where partial liquification probably has occurred, causing distinct outlining of the grain boundaries. The right-hand photo shows the coarse structure of the base metal. Next to this is a photo of the region where the dark phase corresponding to the area of knife-edge attack occurs. This structure shows that the precipitates had a preferred orientation. The prior grain boundaries are also evident. Unfortunately, further analysis of this structure is not practical due to the narrow width of the zone where it exists.

WELD METAL  
(FINE ACICULAR STRUCTURE)

HIGH TEMPERATURE HAZ  
(GRAIN BOUNDARIES OUTLINED)

CENTRAL HAZ  
(SMALL EQUIAXED GRAINS)

LOW-TEMPERATURE  
HAZ  
(SUSCEPTIBLE TO KNIFE  
EDGE ATTACK OF DARK  
PHASE)

BASE METAL  
(COARSE MIXED  
STRUCTURE)

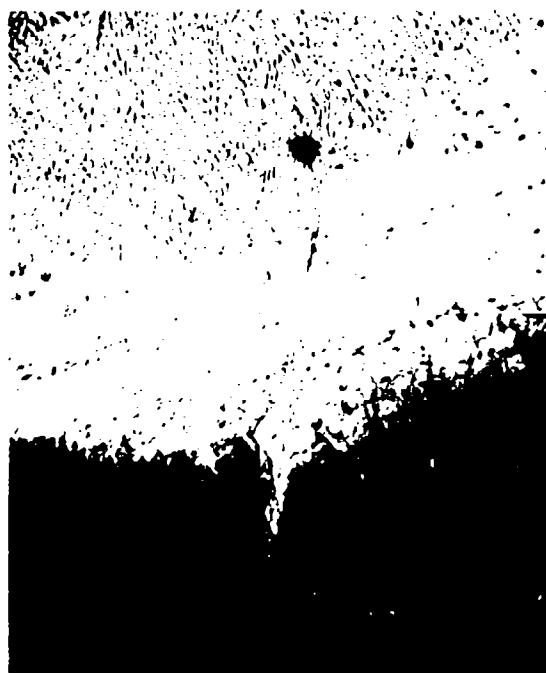
Figure 3-A  
Rehe 41 Weld Cracking (50X)

As-Welded Plate  
End of Crack
