EXPLORATORY DEVELOPMENT OF WELD QUALITY DEFINITION AND  
CORRELATION WITH FATIGUE PROPERTIES

Grumman Aerospace Corporation

AFML-TR-75-7

TECHNICAL REPORT AFML-TR-75-7

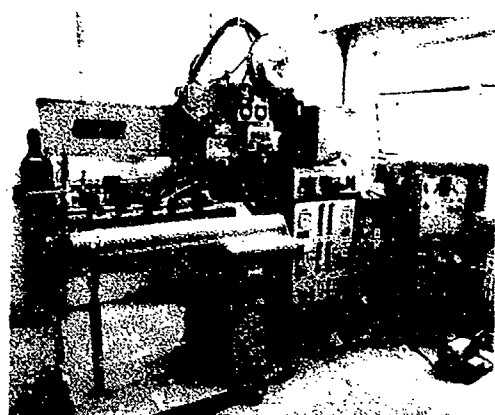
**Figure 3. Automatic Plasma Arc Welding Unit**

The welding equipment used was a 500-ampere (DC), fully automatic plasma-arc welding unit. The associated controls (shielding gas, backup gas, orifice gas and water flow) as well as sloping-in and sloping-out of the weld current are fully automatic. This equipment is shown in Figure 3.

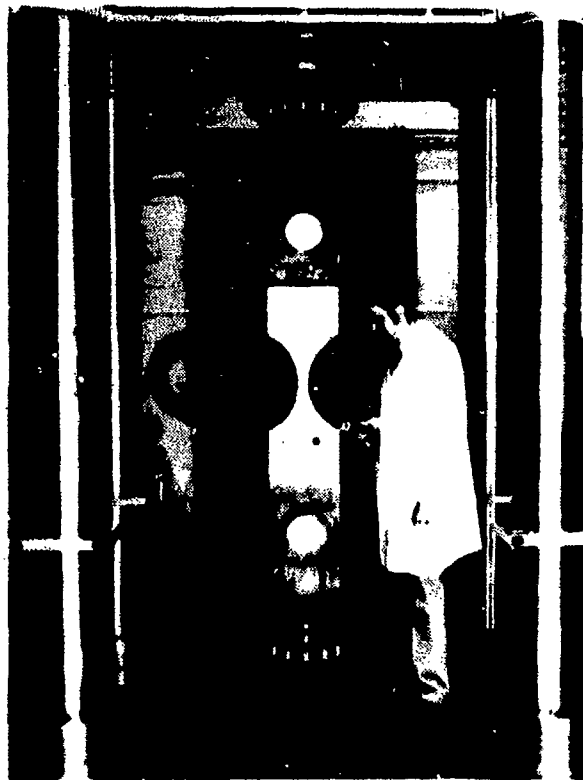
Figure 7. One-Million-Pound MTS Testing Machine

Fatigue characteristics were determined in constant-amplitude tension-tension ( $R = 0.1$ ) fatigue tests at frequencies of 1800-cpm and 20-cpm. The Sonntag SF14 and SF-104 testing machines shown in Figure 6 were utilized to test the 0.090 and 0.25-inch-thick specimens. The 1,000,000-pound capacity MTS system shown in Figure 7 was used to test the 1.5-inch thick specimens.

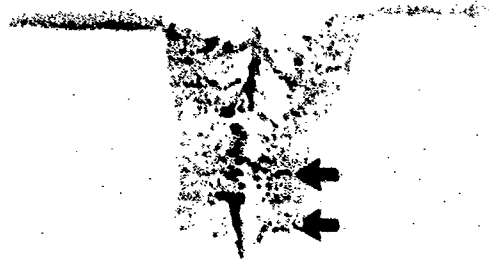
**Figure 21. Weld 4EB-LPX-3 Showing Lack of Penetration, (8X MAG)**

Figures 20 and 21 illustrate the welds produced by the missed seam technique. Figures 22 and 23 illustrate the parameter variation technique. The two defect levels selected were 70% and 90% penetration. The technique selected for Phase II specimen production was that of varying beam power.

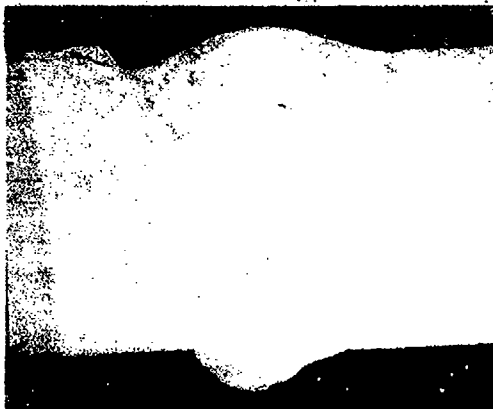
Figure 26. Extensive Undercut in Weld 4PAW-UCX-5 (10X MAG)

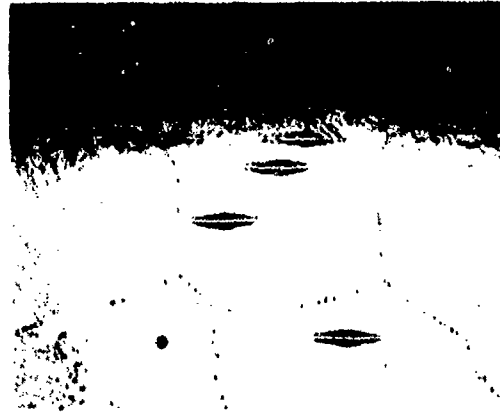
**Figure 38. Weld 4PAW-SUX-3 Hardened Surface Layer and Microhardness Indications. (250X MAG)**

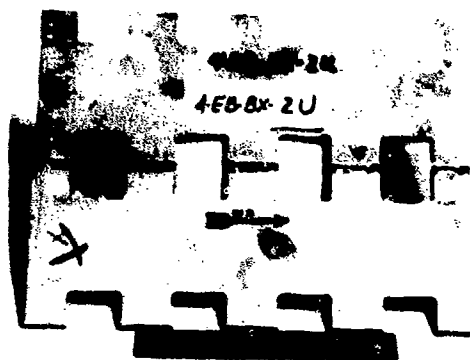
Figure 43. Overall View of Configuration 1 Utilized for Burst Defect Generation (0.7X MAG). Arrow Indicates Weld Direction.

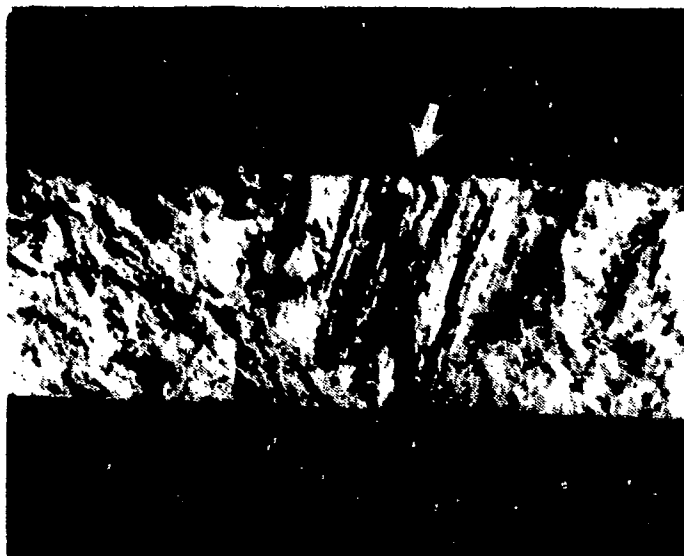
**Figure 81. Surface-Exposed Tungsten Inclusion in 0.080-Inch-Thick GTA Weld (20X MAG)**

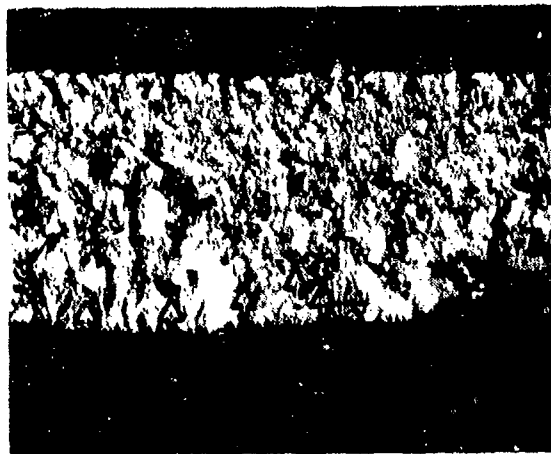
Figure 112. Fracture Surface of Specimen 2-1 For Which Double-Line Porosity Indications Were Detected by Prior Radiography

side of the weld cross-section. Figure 112 shows the fracture surface of a specimen for which double-line RT indications were obtained during pre-test radiography. A heavy concentration of fine porosity is readily detectable in the face-side (top) portion of the weld. Definition of larger porosity in the root-side portion of the weld was somewhat more difficult due to focusing complications related to contour variations.

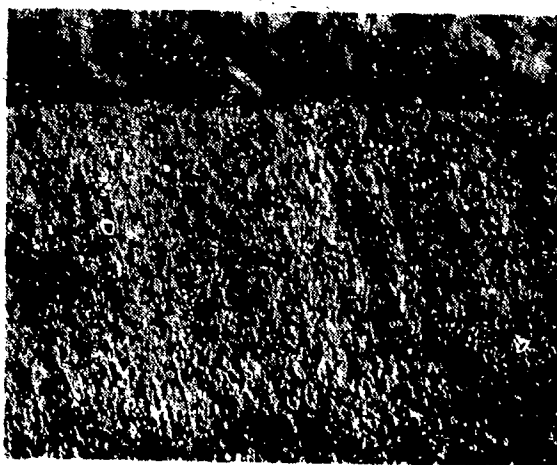
Figure 149. Typical Linear Failure Initiation Site Encountered In Intentional EB Underfills (20X MAG)

Width and depth measurements taken on each underfill configuration are included in Appendix B, Table B-11. Figure 149 shows a typical failure initiation at the radius of an underfill.

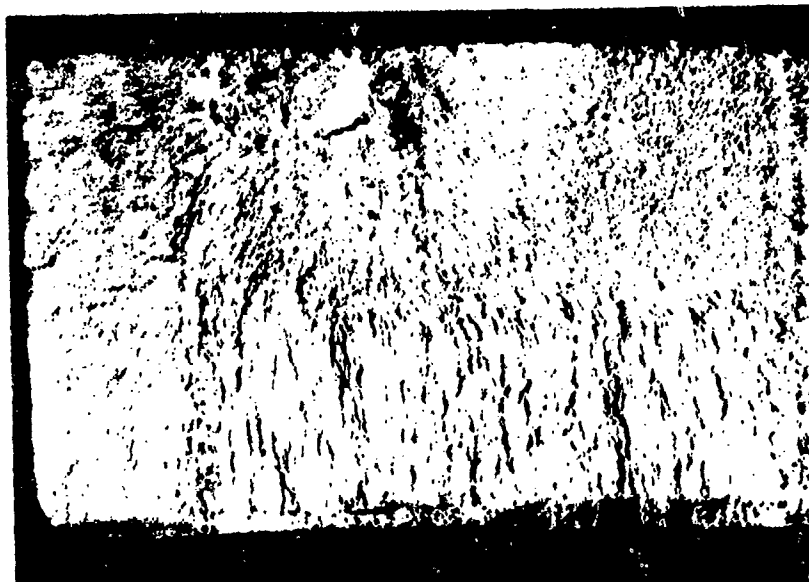
Fig. 158 Burst Indications Detected in B-3 Weld by (1) Metallography (Top, 2.5 X Magn.), (2) Ultrasonic C Scan (Middle, 2.5 X Magn. of the Printout), and (3) Radiography (Actual Size)

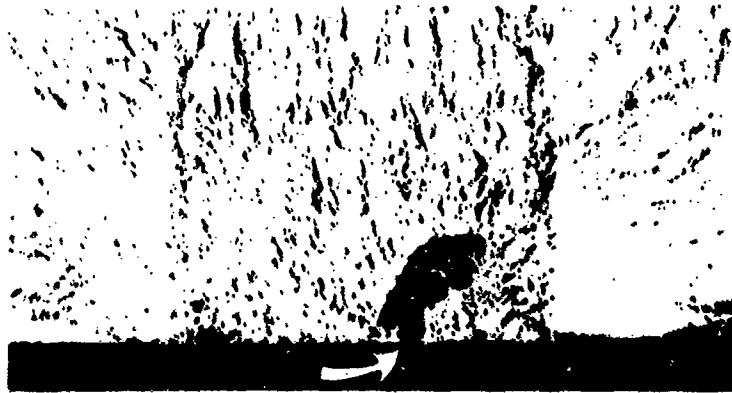
**Fig. 158** Fracture Surfaces in Specimens B-1 (Top) and B-4 (Bottom) Showing Fracture Initiations (Arrows) at Surface-Connected Bursts. Magn. 2.5 X
