**FRANGIBILITY TESTS OF EXISTING  
APPROACH LAMPS AND HOLDERS**

**National Aviation Facilities Experimental  
Center**

| 4. Title and Subtitle<br>FRANGIBILITY TESTS OF EXISTING APPROACH<br>LAMPS AND HOLDERS | | | | 5. Report Date<br>August 1975 | |
| 7. Author(s)<br>Bret B. Castle | | | | 8. Performing Organization Report No.<br>FAA-NA-75-8 | |

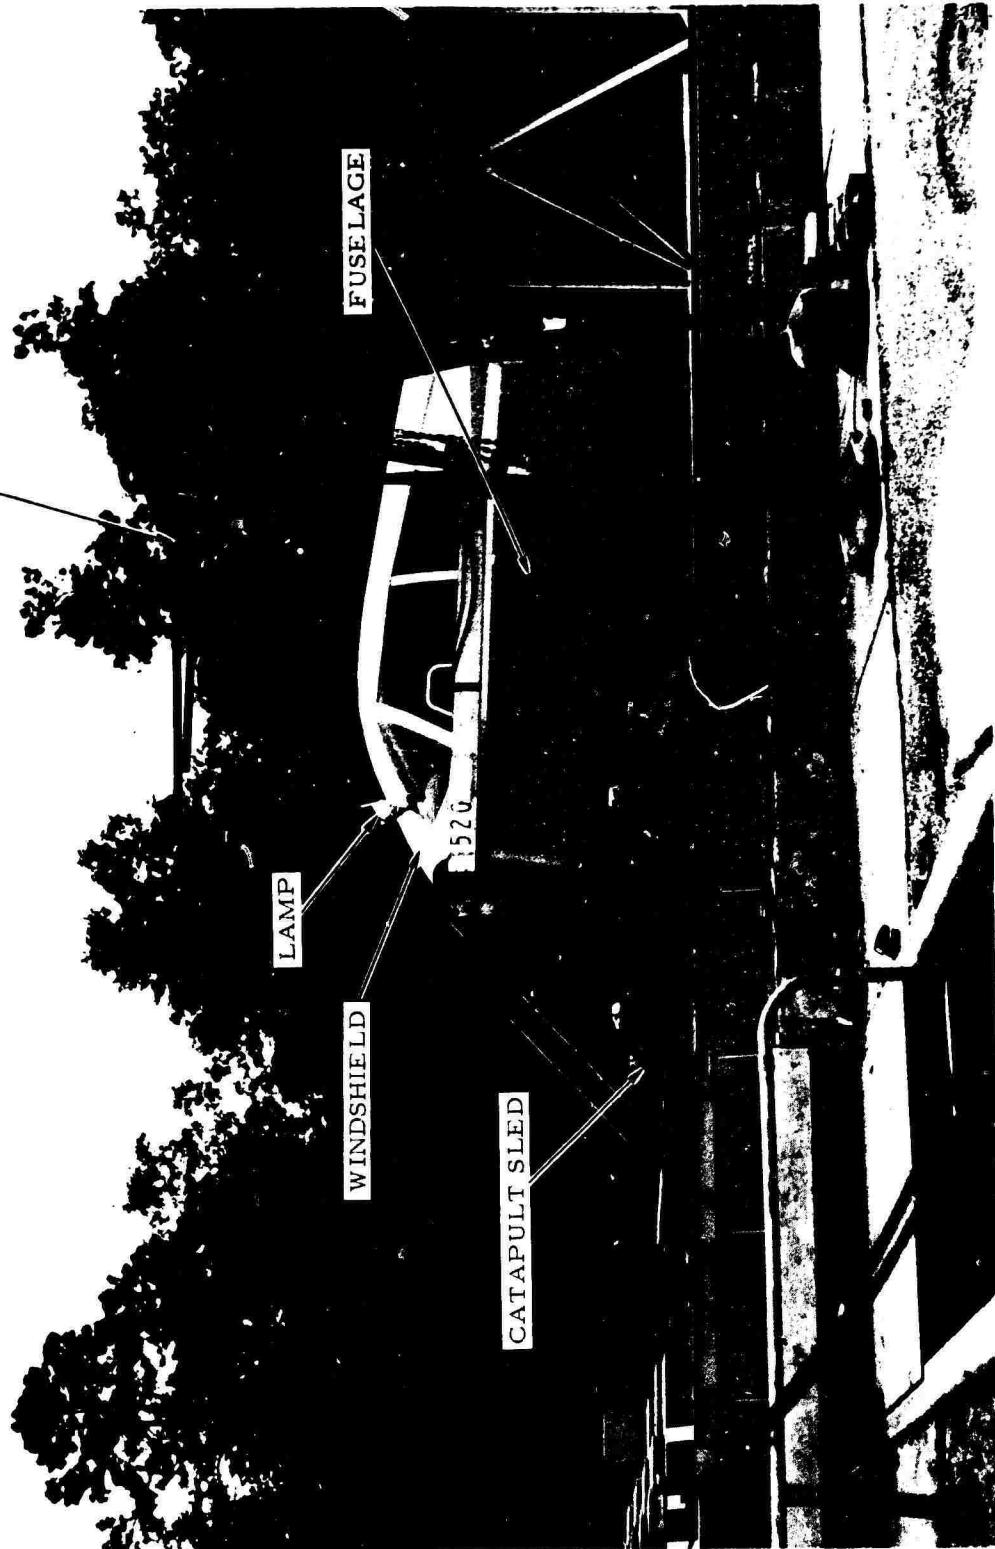
FIGURE 1. CATAPULT LAMP FRANGIBILITY TEST SETUP

The lamps and lamps with holders were hung in the air with as little support as possible and were struck by the windshields at their in-flight attitude (tilted about 30° from horizontal). Speeds started at 20 miles per hour (mi/h) and were increased until windshield penetration thresholds were obtained. Instrumentation consisted of photographic evidence and accelerometer data.

"A" FRAME HOLDING LAMP

LAMP

WINDSHIELD

FUSELAGE

CATAPULT SLED

SET No. 1a. Seven runs (ALS-1 through 7) were made with the Cherokee windshield striking the face of a PAR-56 lamp. Figures 1, 2, 3, and 4 depict the test setup, nonpenetration and penetration runs, and the effect of a penetration run. The results show that the lamps are much less frangible than the windshields. The outcome of the impact tests at 20, 24, 36, 40, 47, and 58 mi/h shows that the lamps actually shattered the windshields at 47 and 58 mi/h.
