Technical Note N-1422

GROUND TRANSPORTATION FOR POLAR OPERATIONS - 16-WHEEL  
LOW-GROUND-PRESSURE VEHICLE (LGPV-16)

January 1976

CIVIL ENGINEERING LABORATORY  
Naval Construction Battalion Center  
Port Hueneme, California 93043

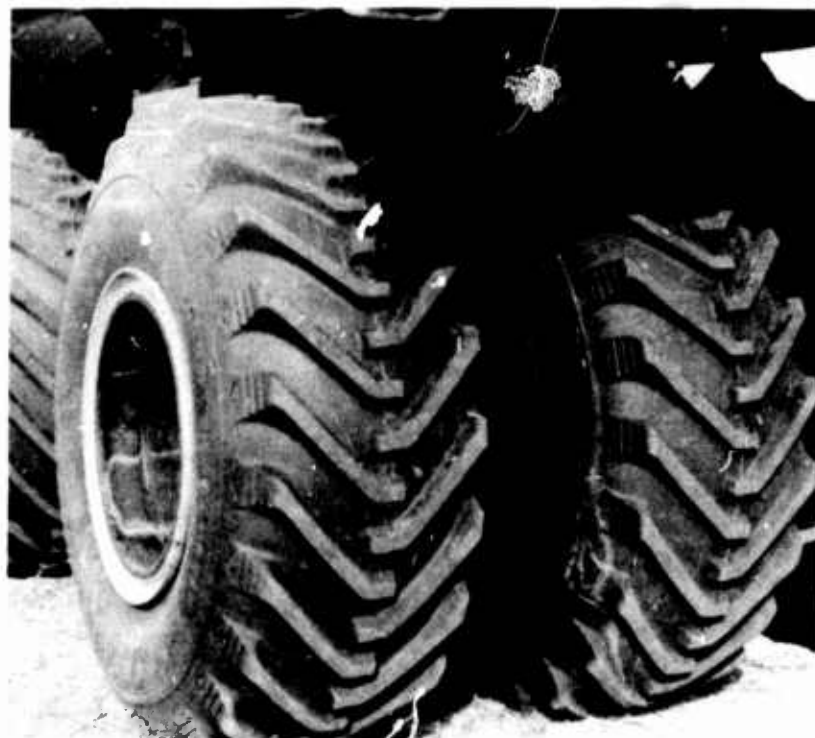
Figure 6. Goodyear 48 x 20.00 x 20 Super Terra-Grip tire, replacement tire.

psi. According to manufacturer's specifications, ground contact area is 280 square inches at no penetration and 590 square inches at 4-inch penetration. The new tires also required new wheels with lockbead rims to eliminate tire-rim slippage at the low inflation pressures. To use the tire also required reversing the wheel drive chains to eliminate the chain link pin ends' rubbing against the tire sidewall. Figures 5 and 6 show the difference in tread design between the original and replacement tires.

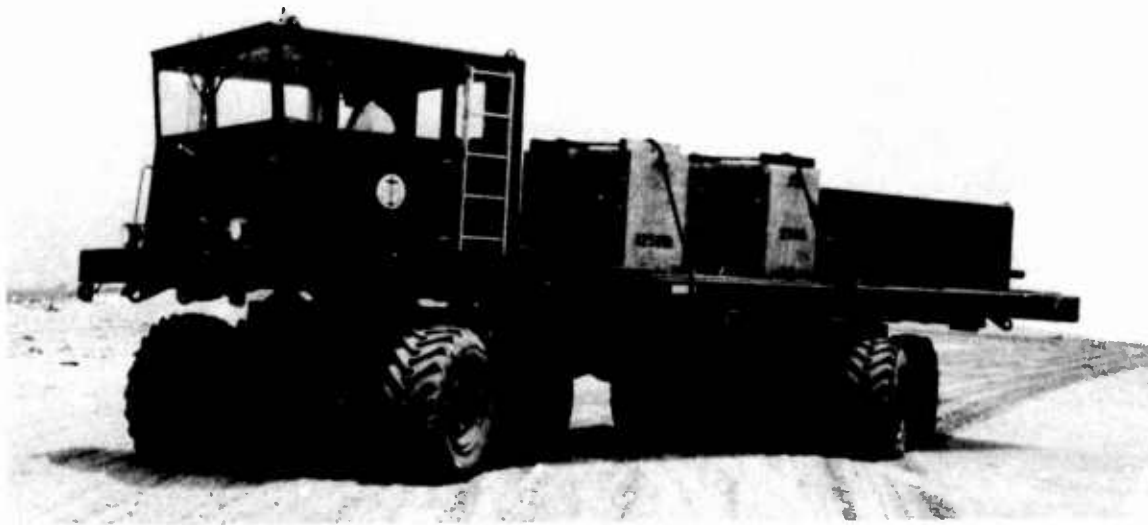
Figure 7. Operating vehicle on beach sand for Terra-Grip tire performance and frame modification tests.

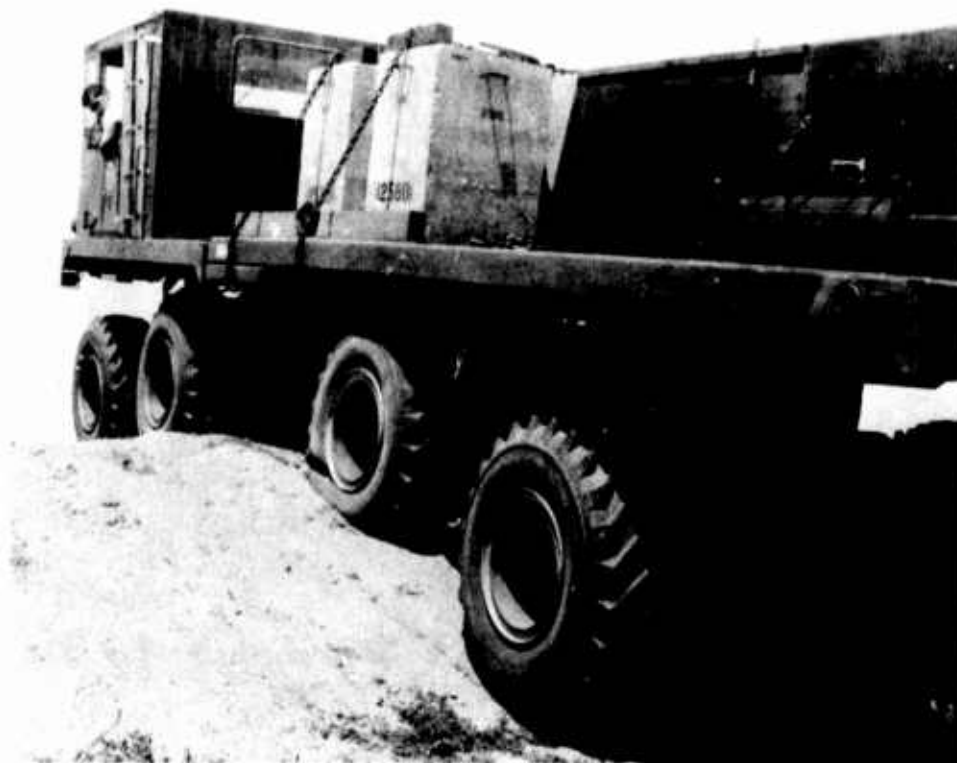
Figure 9. Sequence view of Figure 8, showing severe loading of tire as vehicle progressed over slope.

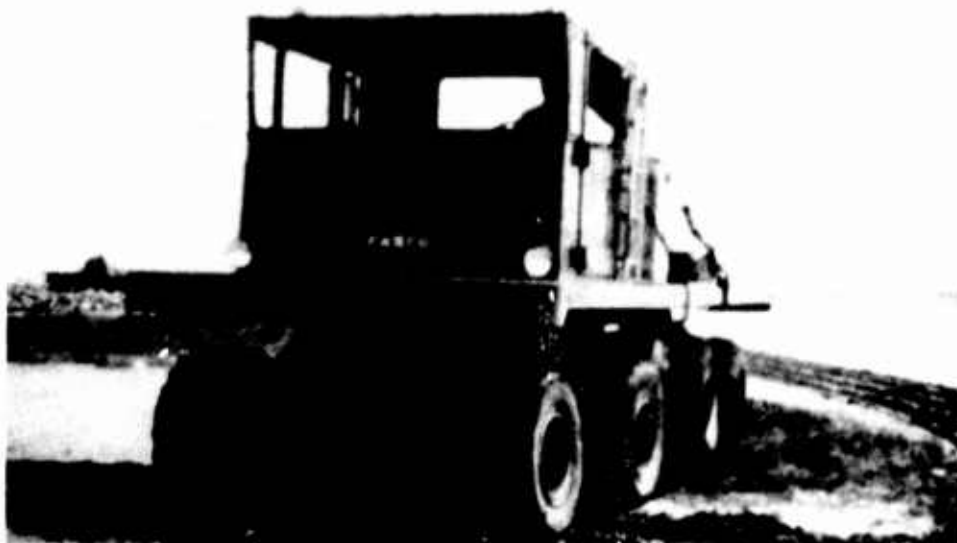
Figure 10. Vehicle making an initial pass over Point Mugu test area.

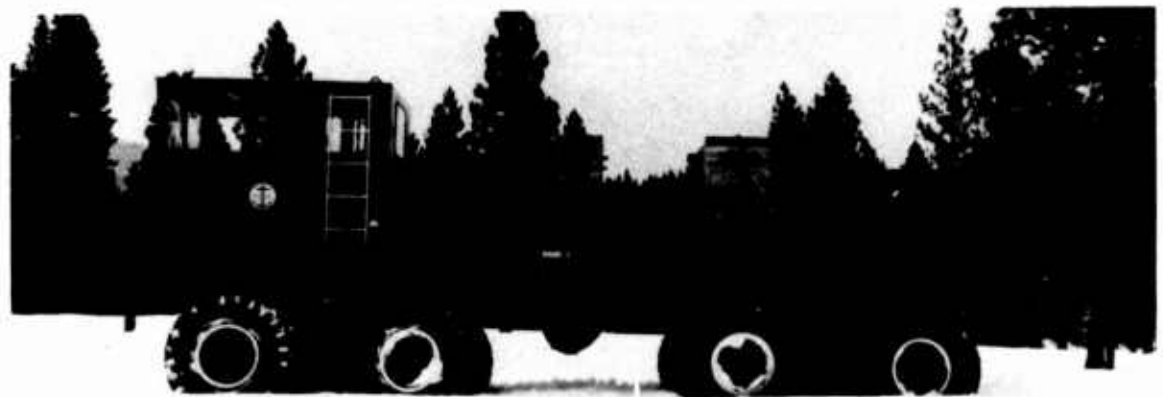
Figure 12. Vehicle operating on level terrain at Truckee test site.

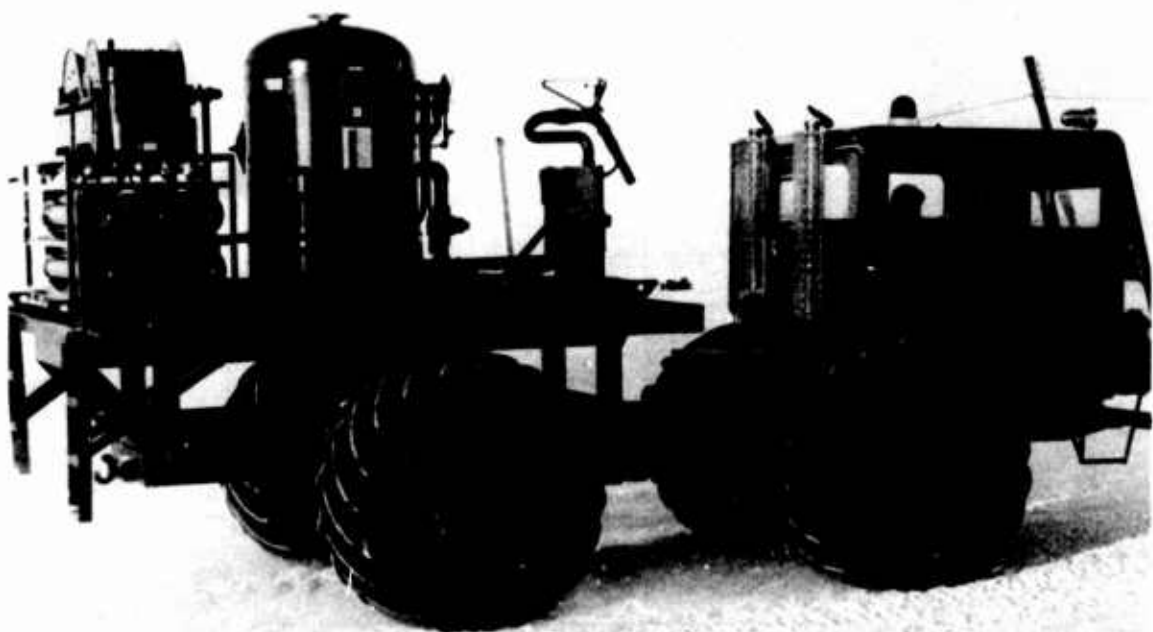
Figure 16. Nodwell Water Trotter vehicle used for aircraft crash/rescue service at McMurdo, Antarctica.
