DESIGN, FABRICATION, AND TESTING OF AN ADVANCED  
COMPOSITE AH-1G TAIL SECTION (TAIL BOOM/VERTICAL FIN)

Hughes Helicopters, Division of Summa Corp.  
Centinela and Teale Streets  
Culver City, Calif. 90230

November 1976

Final Report for Period July 1973 - February 1976

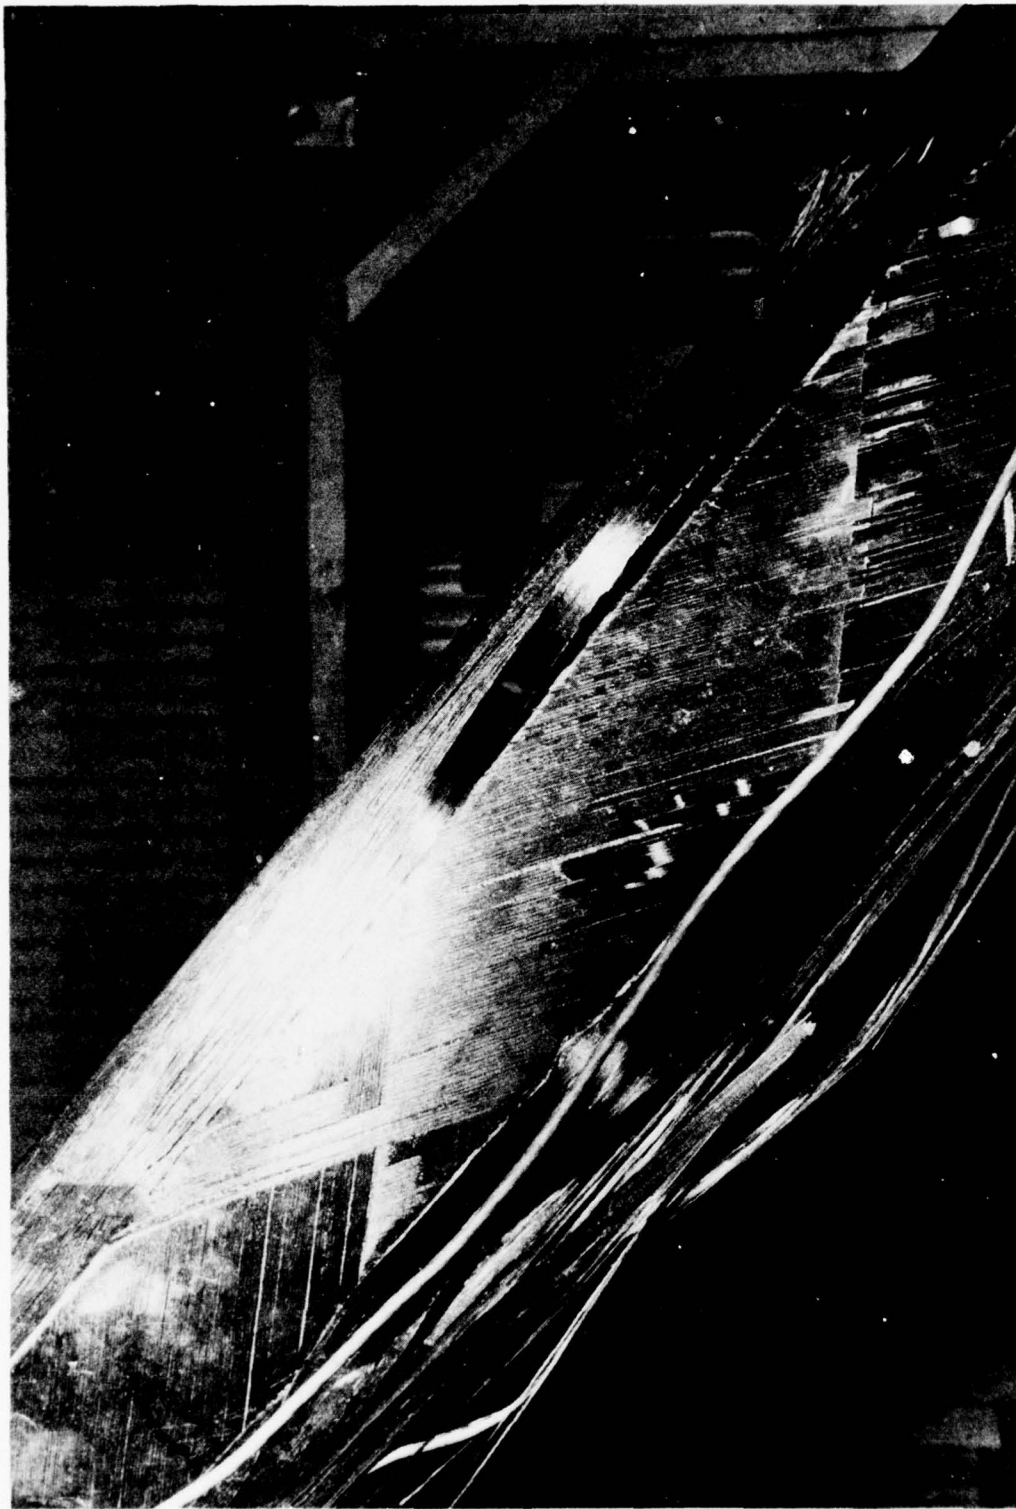
Figure B-6. Spar Failure, Right Side.

Design Load Condition A was selected for the failure test. The load was applied in the same manner and sequence as that for the limit proof load test. However, a failure of the fin spar corner longitudinal fibers occurred at the limit load after the load was held for approximately 2 minutes. The failure was compressive instability failure of the corner longitudinal graphite fibers. It was subsequently determined that a circumferential wrap of the spar had been inadvertently omitted, and this omission had caused the premature spar failure.

The spar was repaired by wrapping and bonding fiberglass fabric around the damaged area. Testing was then resumed to failure, which occurred at 150 percent of the limit load as a compression failure of the right and bottom sides of the boom outside the attachment test areas. The attachment test areas consisted of the four forward bolt fittings and boom supporting structure and the fin spar to boom attachment area. The strength of the attachment test areas was in excess of the design ultimate load; however, the actual strength of the attachments was not established. Refer to Appendix B for additional information, including photographs and measured strains and deflections.
