HEAVY LIFT HELICOPTER - ADVANCED TECHNOLOGY
COMPONENT PROGRAM - HUB AND UPPER CONTROLS.

Boeing Vertol Company
P.O. Box 16858
Philadelphia, Pa. 19142

Sep 1977

Final Report Jul 1971 - Jul 1975

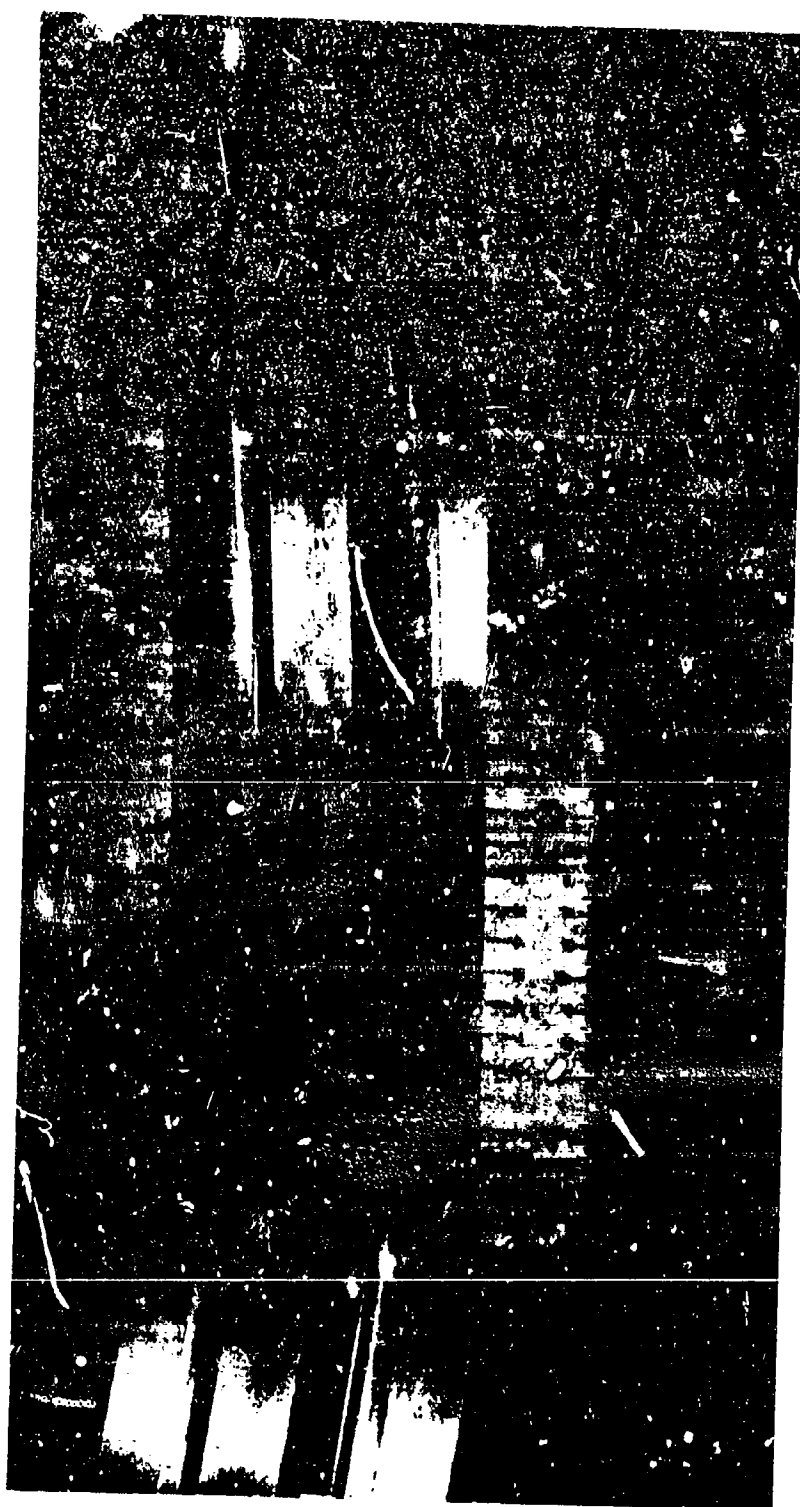
FIGURE 16. UPPER SWASHPLATE ASSEMBLY BEARING AFTER
2,200 HOURS OF TESTING

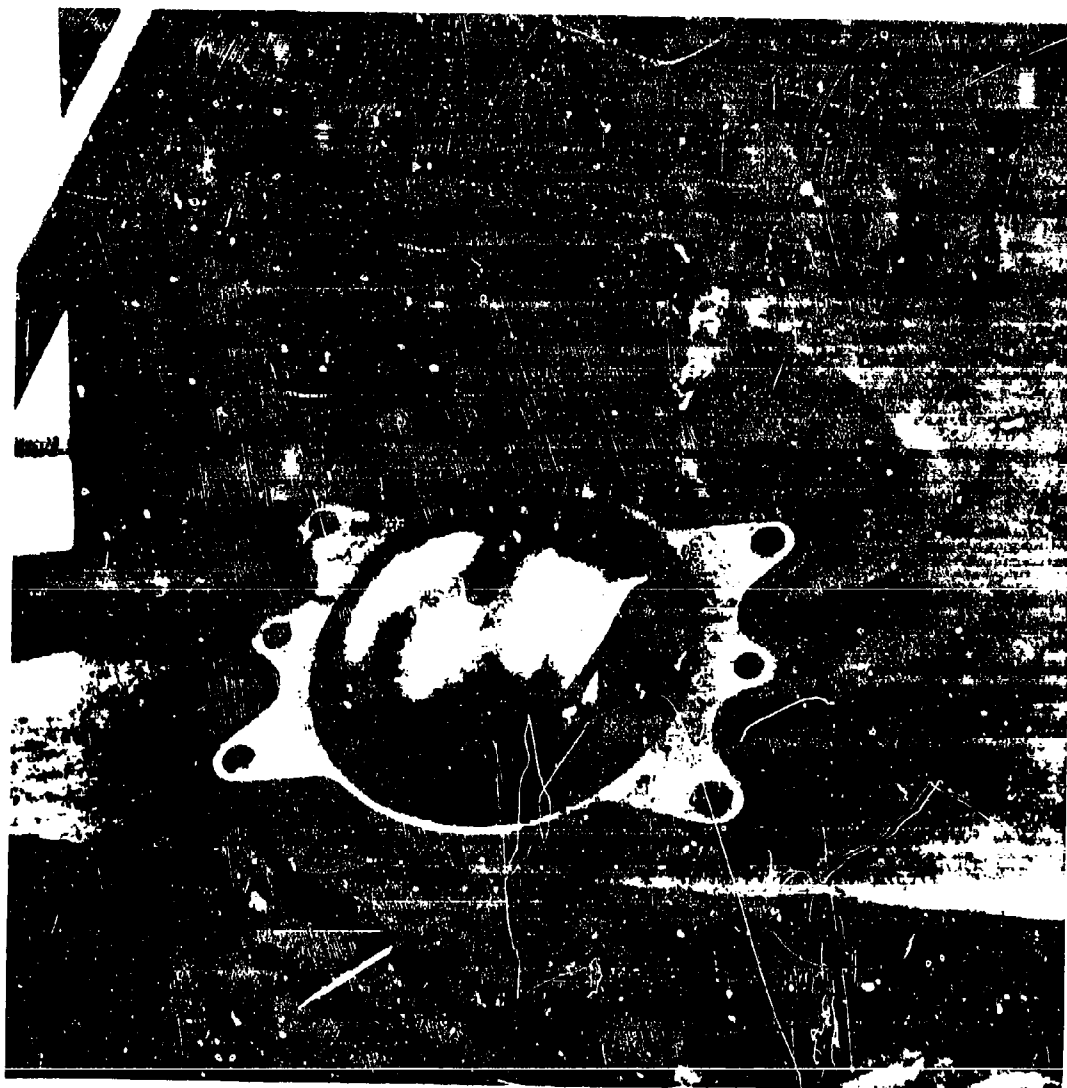
The careful inspection at this time revealed that the surface of the elastomer was covered with a network of shallow cracks. This checking was attributed to ozone attack, a well-known phenomenon with rubber. As was expected, there was no progression noticeable during the whole program, since elastomer bearings are extremely tolerant of this surface checking.

FIGURE 48. FAILED ELASTOMERIC BEARING
