12
TECHNICAL REPORT
NATICK/TR-78/011

ACCORDION SHELTER HARDWARE ANALYSIS

UNITED STATES ARMY
NATICK RESEARCH and DEVELOPMENT COMMAND
NATICK, MASSACHUSETTS 01760

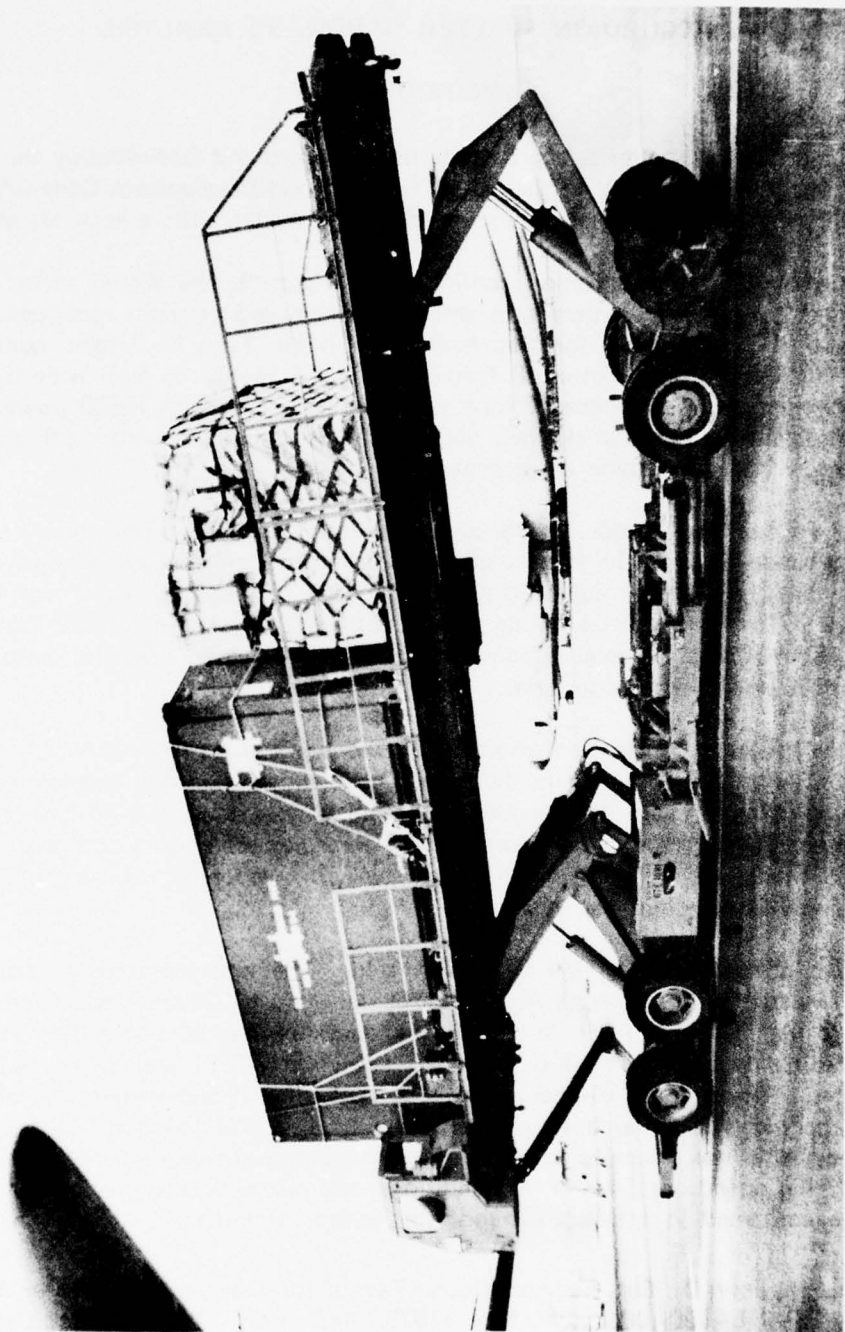
Figure 1. Accordion Shelter, Transportation Configuration. Closed Shelter Being Loaded onto Aircraft.

In the closed transportation configuration, Figure 1, the shelter serves as its own shipping container and conforms to the dimensional and strength requirements of the International Organization for Standardization (ISO) Type IC freight container. It measures nominally 2.4 metres (8 feet) high by 2.4 metres (8 feet) wide by 6 metres (20 feet) long and has a mass of approximately 3855 kilograms (8500 pounds). It can be transported by ship, truck, rail, and air and is compatible with both military and commercial freight handling equipment.

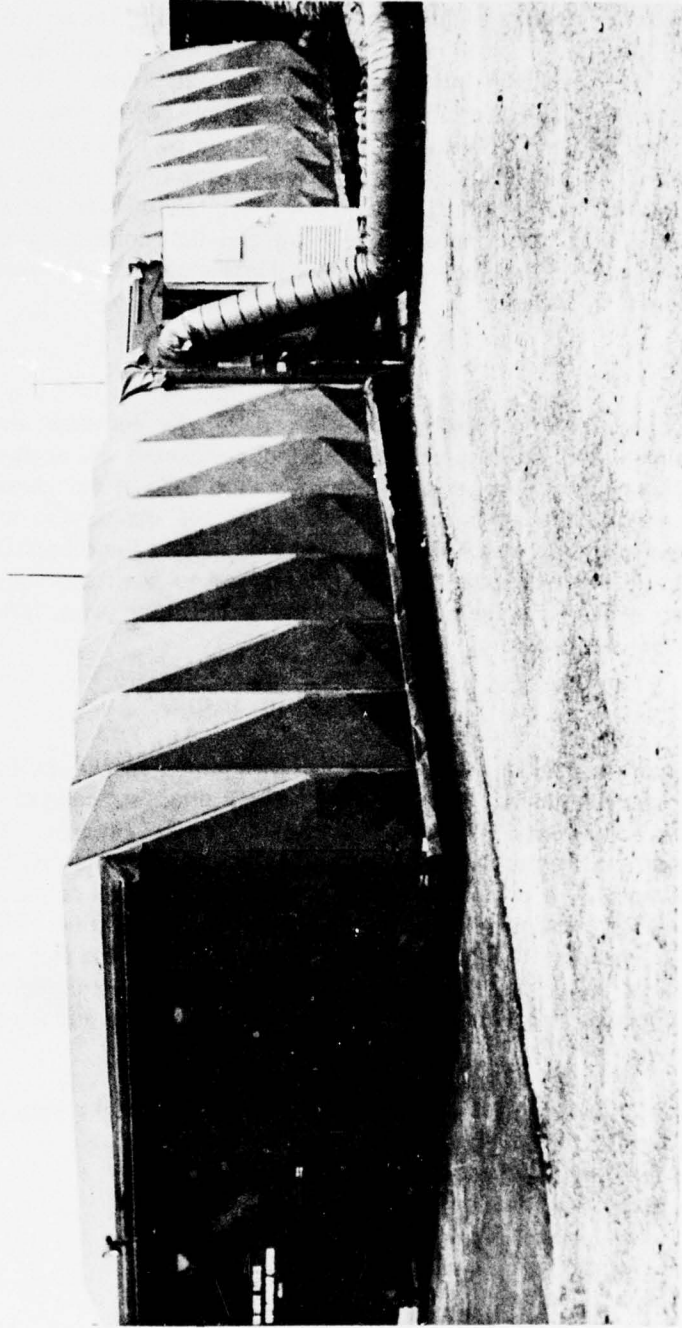
Figure 2. Accordion Shelter, Expanded Habitation Configuration. Both Shells Expanded from Central Core to Form Shelter.

In the habitation mode, Figure 2, the shelter expands from both sides of the closed shipping mode much in the manner of an accordion to form an inclosed, environmentally controlled, lighted shelter approximately 2.4 metres (8 feet) high by 6 metres (20 feet) wide by 15.2 metres (50 feet) long with about 93 square metres (1,000 square feet) of usable floor space. Potential uses of the shelter include barracks, hospital wards, administrative and recreation areas.

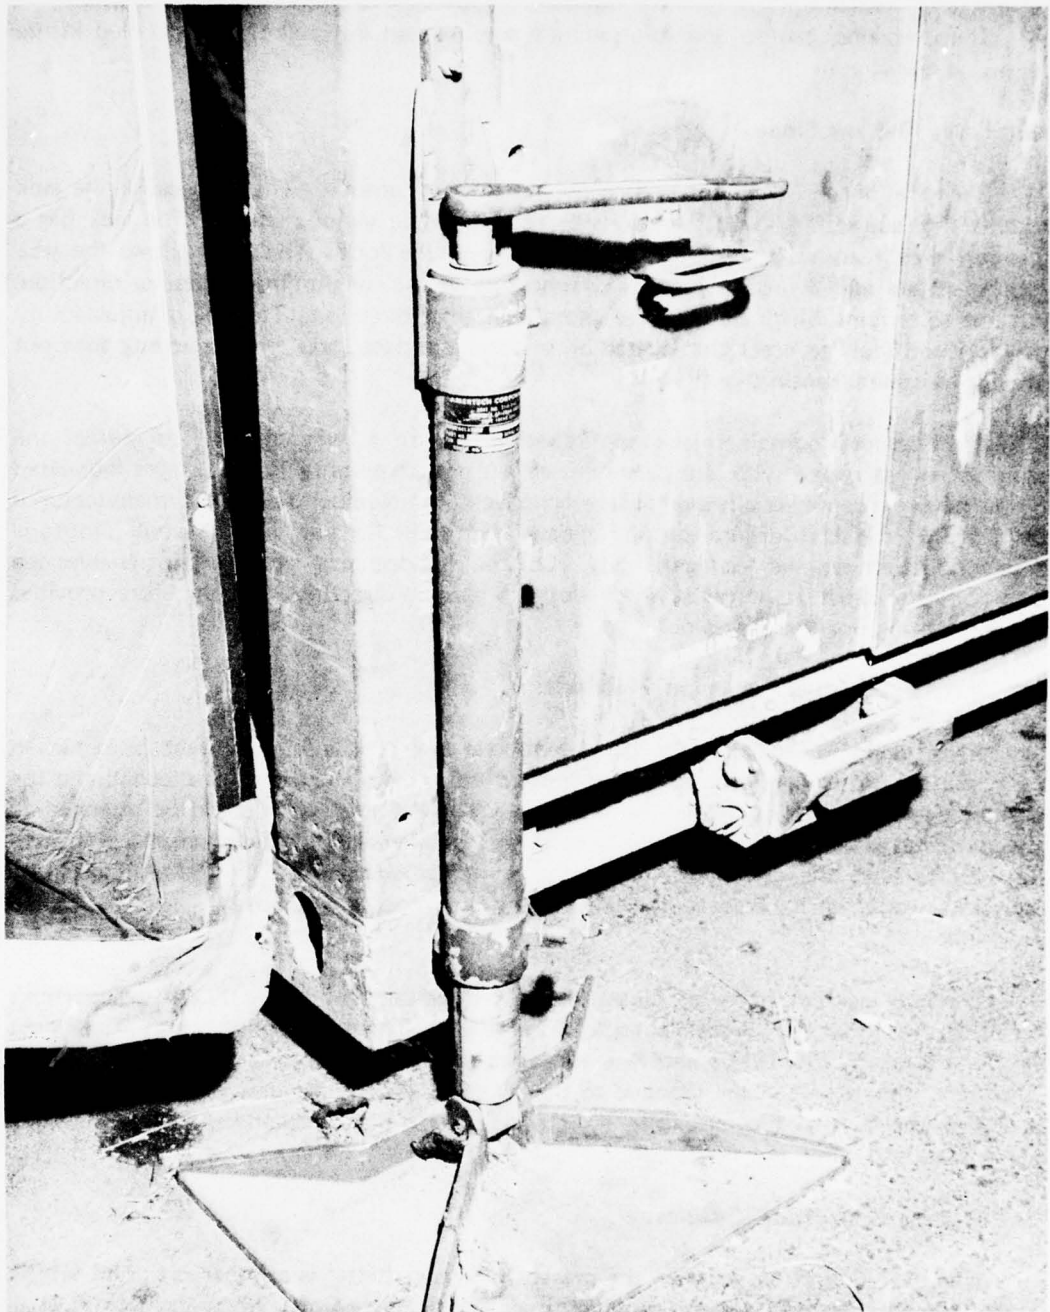
The present container jack, Figure 3, is a modified screw-type commercial item with a mass of approximately 12.5 kilograms (27.5 pounds), capable of a 46-centimetre (18-inch) lift adjustment. It engages the shelter at two points. The bottom fixation point is a heel on the jack which is placed in the bottom side ISO fitting aperture. The top fixation point is a bolt head which is placed in a slotted connector on the container approximately 71 centimetres (28 inches) above the ISO fitting. The container is raised or lowered by rotating the screw head protruding through the jack with a special wrench supplied. The lifting force is applied through the bottom connection and the top connection provides stability. Four jacks are utilized to level and support the main section of the shelter.

Figure 3. Container Jack.

The jack does not sit flat and secure on sloping terrains. This is because the jack foot is not adjustable in all directions to accommodate various slopes. The jack has a one-degree-of-freedom joint between the body and the foot. The joint allows the jack foot to rotate and adjust to terrains which slope in the longitudinal container direction, but not to terrains which slope in the lateral container direction. The lack of adjustability makes it difficult to erect the shelter on a sloping surface, and when erected, does not provide a secure footing.

The top connection between the present jack and shelter is a vulnerable point subject to failure due to the large forces which may act at this point. When the jack is at or near the fully extended position and the shelter is located on sloping terrain, side forces are generated at the foot, transferred through the jack which acts as a lever, the heel

serving as a fulcrum, and are resisted by the top connection. The forces generated are sometimes sufficient to damage the top connection because of the relatively short length of the top lever arm, approximately 71 centimetres (28 inches).

Excessive effort is required to raise or lower the container with the standard jack. Interferences between the path of the jack handle and the container wall require that the jacking operation be a push-pull motion rather than a continuous motion and consequently ten movements of the wrench are needed to raise the container only one centimetre.

The present jack handle has a history of service failures. The jack handle is structurally underdesigned, splits open in use, and can no longer be used to adjust the jack.

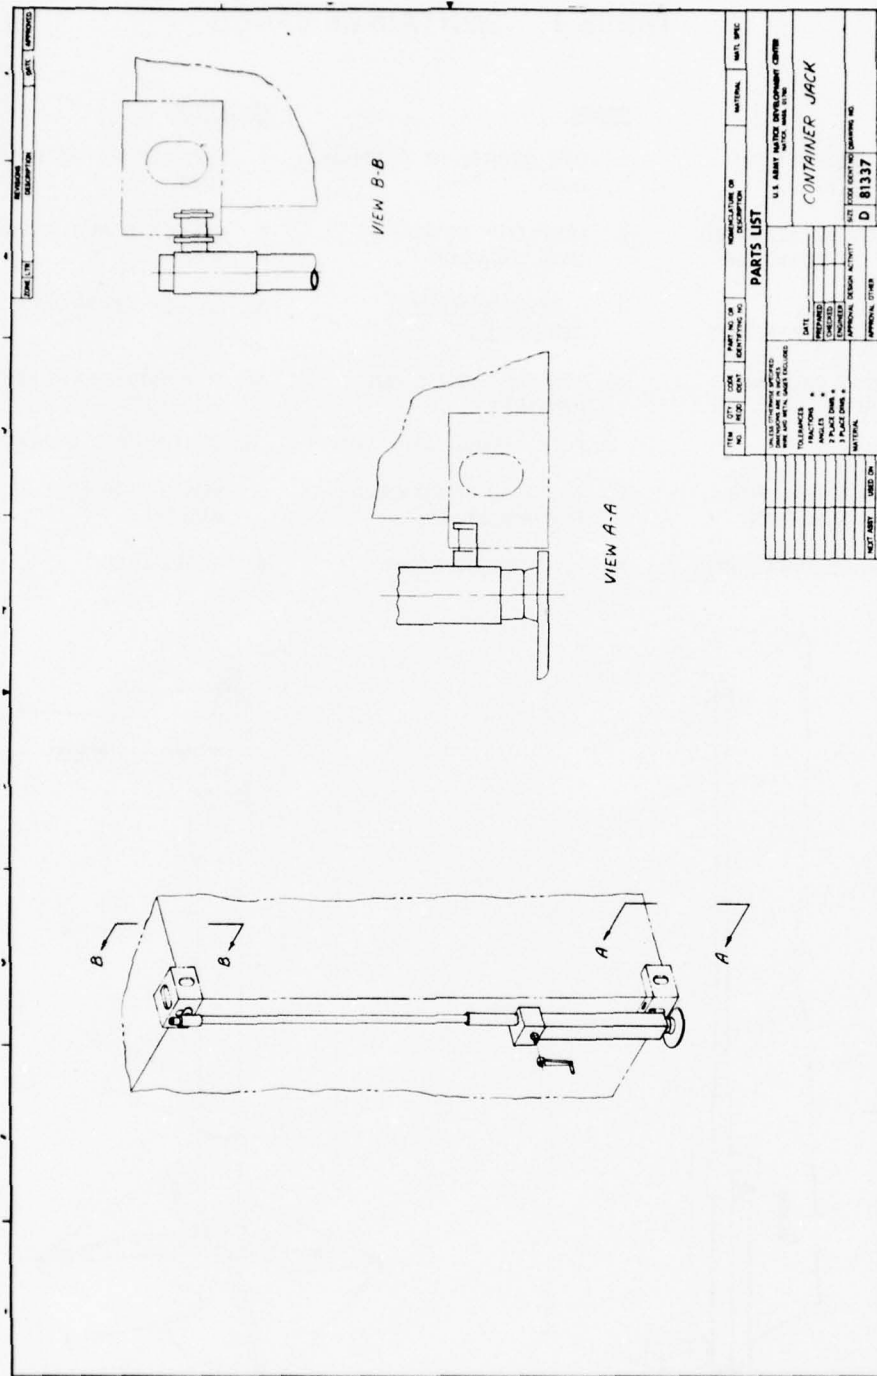
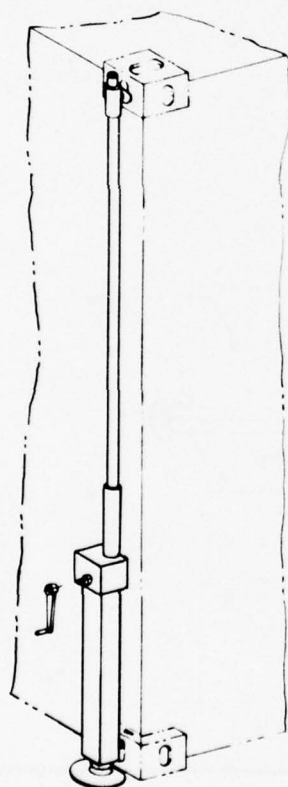
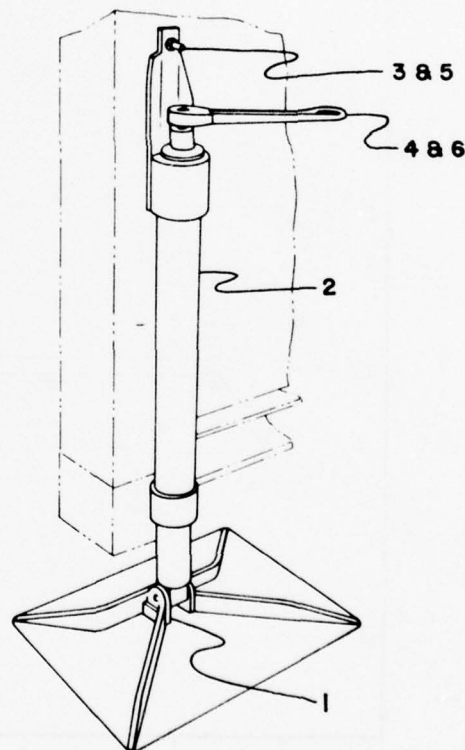
Figure 4. Improved Container Jack Design.

An improved container jack configuration, Figure 4, was designed to correct the deficiencies associated with the present item. A prototype unit, Figure 5, was fabricated by modifying a commercially available leveling jack, Part Number 31030-18, manufactured by Saginaw Products Corporation of Saginaw, Michigan. The new jack has a ball-joint-type connection between the foot and body. The multiple-degree-of-freedom joint enables the jack foot to adjust to terrains which slope in various directions and therefore provides a firm footing for the container.

The new jack configuration allows the jack to be attached to the ISO fitting apertures on either the end or the longitudinal side of the shelter. The mobilizer obstructs attachment of the jack to the ISO fitting end face apertures but not the ISO fitting side face apertures. Therefore, the jacks can be attached to the ISO fitting side apertures while the container is still in the jaws of the mobilizer, thereby decreasing both the time and effort required to remove and level the container.

In the new configuration the upper connection point has been relocated from the container end wall to the top ISO fitting. The relocated attachment point increases the resistive lever arm to 2.4 metres (8 feet) and decreases the force acting at this point. The combination of the decreased force and the increased strength of the connection point, as a result of using the present ISO fitting, eliminates the connection point failures.

On the new jack the wrench attachment point has been moved from the top to the side of the jack, thus eliminating interferences, and the wrench has been replaced with one which mates with the side connection point. The wrench can now be rotated in a continuous 360° circle instead of the previous back-and-forth motion which covered an arc of only 170°. These changes reduce the number of motions required to raise or lower the jack heel by fifty percent.

As previously stated, the new jack is designed to attach to the container at the top and bottom ISO fitting apertures. The apertures are standard on all ISO containers; therefore, the jack will mate with all ISO-type tactical shelters. The problem of incompatibility has been eliminated.

The new jack handle design is stronger than the previous model and should prevent the inservice failures which had been experienced.

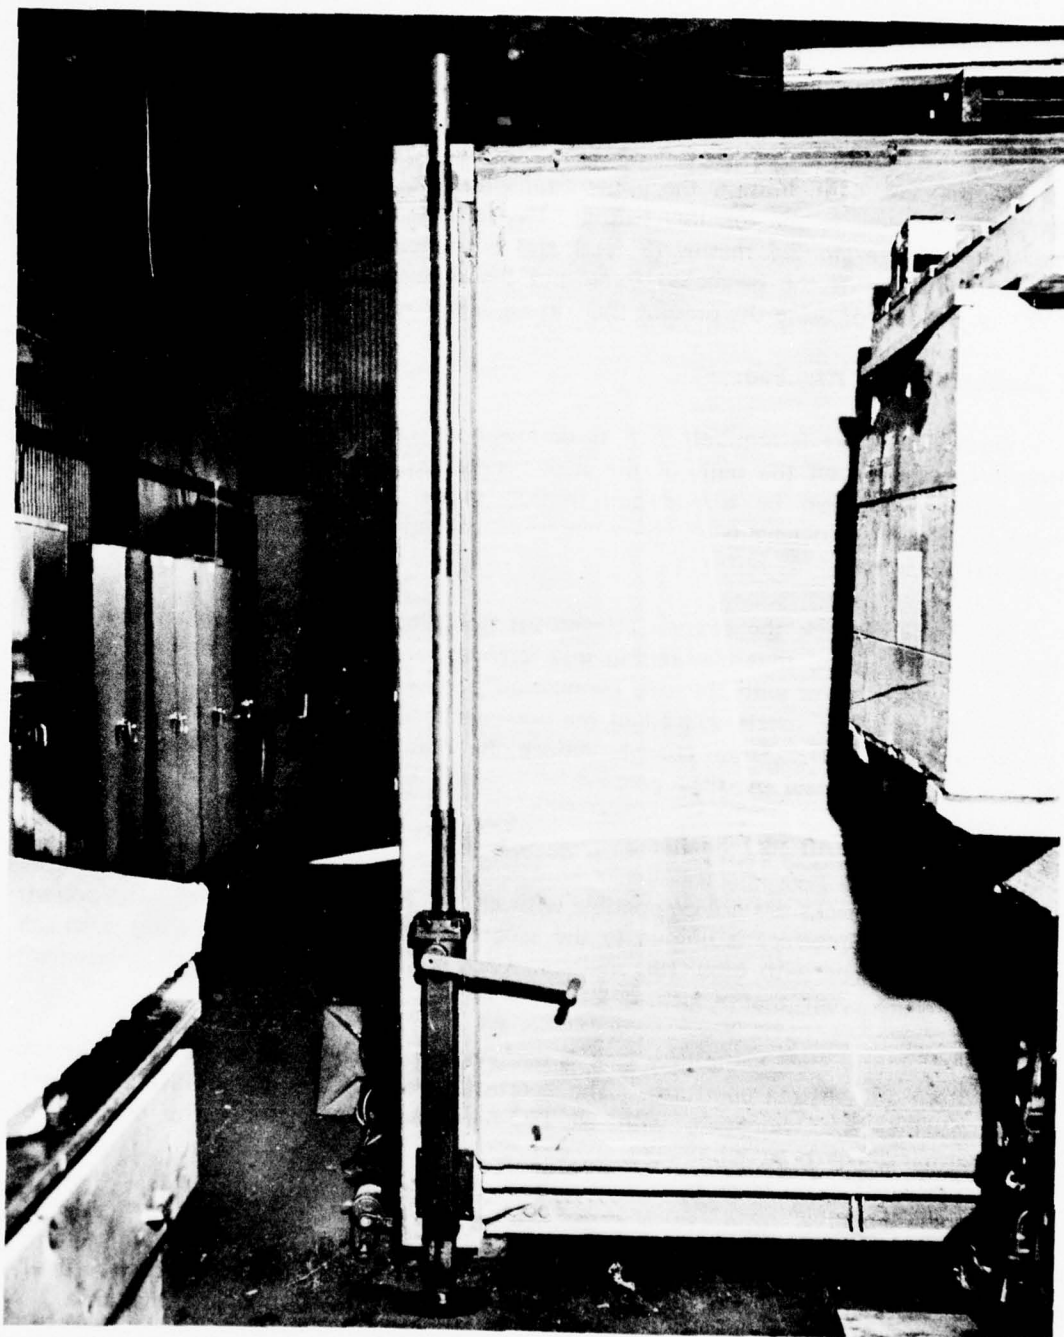
Figure 5. Improved Container Jack Prototype. Modified Jack Mounted on Side of Closed Shelter.

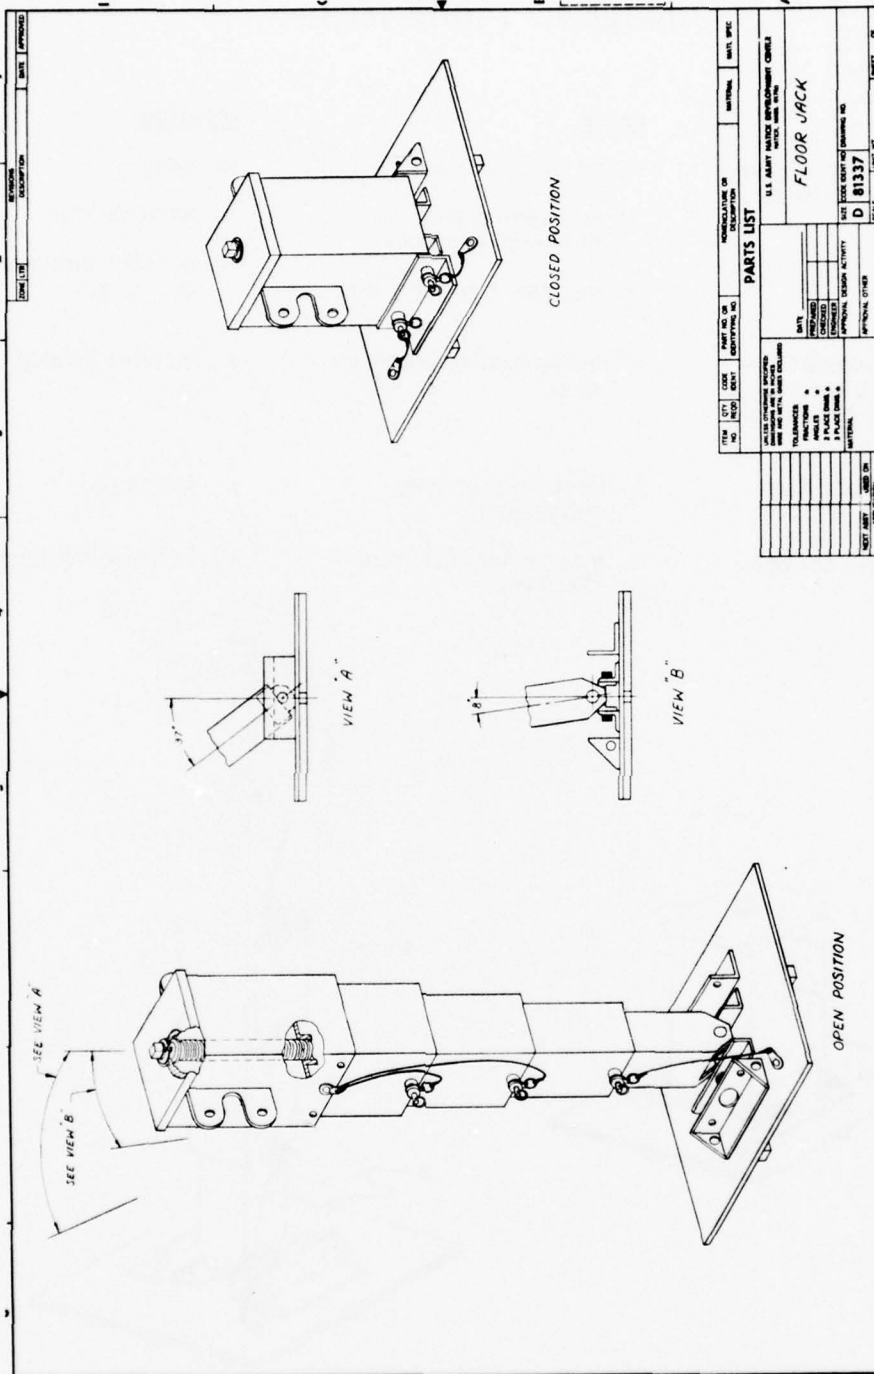
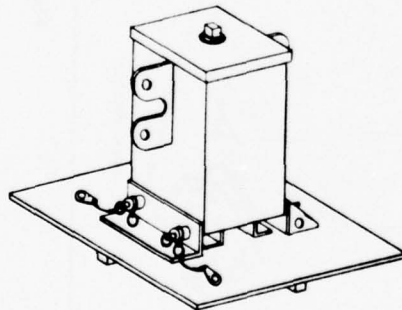
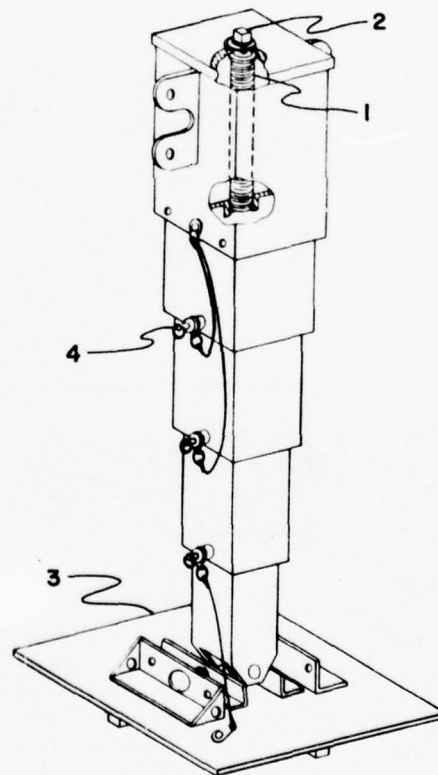
Figure 7. Modified Floor Jack.

The floor jack was modified as shown in Figure 7 to eliminate this and the other problems cited. As part of the modification, the jack screw was replaced with a new jack screw, Figure 8, which has a shoulder that is designed to carry the bushing without damage and positively stop screw motion at the end of travel. The plastic floor caps

which protect the jack screw will also be marked to indicate the proper direction of rotation to raise and lower the jack. These two changes correct the problem associated with loss of the jack screw.

The problem was alleviated by welding a cross to the bottom of the foot. The cross protrudes into the soil when the jack is loaded and resists slippage.

The method of attaching the locking pin lanyards to the jack body has been strengthened to prevent future loss of the pins.

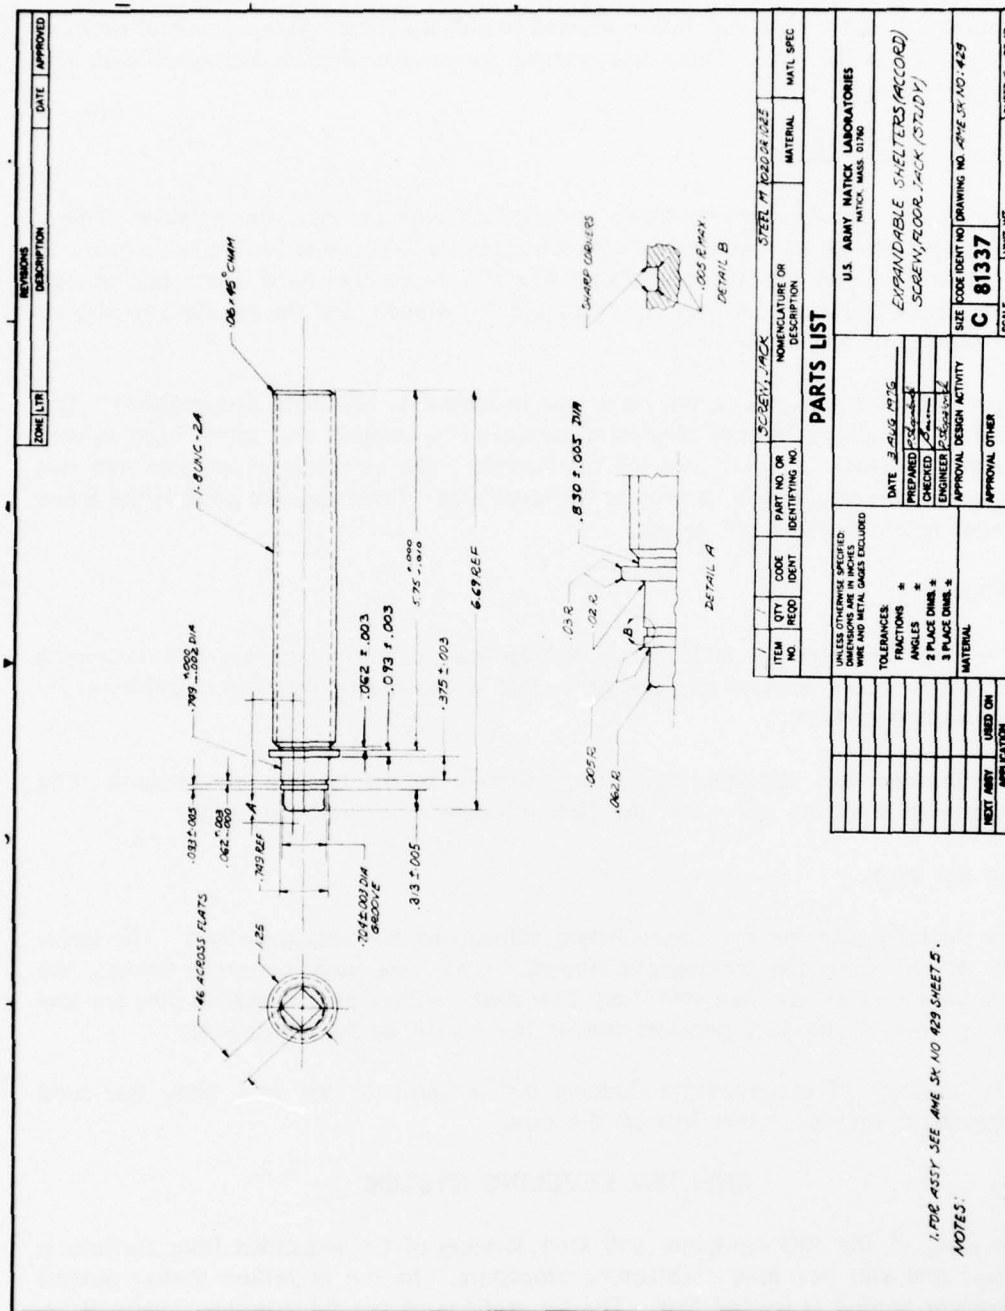
Figure 8. Modified Jack Screw.

The length of the jack screw head was increased to eliminate this problem. The increased length assures proper alignment between the wrench and screw head as well as providing a greater gripping area for the wrench. The thickness of the jack top was also increased correspondingly to protect the screw end. These changes prevent the screw head from being rounded off in use.

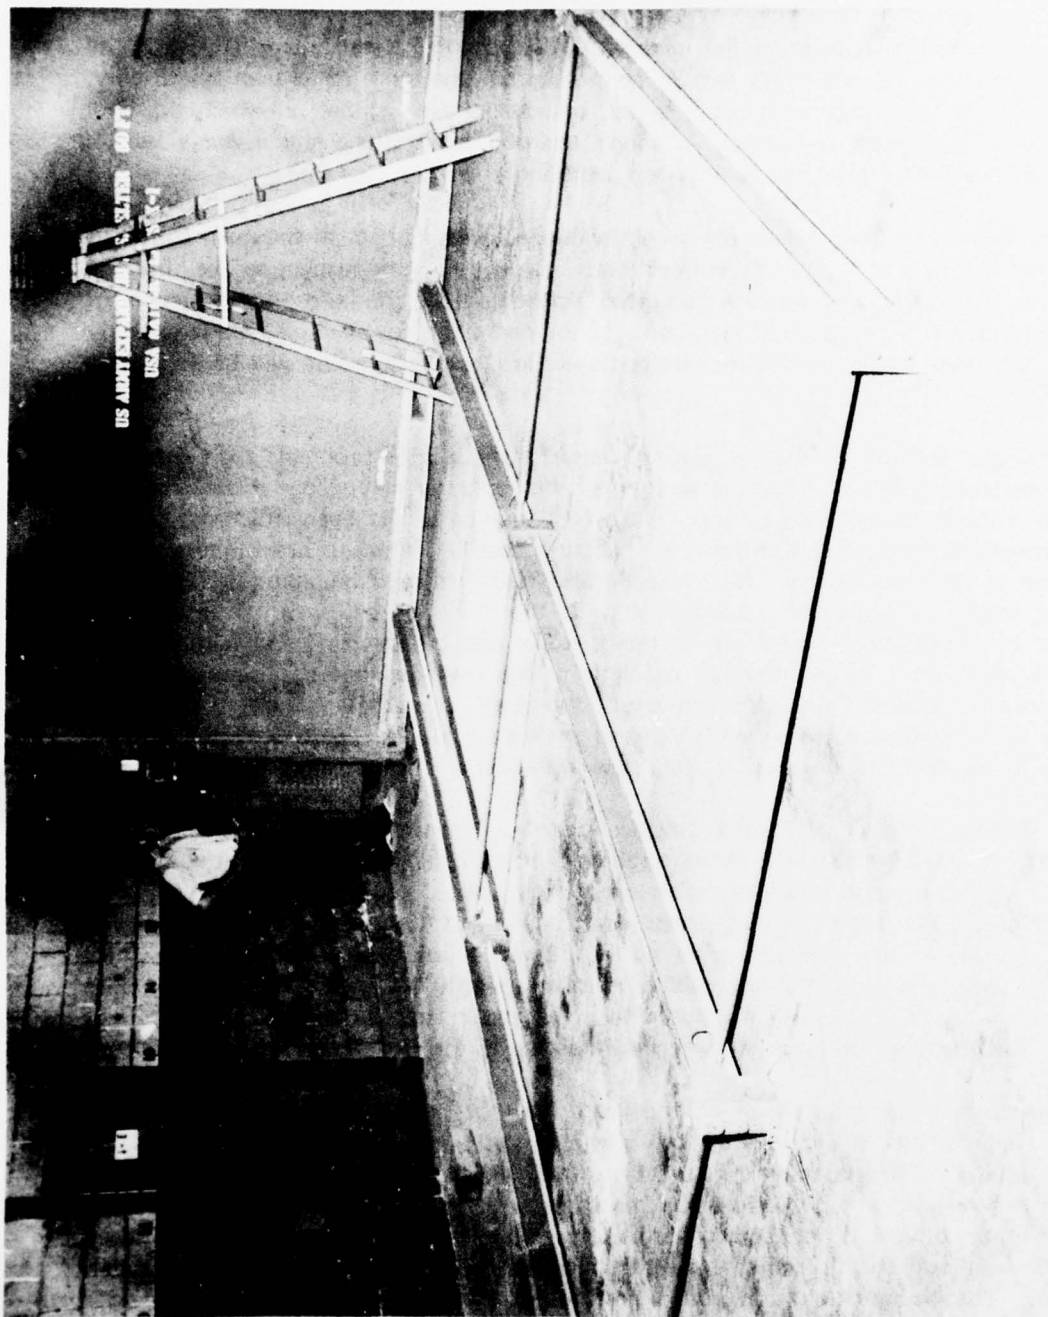
Figure 9. Accordion Shelter Foundation. Six Sections of Floor Beams Attached to Six Floor Jacks with Four Stabilizer Bars. Expanded Floor is Laid on this Foundation.

A mason's level, subject to the inherent deficiency of the instrument, is used in the leveling operation. The mason's level is correct within the range of its own length only. Any local deformity such as a bend, bump, or bow in the member on which the level is positioned will cause an error. Although the points on which the mason's level is placed are level, the total member is not necessarily level.

The first three floor beams are generally leveled with respect to the main container body and the second set of three floor beams is leveled with respect to the first set. Therefore, the accuracy of each measurement depends on the one before it, and any error is compounded throughout the operation. If the container, for example, is not properly leveled, the floor beams, which use the container as a reference point, will be impossible to level.

Improper leveling of the foundation causes more serious problems than merely a sloping or rocking floor. Improper leveling of the container may wedge the shelter sides in place in the shipping configuration. They must then be forced open which can damage the honeycomb panels and also result in a safety hazard if the panels break free suddenly and drop to the floor beams. Poor leveling also results in misalignment of the fasteners used to secure the expanded accordion shell to the floor and end wall. This makes it difficult or impossible to mate the fasteners, can cause overstressing and failure of the fasteners, and result in an interface which is neither weathertight nor blackout proof. An improperly leveled foundation can result, therefore, in a safety hazard to personnel, damage to the shelter, decrease habitability of the shelter and also cause the entire erection process to be difficult, frustrating, and time consuming.

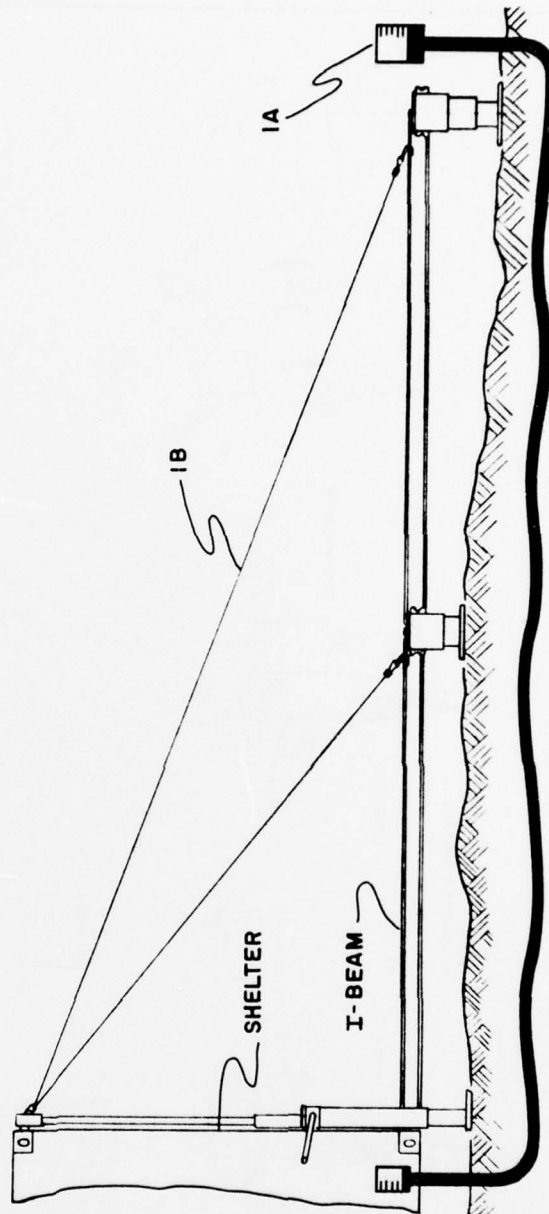
The correct elevation to which the jacks must be adjusted can be indicated by a device similar to that in Figure 10. Two identical graduated cylinders are connected with flexible tubing. The assembly is placed on a level surface and filled up to a convenient reference mark with a suitable liquid. One cylinder is attached to the bench mark jack, and the other cylinder is attached to the jack to be leveled. The jack is raised or lowered until the height of the fluid in the cylinder reaches the reference mark on the graduated cylinder. The two jack-fixation points are then at the same elevation. The process is repeated for the remaining jacks, always referring back to the same reference jack. When all the jacks have been brought to the same elevation, the foundation is level. A standard correction factor is applied when adjusting the floor jacks to the container jacks to account

for floor thickness and leveling device mounting position.

Two new methods of leveling the accordion shelter were proposed, (see Table 3) and prototyped. One method is based on the principle of height difference of two selected points. In this method one foundation supporting point, i.e., container jack, is chosen as a reference. The other fifteen jacks (three container and twelve floor) are then adjusted, one at a time, to the same elevation as the reference jack. If each supporting point is at the same elevation, the foundation must necessarily be level. Local deformities between the jacks, therefore, do not affect the result and individual errors are not accumulative because each jack is leveled in reference to the one chosen bench mark point.

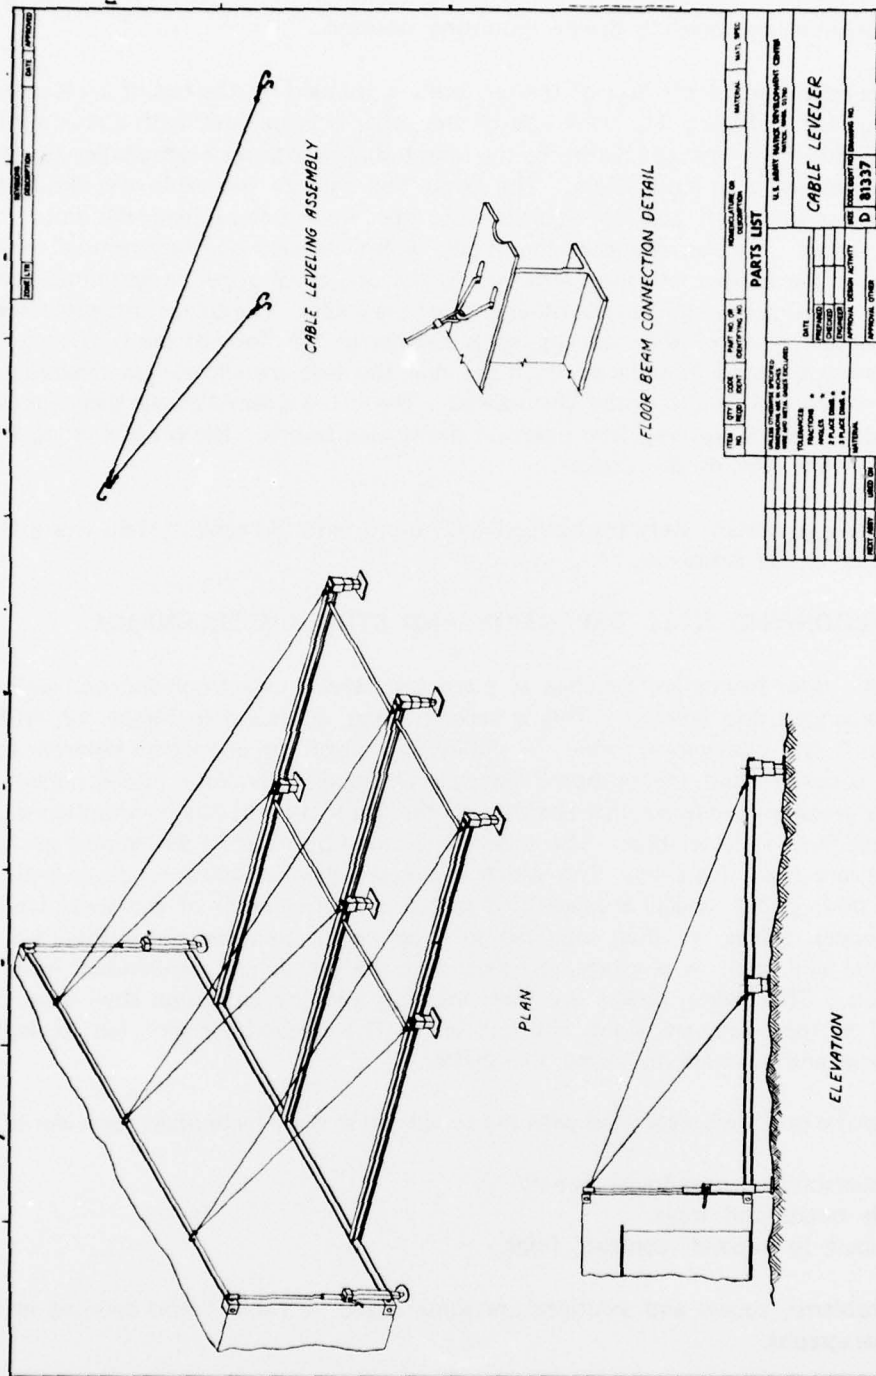
Figure 11. Cable Leveler.

The second proposed method of shelter leveling is based on the use of premeasured cables as depicted in Figure 11. One end of the cable is terminated with a round hook which is inserted into a mating hole in the top longitudinal container beam perpendicularly above the centerline of a floor beam. The other two ends of the cable are terminated with double hooks which can be hooked onto the floor beams near the floor jack attachment points. In use, the container body is first leveled by conventional means. Three sets of cable levelers are then attached to the container upper longitudinal beam, and the floor beams are hung from the other ends of the cables. The cables are premeasured to assure that the plane of the floor beams is parallel to the floor of the container. At this point the suspended floor jacks are freed, and the feet are allowed to telescope to the ground where they are adjusted and locked. The cable assemblies are then removed and the folded floor is lowered into place on the leveled beams. The process is repeated to level the other side of the shelter.

Both leveling systems were prototyped and tested, and the cable system was judged superior based on its simplicity.

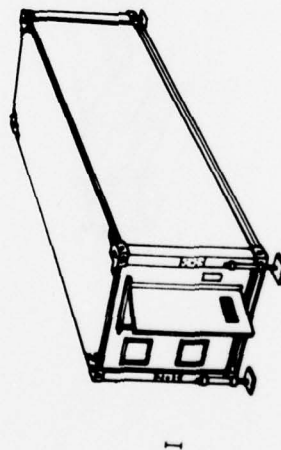
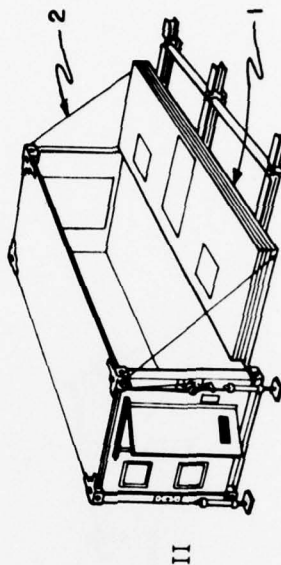
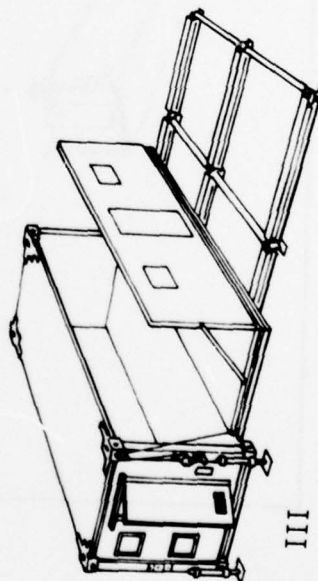
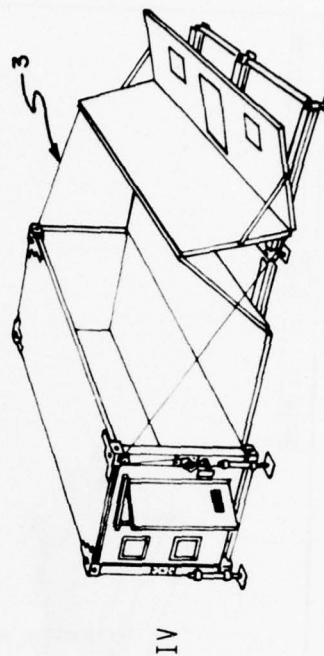
After the floor beams are fastened in place and leveled, the floor and end wall are unfolded, expanded and erected. This is accomplished, as shown in Figure 12, with a series of winch and pulley operations. A pulley and winch are connected between each end of the container and the outboard honeycomb panel. The four folded panels are lowered as a group to the horizontal position on the foundation beams by simultaneously releasing cable from both winches. The end wall is raised by hand to the vertical position and a temporary brace installed. The winch cables are then attached to the corners of the middle floor panel, which is raised and pulled over the center of the second hinge line. The winch cables are then attached to a connector between the outboard floor panel and the end wall, as a safety restraint, and the panels are manhandled into the open position. The ceiling beams are then installed and the accordion shell expanded and secured to the container, floor, and end wall. The sequence is repeated to deploy the other side and reversed to strike the shelter.

Figure 12. Shelter Expansion Technique.

Lowering of the folded panels as a group onto the floor beams is a cumbersome operation for two reasons. First, the winches used to lower the panels are located approximately chest high. This is an awkward location for the operators because it is difficult to apply maximum force in this position. A preferable location would be approximately waist high where good leverage can be attained, but this is impossible because the container jack obstructs the location. Secondly, the panels should be lowered smoothly to assure that the load is evenly split between the two cables and uniformly distributed over the length of the hinge. This is difficult to achieve in actual practice because it requires perfect coordination between the two winch operators. Normally, despite the best efforts of both operators, the panels are lowered in a series of jerks with one winch or the other supporting the total load.

The cable itself was also identified as a problem area. The cable does not wind up on the winch drum uniformly, but tends to twist, overlap, and tangle on the drum as it is being retracted. Individual strands of the cable also break and fray with use. The frayed wires weaken the cable and can cause injury to operators.

The twisting of the cable and breaking of the wires is caused by the use of right lay cable instead of the left lay cable which is called for by the "underwind left to right" left anchorage winch-drum configuration. The problem can be eliminated by retaining the present winch-drum configuration and substituting left lay cable for the right lay cable. However, left lay cable is not always immediately available. A better solution would be to retain the right lay cable and modify the winch drum to an "underwind right to left" right anchorage configuration. This would eliminate the tendency of the cable to crisscross and overlap on the drum with the resulting damage.

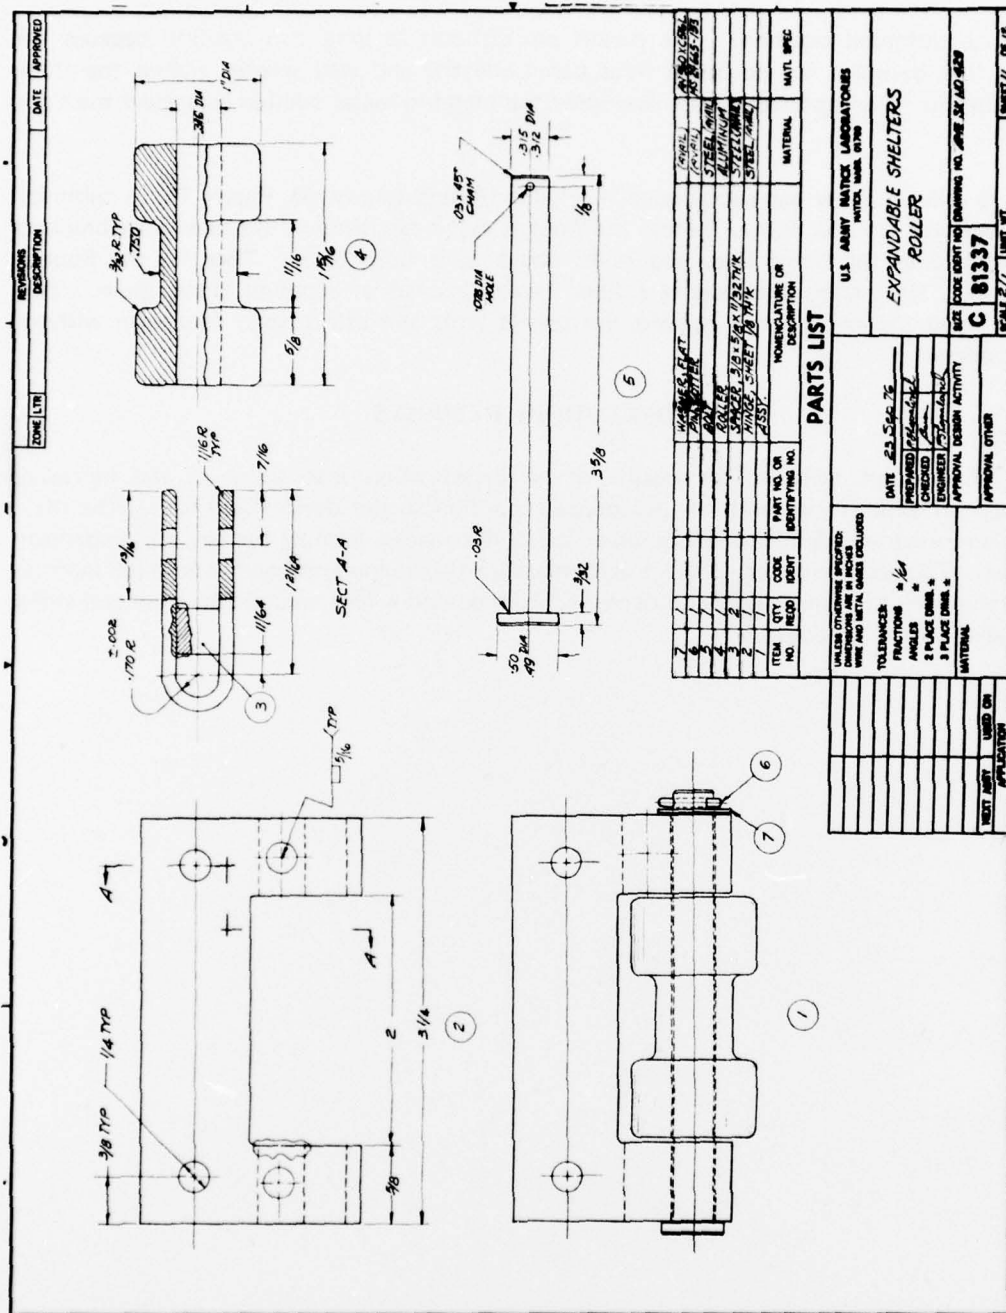
Figure 14. Roller Bracket Design.

A roller bracket has been designed, Figure 14, and fabricated, Figure 15, to minimize the frictional resistive force. Before the floor is expanded, three of the new roller brackets are pinned at the hinge line, one roller above each floor beam. Then, as the floor is expanded, the panels roll over the floor beams instead of scraping along them. Two men, using the rollers, can expand the panels with less effort than four men without the rollers.

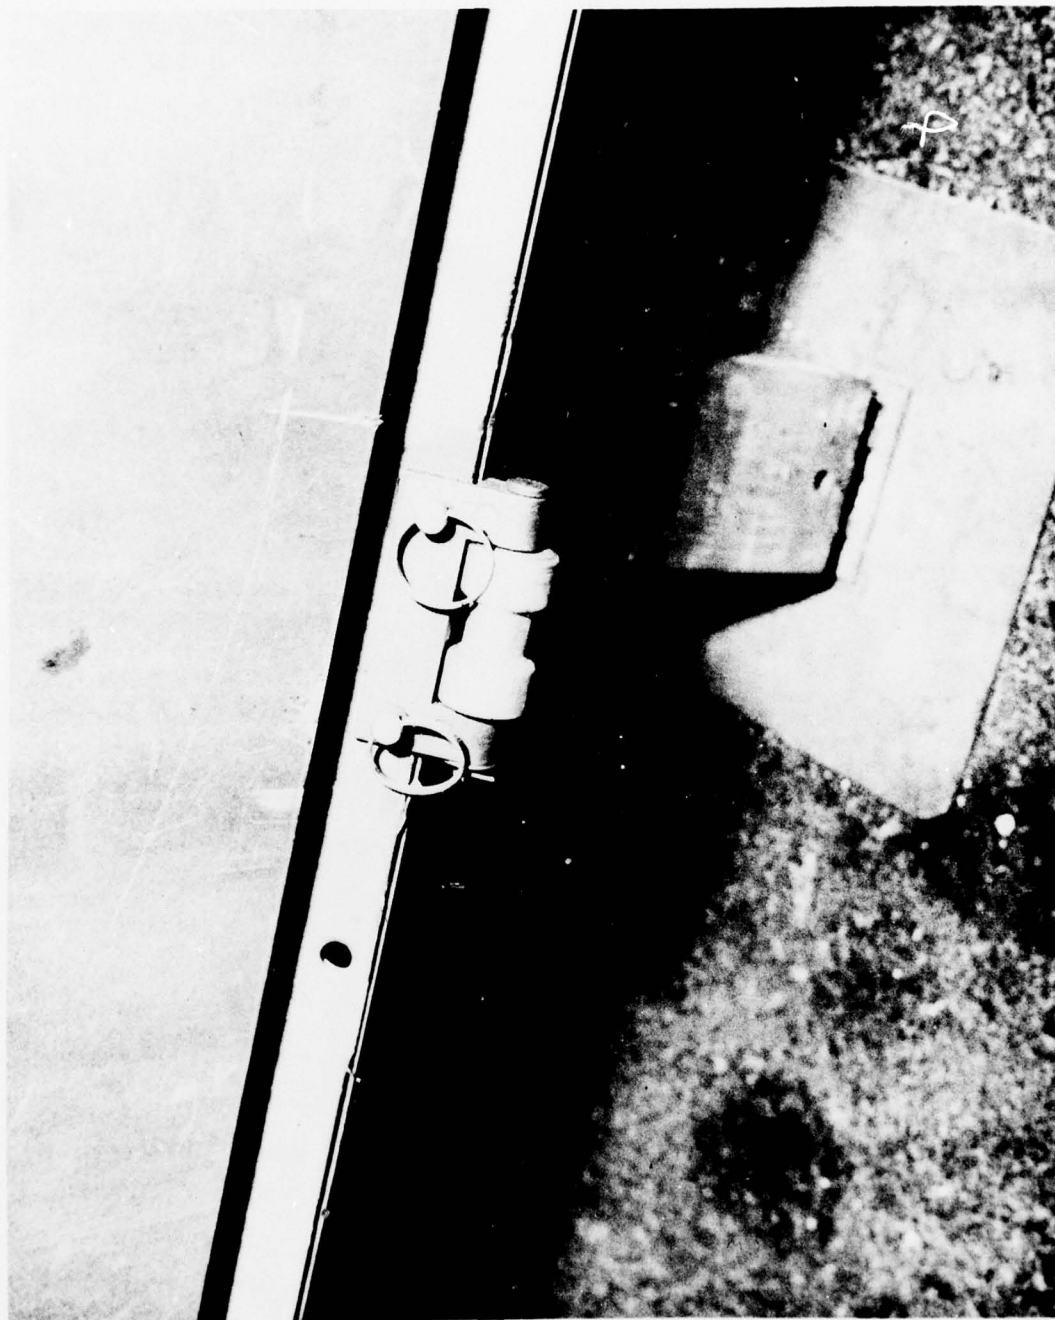
Figure 15. Roller Bracket. Roller Bracket Pinned to Hinge Between Expanding Side Wall and Floor.
