NAVAL AIR TEST FACILITY LAKEHURST N J
PRELIMINARY EVALUATION OF VISUAL LANDING AIDS FOR AV-8A AIRCRAF--ETC(U)
JAN 75

LETTER REPORT

NATF-A77

6 Preliminary evaluation of visual landing aids for AV-8A aircraft operations at VSTOL Forward Operating Facilities.

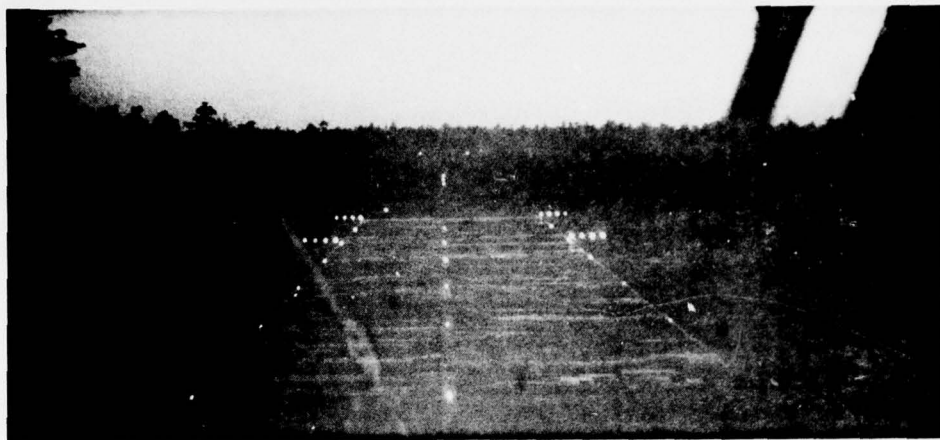
Figure 4 - Approach by Helicopter From Approximately 1-1/2 Miles Out
to Transition to Hover Over the Runway Threshold
(VSTOL Forward Operating Facility)

(2) Field boundary identification was greatly enhanced by the placement of the red obstruction lights at the tree line at both ends of the runway corridor and in line with the runway edge lights. Although not tested, placement of the obstruction lights at treetop level would ensure aircraft clearance and provide a downwind positioning cue to the pilot. These lights also aided in center lineup and closure rate. Once the helicopter is clear of the tree line, centering information and altitude cues are obtained from all runway environment lights and the GSI (Figure 4).

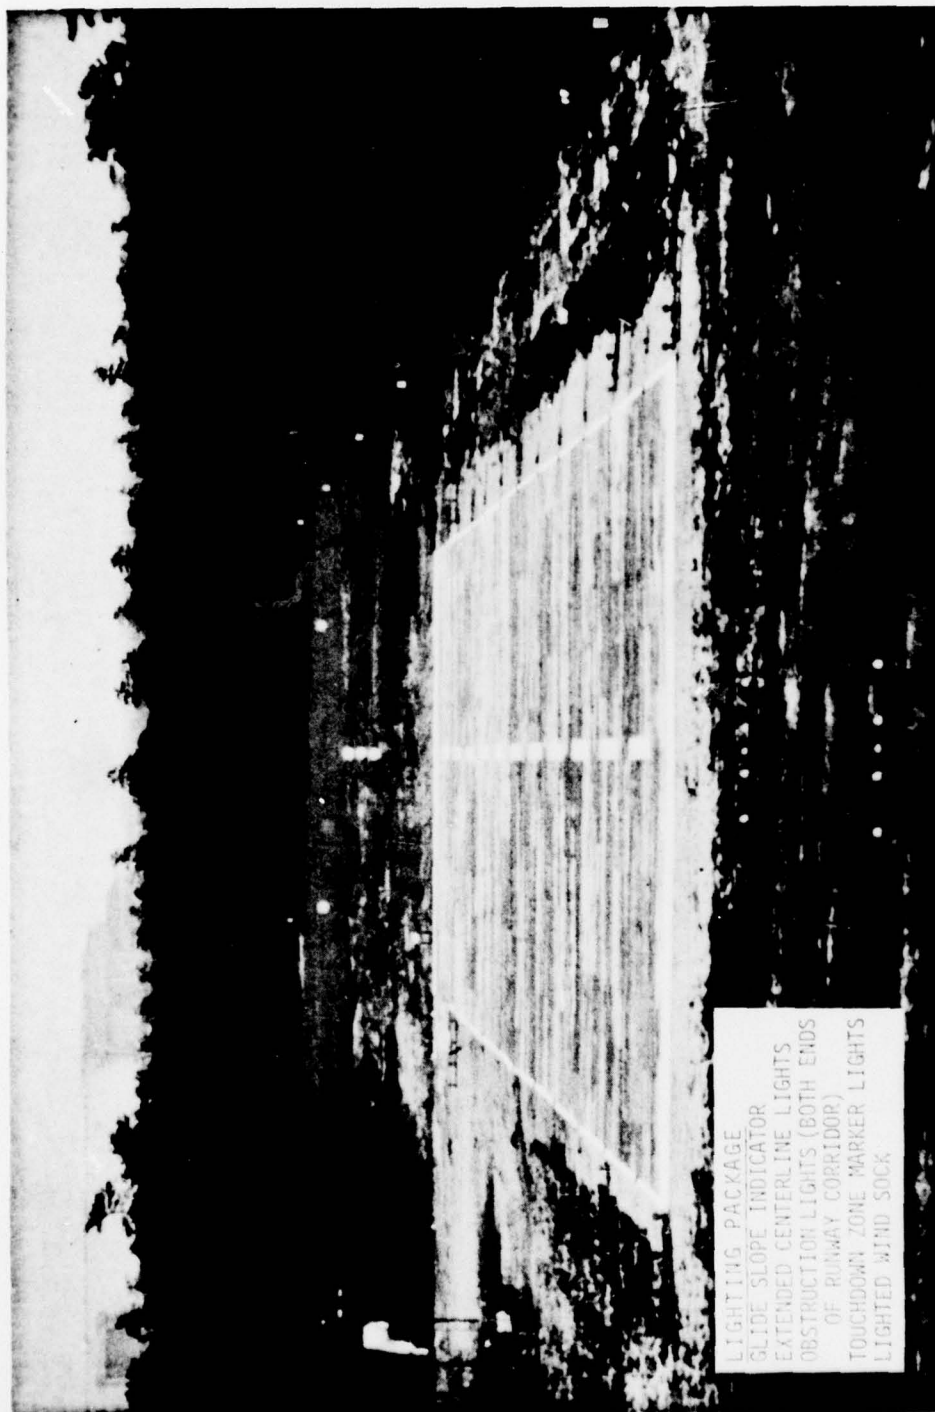
Figure 6 - Minimum Lighting Package Acceptable for Safe Operations
at a VSTOL Forward Operating Facility

(1) A series of tests was conducted to determine the minimum lighting package for safe operations. This lighting package consisted of the GSI, the extended centerline lights, the obstruction lights at both ends of the runway corridor, the touchdown zone marker lights, and the lighted wind sock (Figure 6). These lights provided sufficient cues for the following:
