GENERAL ELECTRIC CO CINCINNATI OHIO MATERIAL AND PRO--ETC F/G 11/6  
SUPERALLOY KNIFE EDGE SEAL REPAIR.(U)  
MAY 78 R E KUTCHERA, P G BAILEY

AFML-TR-78-56

**SUPERALLOY KNIFE EDGE SEAL REPAIR**

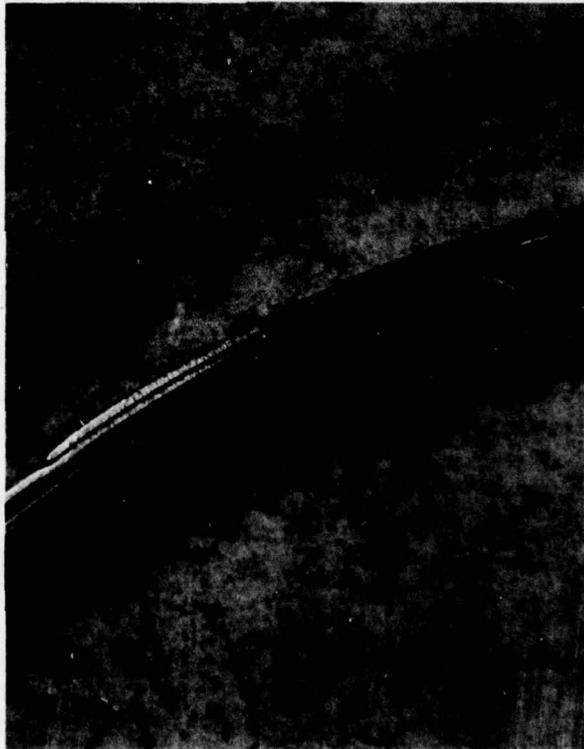
Figure 15. Single and Double Overlap End Closures.

Top: Double Overlap Scarf Joint

Bottom: Single Overlap Scarf Joint

Completing a full 360° tooth repair involves a butt or overlap joint in the cover strip material and to this end, two designs of end closure joints were evaluated: single and double overlap scarf joints as shown in Figure 15. The scarves were made by machining the ends of the cover strip from the full thickness of .065 inch to a knife edge in 1.5 inch, generating a 2.5° bevel. The closure was produced using the approach pictorially presented in Figure 16. Bonding was started beyond the closure, continued around the ring over the closure, ending 1 to 2 inches past the starting point. Rather than use a "running start", the CSDB parameters were brought to the full value before travel was initiated. The same parameters of heating current, force and travel speed, as applied to bonding the cover strip to the teeth, were used for the closure. This technique was used because varying the parameters in the 1.5 inch length of the closure was impractical and unnecessary. The scarf interface in the closure produced an additional resistance/voltage drop in the bonding circuit. Consequently, it was bonded in the same manner as the original interface because a constant current was being used during bonding. Additional power was required which was supplied by the ISR machine. The length of the cover strip was determined by calculating what its mean length would be after CSDB. This length was shorter than the measured length prior to CSDB due to the compression/distortion of the teeth. Therefore, there was a slight gap between the tapered surfaces of the closure in the bonding layout. However, it closed during CSDB.

The trial closure from ring #2 had the double overlap joint while that of ring #4 had the single overlap as previously shown in Figure 15. Visually, they both appeared to be bonded. However, considerable deformation resulted in the seal teeth under the single overlap joint.
