FLOODS IN KANSAS CITY, MISSOURI AND KANSAS, SEPTEMBER 12-13, 1977

Water-Resources Investigations 78-63

Floods in Kansas City, Missouri and Kansas,  
September 12-13, 1977

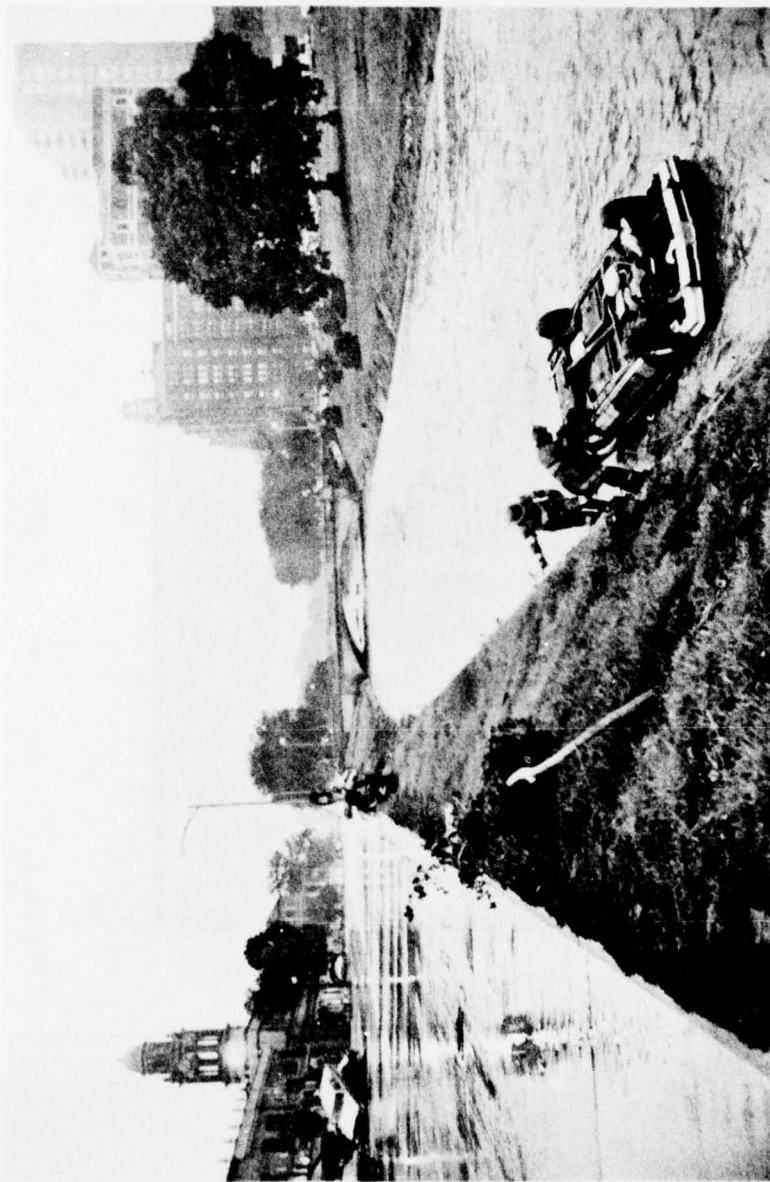
Figure 2.--View of Brush Creek after flood crest, looking east along Ward Parkway,  
at Wornall Road at Country Club Plaza, Kansas City, Missouri.

Flood of  
9-12-77,  
high-water  
mark.

The greatest damage to commercial property occurred in the Brush Creek basin and lower Blue River. Most commercial business and development in the flood-affected area is centered along Brush Creek in Missouri and Kansas. Shops and stores in the Country Club Plaza of Kansas City, Mo., just upstream from the U.S. Geological Survey Brush Creek gaging-station at Main Street received as much as 6 ft of water as evidenced by figures 2-5. Marks left by the flood can be seen in the window of the U.S. Post Office at Plaza Center (fig. 3).

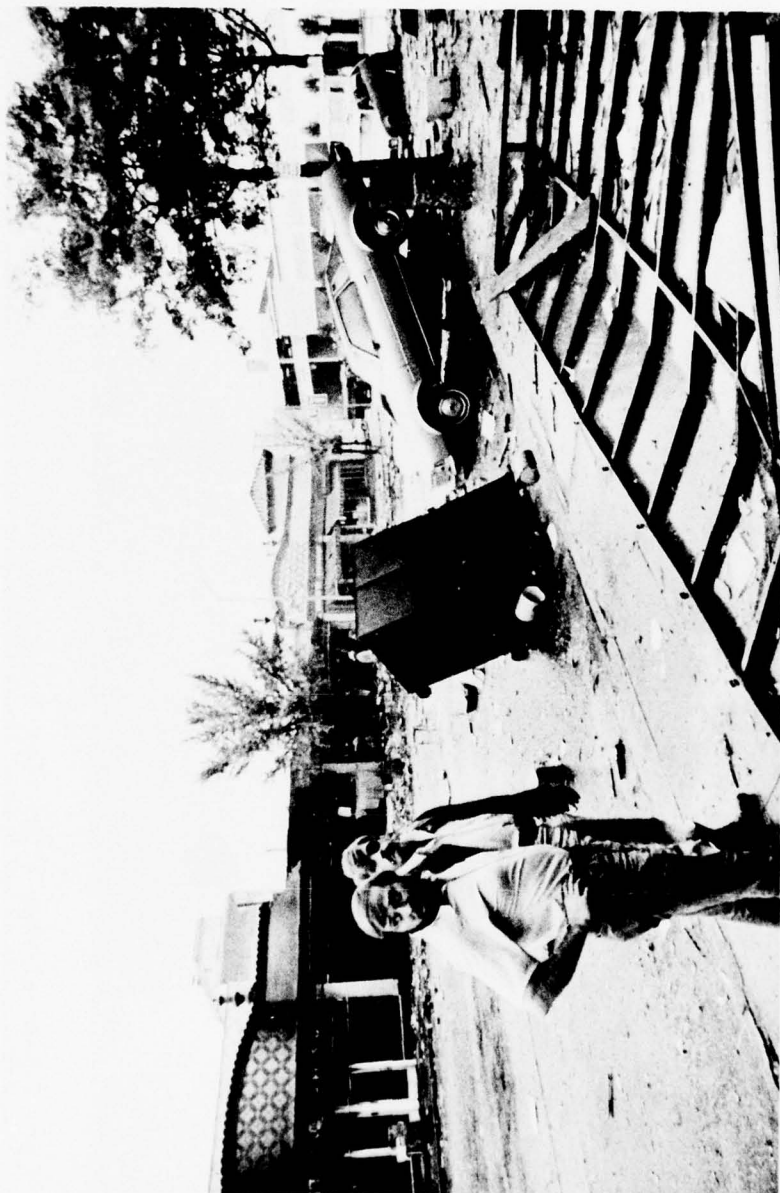
Figure 4.--View of 600 block of West 48th Street, after Brush Creek flood crest,  
at Country Club Plaza, Kansas City, Missouri.

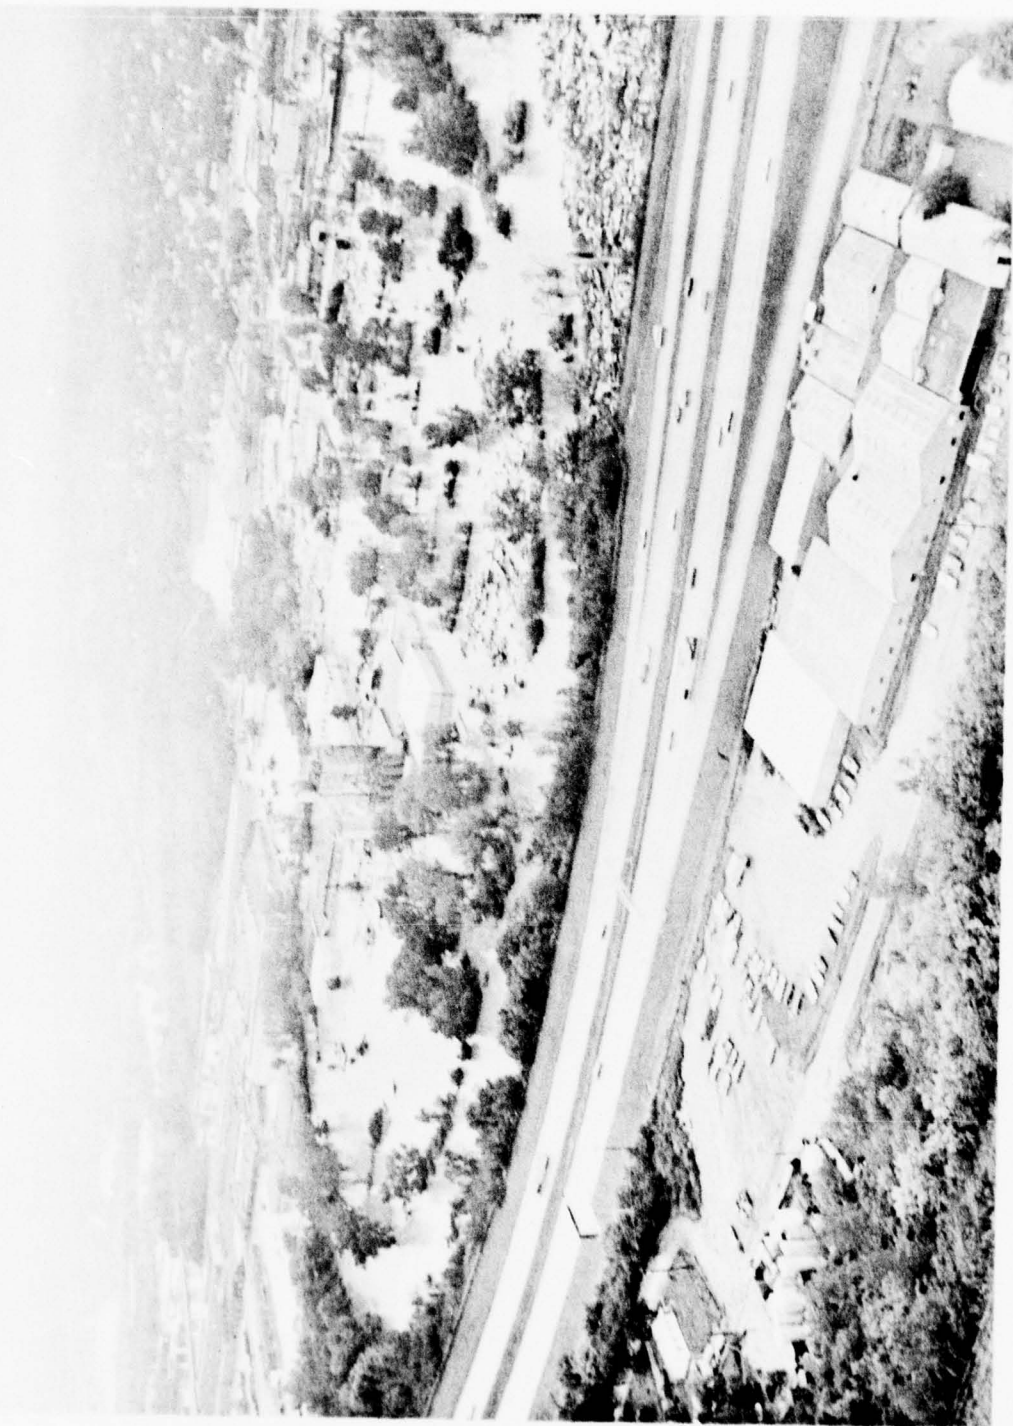
Figure 5.--Aerial view after flood crest, looking west along Blue River between 23rd Street and Truman Road at Kansas City, Missouri. (U.S. Corps of Engineers.)

The industrialized lower Blue River flood plain also received its share of damage. Railroad tracks were undermined as much as 3 to 4 ft along bridge approaches. Figure 5 shows the general flooding in the industrial area in the Blue River basin between 23rd Street and Truman Road. In the Brush Creek basin, many shoppers had parked their cars in underground sections of multi-level parking lots and along streets that were inundated during the flood.

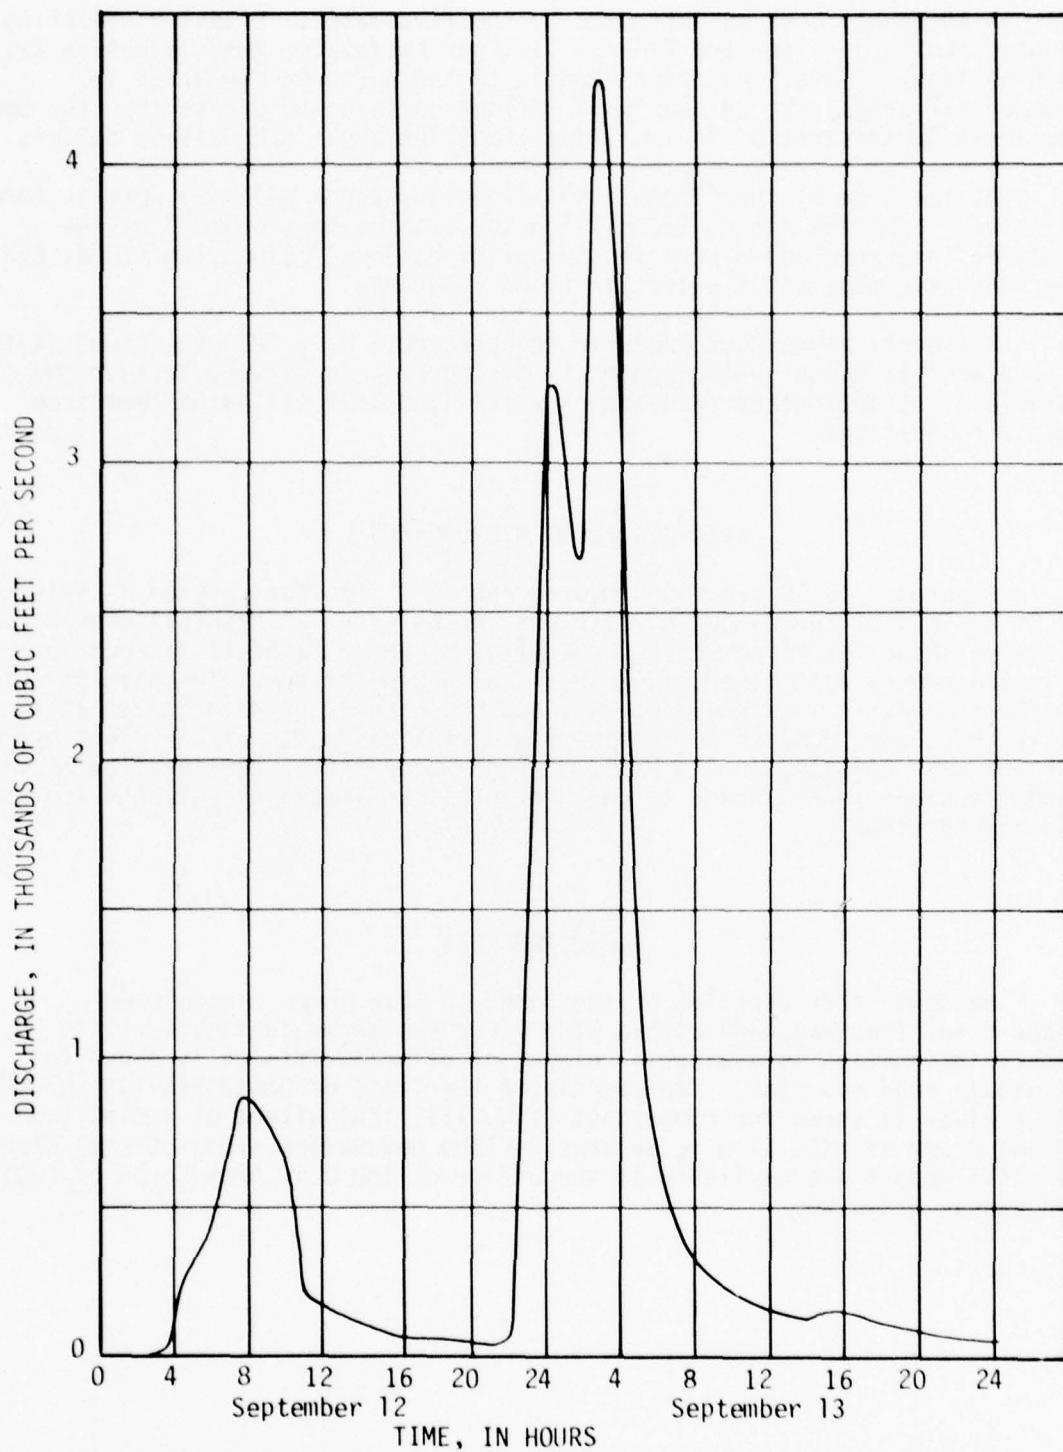
Figure 6.--Flood hydrograph at U.S. Geological Survey gaging-station, on Tomahawk Creek at Overland Park, Kansas, flood of September 12-13, 1977.

Figures 6 to 10 are flood hydrographs for the storm period at selected U.S. Geological Survey gaging-stations in the area. A rainfall mass curve is also shown for Round Grove Creek (fig. 9) where rainfall is recorded simultaneously with river stage in a dual gaging system. The gage structures on Rock Creek at Independence, Mo., and Brush Creek at Main Street at Kansas City, Mo., were damaged during the flood peak and parts of the flood hydrographs were computed on the basis of high-water marks, earlier flow records, and the stage record prior to gage failure. Estimated hydrographs are shown as dashed lines.

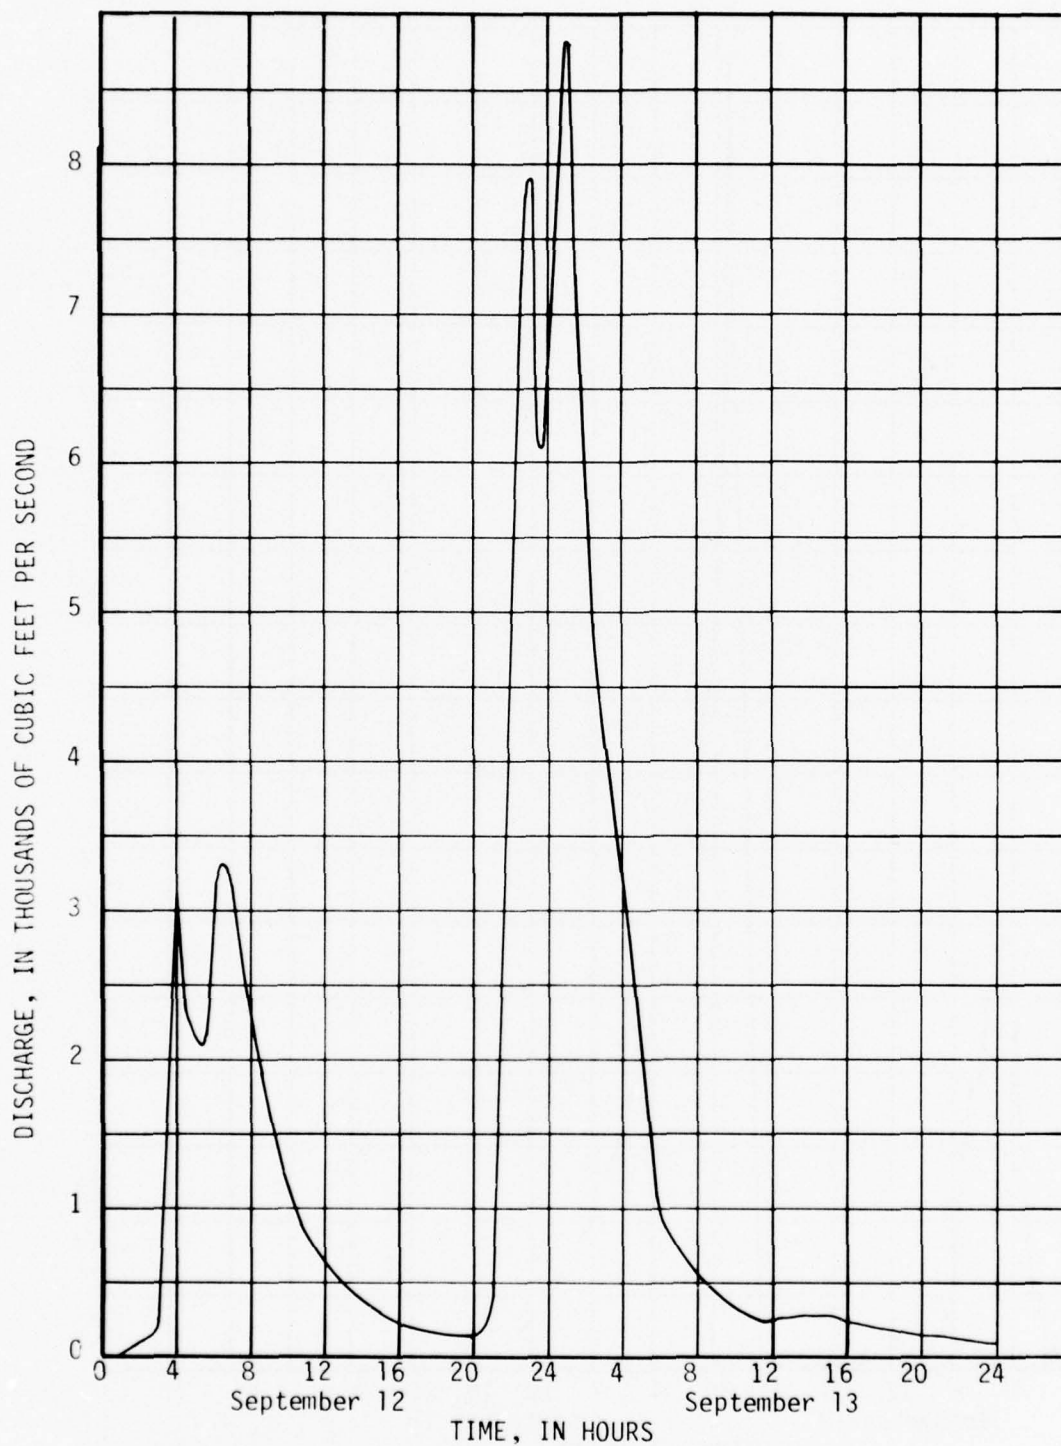
Figure 7.--Flood hydrograph at U.S. Geological Survey gaging-station, on Indian Creek at Overland Park, Kansas, flood of September 12-13, 1977.

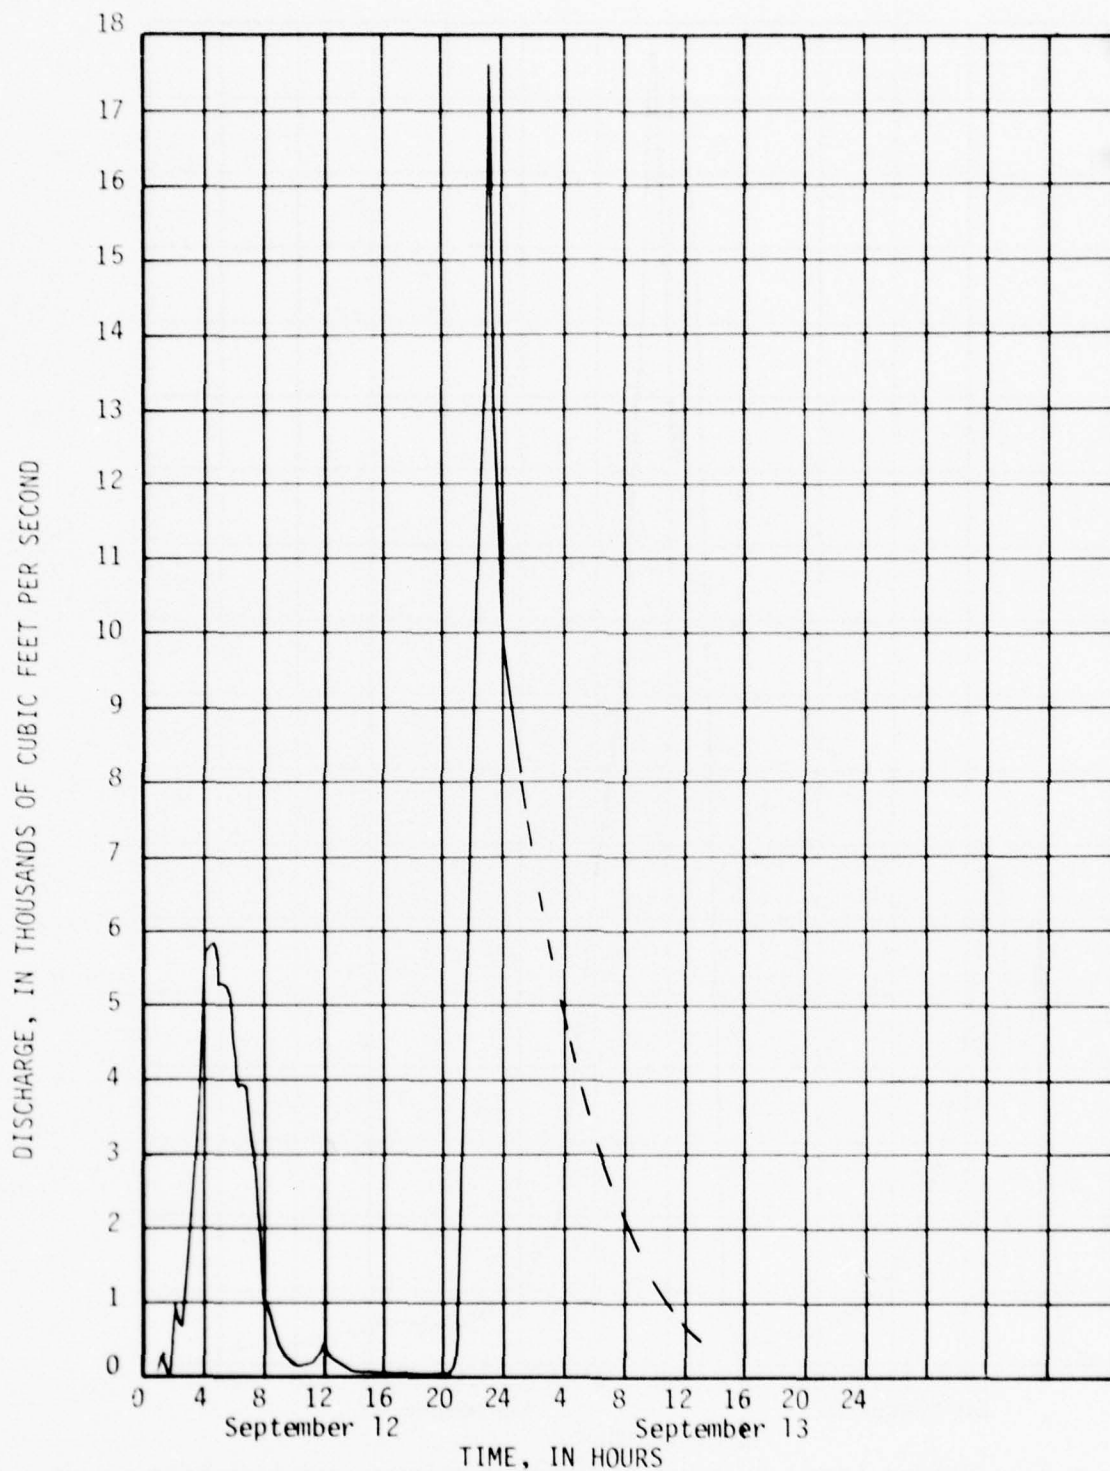
Figure 8.--Flood hydrograph at U.S. Geological Survey gaging-station, on Brush Creek at Main Street, Kansas City, Missouri, flood of September 12-13, 1977.

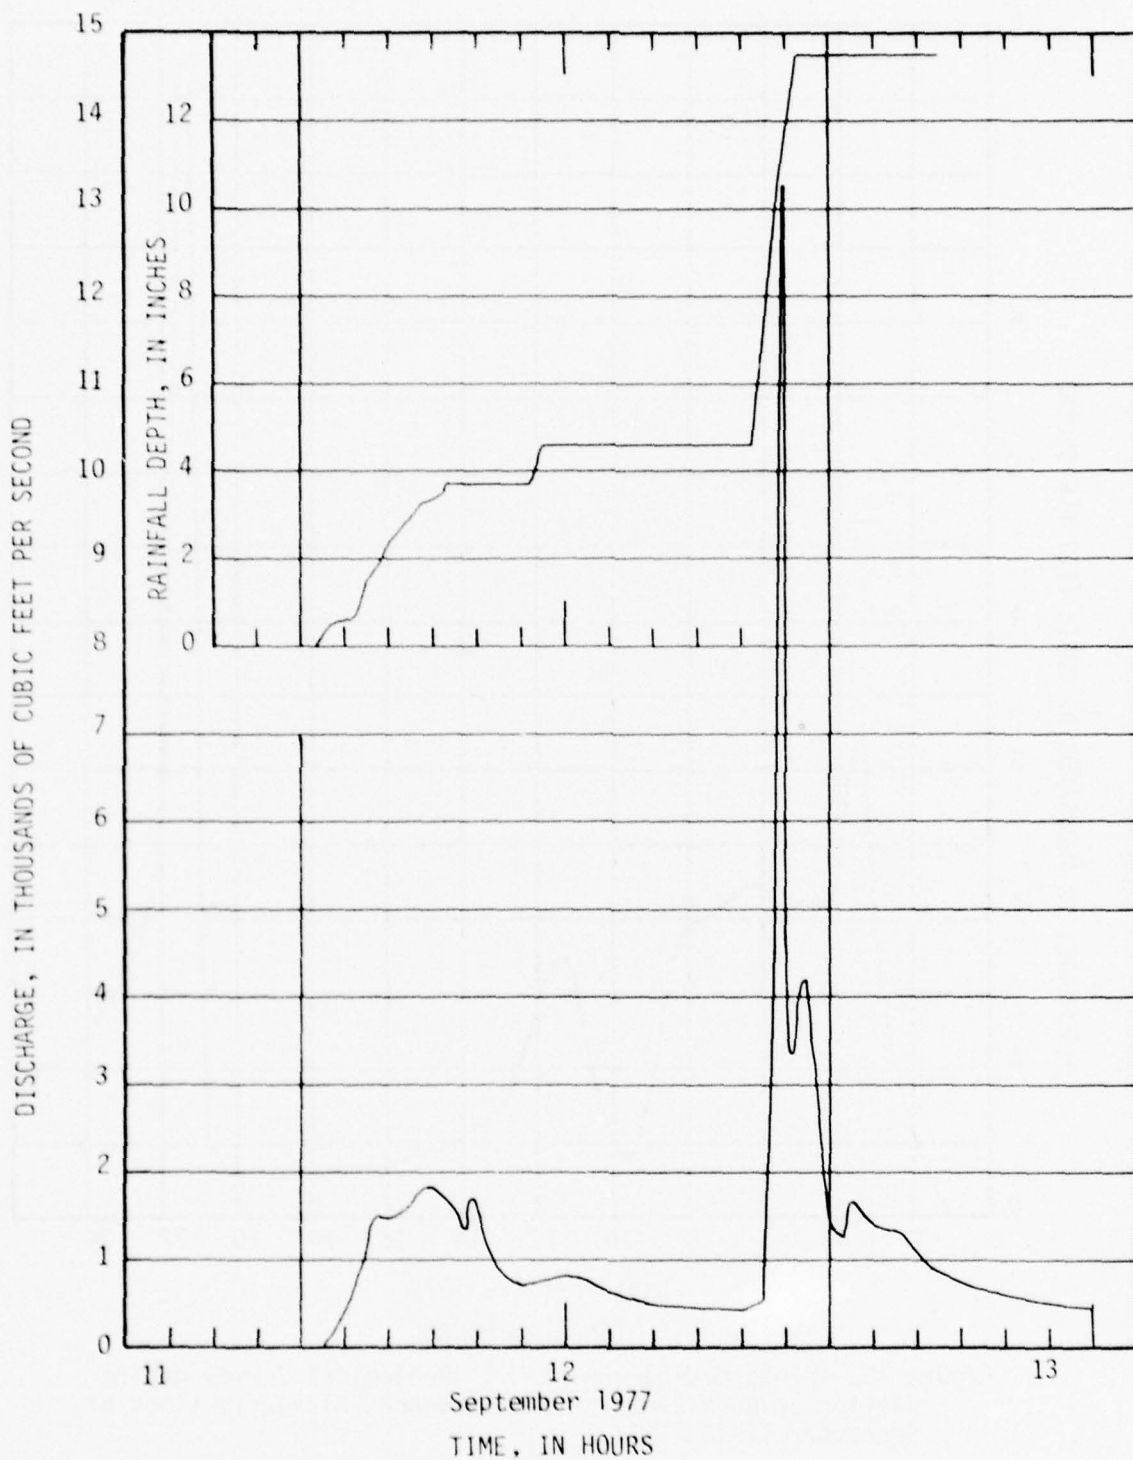
Figure 9.--Flood hydrograph and mass curve of rainfall at U.S. Geological Survey gaging-station on Round Grove Creek at Raytown, Missouri, flood of September 12-13, 1977.

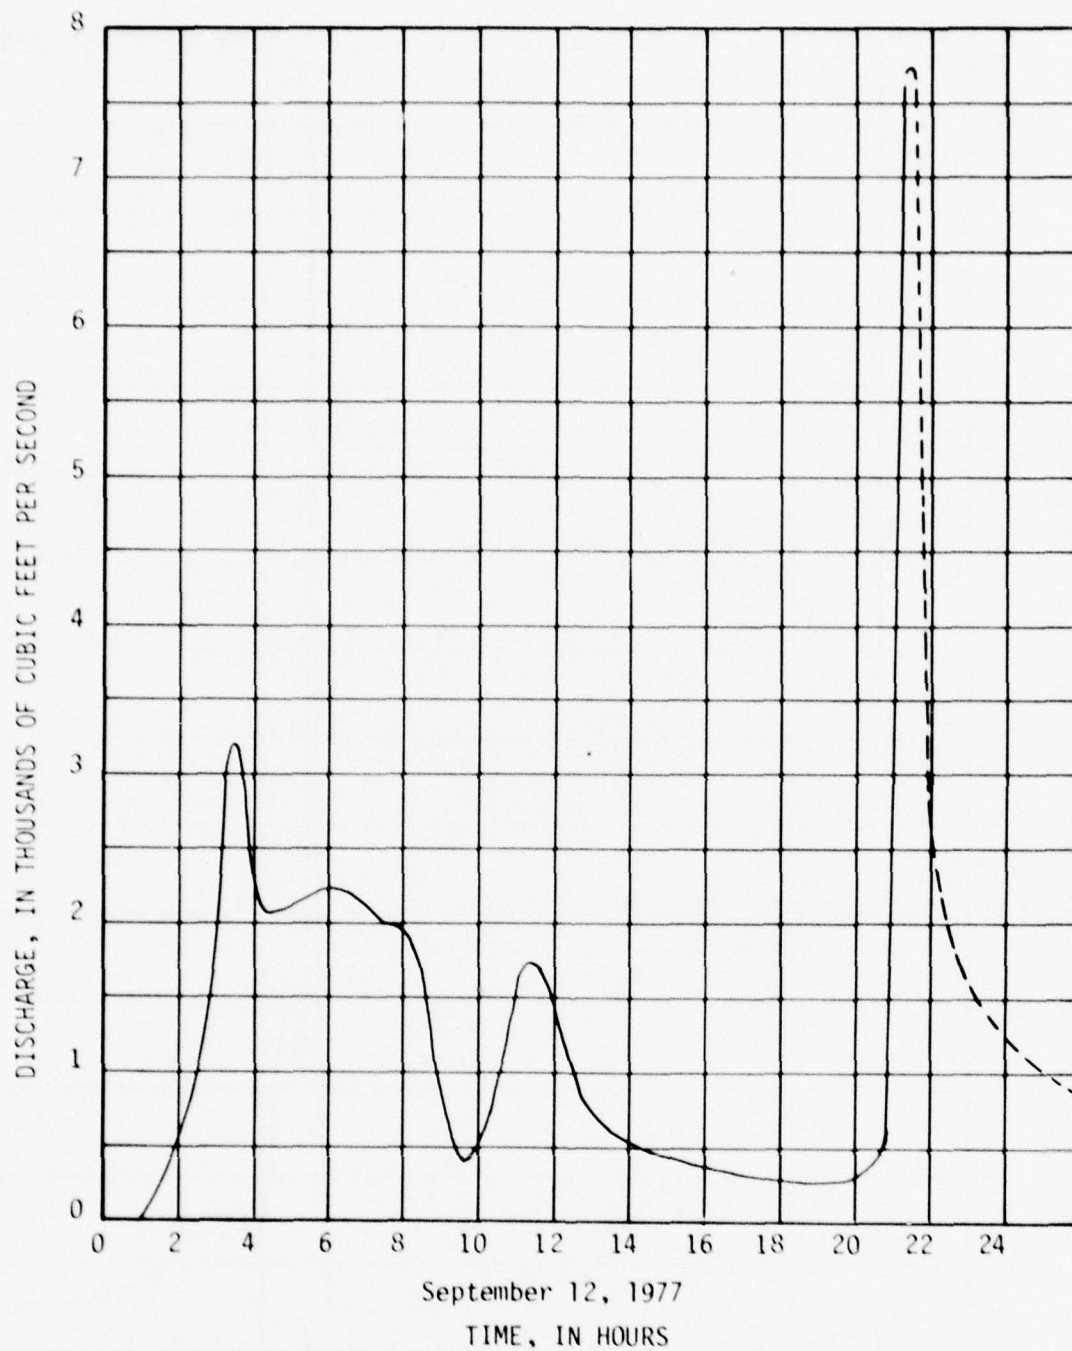
Figure 10.--Flood hydrograph at U.S. Geological Survey gaging station on Rock Creek at Independence, Missouri, flood of September 12-13, 1977.

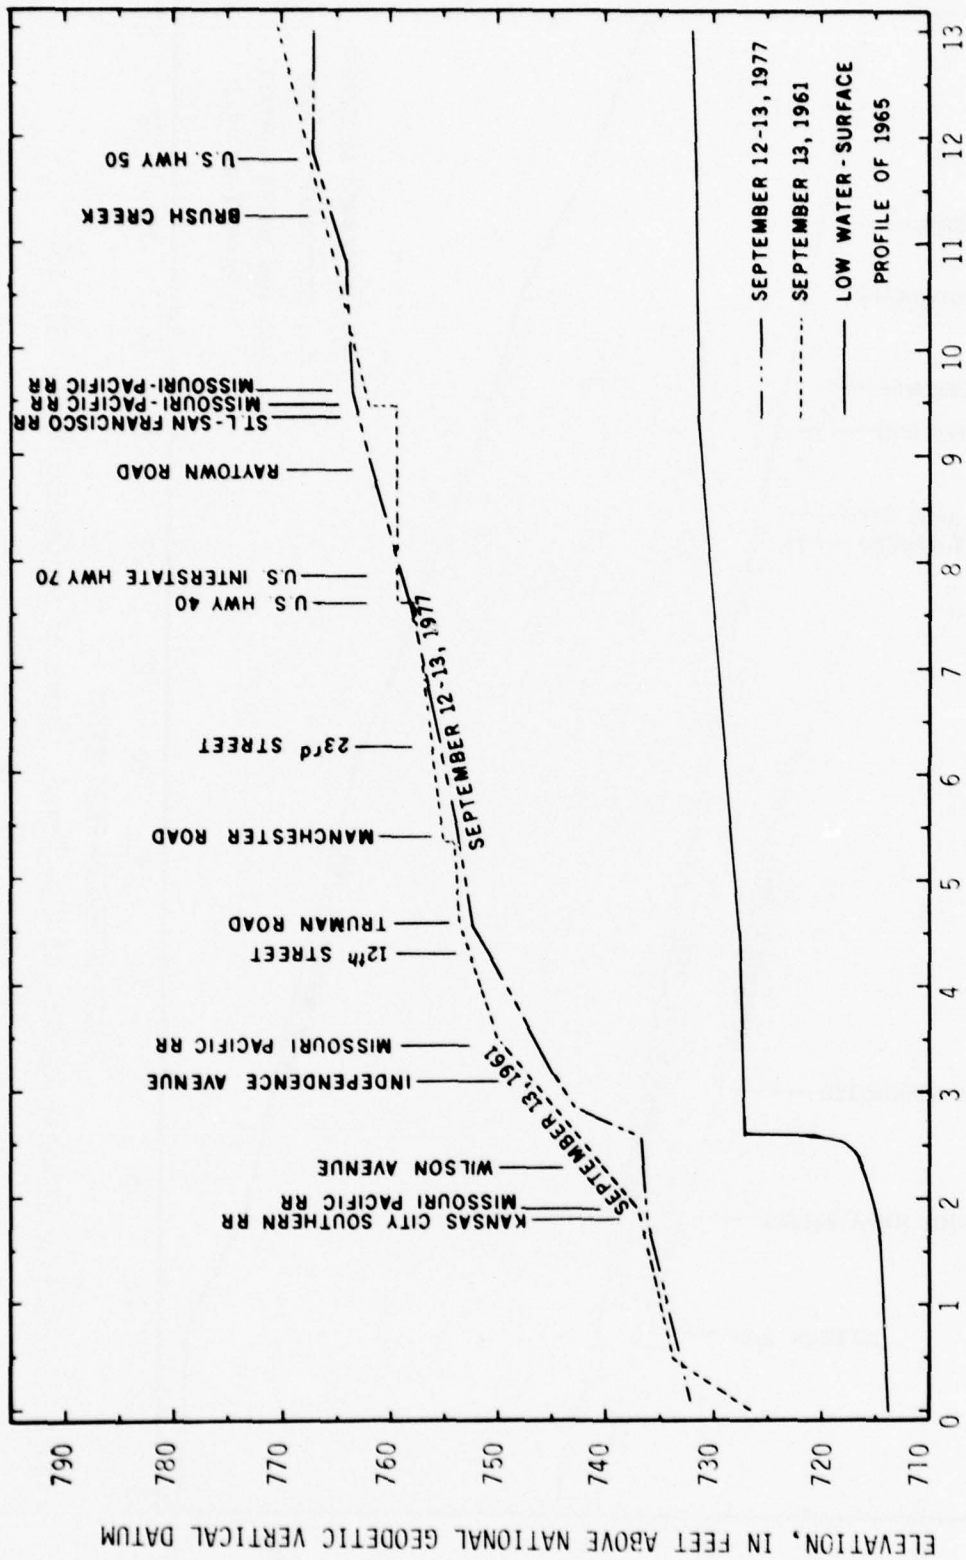
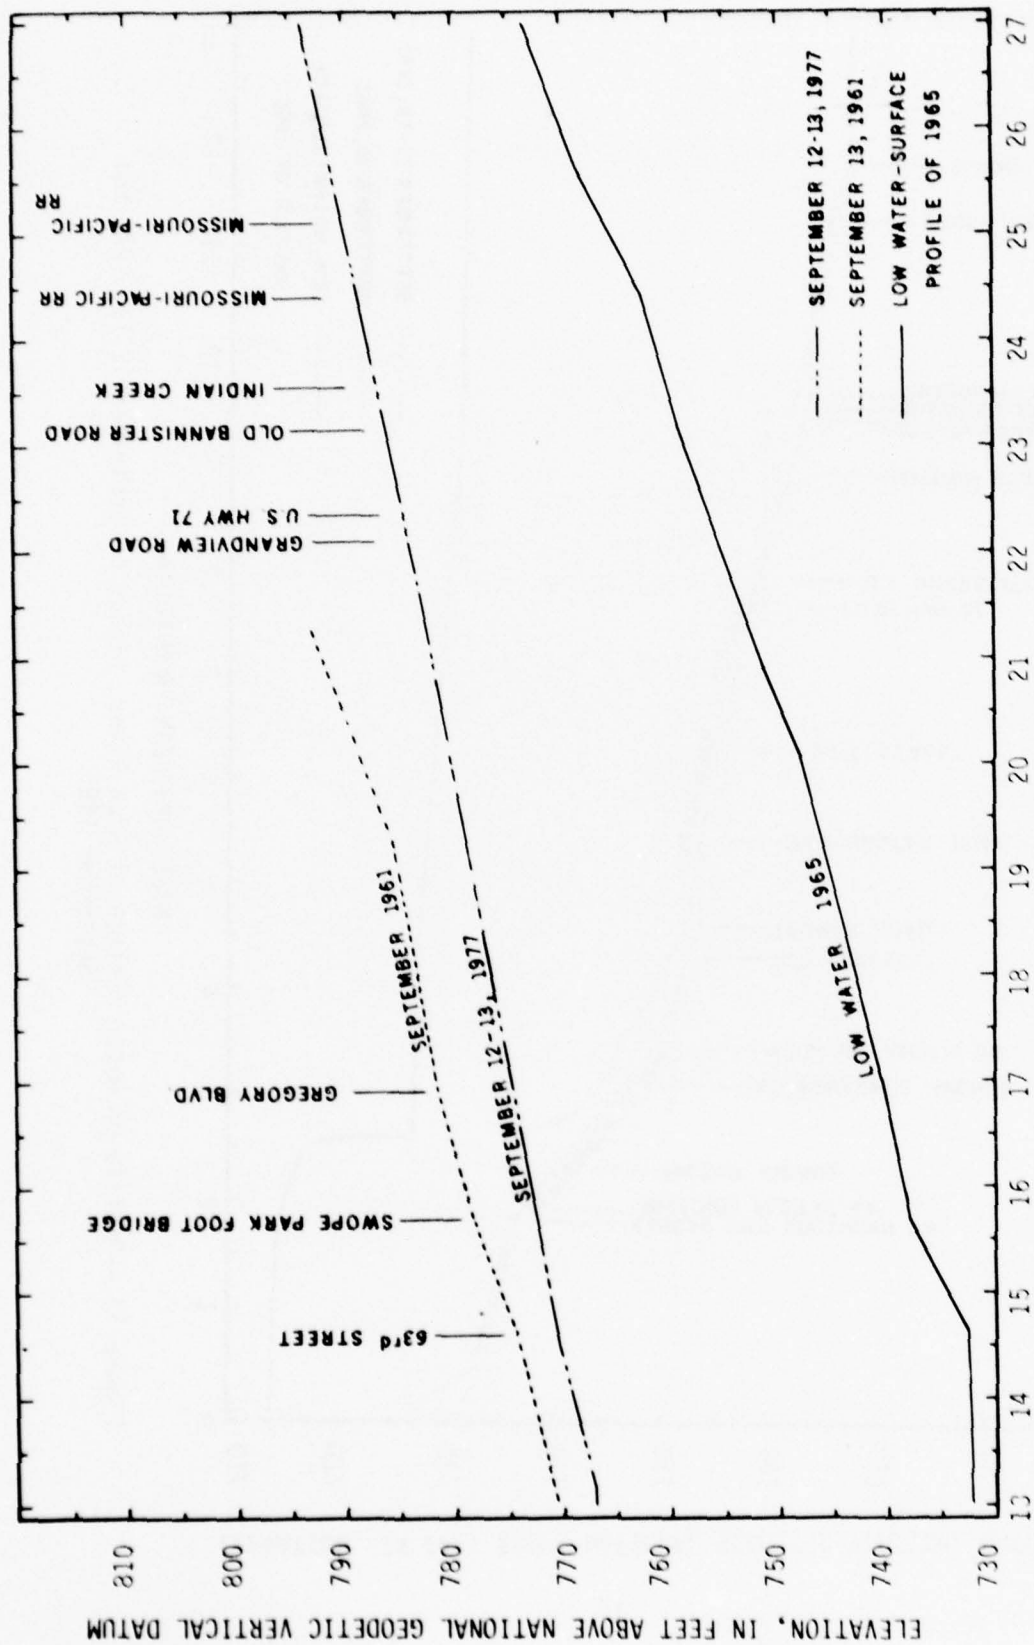
Figure 11.--Profile of water surface of Blue River, floods of September 12-13, 1977 and September 1961.

Figure 11.--Profile of water surface of Blue River, floods of September 12-13, 1977 and September 1961--continued

Water-surface profiles of the flood on Blue River, Brush Creek, Rock Creek (Kansas), and Little Blue River are shown in figures 11 to 14. Where information is available, elevation of bridge floors is shown to indicate road overflow. The profile of the flood of September 1961 on the Blue River is shown for comparison (fig. 11). The effect of inflow from Brush Creek at mile 11.8 is evident. Flood boundaries along streams discussed in this report are available at the office of the U.S. Army Corps of Engineers, in Kansas City, Mo.

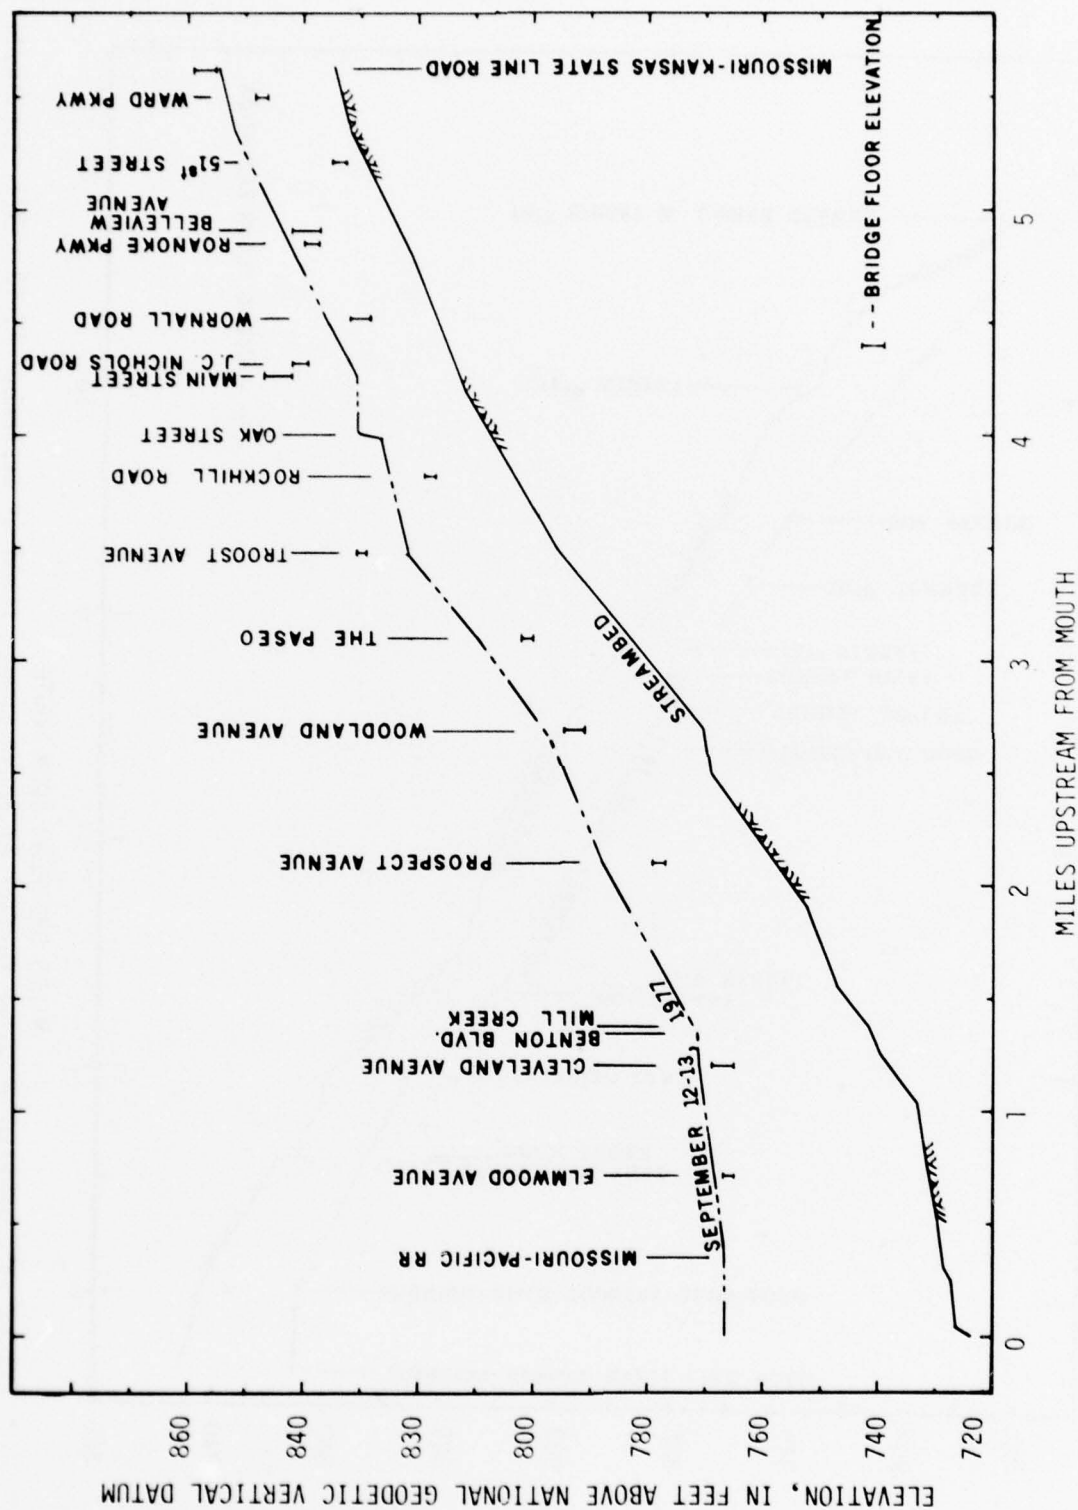
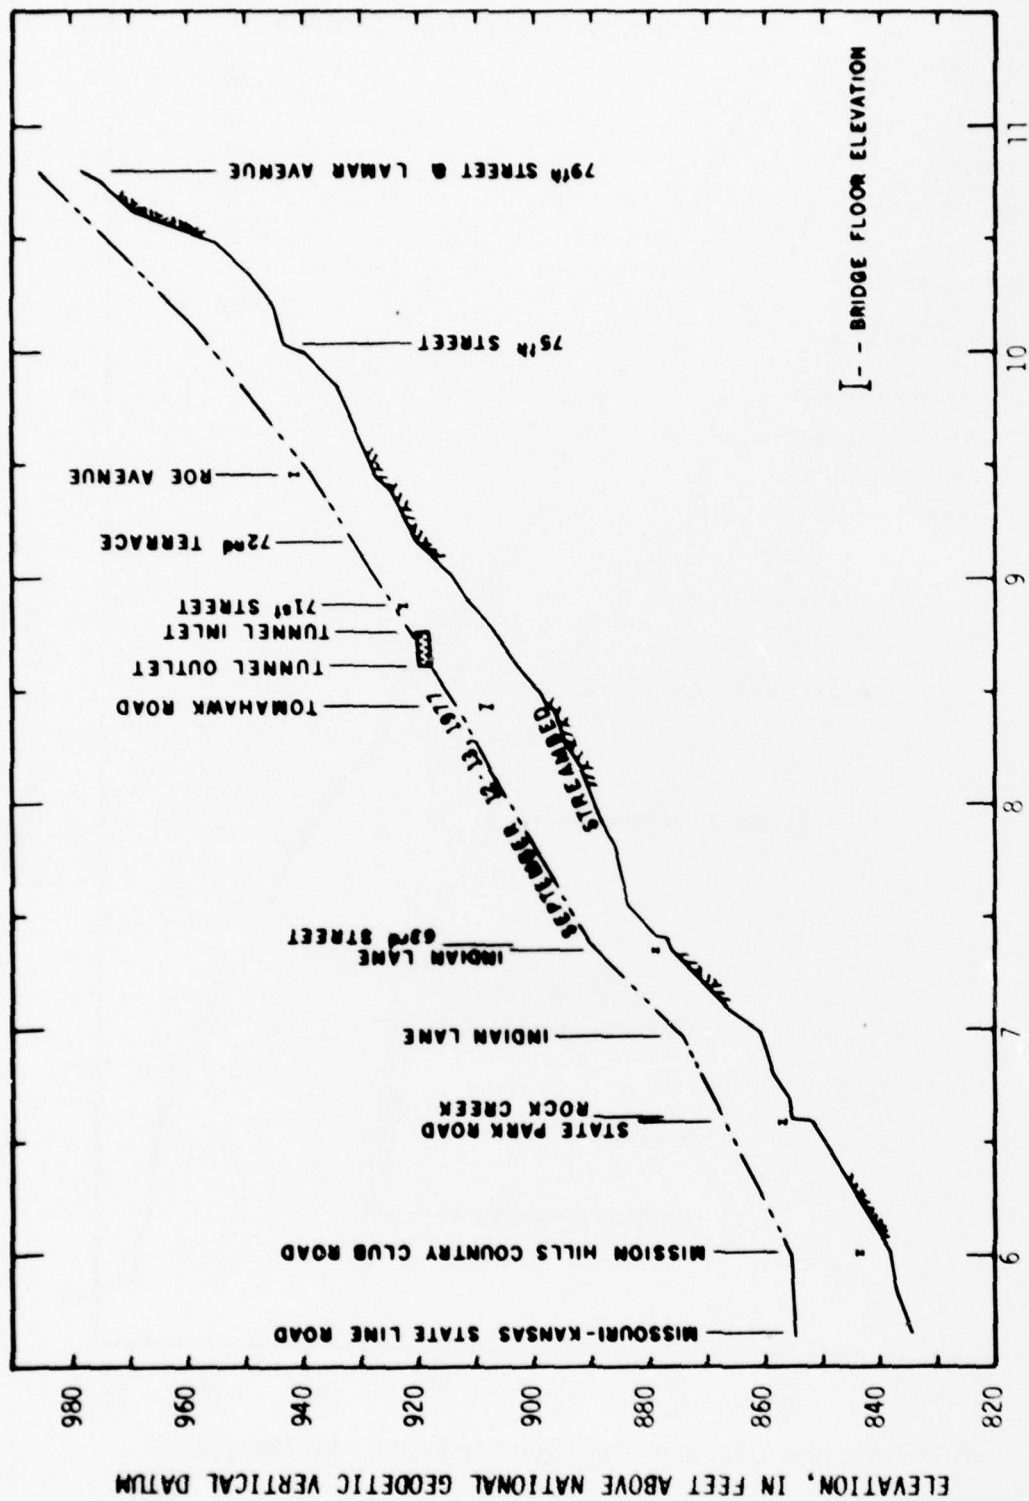
Figure 12.--Profile of water surface of Brush Creek, flood of September 12-13, 1977.

Figure 12.--Profile of water surface of Brush Creek, flood of September 12-13, 1977--continued

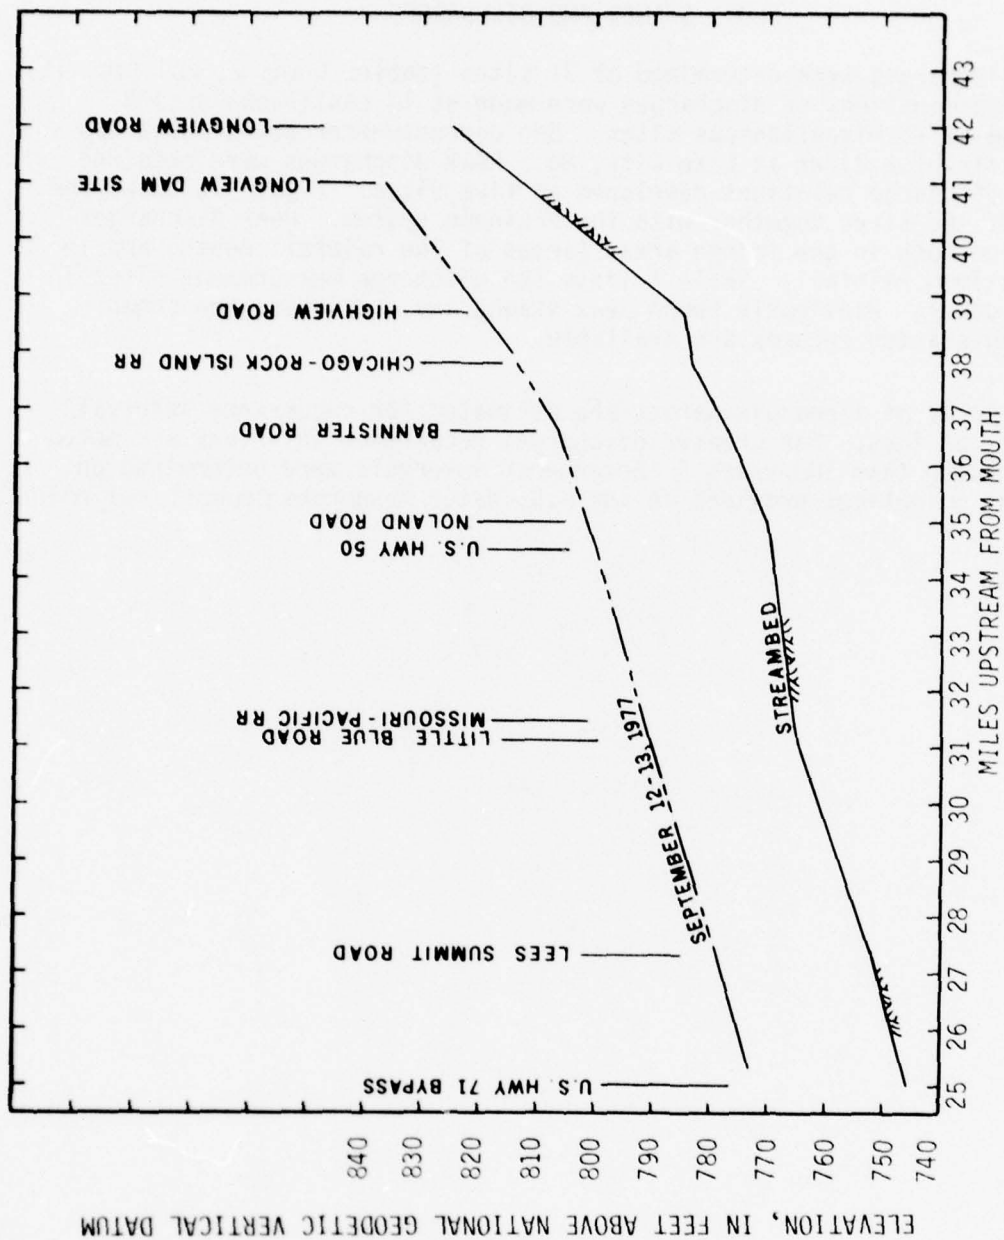
Figure 14.--Profile of water surface of Little Blue River, flood of September 12-13, 1977.

Figure 14.--Profile of water surface of Little Blue River,  
flood of September 12-13, 1977--continued.

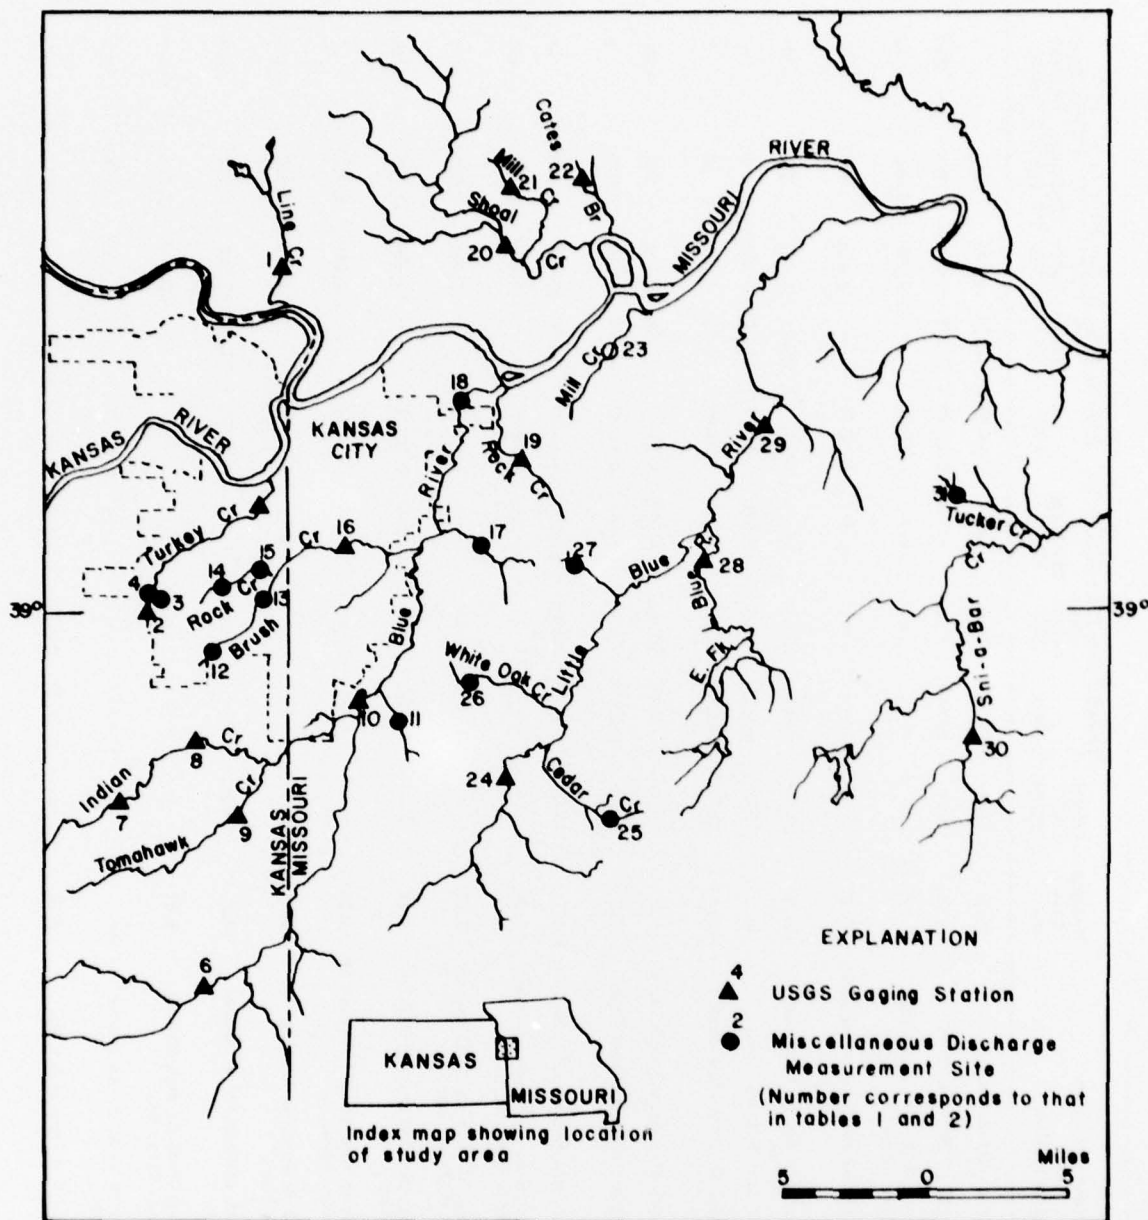
Figure 15.--Flood area and location of flood-determination points.

Peak discharges were determined at 31 sites (tables 1 and 2, and fig. 15). Indirect determinations of discharges were made at 13 continuous-record stations and at 13 miscellaneous sites. One current-meter measurement was made on Little Blue River at Lake City, Mo. Peak discharges were obtained from stage-discharge relations developed at five sites. Figure 15 shows the locations of the sites together with the drainage system. Peak discharges were measured both in the fringe areas (areas of low rainfall depth) and in areas of maximum rainfall. Table 1 lists the discharge measurement sites in downstream order. Previously known peak stages and discharges are shown where gaging-station records are available.

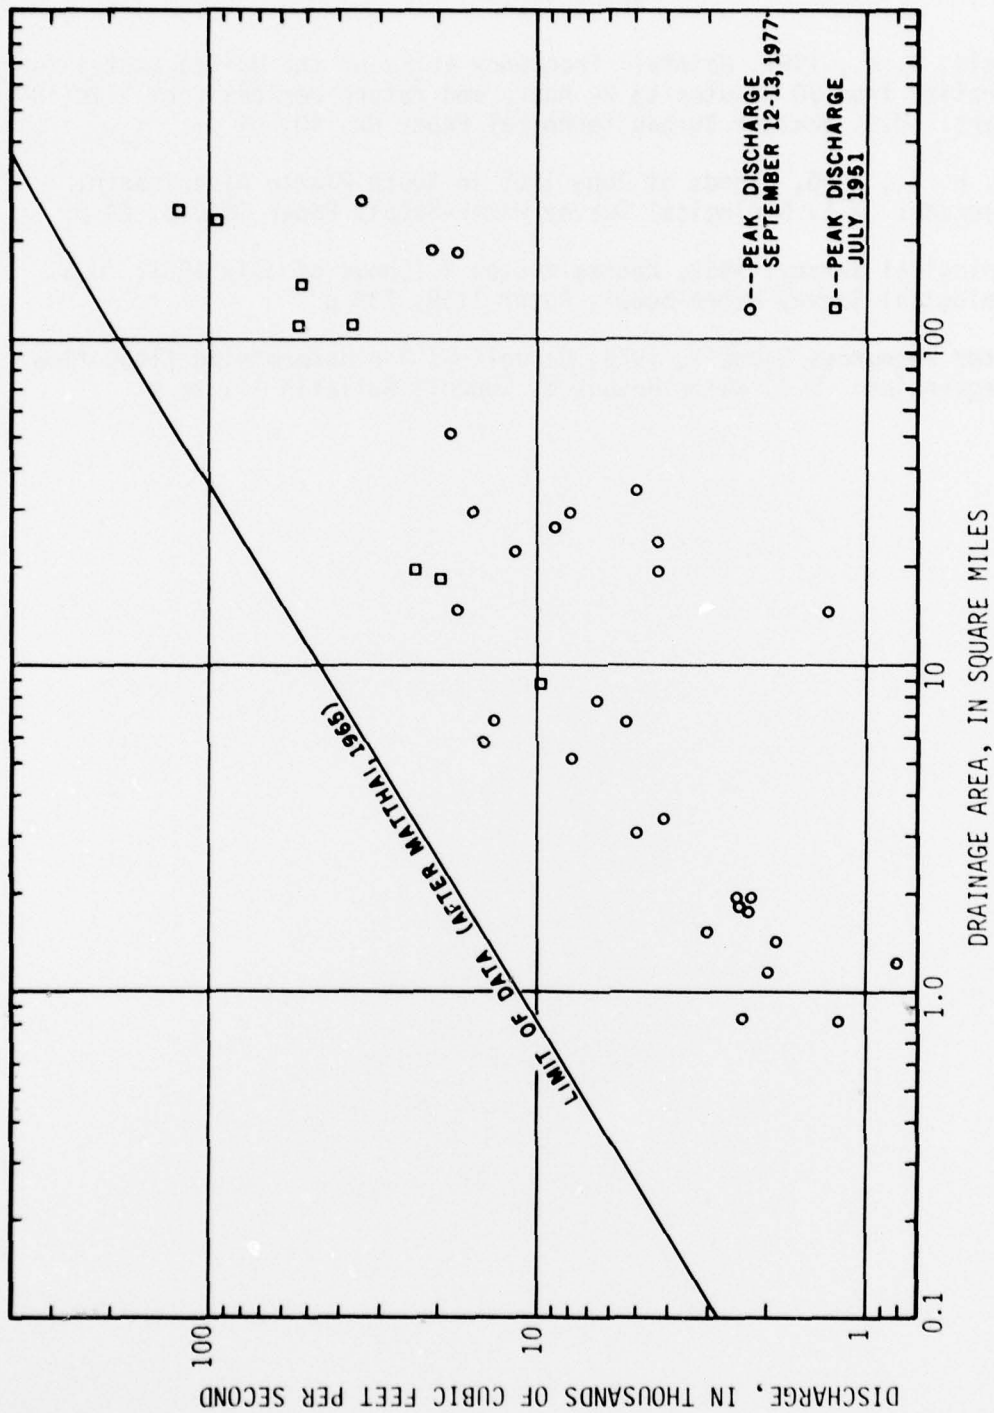
Figure 16.--Comparison of September 12-13, 1977, peak discharges to upper limit of known floods in the United States.

Peak discharges of the September 1977 flood, together with peak discharges of the July 1951 flood in Missouri and Kansas (U.S. Geol. Survey, 1952, p. 199), are plotted against their respective drainage areas in figure 16 for comparison with previous maximum discharges known in the United States. A curve developed by Matthai (1965) on basis of maximum floods known in the United States defines the approximate upper limit of known floods in 1965 (fig. 16). Peak discharges encountered in the September 1977 flood do not approach the maximum flood experience defined by Matthai. Curve values are more than double the highest peak flows of September 12-13, 1977.
