FIELD TESTS OF SIX OFFSHORE  
OIL CONTAINMENT BOOMS

P. R. Corpuz and R. A. Griffiths

November 1978

Final Report  
Part 1

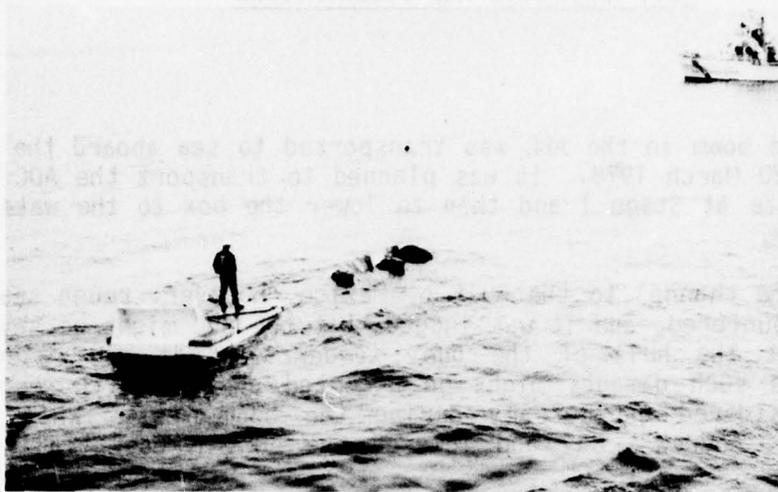
Figure 21. The Coast Guard boom being extracted from the ADC.

Figure 21 shows the boom being extracted from the ADC by the USCGC POINT LOBOS. A man is needed aboard the ADC to release the tailgate and assist in connecting the tow line. During extraction, four flotation bags failed to inflate. The CO<sub>2</sub> bottle on one of these four triggered but failed to inflate the bag due to an improperly tightened valve. The valve was corrected, and the bag inflated properly with a spare CO<sub>2</sub> bottle. The other three did not trigger during extraction, but inflated properly when triggered manually from a Zodiac boat.

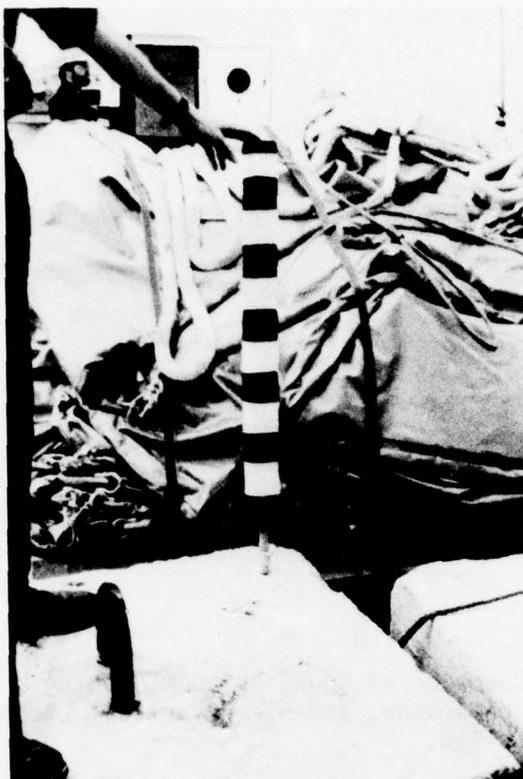
The bottom of the dowel was fastened to the bottom of the skirt, and the styrofoam was slid up or down the dowel so that the pole would float almost vertically but not pull up the skirt excessively. This trick was also tried later with the Whittaker and Bennett booms; however, it failed and provided no useful information.

Figure 31. A "barber pole," which was attached to the bottom of the Sjuntorp boom skirt to attempt to observe the skirt motions.

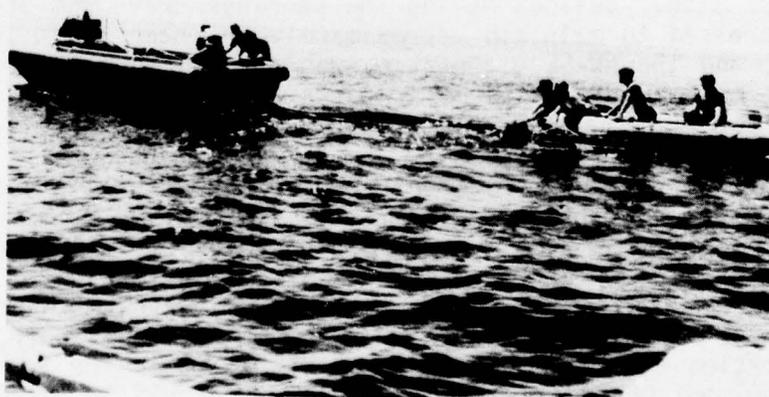
Figure 33. The Vikoma Seapack with the boom being deployed from the stern.

The boom was deployed from the Seapack with the assistance of Canadian Coast Guard personnel. The boom did not deploy automatically as the towing continued after releasing the backboard on the Seapack, however. An installation error resulted in premature inflation of the flotation cuff on the top of the boom, making it very difficult to complete deployment and causing a split seam on the cuff. A further complication was caused by a jammed mechanism in the Seapack which had to be forced physically before deployment could be completed. Rather than merely towing the Seapack to deploy the boom, a Zodiac boat assisted in extracting the boom, as shown in Figure 33.

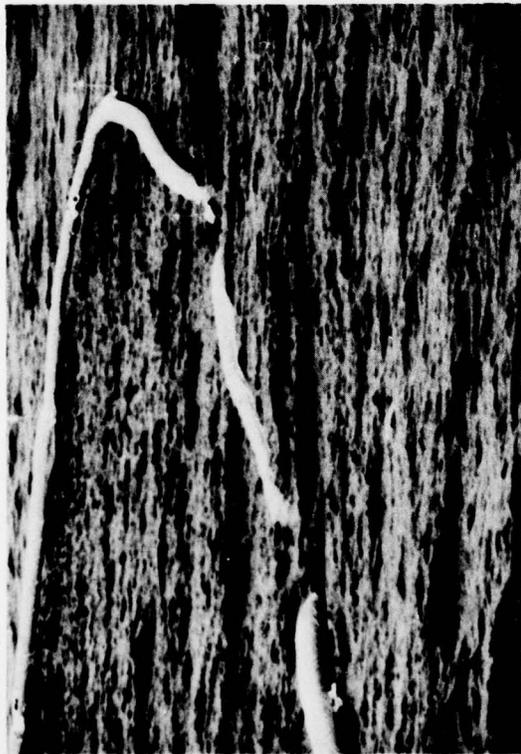
Figure 46. Air leaks in the Bennett boom connectors led to sinking.
