MISCELLANEOUS PAPER SL-79-16

## EXAMINATION OF GROUT AND ROCK FROM DUVAL MINE, NEW MEXICO

This report covers a small part of the work involved in the Borehole Plugging Program which the U. S. Army Engineer Waterways Experiment Station (WES) is conducting for the U. S. Department of Energy.

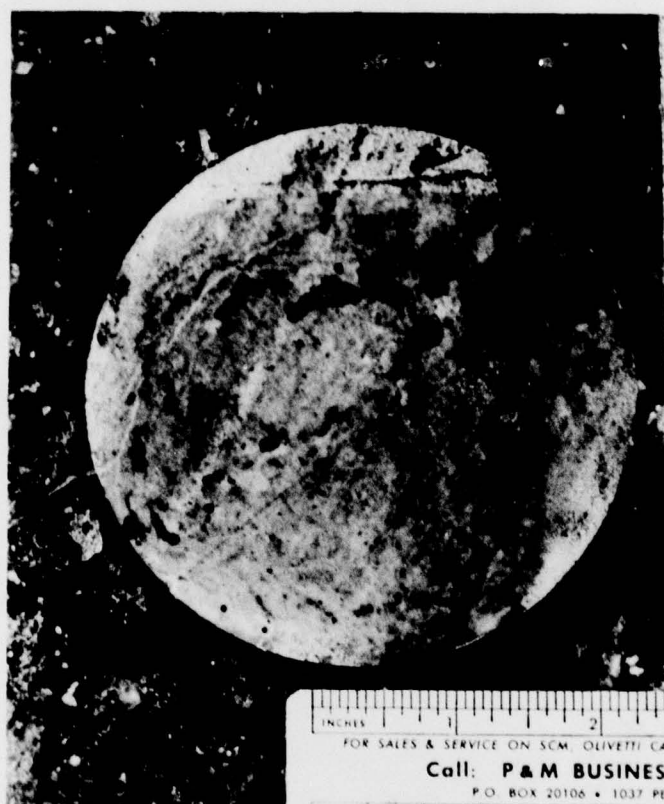
Figure 1. Central portion of sawed surface from lower part of Section 1, X0.8. The circular area is the grout plug surrounded by rock salt. Note the uniformly tight contact of grout and rock salt.

6. The upper surface of the slice from the bottom of Section 1 is shown in Figure 1. Samples of grout, rock, and their contact were obtained by taking small cores about 1/2 in. in diameter from this surface with a small diamond core drill. A small amount of lubricating water was used during the drilling.

a. The contact between the grout and the rock was tight everywhere that it could be seen. This tight contact is well shown in Figure 1. The interface in the F samples had to be separated using pliers which also indicates the tightness of the contact.

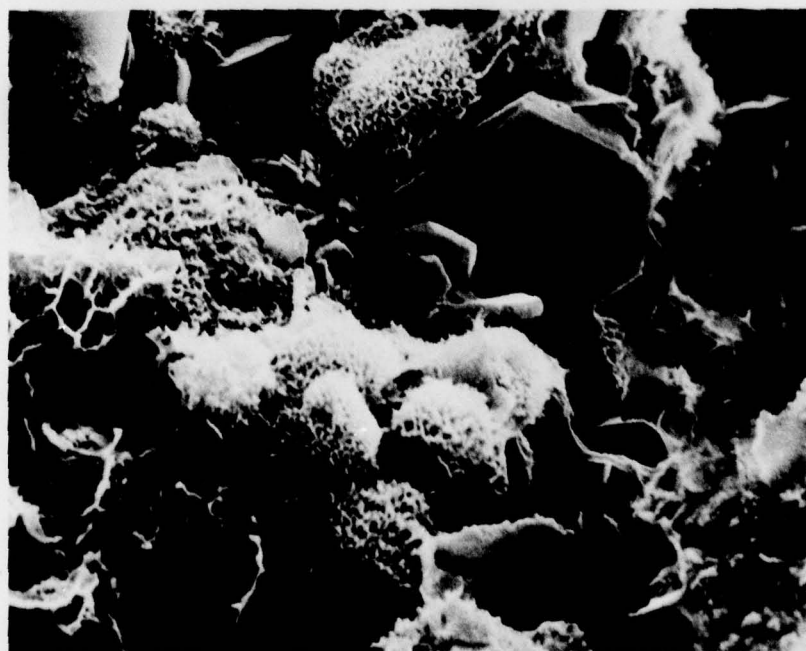
Figure 2. Samples X230 (top) and X2300 (bottom) of grout side of grout to rock salt contact from Section 1 (Sample F), Duval Mine. X2300 is an enlargement of the midportion of X230; it is believed to show CSH, calcium hydroxide, possibly monochloroaluminate, and evaporated salt.

14. Eight scanning electron micrographs of the grout are shown in Figures 2-5. The pair in Figure 2 show the grout side of the grout to rock contact (sample F) at two magnifications. While it is not shown, the rock side was similar but showed more salt, as would be expected, than the grout side. Figures 3 and 4 show grout sample E at two magnifications. They also show that the effect of freeze drying after lengthy vacuum drying was not significant. These four photomicrographs show the typical microstructure of this grout. This open microstructure, when compared with the microstructure of other cement pastes of known low water-cement ratio, is proof that the Duval sample had a high water content. This comparison was illustrated by SEM photomicrographs in the ERDA 10 report.<sup>1</sup> The low unconfined compressive strength of about 300 psi for the Duval Mine grout verifies what is indicated by the open structure in Figures 3 and 4.

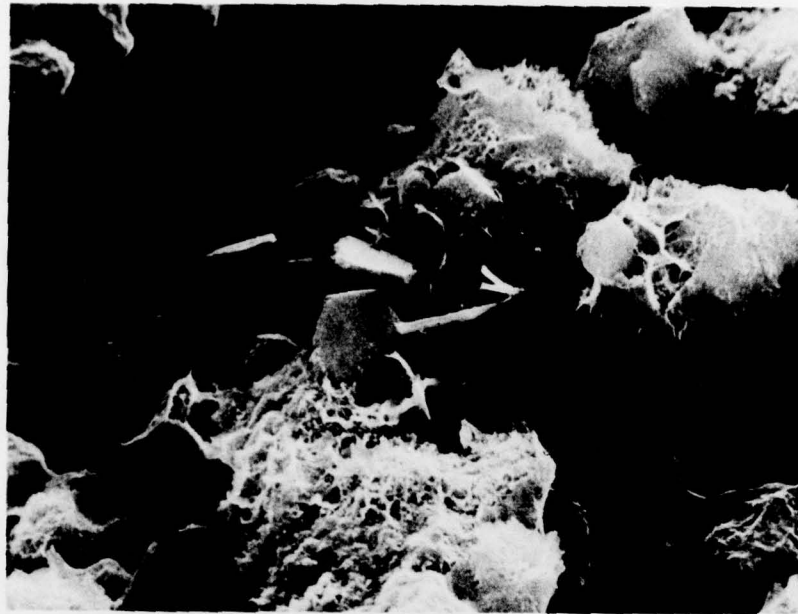
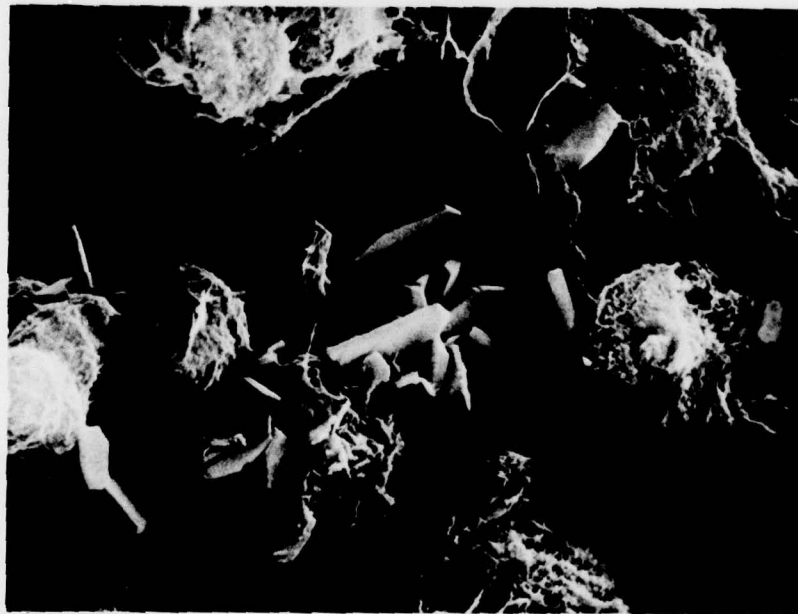
Figure 4. Grout samples E, X2300. Upper sample was freeze dried following vacuum drying while bottom one was not. There is no detectable effect of this difference. These are enlargements of the areas shown in Figure 3.
