PHASE IV REPORT

APPENDICES A THROUGH G

**RESULTS AND INTERPRETATION OF
CHEMICAL GROUTING TEST PROGRAM**

**EXISTING LOCKS AND DAM NO. 26
MISSISSIPPI RIVER, ALTON, ILLINOIS**

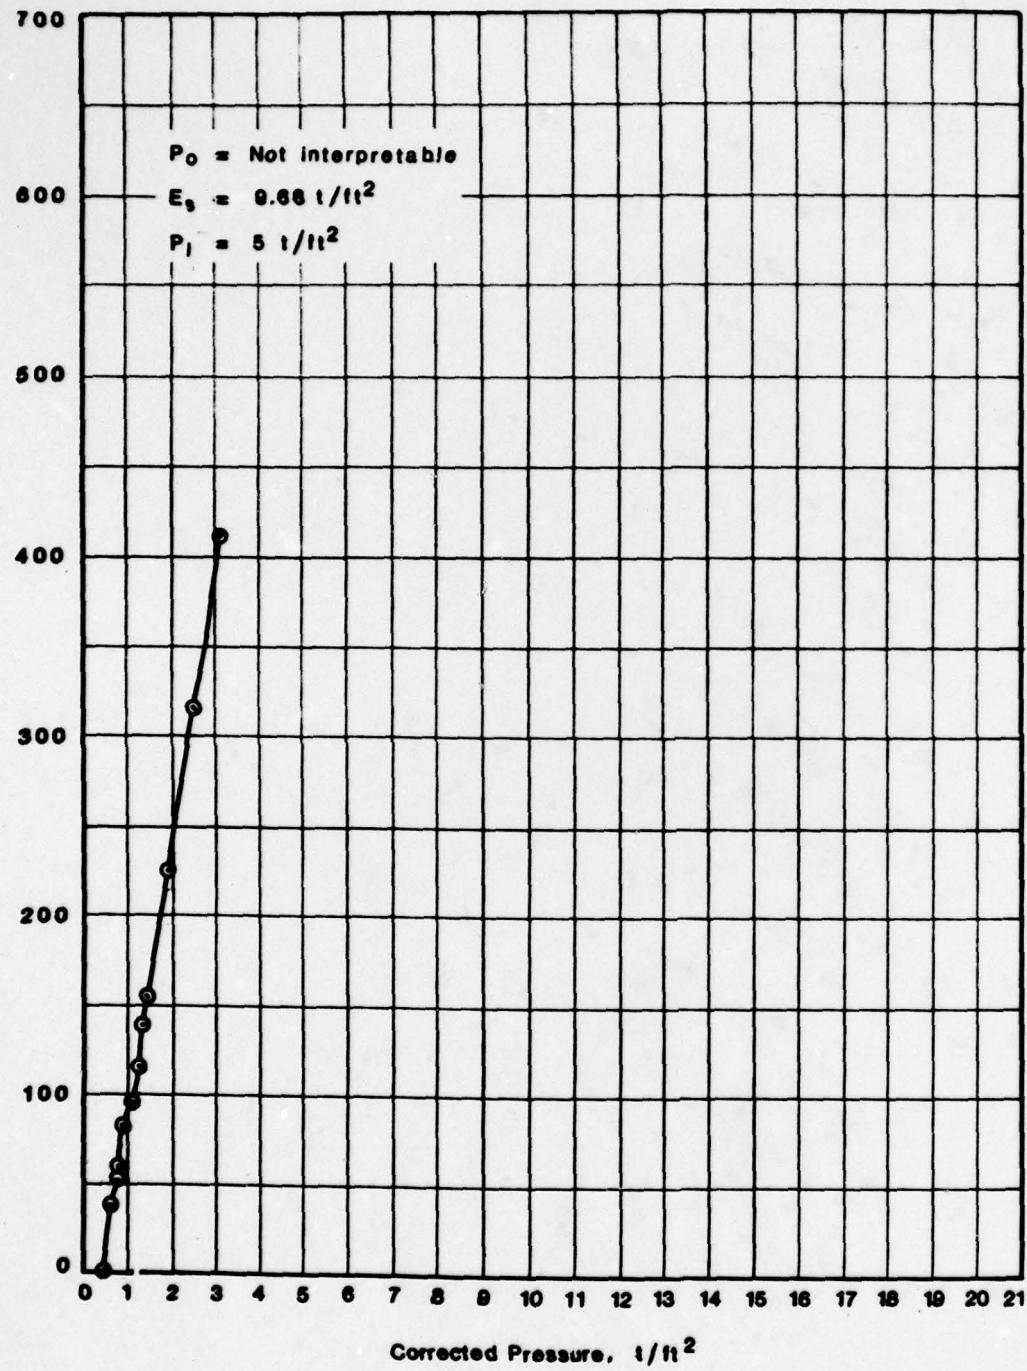
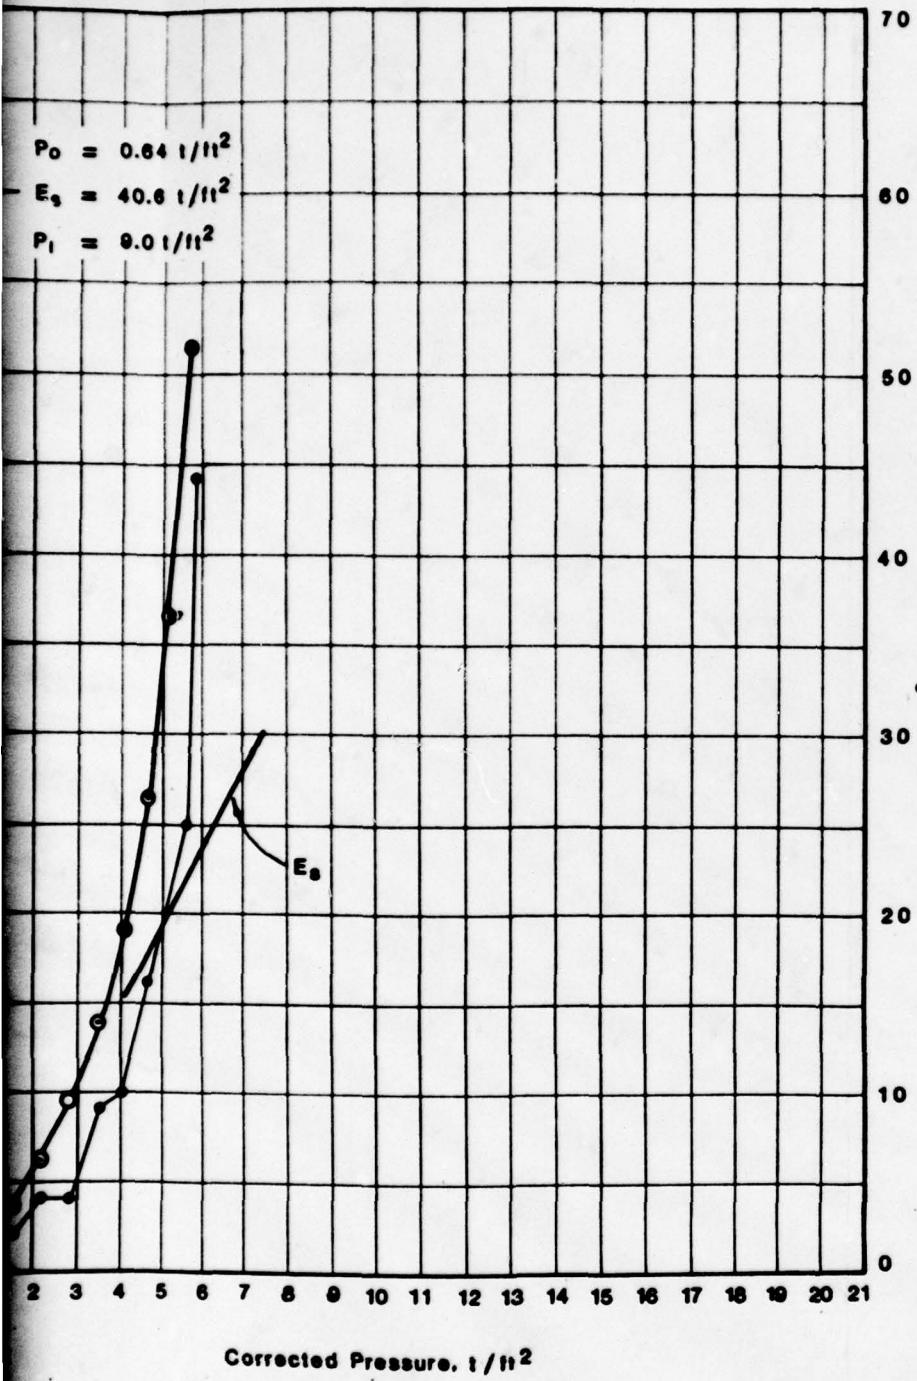
CHEMICAL GROUTING TEST PROGRAM	
PRESSUREMETER TEST RESULTS BEFORE GROUTING.	
FOUNDATION INVESTIGATION AND TEST PROGRAM	
EXISTING LOCKS AND DAM NO. 20	
ST. LOUIS DISTRICT, CORPS OF ENGINEERS.	
DACPW43-78-C-0008	
Woodward-Clyde Consultants V7C025 Phase II	Fig. A.1

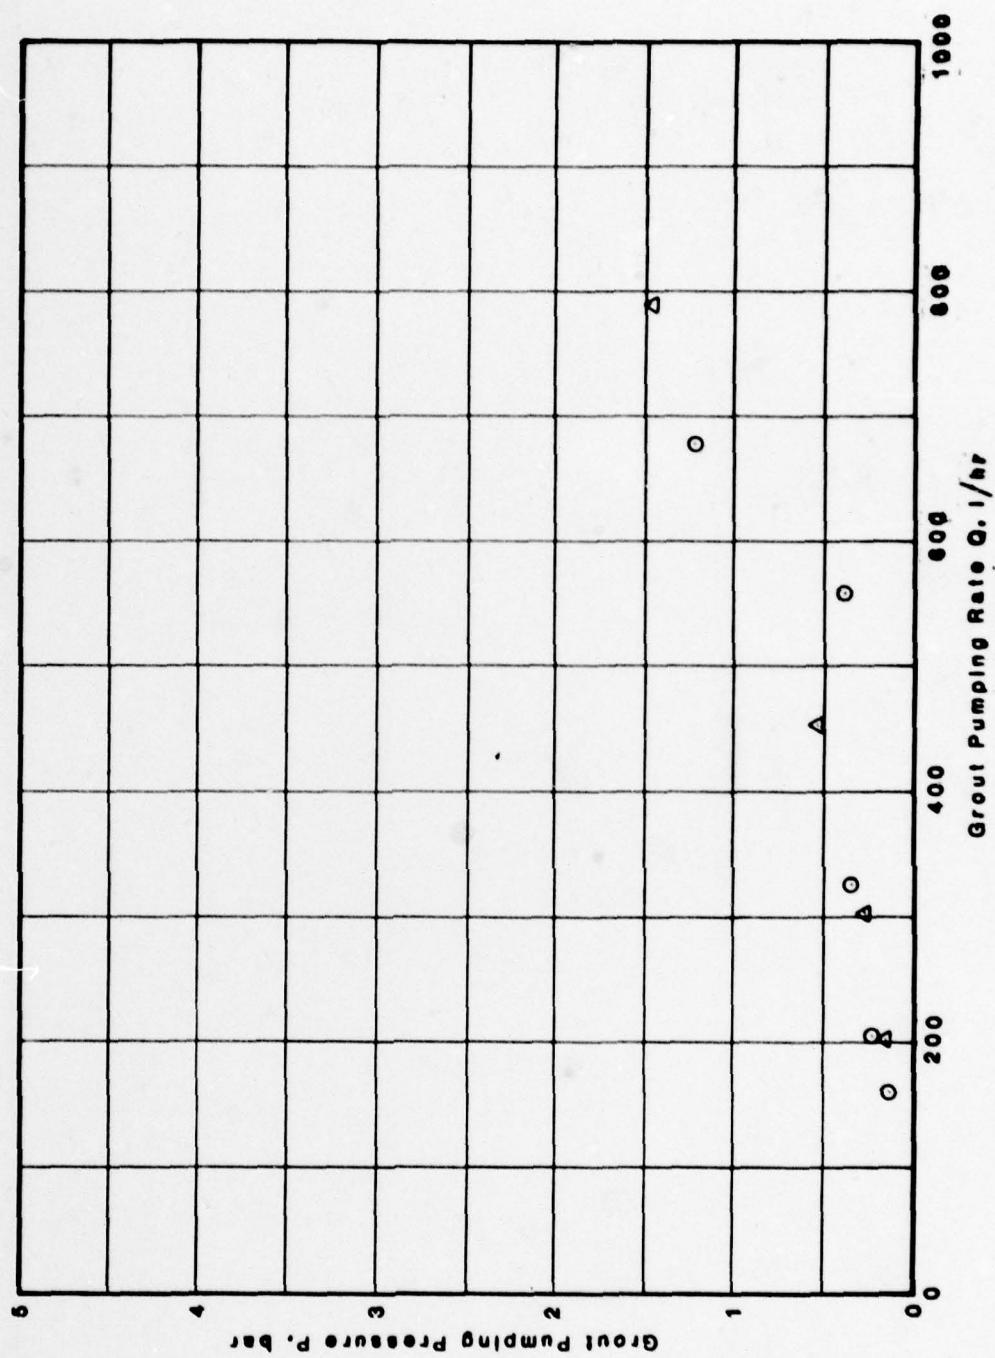
Figure D.1 RESULTS OF HYDRAULIC FRACTURING TESTS
through
Figure D.11

RESULTS OF HYDRAULIC
FRACTURING TEST
GROUT HOLE NO. 3-3

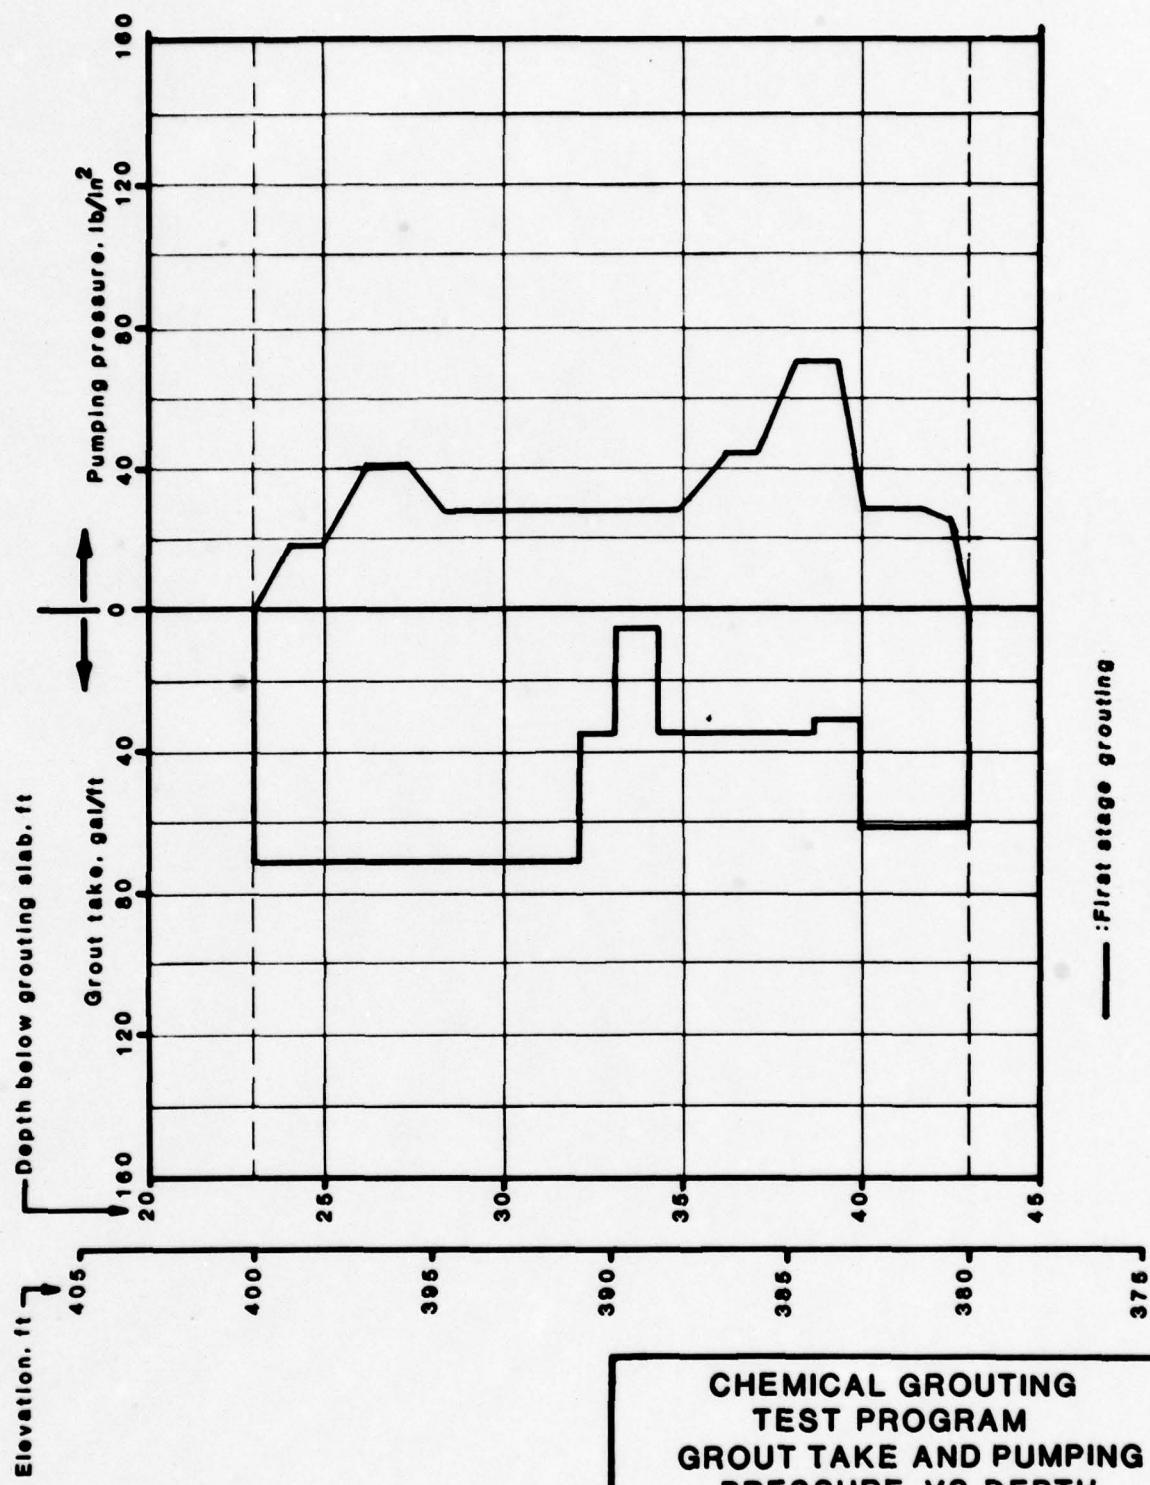
Fig. E.3

**CHEMICAL GROUTING
TEST PROGRAM
GROUT TAKE AND PUMPING
PRESSURE VS DEPTH
GROUT HOLE No. 1-4**

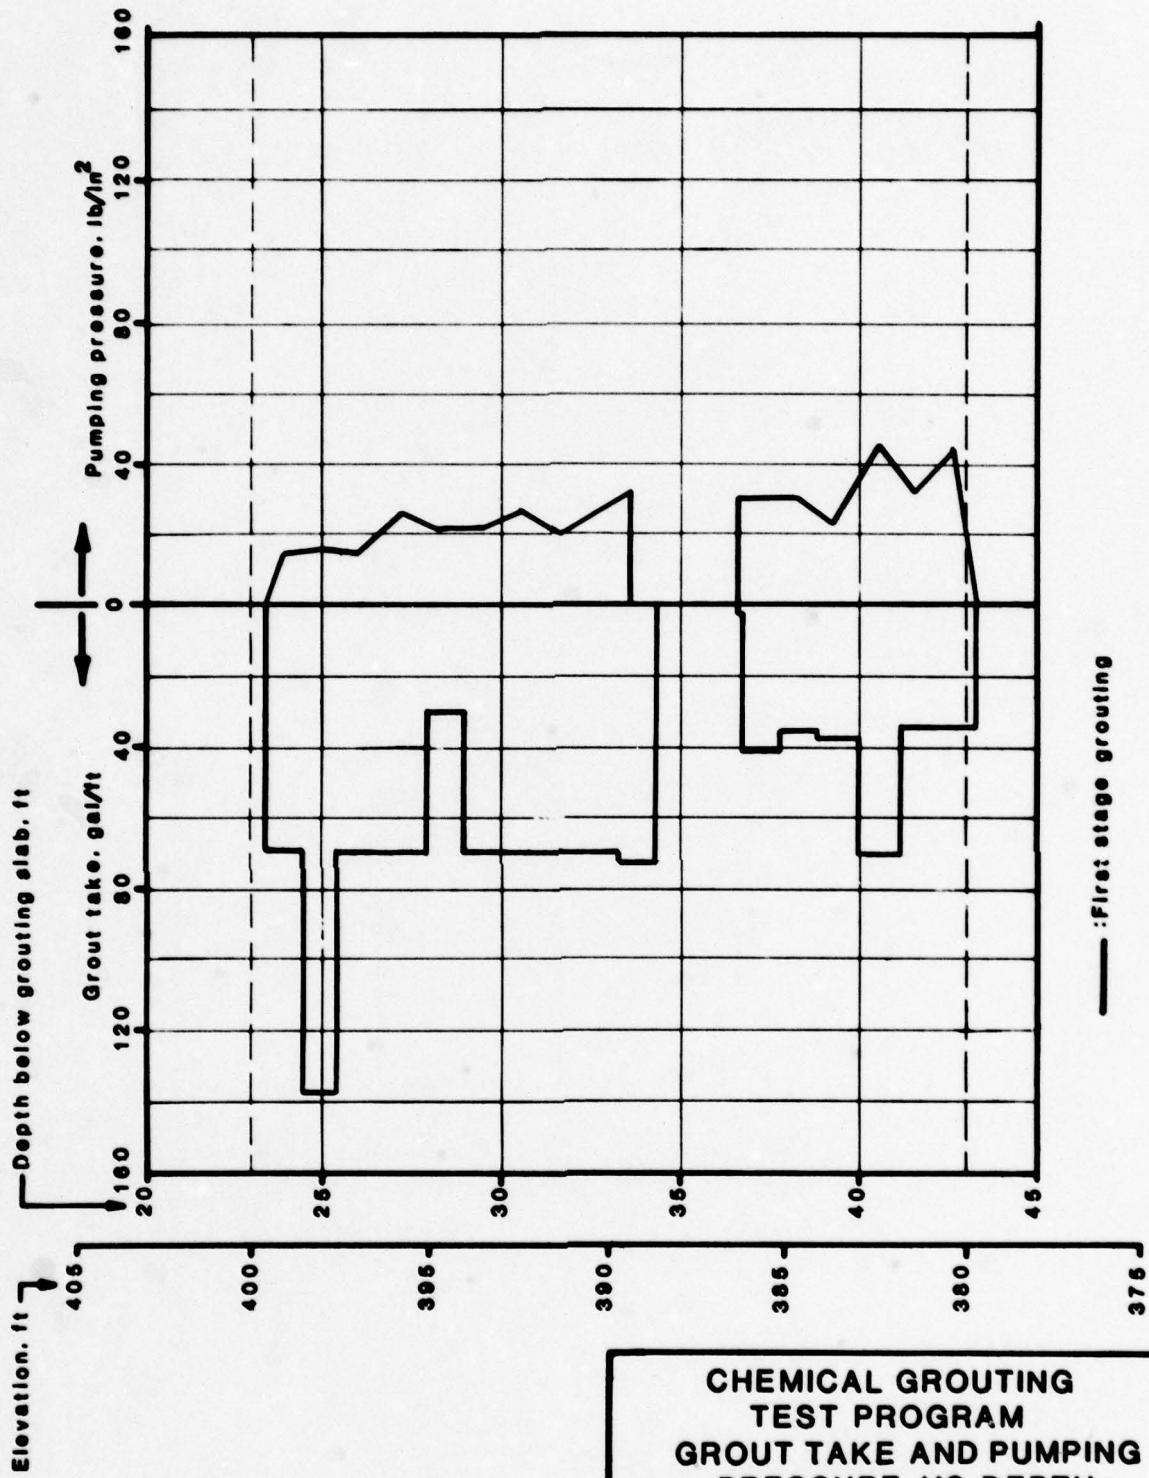
Fig. E.7

**CHEMICAL GROUTING
TEST PROGRAM
GROUT TAKE AND PUMPING
PRESSURE VS DEPTH
GROUT HOLE No. 2-2**

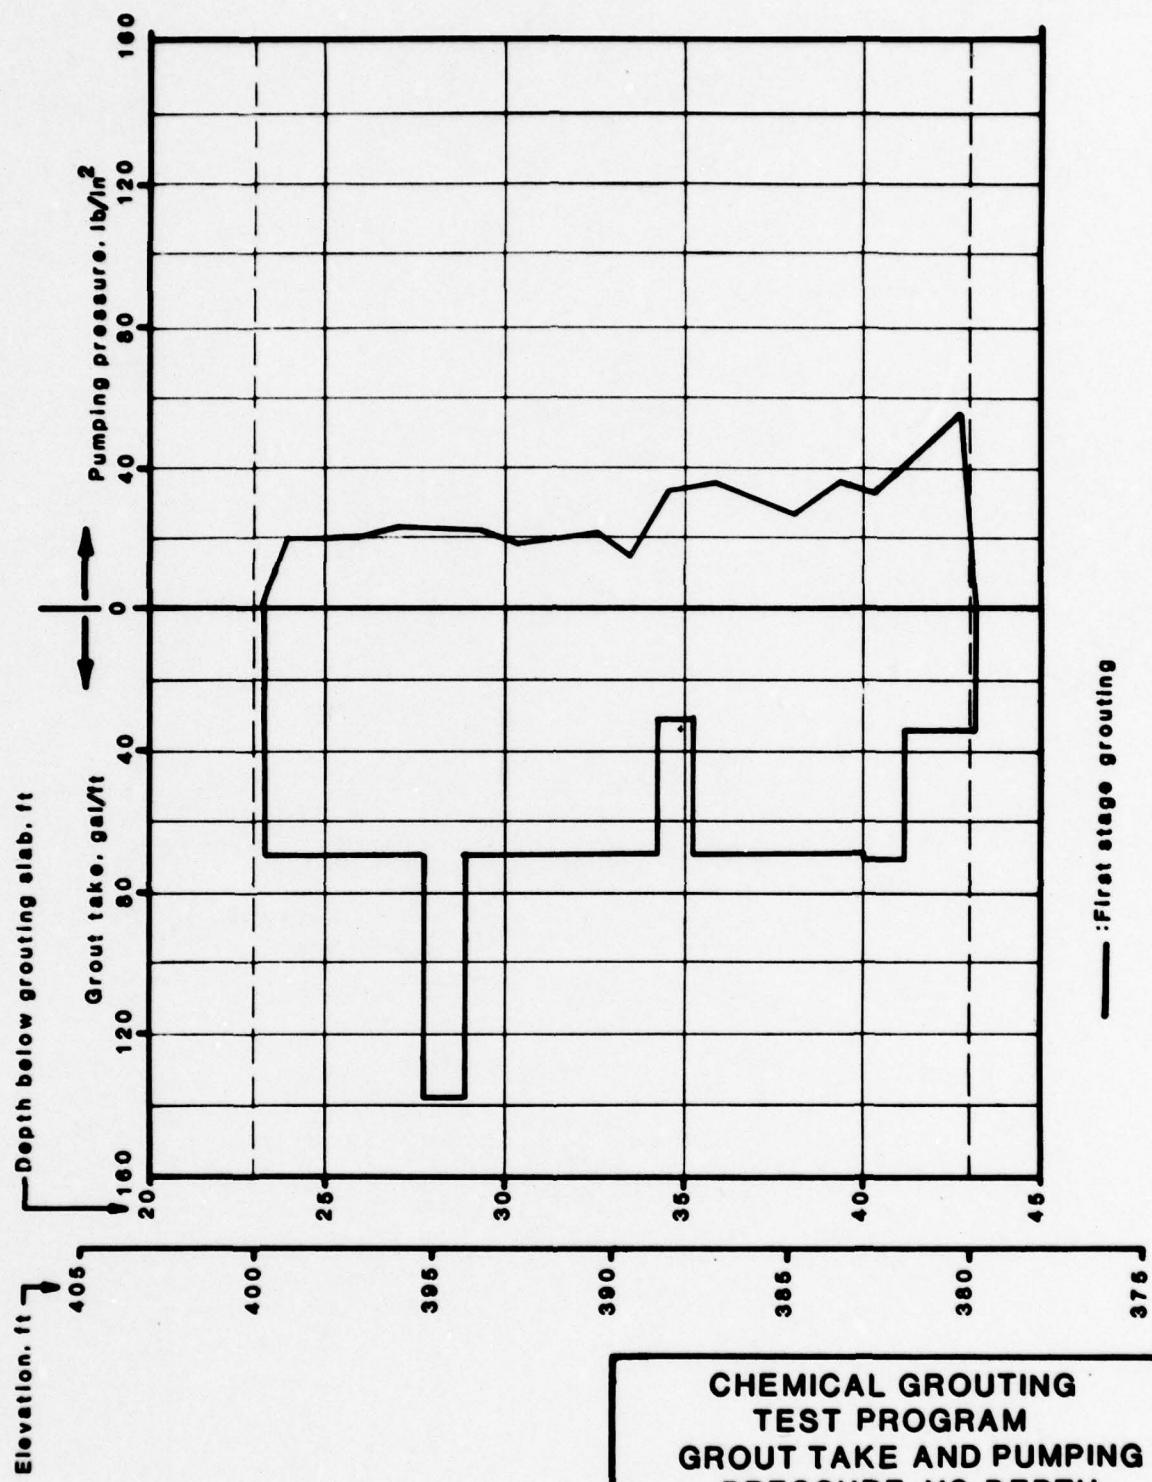
Fig. E.9

**CHEMICAL GROUTING
TEST PROGRAM
GROUT TAKE AND PUMPING
PRESSURE VS DEPTH
GROUT HOLE No. 2-3**

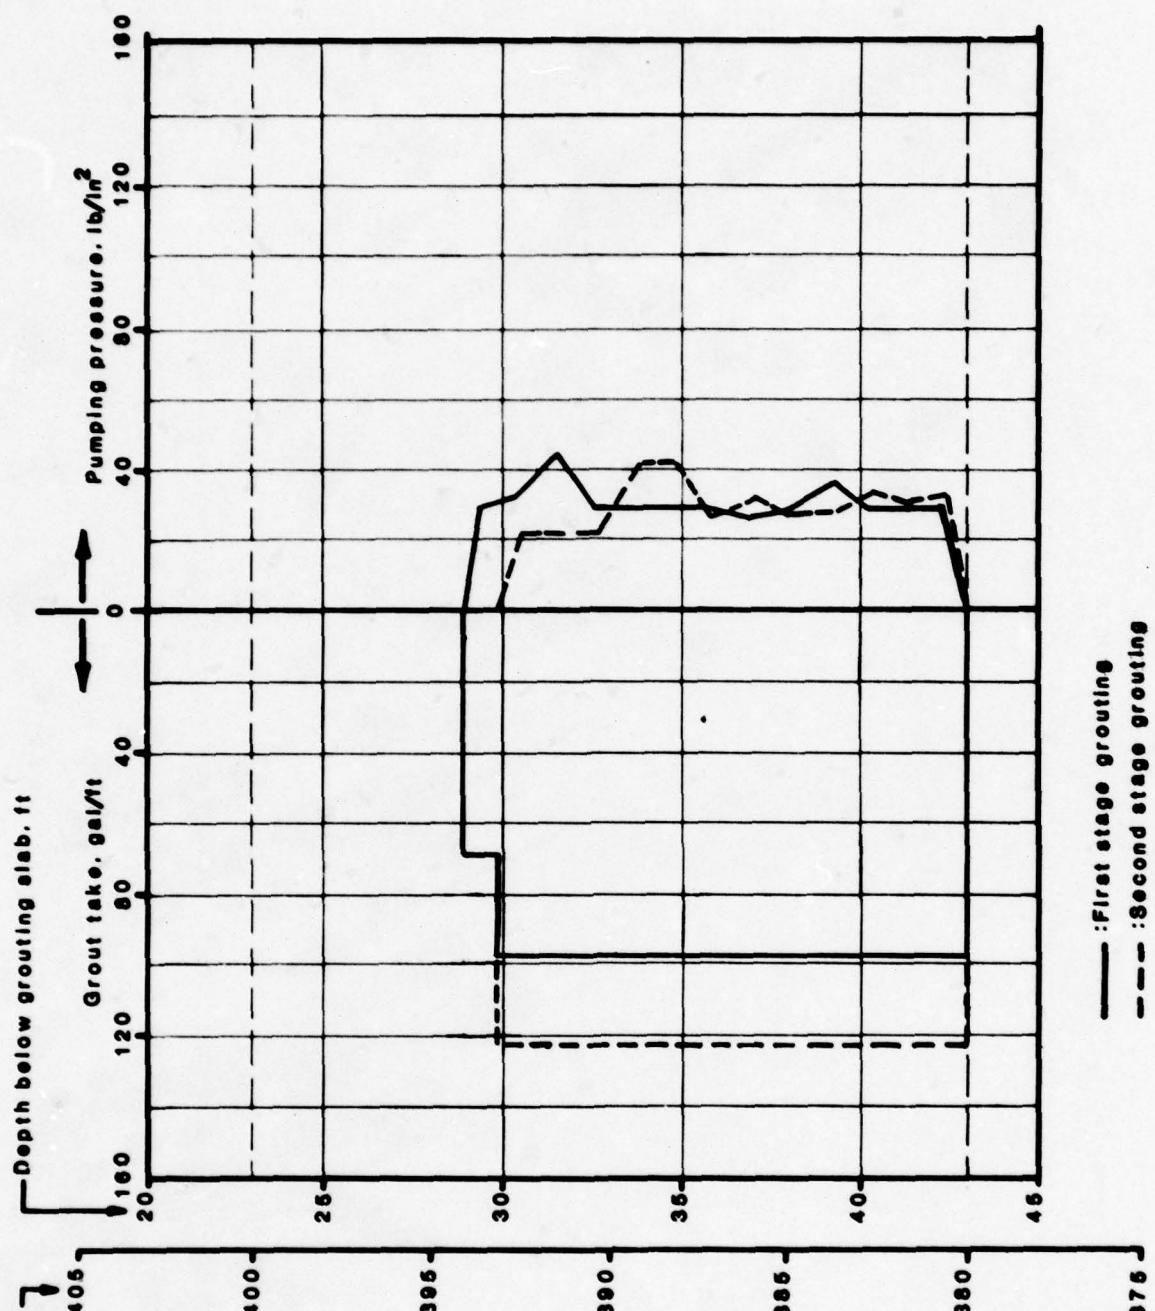
**CHEMICAL GROUTING
TEST PROGRAM
GROUT TAKE AND PUMPING
PRESSURE VS DEPTH
GROUT HOLE No. 3-1**

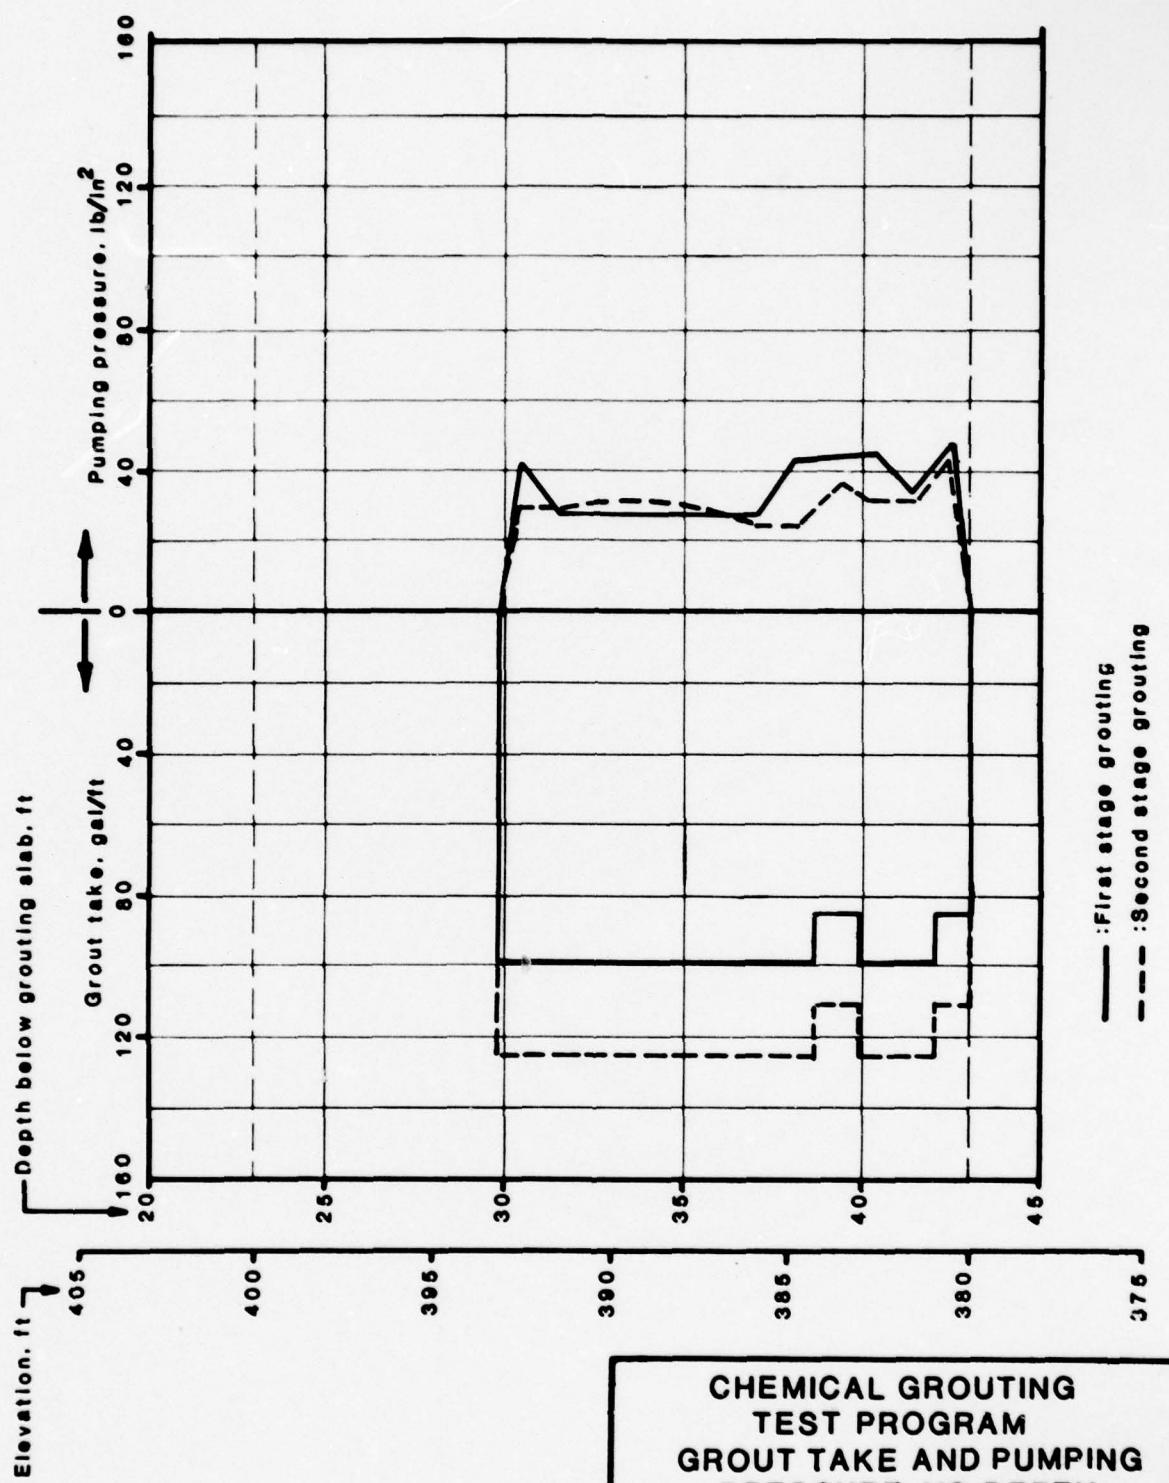
**CHEMICAL GROUTING
TEST PROGRAM
GROUT TAKE AND PUMPING
PRESSURE VS DEPTH
GROUT HOLE No. 3-3**

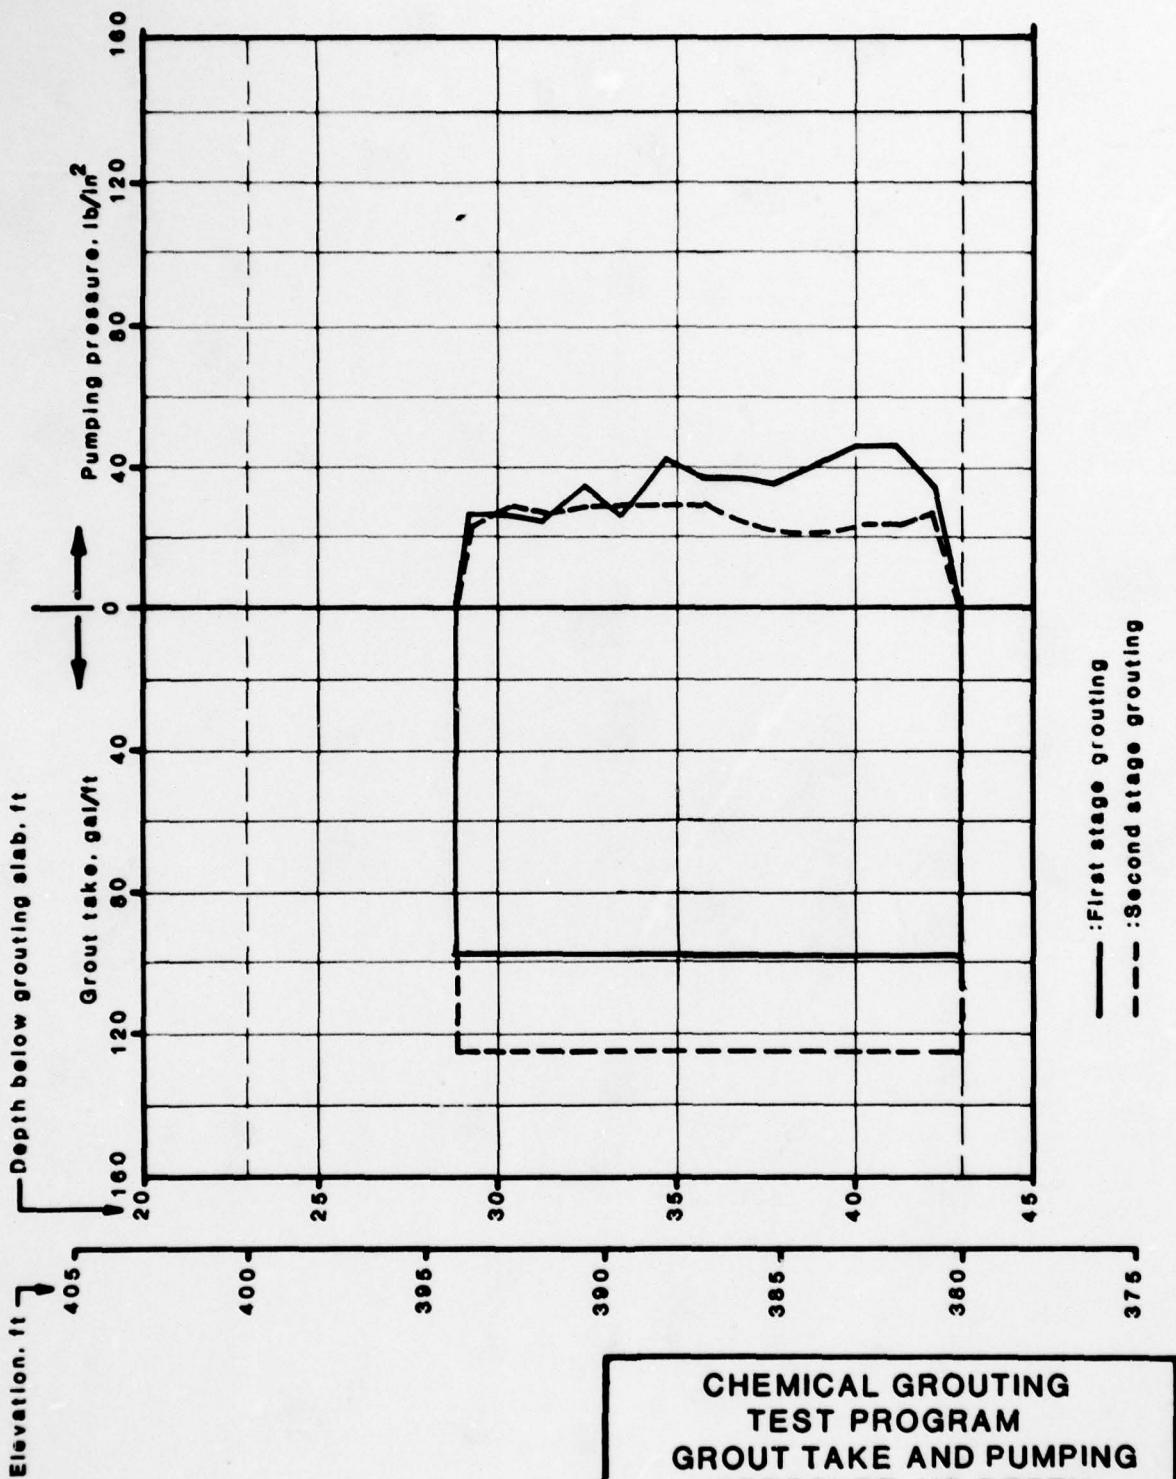
Fig. E.14

**CHEMICAL GROUTING
TEST PROGRAM
GROUT TAKE AND PUMPING
PRESSURE VS DEPTH
GROUT HOLE No. 3-4**

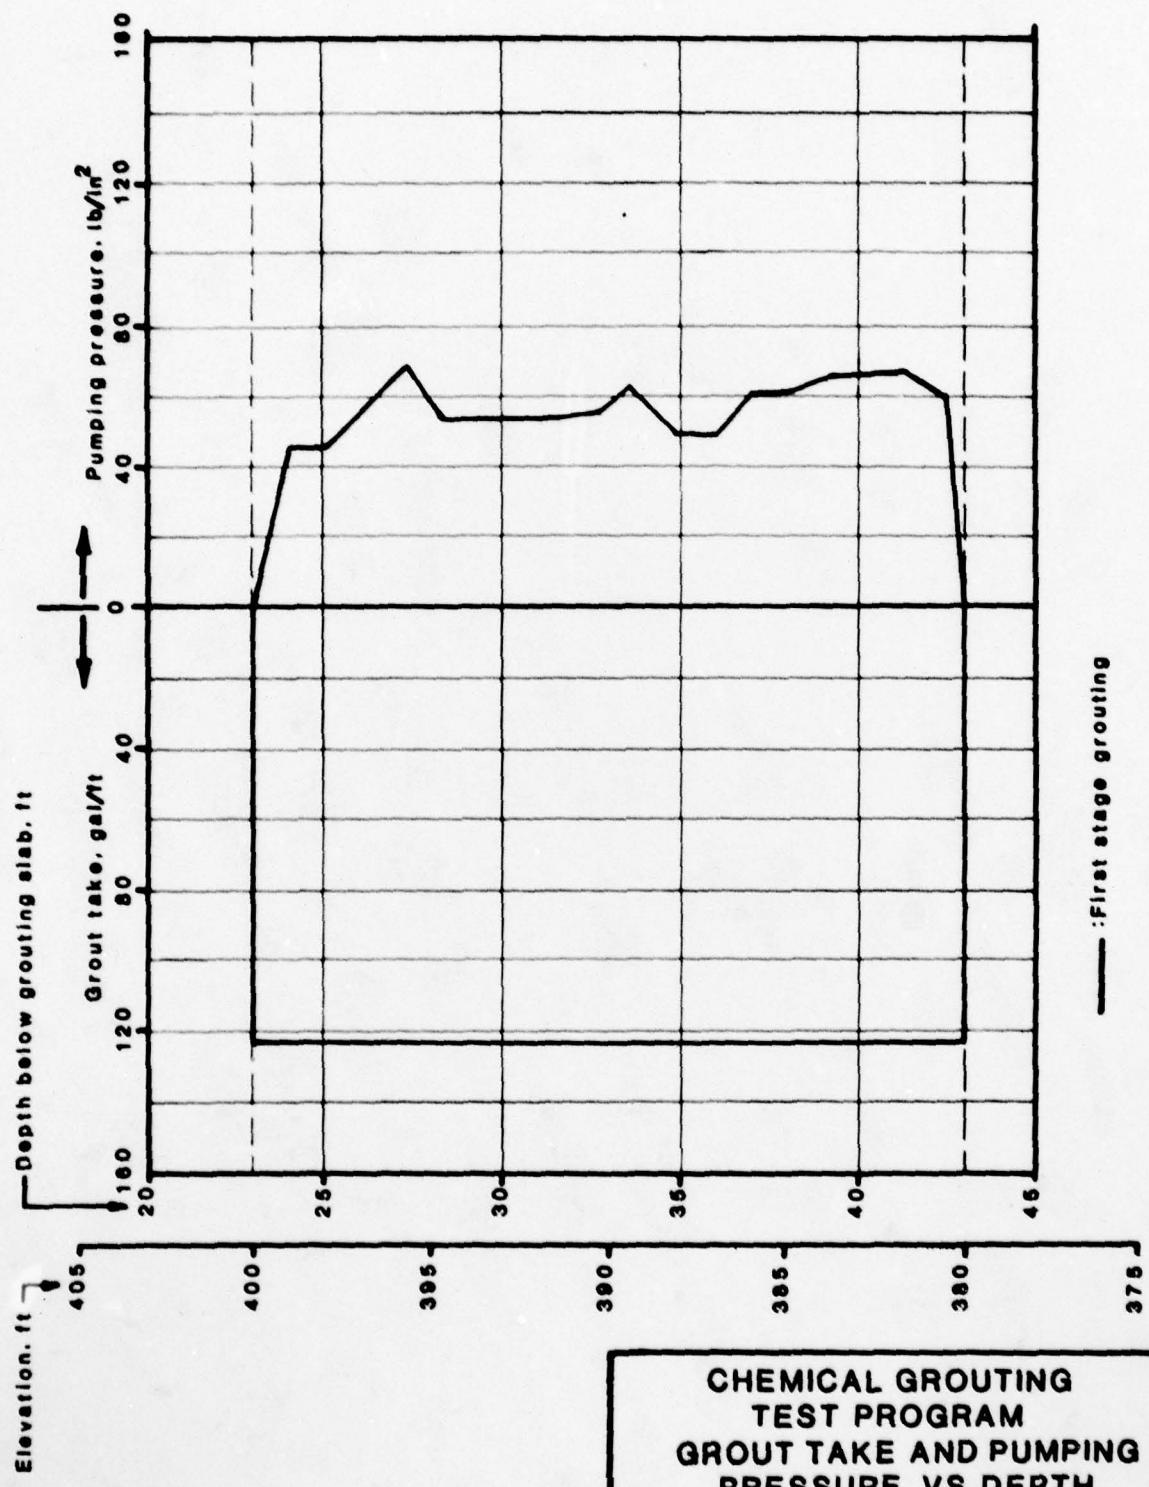
Fig. E.15

**CHEMICAL GROUTING
TEST PROGRAM
GROUT TAKE AND PUMPING
PRESSURE VS DEPTH
GROUT HOLE No. 4-1**

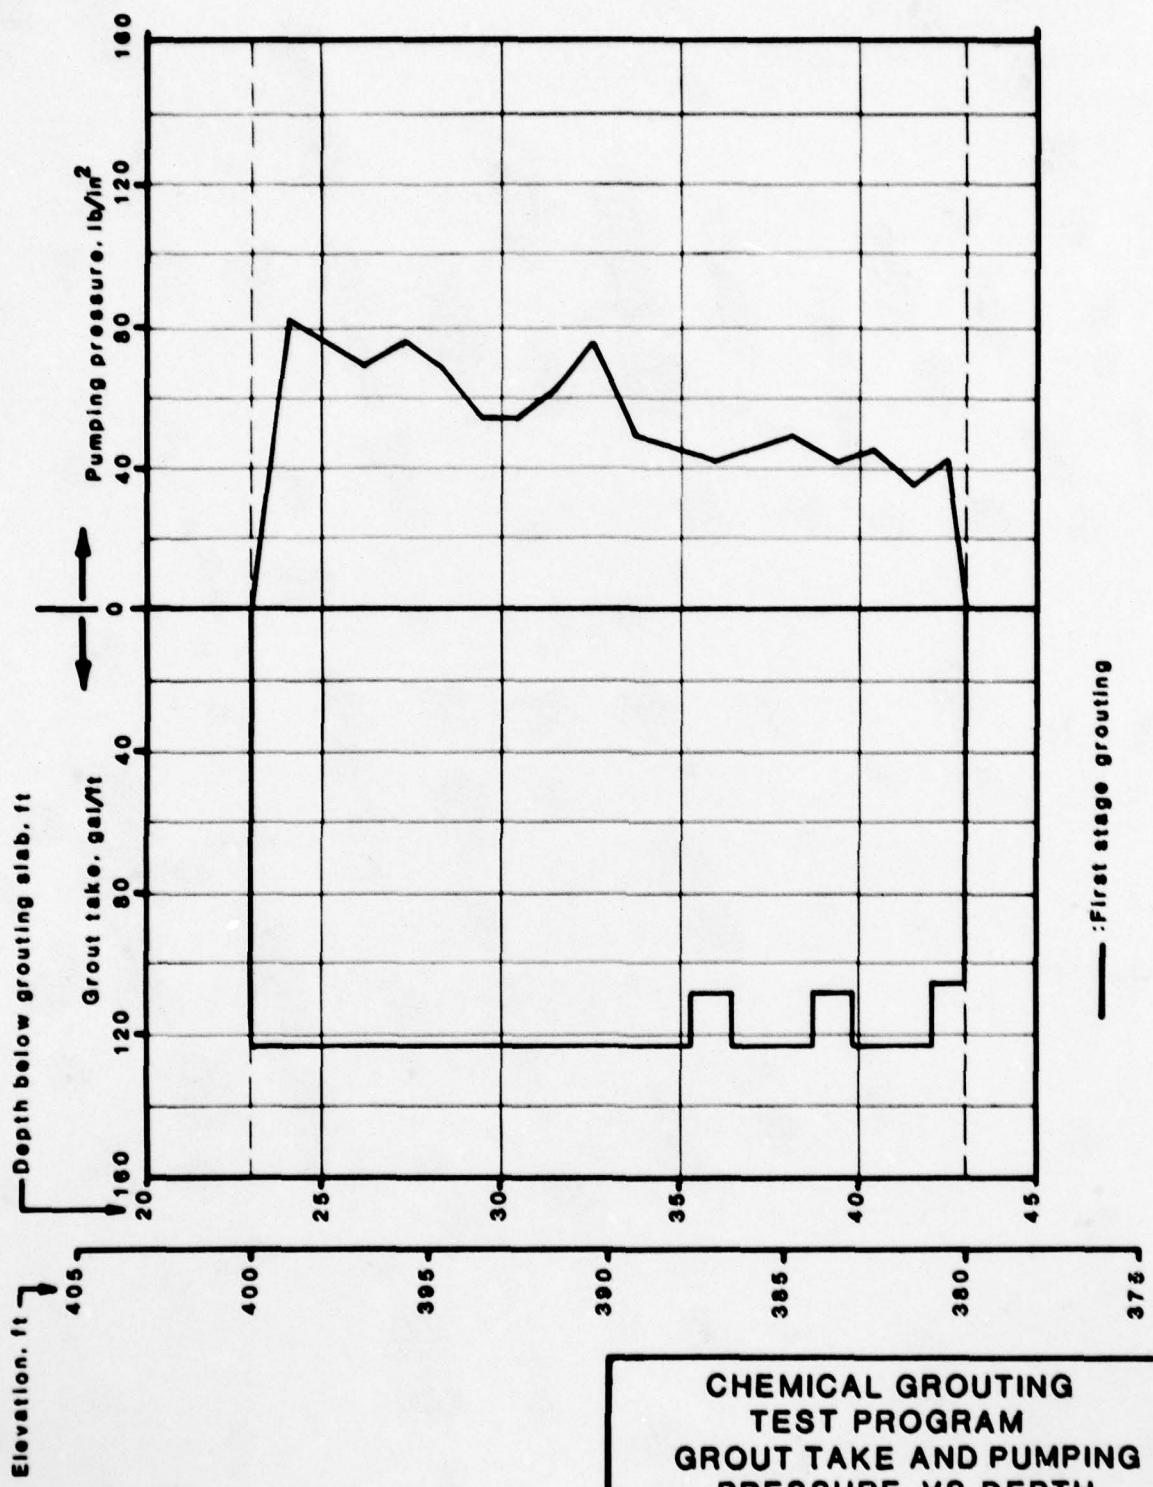
Fig. E.16

**CHEMICAL GROUTING
TEST PROGRAM
GROUT TAKE AND PUMPING
PRESSURE VS DEPTH
GROUT HOLE No. 4-2**

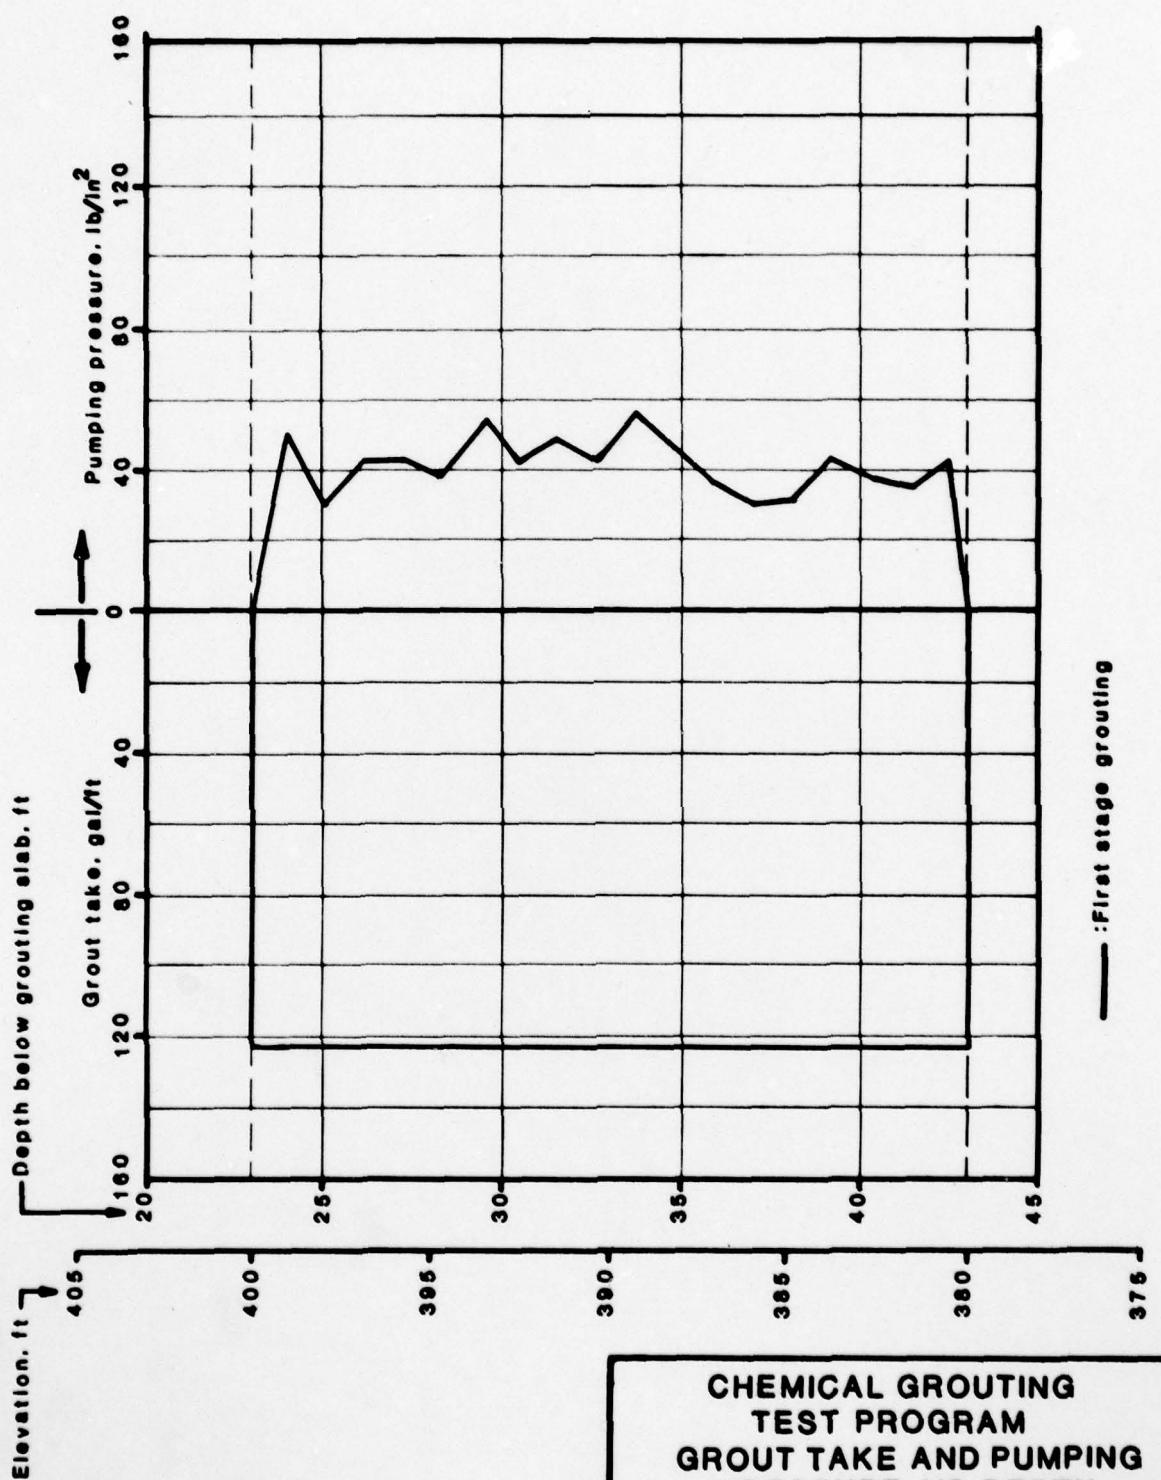
Fig. E.17

**CHEMICAL GROUTING
TEST PROGRAM
GROUT TAKE AND PUMPING
PRESSURE VS DEPTH
GROUT HOLE NO. 4-3**

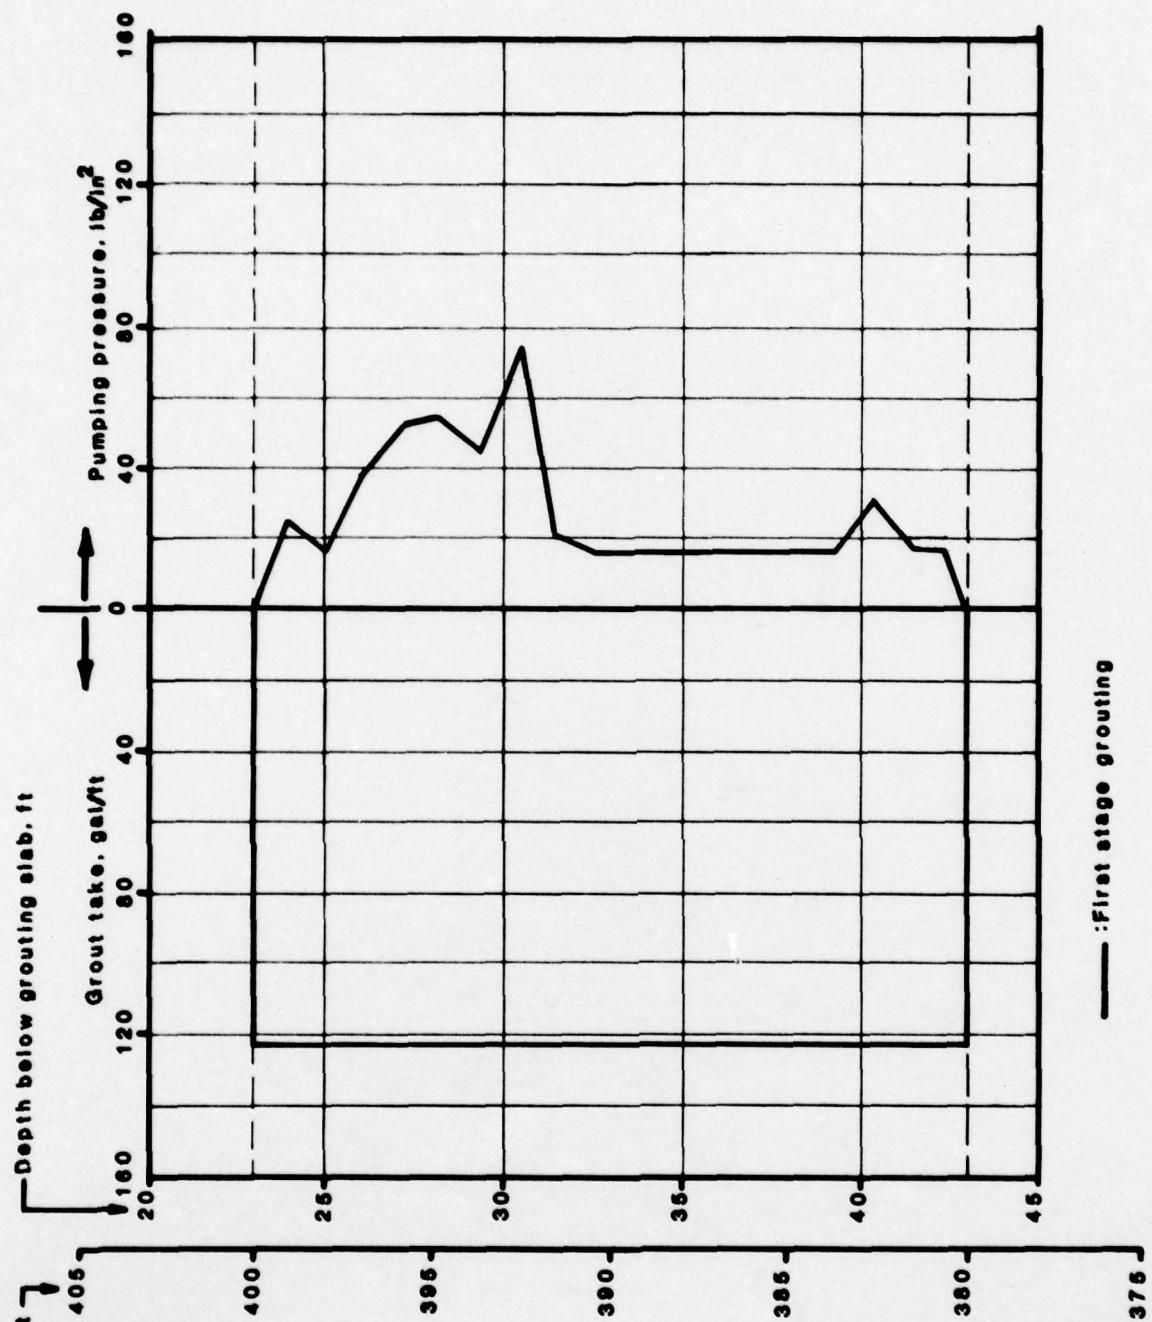
Fig. E.18

**CHEMICAL GROUTING TEST PROGRAM
GROUT TAKE AND PUMPING PRESSURE VS DEPTH
GROUT HOLE No. 4-4**

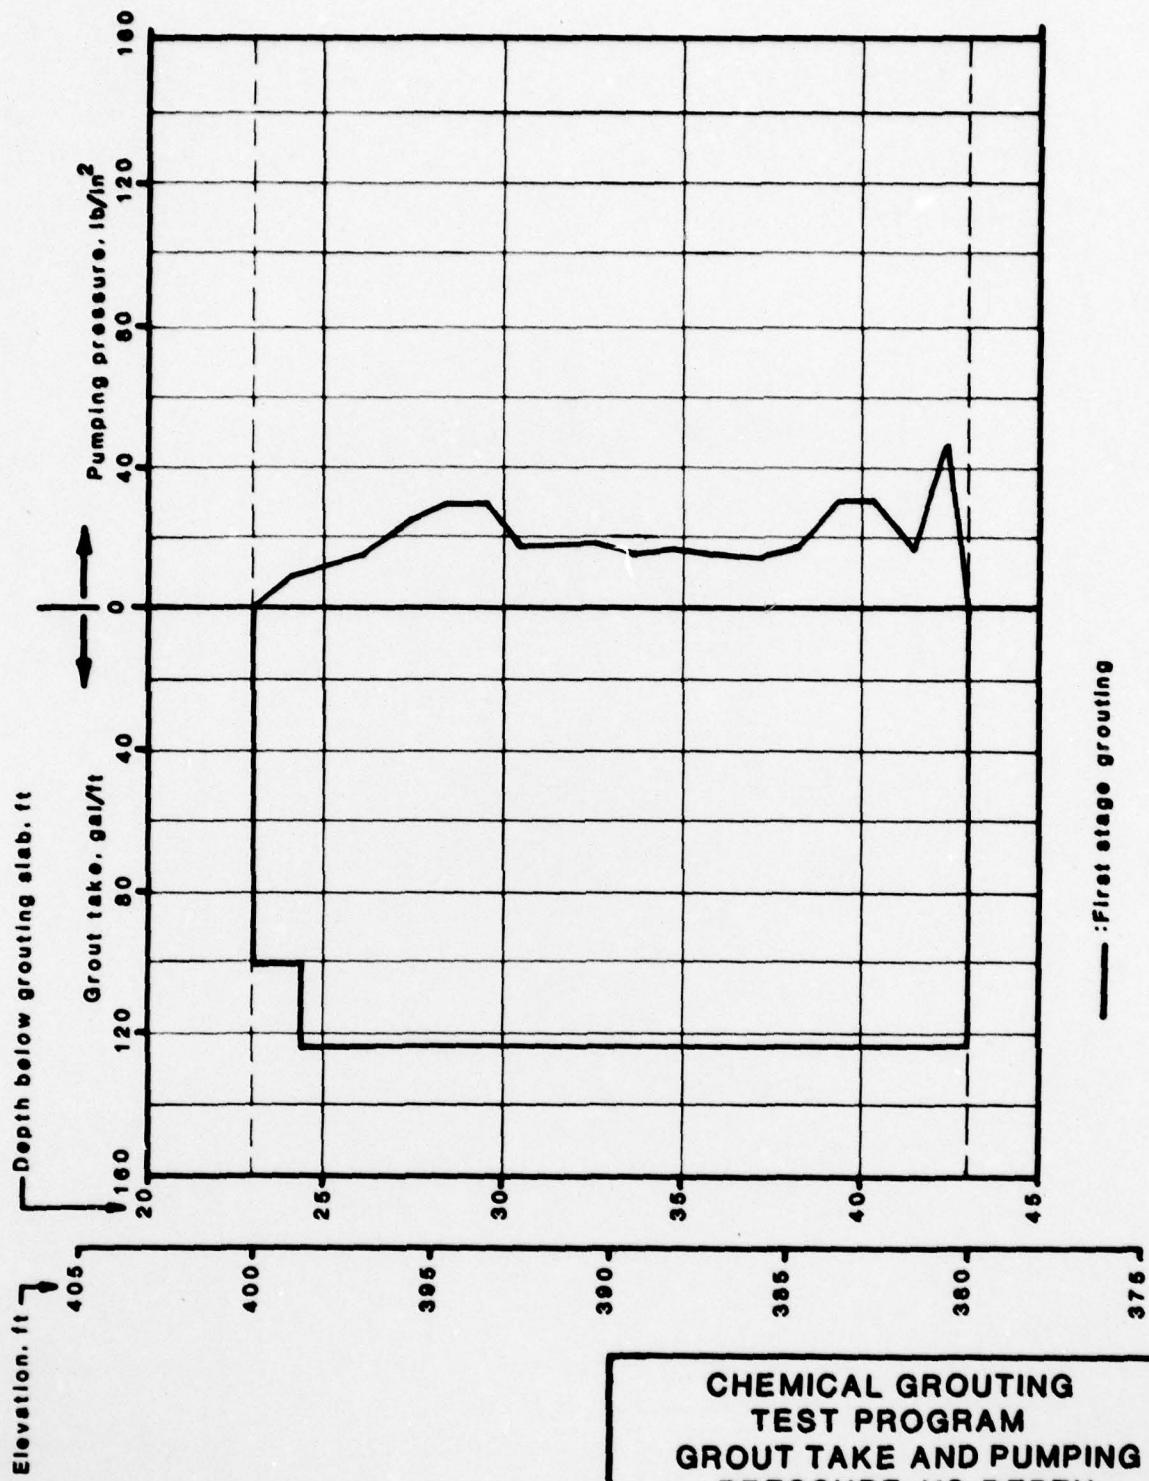
Fig. E.19

CHEMICAL GROUTING
TEST PROGRAM
GROUT TAKE AND PUMPING
PRESSURE VS DEPTH
GROUT HOLE No. 4-5
