PHASE IV REPORT

APPENDICES A THROUGH G

**RESULTS AND INTERPRETATION OF
CHEMICAL GROUTING TEST PROGRAM**

**EXISTING LOCKS AND DAM NO. 26
MISSISSIPPI RIVER, ALTON, ILLINOIS**

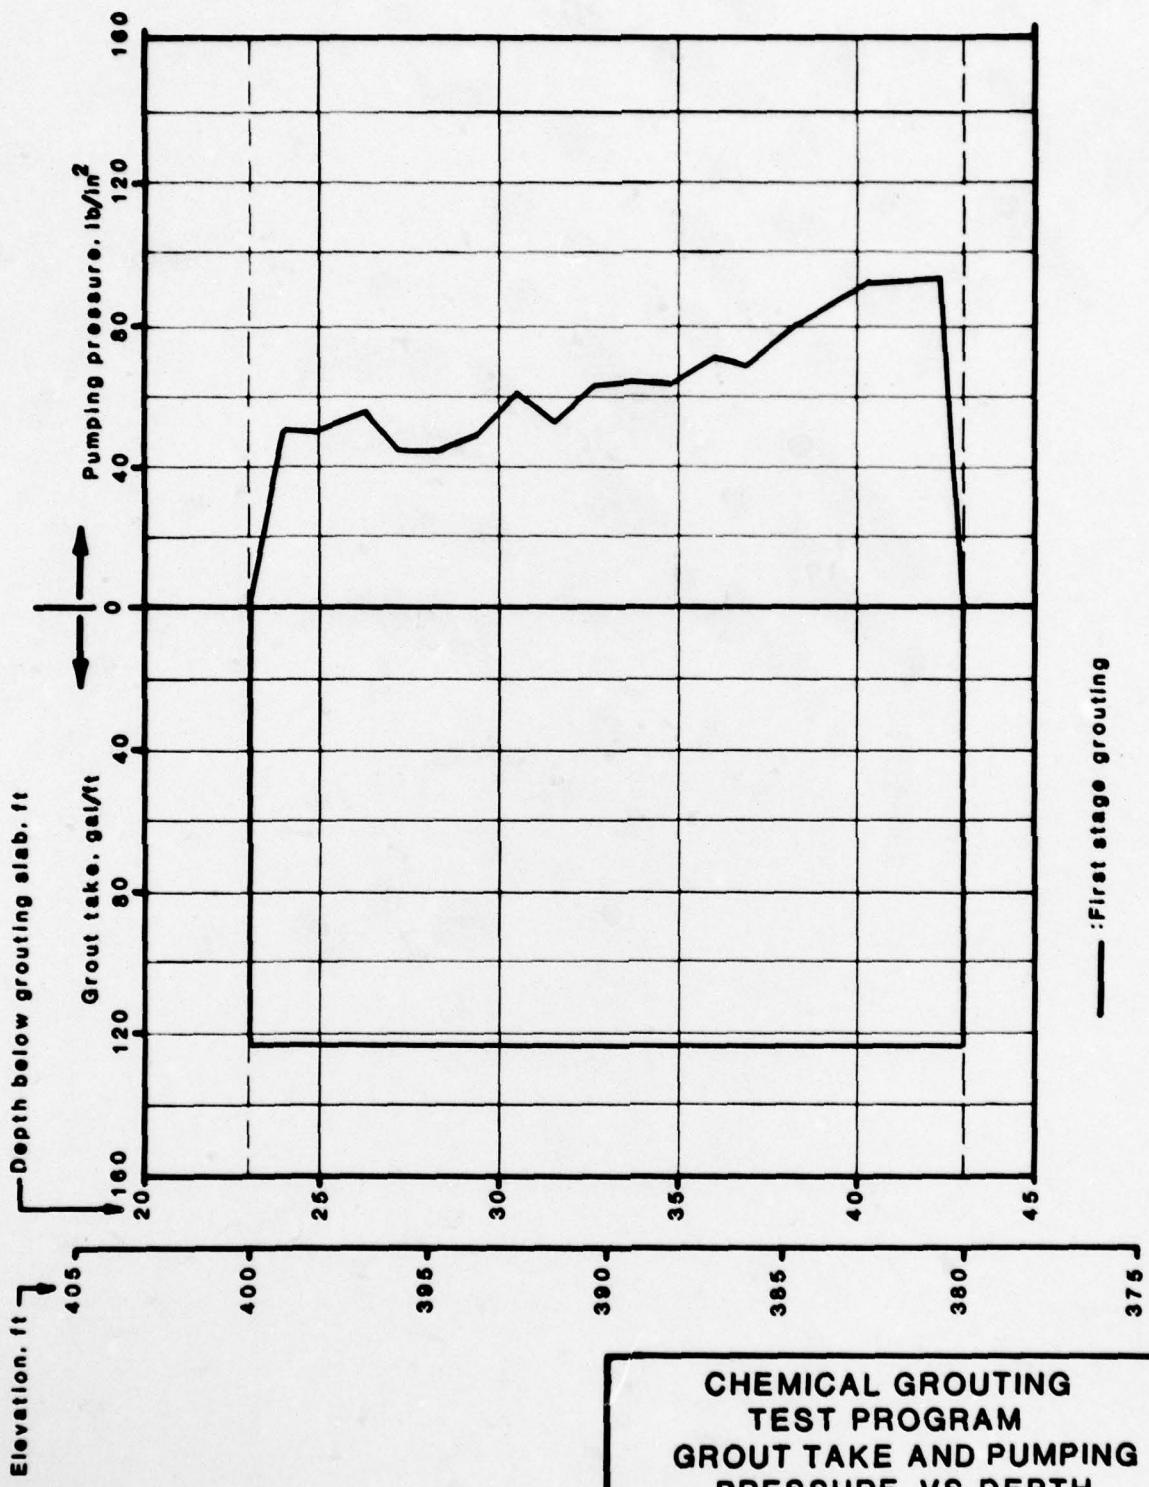
Fig. E.20

**CHEMICAL GROUTING
TEST PROGRAM
GROUT TAKE AND PUMPING
PRESSURE VS DEPTH
GROUT HOLE No. 5-1**
FOUNDATION INVESTIGATION AND TEST PROGRAM
EXISTING LOCKS AND DAM NO. 26
ST LOUIS DISTRICT, CORPS OF ENGINEERS.
DAGW43-78-C-0008

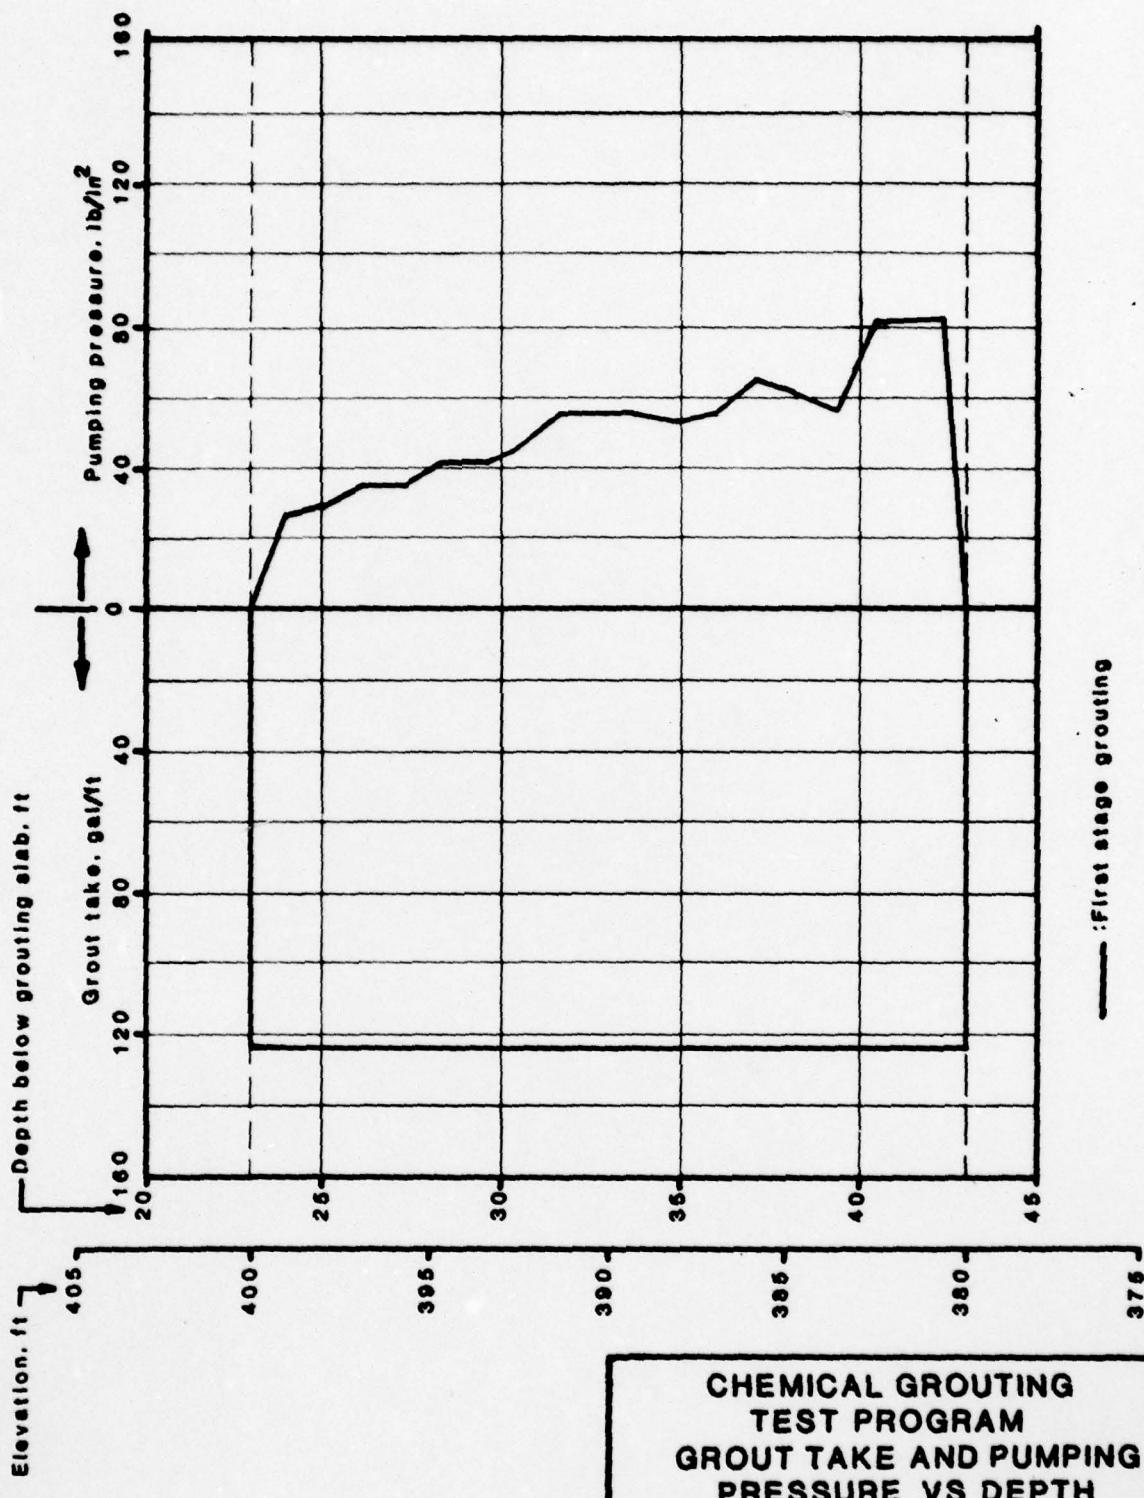
Fig. E.21

**CHEMICAL GROUTING
TEST PROGRAM
GROUT TAKE AND PUMPING
PRESSURE VS DEPTH
GROUT HOLE No. 5-2**

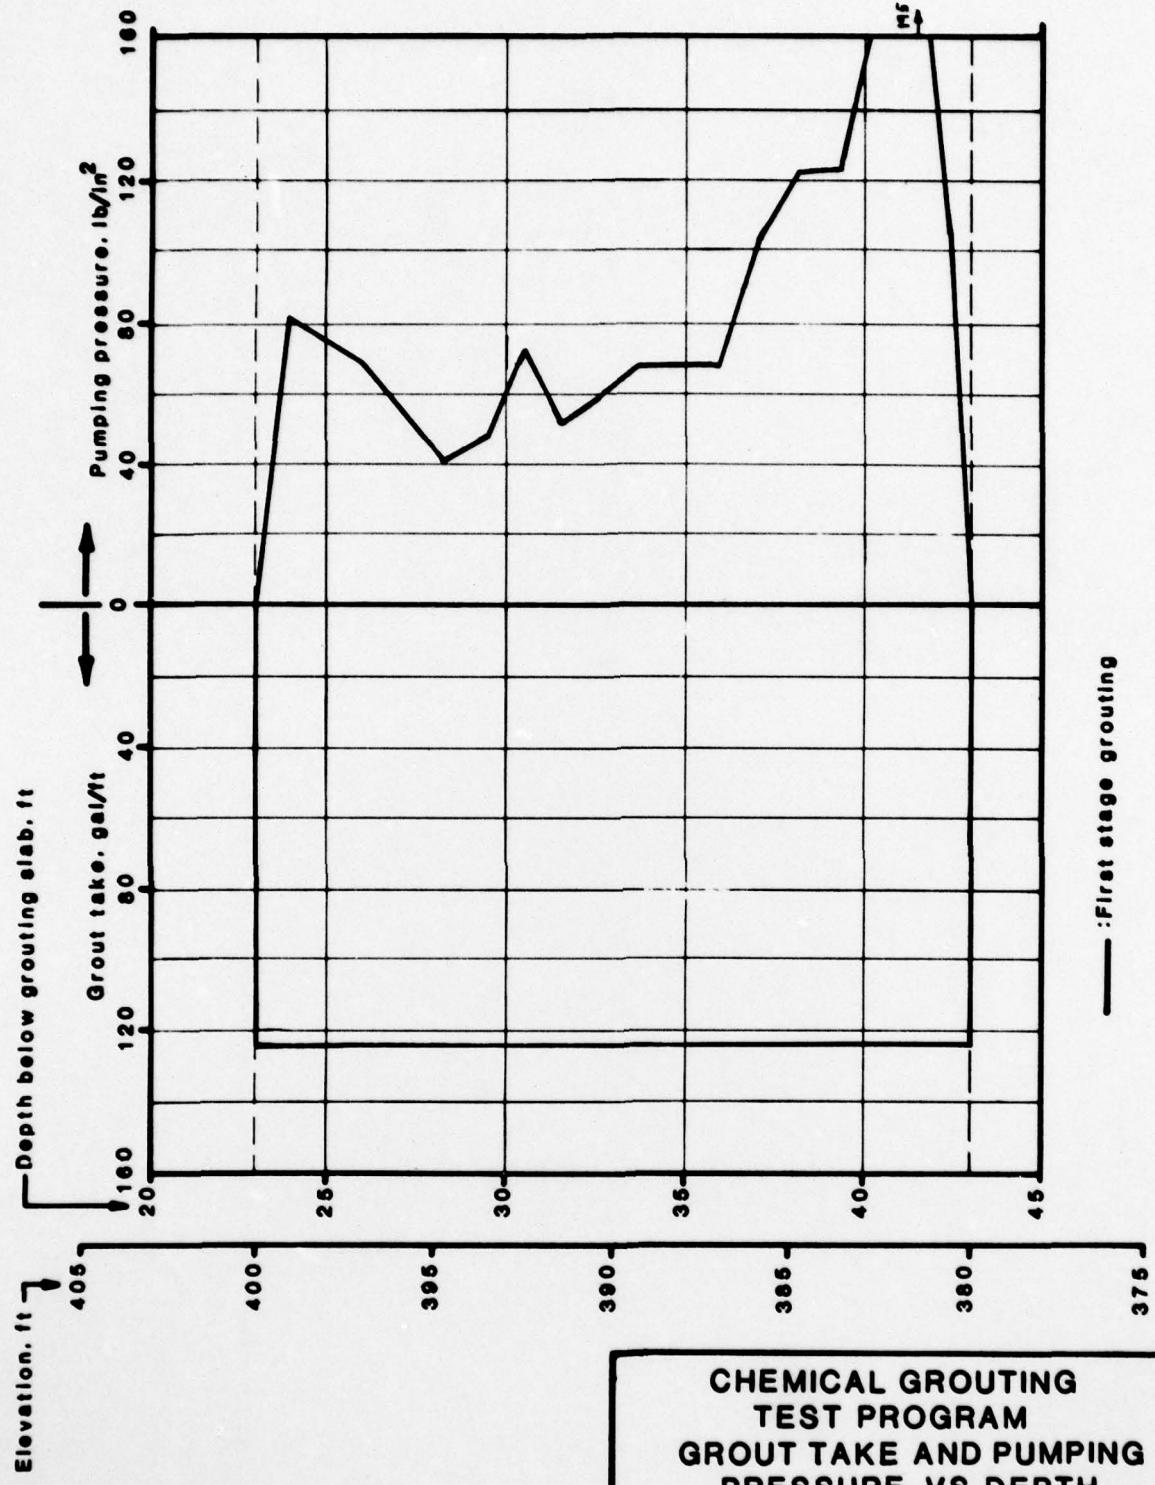
Fig. E.22

**CHEMICAL GROUTING
TEST PROGRAM
GROUT TAKE AND PUMPING
PRESSURE VS DEPTH
GROUT HOLE No. 5-4**

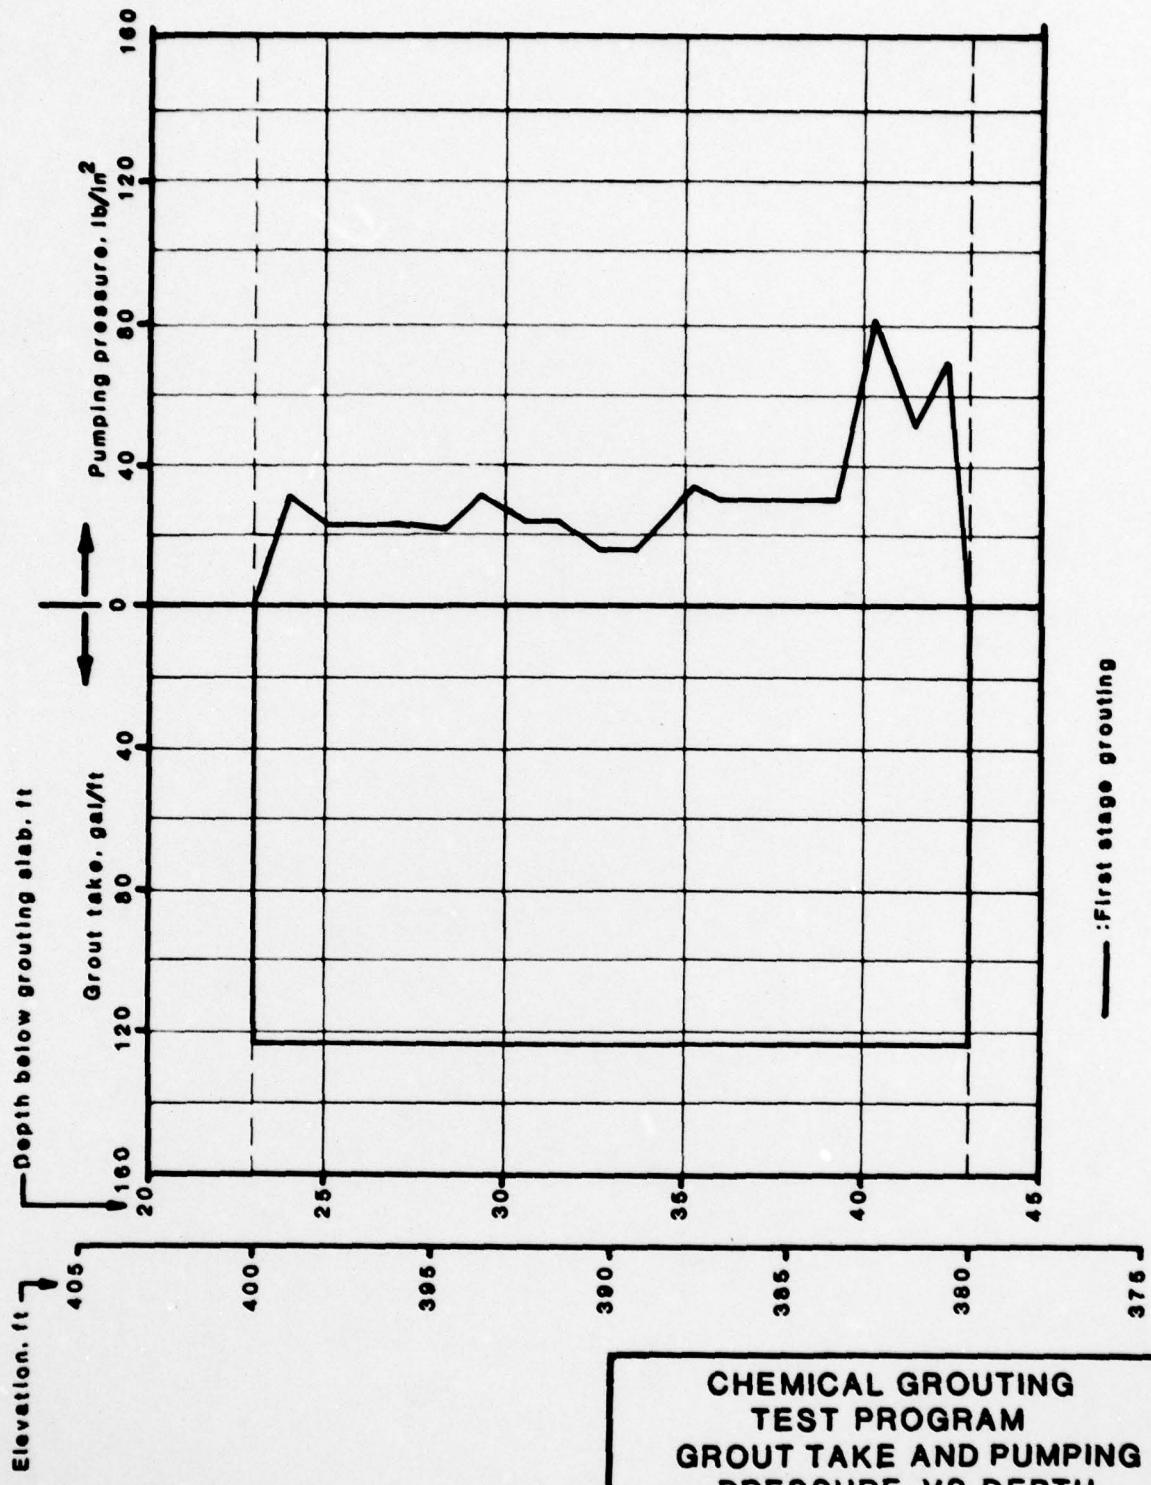
Fig. E.23

**CHEMICAL GROUTING
TEST PROGRAM
GROUT TAKE AND PUMPING
PRESSURE VS DEPTH
GROUT HOLE No. 5-5**

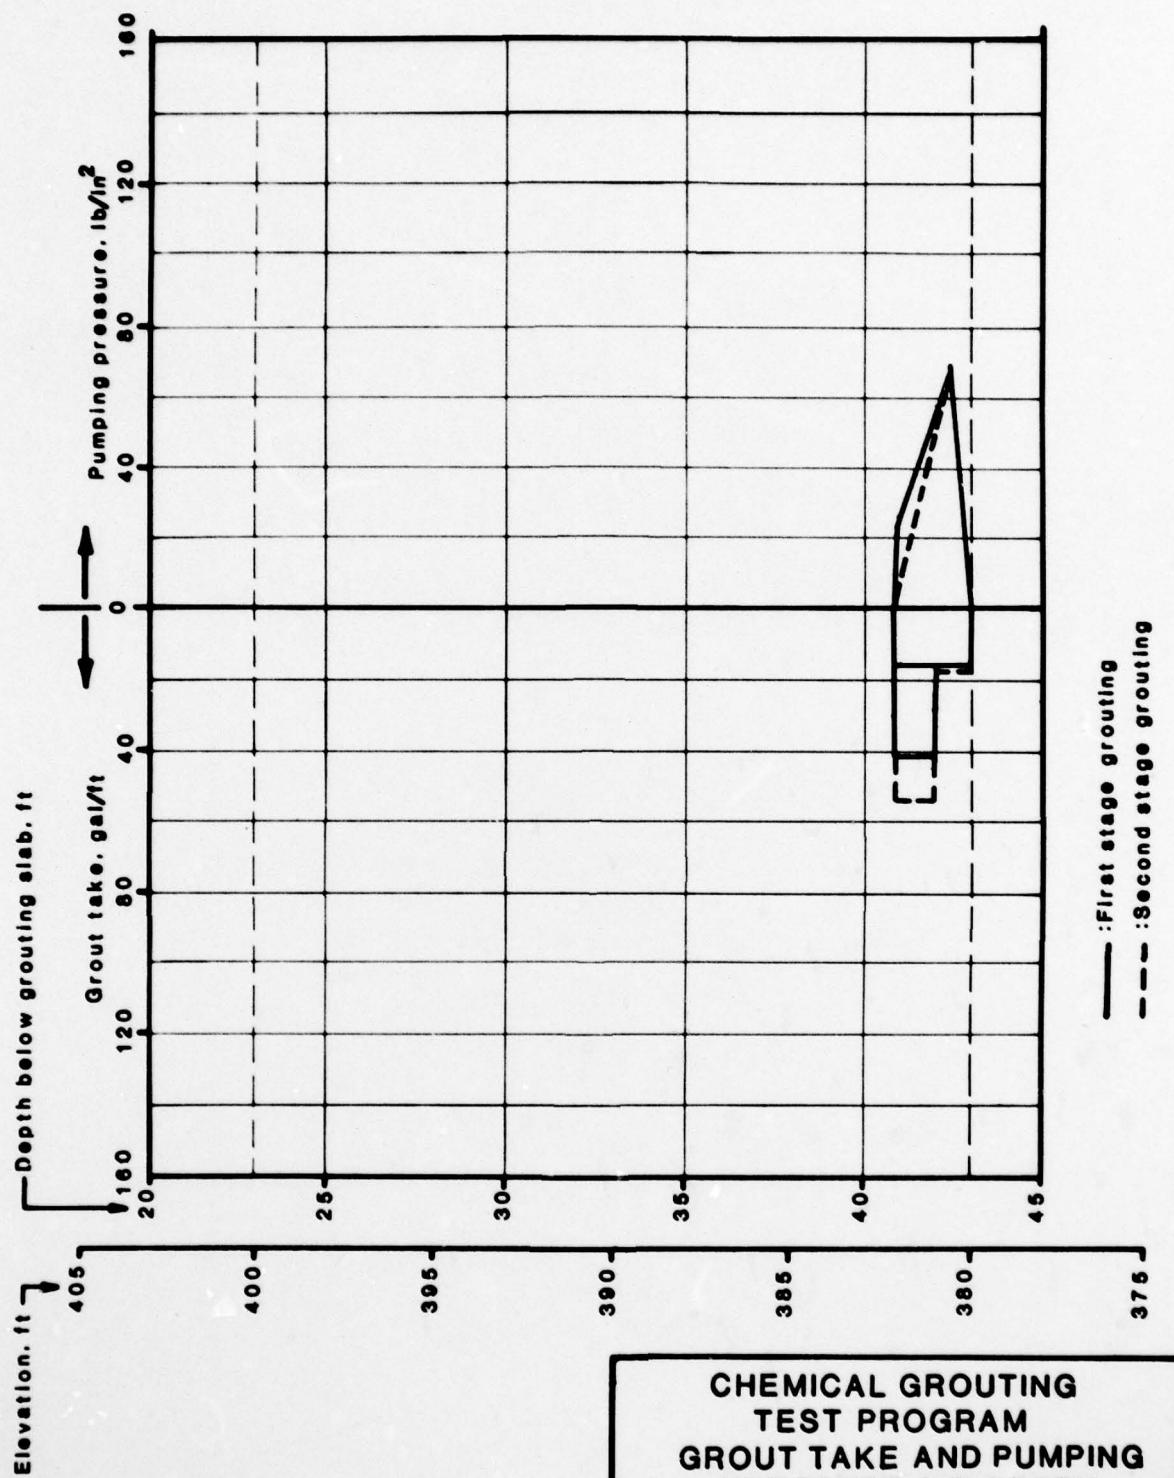
**CHEMICAL GROUTING
TEST PROGRAM
GROUT TAKE AND PUMPING
PRESSURE VS DEPTH
GROUT HOLE No. 5a-6**

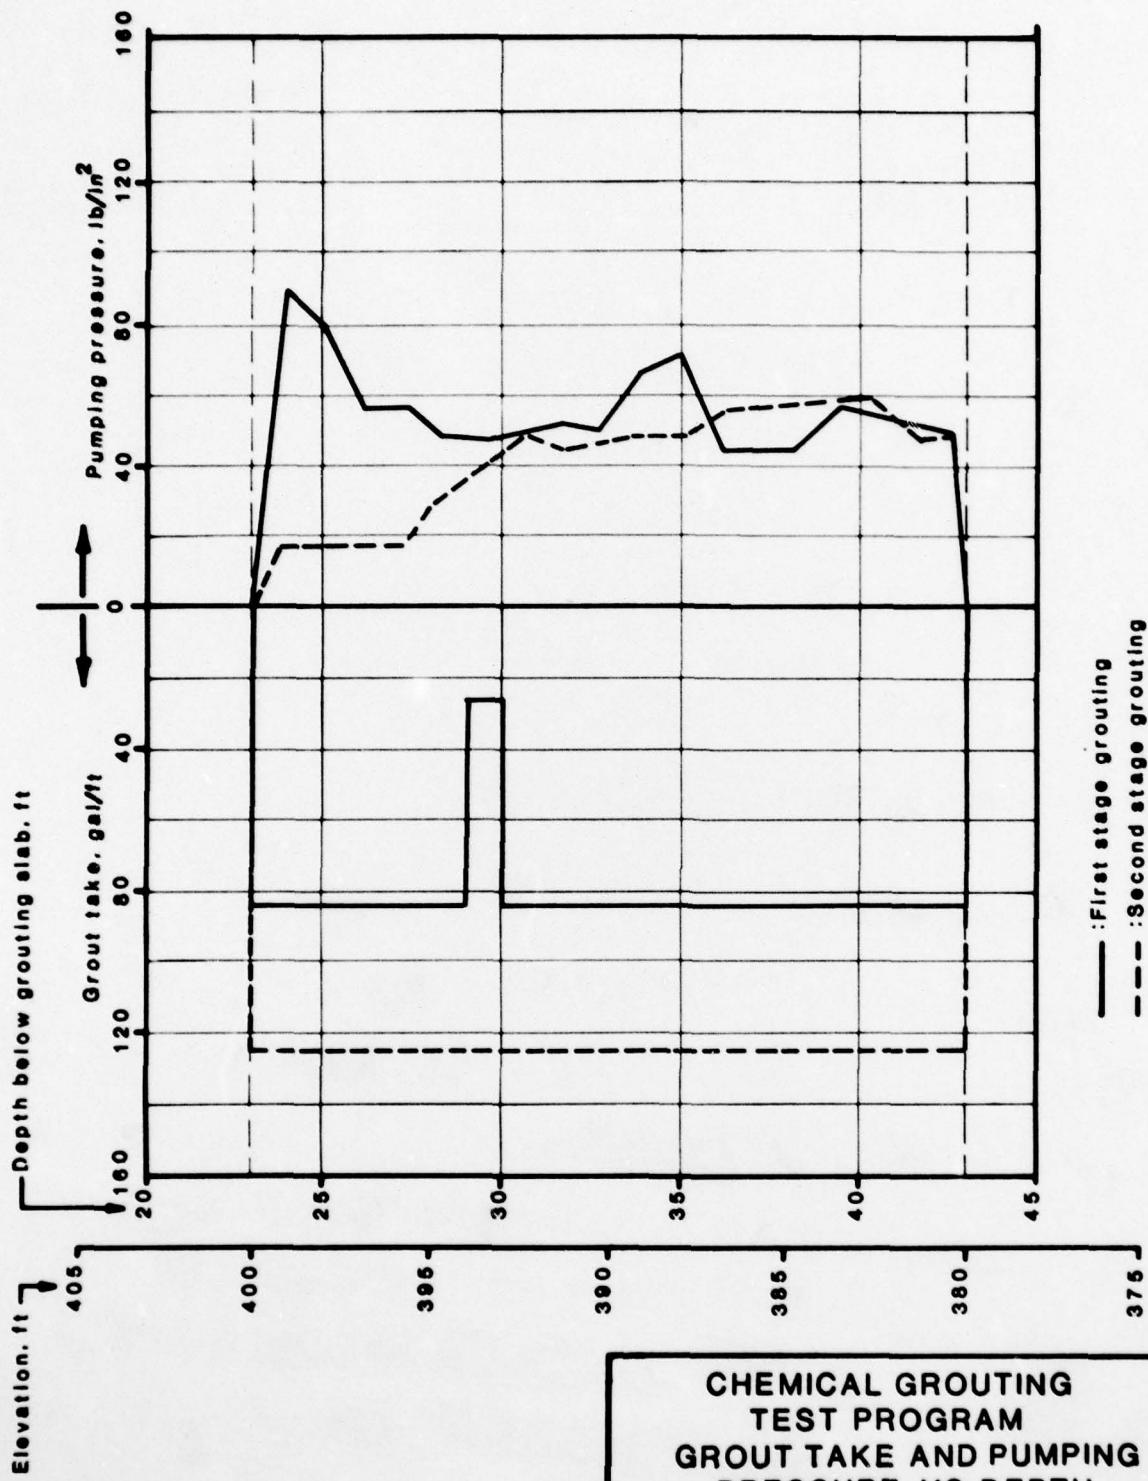
Fig. E.26

**CHEMICAL GROUTING
TEST PROGRAM
GROUT TAKE AND PUMPING
PRESSURE VS DEPTH
GROUT HOLE No.6-1**

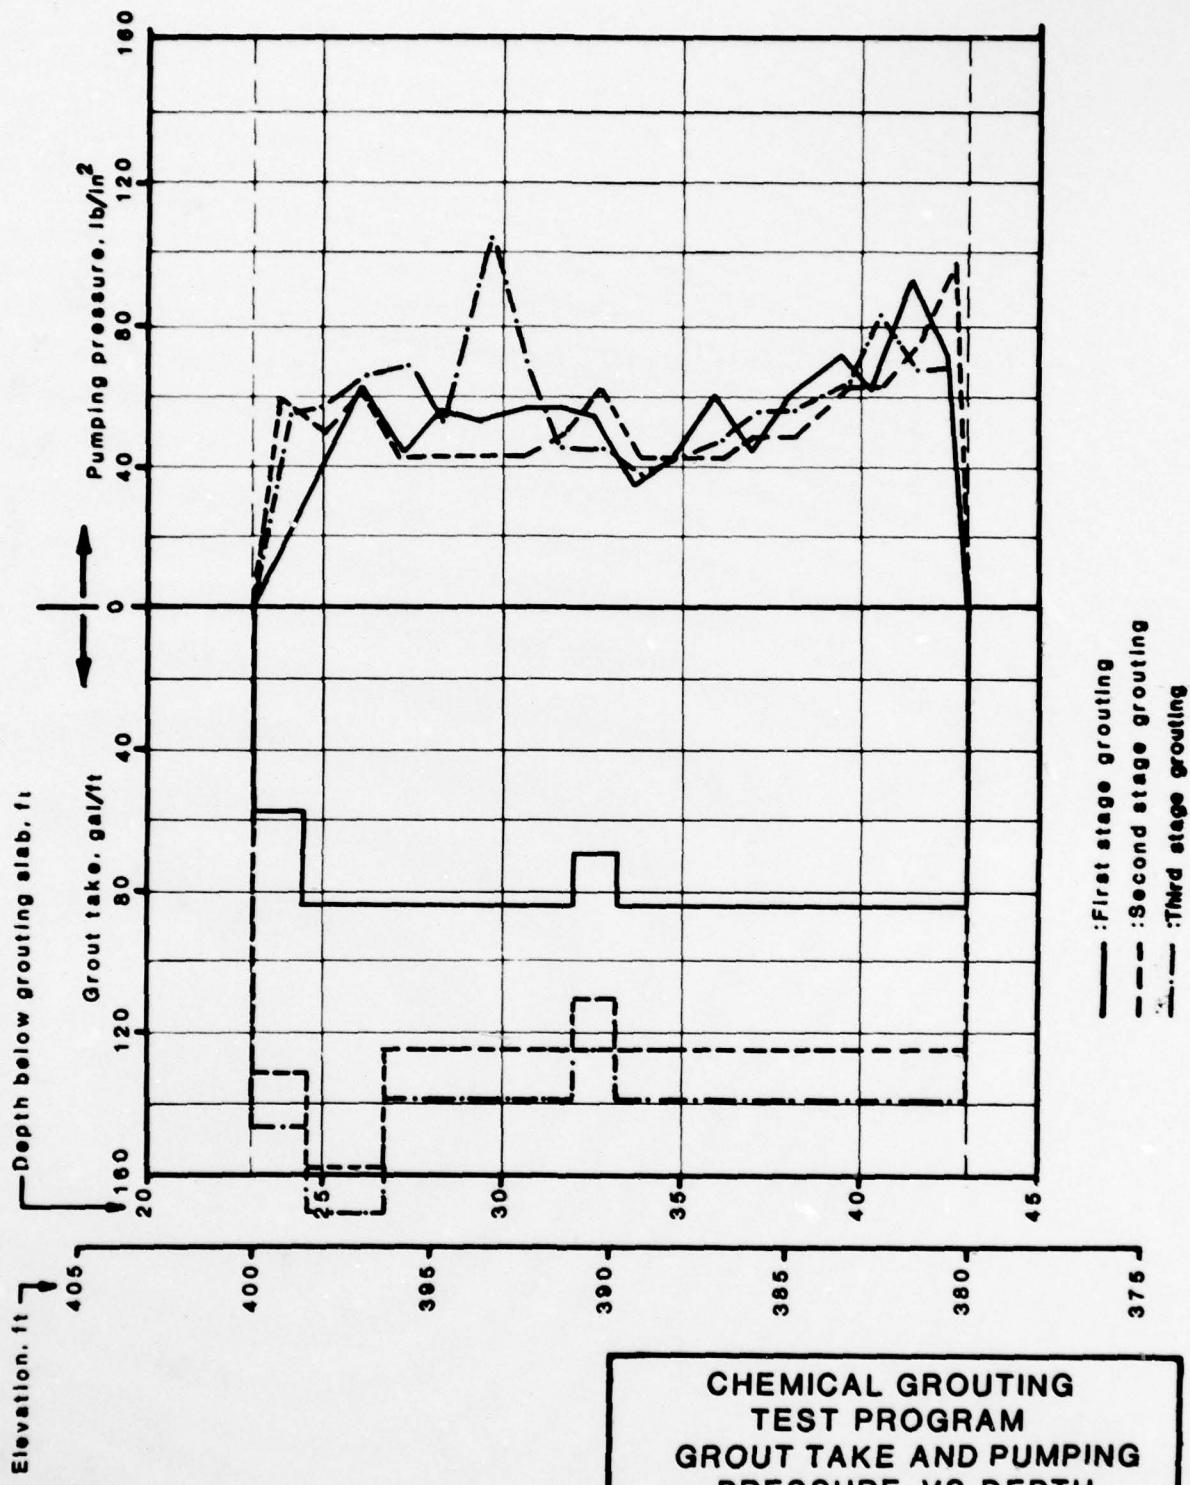
Fig. E.27

**CHEMICAL GROUTING
TEST PROGRAM
GROUT TAKE AND PUMPING
PRESSURE VS DEPTH
GROUT HOLE No. 6-2**

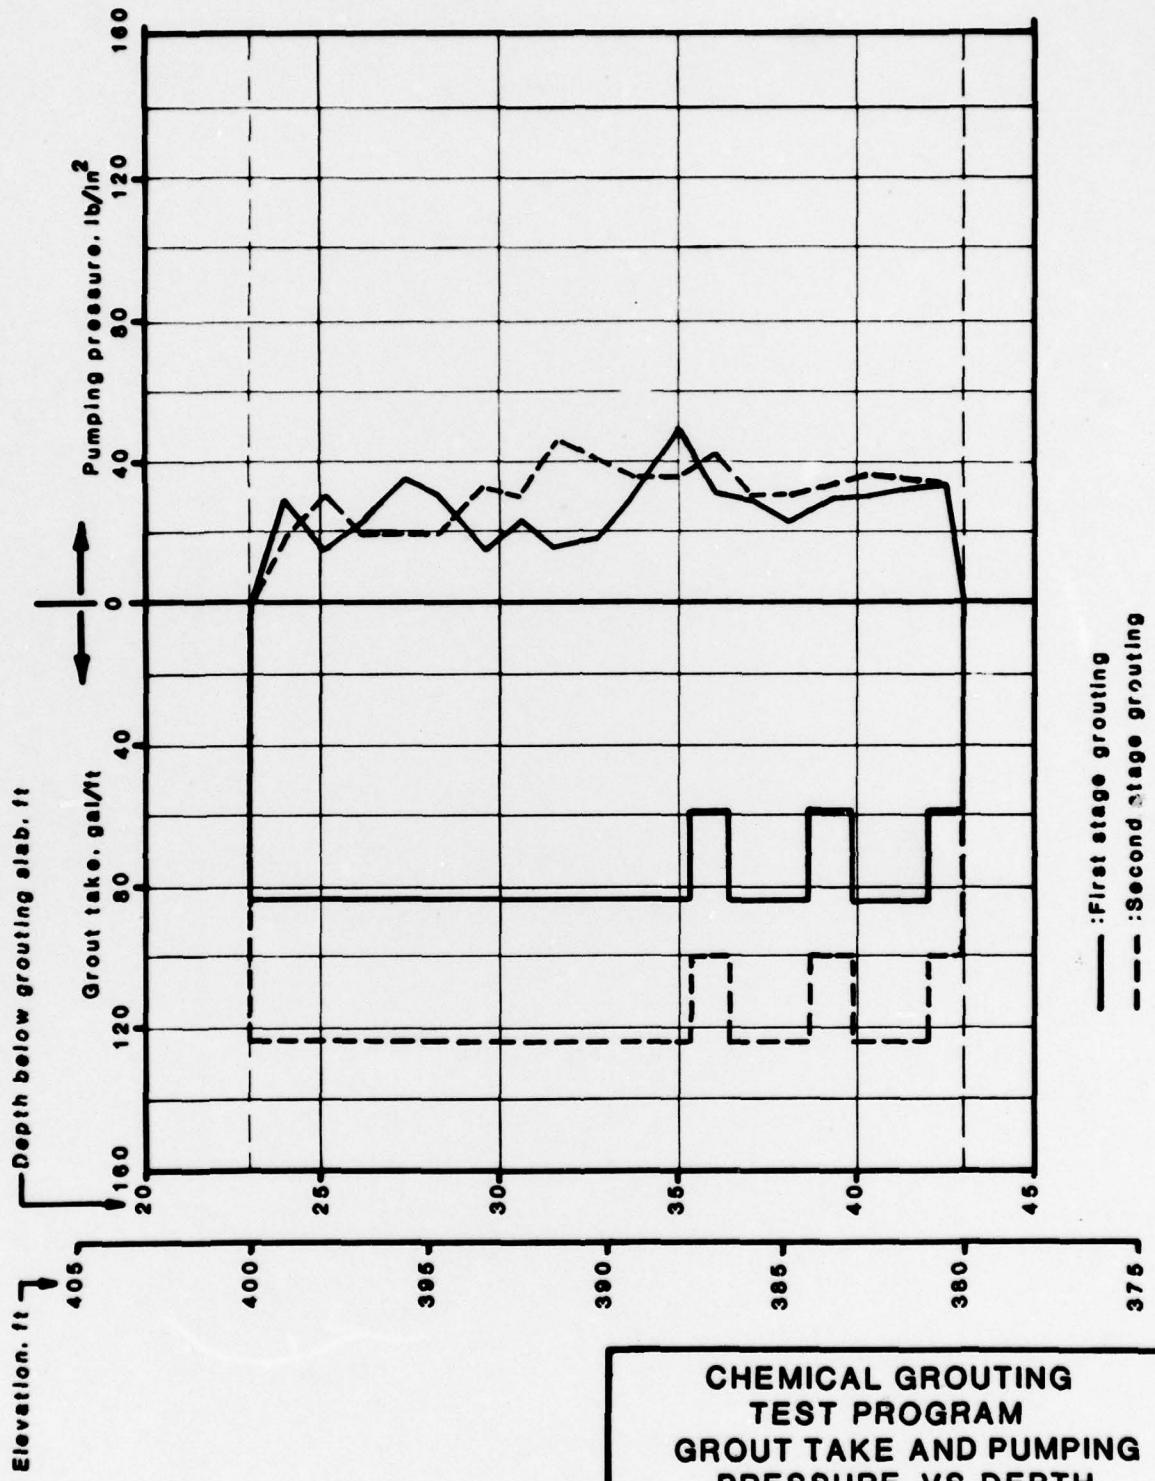
**CHEMICAL GROUTING
TEST PROGRAM
GROUT TAKE AND PUMPING
PRESSURE VS DEPTH
GROUT HOLE No. 6-3**

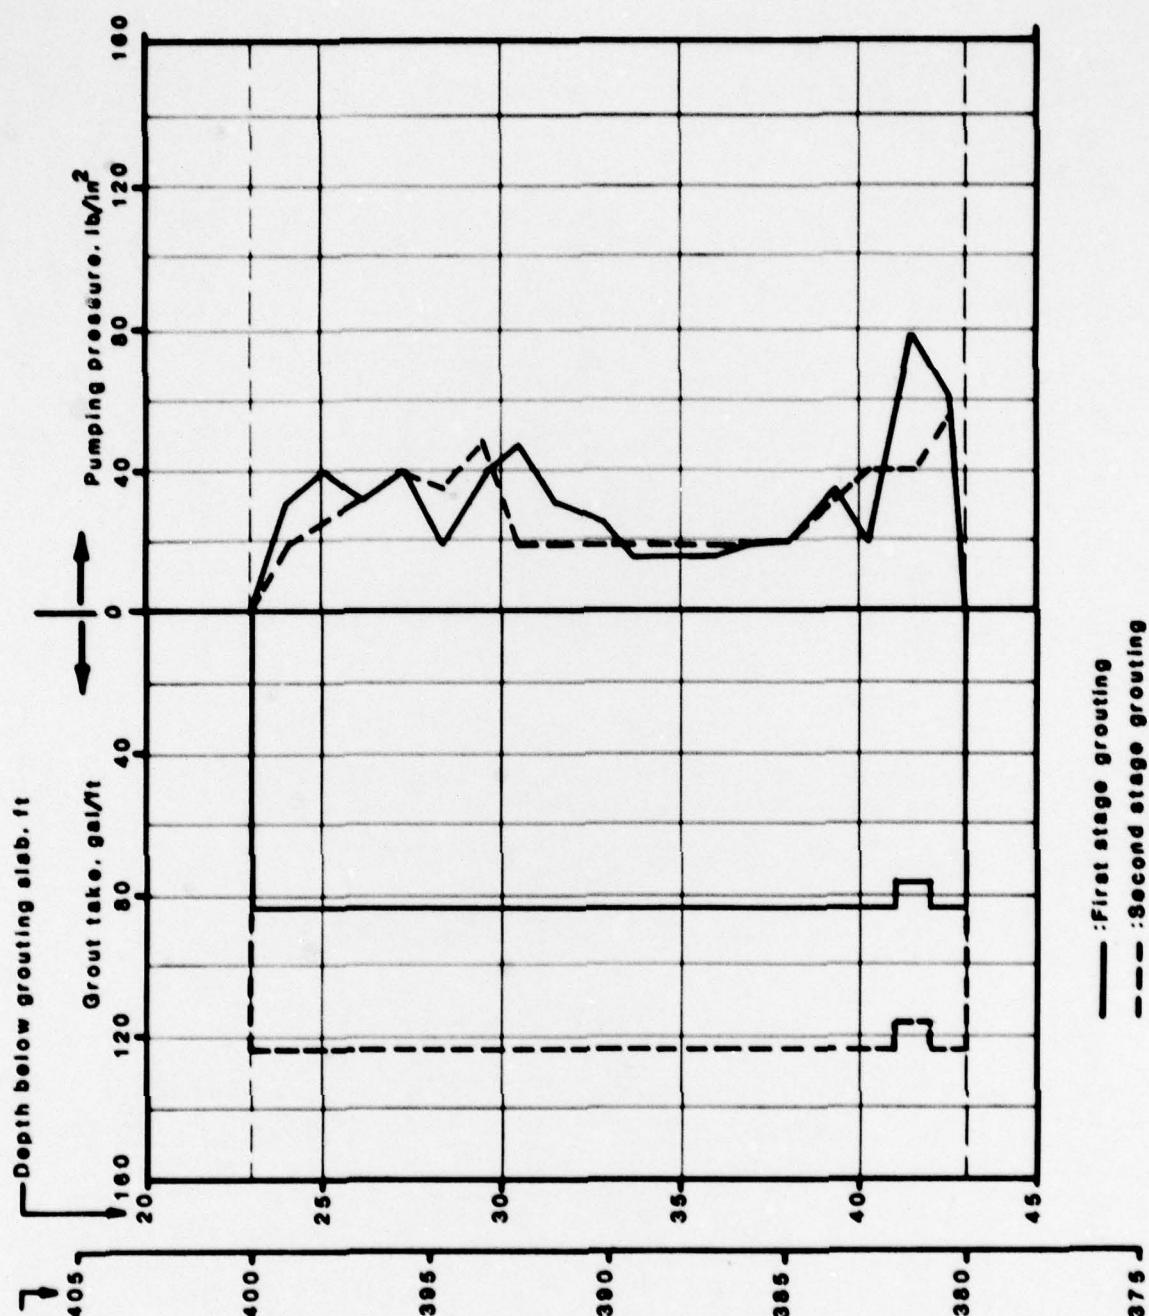
Fig. E.29

**CHEMICAL GROUTING
TEST PROGRAM
GROUT TAKE AND PUMPING
PRESSURE VS DEPTH
GROUT HOLE No. 6-4**

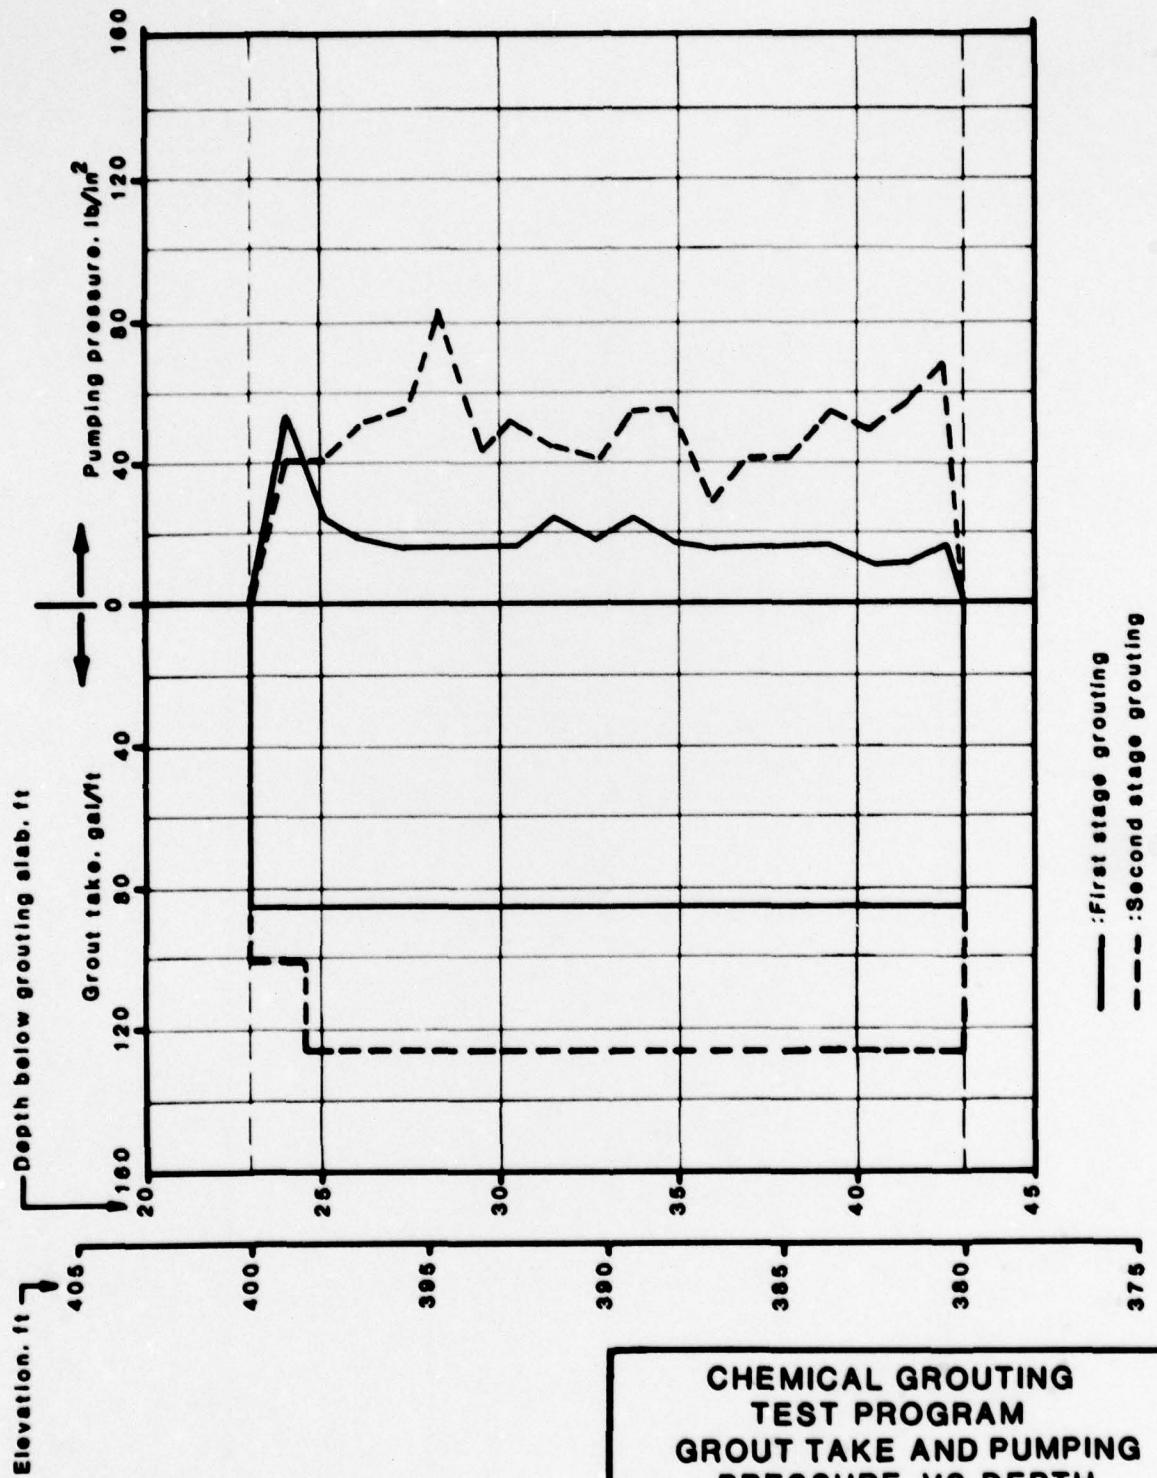
Fig. E.30

**CHEMICAL GROUTING
TEST PROGRAM
GROUT TAKE AND PUMPING
PRESSURE VS DEPTH
GROUT HOLE No. 6-5**

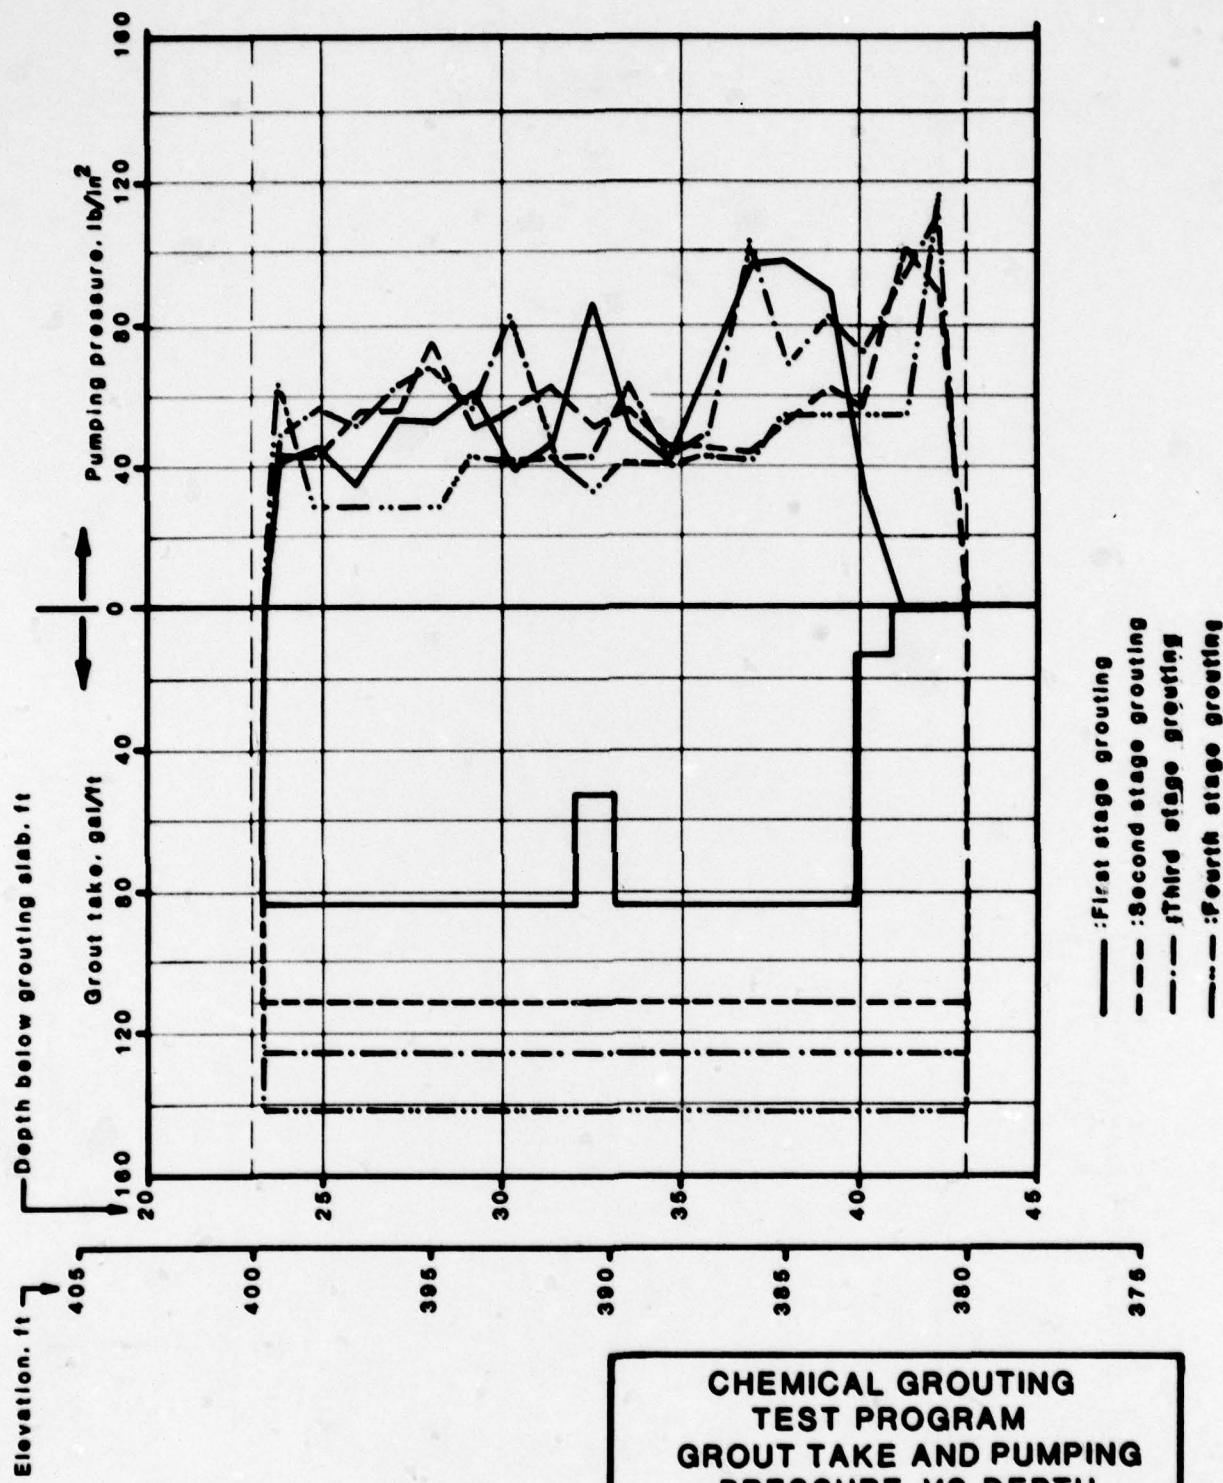
Fig. E.31

**CHEMICAL GROUTING
TEST PROGRAM
GROUT TAKE AND PUMPING
PRESSURE VS DEPTH
GROUT HOLE NO. 7-1**

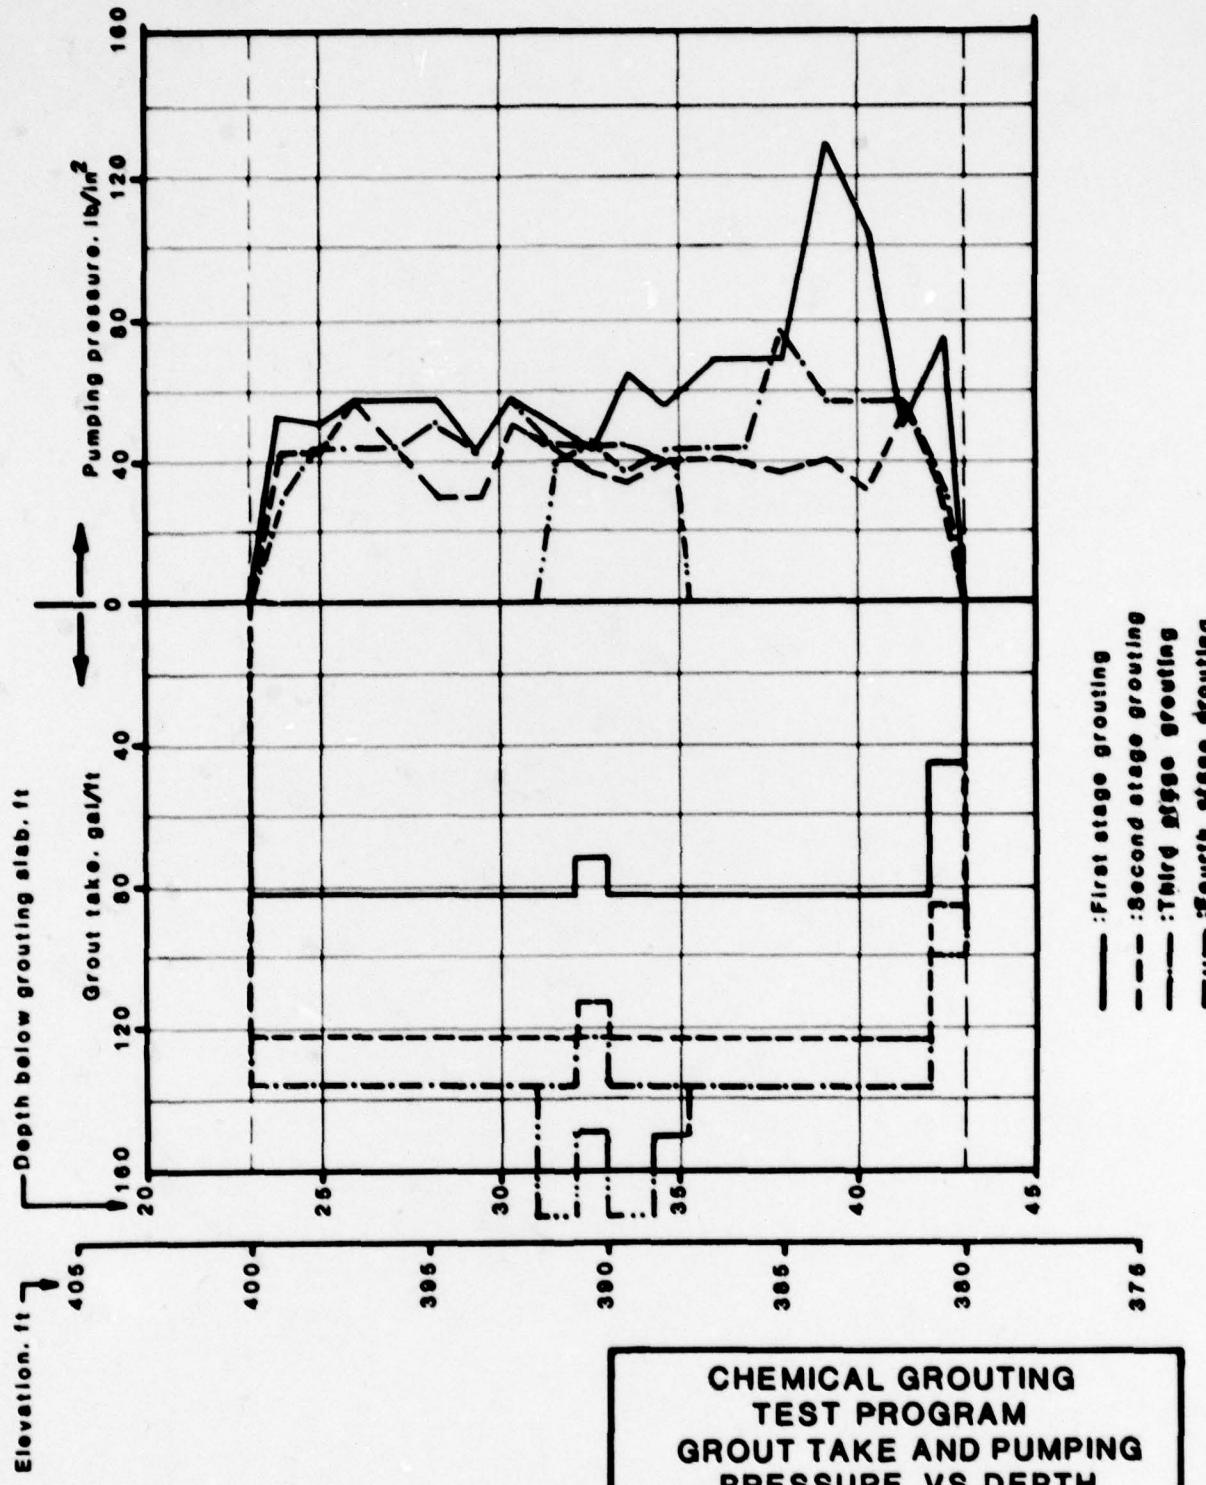
**CHEMICAL GROUTING
TEST PROGRAM
GROUT TAKE AND PUMPING
PRESSURE VS DEPTH
GROUT HOLE No. 7-3**

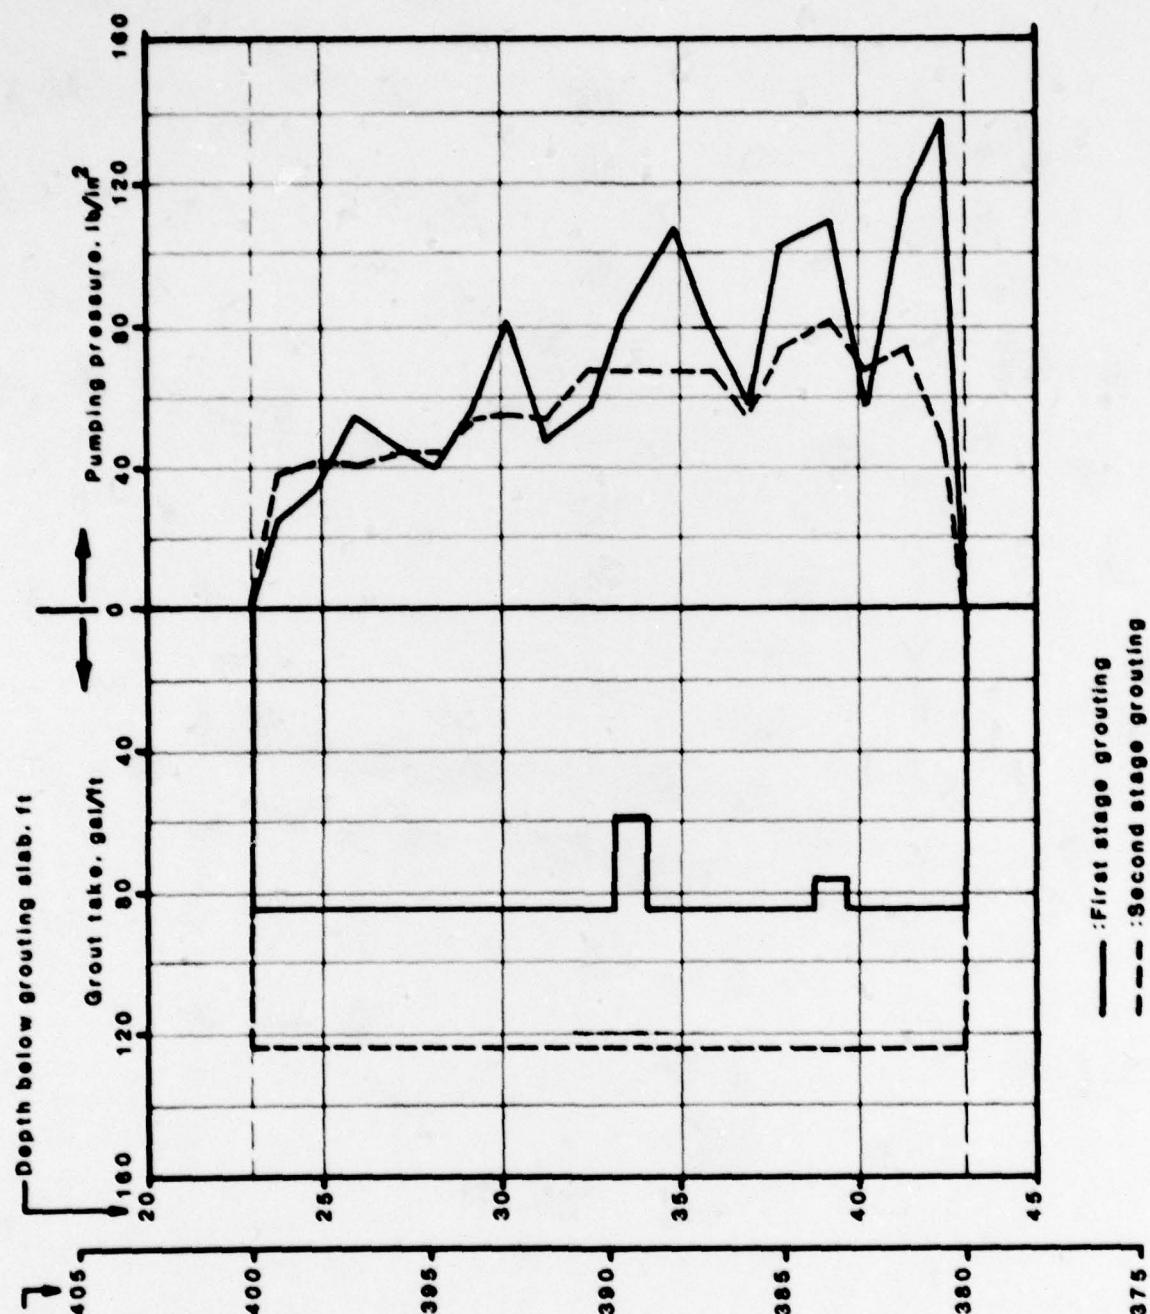
Fig. E.34

**CHEMICAL GROUTING
TEST PROGRAM
GROUT TAKE AND PUMPING
PRESSURE VS DEPTH
GROUT HOLE NO. 7-4**
