PHASE IV REPORT

APPENDICES A THROUGH G

**RESULTS AND INTERPRETATION OF
CHEMICAL GROUTING TEST PROGRAM**

**EXISTING LOCKS AND DAM NO. 26
MISSISSIPPI RIVER, ALTON, ILLINOIS**

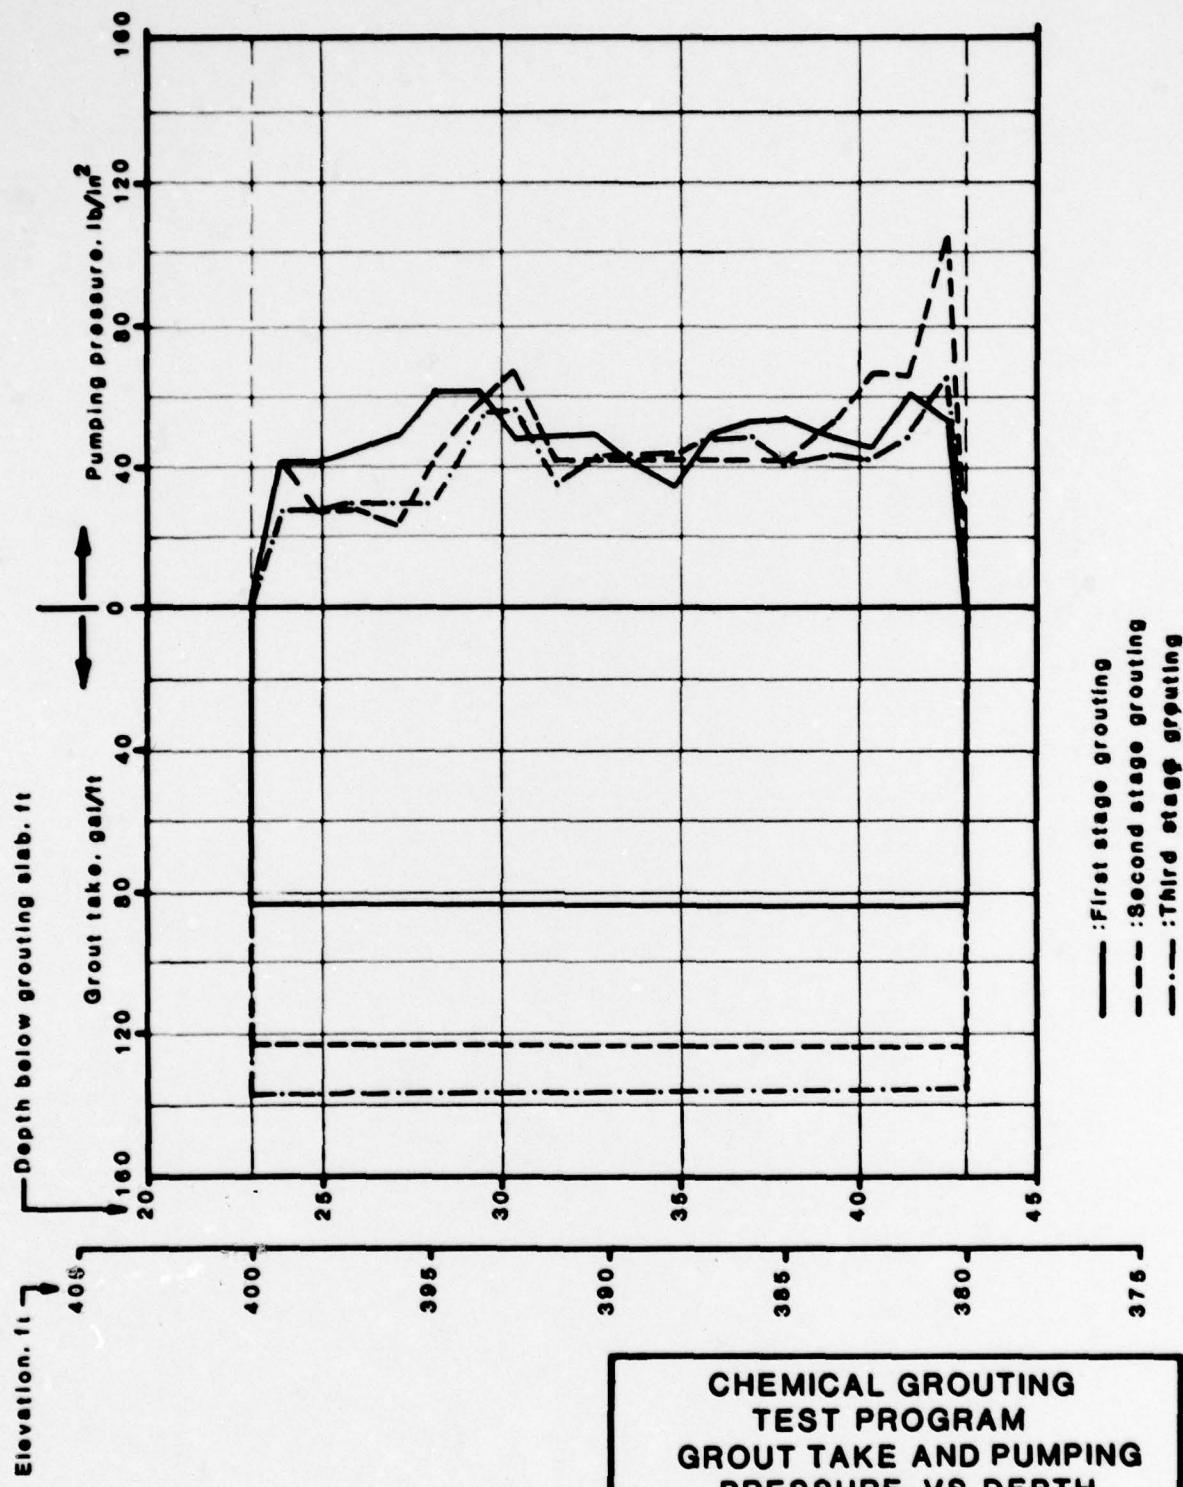
Fig. E.35

**CHEMICAL GROUTING
TEST PROGRAM
GROUT TAKE AND PUMPING
PRESSURE VS DEPTH
GROUT HOLE No. 7-5**

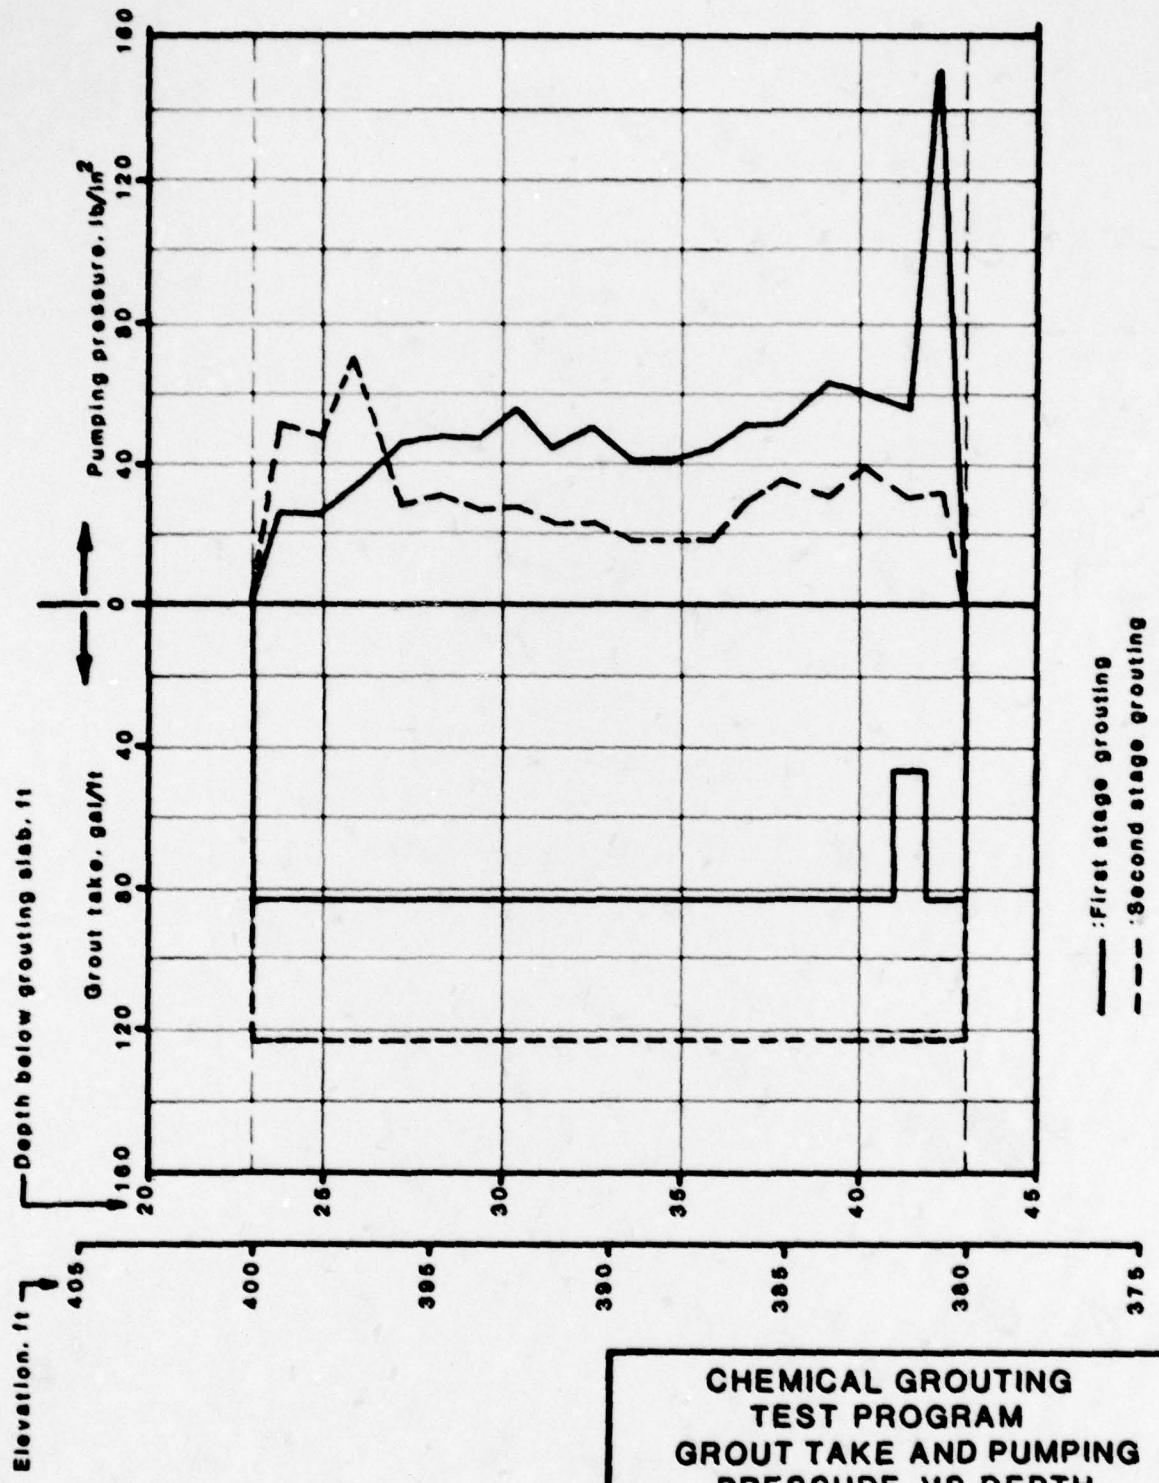
Fig. E.36

**CHEMICAL GROUTING
TEST PROGRAM
GROUT TAKE AND PUMPING
PRESSURE VS DEPTH
GROUT HOLE NO. 7-6**

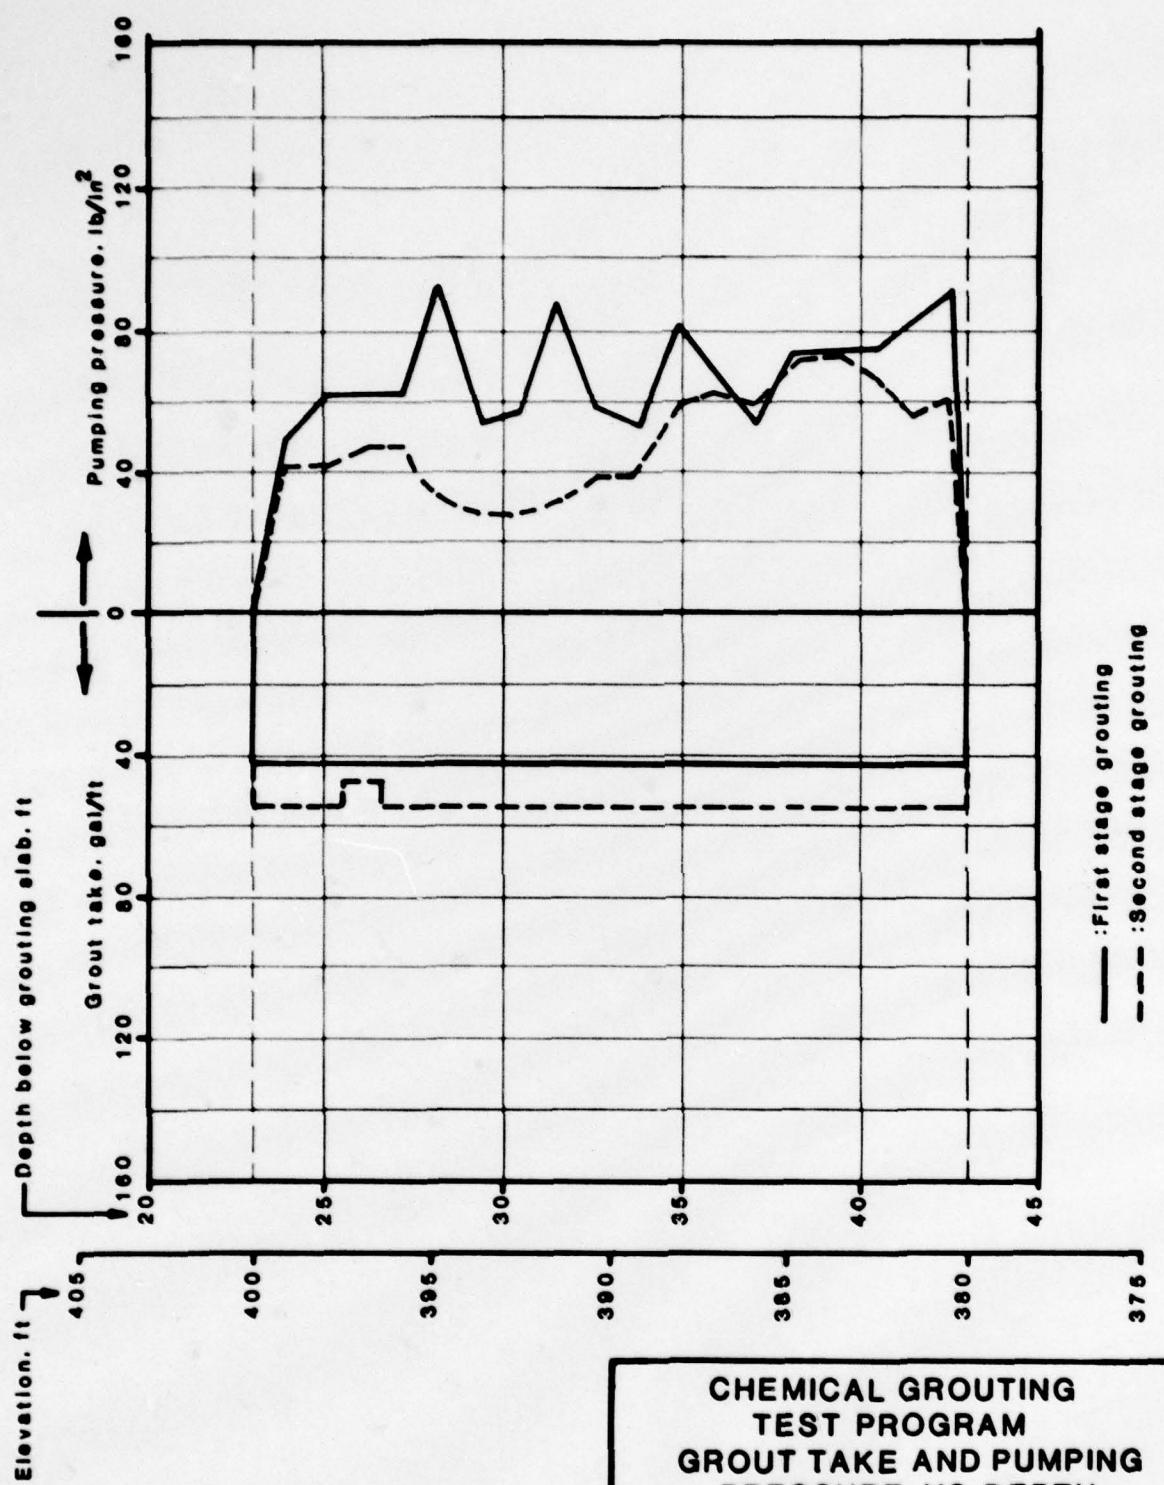
Fig. E.37

**CHEMICAL GROUTING
TEST PROGRAM
GROUT TAKE AND PUMPING
PRESSURE VS DEPTH
GROUT HOLE No. 8-1**

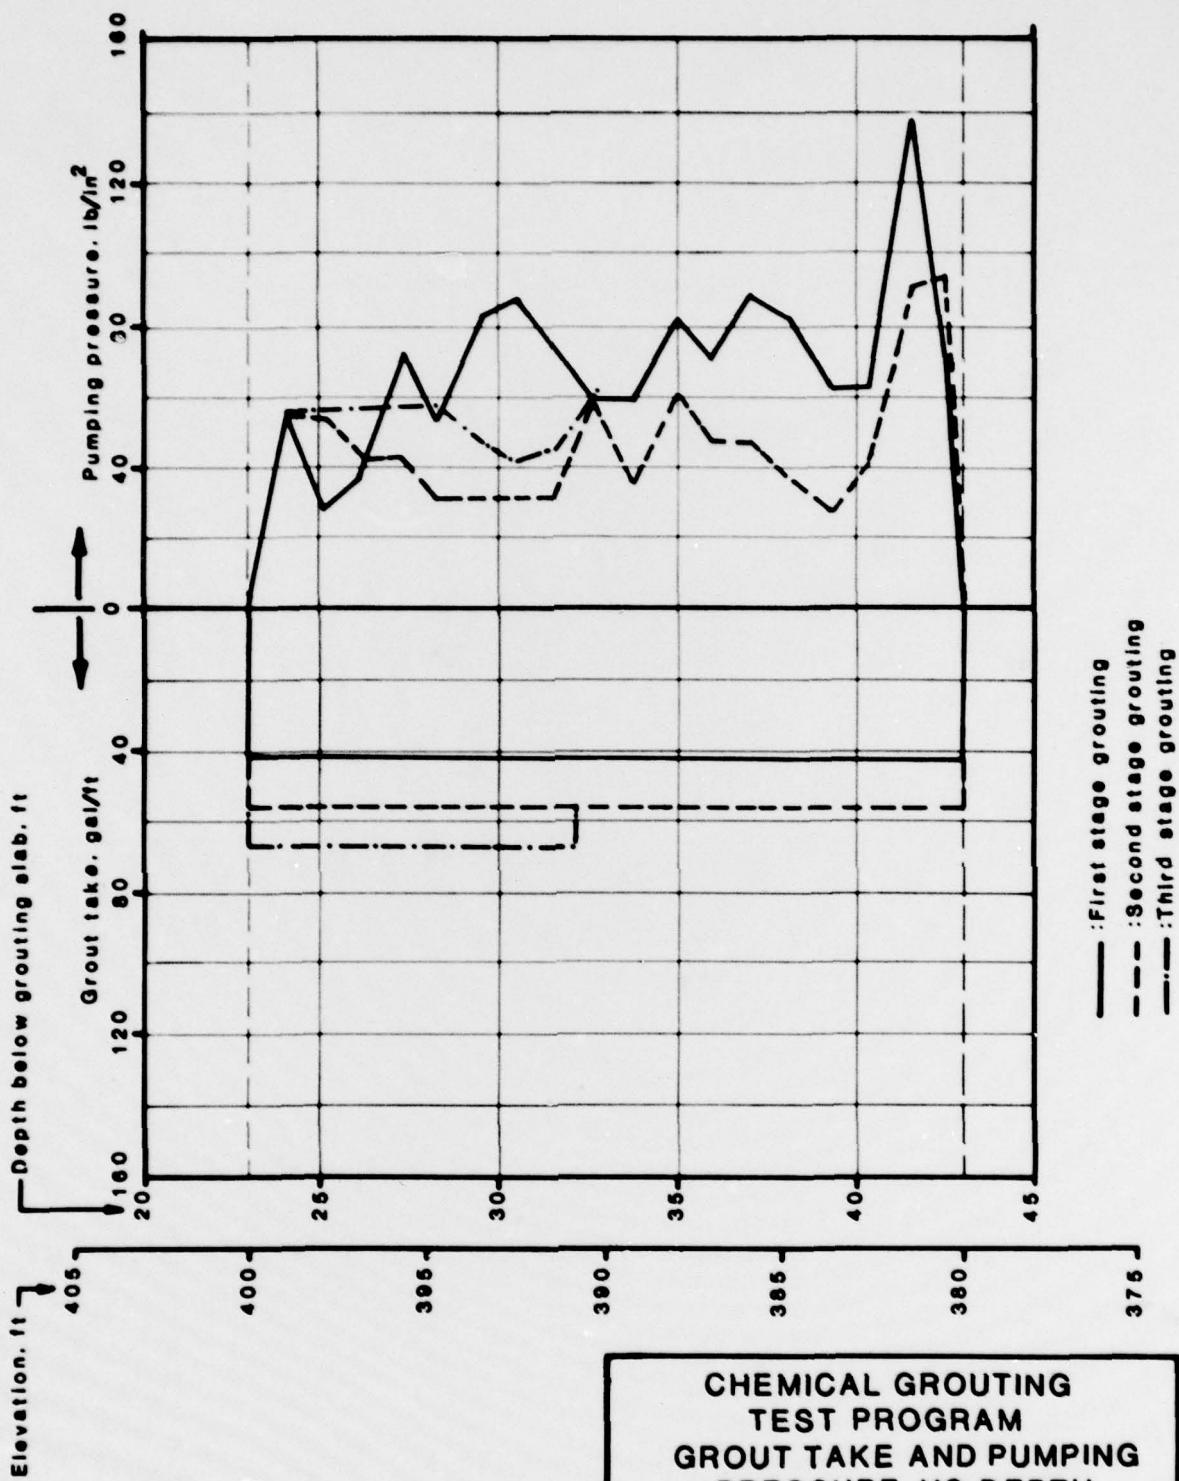
Fig. E.38

**CHEMICAL GROUTING
TEST PROGRAM
GROUT TAKE AND PUMPING
PRESSURE VS DEPTH
GROUT HOLE No. 8-2**

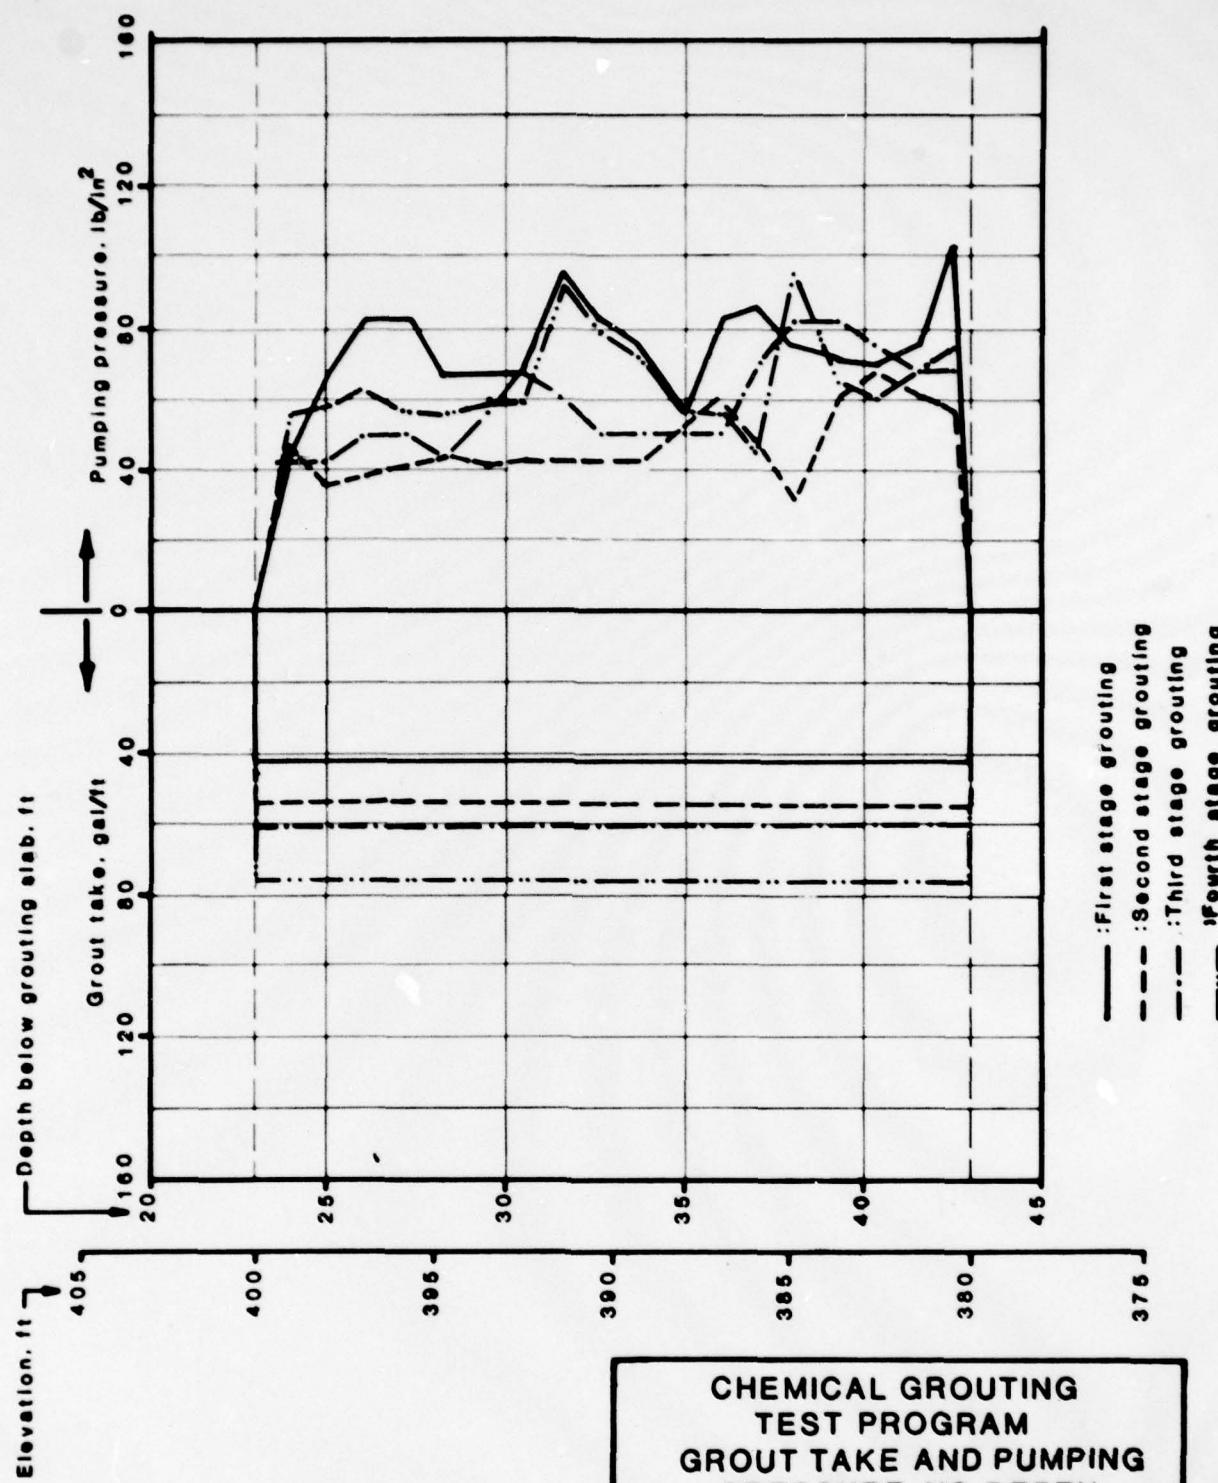
Fig. E.39

**CHEMICAL GROUTING
TEST PROGRAM
GROUT TAKE AND PUMPING
PRESSURE VS DEPTH
GROUT HOLE No. 8-3**

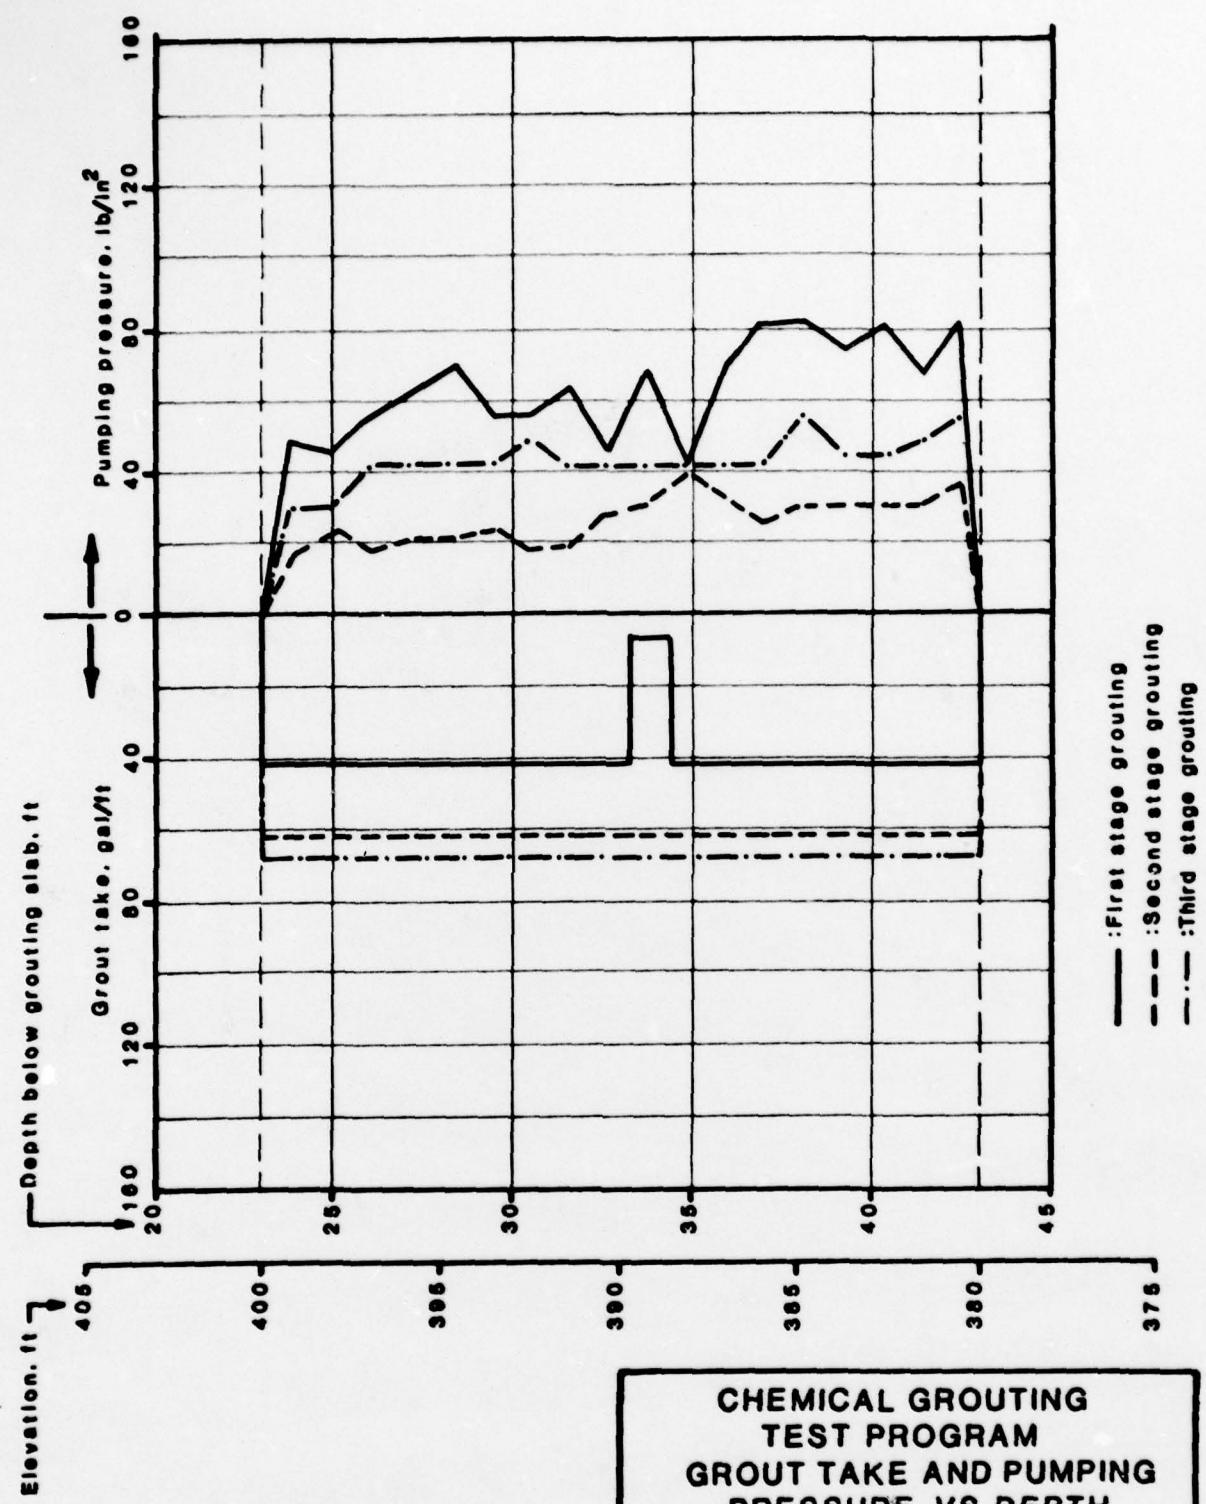
**CHEMICAL GROUTING
TEST PROGRAM
GROUT TAKE AND PUMPING
PRESSURE VS DEPTH
GROUT HOLE NO. 8-6**

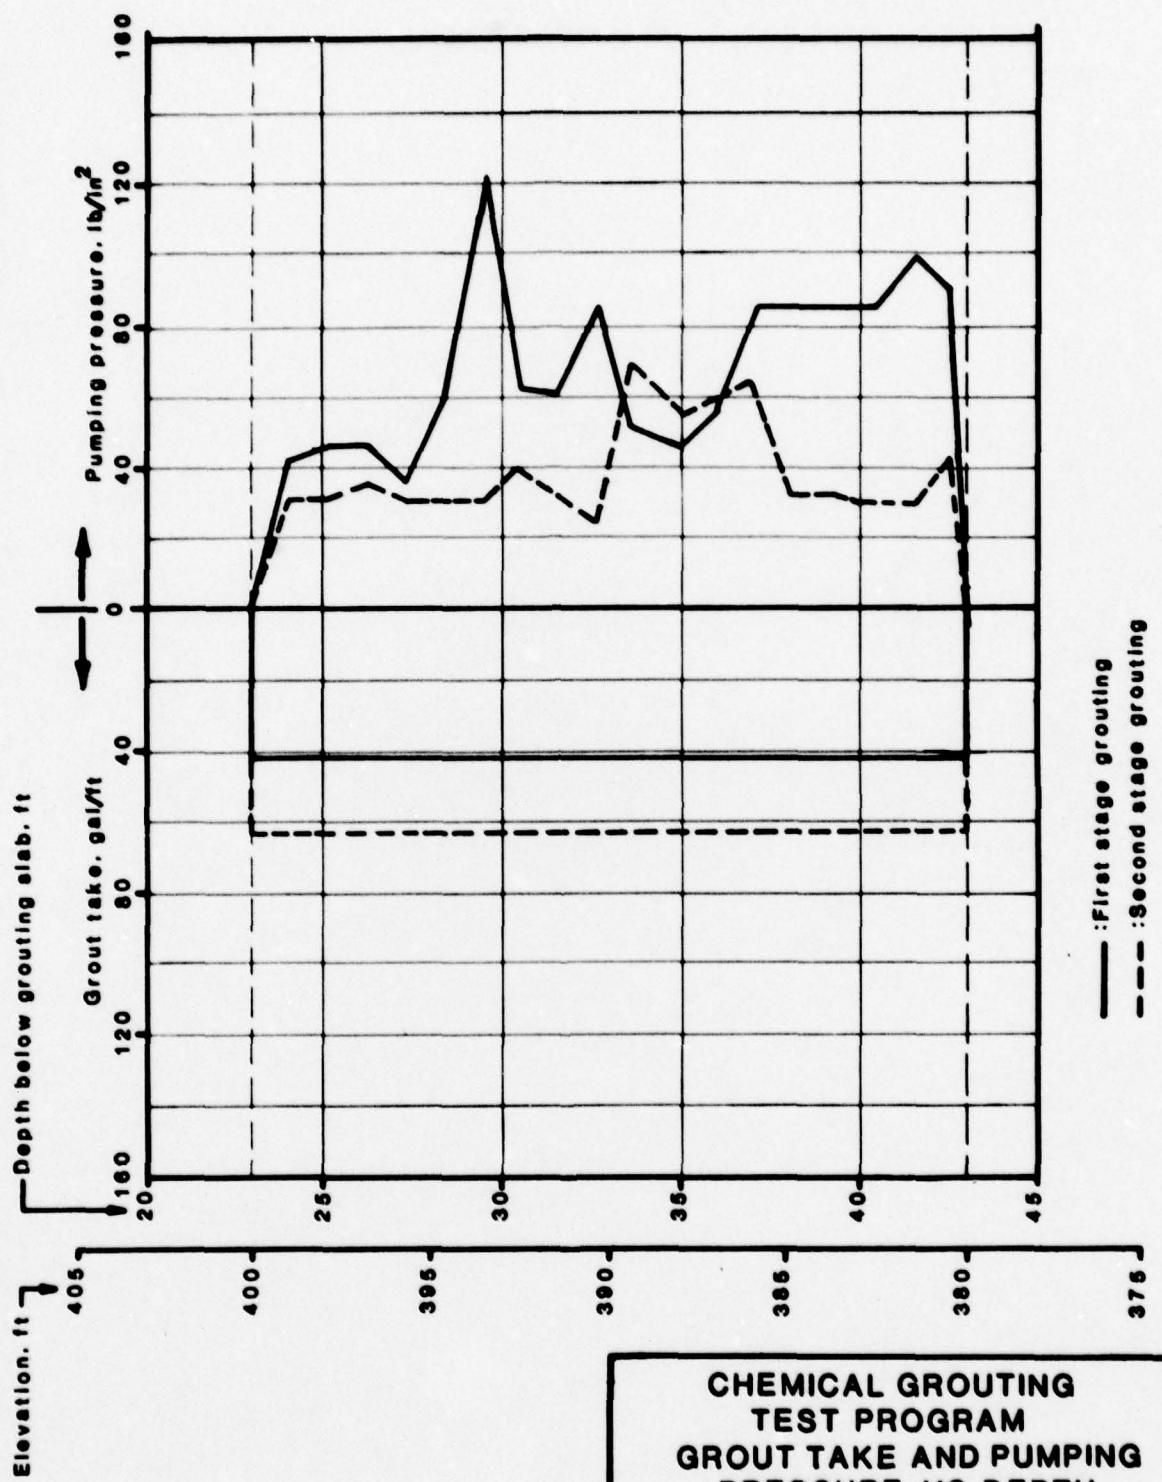
Fig. E.43

**CHEMICAL GROUTING
TEST PROGRAM
GROUT TAKE AND PUMPING
PRESSURE VS DEPTH
GROUT HOLE No. 8-7**

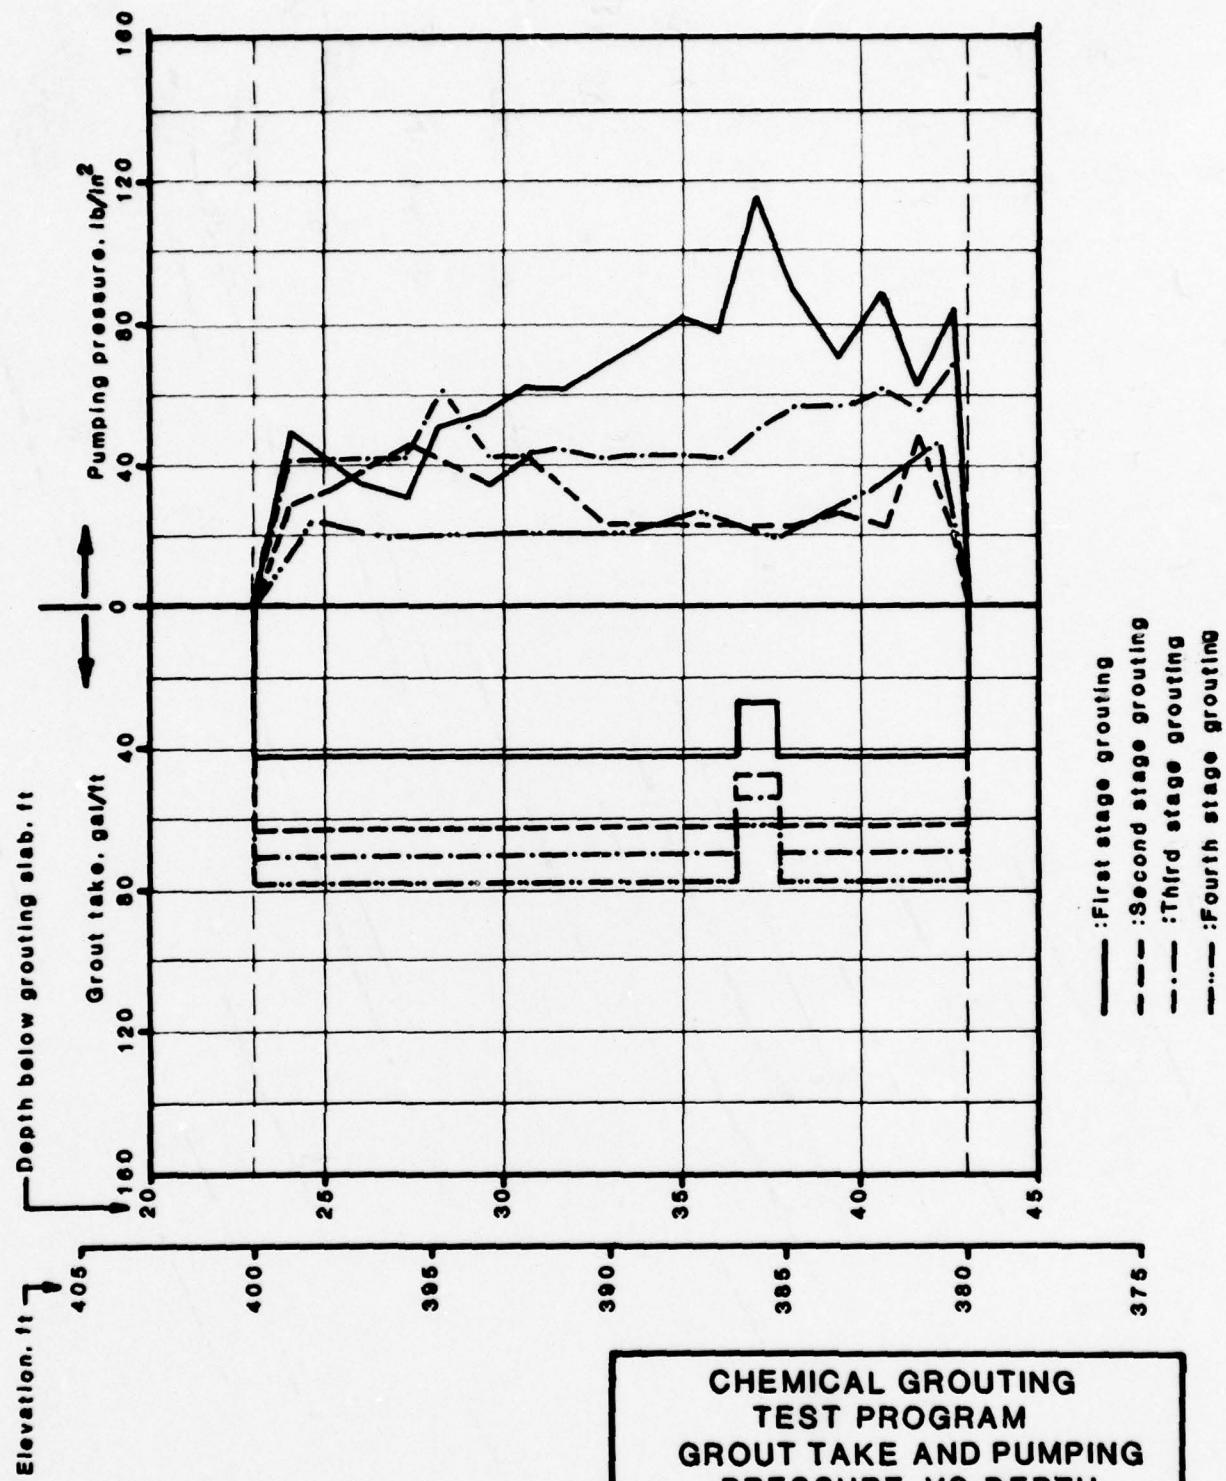
Fig. E.44

**CHEMICAL GROUTING
TEST PROGRAM
GROUT TAKE AND PUMPING
PRESSURE VS DEPTH
GROUT HOLE No. 8-8**

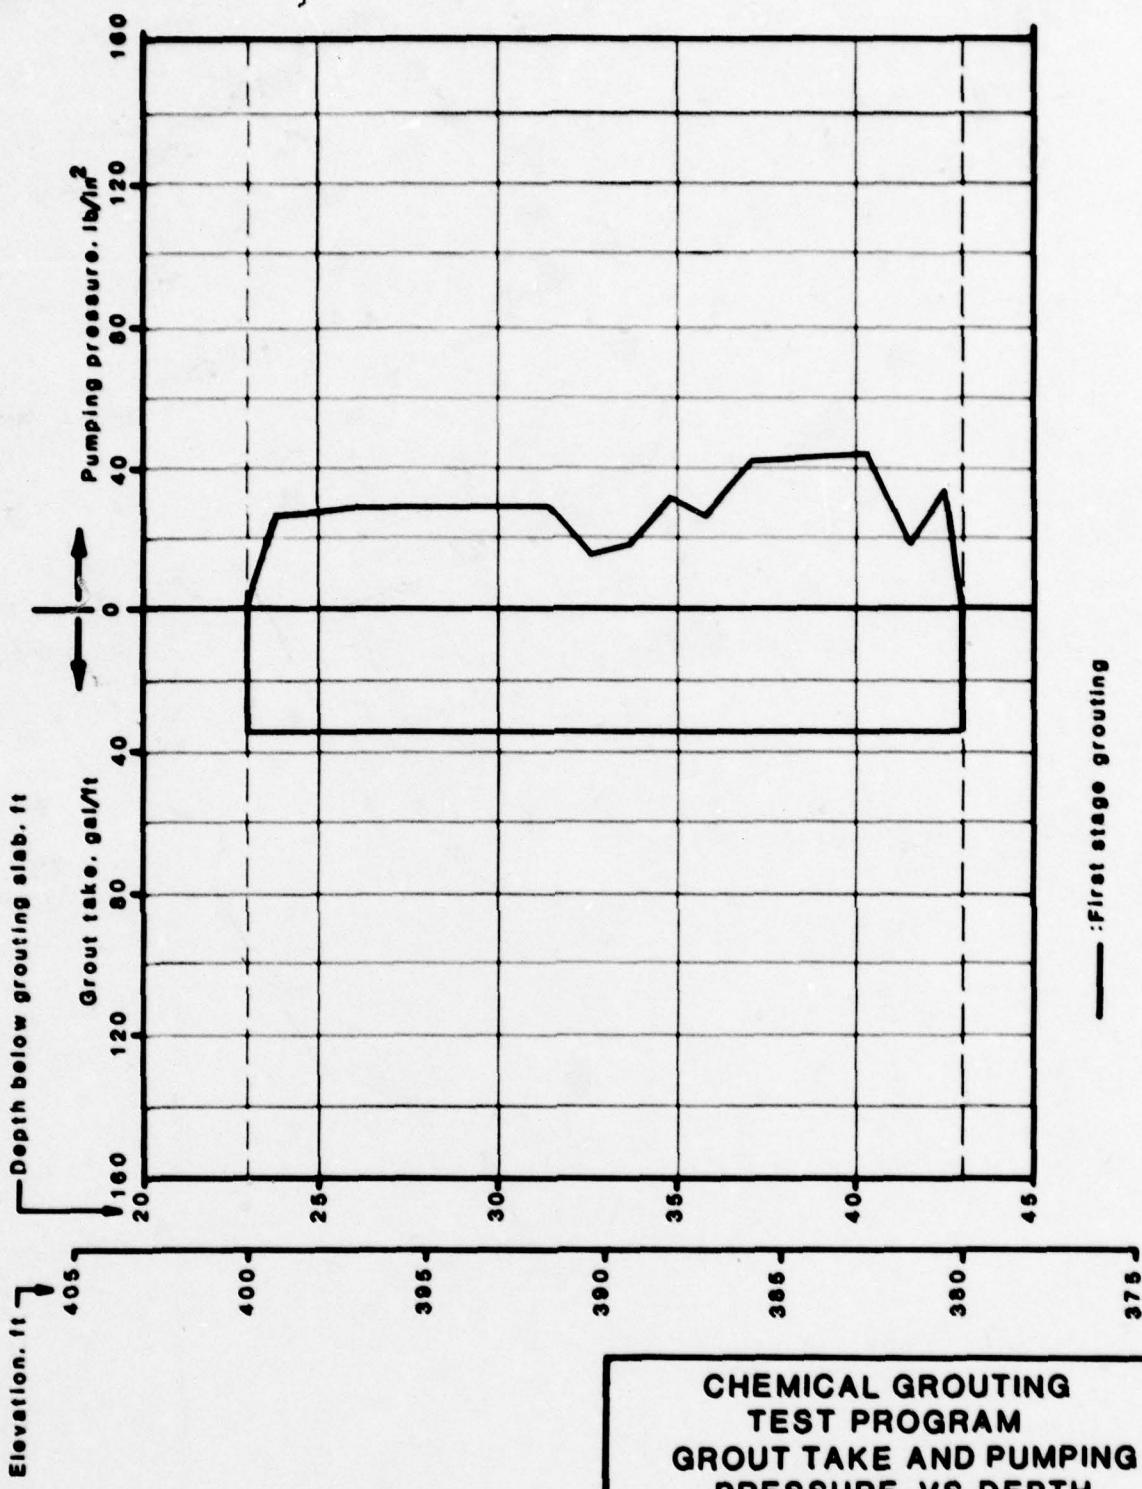
Fig. E.45

**CHEMICAL GROUTING
TEST PROGRAM
GROUT TAKE AND PUMPING
PRESSURE VS DEPTH
GROUT HOLE No. 9-1**

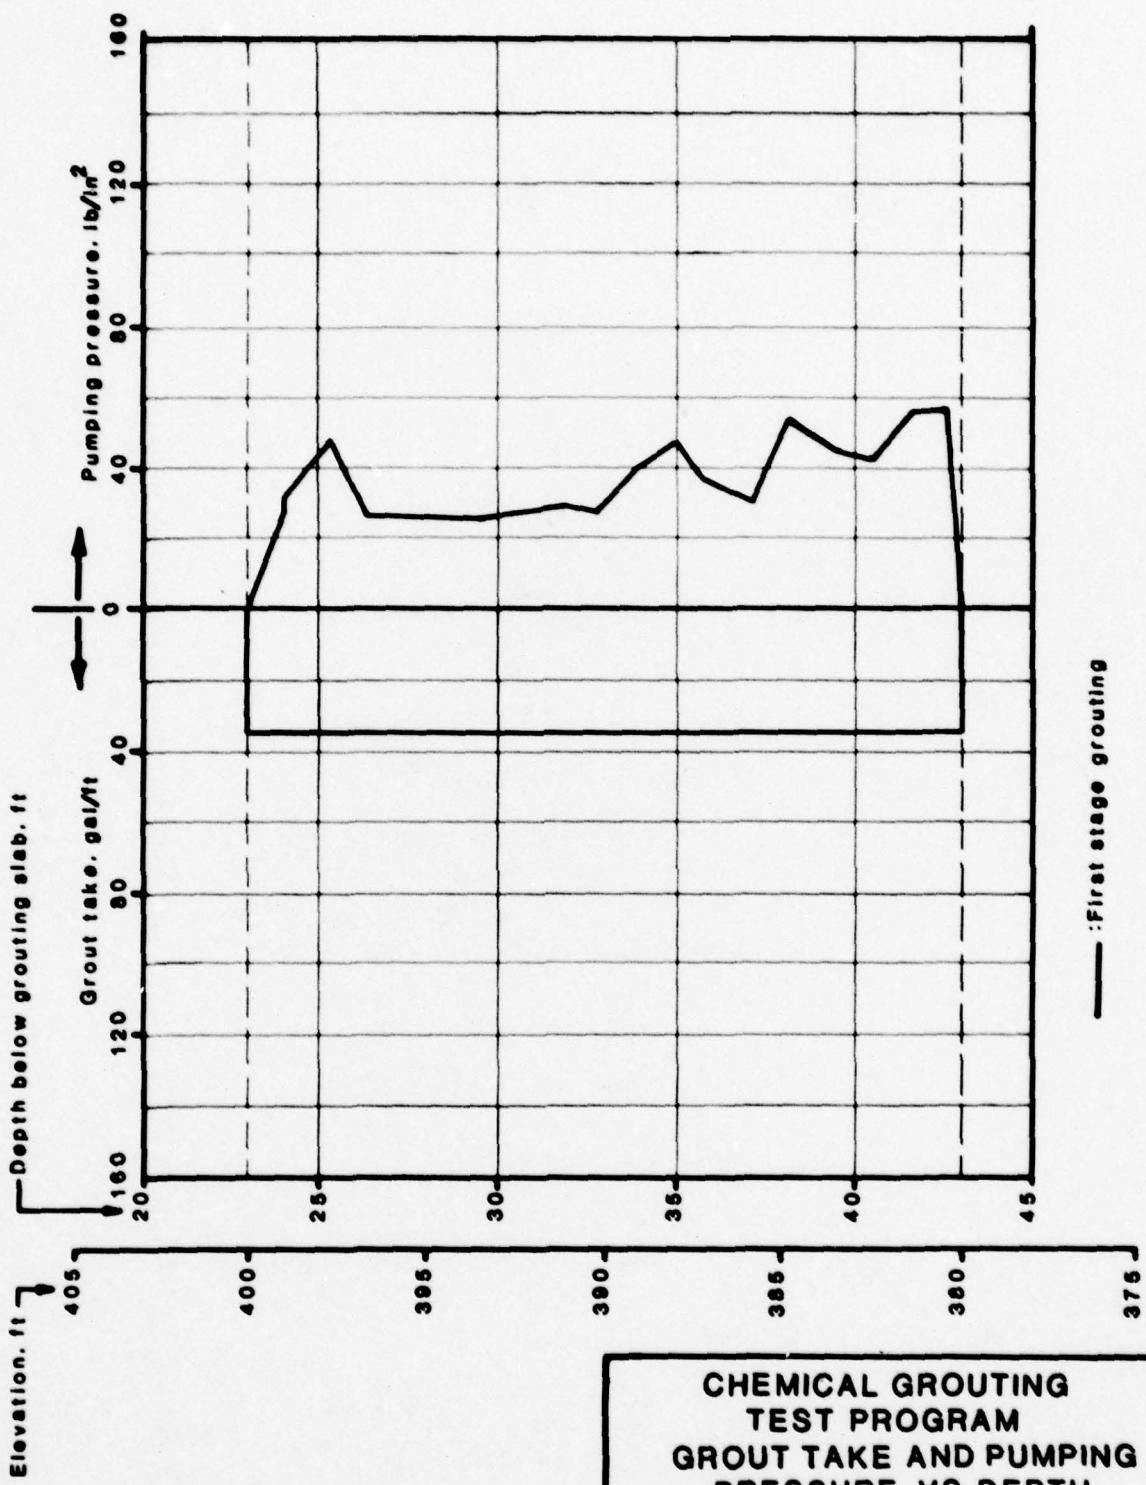
Fig. E.46

**CHEMICAL GROUTING
TEST PROGRAM
GROUT TAKE AND PUMPING
PRESSURE VS DEPTH
GROUT HOLE No. 9-2**

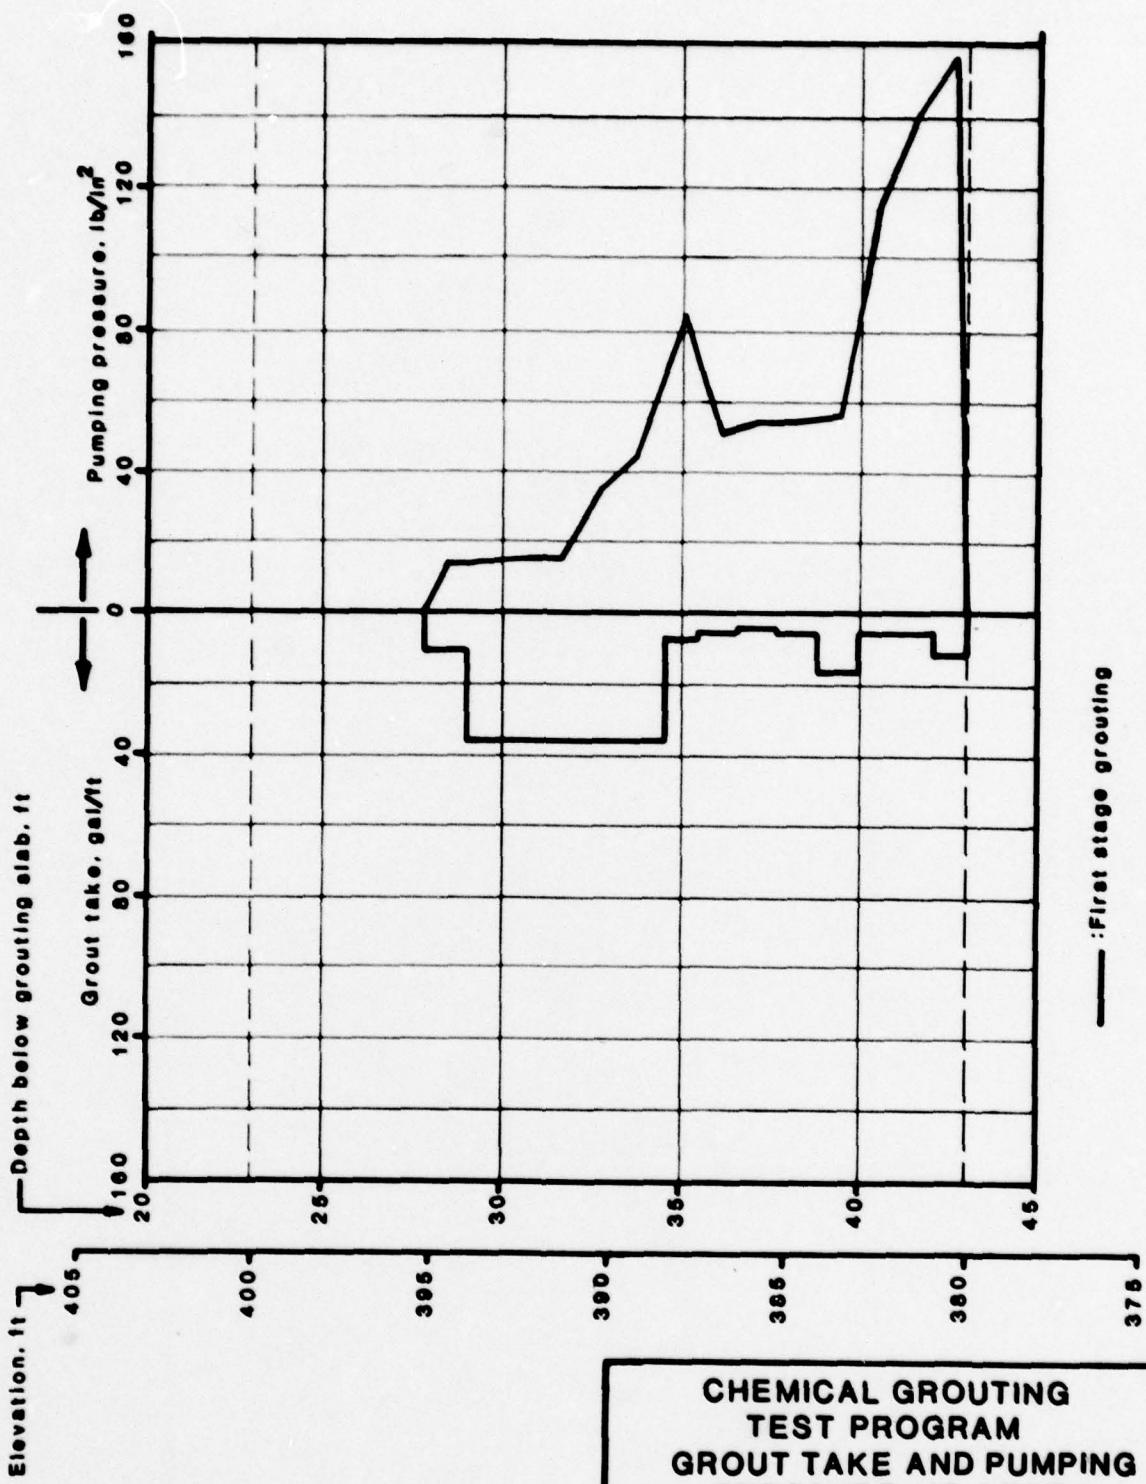
Fig. E.47

**CHEMICAL GROUTING
TEST PROGRAM
GROUT TAKE AND PUMPING
PRESSURE VS DEPTH
GROUT HOLE No. 9-3**

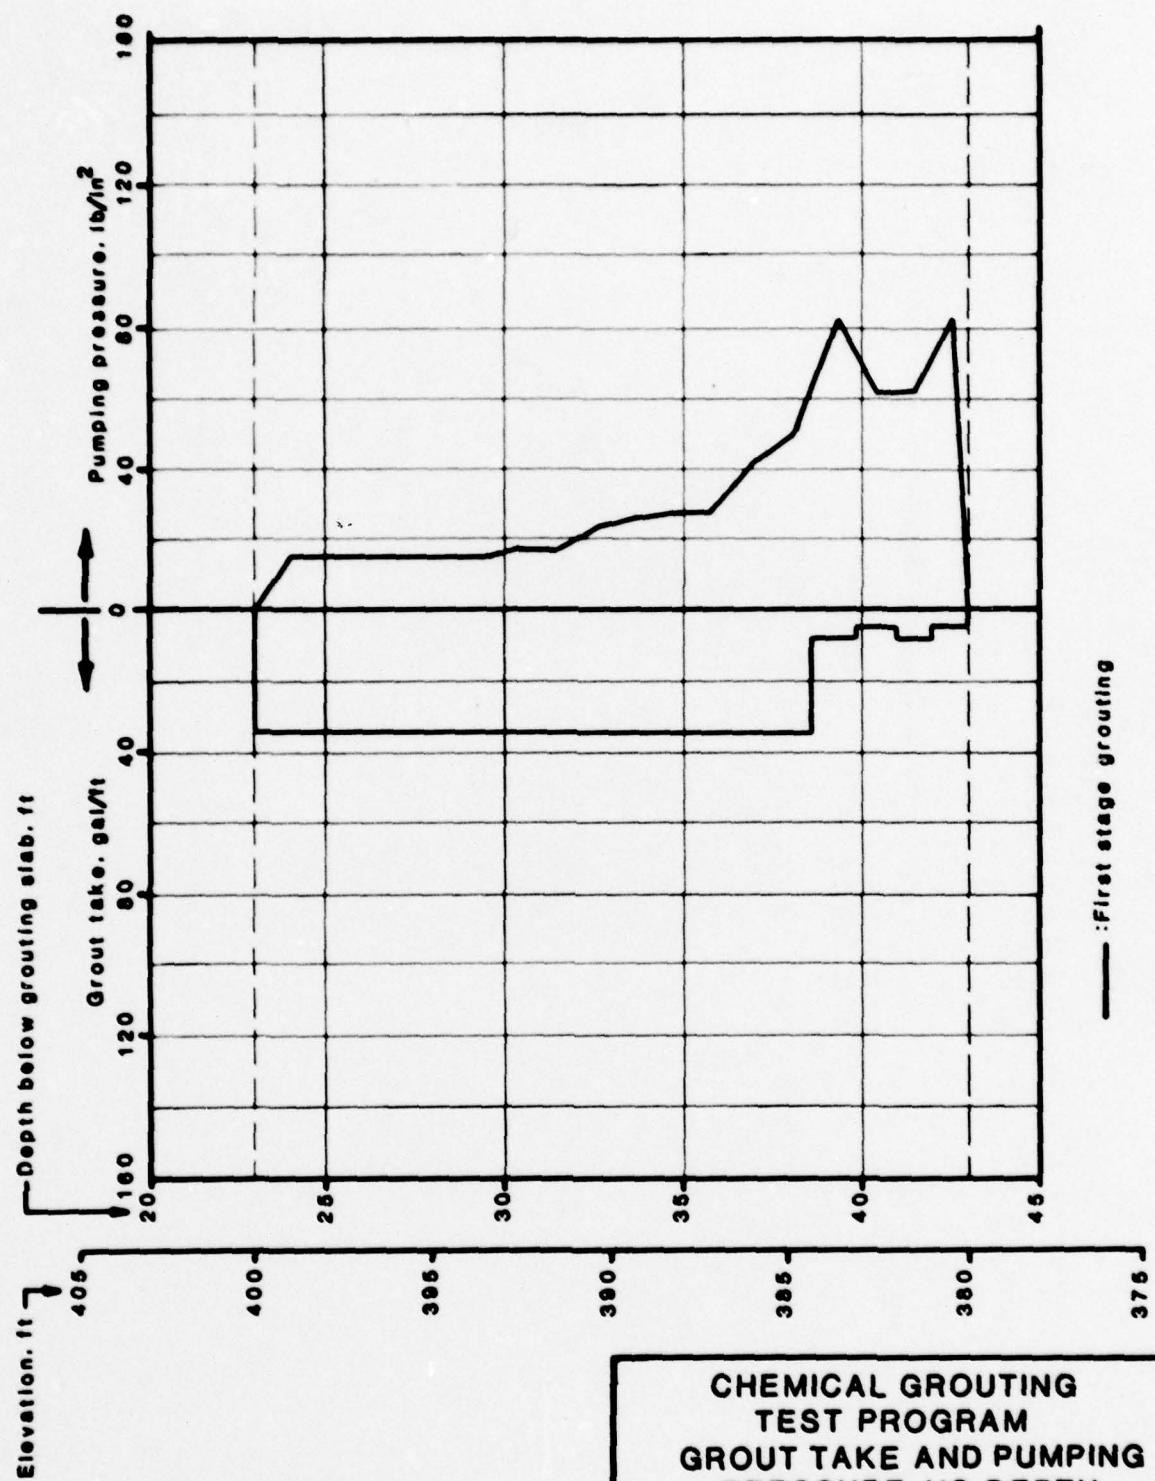
Fig. E.48

CHEMICAL GROUTING TEST PROGRAM GROUT TAKE AND PUMPING PRESSURE VS DEPTH GROUT HOLE No. 9-4

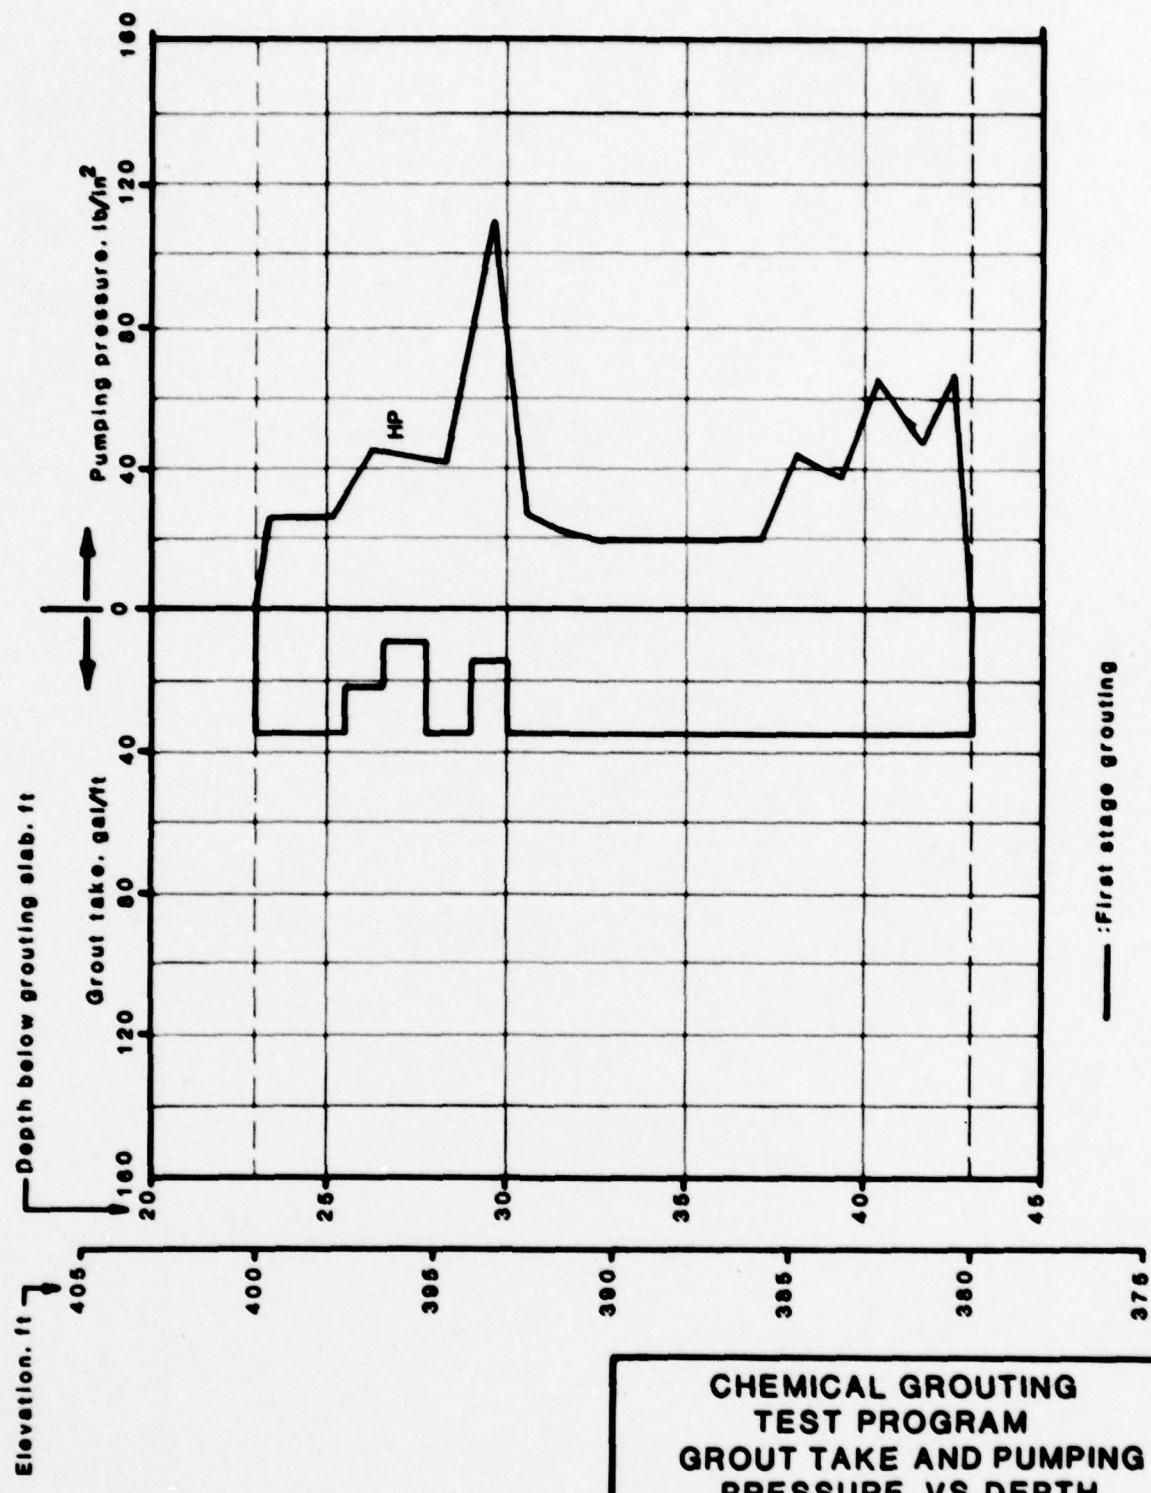
Fig. E.49

**CHEMICAL GROUTING
TEST PROGRAM
GROUT TAKE AND PUMPING
PRESSURE VS DEPTH
GROUT HOLE No.9-5**
