PHASE IV REPORT

APPENDICES A THROUGH G

**RESULTS AND INTERPRETATION OF
CHEMICAL GROUTING TEST PROGRAM**

**EXISTING LOCKS AND DAM NO. 26
MISSISSIPPI RIVER, ALTON, ILLINOIS**

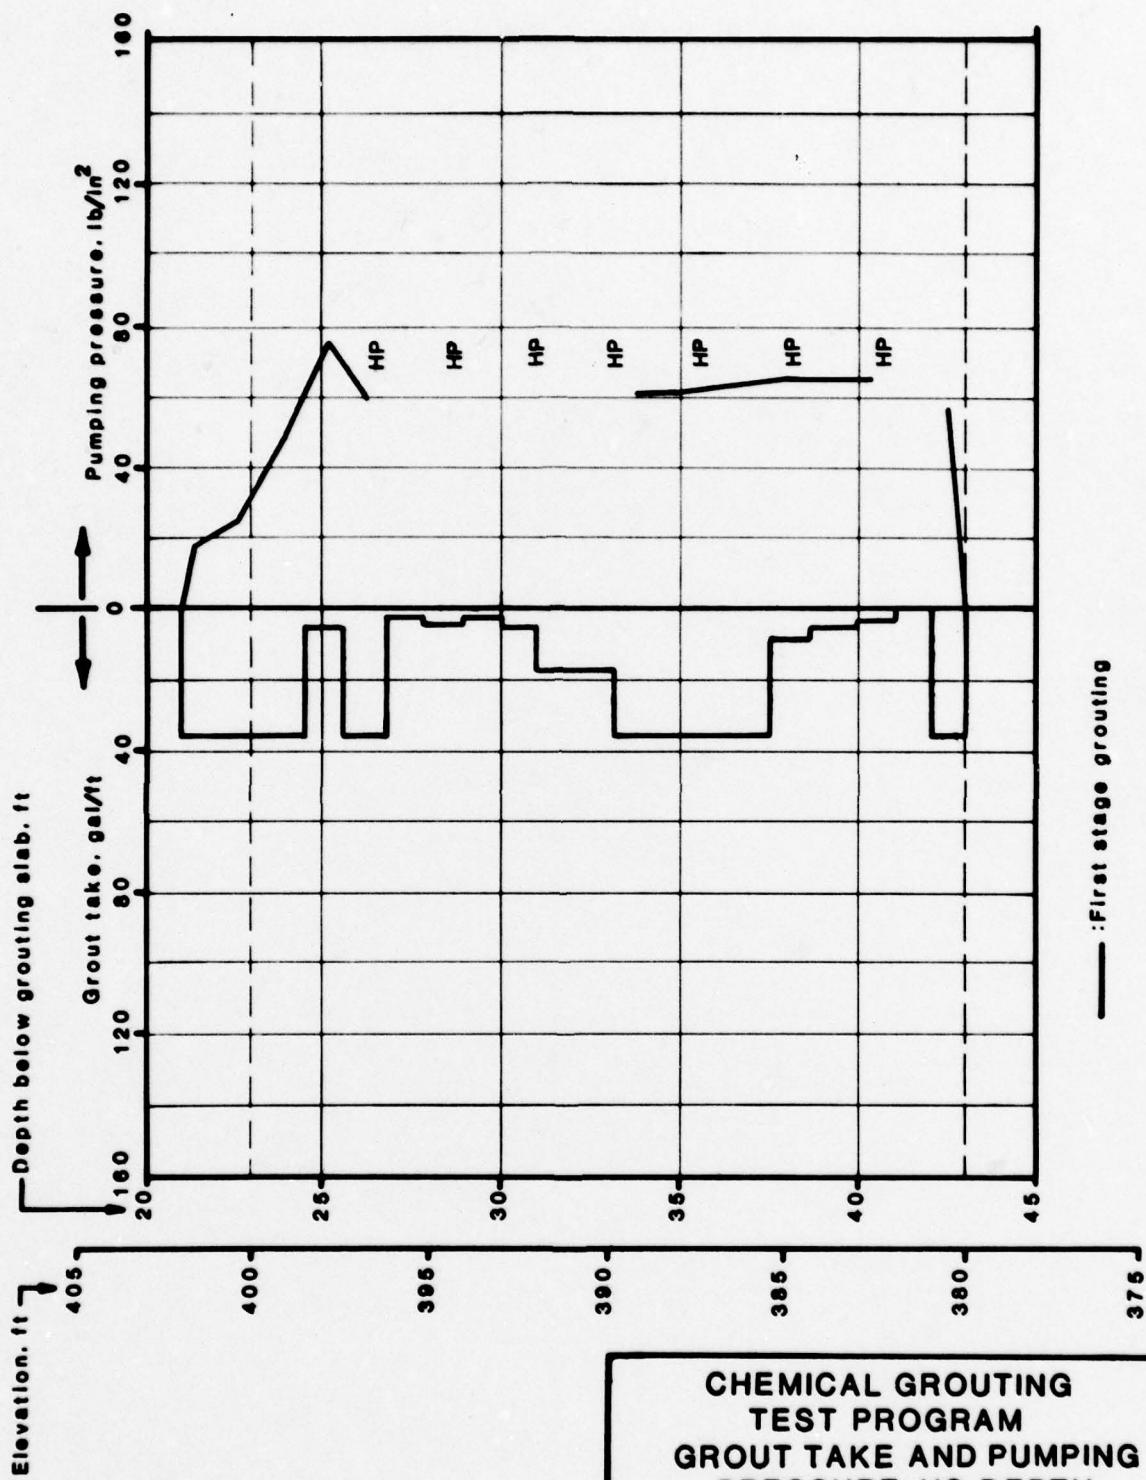
Fig. E.50

**CHEMICAL GROUTING
TEST PROGRAM
GROUT TAKE AND PUMPING
PRESSURE VS DEPTH
GROUT HOLE No. 9-6**

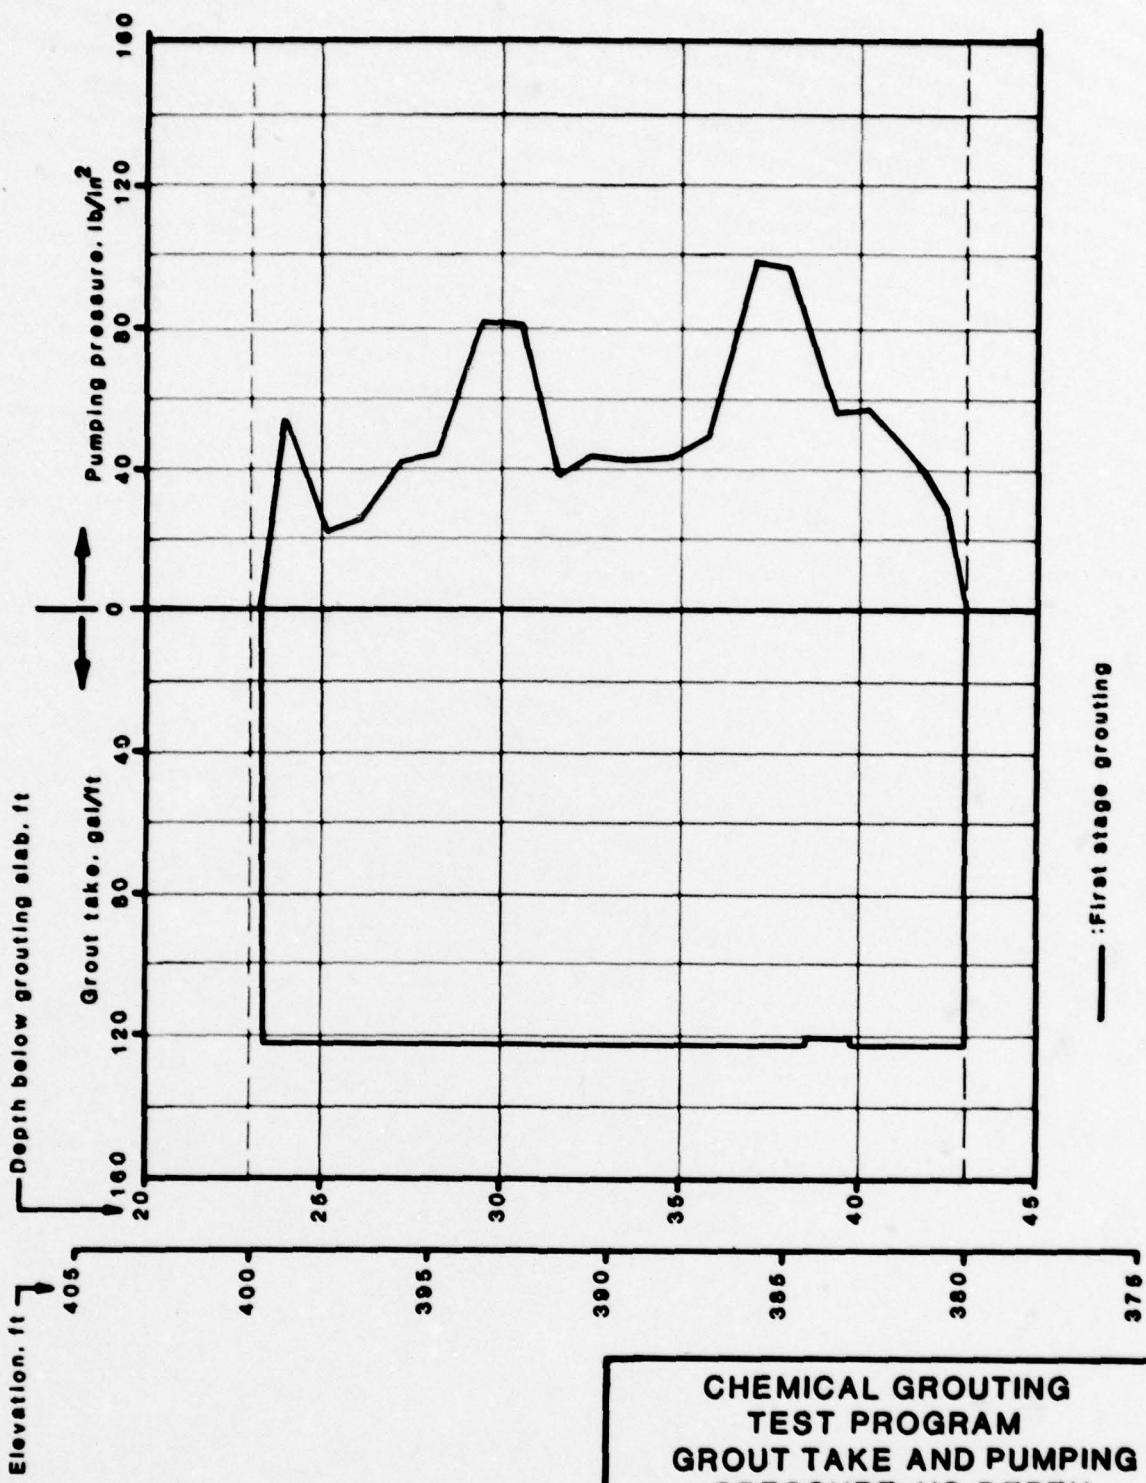
Fig. E.51

**CHEMICAL GROUTING
TEST PROGRAM
GROUT TAKE AND PUMPING
PRESSURE VS DEPTH
GROUT HOLE No. 10-1**

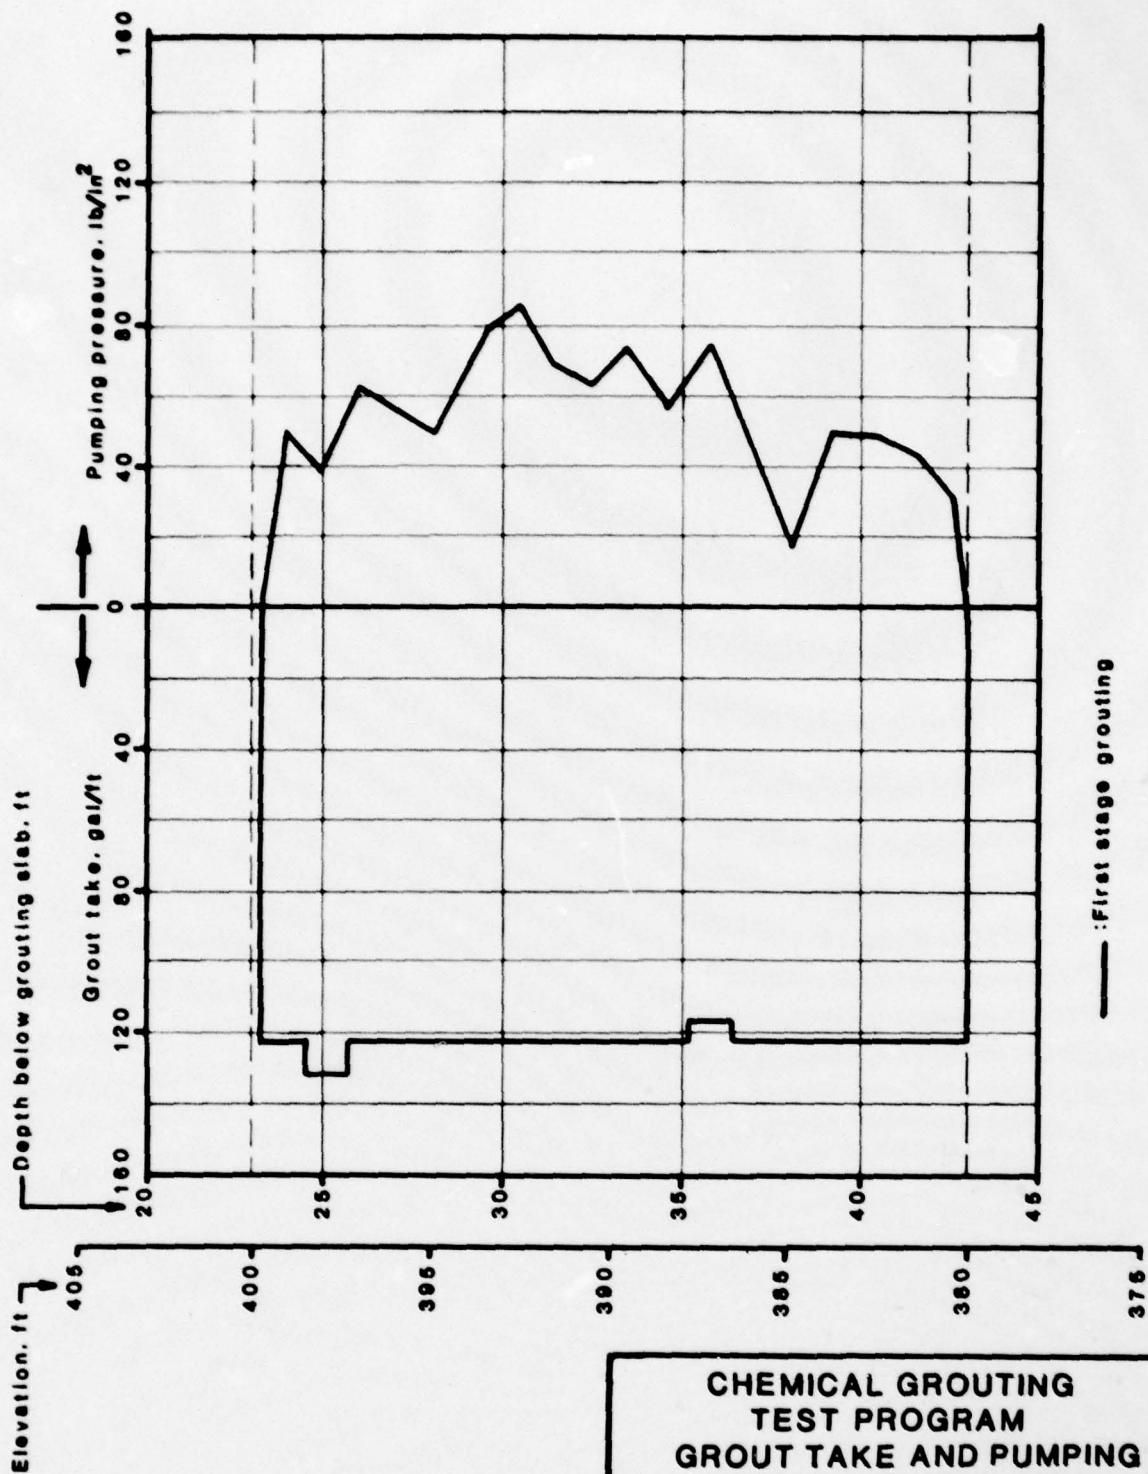
**CHEMICAL GROUTING
TEST PROGRAM
GROUT TAKE AND PUMPING
PRESSURE VS DEPTH
GROUT HOLE No. 10-3**

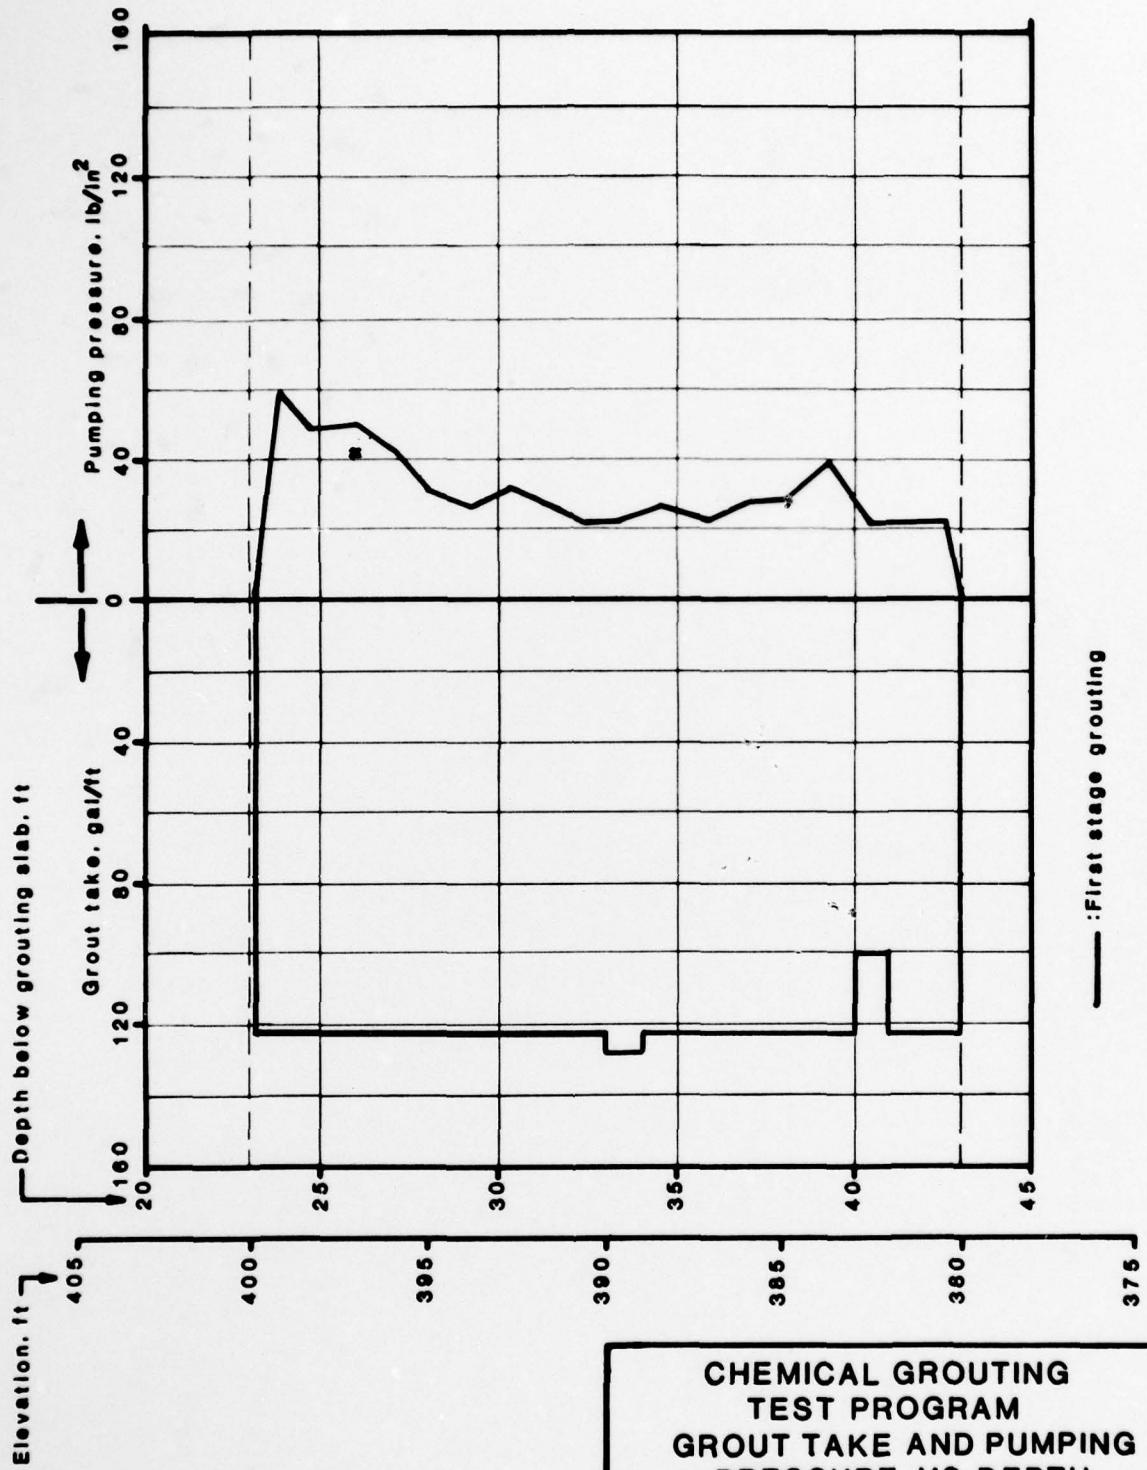
Fig. E.54

**CHEMICAL GROUTING
TEST PROGRAM
GROUT TAKE AND PUMPING
PRESSURE VS DEPTH
GROUT HOLE No. 10-4**

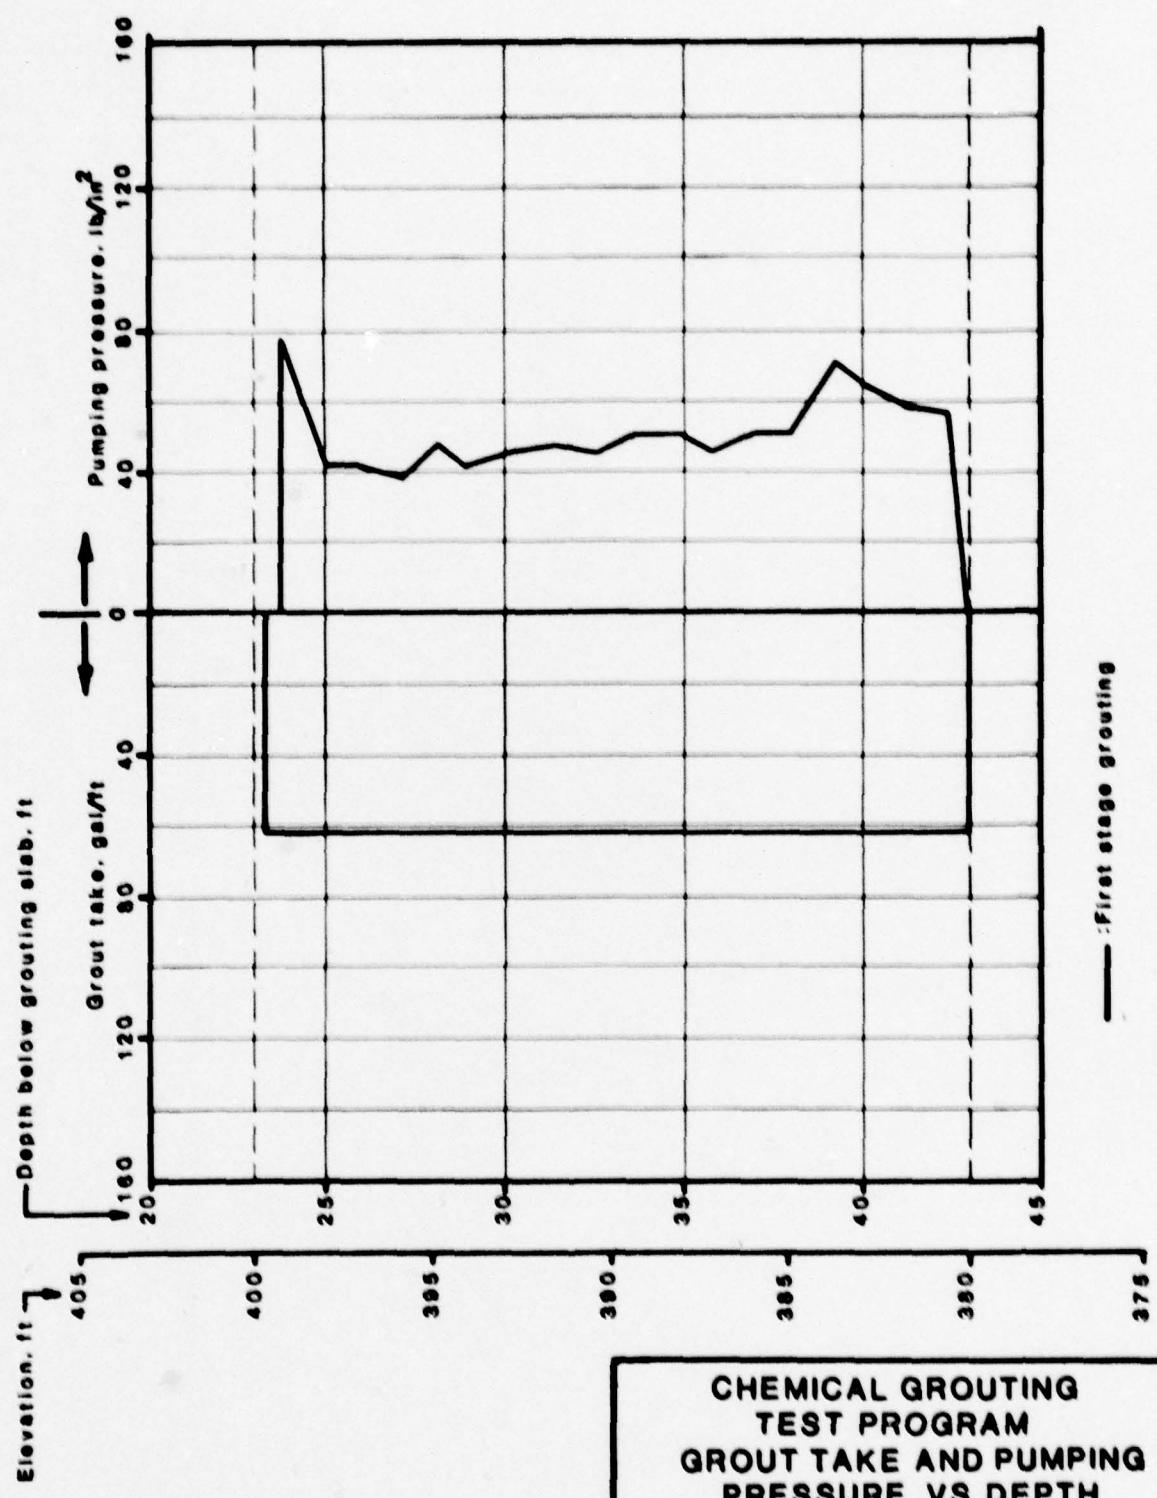
Fig. E.57

**CHEMICAL GROUTING
TEST PROGRAM
GROUT TAKE AND PUMPING
PRESSURE VS DEPTH
GROUT HOLE No. 11-1**

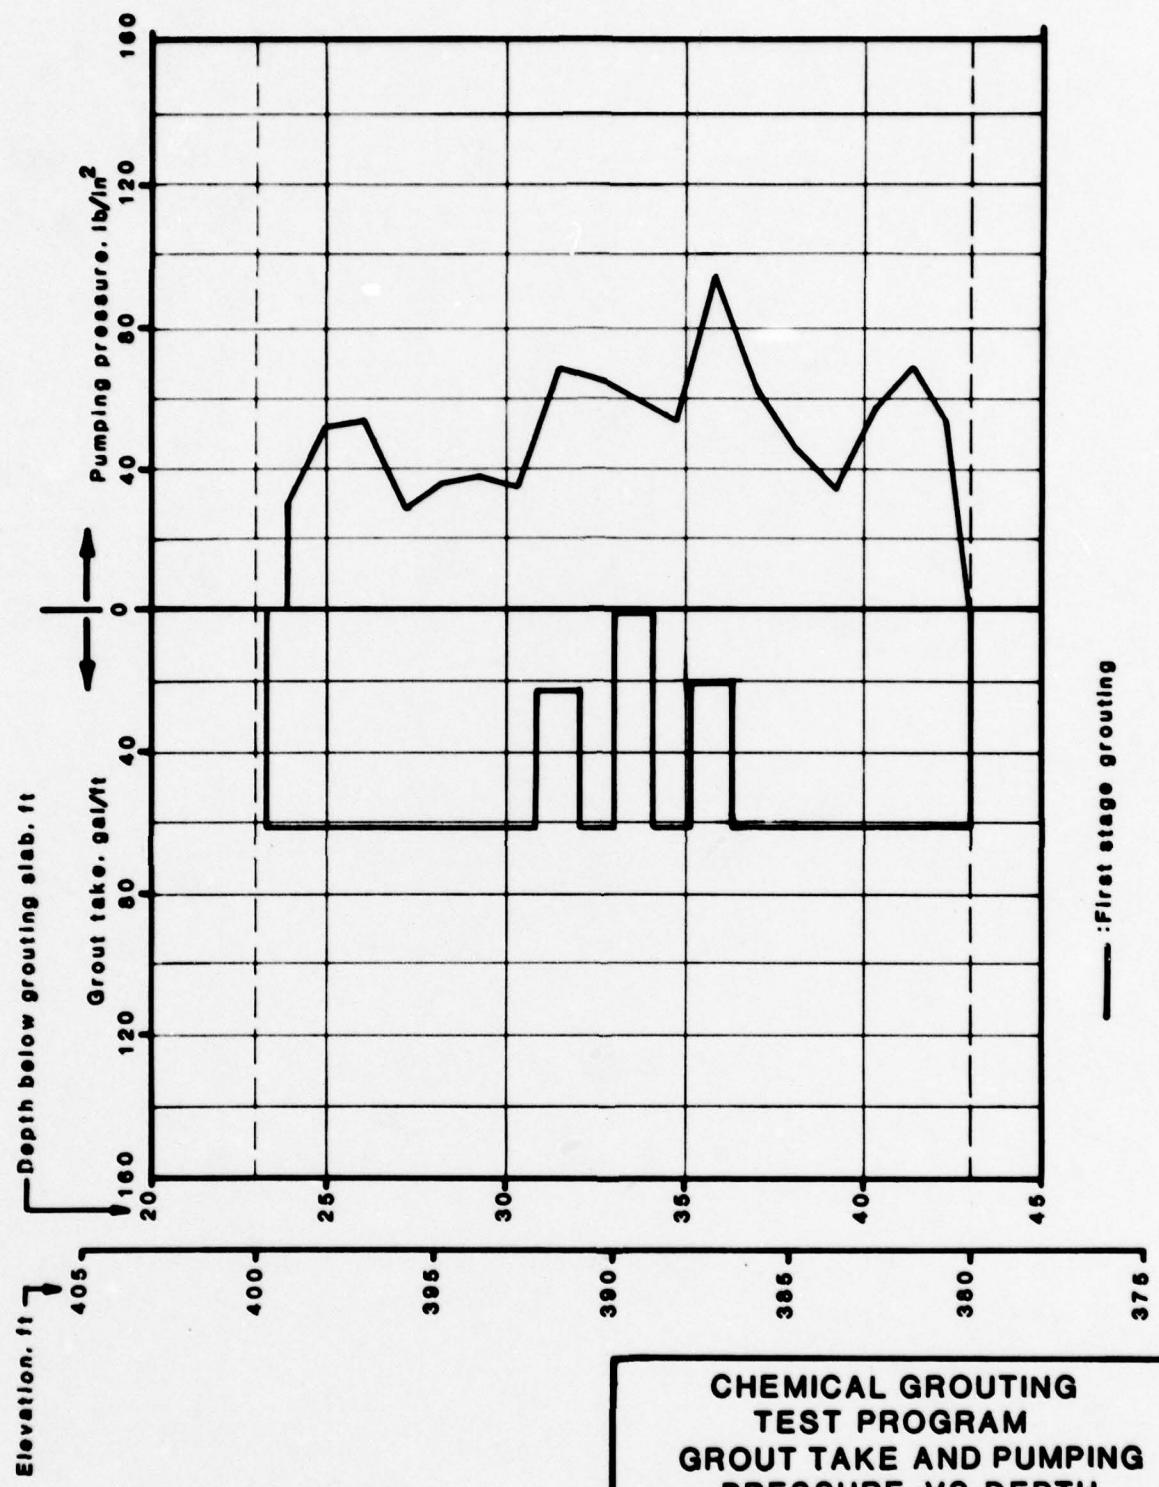
**CHEMICAL GROUTING
TEST PROGRAM
GROUT TAKE AND PUMPING
PRESSURE VS DEPTH
GROUT HOLE No. 11-3**

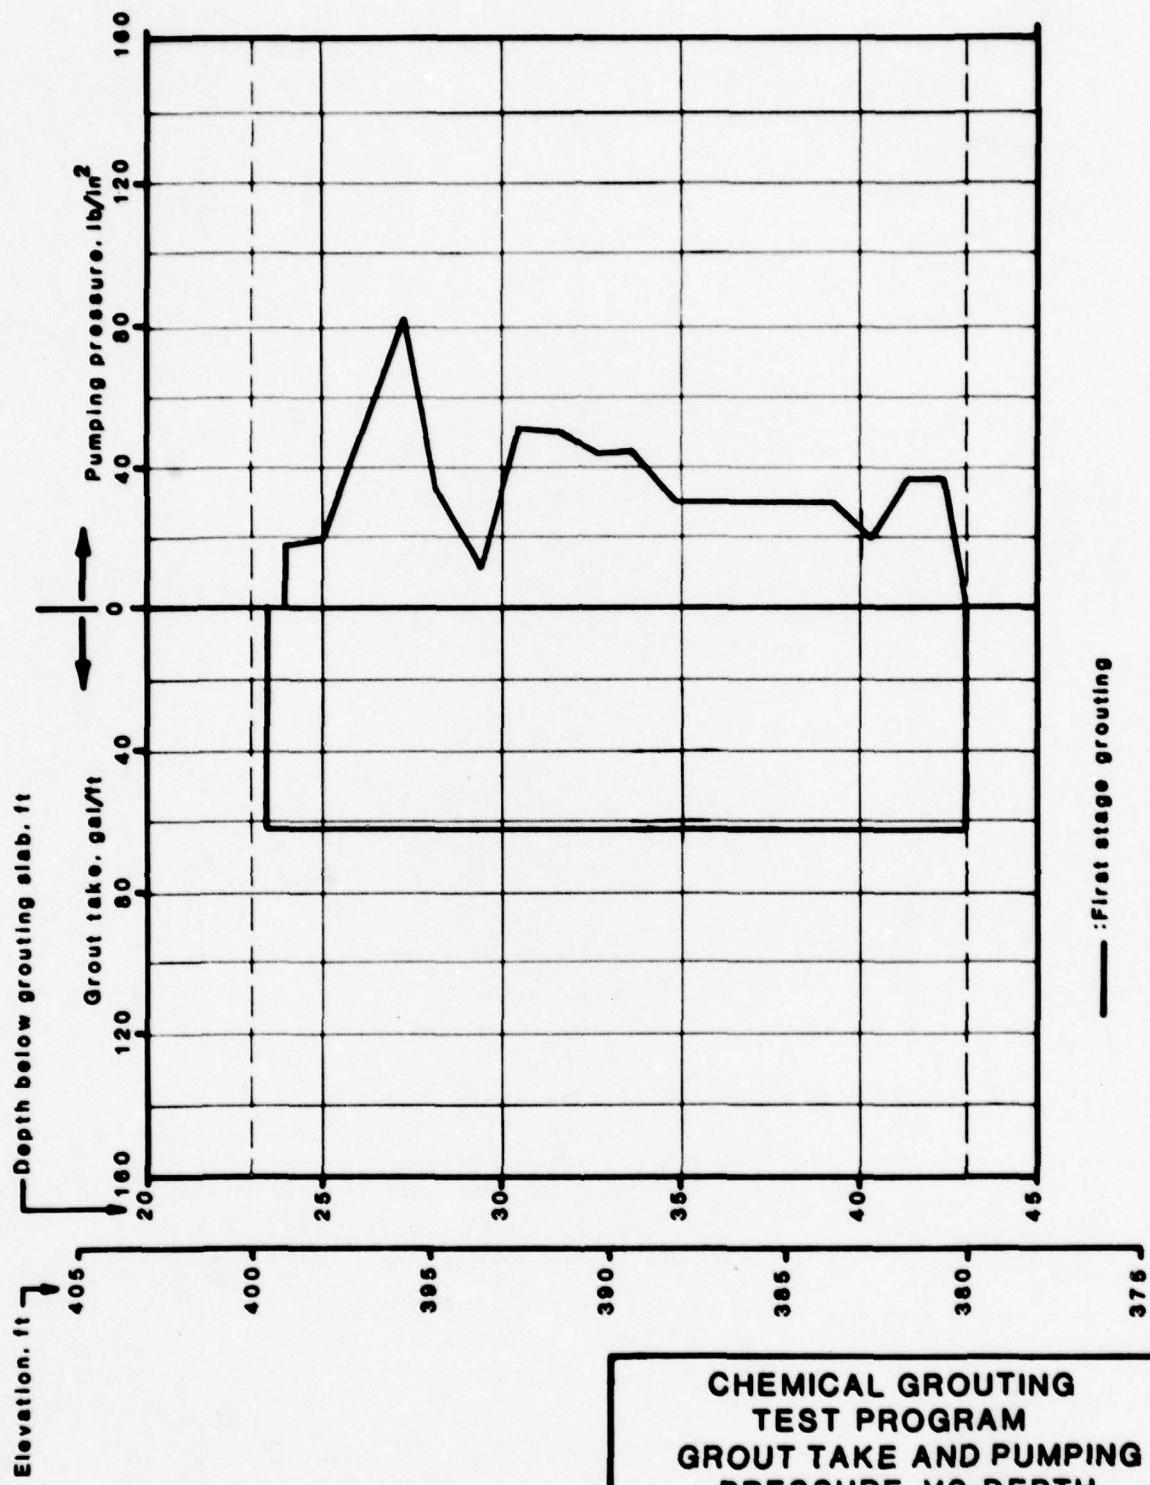
Fig. E.61

**CHEMICAL GROUTING
TEST PROGRAM
GROUT TAKE AND PUMPING
PRESSURE VS DEPTH
GROUT HOLE No. 11-5**

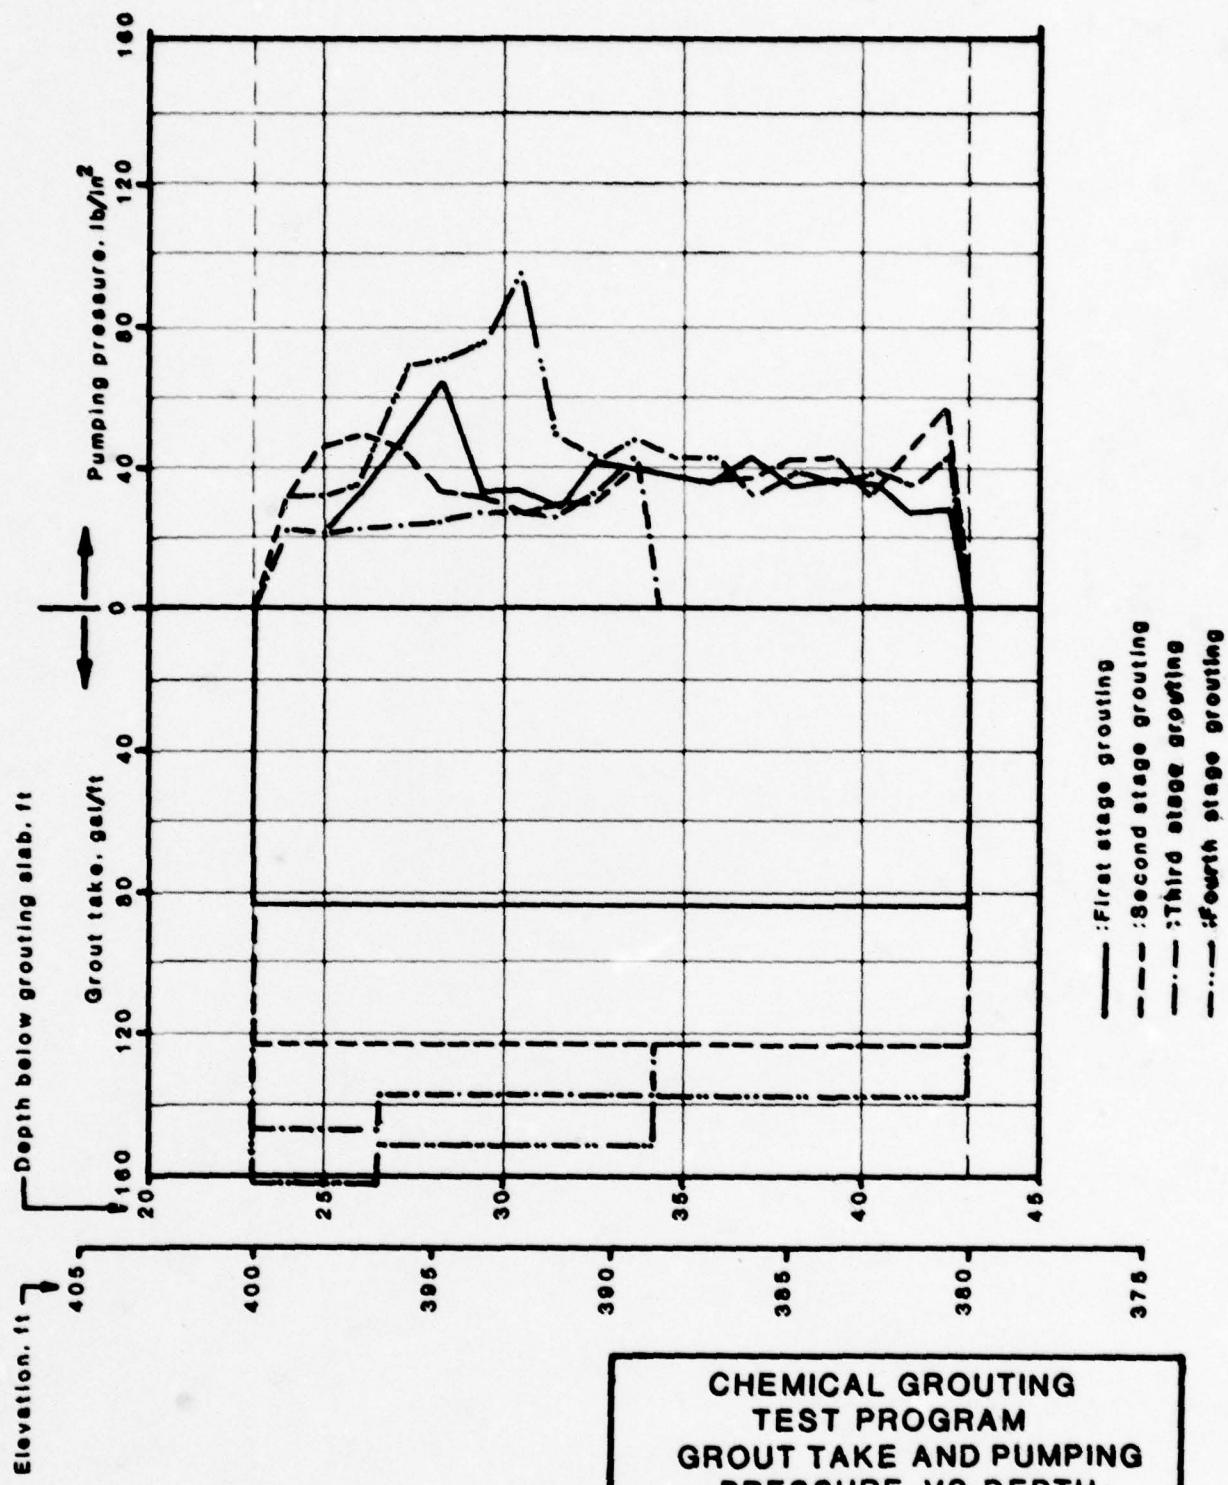
**CHEMICAL GROUTING
TEST PROGRAM
GROUT TAKE AND PUMPING
PRESSURE VS DEPTH
GROUT HOLE No. 12-1**

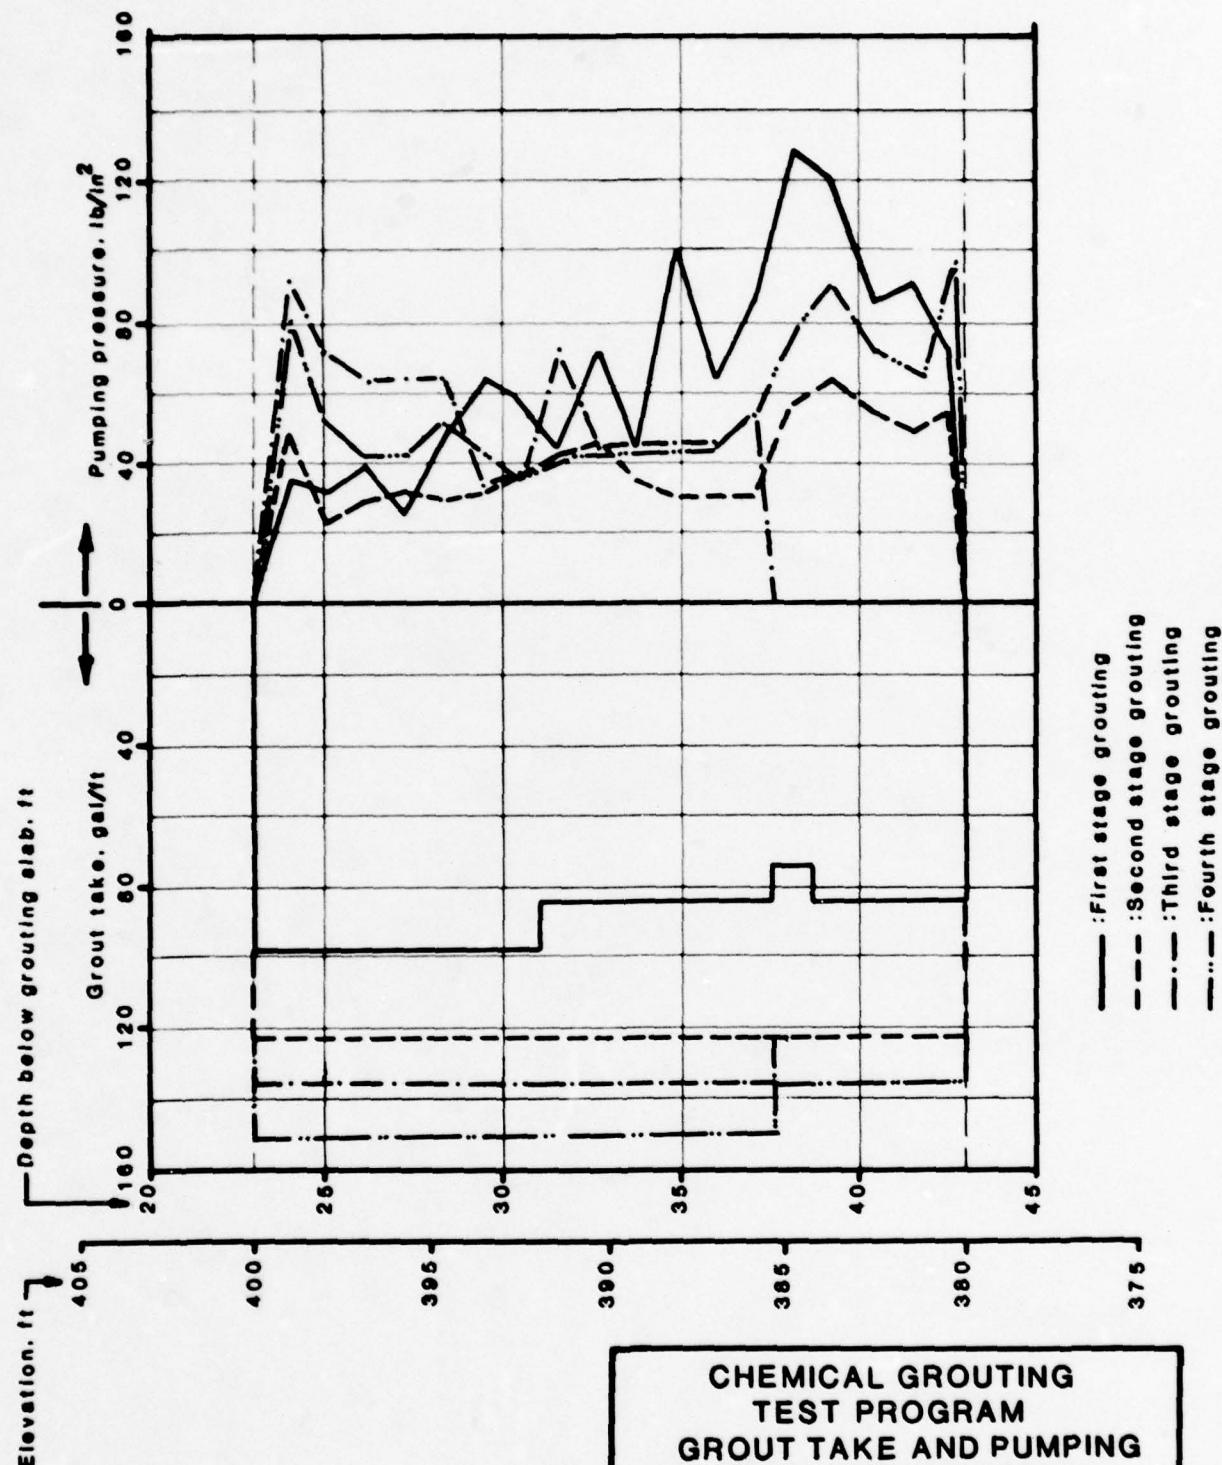
Fig. E.66

**CHEMICAL GROUTING
TEST PROGRAM
GROUT TAKE AND PUMPING
PRESSURE VS DEPTH
GROUT HOLE No. 12-3**

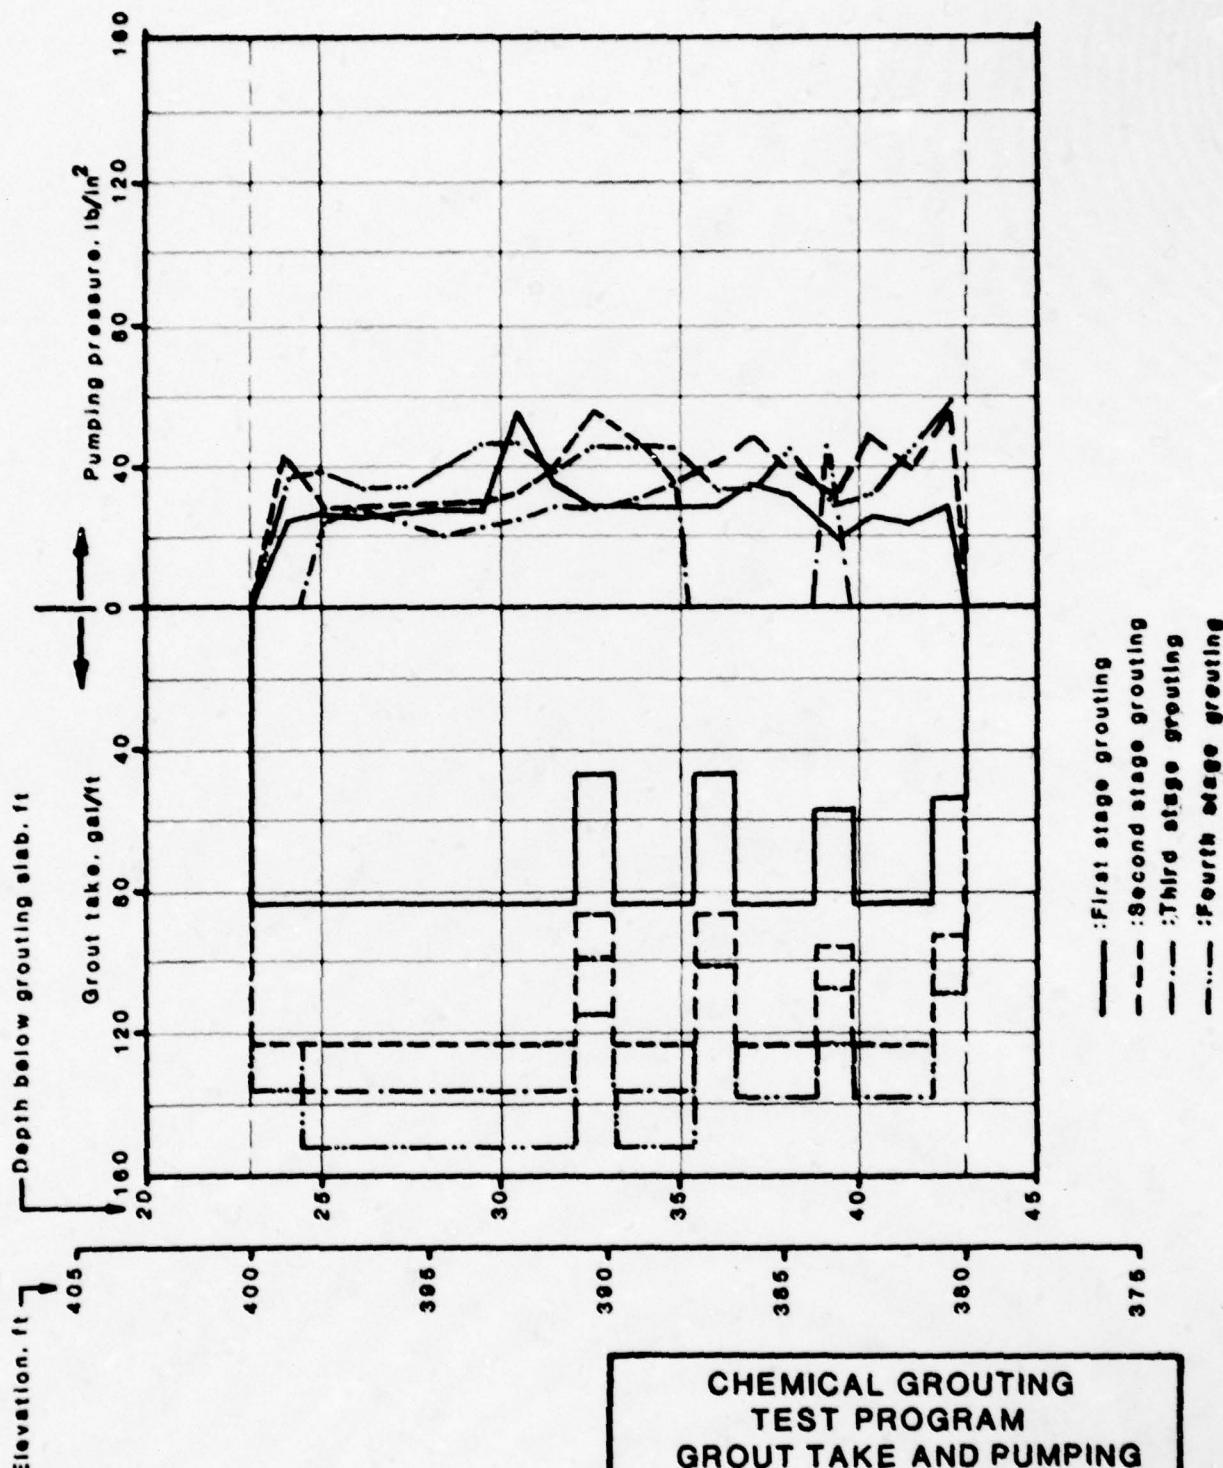
Fig. E.67

**CHEMICAL GROUTING
TEST PROGRAM
GROUT TAKE AND PUMPING
PRESSURE VS DEPTH
GROUT HOLE No. 12-4**

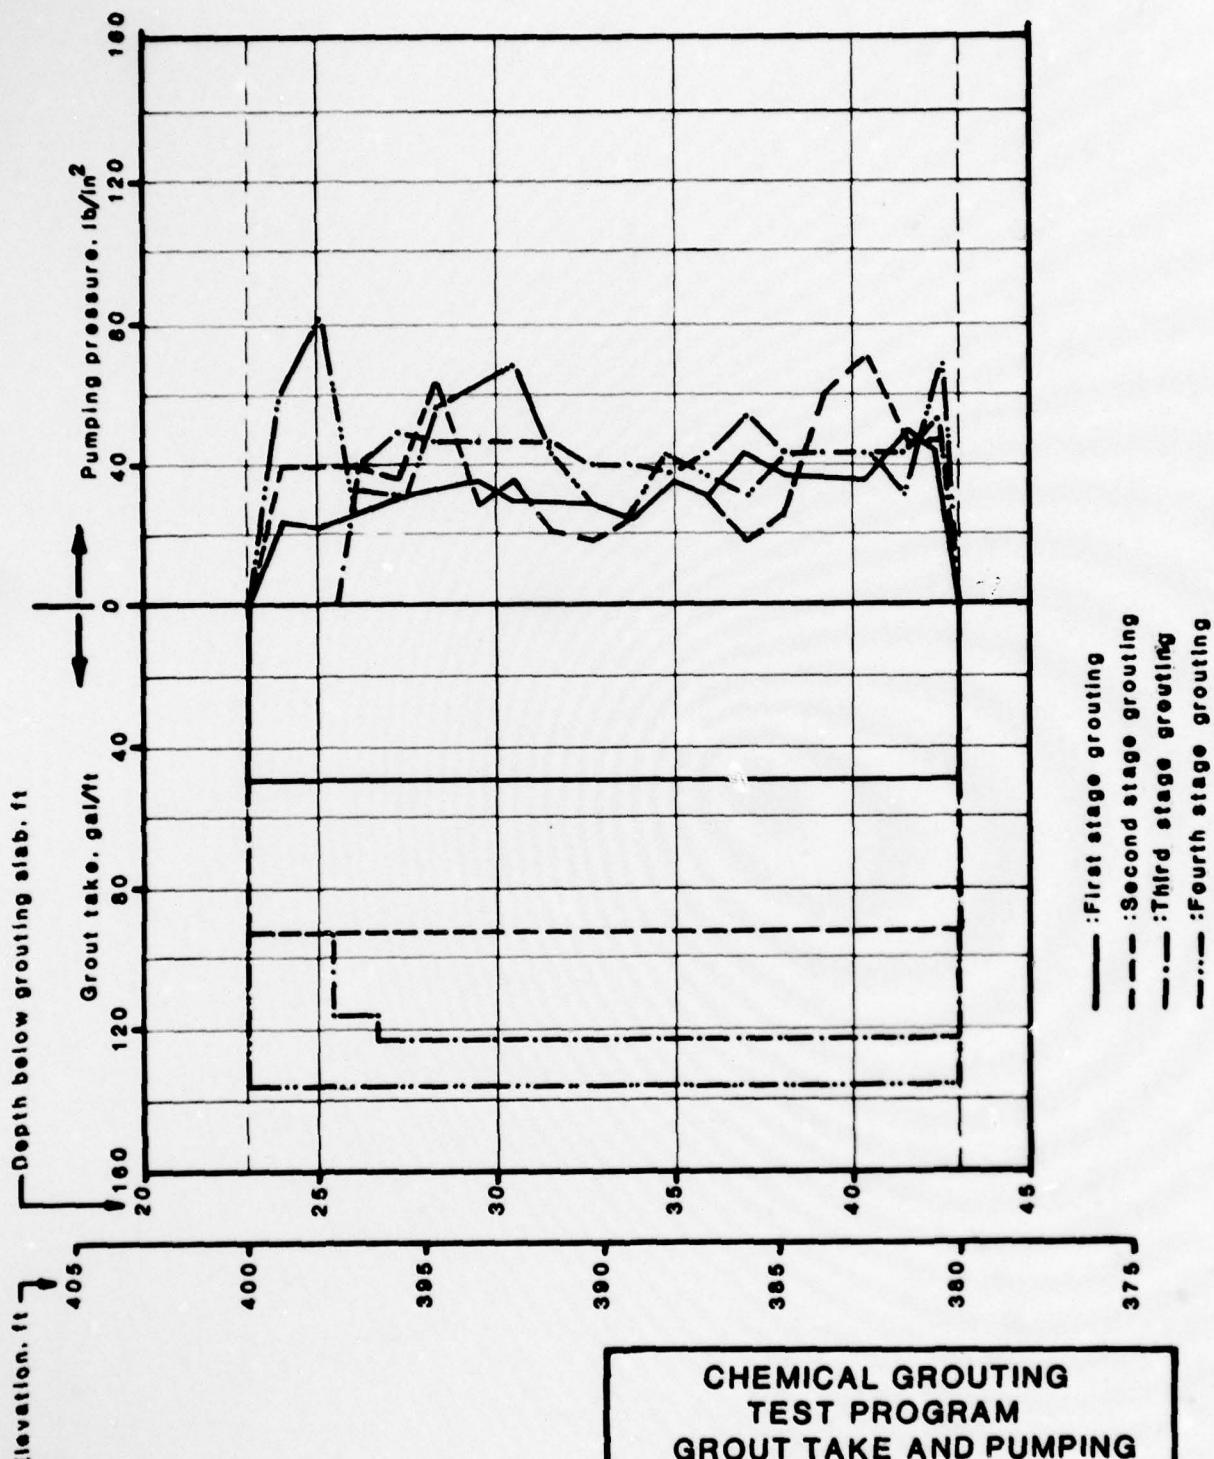
Fig. E.68

CHEMICAL GROUTING TEST PROGRAM GROUT TAKE AND PUMPING PRESSURE VS DEPTH GROUT HOLE No. 12-5

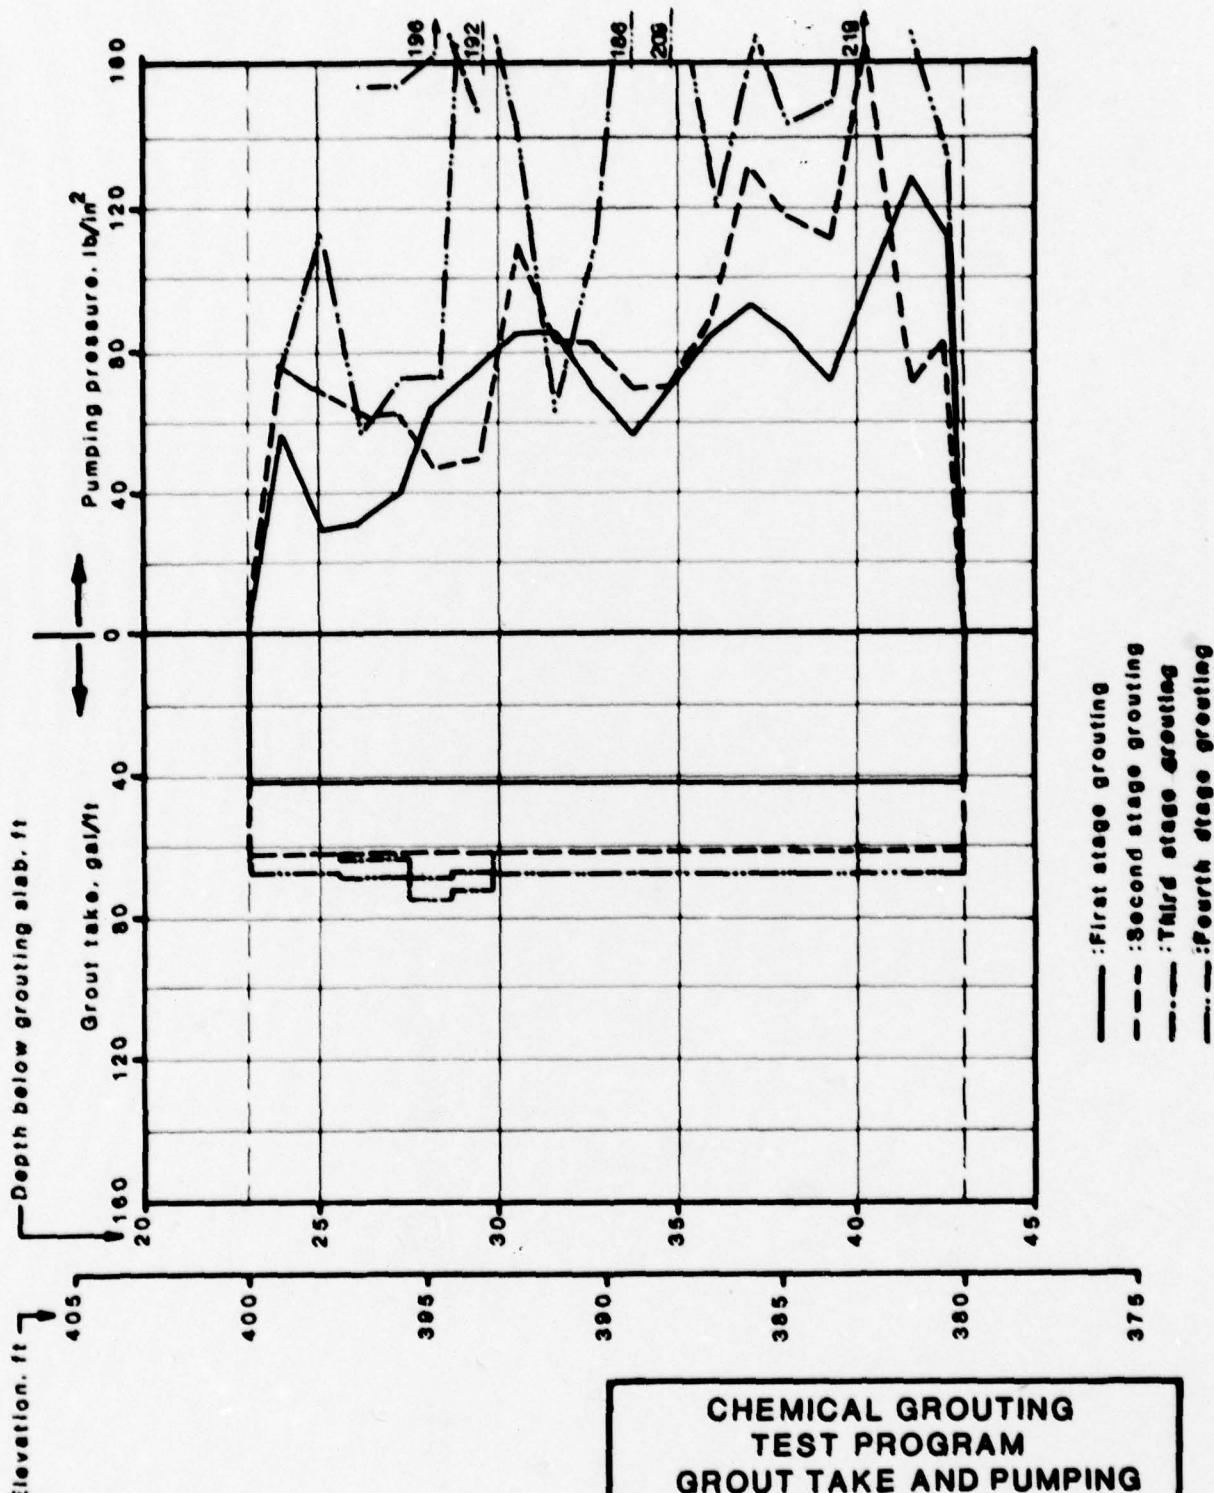
Fig. E.69

**CHEMICAL GROUTING
TEST PROGRAM
GROUT TAKE AND PUMPING
PRESSURE VS DEPTH
GROUT HOLE No. 13-1**

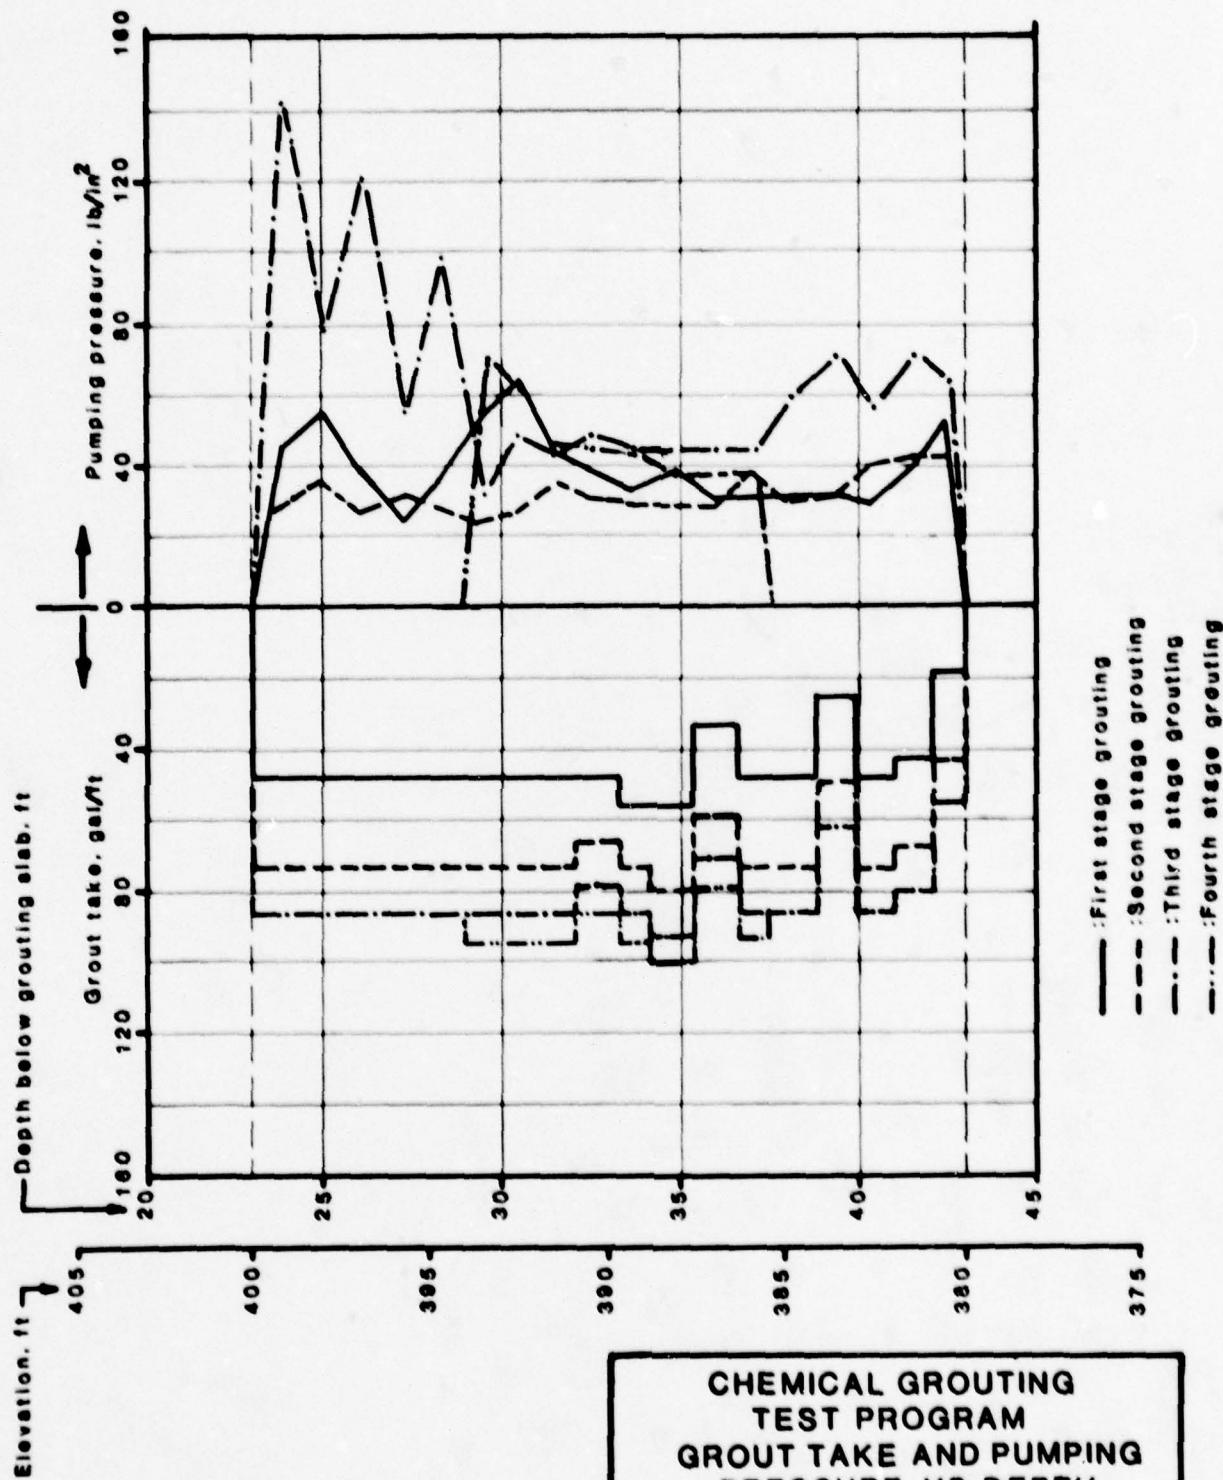
Fig. E.70

**CHEMICAL GROUTING
TEST PROGRAM
GROUT TAKE AND PUMPING
PRESSURE VS DEPTH
GROUT HOLE No. 13-2**
