PHASE IV REPORT

APPENDICES A THROUGH G

**RESULTS AND INTERPRETATION OF
CHEMICAL GROUTING TEST PROGRAM**

**EXISTING LOCKS AND DAM NO. 26
MISSISSIPPI RIVER, ALTON, ILLINOIS**

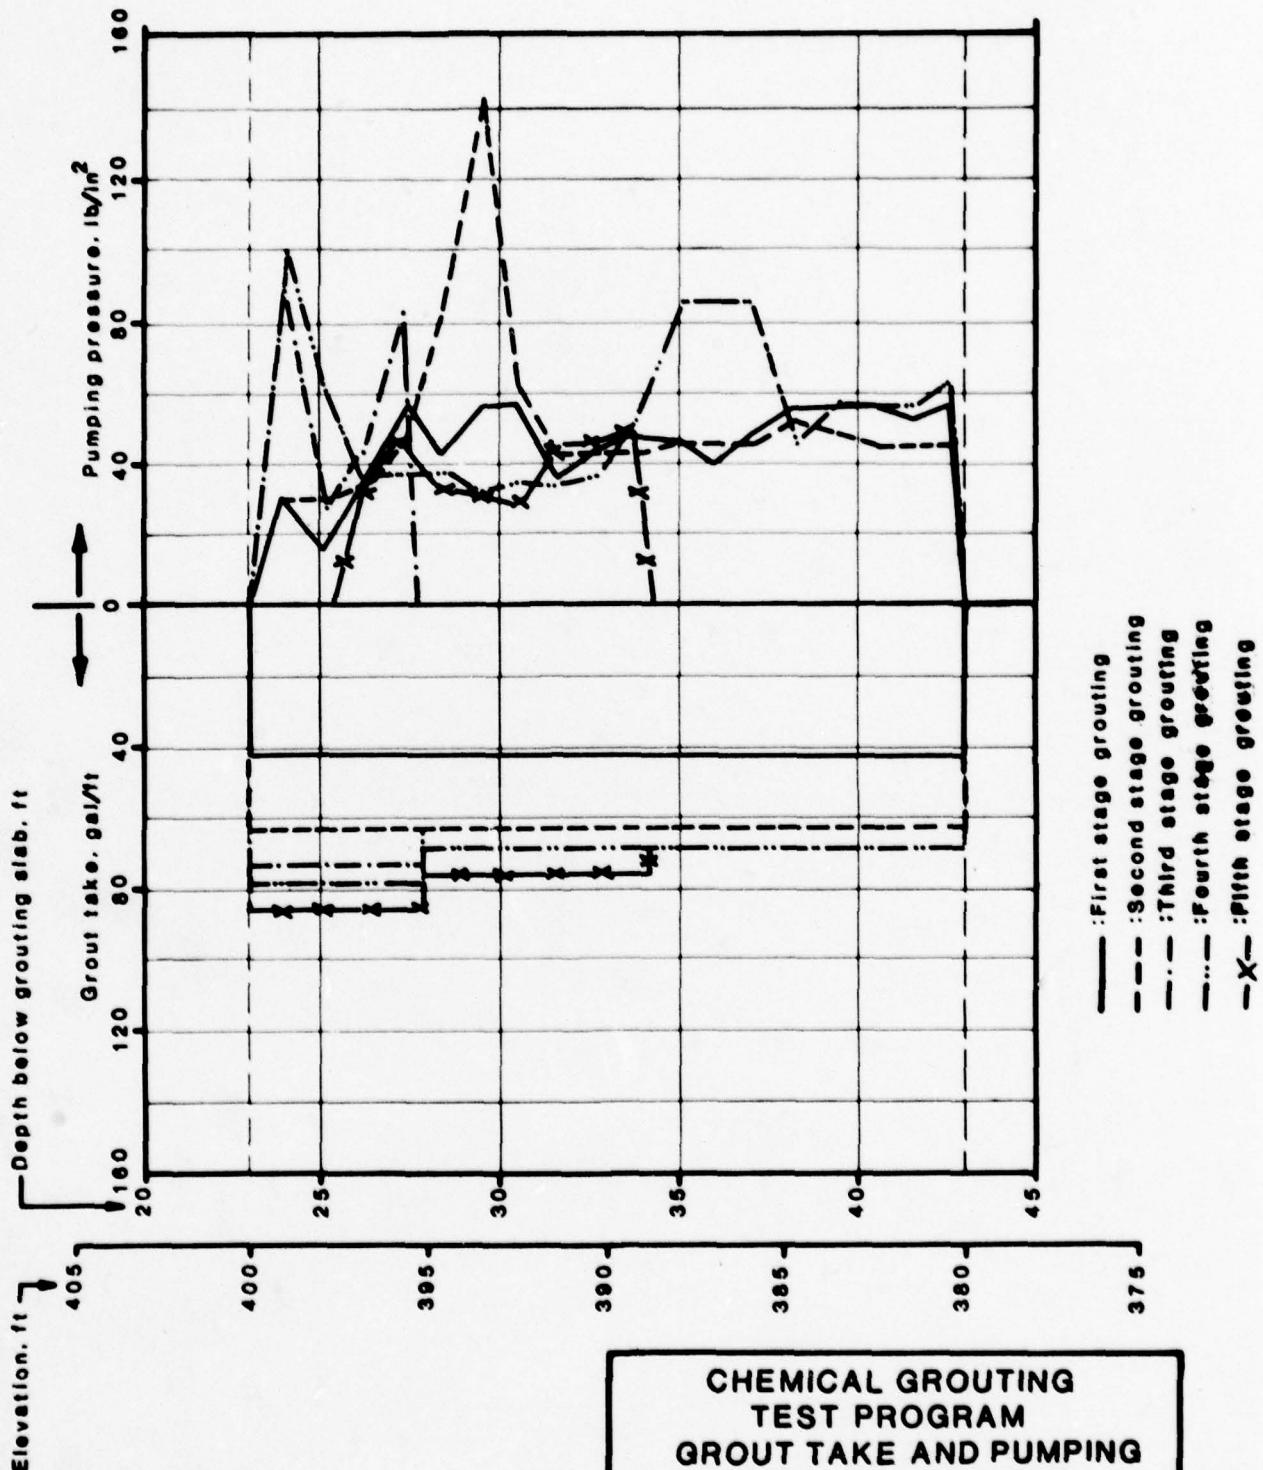
Fig. E.71

**CHEMICAL GROUTING
TEST PROGRAM
GROUT TAKE AND PUMPING
PRESSURE VS DEPTH
GROUT HOLE No. 13-3**

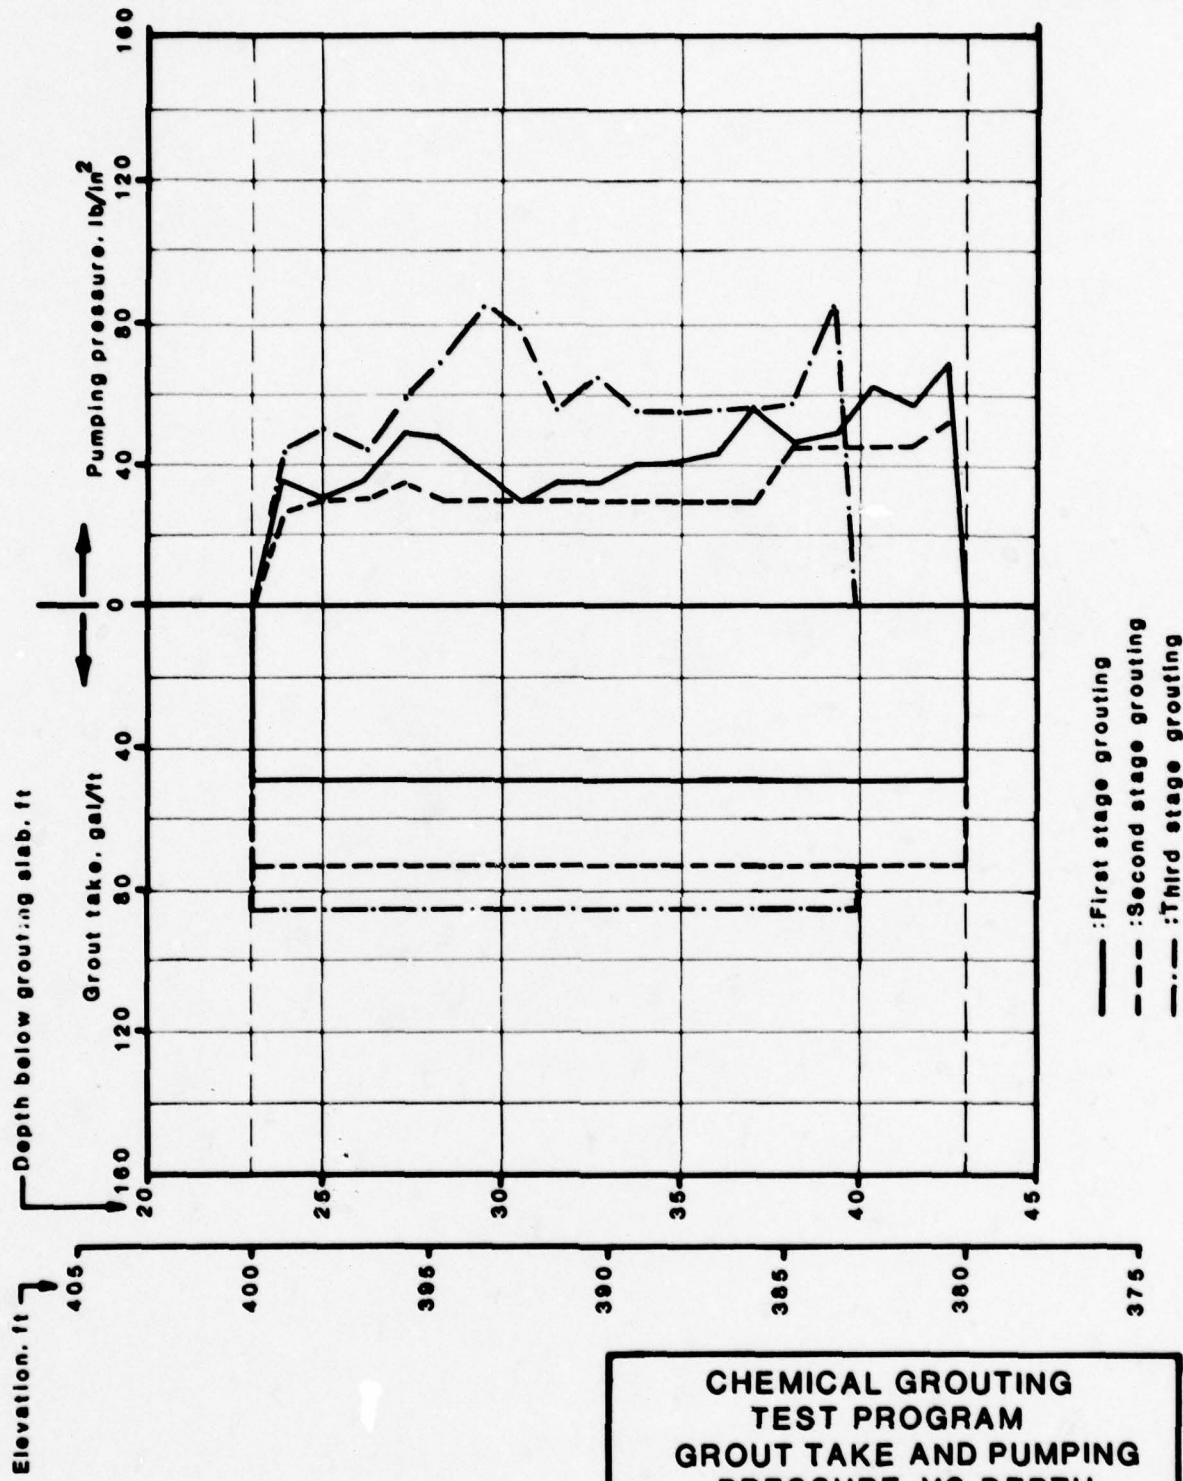
Fig. E.72

**CHEMICAL GROUTING
TEST PROGRAM
GROUT TAKE AND PUMPING
PRESSURE VS DEPTH
GROUT HOLE No. 13-4**

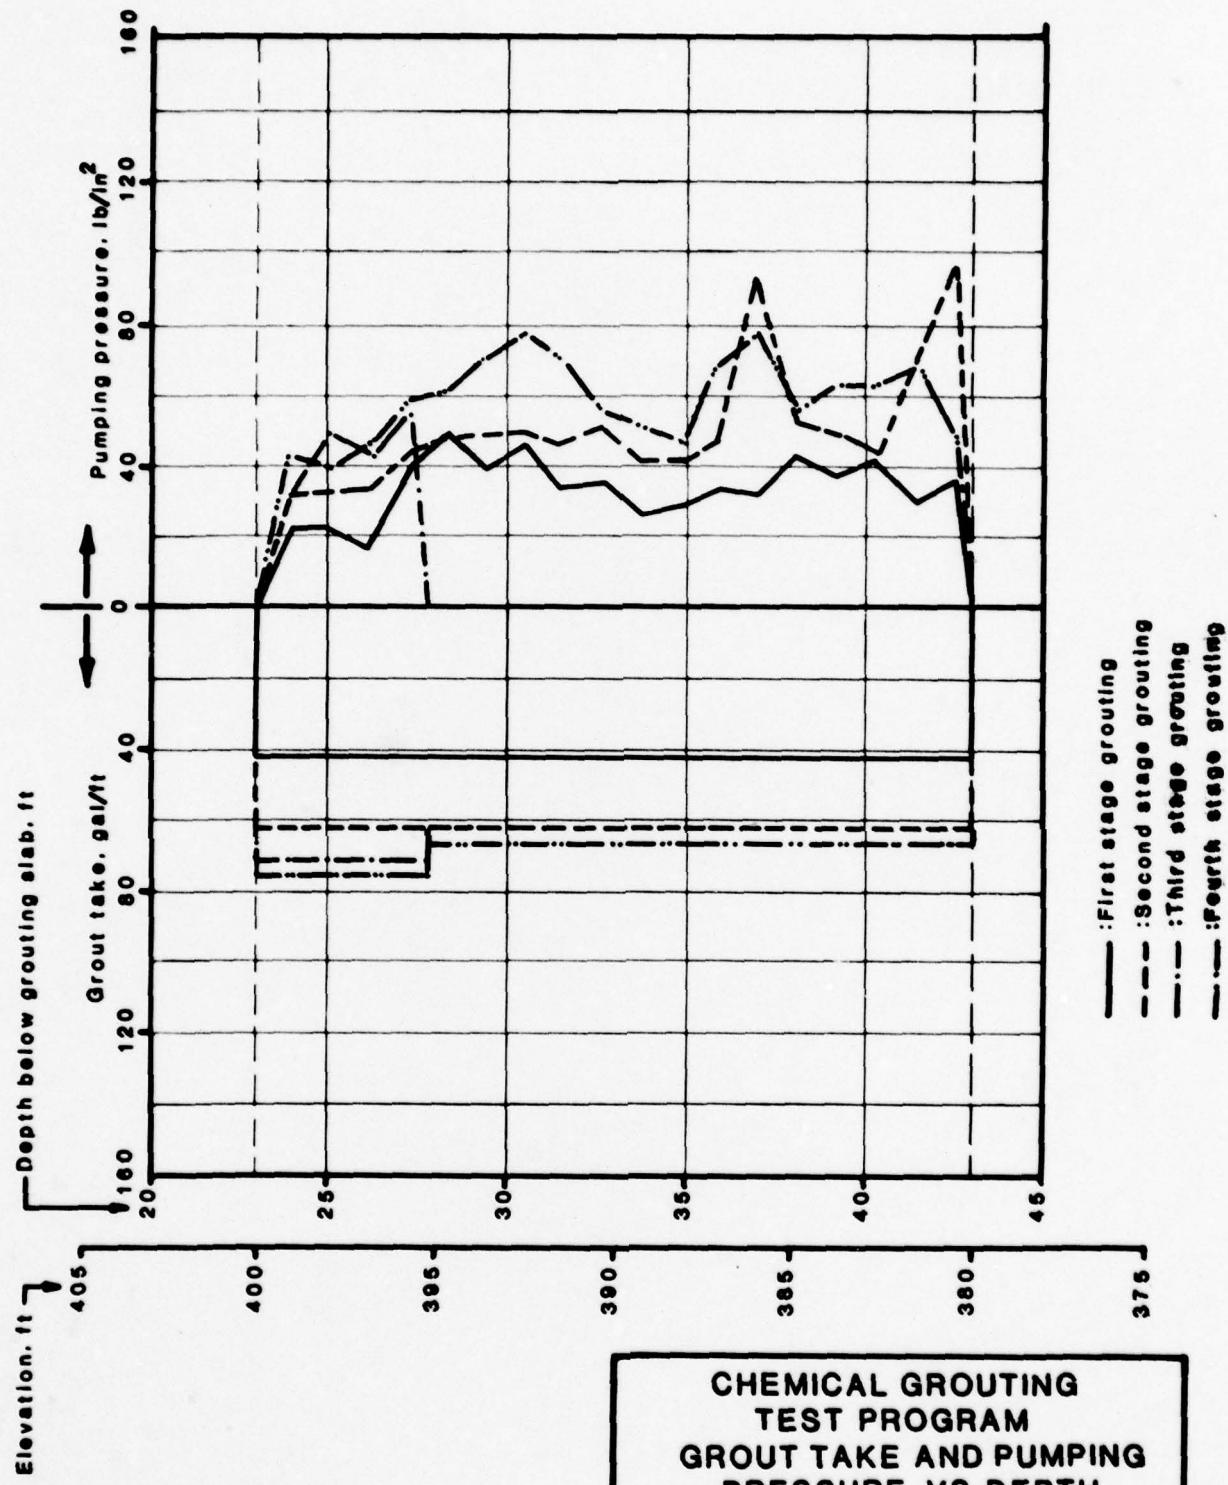
Fig. E.73

CHEMICAL GROUTING TEST PROGRAM GROUT TAKE AND PUMPING PRESSURE VS DEPTH GROUT HOLE No. 13-5

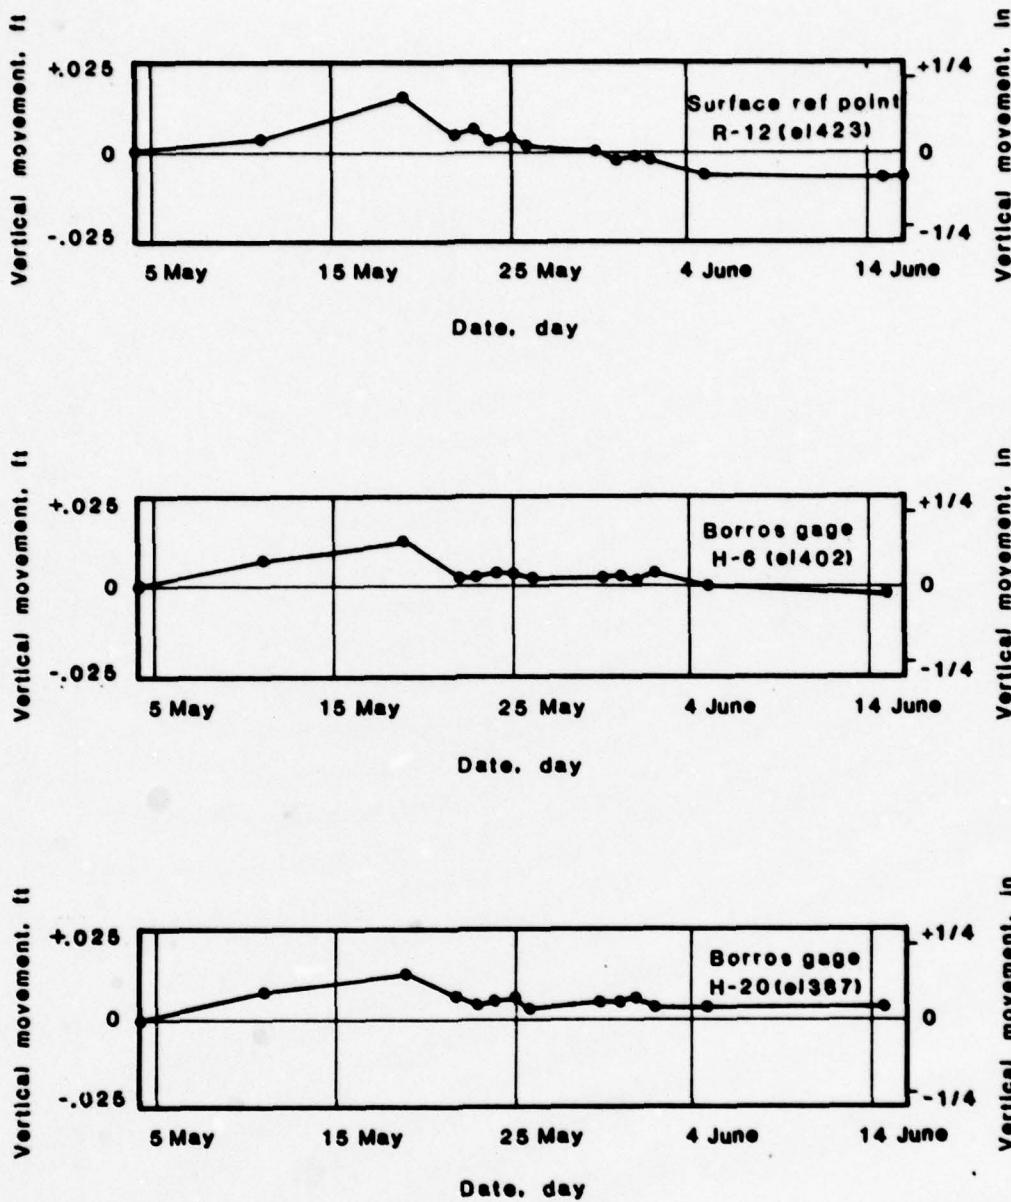
Fig. F.13

CHEMICAL GROUTING TEST PROGRAM
COMPARISON BETWEEN
RESULTS OBTAINED WITH
BORROS GAGES AND
SURFACE REFERENCE POINT

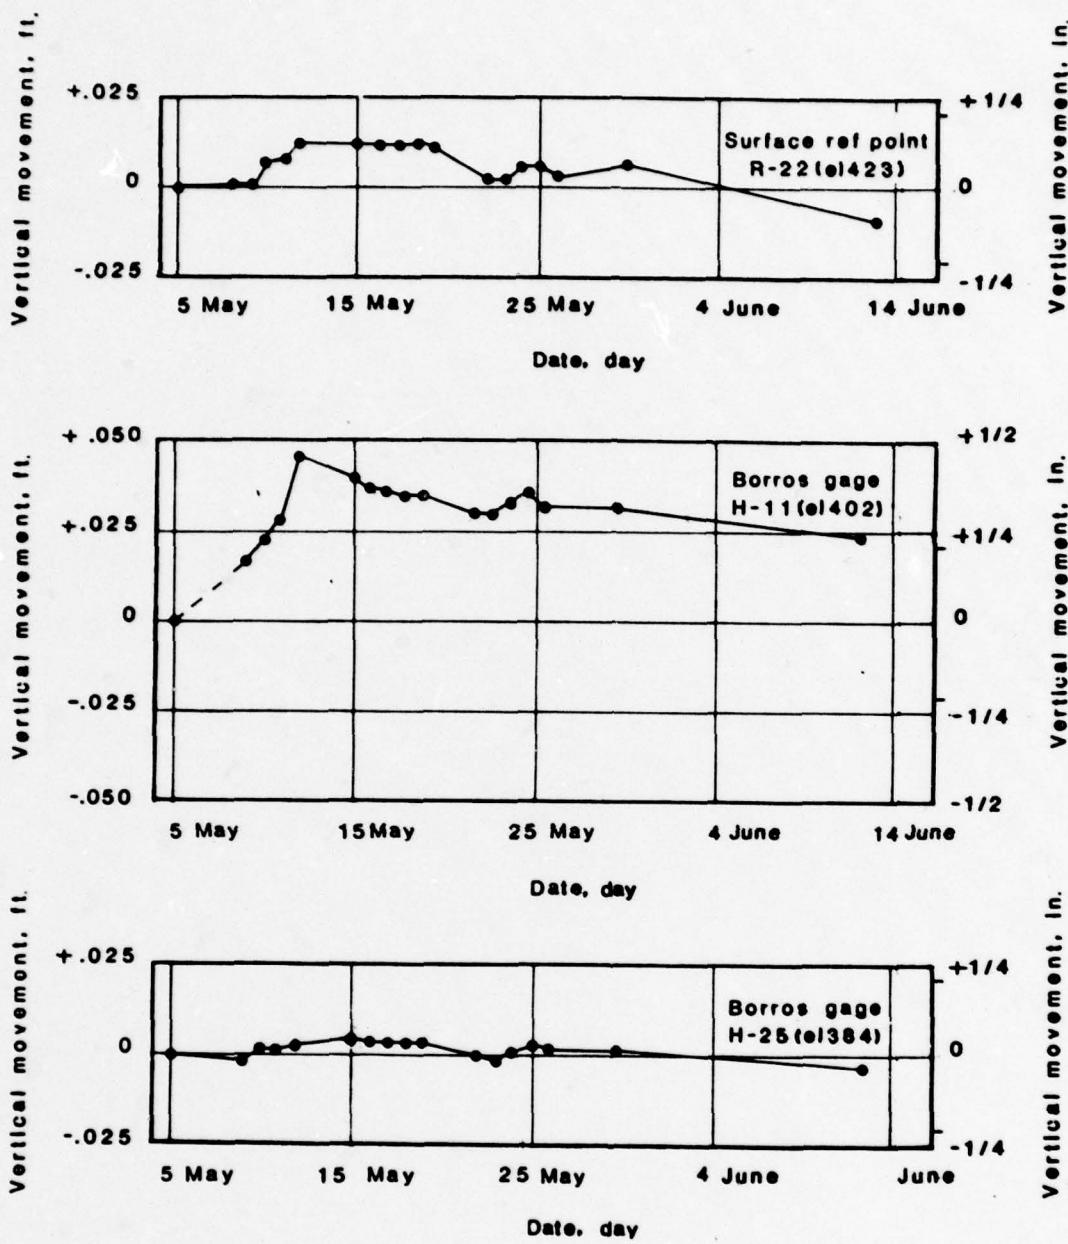
Fig. F.18

**CHEMICAL GROUTING TEST PROGRAM
COMPARISON BETWEEN
RESULTS OBTAINED
WITH BORROS GAGES AND
SURFACE REFERENCE POINT**

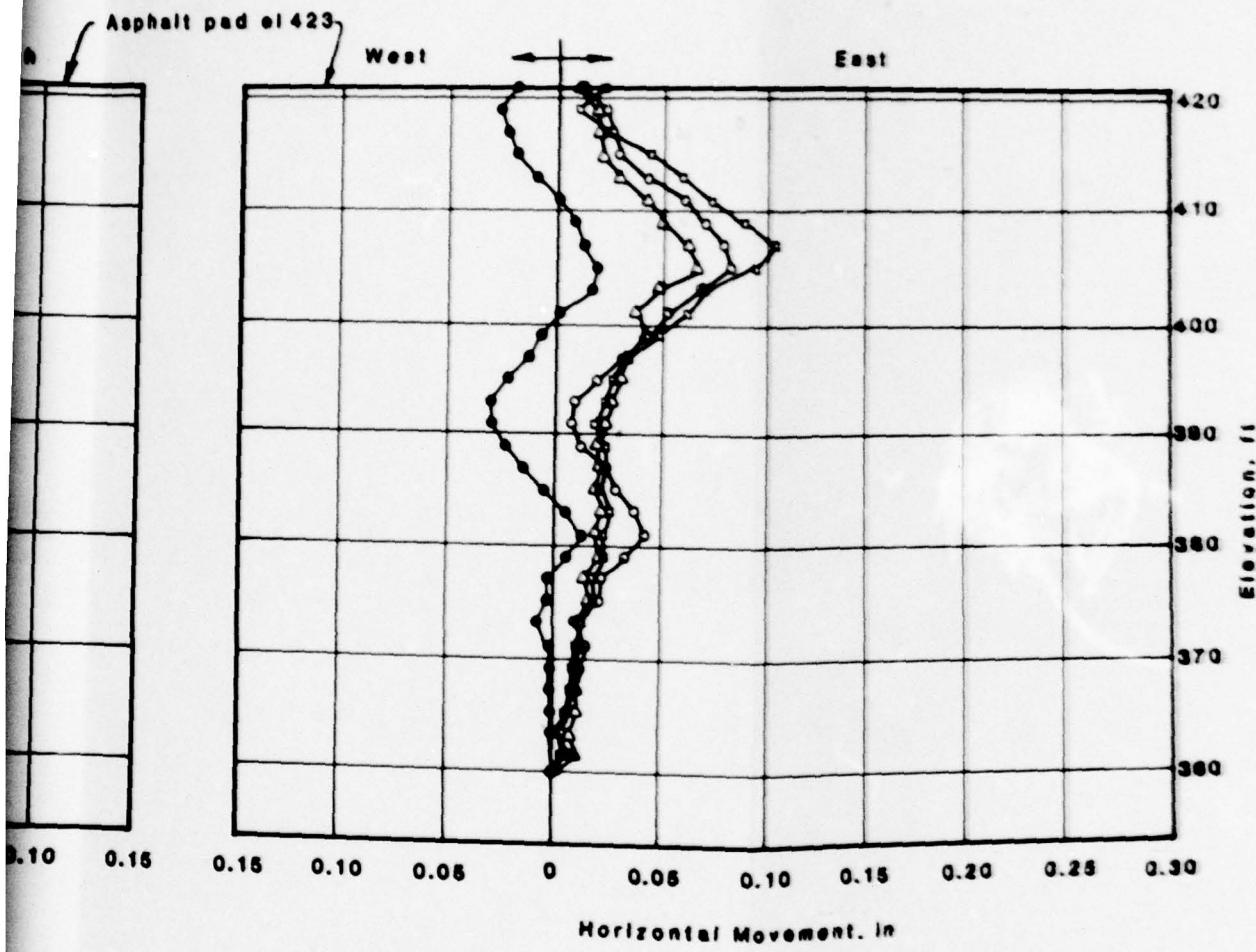
<u>Symbol</u>	<u>Date of reading</u>
●	1 May 1978
○	5 May 1978
□	8 May 1978
△	9 May 1978

**CHEMICAL GROUTING TEST PROGRAM
RESULTS OF INCLINOMETER I-6
MEASUREMENTS
1 MAY THROUGH 9 MAY 1978**

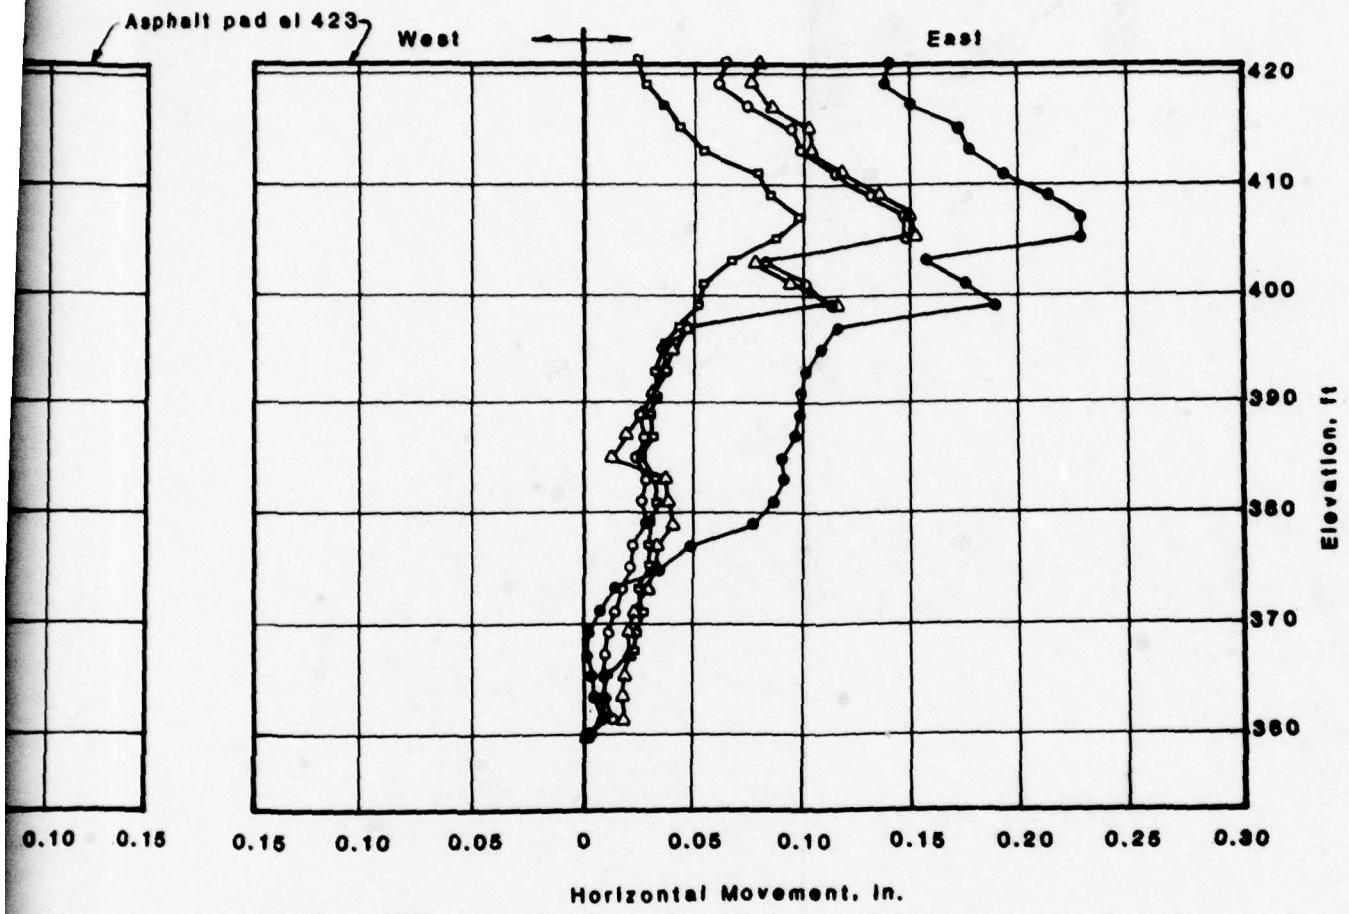
<u>Symbol</u>	<u>Date of reading</u>
○	10 May 1978
●	15 May 1978
□	16 May 1978
△	17 May 1978

CHEMICAL GROUTING TEST PROGRAM
RESULTS OF INCLINOMETER I-6
 MEASUREMENTS
 10 MAY THROUGH 17 MAY 1978
 FOUNDATION INVESTIGATION AND TEST PROGRAM
 EXISTING LOCKS AND DAM NO. 20
 ST. LOUIS DISTRICT, CORPS OF ENGINEERS.
 DACW43-78-C-0008

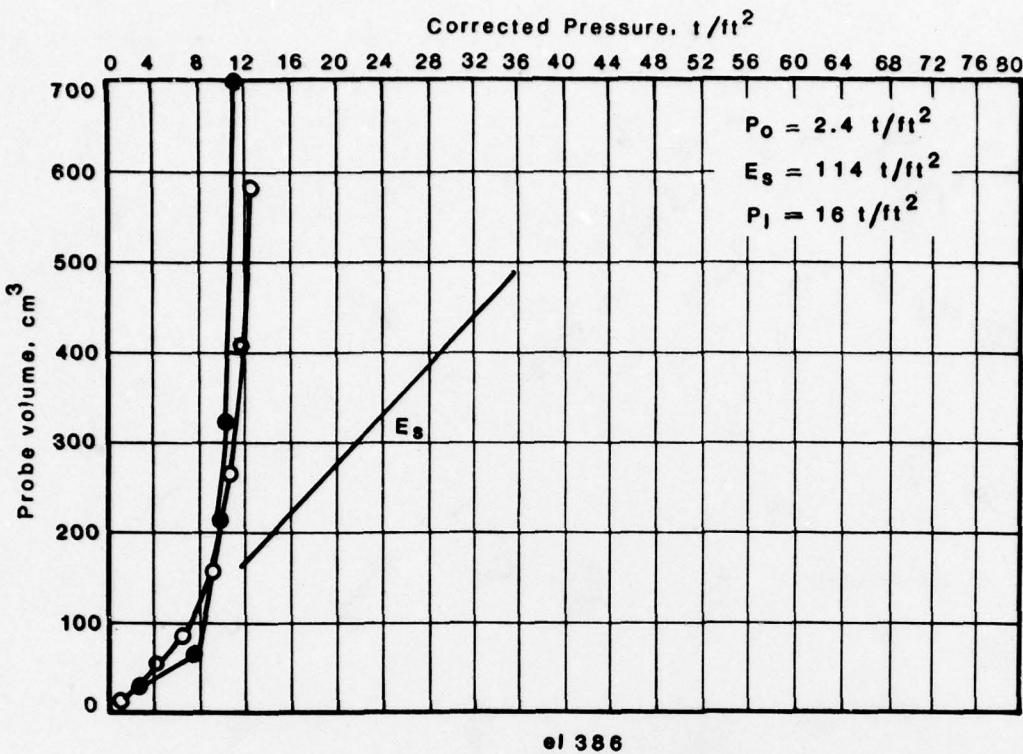
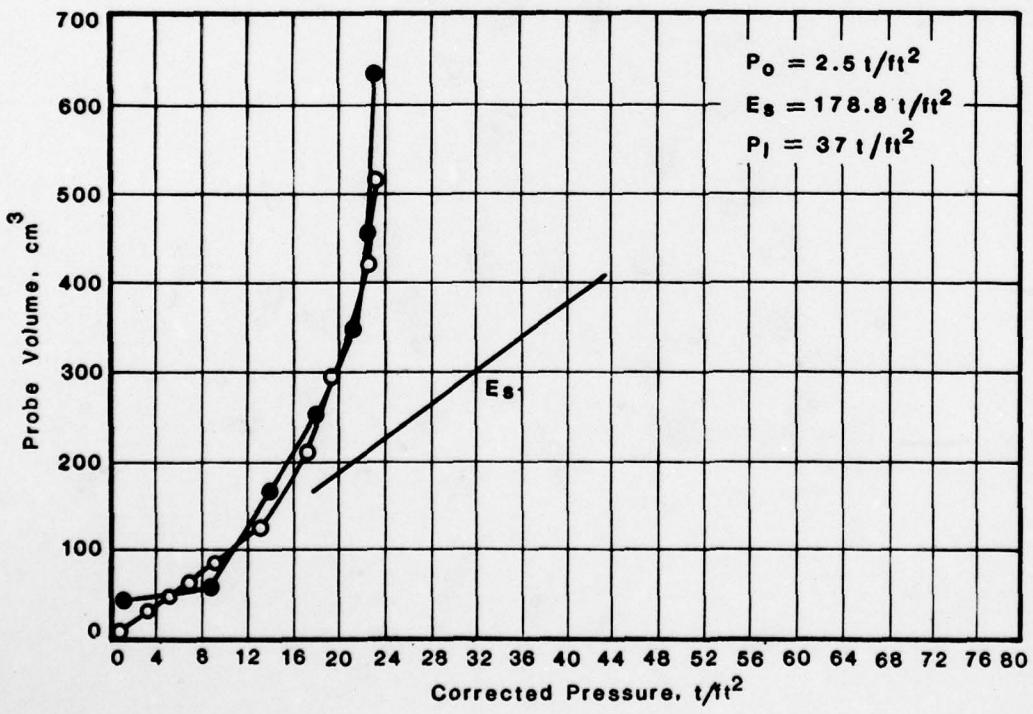
CHEMICAL GROUTING TEST PROGRAM	
PRESSUREMETER TEST RESULTS AFTER GROUTING SUBAREA 1	
FOUNDATION INVESTIGATION AND TEST PROGRAM EXISTING LOCKS AND DAM No. 26 ST LOUIS DISTRICT, CORPS OF ENGINEERS. DACPW43-78-C-0005	
Woodward-Clyde Consultants VTCB25 Phase IX	Fig. G.1

Test results obtained from boring AG-A1-5

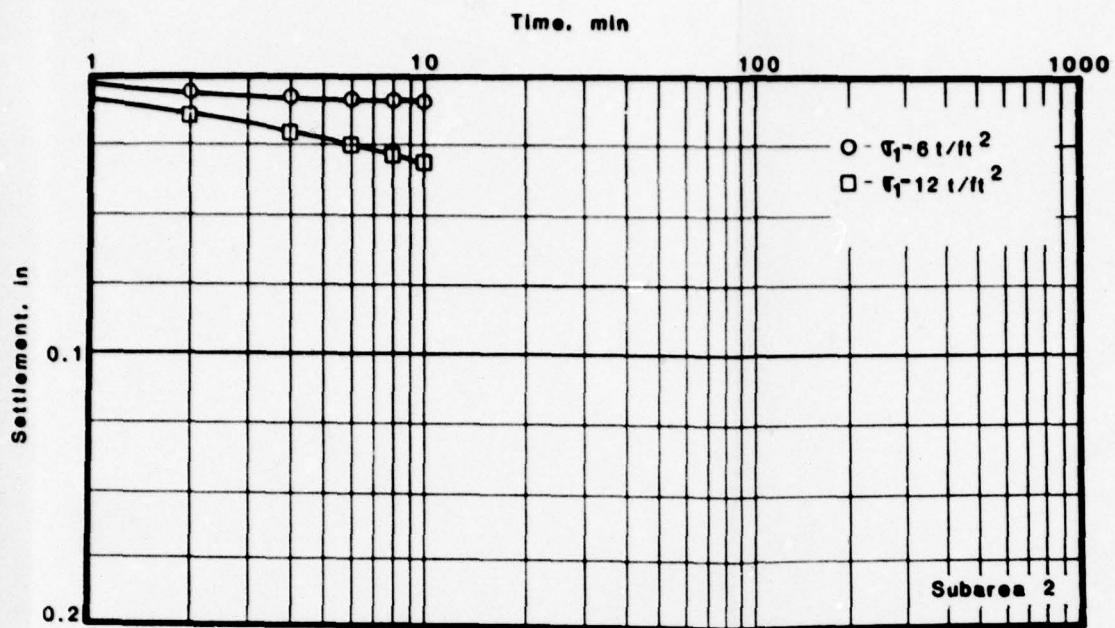
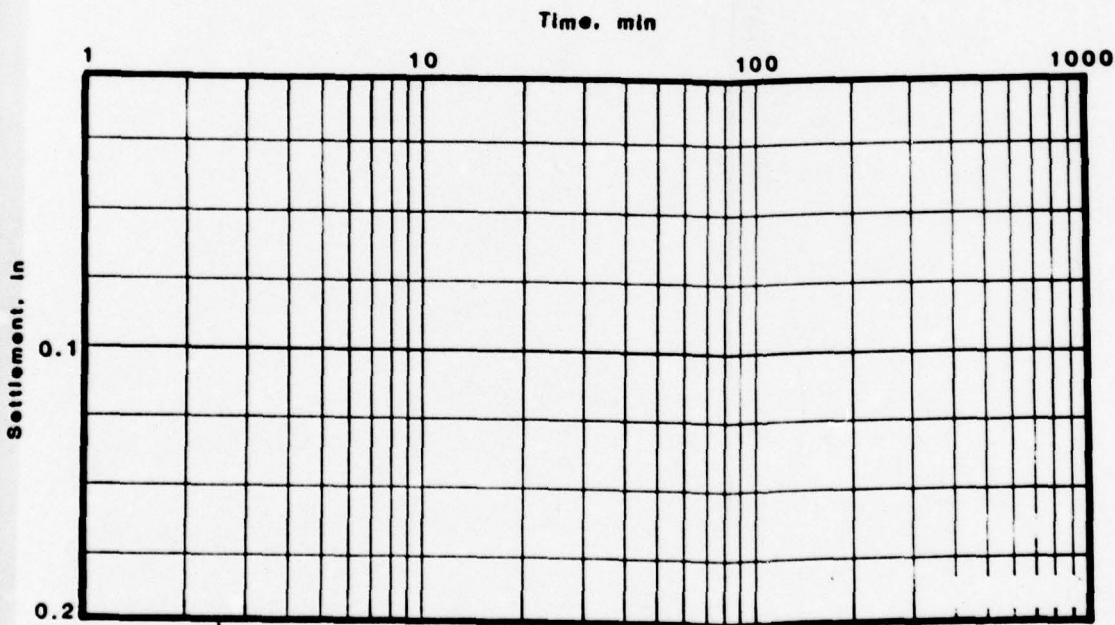
CHEMICAL GROUTING TEST PROGRAM
CREEP RESULTS FROM
PLATE LOAD TEST
SUBAREAS 1,2,4

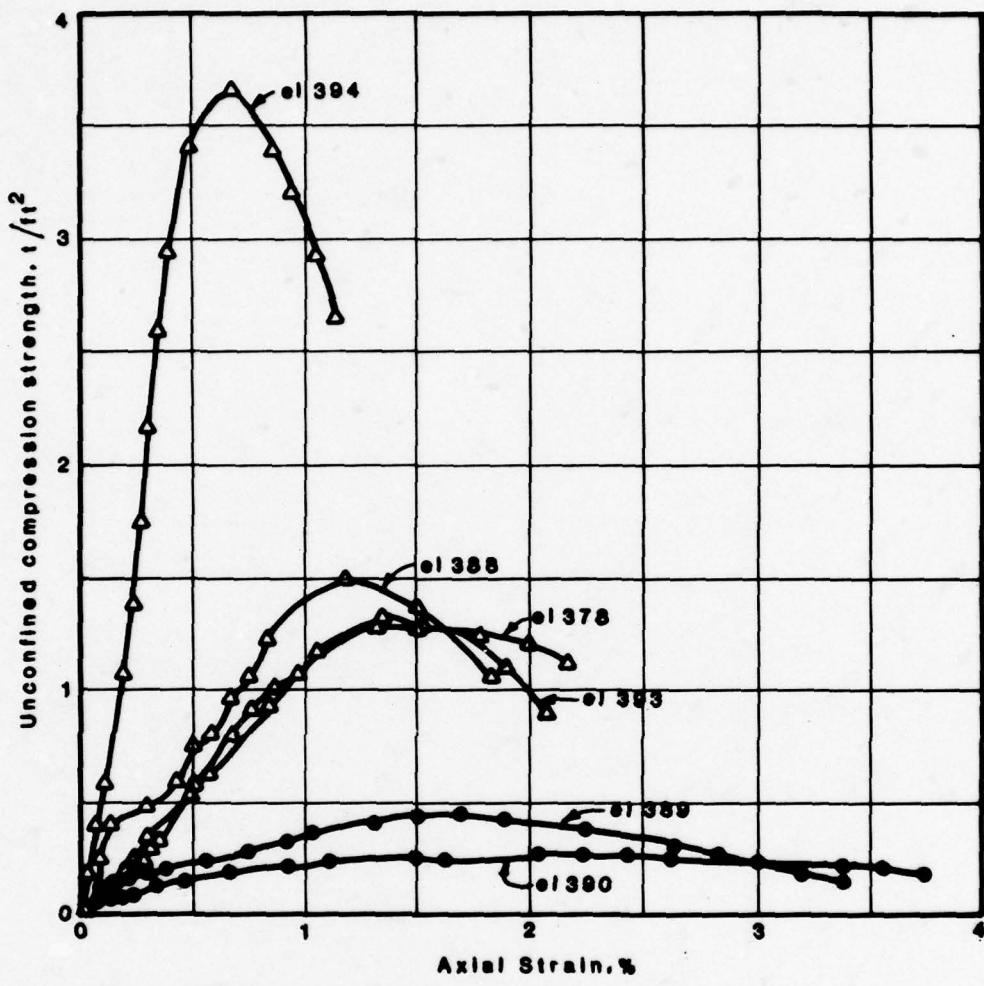
Fig. G. 20

**CHEMICAL GROUTING TEST PROGRAM
RESULTS OF UNCONFINED
COMPRESSION TESTS
BOREHOLE SAMPLES
35 % SIROC 142**
