**RADC-TR-80-124**  
Interim Technical Report  
April 1980

# **RELIABILITY EVALUATION OF GaAs POWER FETs**

**Texas Instruments, Incorporated**

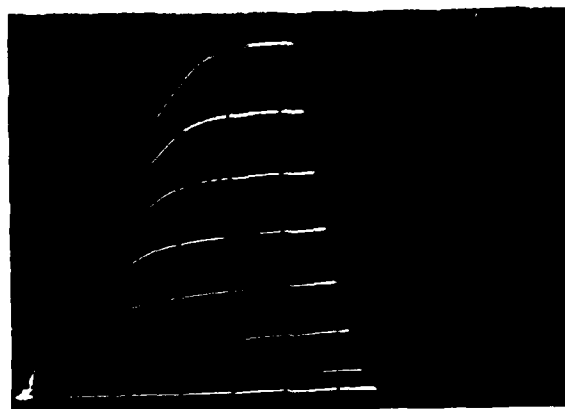
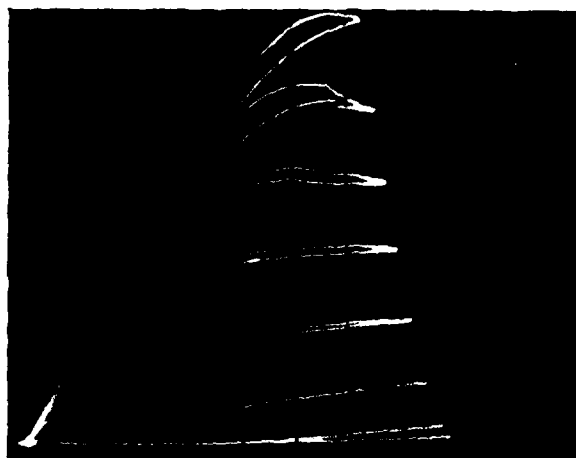
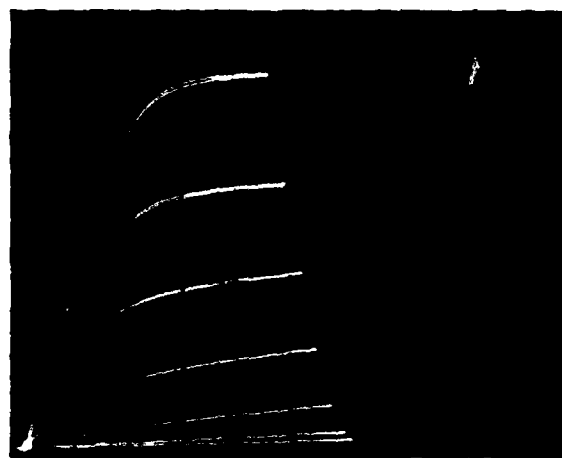
(a) TI MSX802  
50 mA/div.  
0.5 V/div  
0.5 V/step

(b) TI Laboratory  
50 mA/div  
0.5 V/div  
1 V/step

(c) Dexcel 3615A  
100 mA/div  
0.5 V/div  
1 V/step

Figure 9 Current-Voltage Characteristics of Typical Devices

(d) NEC 868196  
 50 mA/div  
 0.5 V/div  
 1 V/step

(e) MSC 88002  
 50 mA/div  
 0.5 V/div  
 1 V/step

By examining the I-V characteristics of the devices from each manufacturer, further insights can be gained into the material properties. Figure 9 contains photographs of I-V characteristics of typical devices from each manufacturer. The TI devices have higher maximum transconductances than the others due to a combination of high doping level, low parasitic resistance owing to the recessed gate, and high mobility. The Dexcel devices have a high "knee" voltage due to the high parasitic resistance caused by the lack of a recessed gate. The MSC device has a low knee voltage due to the  $n^+$  contacts and the small source-drain separation. In Figure 10 the drain current of these devices is plotted as a function of gate voltage at constant drain voltage. The current is normalized to  $1200\text{ }\mu\text{m}$  gate width. The TI devices have

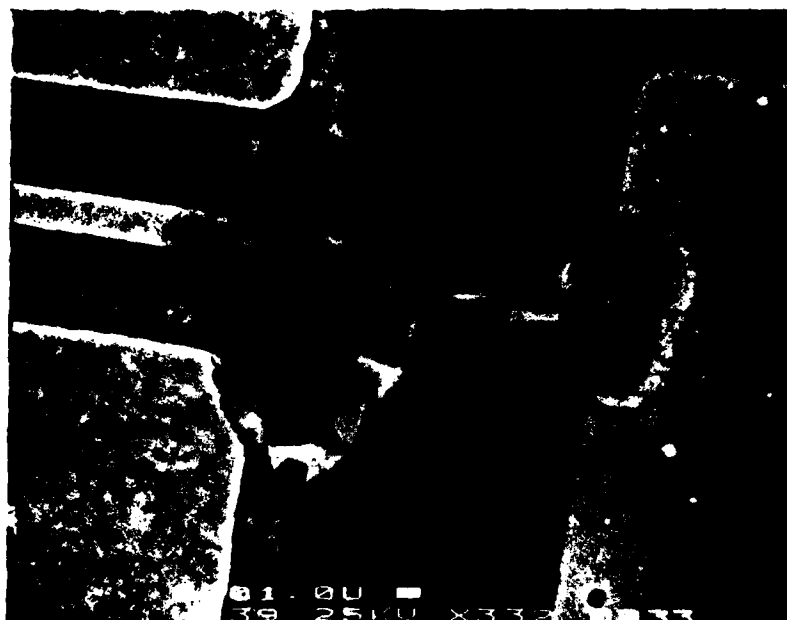
In spite of the series resistor, many of the devices in all five stress tests underwent some melting following failure, which partially obscured the failure area. An example is shown in Figure 29, a photograph of TI production device No. 2 from the drain voltage ( $V_g = 0$ ) stress test. Upon failure, the gate shorted to the drain through the GaAs. This caused a high current to flow between the gate and drain terminals, producing localized melting of the gate and surrounding GaAs. Previous experience indicates that if the 50  $\Omega$  resistor had not been present, the melting would have been much worse, covering a much larger area than included in the entire photograph of Figure 29. There appear to be some dark spots between the gate and drain near the melted area that could be holes in the GaAs. These are similar to published photographs of

Figure 29 SEM Photograph of Failed TI (Production) Device No. 2

failed devices where the failure was attributed to avalanche injection of electrons into the substrate at the drain contact. Failed devices from other manufacturers had similar morphologies; MSC device active regions could not be observed due to the device structure.

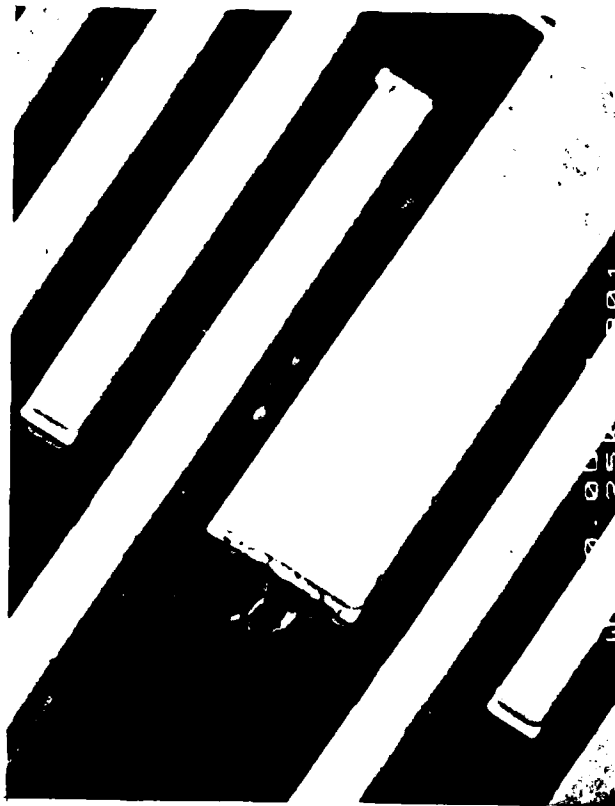
Figure 33 is an SEM photograph of NEC device 86M-65 #25 following failure. There are holes in the GaAs on both sides of one gate stripe. It is not known in what order the holes were made or the dynamics of the failure, but this is evidence for the failure being due to some type of avalanche current in the substrate. It is likely that once the channel was shorted, the gate pad shorted to the drain, resulting in the large melted area on the bottom of the photograph. The other failed devices had similar appearances, but the failure sites were more obscured by localized melting.

Figure 33 SEM Photograph of Failed NEC 86M-65#25 Device.

These devices were tuned for maximum output power at 8 GHz with 4 dB gain and 8 V drain bias. The rf input power was then increased in 1 dB steps until the devices failed. The circuit impedances were rematched at each power level to maximize output power and minimize reflected power. The maximum input power sustained by each device is recorded in Table 14. There were no significant differences between the manufacturers, but this test did demonstrate that these devices can sustain quite high powers before failure. The measured output power is plotted as a function of rf input power in Figure 38. SEM photographs showed that some of the failed devices appeared similar to Figure 37 and some to Figure 33 with holes in the GaAs.
