NAVAL WEAPONS CENTER CHINA LAKE CA  
SOIL STABILIZATION PROJECT. (U)

(13) 346  
(11) Mar 77  
9) Final rept.  
(18) GIDEP  
(19) E144-2433  
(16) SOIL STABILIZATION PROJECT FINAL REPORT

(14) NWC-TM-3818

March 1979

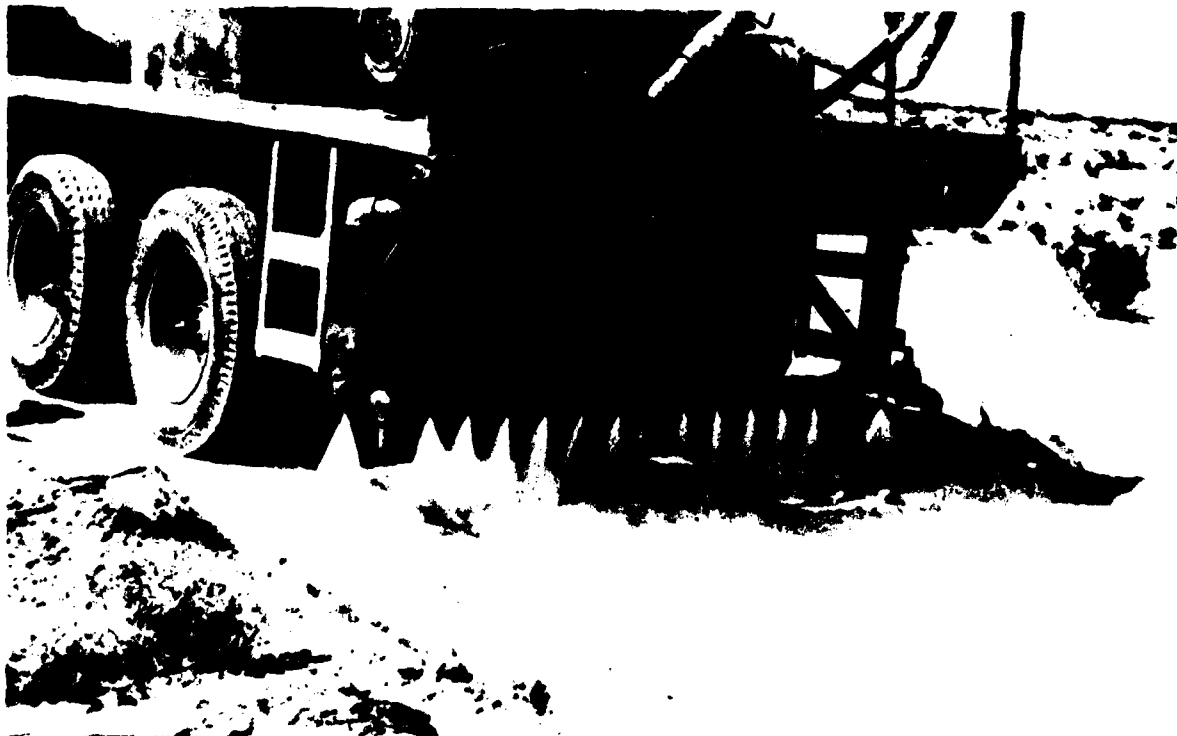
FIGURE 2. Truck Spray-bar Application Method.

The truck spray-bar application method tried earlier (NAF test) was definitely unsatisfactory. The fire hose technique was adequate but slow and cumbersome. It was therefore decided to try a sprinkler system.

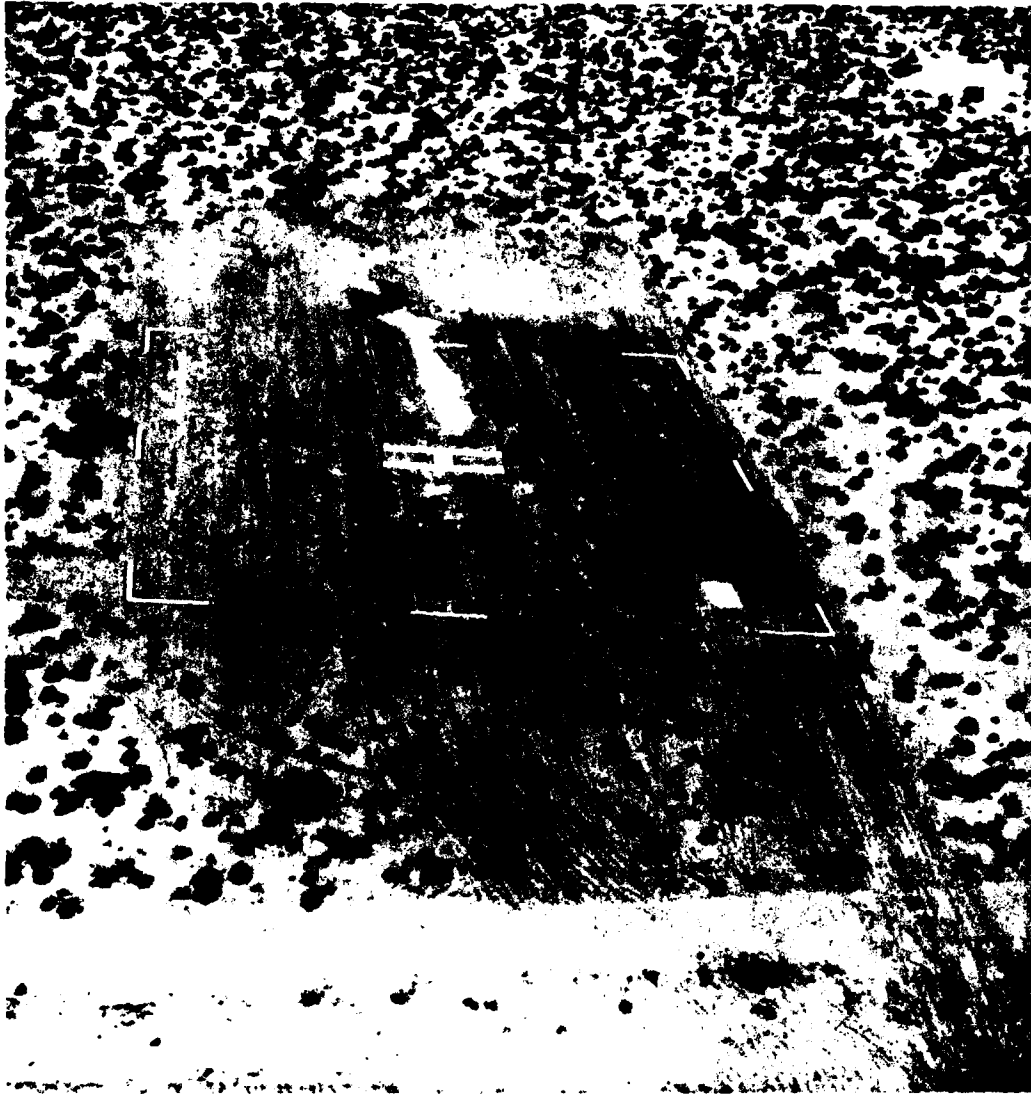
FIGURE 3. Aerial View of NAF Site After Application.

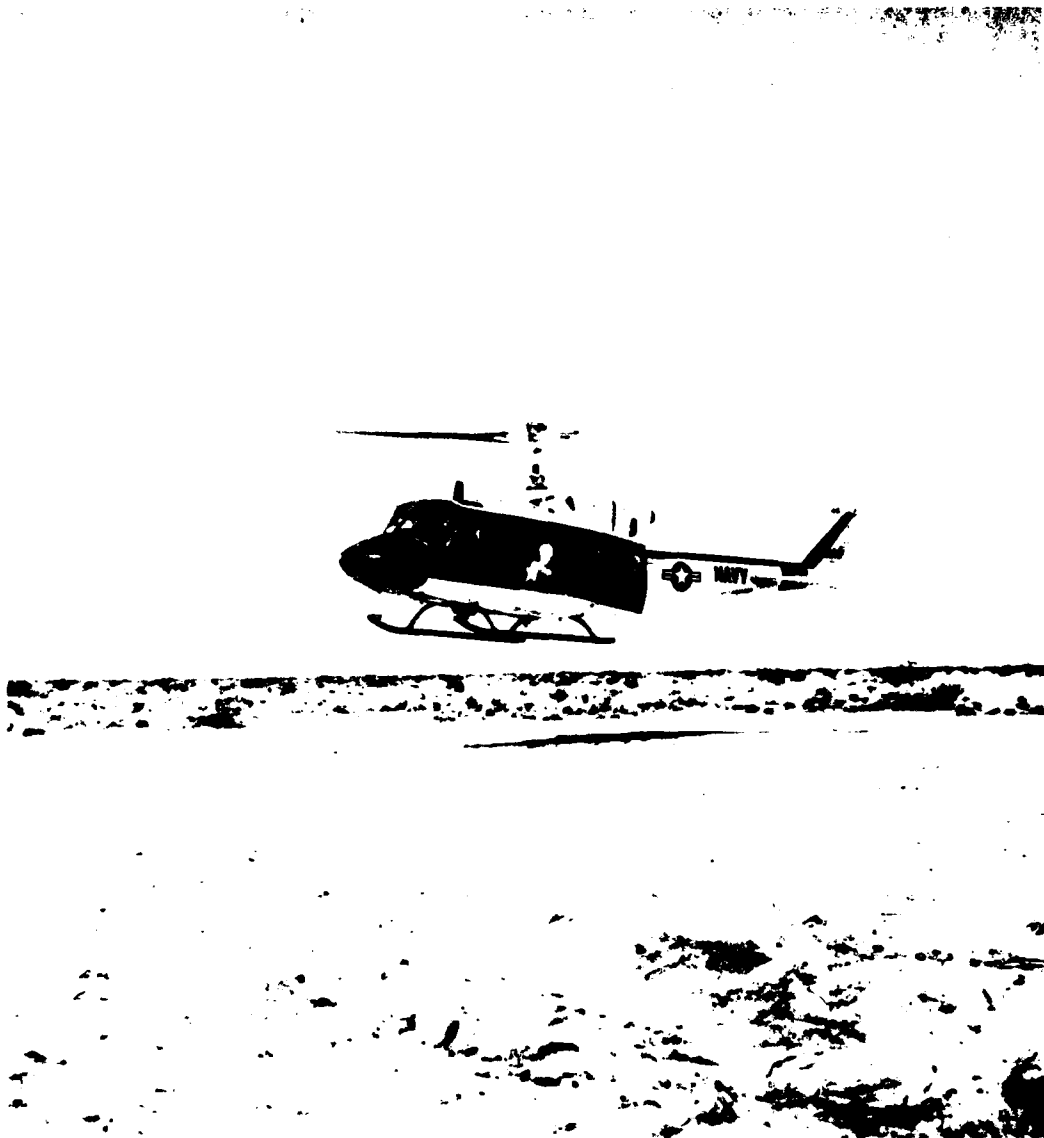
FIGURE 5. Helicopter Landing at NAF Site After Application of Emulsion.

After a 40 to 48 hour drying (cure) period, the ground was stabilized into an adequate helicopter landing pad. Figures 4 and 5 compare helicopter landing conditions before and after application of the emulsion. A helicopter landing operation did cause some damage to the surface soil (Figure 6), but this is easily and quickly repaired. The test pad has since withstood more than a year's weather with little damage.
