SECURITY CLASSIFICATION OF THIS PAGE (When Data Entered)	
REPORT DOCUMENTATION PAGE	READ INSTRUCTIONS BEFORE COMPLETING FORM
1. REPORT NUMBER 2. GOVT ACCESSION NO.	3. RECIPIENT'S CATALOG NUMBER
Flood Plain Information Colorado River-Onion Creek	5. TYPE OF REPORT & PERIOD COVERED Flood Plain Information
to Montopolis Bridge Austin, # Teras.	6. PERFORMING ORG. REPORT NUMBER

PREFACE

The purpose of this report is to furnish information on the flood hazard areas in the Colorado River watershed in the vicinity of Austin, Travis County, Texas. As shown on Plate 1, the study area considered encompasses about 14.7 miles of channel, extending from the confluence with Onion Creek to Montopolis bridge (US Highway 183). The report's contents are designed to provide local, State, and Federal government agencies, commercial interests, and concerned citizens in this area of the Colorado River watershed with definitive data that will aid in planning the best use of flood prone lands or contribute to the solution of local flood problems. Aside from serving as a tool for improving general land use management, the report can be helpful in locating and designing bridges and establishing criteria for

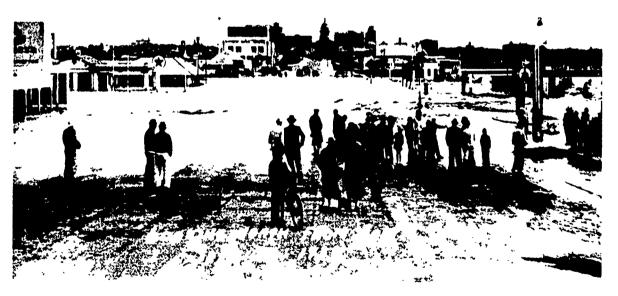
FIGURE 2.--HISTORICAL FLOOD SCENES ON COLORADO RIVER Upper photograph is view of Congress Avenue Bridge from south bank during December 1913 flood. Lower photograph is scene during September 1936 flood looking north from south bank. (Photos courtesy of Austin-Travis County Collection, Austin, Texas, Public Library.)

Scenes of damages inflicted by historic floods in Austin are shown in Figures 2 and 3 on pages 20 and 21.

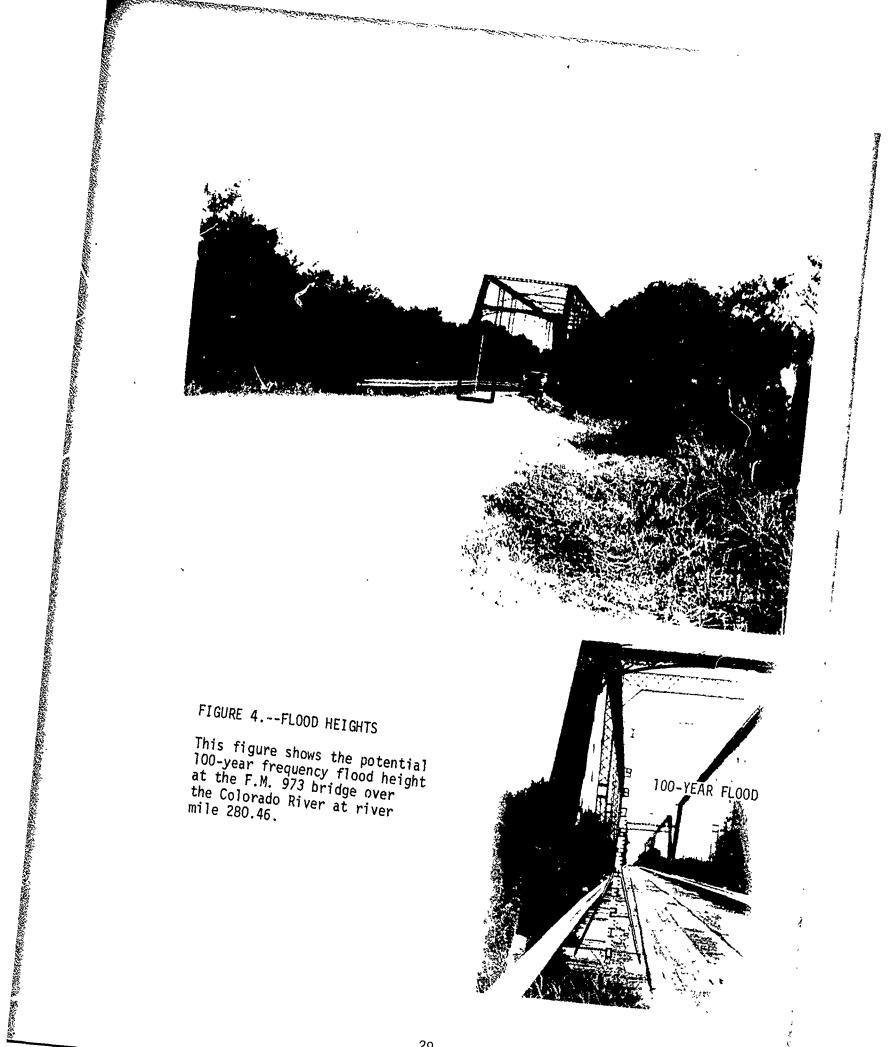
FIGURE 4.--FLOOD HEIGHTS

This figure shows the potential 100-year frequency flood height at the F.M. 973 bridge over the Colorado River at river mile 280.46.
