MISCELLANEOUS PAPER SL-80-10

# CONSTRUCTION OF TREMIE CONCRETE CUTOFF WALL, WOLF CREEK DAM, KENTUCKY

Structures Laboratory  
U. S. Army Engineer Waterways Experiment Station  
P. O. Box 631, Vicksburg, Miss. 39180

September 1980

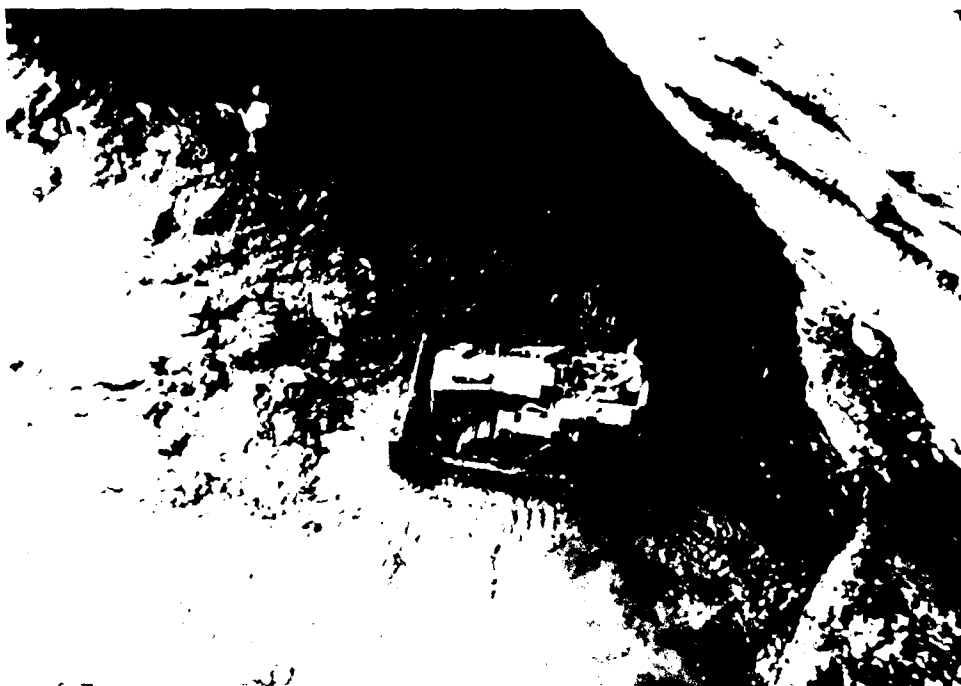
Figure 2. Construction of cutoff trench (Continued)

a. Note overhang left in place

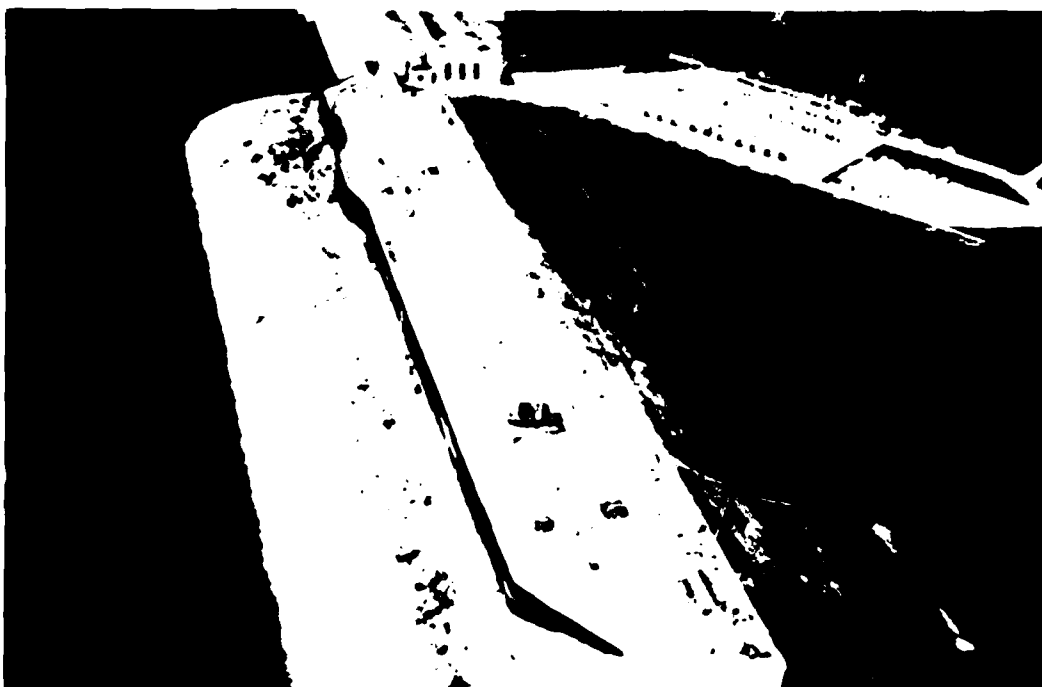
Figure 5. View of contractor's platform. This photo was taken during the first phase of the project adjacent to the concrete section of the dam

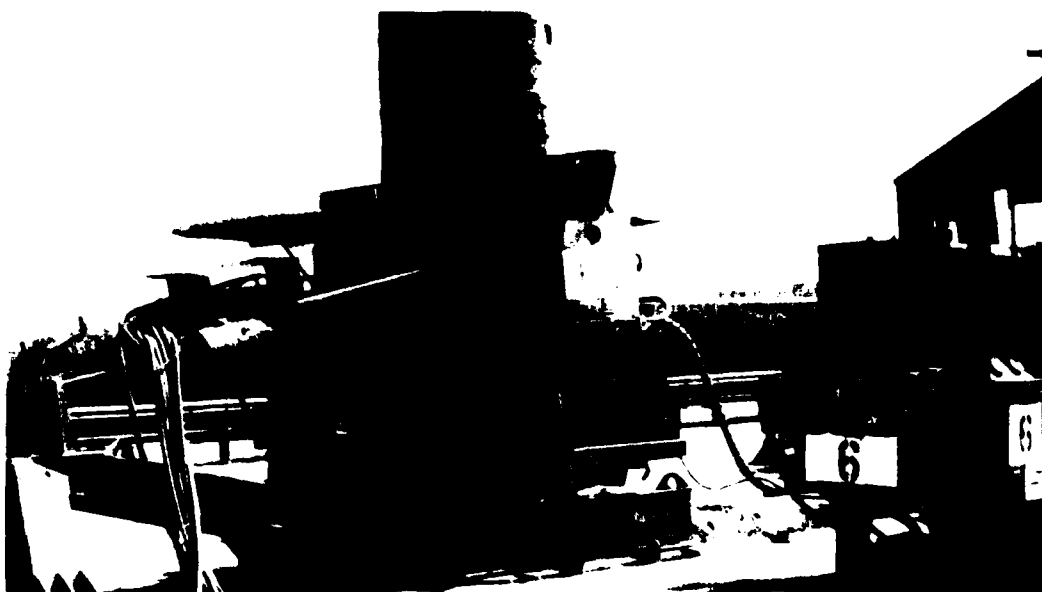
Figure 6. Casing for primary elements

a. Casing handling machine. This machine both rotates and applies vertical force for casing installation or removal

b. Details of casing joint

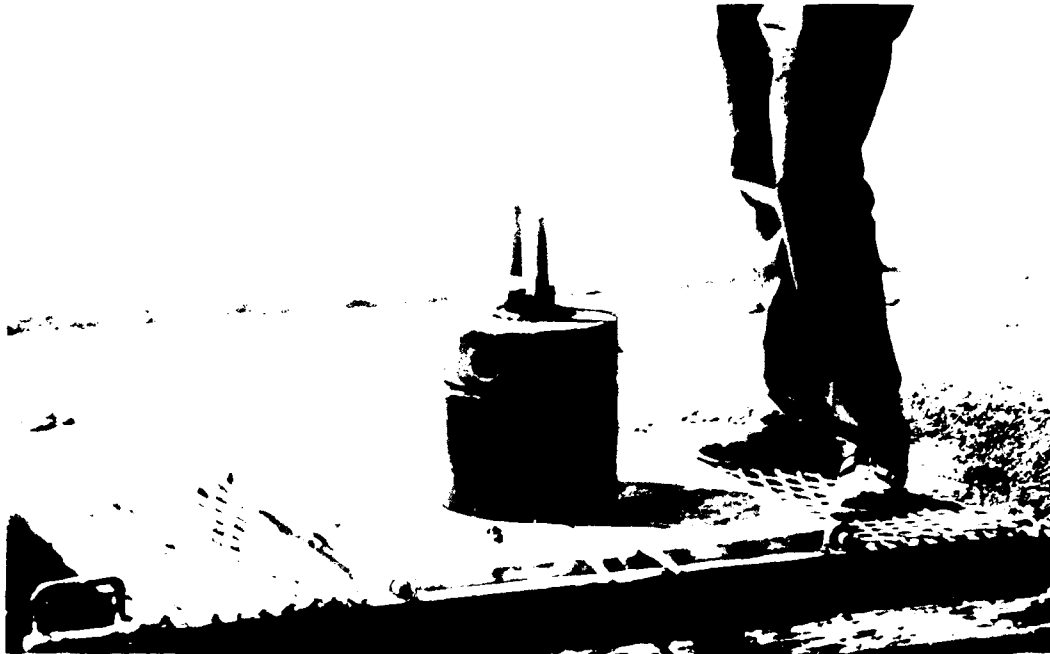
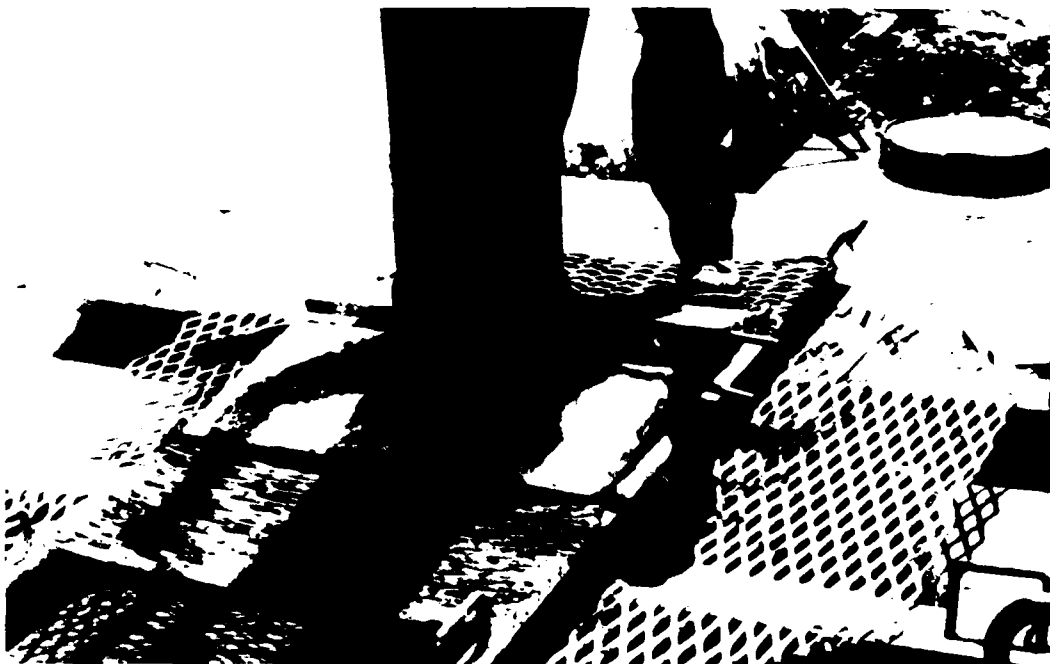
Figure 9. Tremie support scheme

a. Tremie pipe supported by coupling. Loop is used to raise tremie as sections are removed

b. Tremie pipe being raised (note how support plates open to allow passage of couplings)

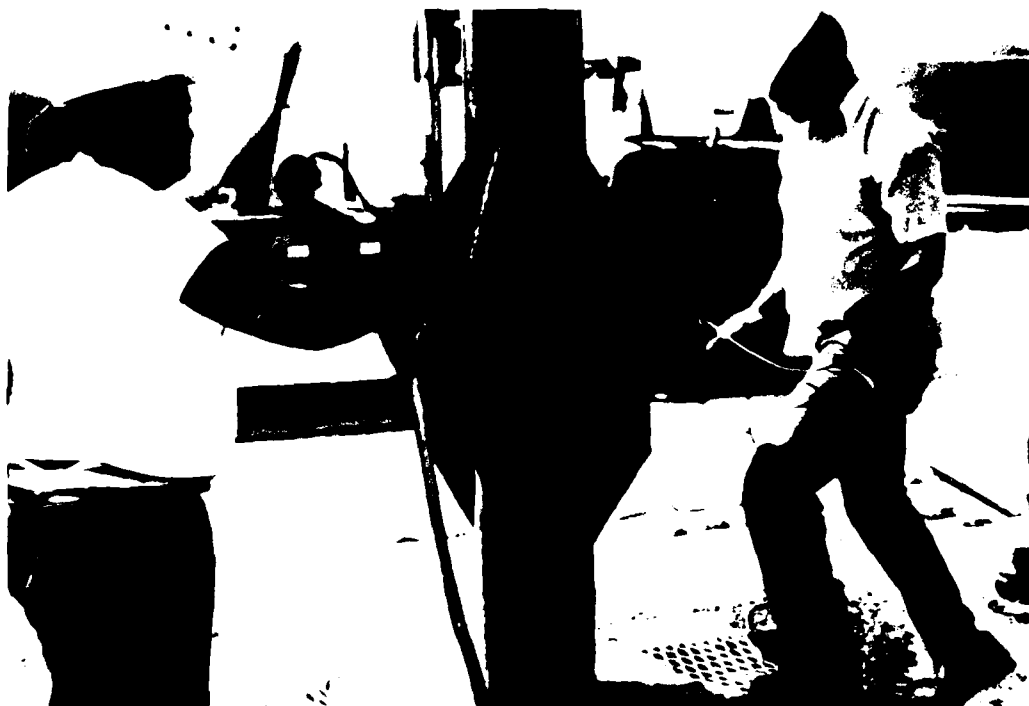
Figure 16. Fins added to tremie pipe  
to ensure proper centering
