# Special Report 81-3

## AN INVESTIGATION OF THE SNOW ADJACENT TO DYE-2, GREENLAND

H.T. Ueda, M.A. Goff and K.G. Nielsen

UNITED STATES ARMY  
CORPS OF ENGINEERS  
COLD REGIONS RESEARCH AND ENGINEERING LABORATORY  
HANOVER, NEW HAMPSHIRE, U.S.A.

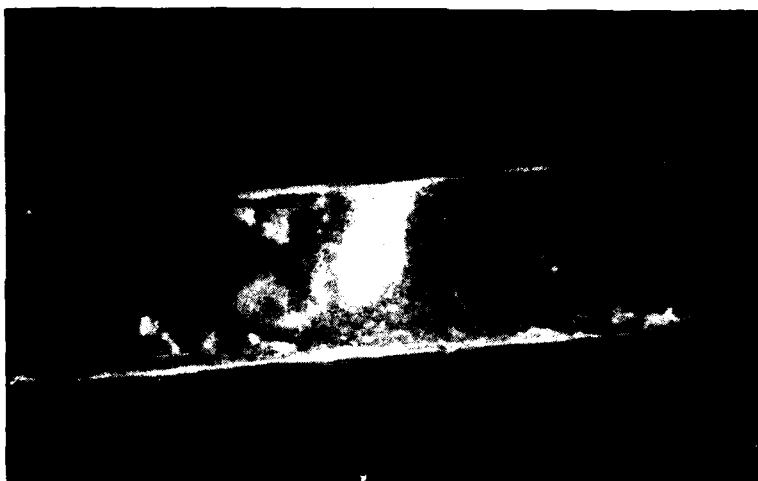
*Figure 7. Typical sample photographs.*

*a. Sample with snow/ice mixture.*

*b. Sample with snow/ice mixture.*

*c. Sample heavily contaminated with oil (left piece).*

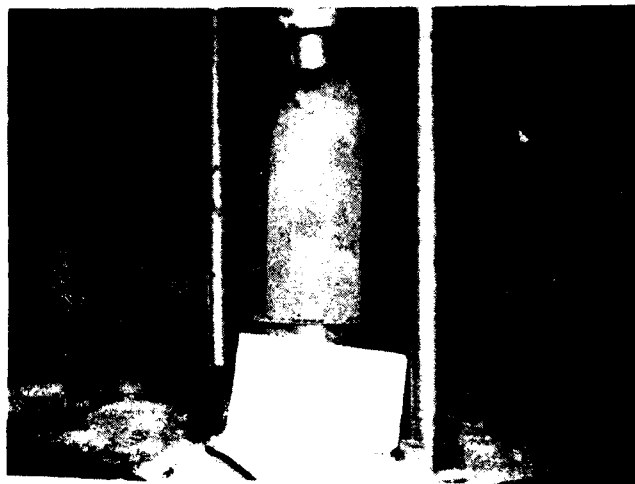
Figure B1. Sample A15 (time interval 1s).

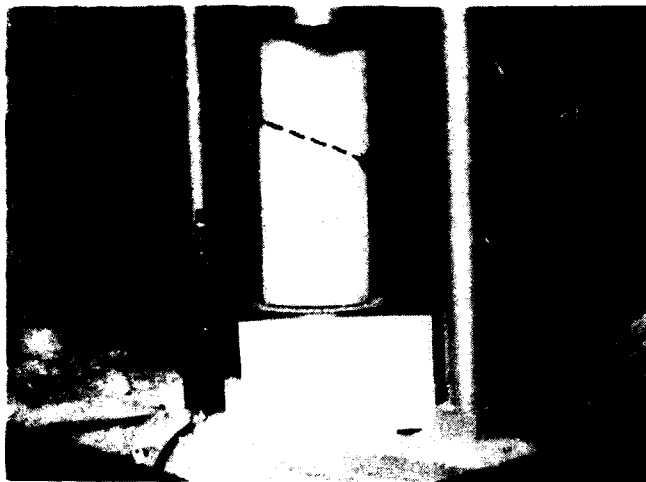
Figure B5. Sample B8, dashed line shows failure mode (time interval 1s).
