CORPS OF ENGINEERS BUFFALO N Y BUFFALO DISTRICT  
FLOOD PLAIN INFORMATION, CUYAHOGA RIVER, AKRON TO SUMMIT-PORTAGE--ETC (U)  
MAY 71

| REPORT DOCUMENTATION PAGE | | READ INSTRUCTIONS<br>BEFORE COMPLETING FORM |
|---|---|---|
| 4. TITLE (and Subtitle)<br>Flood Plain Information, Cuyahoga River, Akron<br>to Summit-Portage County Line, Ohio. | | 5. TYPE OF REPORT & PERIOD COVERED<br><b>(1) Final</b> |
| 9. PERFORMING ORGANIZATION NAME AND ADDRESS<br>U.S. Army Engineer District, Buffalo<br>1776 Niagara Street<br>Buffalo, New York 14207 | | 8. CONTRACT OR GRANT NUMBER(s)<br><b>(1) 71</b> |

CUYAHOGA RIVER  
AKRON TO SUMMIT-PORTAGE  
COUNTY LINE, OHIO  
FLOOD PLAIN INFORMATION REPORT  
FLOODS ABOVE  
BANKFULL STAGE  
U. S. ARMY ENGINEER DISTRICT, BUFFALO  
MAY 1971

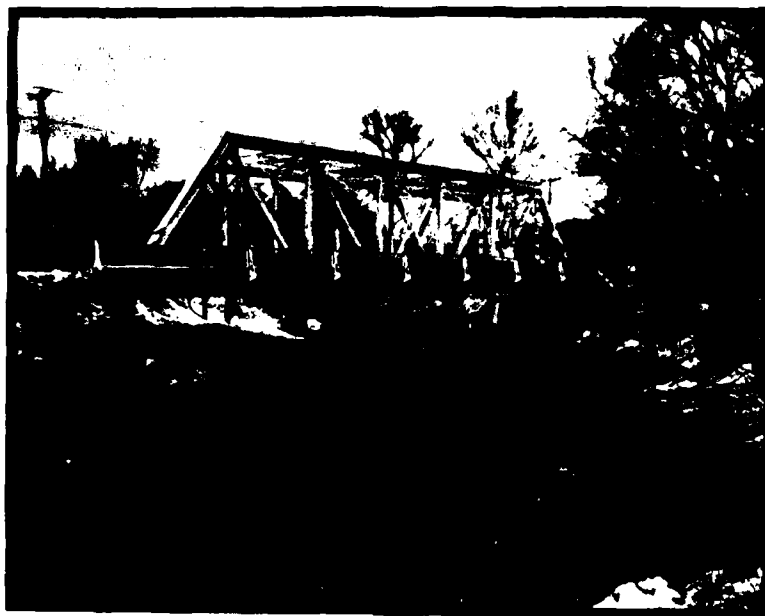
Figure 10 - Upstream face of the Akron-Peninsula Road bridge, stream mile 40.25.

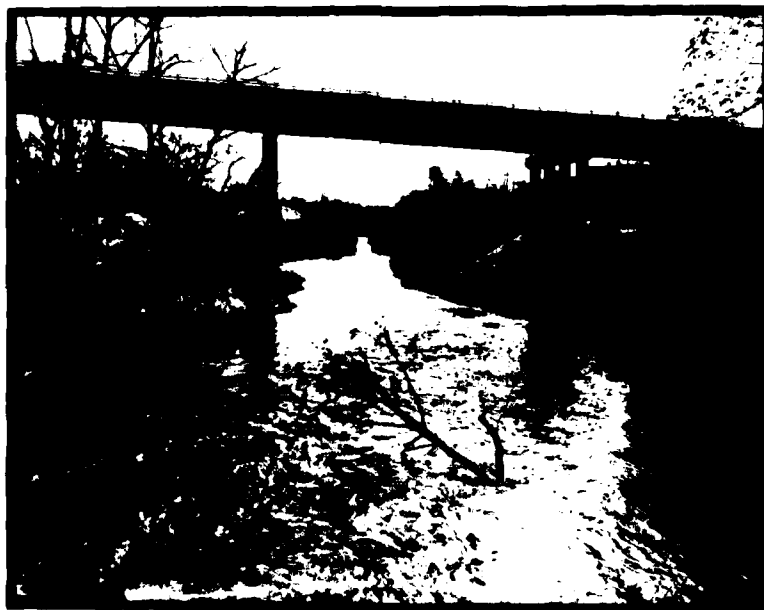
Figure 11 - Upstream face of the new Portage Trail bridge, stream mile 46.58.

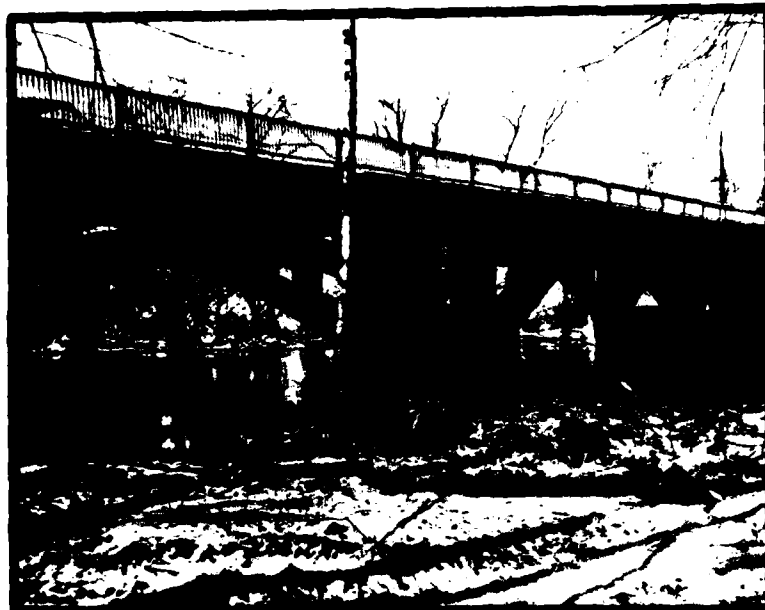
Figure 12 - Upstream face of the Oak Park Boulevard bridge, stream mile 47.72.

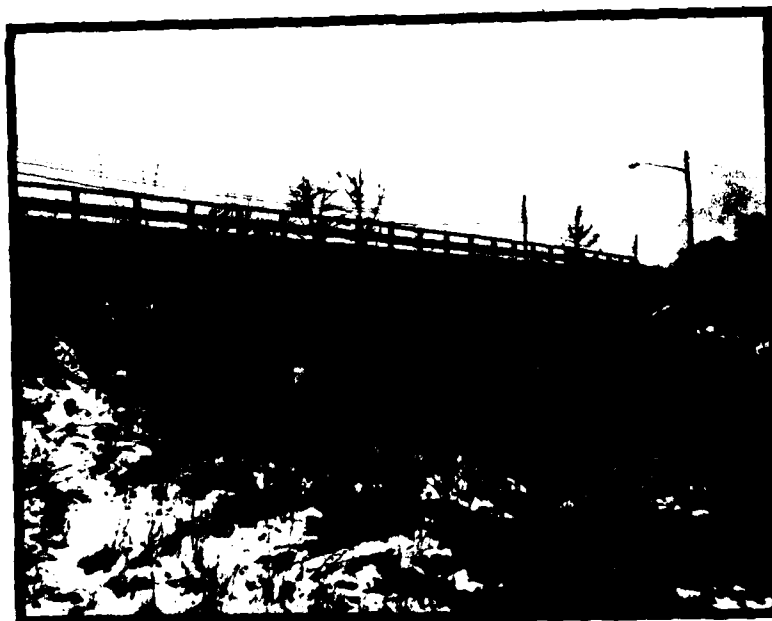
Figure 13 - Upstream face of the Darrow Road bridge, stream mile 49.96.

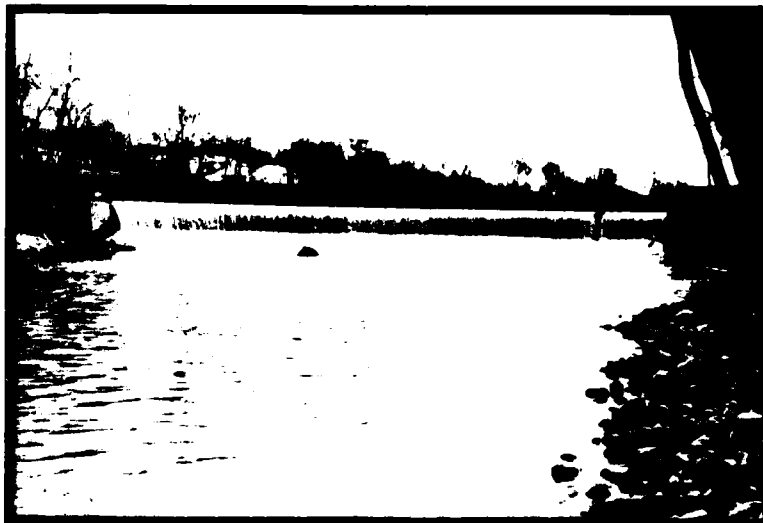
Figure 15 - Downstream face of dam in Munroe Falls,  
stream mile 50.09.

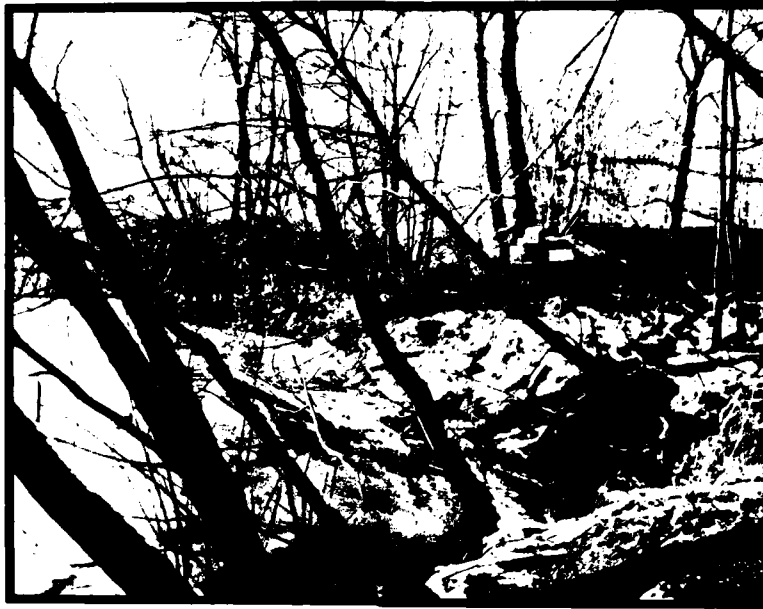
Figure 16 - Dumping along right bank downstream of the Akron-Peninsula Road bridge, stream mile 40.2.

OBSTRUCTIONS TO FLOOD FLOWS - Inadequate bridge areas, abandoned dams, encroachments, and fills are some of the obstructions to flood flows. Other serious obstructions are bends in the stream, irregularity of channel section, and heavy brush, weeds, and large trees growing on the channel banks and extending into the stream. Figures 16 through 19 show obstructions which tend to reduce floodway capacity and increase river stages.

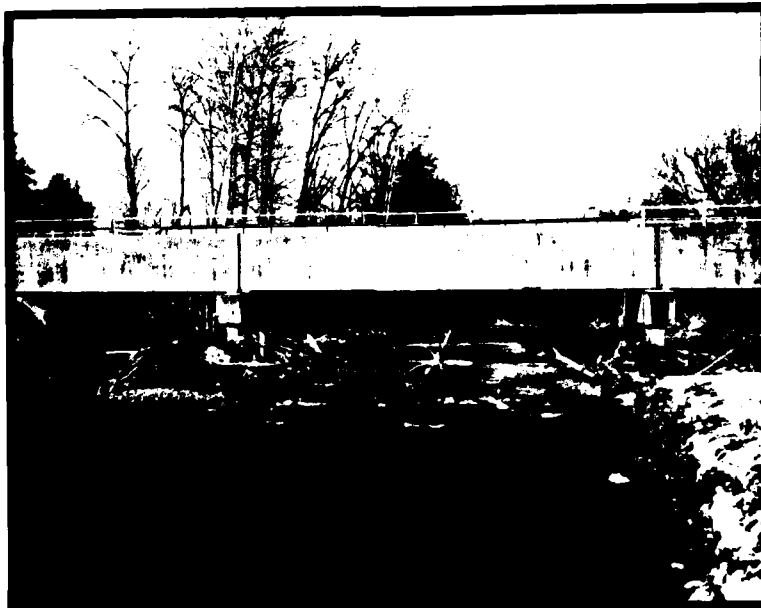
Figure 17 - Debris at bridge on Little Cuyahoga River.

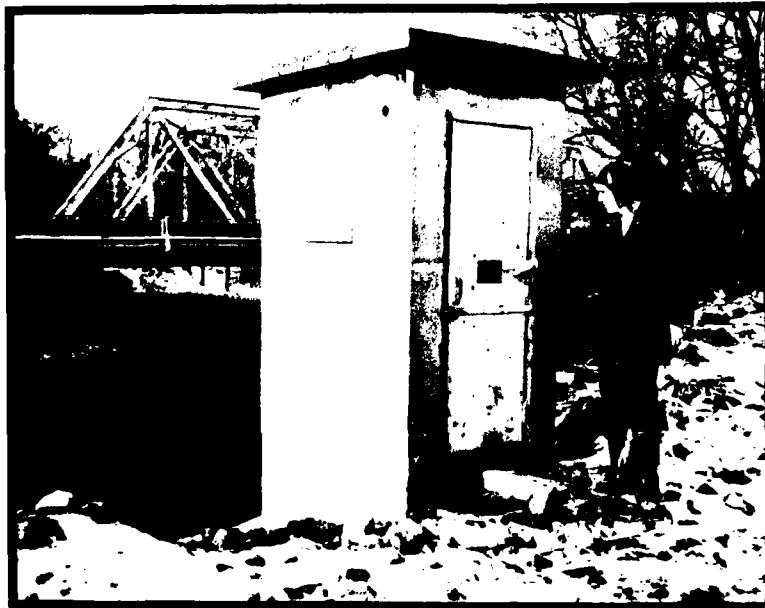
Figure 20 - U.S.G.S. gaging station at Old Portage, which is located on right bank upstream of the Akron-Peninsula Road bridge, stream mile 40.27.

FLOOD STAGES AND DISCHARGES - Table 5 lists flood crests and peak discharges for the known floods exceeding bankfull stage of 9.0 feet at the Old Portage gage. (See figure 20) A discharge of approximately 3,500 cfs will produce a stage of 9.0 feet at the gage.

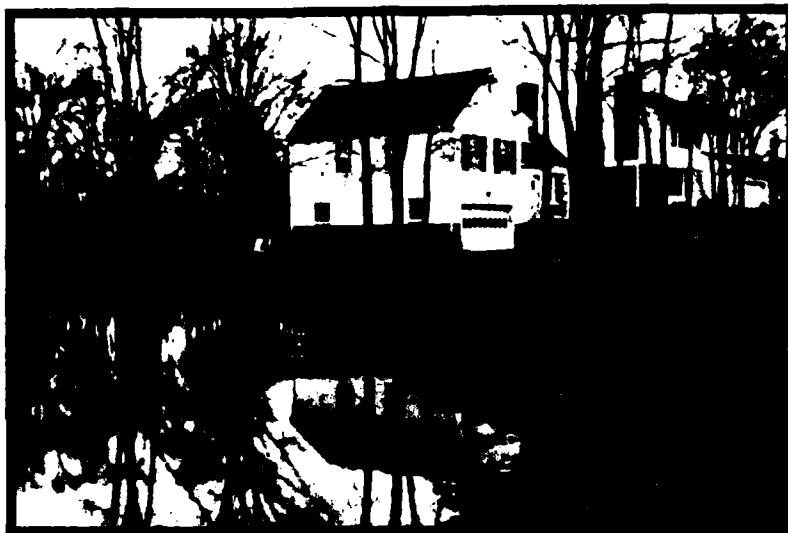
Figure 21 - Flooding conditions in January 1959  
near South Park Drive in Silver Lake, stream  
mile 48.0.

and snow melt averaged 2.94 inches. Three of the five Cuyahoga Falls' water pumping stations were surrounded by swirling water. The Cuyahoga River swelled 700 feet beyond its banks at the Waterworks Park and surrounded three picnic shelter houses. The swollen river carried away 20 picnic tables from the park. At the Old Portage gage the January 1959 flood reached elevation 751.6, U.S.C. & G.S. datum, which is approximately 2.5 feet above bankfull stage. Flooding conditions in January 1959 are shown on figures 21 and 22.

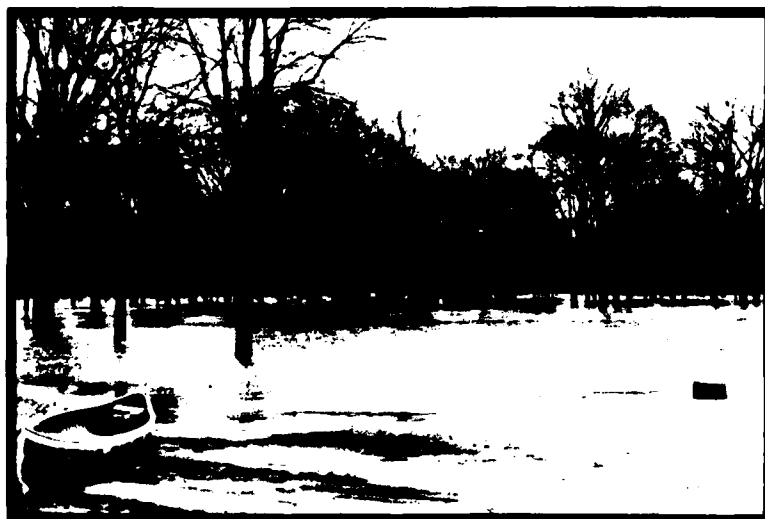
Figure 22 - Flooding conditions in January 1959 at  
Waterworks Park, stream mile 48.6.

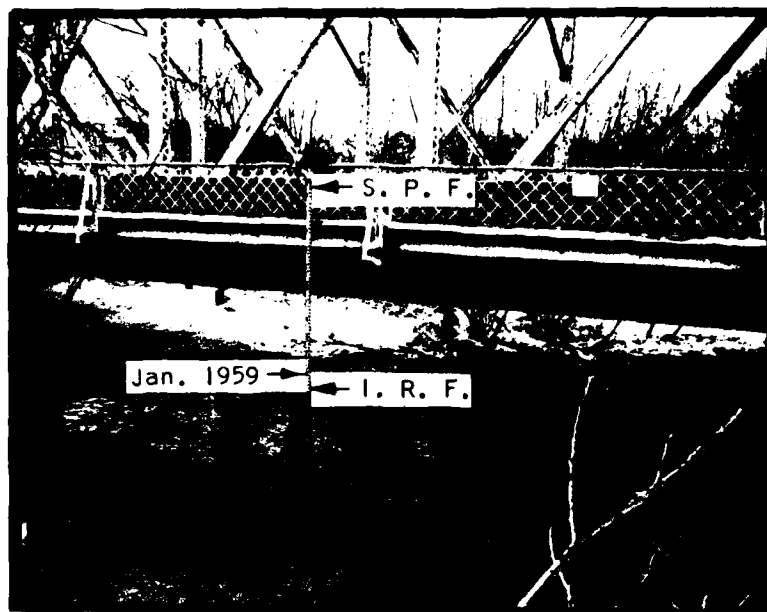
Figure 29 - Arrows indicate the heights of the Standard Project, Intermediate Regional, and the January 1959 floods at the upstream face of the Akron-Peninsula Road bridge, stream mile 40.25.

The approximate heights of the Standard Project Flood, the Intermediate Regional Flood, and the January 1959 flood at selected sites are shown in figures 29 through 35.

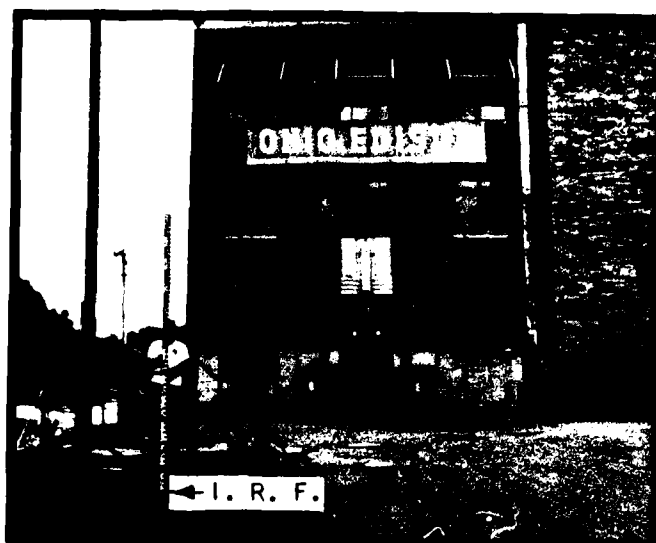
Figure 31 - Arrow indicates the height of the Intermediate Regional Flood at the Ohio Edison Company, stream mile 45.20.

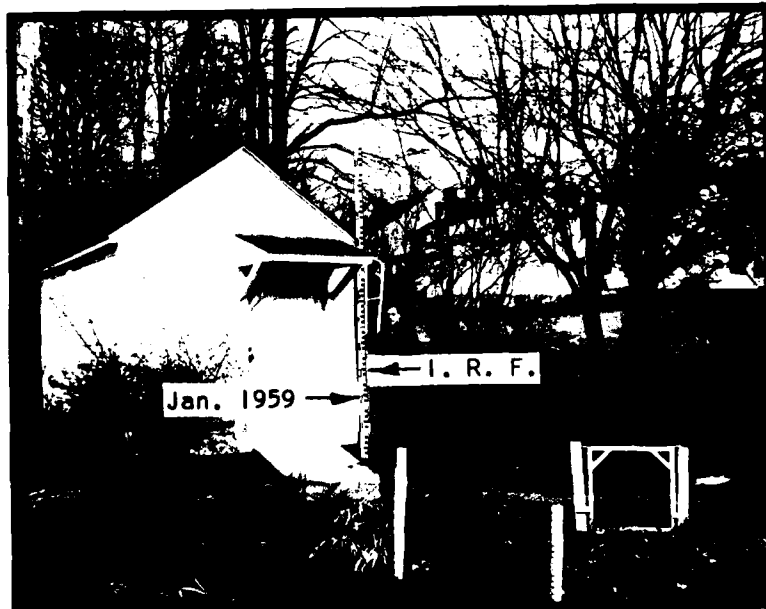
Figure 34 - Arrows indicate the heights of the Intermediate Regional and the January 1959 floods along South Park Drive in the Village of Silver Lake, stream mile 47.95.

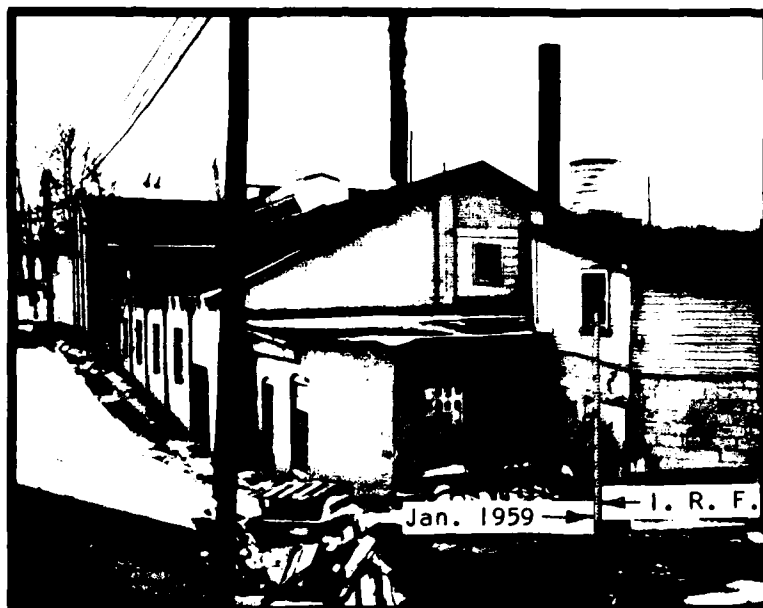
Figure 35 - Arrows indicate the heights of the Intermediate Regional and the January 1959 floods at the Sonoco Products Company, 59 N. Main St., Munroe Falls, stream mile 49.95.
