**TEST AND EVALUATION OF AN EXPERIMENTAL FEASIBILITY  
PROTOTYPE PASSIVE SEAT MOUNTED LIMB RESTRAINT SYSTEM**

Marcus Schwartz  
Aircraft and Crew Systems Technology Directorate  
NAVAL AIR DEVELOPMENT CENTER  
Warminster, Pennsylvania 18974

20 May 1981

PHASE REPORT  
AIRTASK NO. 1F41-400-000  
Work Unit No. ZA61D  
Program Element No. 62241N

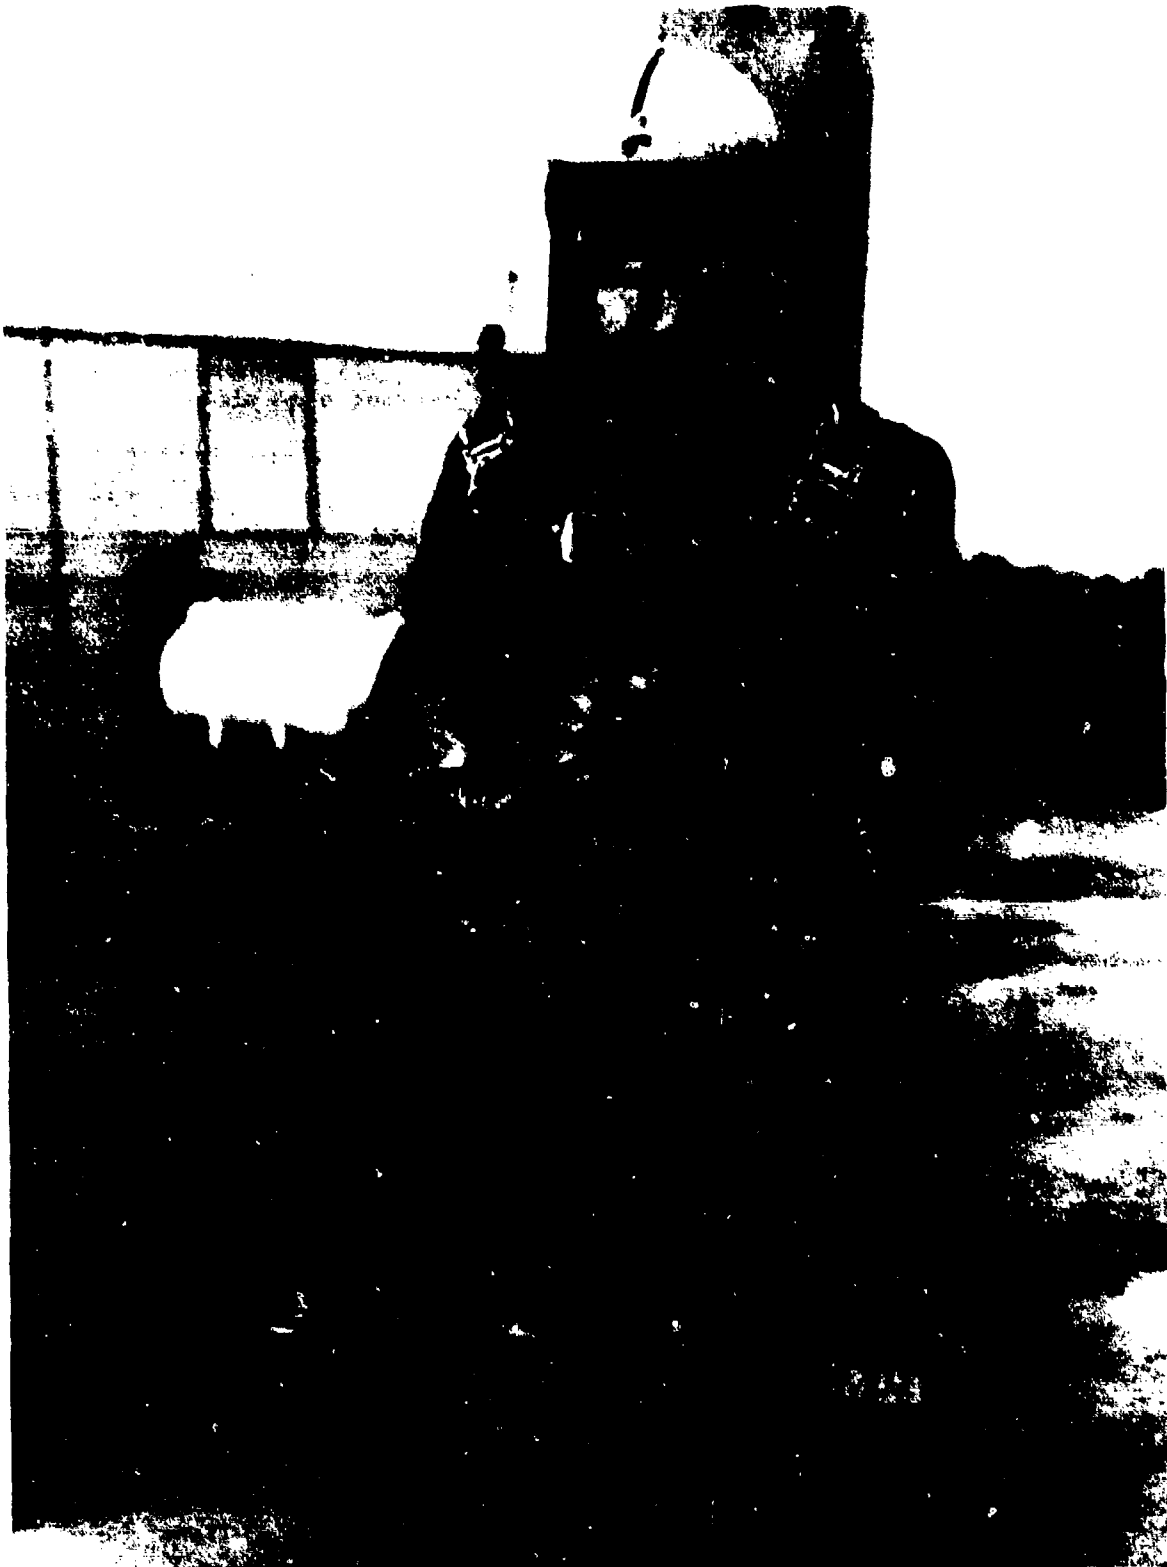
FIGURE 24 - Post Test Condition - 45 Degree Yaw - 537 Knots

After resetting the strap tension loads in the leg lines, the system was subjected to a 550-knot windblast exposure. The system was examined immediately after the test and the dummy's limbs were found to be perfectly restrained and secured in the ejection position. Subsequent analysis of the high-speed film coverage confirmed the adequacy of the restraint configuration to protect and secure the limbs for this condition. As before, the only motion in the dummy was some slight sideways motion of one leg in the direction of the windblast (figure 24).

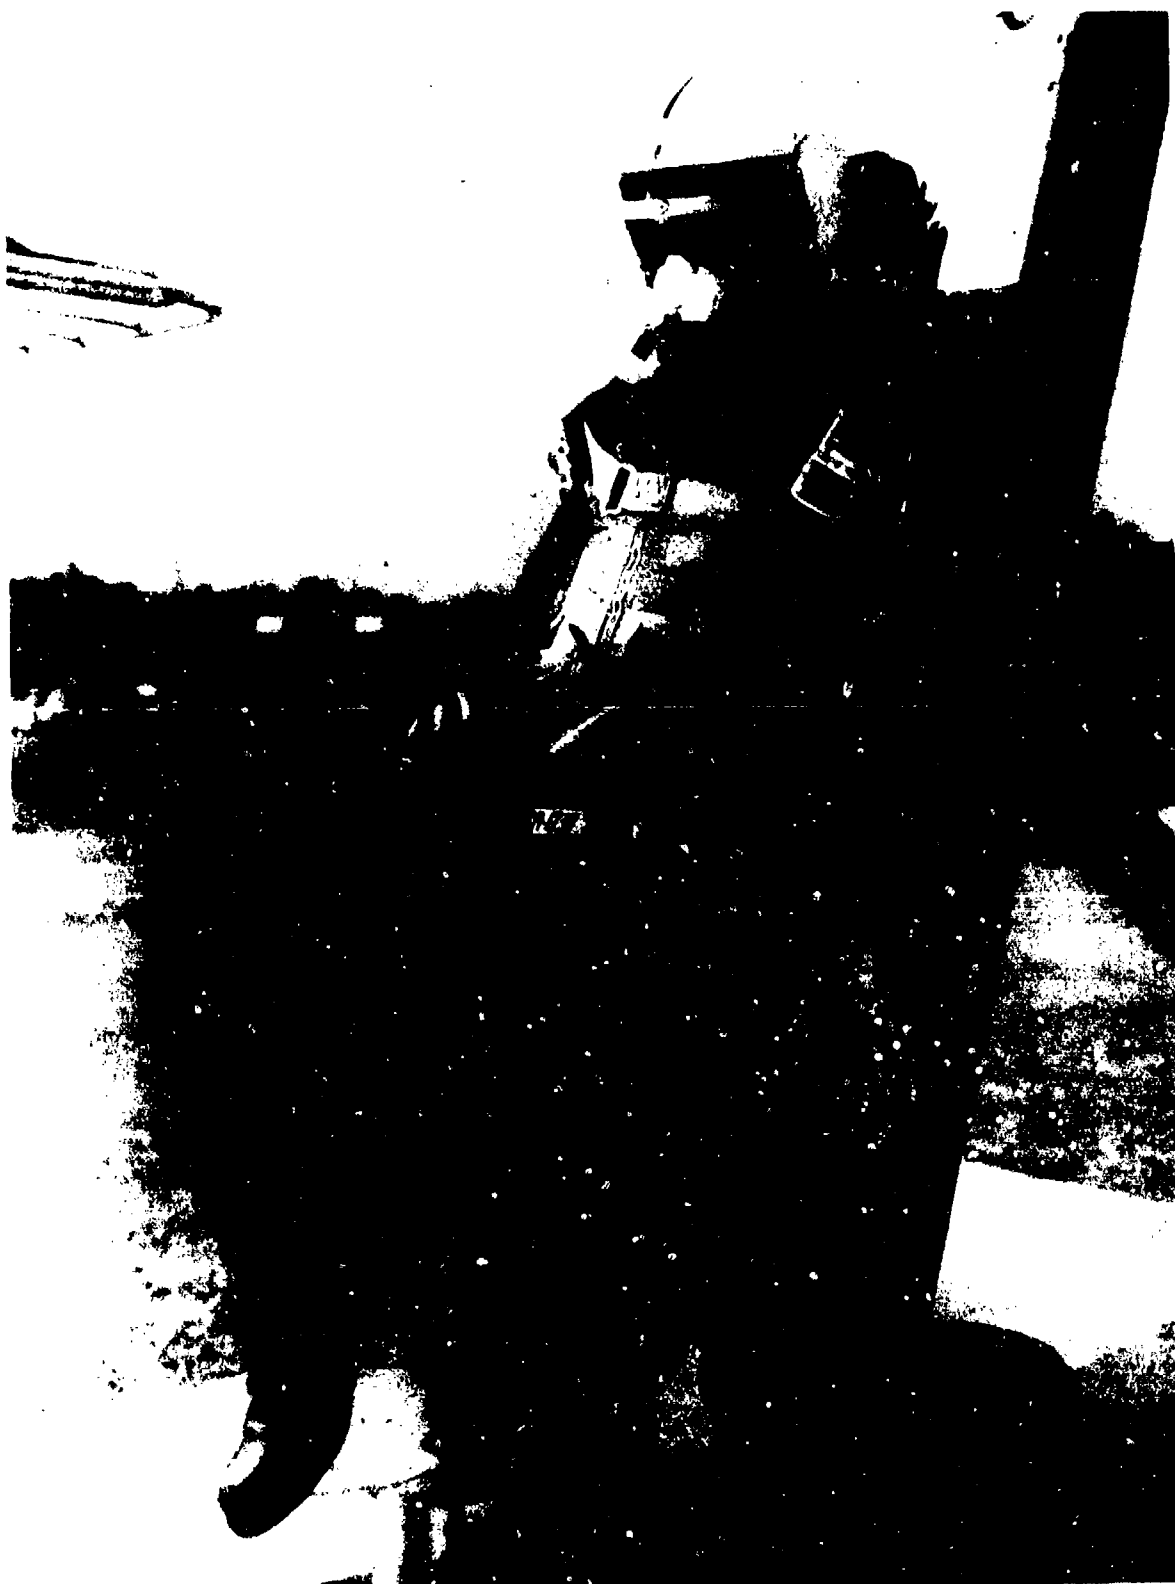
FIGURE 26 - Post Test Condition 605 Knots Port Side

At peak exposure, the dummy's left arm translated down approximately parallel to the seat back (figure 26), but was still entrapped by the arm net. The arm was prevented from flailing. The obvious reason for this arm motion was due to the extra slack allowed in the restraint line because of the problem with locking the snubber at the 400-lb. load level.
