Report No. DOT/FAA/RD-81/26  
DOT/FAA/CT-81/66

# EVALUATION OF CATHODE-RAY TUBE PROTECTION FOR THE ELECTRONIC TABULAR DISPLAY SUBSYSTEM (ETABS) ENGINEERING MODEL

FINAL REPORT

SEPTEMBER 1981

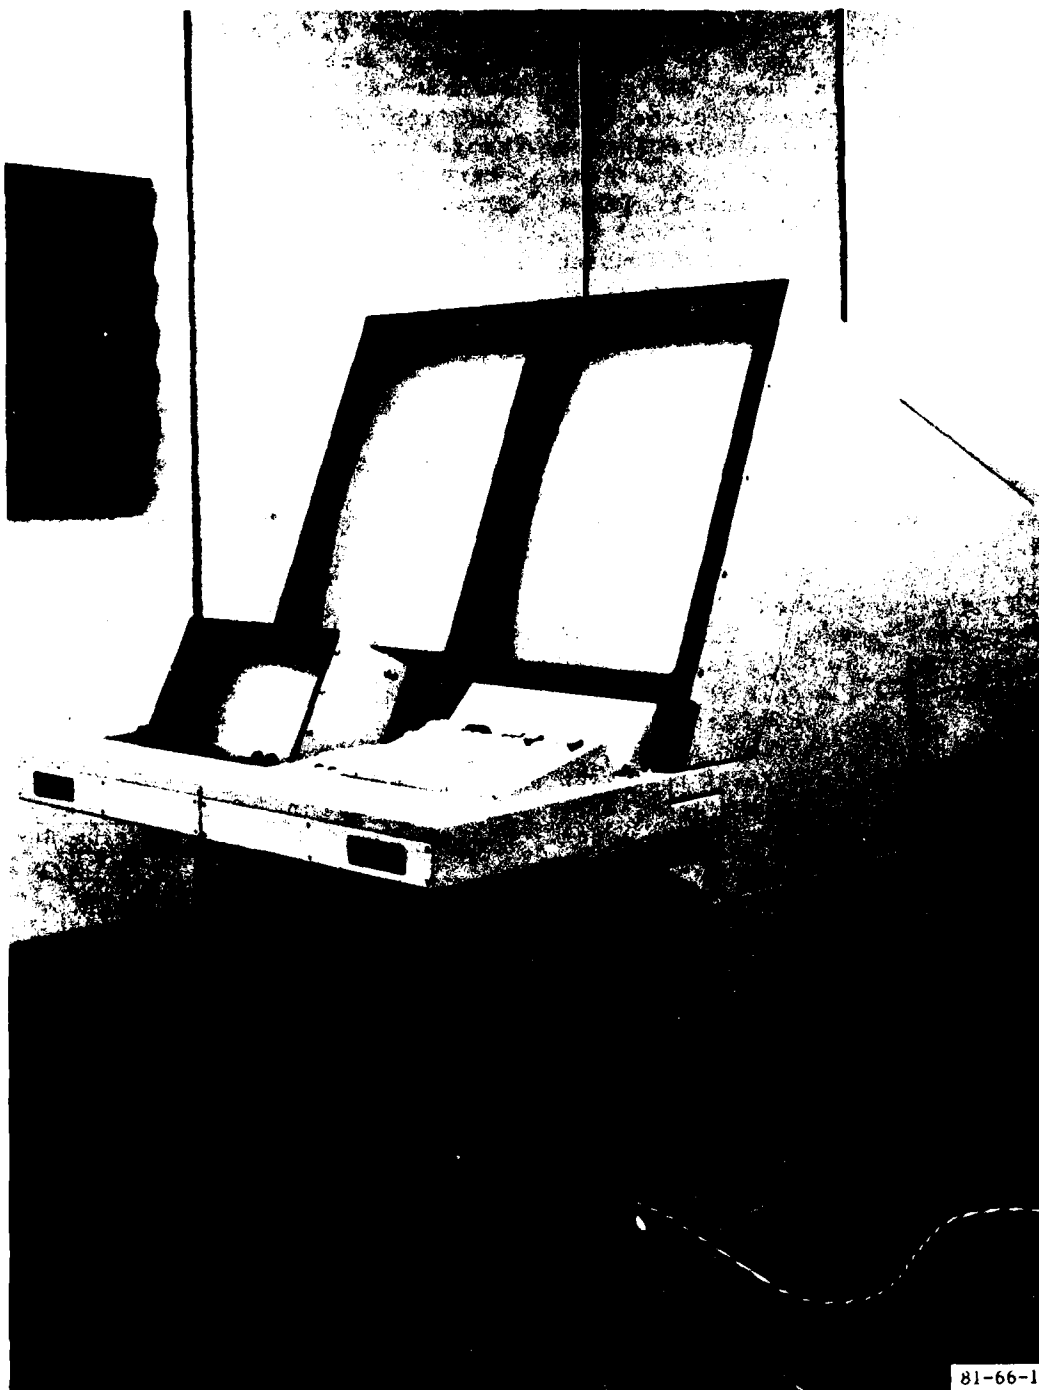
FIGURE 1. ETABS CONSOLE

The FAA Technical Center will be evaluating the ETABS engineering model for possible application in FAA ARTCC's. ETABS would replace the paper flight strips currently used by the air traffic controller to list pertinent data of the flights under control. The ETABS console is equipped with two 25-inch (diagonal) rectangular CRT's (see figure 1). The 25-inch rectangular CRT incorporates the same Kimcode rimband device and protective glass panel that the 23-inch CRT incorporates. It was determined that the FAA Technical Center would perform a safety evaluation on the 25-inch rectangular CRT similar to the evaluation conducted on the 23-inch CRT.

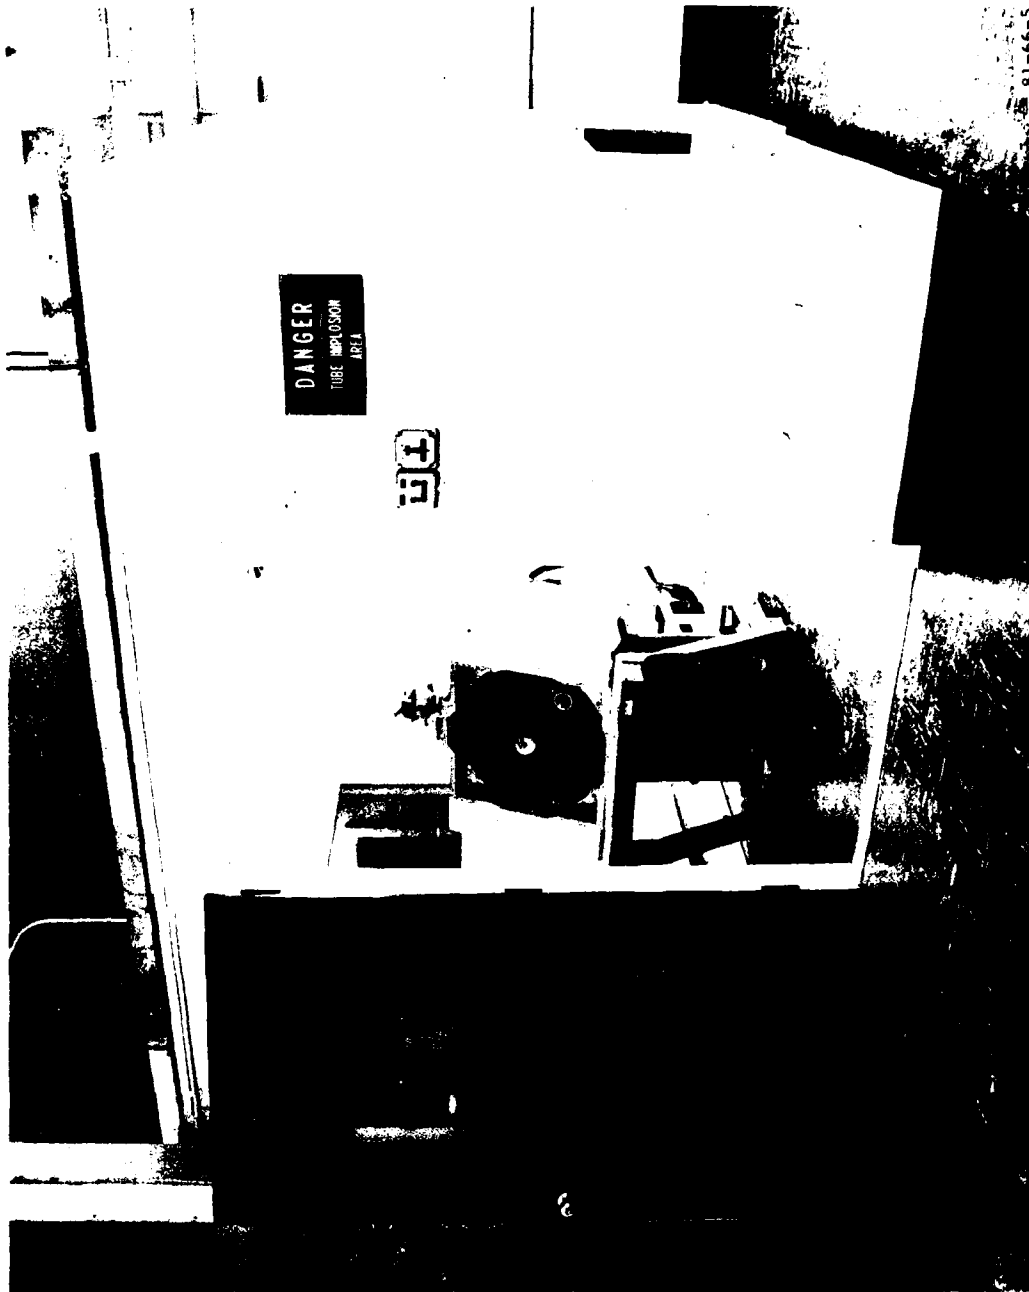
FIGURE 5. IMPLORSON ROOM

4. The implosion room (see figure 5) houses the test setup previously described. A hole was cut through the implosion room door for insertion of the hammering rod and center punch used to penetrate the CRT. (See figure 6.)
