The Alaska Good Friday Earthquake of 1964

CRREL Report 82-1

George K. Swinzow

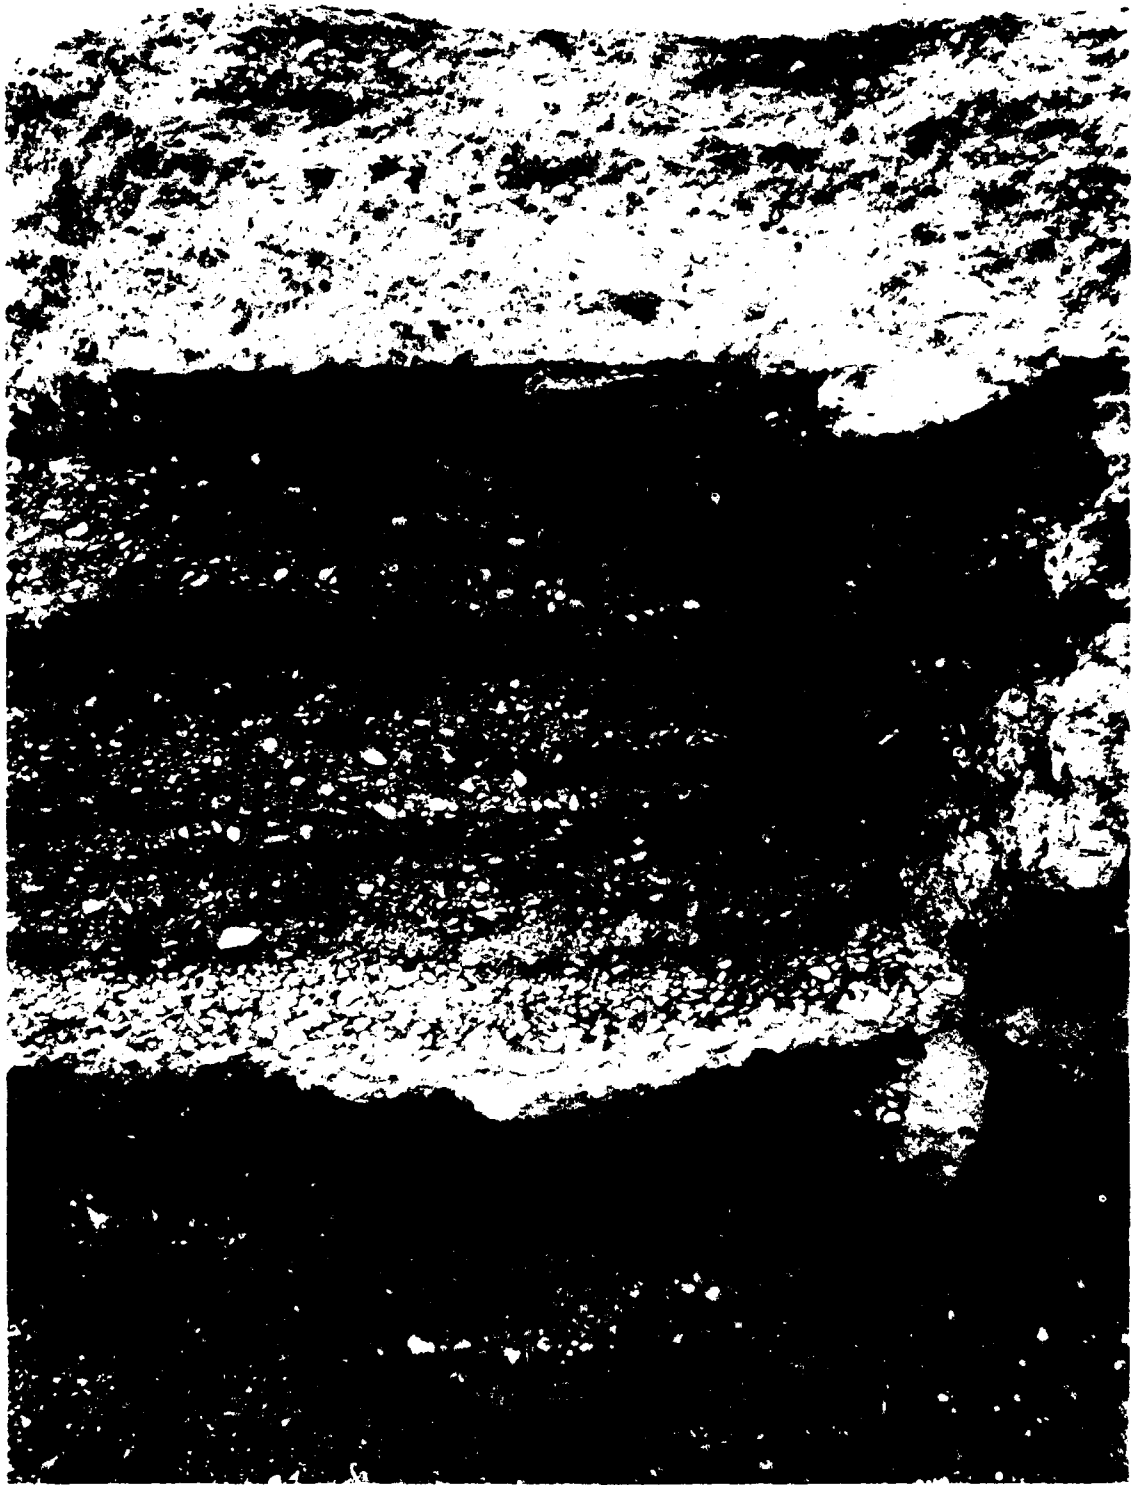
Figure 11. Frozen gravel exposed in Anchorage. The very top is constituted of completely ice-saturated material while the gravel at the bottom does not contain as much ice. Some of the top material is covered.

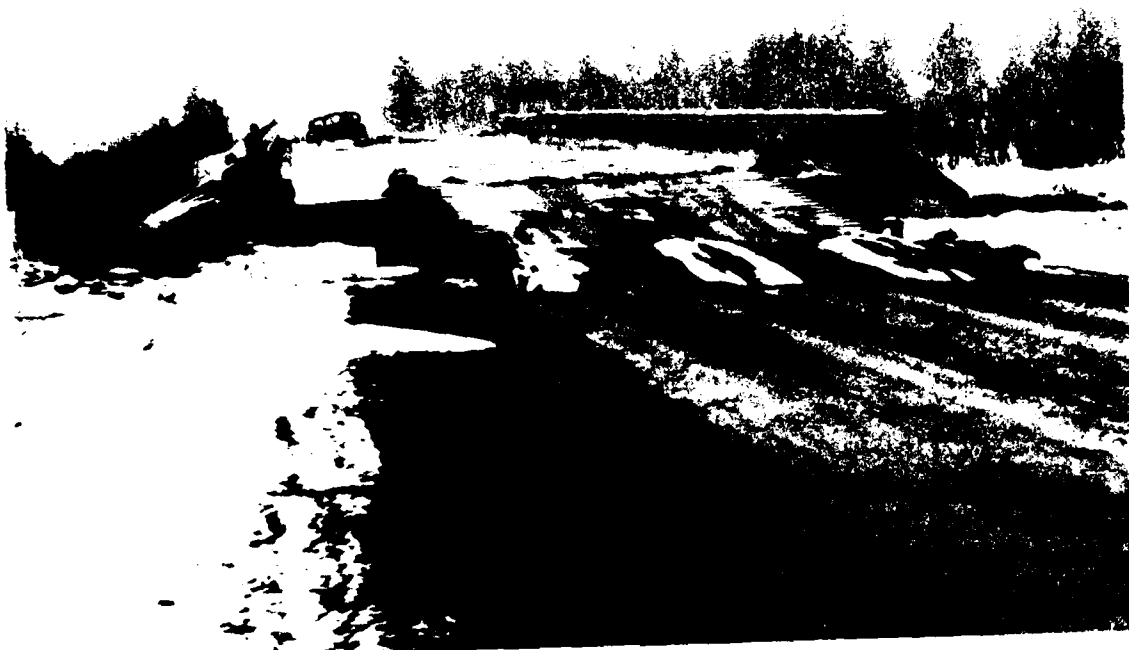
Figure 22 A pile foundation bridge in the Portage area. The ice encasing the pile clusters adhered firmly. The rapid rise and fall of the water in the stream resulted in a regular uplift. Some till and lumber were used to make it passable.

around embedded piles of shore installations may be significantly different from the cases illustrated in Figures 22 and 23. Figure 22 shows a rigid reinforced concrete structure resting on eight piles embedded into unfrozen, unconsolidated water saturated river deposits. The total weight of the 24 x 60 ft reinforced concrete structure was probably in the vicinity of 200,000 lb. The bond strength between the piles and the surrounding ice was 100 to 150 psi (instantaneous resistance; long term application would produce less). The skin friction of the bearing parts of the piles embedded in the river bottom was between 1 and 5 psi.

The eight 14 in. diameter piles had a total of about 422,000 in.² of skin contact with the unconsolidated riverbed deposits. This made a pull out resistance of approximately $(422,000 \times 2) = 844,000$ lb. Adding to this the weight of the bridge gives over 500 tons of pull out resistance. The ice to which the force of the passing wave was applied had a total surface area in contact with the piles of about 12,600 in.². At 150 psi of bond strength between the ice and the piles, a lifting force of approximately 950 tons could have been applied to the bridge. Therefore, the bridge damage mechanism suggested in Figure 21 is plausible.

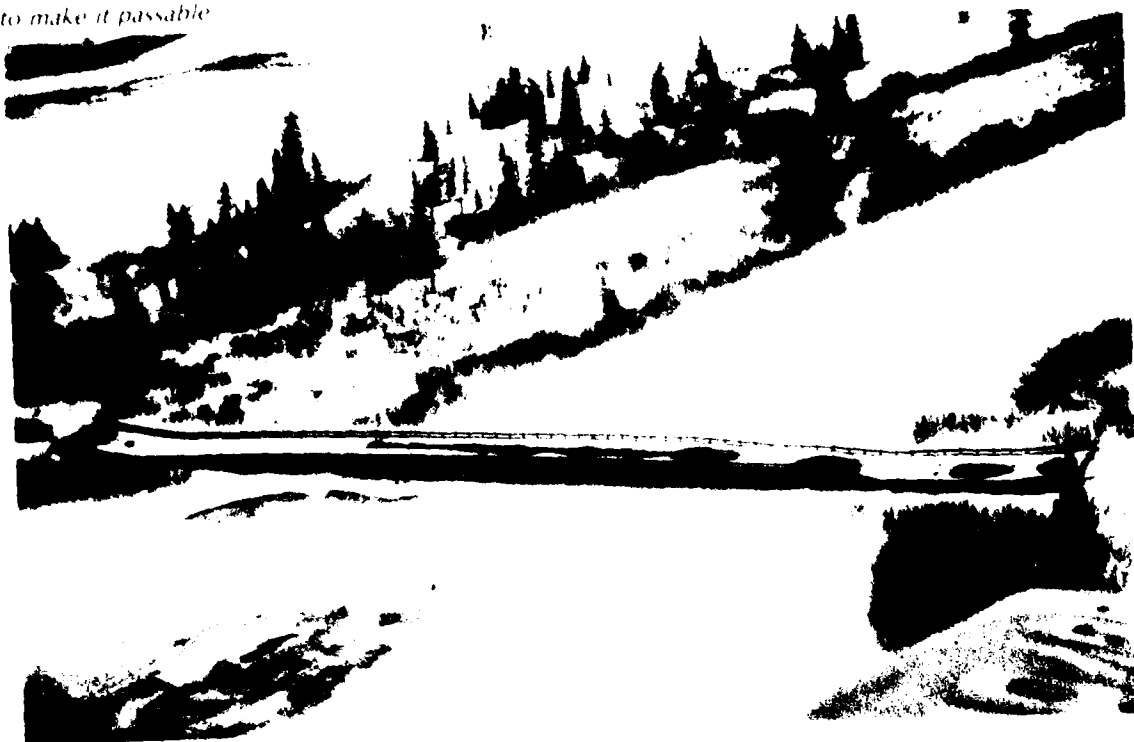
Figure 23 Differential heave. Parts of this bridge were differentially uplifted by the mechanism indicated in Figure 21. Due to the different composition of the materials in which the pile clusters were embedded, the bridge settled differentially.

There were many different combinations of mechanisms by which highways and bridges were destroyed or damaged (e.g. Figure 23).

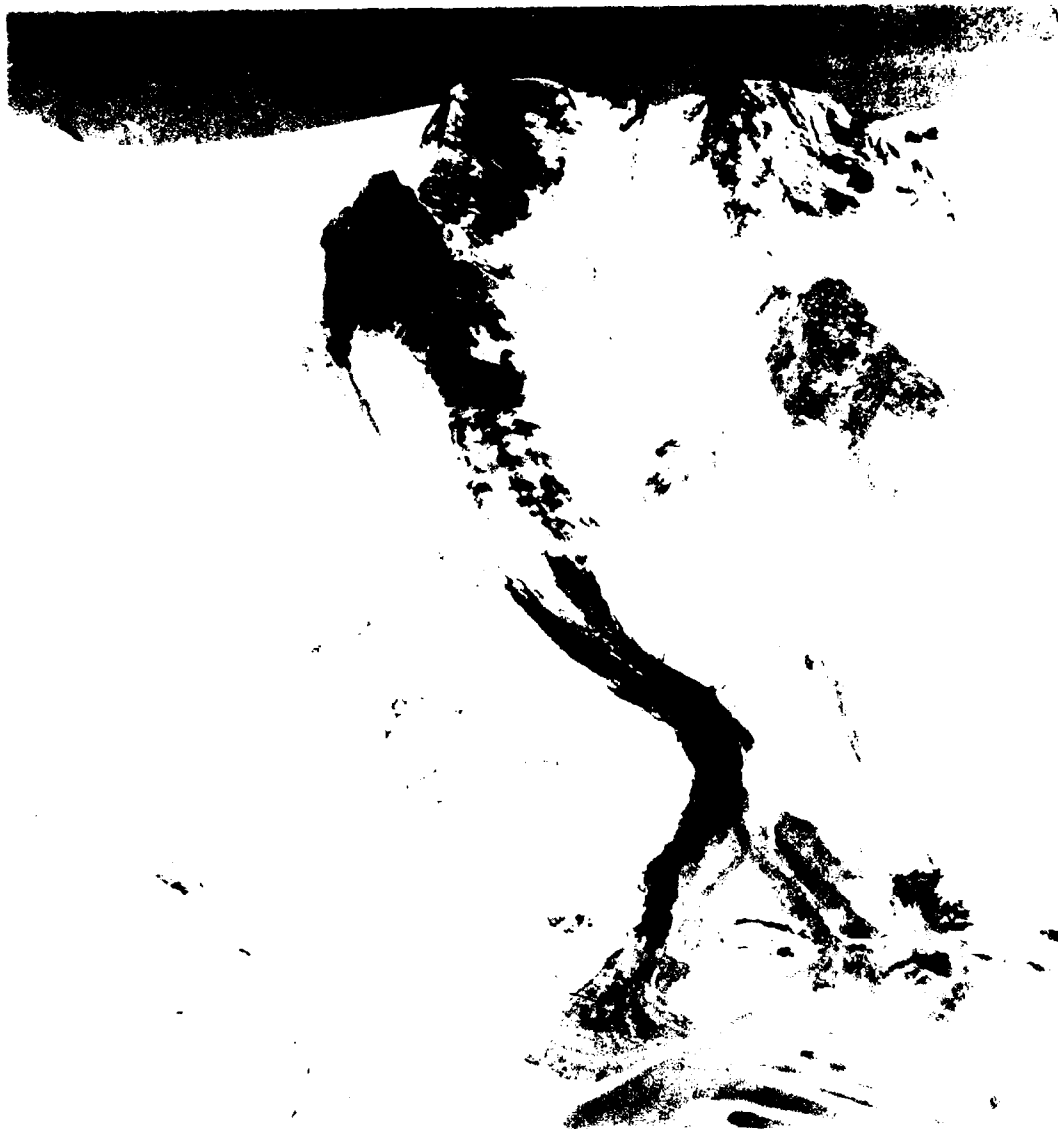
Figure 25. Rock avalanche. A large rock flow on the Yalik Glacier came to rest at the bottom in a way suggesting fluid flow.

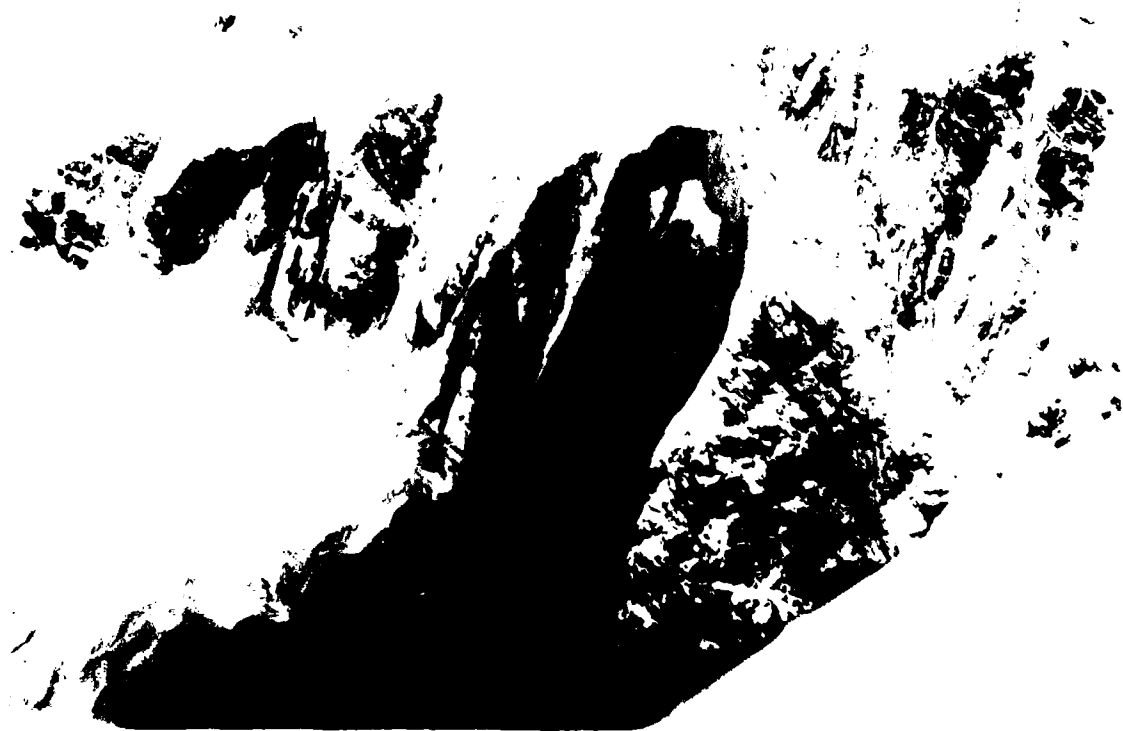
Figure 27. Dingelstadt Glacier. The large rock slide landed in the fiord, apparently shattering a part of the glacier snout. A strong subglacial stream emerges at the lower left.

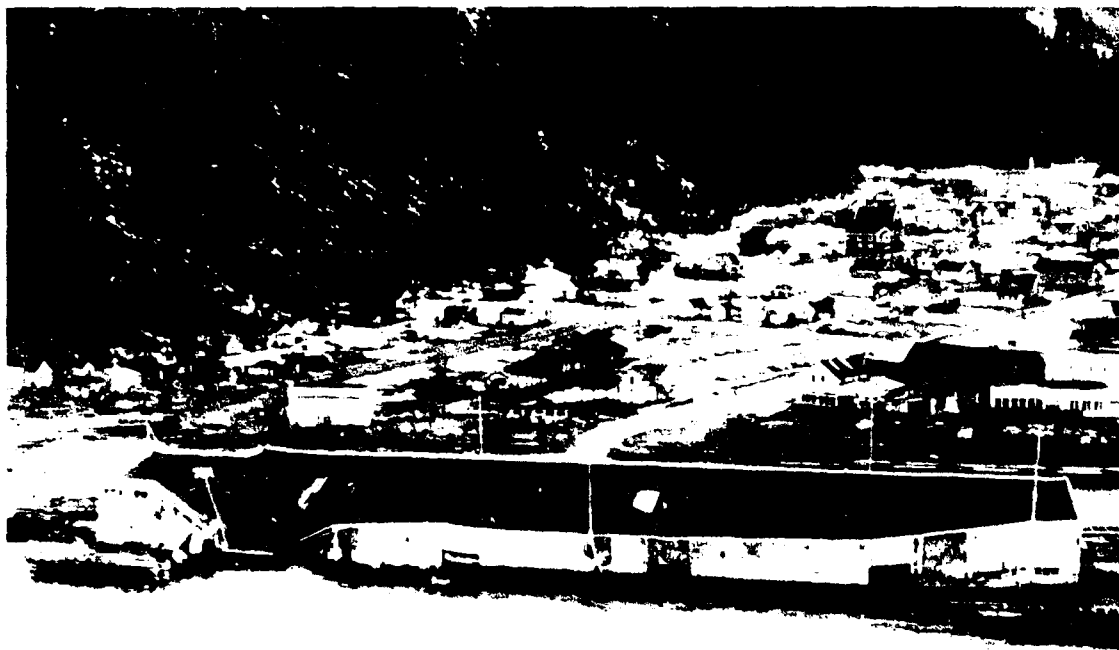
Figure 32. Waterfront in Seward. The earthquake triggered several large tidal waves. Satellites say that the first came immediately after the earthquake, apparently due to massive coastal slippage to the sea. The photograph shows the damage in the southern part of the town.

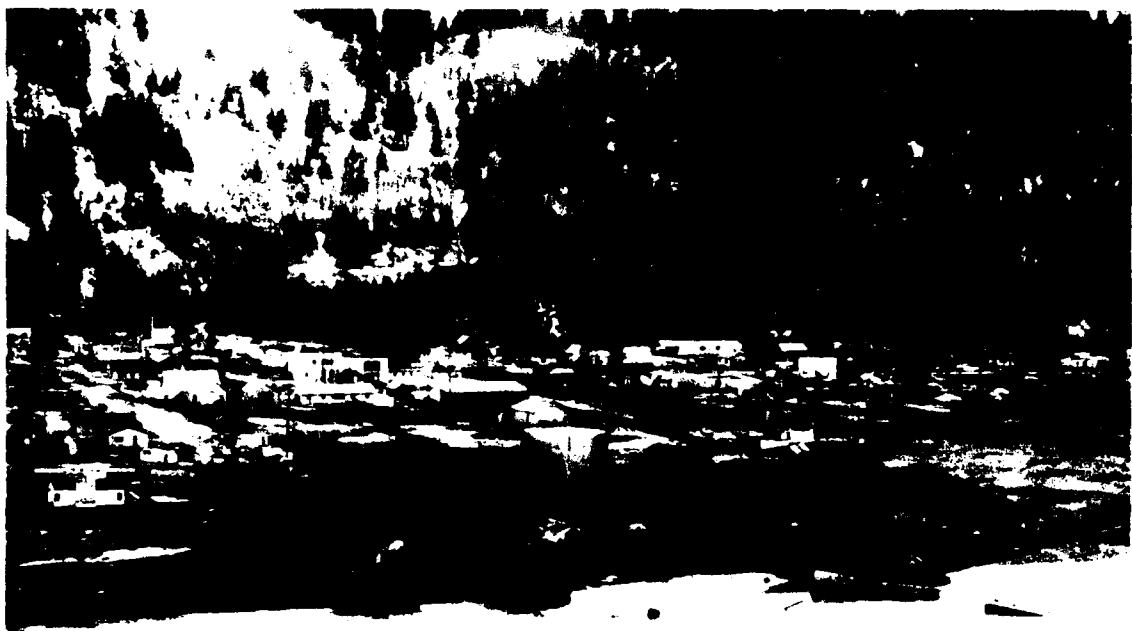
Figure 34. Effects of sea waves. The toppled storage tanks caught fire and burned. The waterfront was destroyed by several waves. It was difficult to distinguish between tsunamis and the many waves formed by submarine local landslides, but the toll in life and property loss due to both types of waves invading the land was high. Abnormally large waves continued to invade Prince William Sound until the day after the earthquake.
