# TESTING OF TRITIUM-POWERED RUNWAY DISTANCE AND TAXIWAY MARKERS

K. W. HAFF F. J. SCHULTZ  
F. N. CASE J. A. TOMPKINS

OPERATIONS DIVISION  
OAK RIDGE NATIONAL LABORATORY  
OAK RIDGE, TENNESSEE 37830

AUGUST 1981

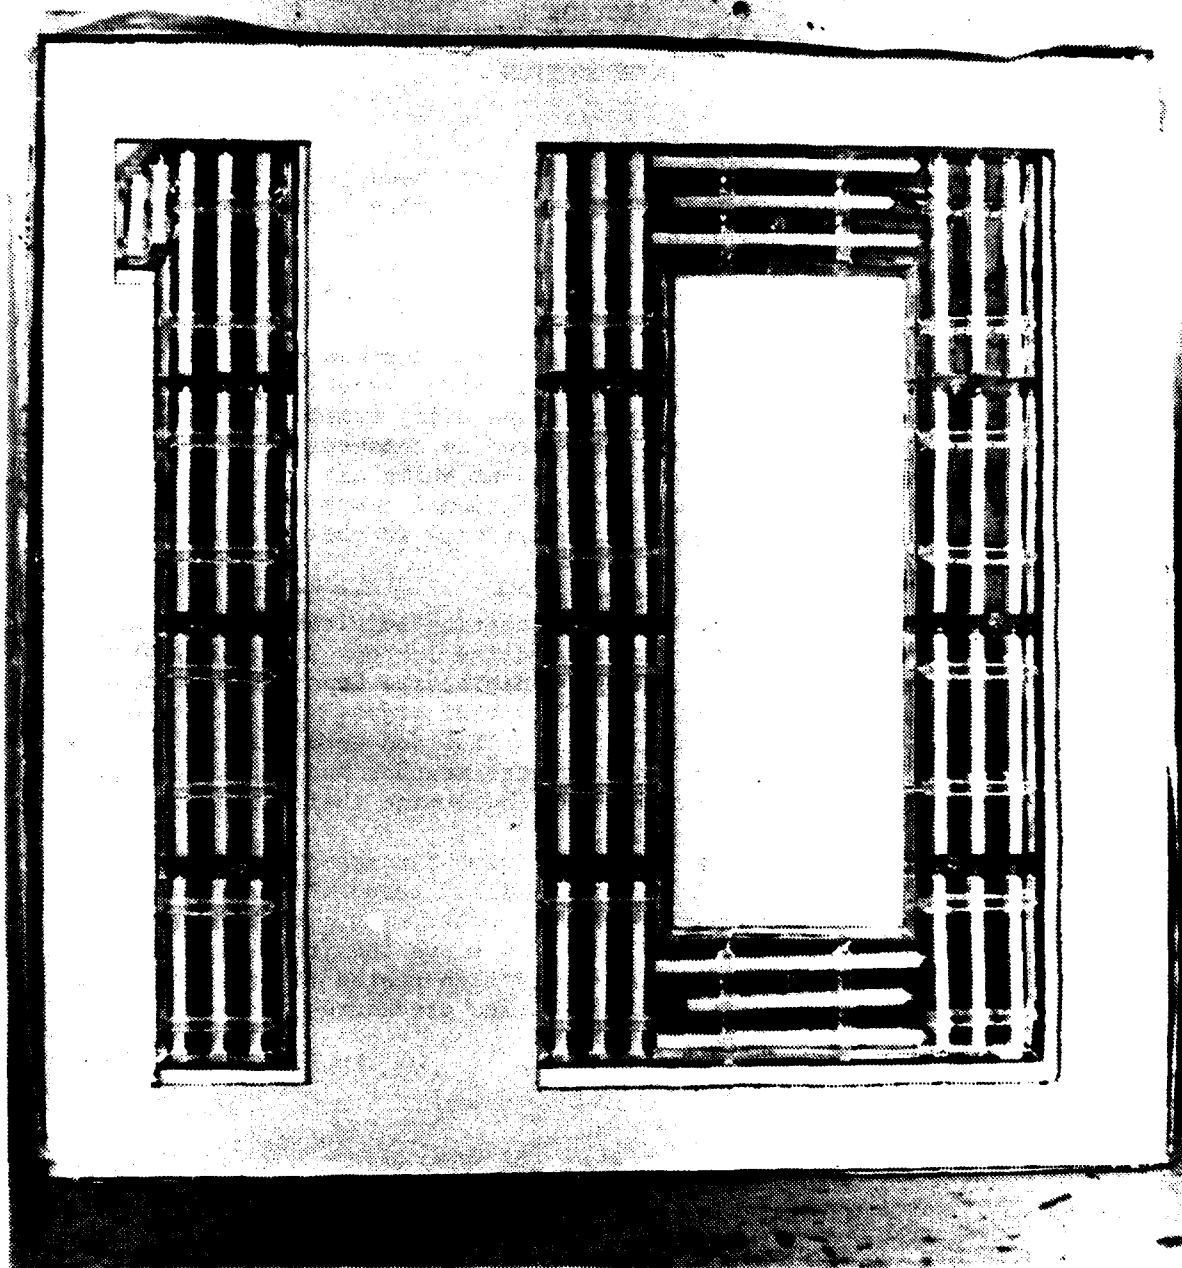
FIGURE 1. Runway Distance Marker With Front Face Removed to Show Tritium-Filled Phosphor Coated Tubes

Four runway distance markers (FIGURE 1) were furnished by AFESC. Oak Ridge National Laboratory installed tritium-filled tubes (FIGURE 2) in three of the signs and installed empty tubes in the other sign. FIGURE 3 is a drawing of source mounting of signs. FIGURE 4 shows the front face of the complete sign. Oak Ridge National Laboratory then tested the four signs in accordance with the prescribed test sequence and procedures.

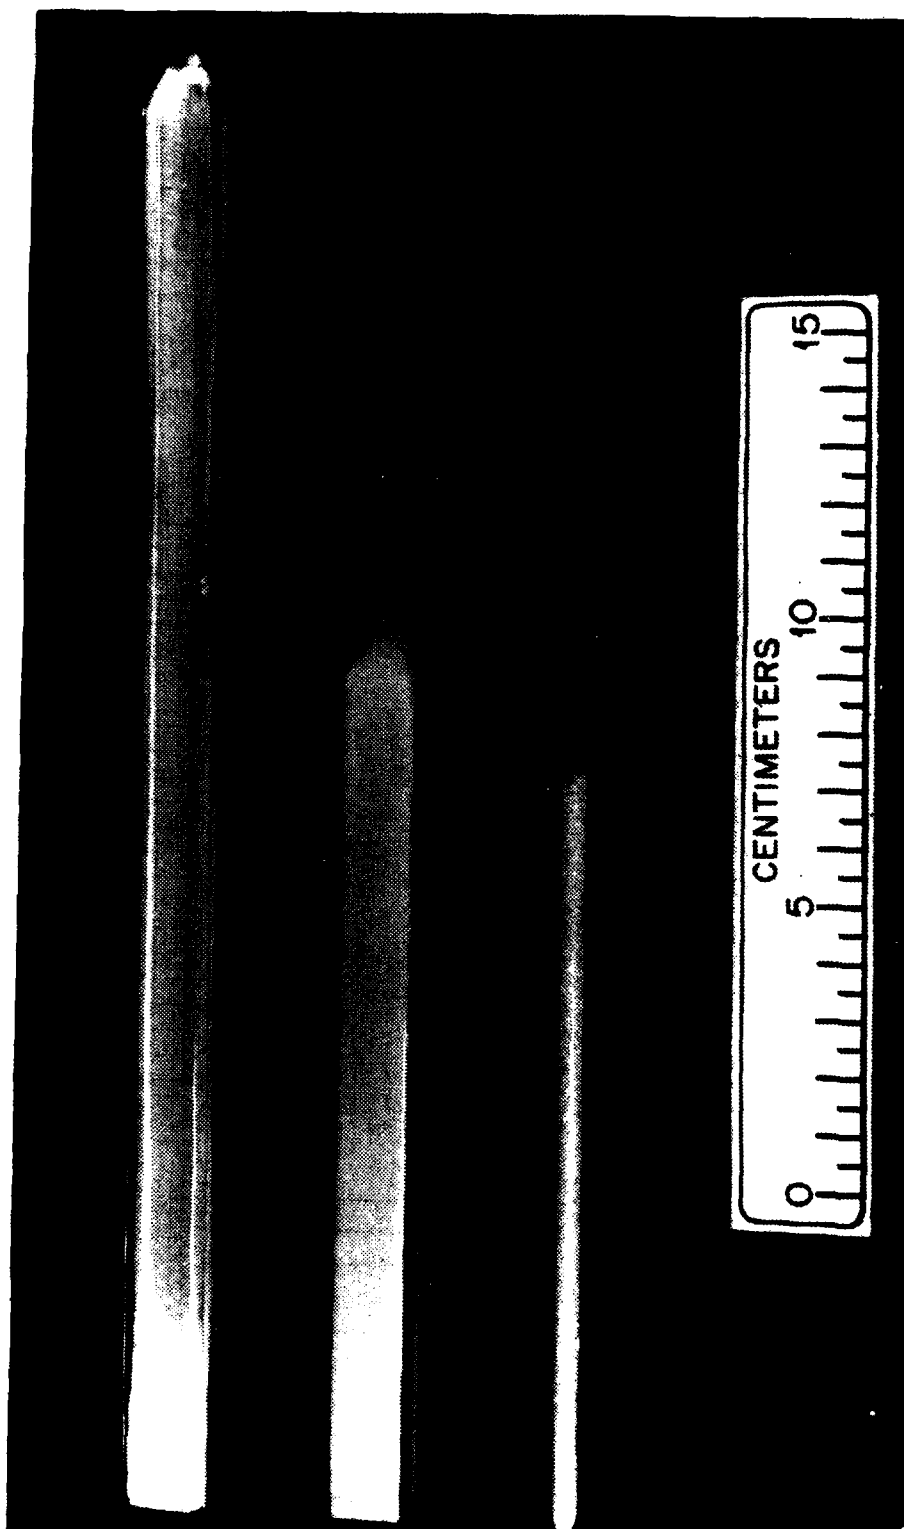
FIGURE 2. Phosphor Coated Tritium-Filled Pyrex Glass Tubes. (Top two are tubes typical of those used in Air Force Runway Distance Marker signs.)
