**TECHNICAL REPORT ARPAD-TR-81006**

**PROFILES OF CRACKS IN BASES OF 155-MM M483A1,  
M692, AND M731 PROJECTILES**

**US ARMY ARMAMENT RESEARCH AND DEVELOPMENT COMMAND  
PRODUCT ASSURANCE DIRECTORATE  
DOVER, NEW JERSEY**

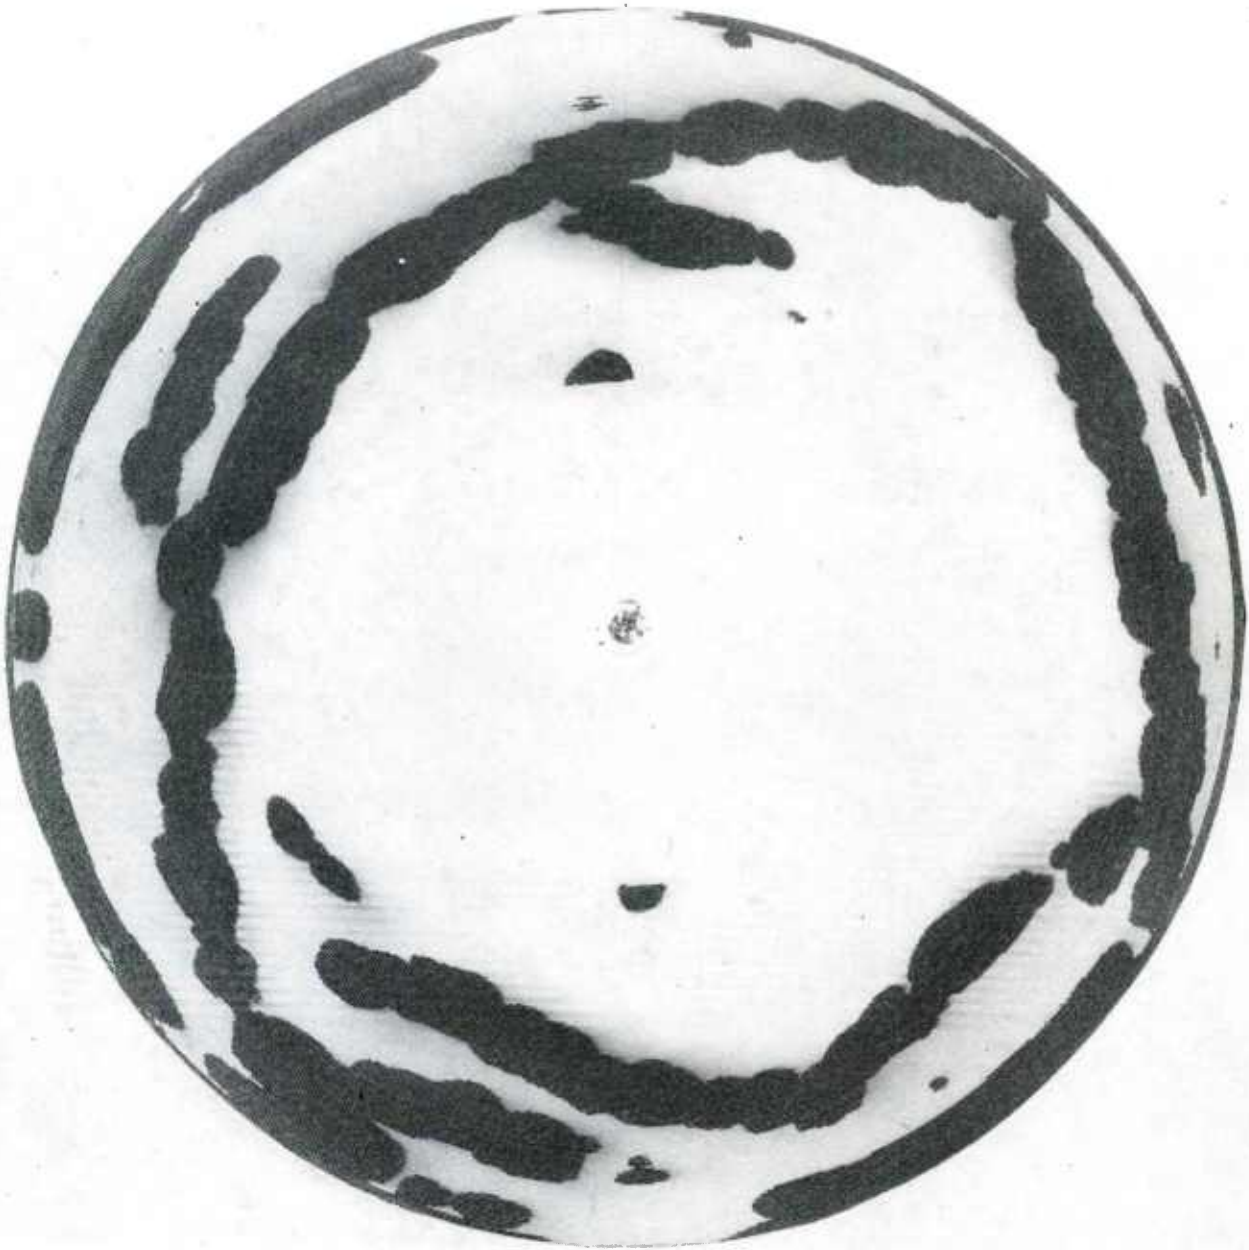
Ultrasonic C-scans were made of all bases. Most of the C-scans which showed flaws (figs. 6 through 29) are included in this report. All detected flaws were on the forward surface of the bases. The gain setting for the ultrasonic flaw detector was 50 decibels. A sample calibration using the standard is shown in figure 30.

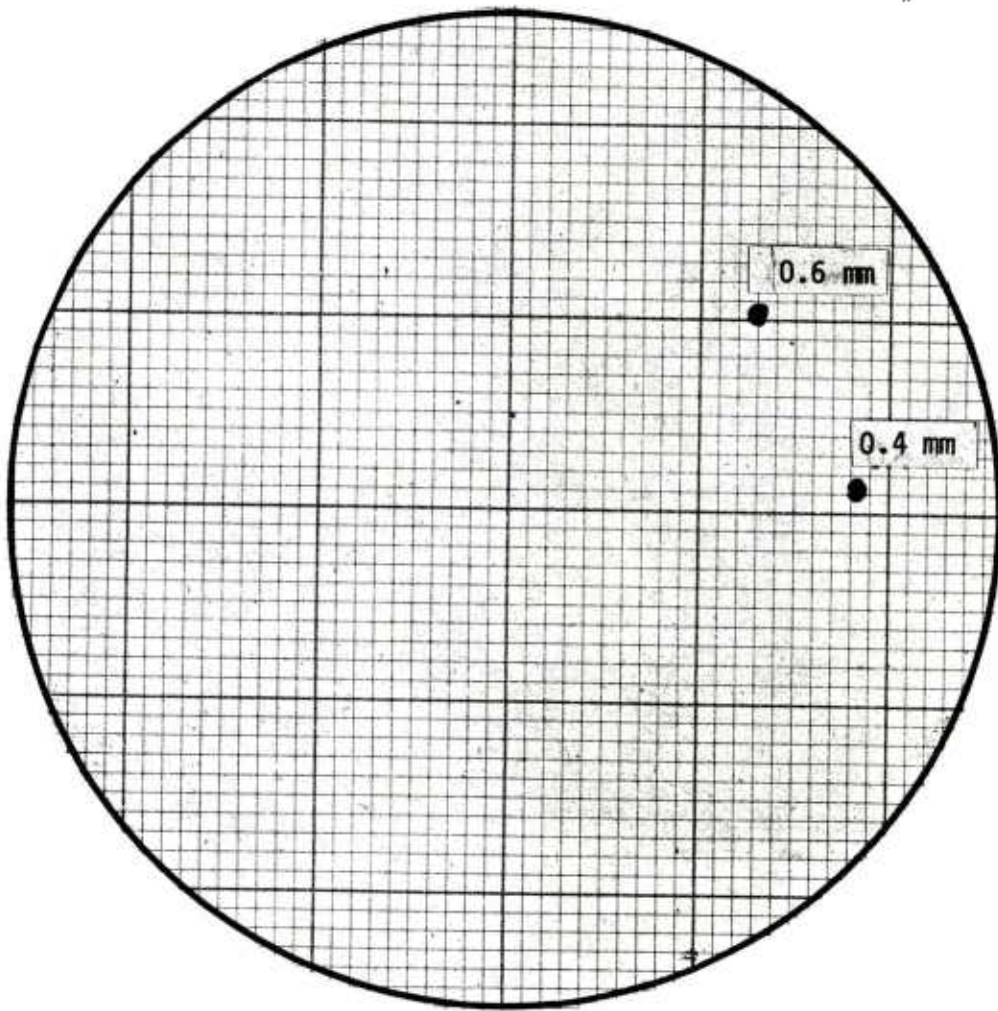
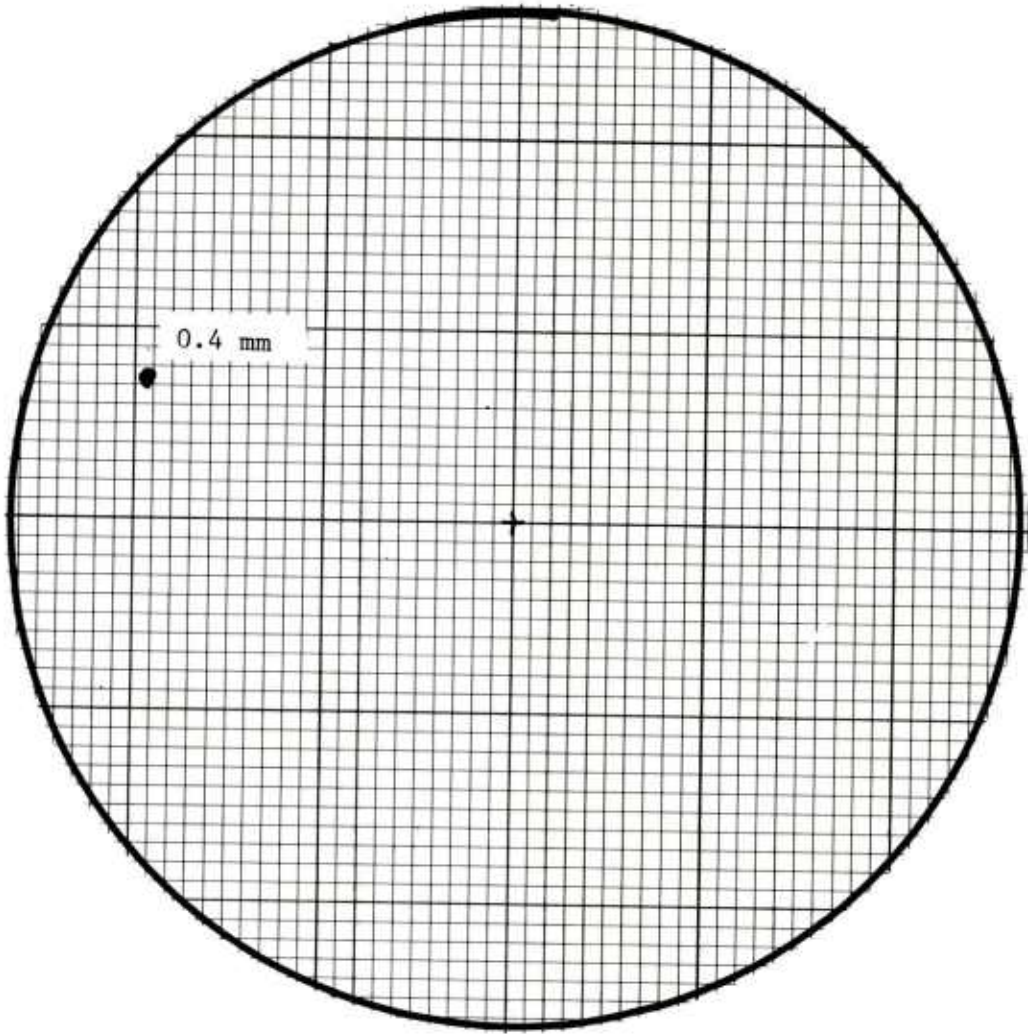
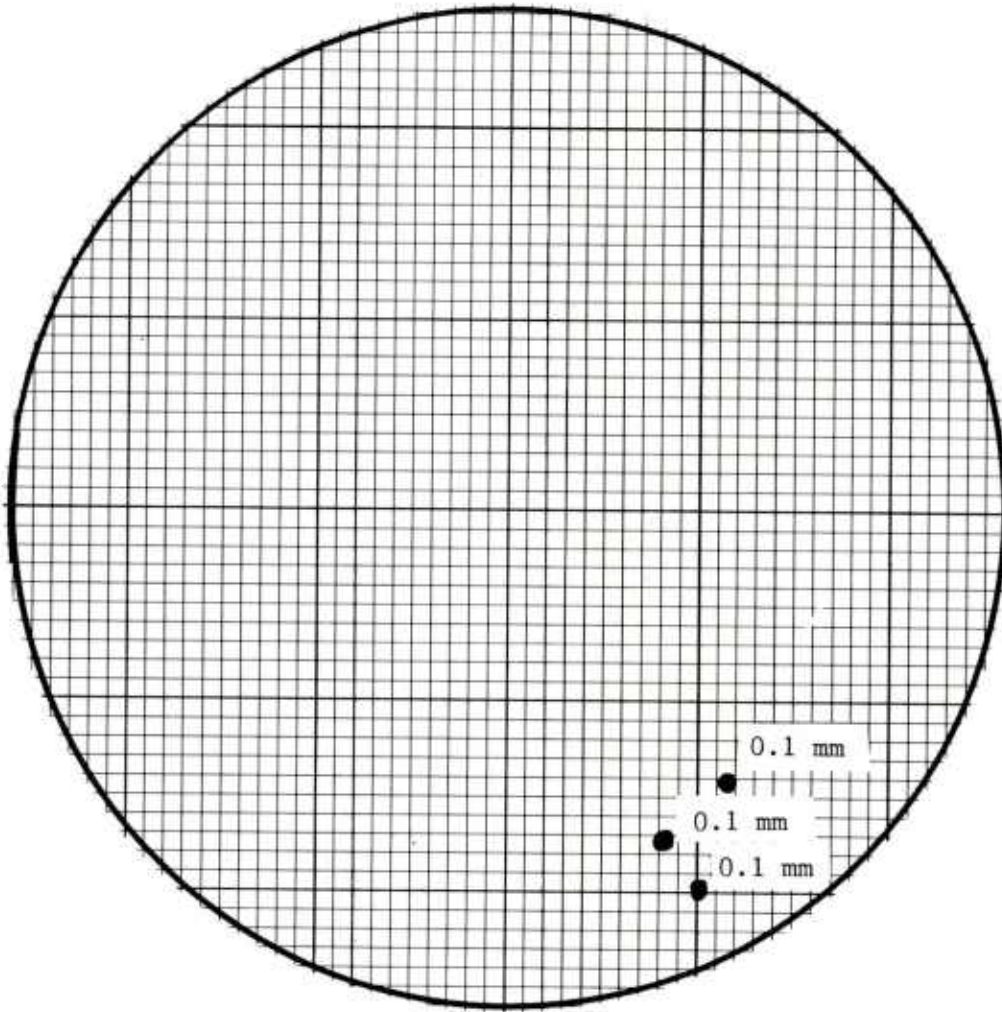
From the 12 bases selected for further analysis, six were found to have spots. Spots are considered to be inclusions or porosity-type-defects. The distribution of some of the spots is illustrated in figures 39 through 42. The difference in eddy current sensitivity between the use of 500-kHz and 75-kHz frequencies is illustrated in figure 42. The three spots shown, which were originally detected with the more sensitive 500-kHz probe, are just barely perceptible with the 75 kHz probe. Another difference in eddy current sensitivity is illustrated in figure 43. The deepest spot that was originally measured as being

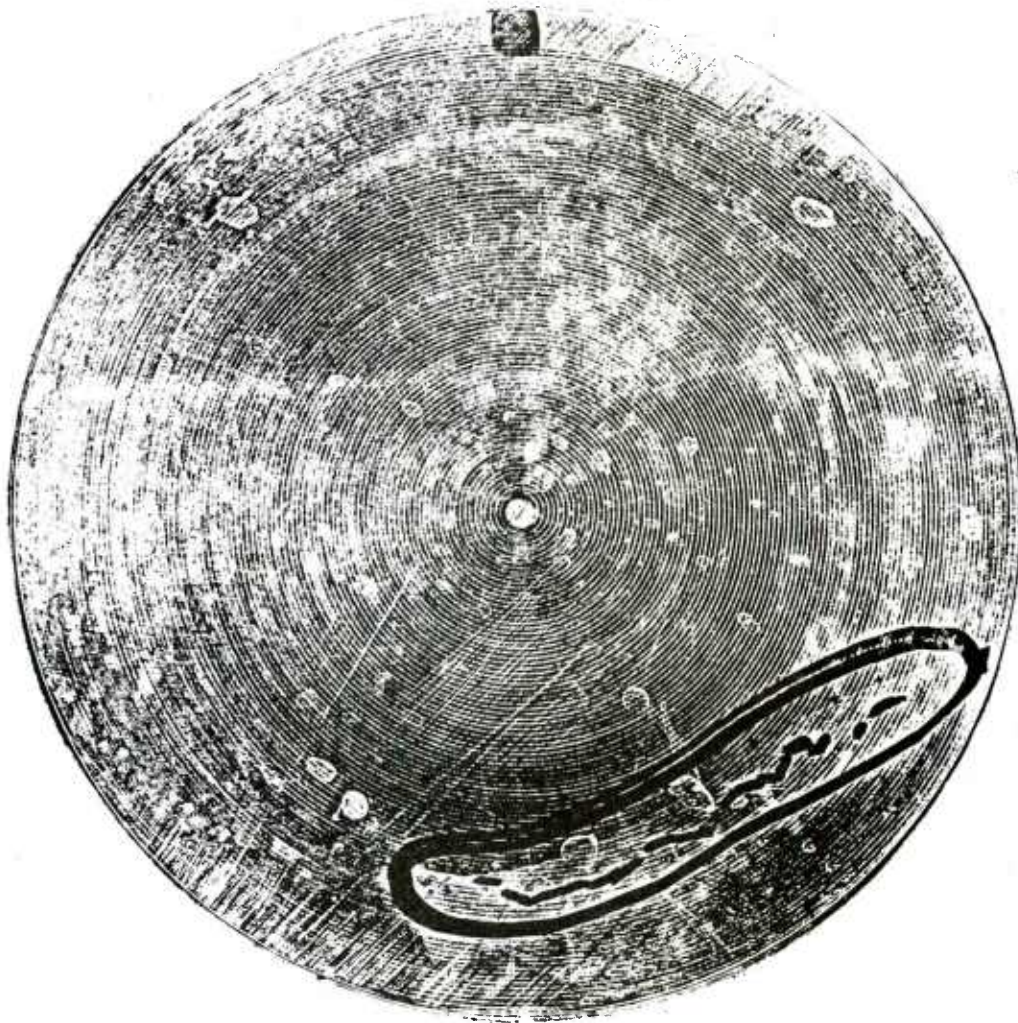
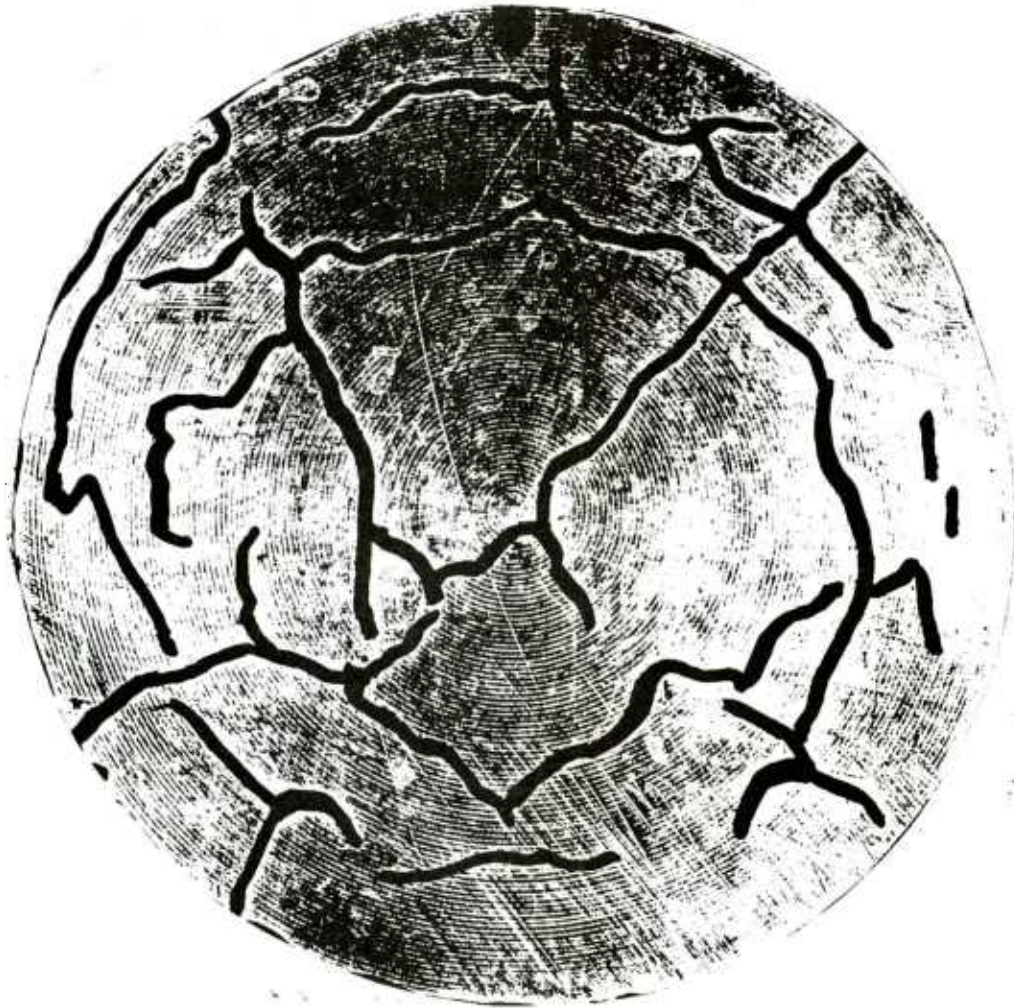
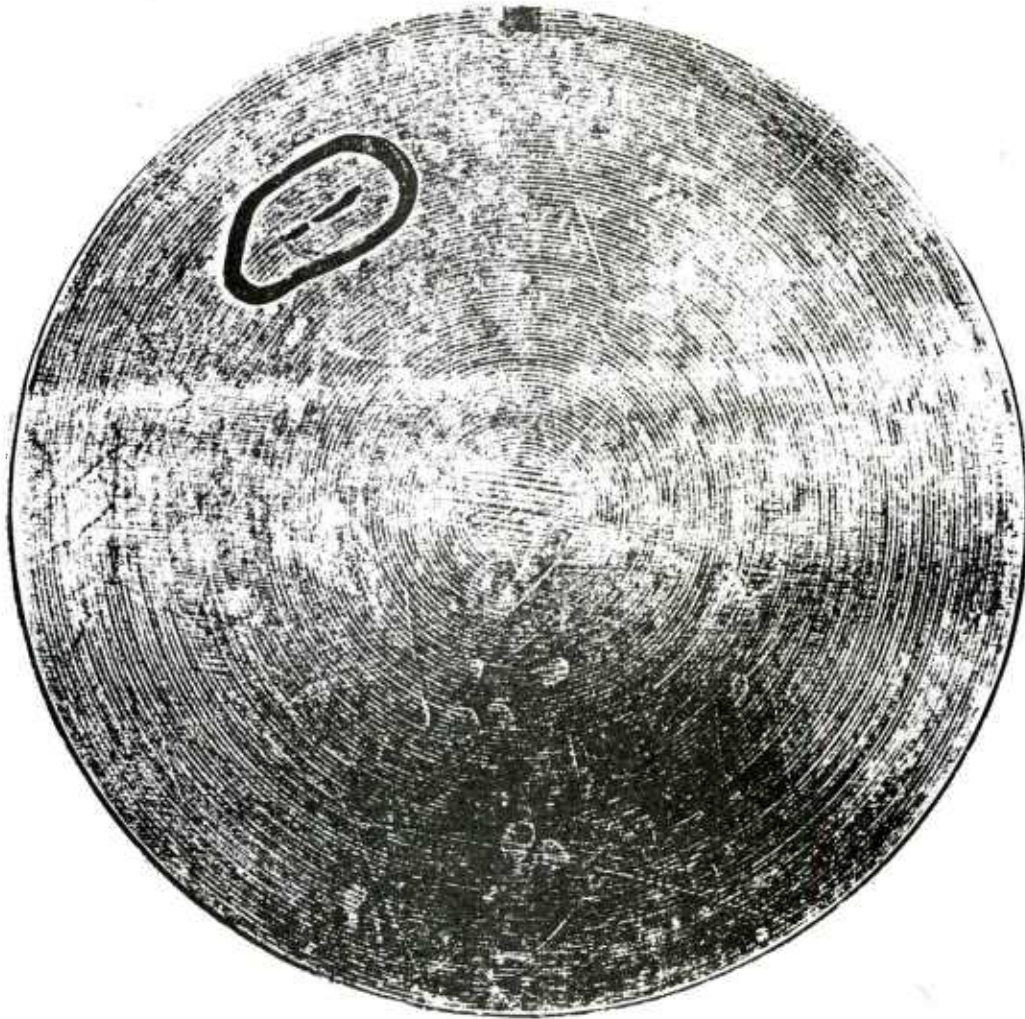
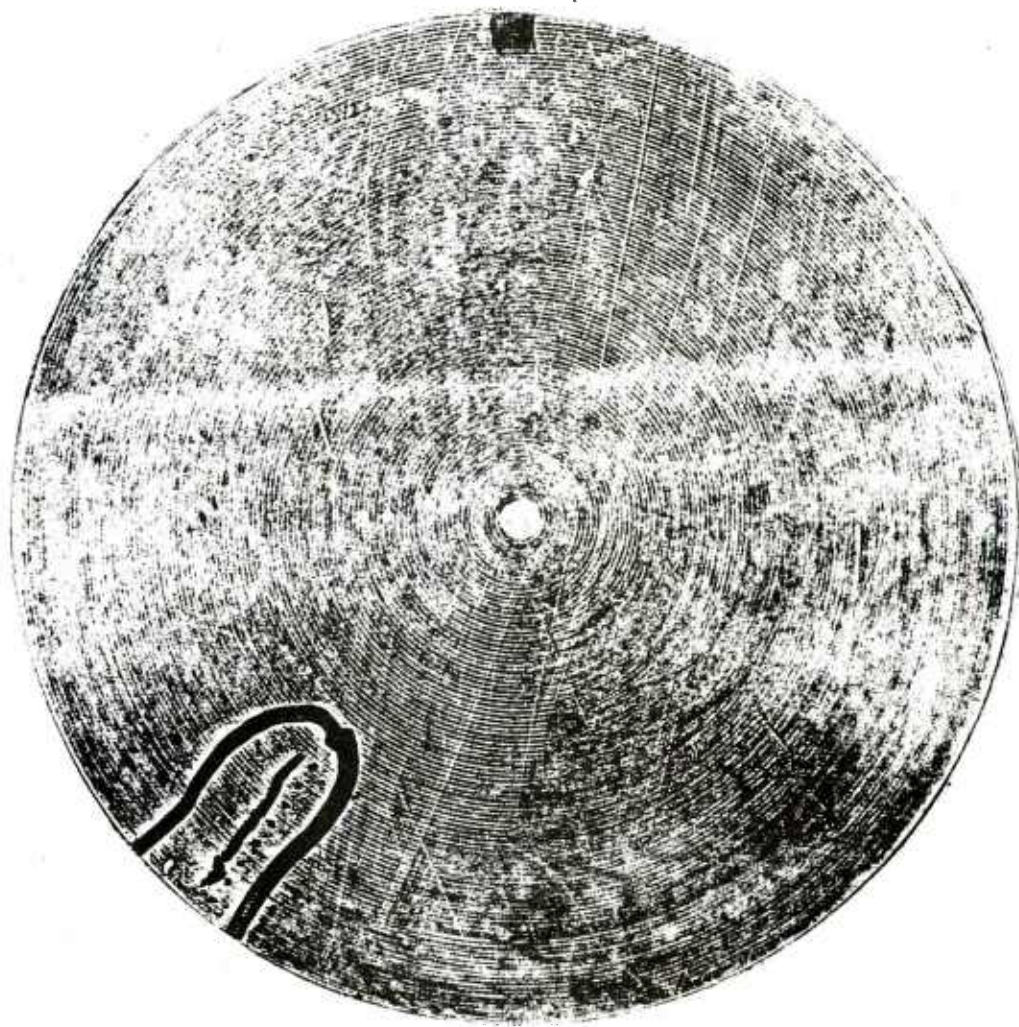
Eleven bases were inspected with fluorescent liquid penetrant (table 3). Five of these bases were known to have cracks. Four revealed their cracks (figs. 44 through 47). Base no. A-CMC/LAAP 4 did not reveal its crack. It was later found with eddy current inspection (table 2) that this crack was small, having a length of 10 mm (0.4 in.) and a maximum depth of 0.6 mm (0.02 in.). The other six bases had spots. Only three of these spots (all in base no. CMC/KAAP 76) were revealed by fluorescent liquid penetrant (fig. 48). This occurrence hints that the spots in the other five bases were beneath the surface.
