DEVELOPMENT AND EVALUATION OF WIDE CLEARANCE
BRAZE JOINTS IN GAMMA PRIME ALLOYS

J. W. Chasteen
University of Dayton
Research Institute
Dayton, Ohio 45469

March 1982

Final Report for Period May 1, 1979 - May 1, 1981

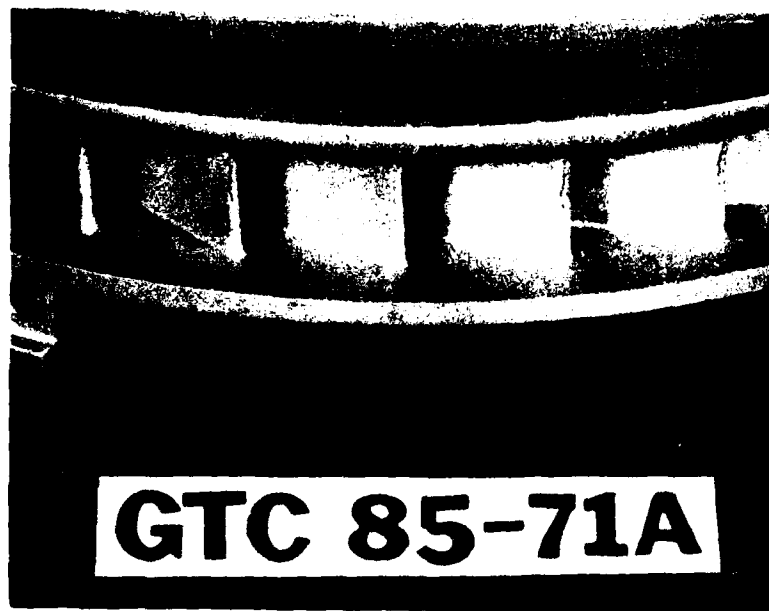
Figure 13. The nozzle of Figure 12 after initial build-up.

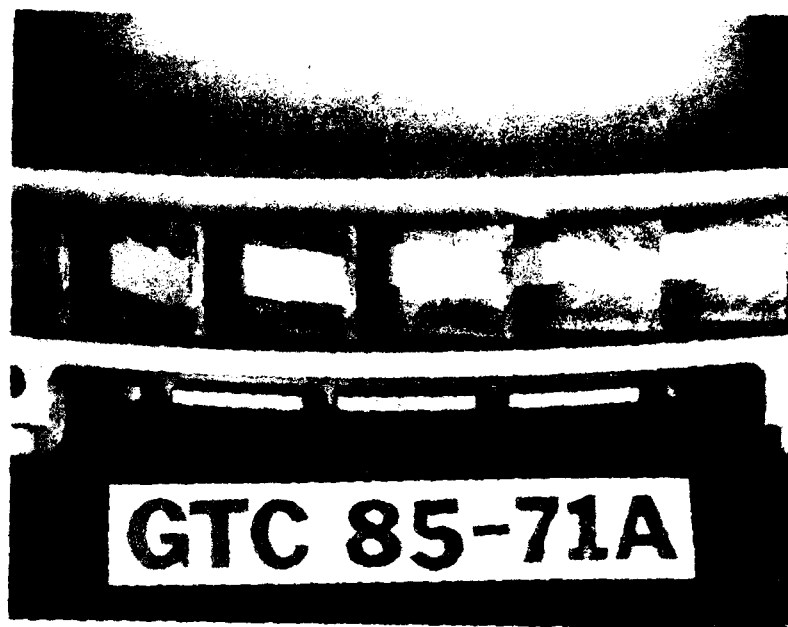
Figure 15. The nozzle of Figure 14 after application of the area brazes.

The leading edges were built-up by applying a 2:1 mixture of Nicrogap 108 and Nicrobraz 200 suspended in Nicrobraz Cement No. 500. The mixture was applied by layers dropped on with an eyedropper. The dried green deposits were then dressed with an abrasive cloth and made to conform to the blade contour. This assembly was then brazed in vacuum at 2065°F for 1/2 hr. The result of this operation is shown in Figure 13. The edges were then mechanically dressed (see Figure 14) and the area brazes were applied. These were brushed on from a suspension of Nicrobraz 200 in Nicrobraz Cement No. 500 thinned with acetone. Area braze was applied to the other nozzle as well. Photographs of the nozzles at this stage of repair are presented in Figures 15 and 16.

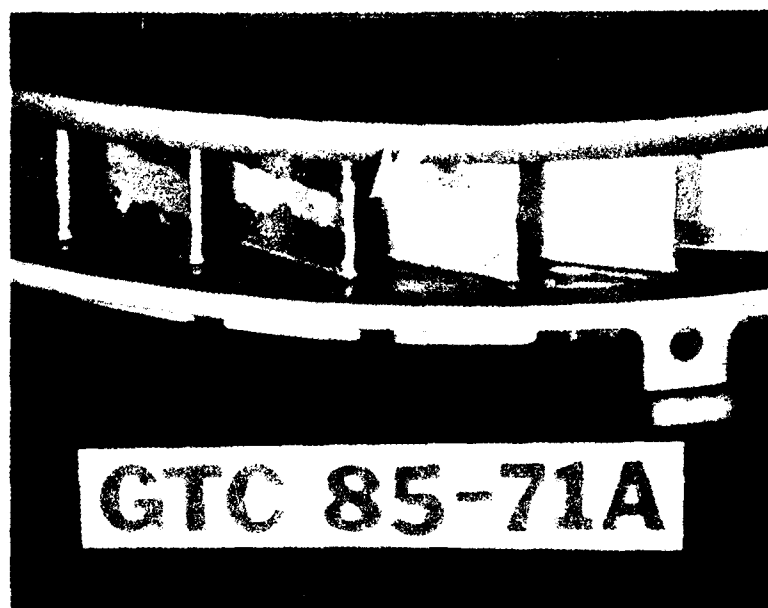
Figure 17. Leading edges of the braze repaired GTC 85-71A nozzle.

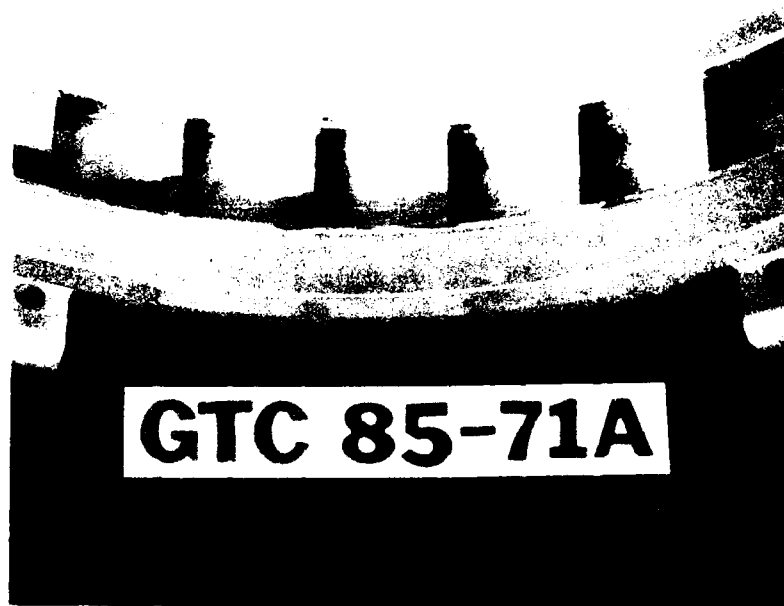
Figure 19. Trailing edges of the nozzle of Figure 17.
