CORPS OF ENGINEERS BUFFALO NY BUFFALO DISTRICT
DETAILED PROJECT REPORT AND ENVIRONMENTAL ASSESSMENT. SECTION 1--ETC(U)
NOV 81

REPORT DOCUMENTATION PAGE		READ INSTRUCTIONS BEFORE COMPLETING FORM
1. REPORT NUMBER	2. GOVT ACCESSION NO. ADA220366	3. RECIPIENT'S CATALOG NUMBER
4. TITLE (and Subtitle) Detailed Project Report and Environmental Assessment: Section 111, Shores East of Diked Disposal Area, Lorain Harbor, Ohio		5. TYPE OF REPORT & PERIOD COVERED Final

20. ABSTRACT (Continue on reverse side if necessary and identify by block number) A study of the impacts of the Lorain diked disposal area on the shoreline east of the area. The report found that the disposal area had not caused the total erosion problem and recommended no federal action.

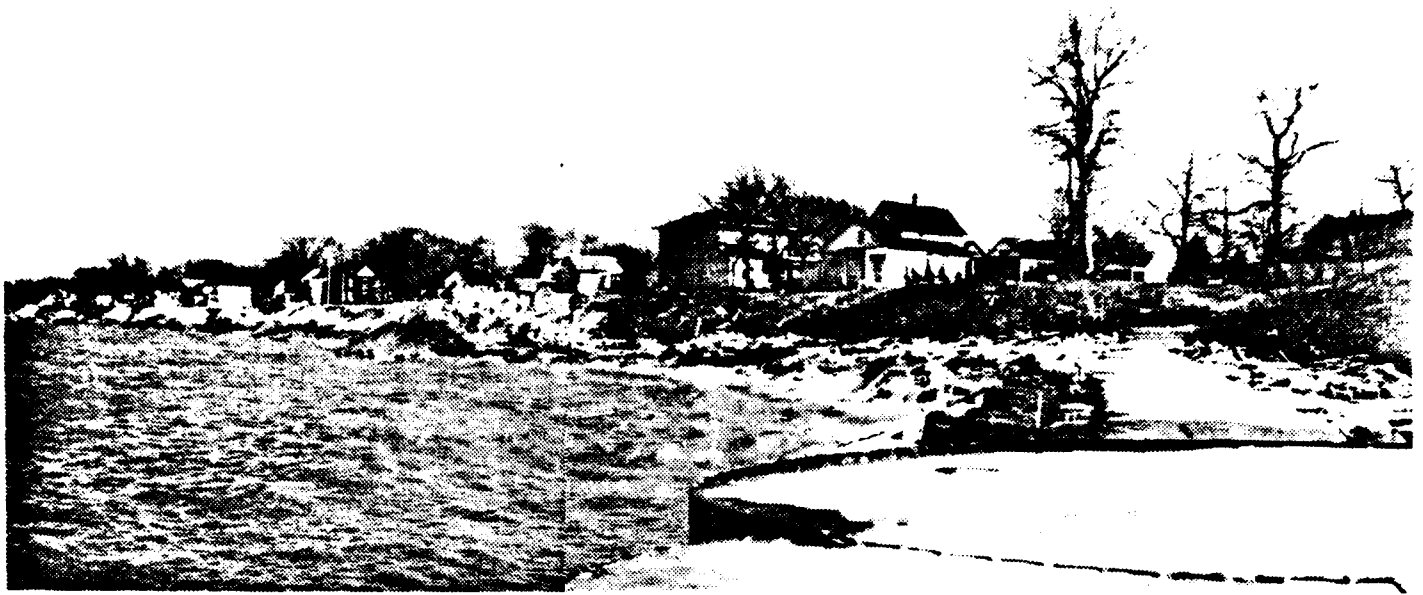
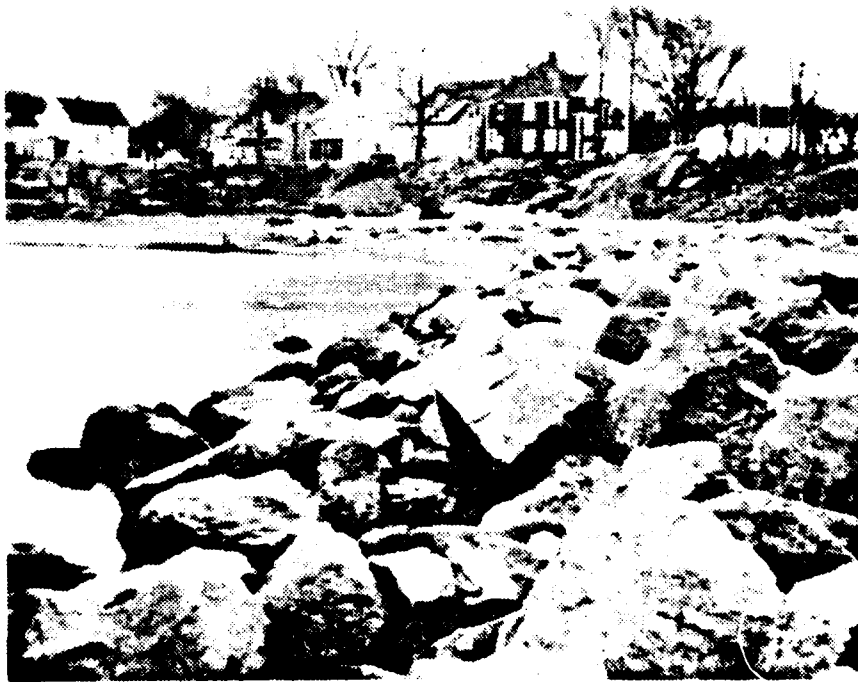
Figure 2

Shoreline at East Breakwater Shorearm
Fall 1976

Shoreline at Spending Beach Revetment
Spring 1978

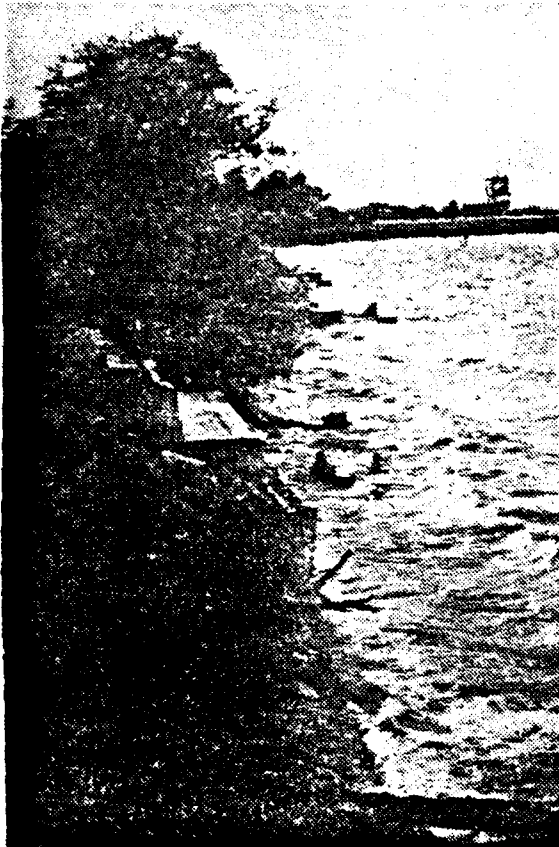
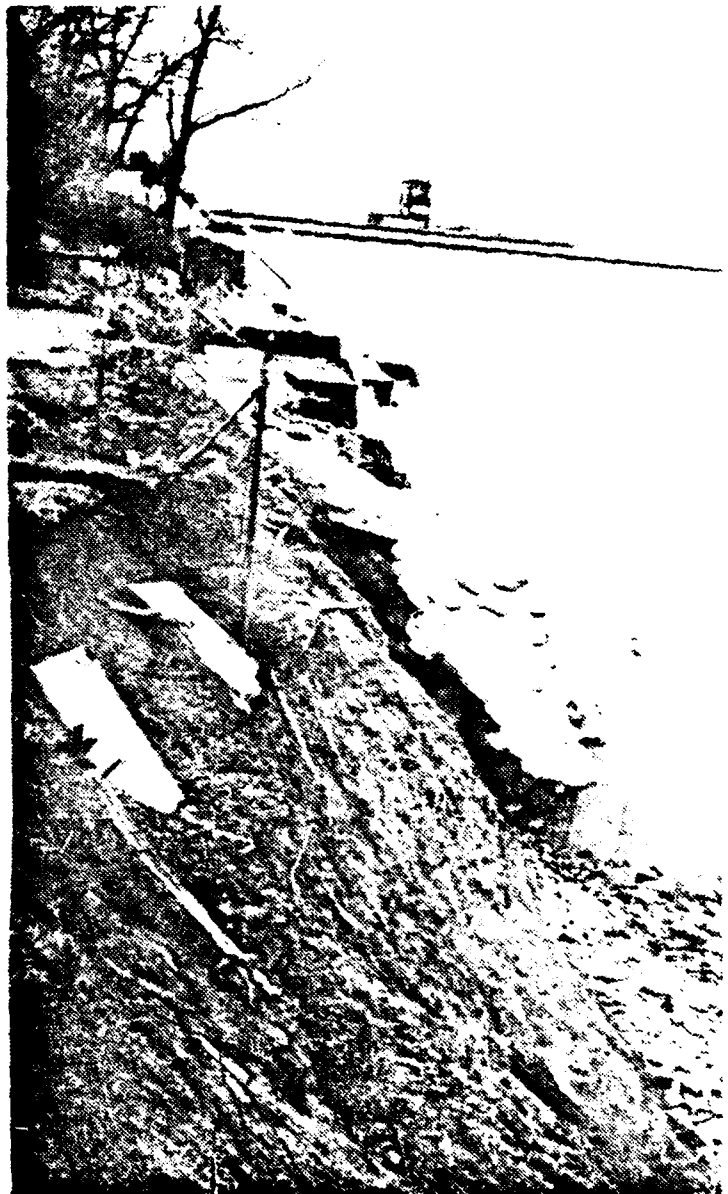
Figure 2A

Looking West along
Shoreline toward Spending
Beach Revetment
October 1979

Looking west from House Lot #739
Fall 1976

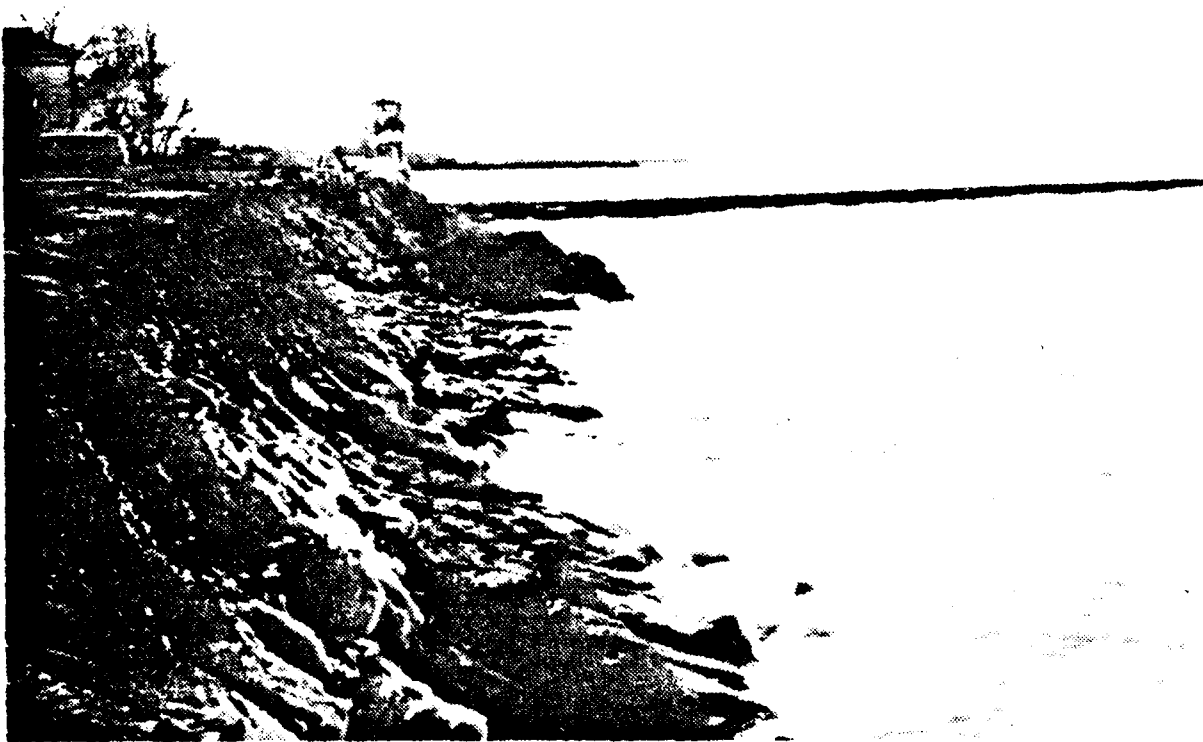
Figure 2B

Looking West from Colorado Avenue
Fall 1976

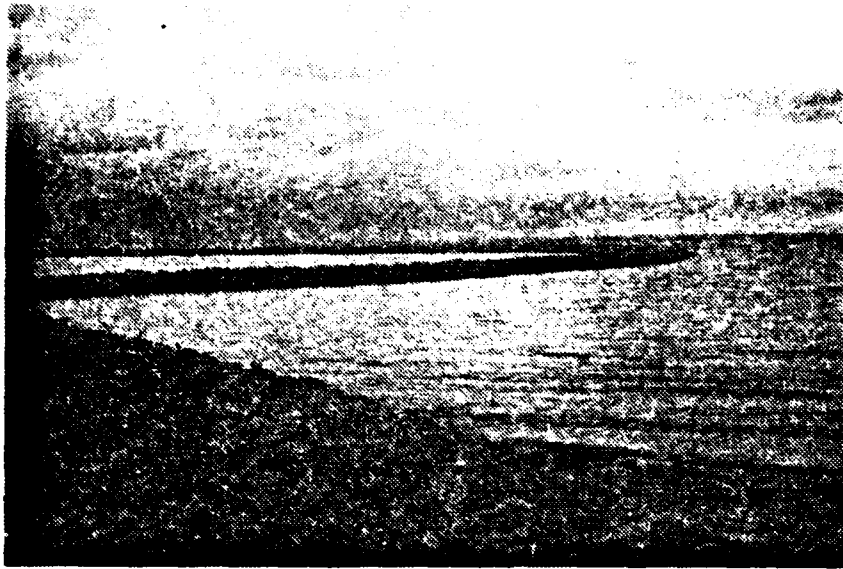
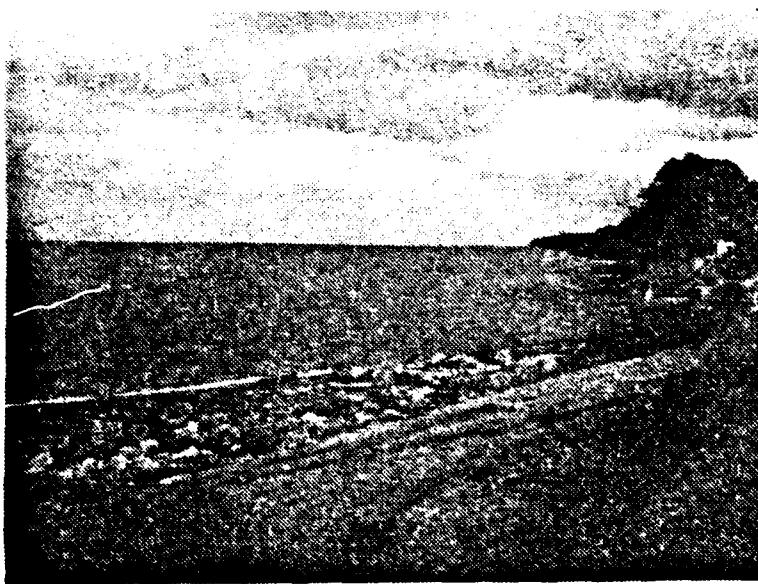
Figure 2C

Spending Beach Revetment and
Disposal Retention Dike
October 1979

Looking East from Spending Beach
Revetment, October 1979

Seawall Condition at the foot
of Idaho Avenue, October 1979

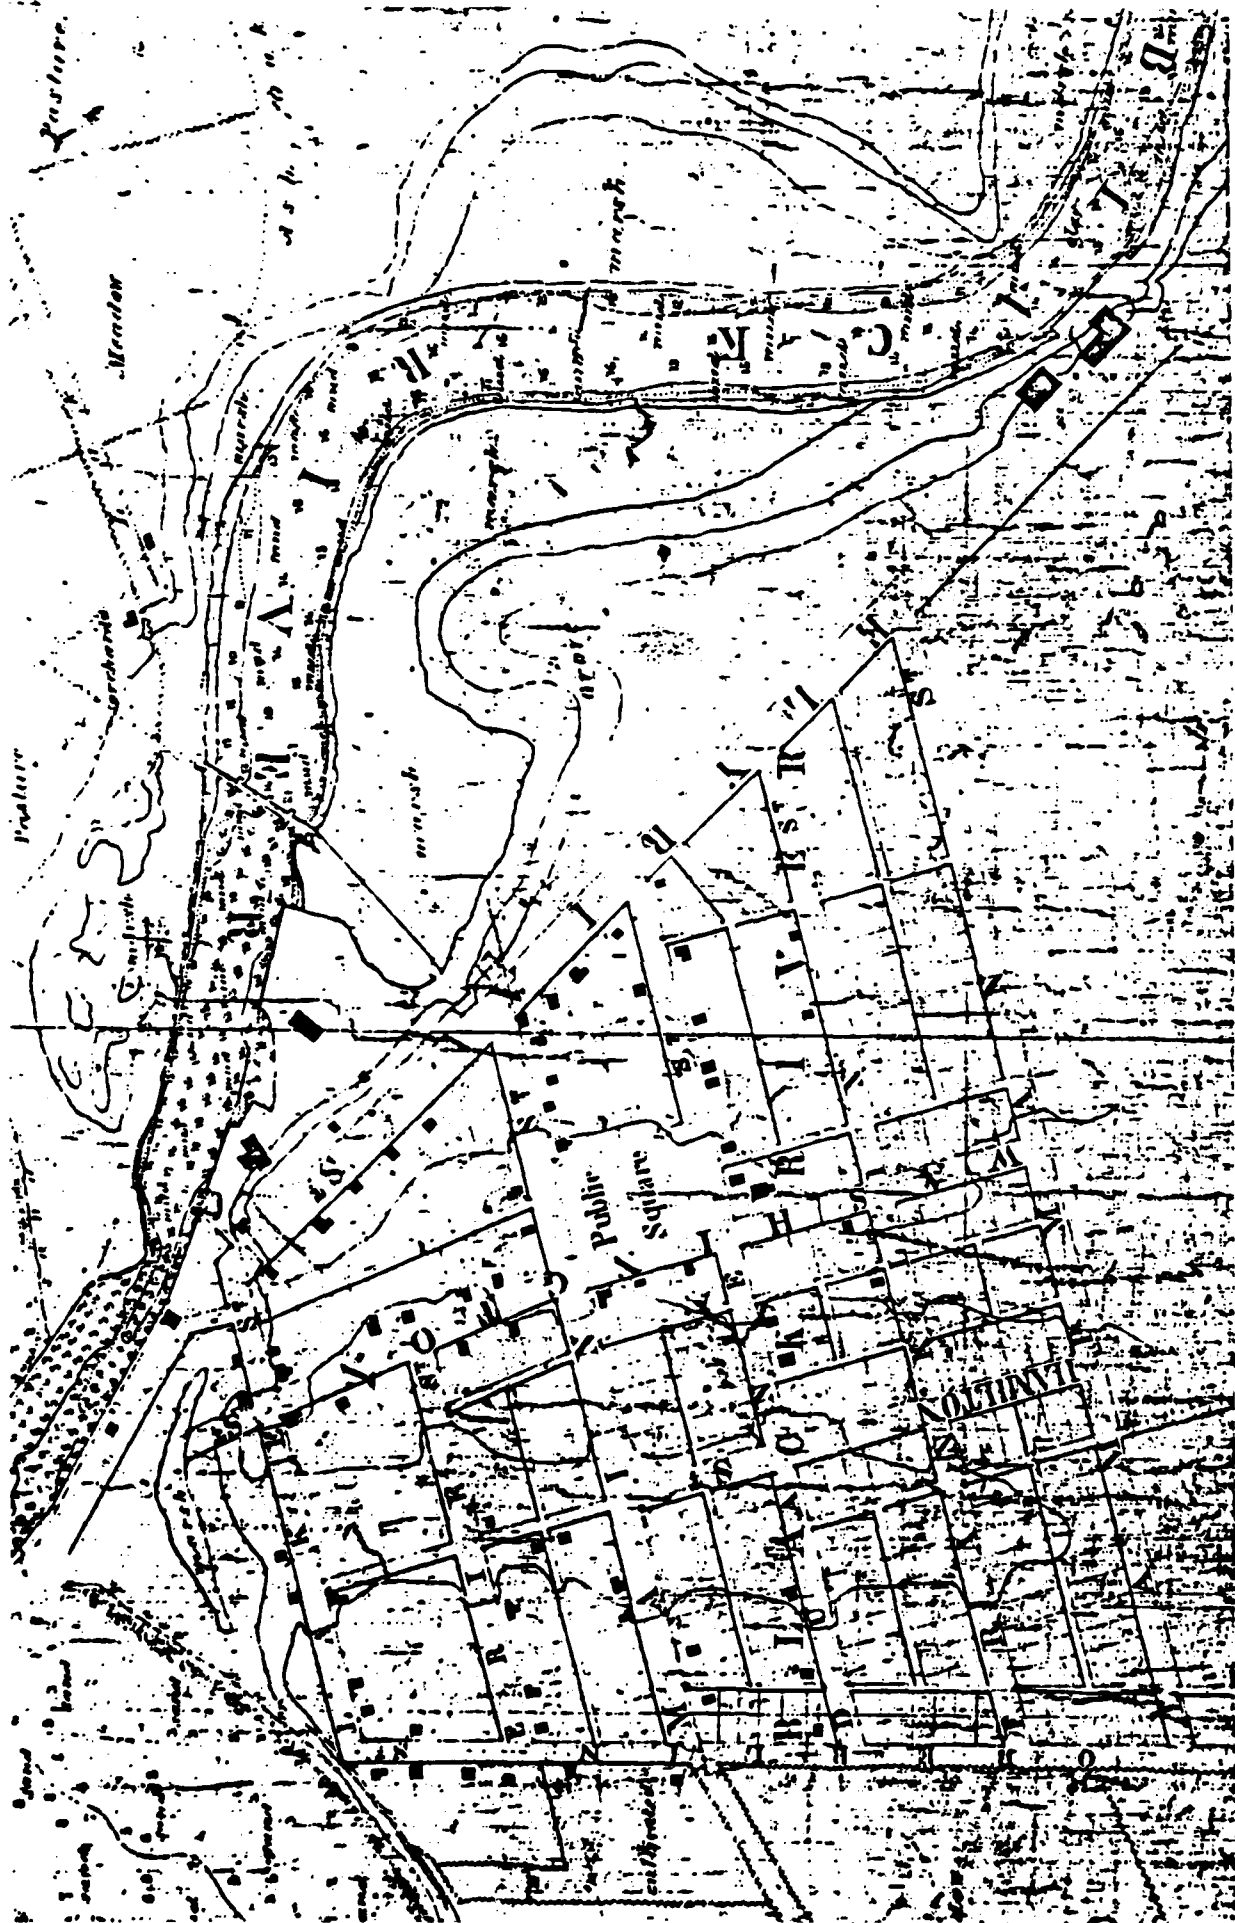
DUCED FROM: MAP OF THE
 R OF BLACK RIVER, OHIO 22 MAY 1865
 NY CORPS OF ENGINEERS

Black River (Charleston) was on the verge of becoming a ghost town when several businessmen realized the importance of the Black River harbor as a lake port for the export of coal from southern Ohio. The railroad was opened to Black River (Charleston) in 1872 by the Cleveland, Tuscarawas Valley and Wheeling Railroad, later renamed the Cleveland, Lorain, and Wheeling Railroad and now part of the Baltimore and Ohio Railroad system. At that time, there were less than 500 inhabitants in Black River, and the plat map of the village shows only a few blocks of structures situated on both the east and west side of the river near the harbor (Ref. 3). Figure 4 shows the project vicinity in 1865, which was identical to that shown on the 1872 map.
