DTNSRDC-82/082

## STRUCTURAL EVALUATION OF AN ADVANCED COMPOSITE HYDROFOIL FOIL COMPONENT

TEST AND EVALUATION REPORT

| REPORT DOCUMENTATION PAGE | | READ INSTRUCTIONS<br>BEFORE COMPLETING FORM |
|---|---|---|
| 20. ABSTRACT (Continue on reverse side if necessary and identify by block number)<br><br><b>An advanced composite foil test component (tapered box beam) was designed by the McDonnell Douglas Astronautics Company under contract to the Naval Sea Systems Command. Two identical box beams were fabricated for static and fatigue testing. Each consisted of two hybrid graphite epoxy skins bolted and bonded to three HY-130 steel spars. The box beams were tested at the David W. Taylor Naval Ship Research and Development Center to determine their structural behavior under a cantilever bending stress distribution due to a concentrated load, to establish a load versus stress relationship for the simulated sea load fatigue test, and to compare their response to cyclic loading with that of candidate metallic designs. In addition, initial flaws and</b><br><br><b>(Continued on reverse side)</b> | | |

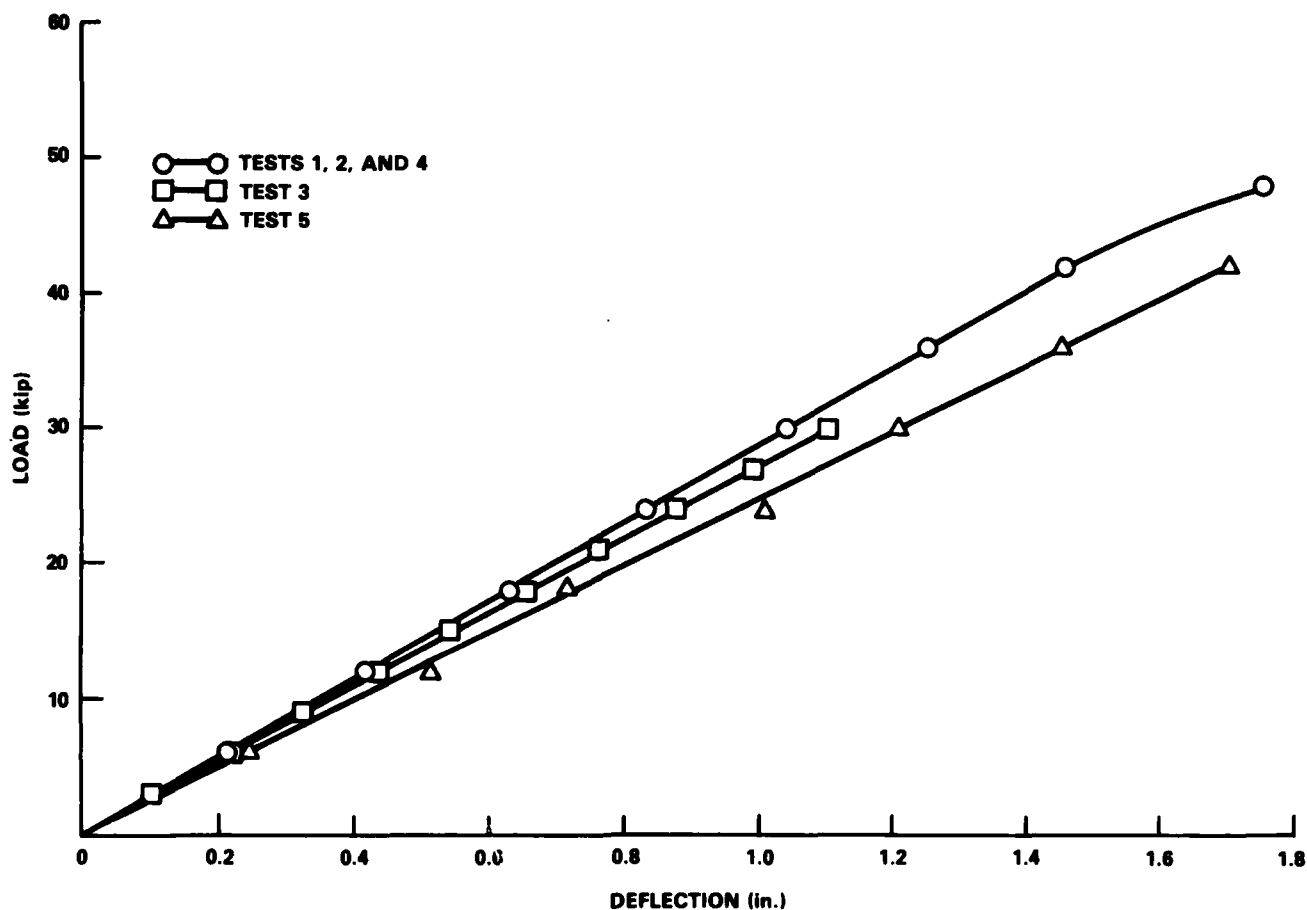
Figure 5 - Box Beam 1 Static Deflection Behavior

The tests performed on Box Beam 1 are summarized in Table 4. As noted therein, following test 1 run 2, all subsequent tests were on the box beam which contained internal delaminations. As described later, attempts to repair these delaminations without removing the hybrid composite skins from the steel substructure were unsuccessful. The load-deflection data for Box Beam 1 corresponding to various tests are summarized in Table 3, and are also plotted in Figure 5.
