NRL Memorandum Report 5699

# Cracking Resistance in a 4.5-inch (114-mm) Plate of 7075-T7351 Aluminum Alloy

December 12, 1985

NAVAL RESEARCH LABORATORY  
Washington, D.C.

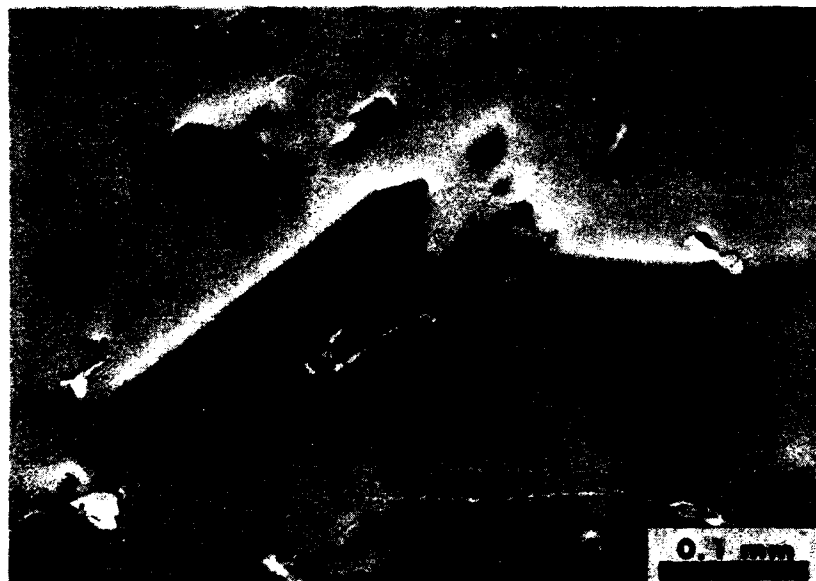
Fig. 7 - Large shrinkage cavity at plate midthickness location, as polished.

On infrequent occasions, defects much larger than the scale of constituent particle dimensions were observed. From their morphology, these appear to be rather gross shrinkage cavities - with dimensions as large as 0.016 inch (400  $\mu\text{m}$ ). It is difficult at this point to fully characterize the distribution of these very large cavities in the plate, as they have been observed in only three instances (all from the plate midthickness location) from among some two dozen or so metallographic samples. One of these shrinkage cavities is illustrated in Fig. 7. However, numerous other cavities similar in morphology but significantly smaller in dimension have also been observed.

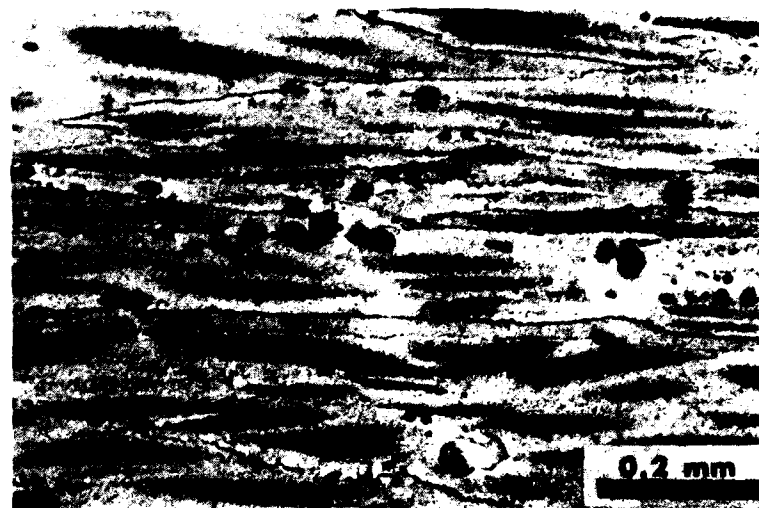
Fig. 9 - Microstructure as etched with Keller's reagent, plate midthickness location, T-orientation.

The microstructure, as etched with Keller's reagent, is shown in Fig. 9 for the T-orientation at the plate midthickness location.
